Mauao Awaiti Viewing Platform - Building Consent No. BC330131 - Ground Confirmation Statement

Site Visit Report N° 001

Project: Mauao Placemaking Project

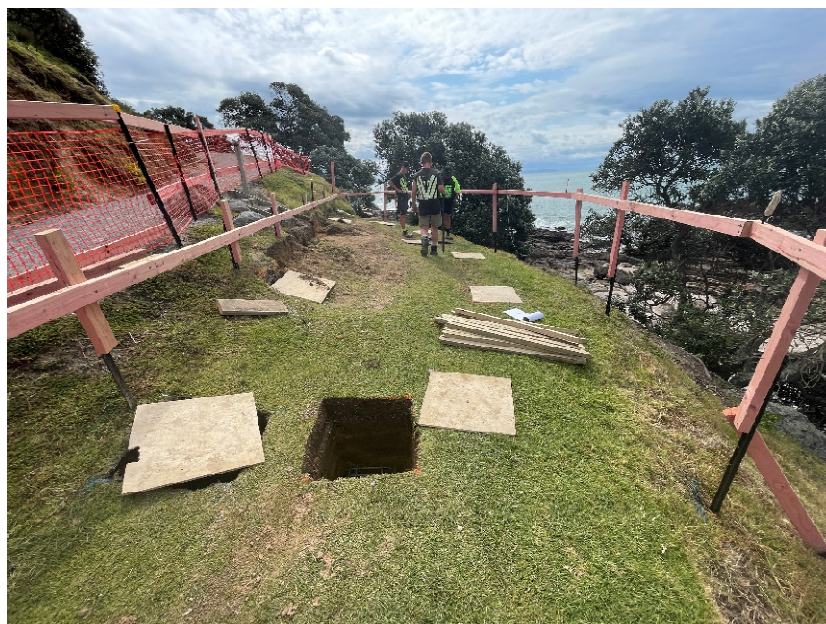
Figure 1: Overview of Site

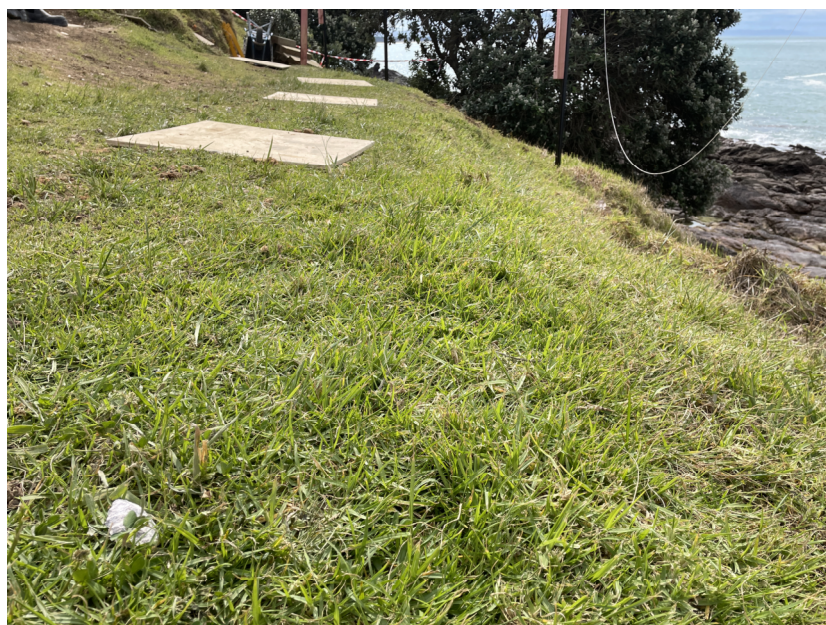
Figure 2: General Slope

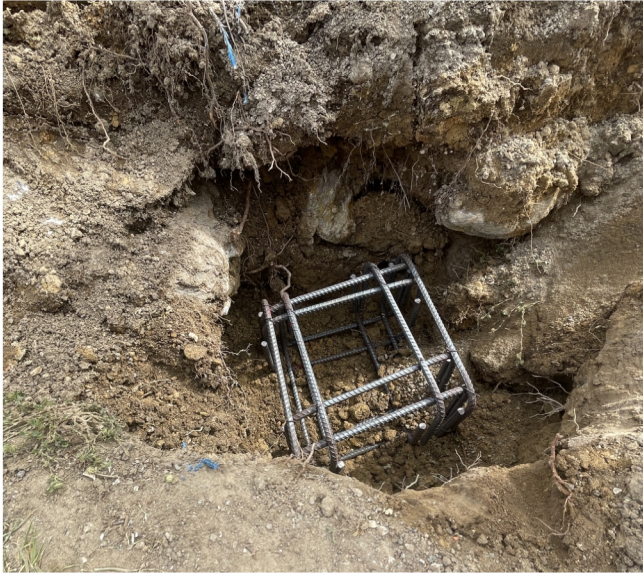
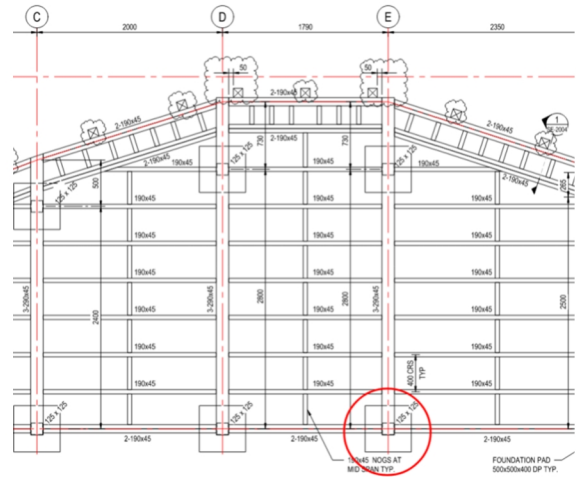
Figure 3: Hole with Boulders underneath

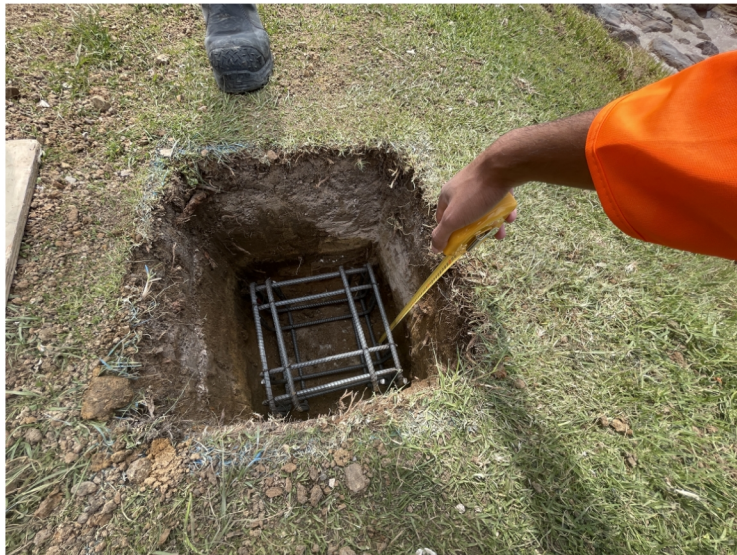
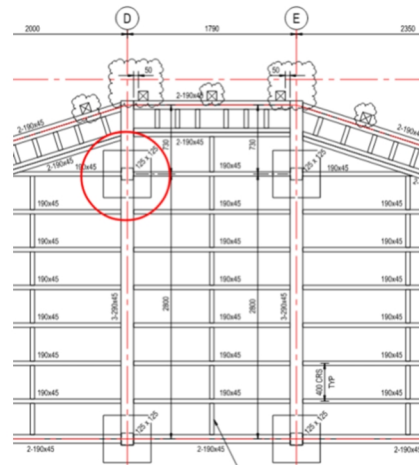
Beca has carried out a site visit during construction to inspect the ground conditions. A record of our site visit is included in Attachment 1. Dimensions and position of the foundations comply with the minimum requirements set out on drawing 4280807-SE-2005 Rev 0A except for one location on Grid D where excavation terminated 100mm above the target founding level. However, the ground conditions at this location where rock was encountered are more favourable than those assumed in design.

Comments made to/by contractor's representative: <ul style="list-style-type: none"> Contractor noted that the hole that was only 600mm deep (along grid D) could not be dug any deeper due to there being rock below. Contractor proposed to chemset reinforcing into the rock to mitigate lateral forces and therefore slips. Contractor noted that the soil material below the top soil was very hard and difficult to excavate Beca noted that subgrade testing was required as per note 3.0 on SE-2001 on the structural drawings. Beca noted that a construction methodology was required to be send to the engineer as per 1. on SE-2001

Figure 4: Hole only 600mm deep

- Contractor to provide subgrade testing
- Contractor to provide construction methodology
