To:	Tauranga City Council	Your fax no:	07 577 7099
Attention:	s 7(2)(f)(ii)	Job no:	3071
From:	s 7(2)(a) - Privacy	Reply fax no:	07 - 579 9702
Page:	1 of 34	Date:	21 August 2006
Subject:	Landslip Repairs, Waikorere Track, Mauao

Project: Tauranga City - Waikorere Track Repairs, Mauao

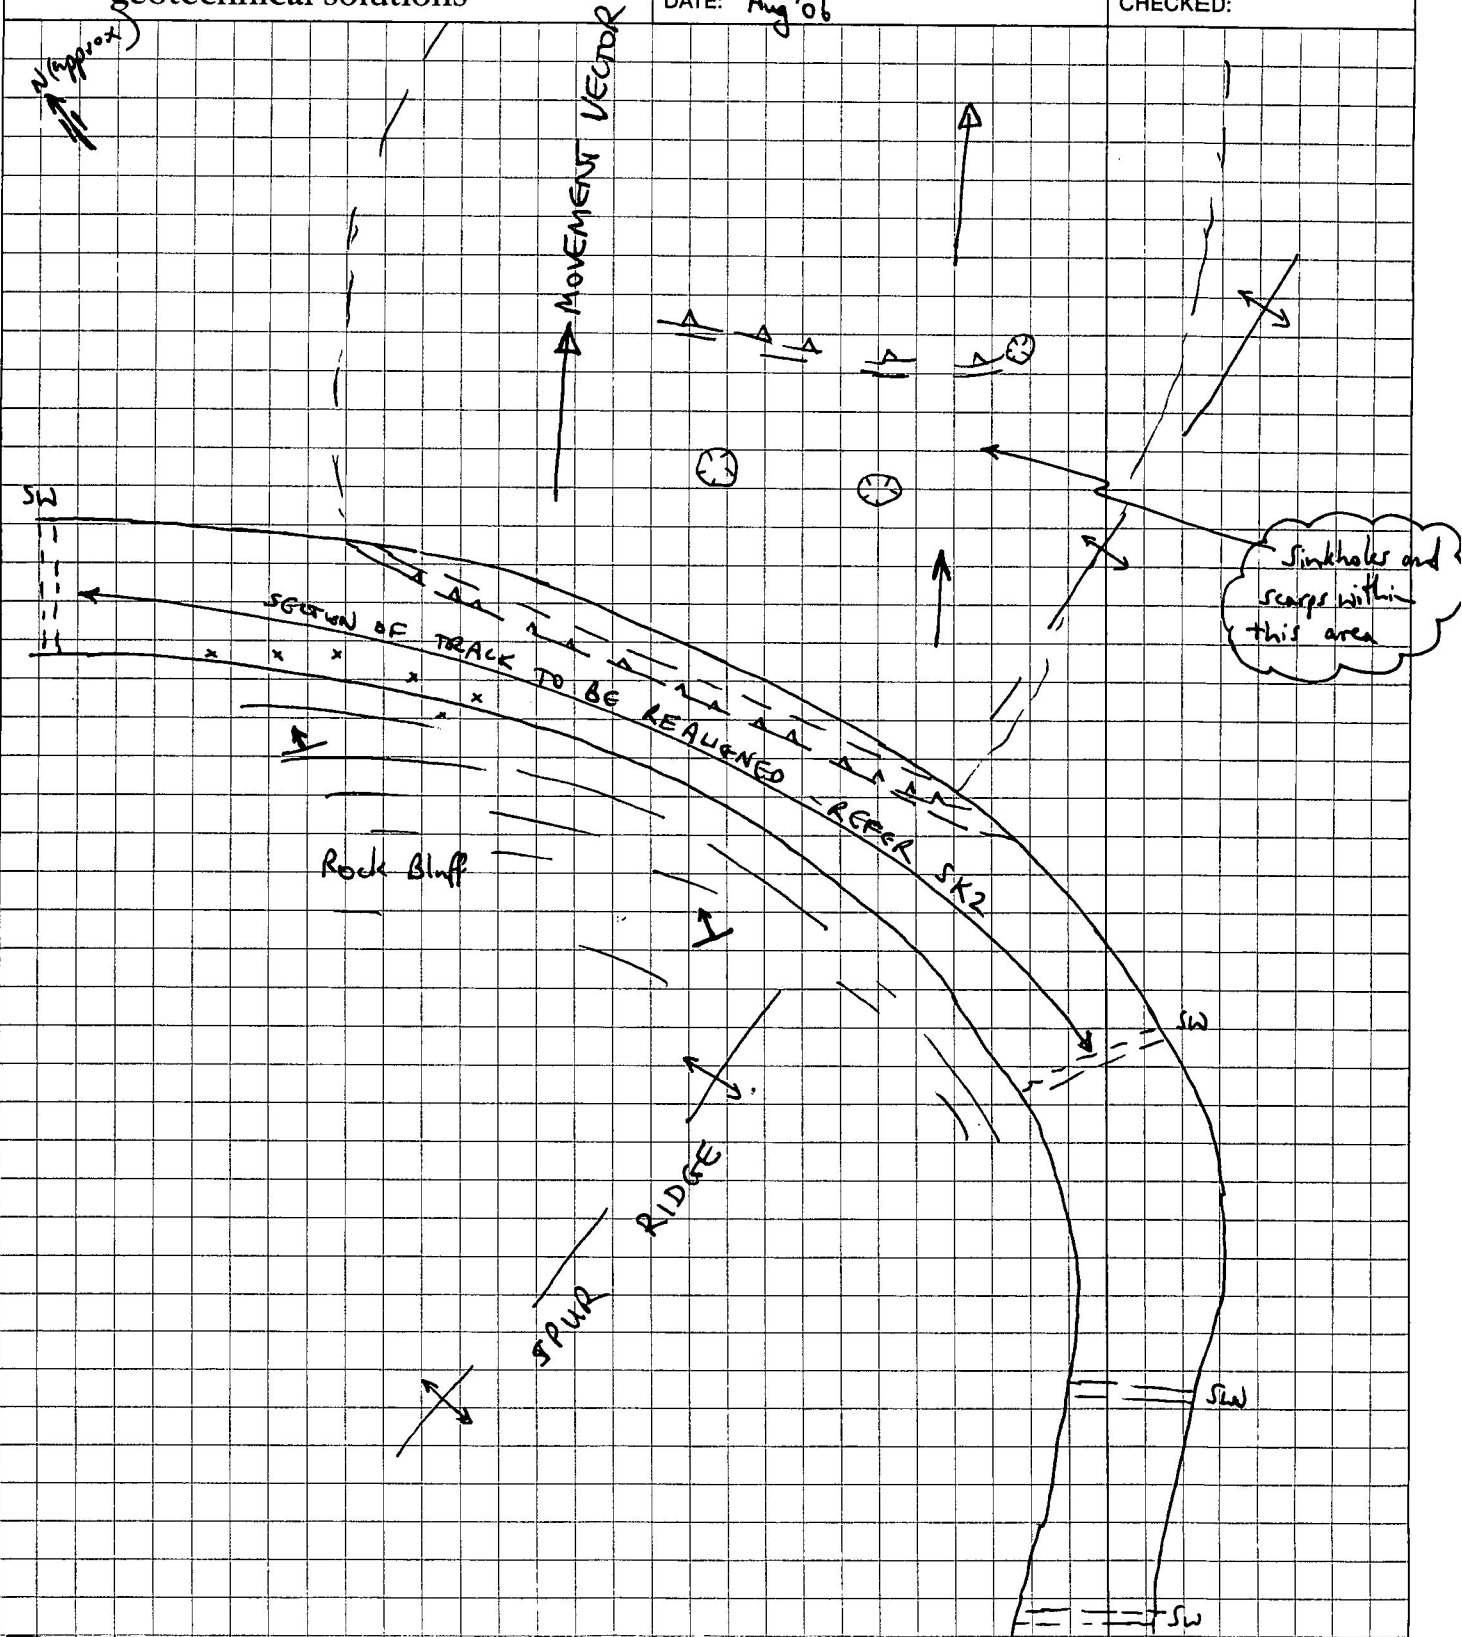
A section of the Waikorere Track has suffered incipient slippage, in the area below camp bluff. Tension cracking and incipient movement extends over a length of approximately 8 - 10 metres along the outside edge of the track. The movement to date is in the order of 100 - 250 mm.

The slip is occurring on a very steep slope. There is at least one other significant scarp within the landslip mass. The material affected appears to be a combination of the natural slope-wash, sandy silt soils and the side-cast spoil from the original formation of the track.

Several small sinkholes were observed within the general area, indicating there are small cavities being formed by infiltration seepage along the soil-rock interface, washing out the very erodible silt soils.

The proposed approach is to lower the track as per attached sketch details SK1 and SK2.
