Frame Group Limited

Tauranga City Council
Private Bag 12022
Tauranga

9th June 2006

Re: Review of Mauao Base Track Surfacing and Stability**1. Executive Summary**

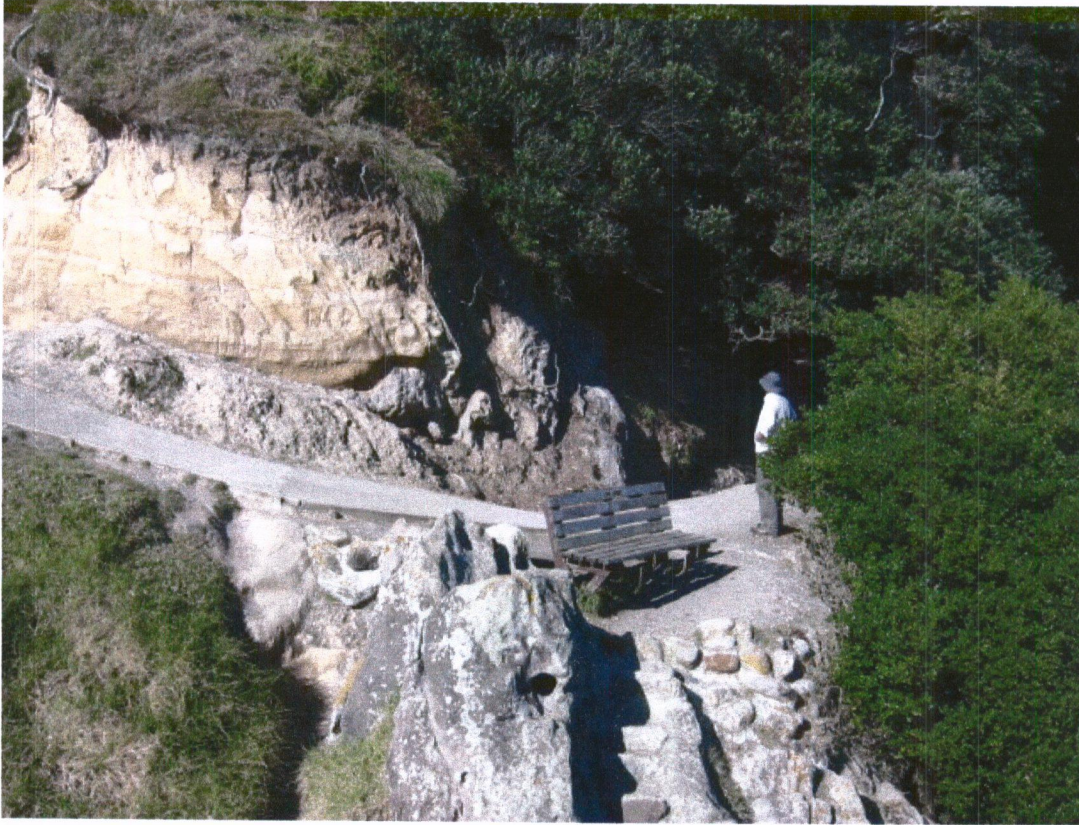
The steep concrete section of track at the NW Rock has a gradient of 25%. There is a high slipping risk on this concrete section, especially when loose gravel spills onto the concrete from the track above.

Short sections of track with 25% grade represent a slipping hazard
Grade could be reduced by filling bottom of steeper sections

Correction of the steeper gradient sections of track is relatively easy on all sections of the Base Track where a current gradient of 17% is exceeded.

This simply requires the filling of the low points with suitable fill material. It is acknowledged that cutting into the batters beside the track or excavating below the existing track level to obtain fill is unlikely to be acceptable on Mauao. The surplus slip material removed from Mauao after the May 2005 storm could be brought back onto the site and used for filling the track to reduce the gradient, provided the material is fairly dry at the time of placement and does not contain excessive amounts of organic material. Grade correction to reduce the steep grades is best carried out by surveying the existing track profile and then using simple geometric design methods to determine the depth of fill needed to achieve the required gradient. At the concrete paved area at NW Rock, the existing 25% grade could be reduced to 17% maximum by adding approx 1.2m depth of fill at the base of the steep slope. Where necessary this fill material would be retained at the outside edge with a stone retaining wall to match the other stone walls on the site.

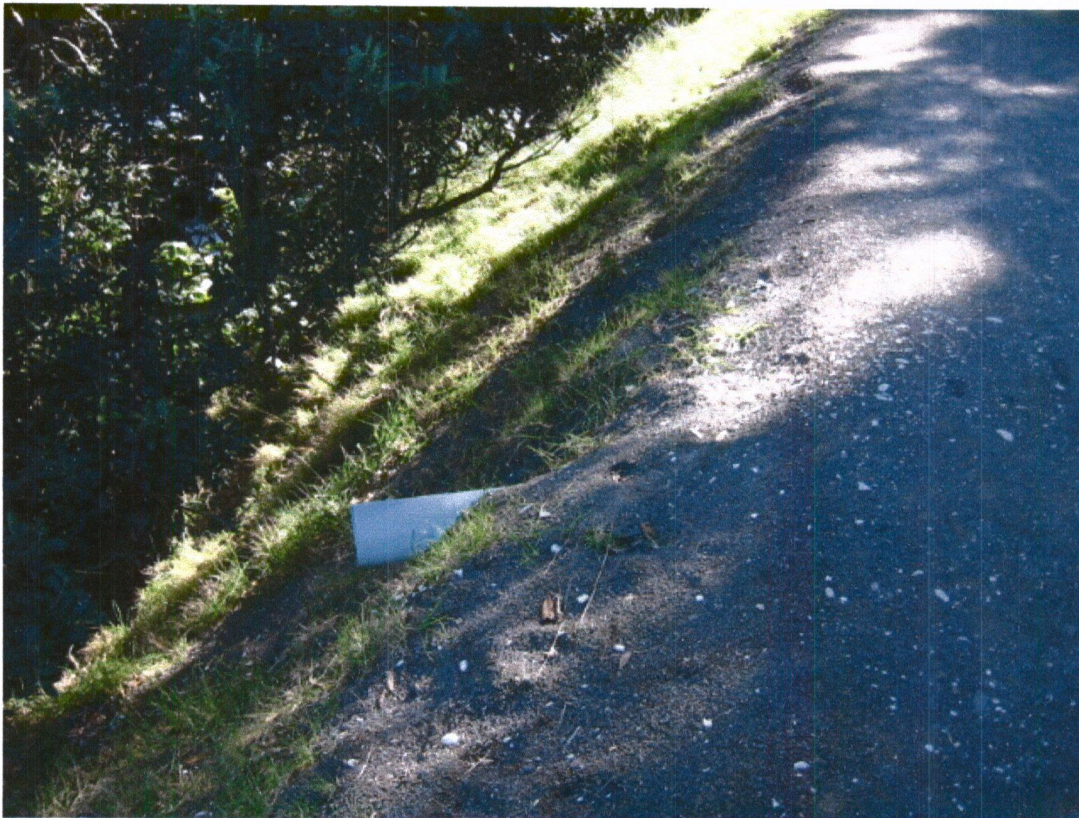
Projecting culvert pipe outlets encourage slope erosion
Note the surplus track surfacing aggregate that has migrated off the track

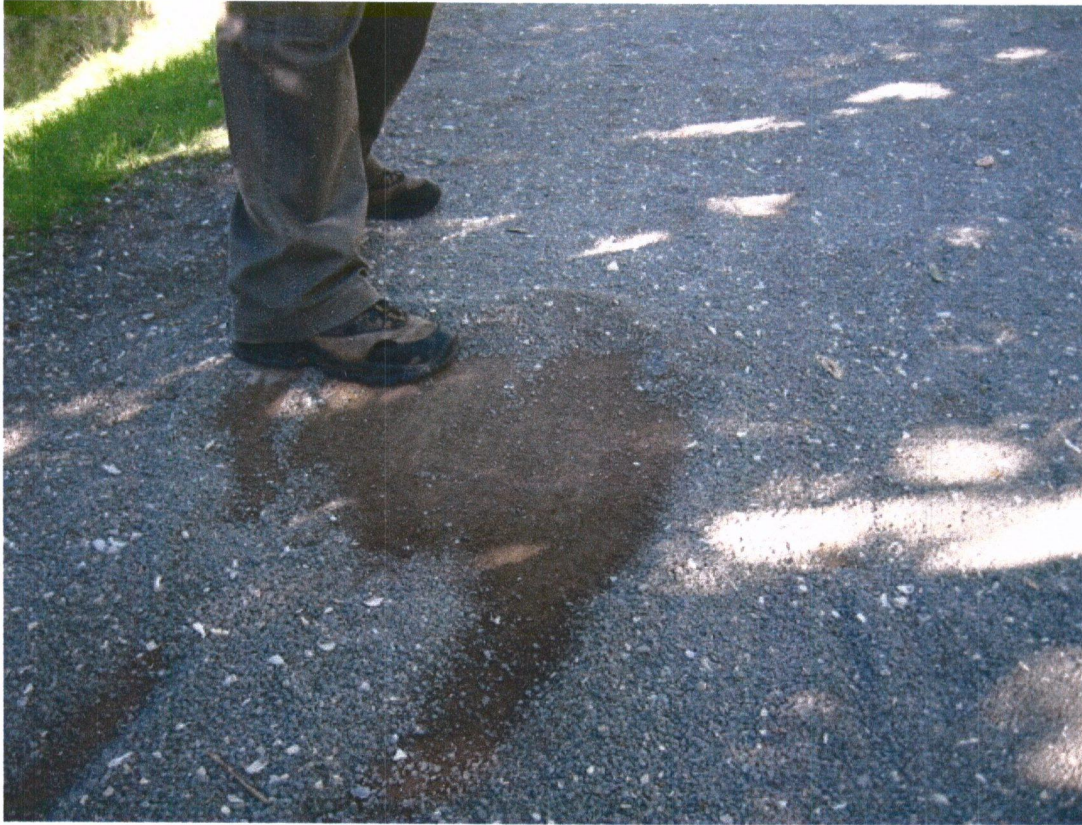
Currently the Base Track pavement is characterised by a layer of loose, unbound gravel consisting of particles in the 5mm to 7mm range. A large amount of this material litters the ground at the sides of the track and has been washed off the surface in places where water has flowed over the track. It is probable that as much as 50% of the aggregate that was applied has, in the 12 month period since application, migrated off the track and is wasted. This particular greywake aggregate is poorly suited for walking track paving. It is likely that this aggregate is produced as a free draining filter material for building work rather than as a pavement material. The loose gravel surface has probably been a significant factor in a high recorded number of the injury incidents caused by slipping.

Loose aggregate on track surface represents a slipping hazard
A "well graded" aggregate would provide a better bound surface

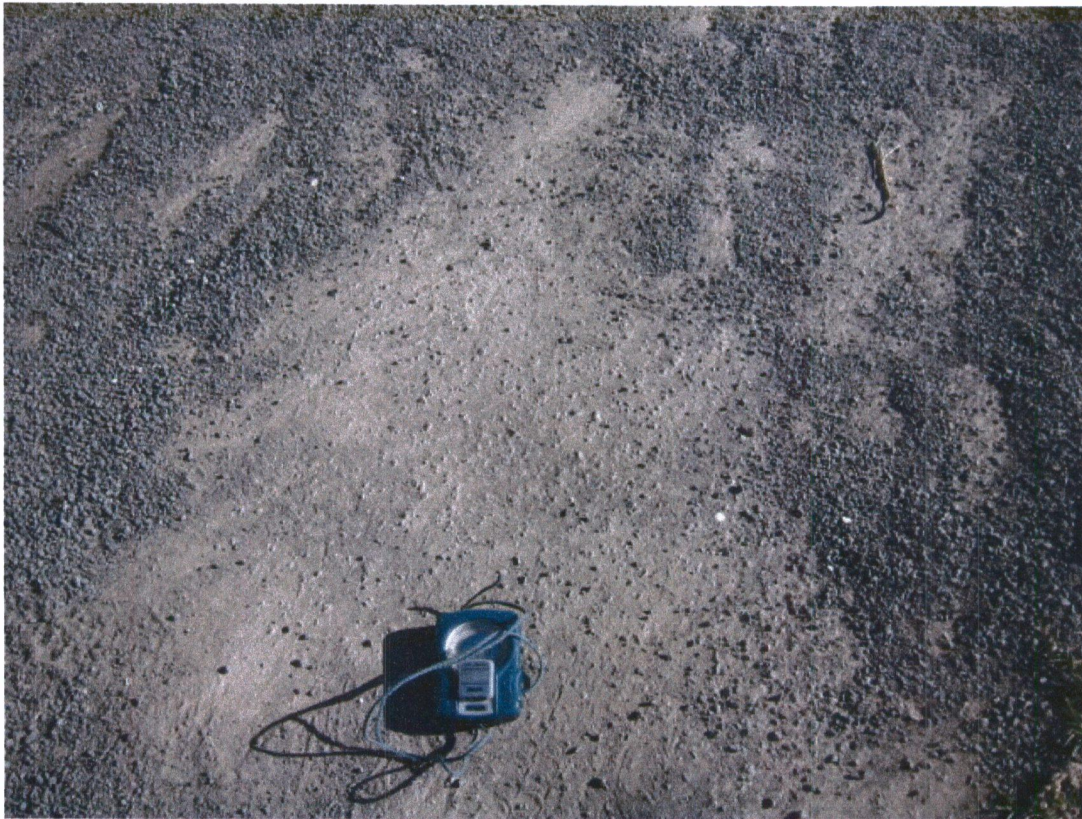
The small amount of fines that was present in the aggregate has been washed to the bottom of the layer and in some places has bound with the larger aggregate below. In these places, sweeping away the loose gravel reveals a well bound track pavement. This has a much better skid

A suitable bound walking surface below the loose gravel
Sweeping the existing track is recommended

resistance in dry conditions than the loose gavel surface. Where larger aggregate particles are appearing on this well bound surface, the skid resistance is likely to be good in both wet and dry conditions. Hence, sweeping the loose aggregate off the track is recommended on all sections where the gradient is greater than 8% and in other locations where it exists as a thin layer over a compacted base. This swept material should be retained in stockpiles for future blending and use as surfacing.

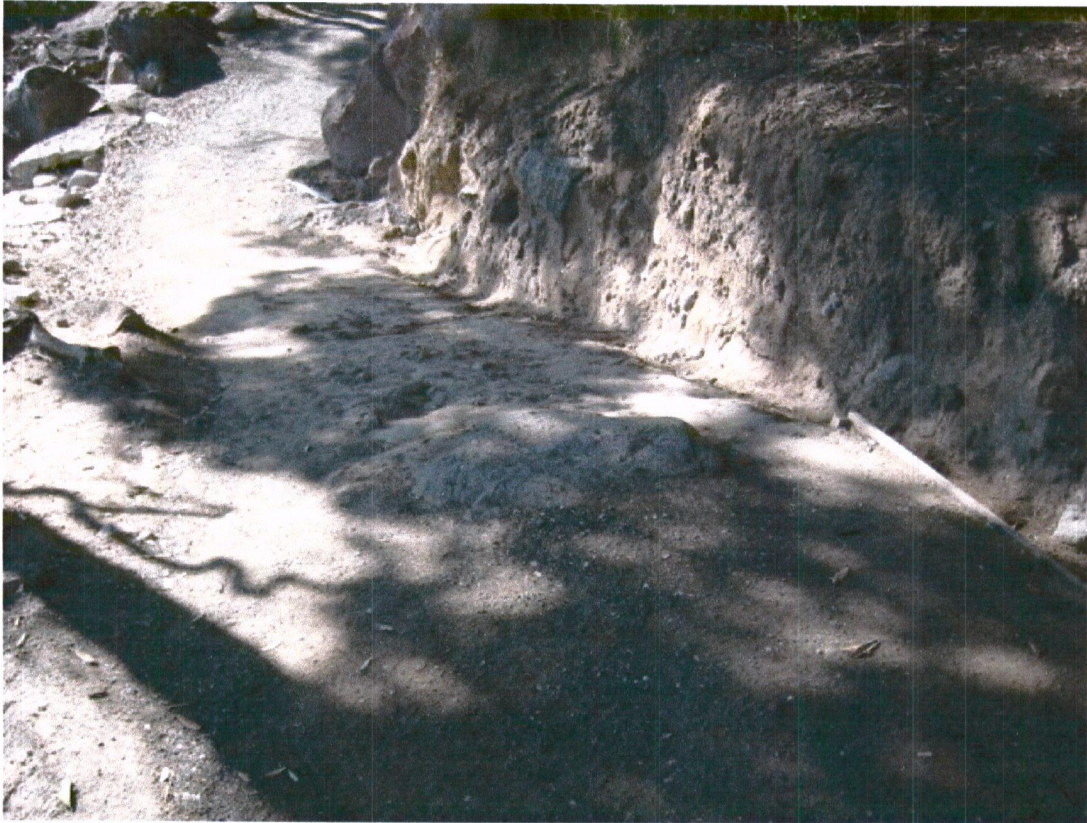
Any aggregate track surface will erode over time. This is because of losses of material from foot traffic wear, water erosion and wind erosion. On tracks that have a high level of foot traffic, the loss of surface material could be 50mm or more of depth per year. This loss is evident on some of the steeper sections of track where large rocks provide a reference to track level. The loss of surface will be faster when the track surface aggregate consists of poorly bound small gravel particles. On tracks that have very high foot traffic numbers, the only way of overcoming the loss of surface material is to provide a hardened track pavement such as asphalt, concrete, chip seal or paving blocks.

Foot traffic wear of the track surface, especially on steep sections
Provision of an asphalt surface is the best long term low maintenance option

- **Asphalt:** Provision of a hardened track surface is likely to become necessary in the medium future if the pedestrian numbers on the Mauao Base Track continue to increase. Asphalt offers a versatile and durable pavement surfacing option for the Base Track in the long term. It can provide a wear resistant waterproof surface that has good slip resistance and is easily repaired in the event of storm damage or tree root movement. The key advantage to the Council from providing an asphalt surface would be a significant reduction in maintenance costs. The benefit to users would be a safer and more pleasant walking surface. An asphalt surface would be more suitable for wheelchair use than the current aggregate surfacing. There may be some public resistance to the use of a hardened surface on Mauao, however any adverse comment is likely to be offset by the favourable response from most users of the Base Track who appreciate the better walking surface. Any installation of asphalt or other hardened surface should not be carried out until the grade correction and drainage issues are first dealt with.

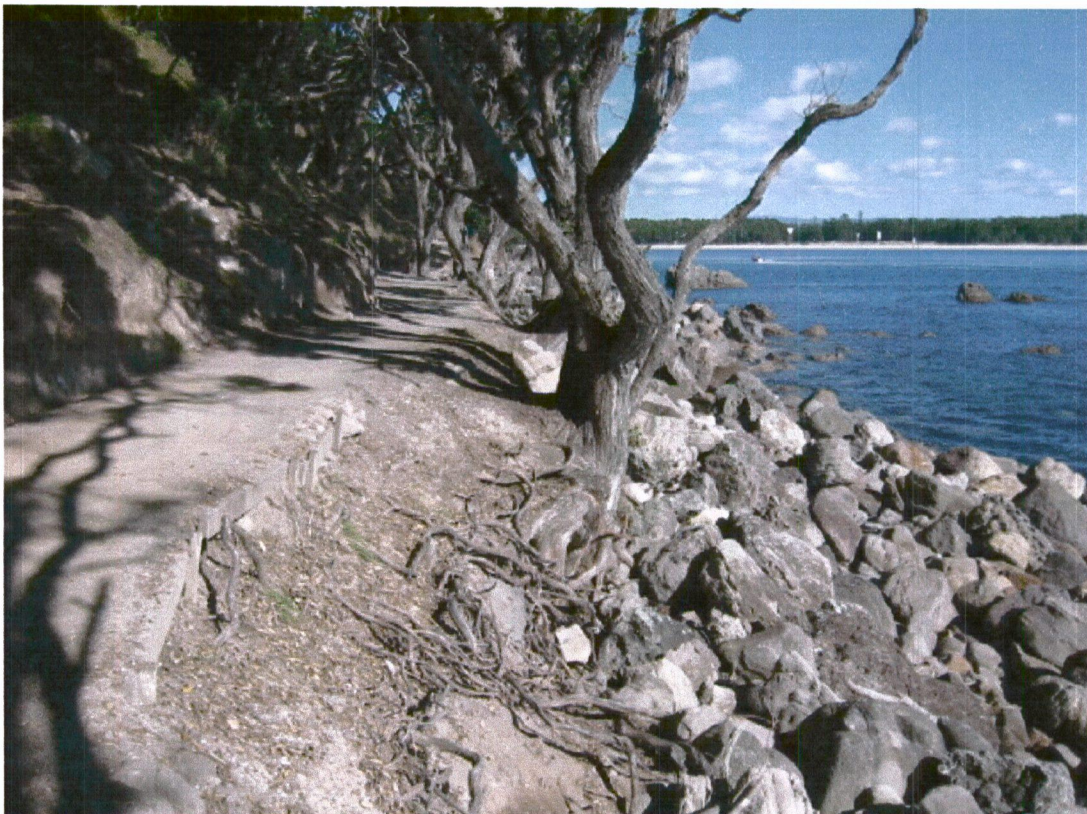
A section of track between NW Rock and North Rock follows the high tide margin closely and consists of an eroded soil edge above a rocky intertidal zone. The shore edge is characterised by mature pohutukawa trees with exposed roots over the eroding ash at the toe of the slope. In places the track bench is undercut by up to 500mm with a risk of partial collapse of the track formation.

Coastal erosion and track undercutting from wave attack
Armouring of the high tide line with local rock recommended

The rate of erosion of this exposed coastal section could however be slowed by carrying out non intrusive armouring of the exposed toe of the ash slope. The intertidal zone in this location is littered with large rocks that have rolled from the upper slopes of the mountain or have been dislodged from the base of the slope. We believe it would be possible in calm sea conditions for an excavator to access this section of shore by working from a barge. This would be used to re-locate some of the shoreline boulders to the high tide line where they can be backfilled to provide protection to the pohutukawa tree roots and reduce the rate of track bench erosion. An excavator of 30 tonne size fitted with a long reach boom and a rock grab is
