25 June 2020

Mauao - Additional Works Optioneering

2-9b463.02

Site Inspection Photos

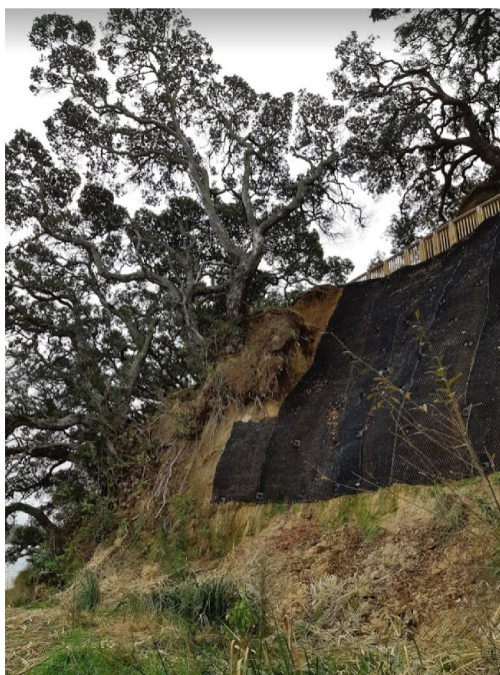
Figure 1: Location of tree is at the western end of the recently repaired section of the base track on the southern side of Mauao.

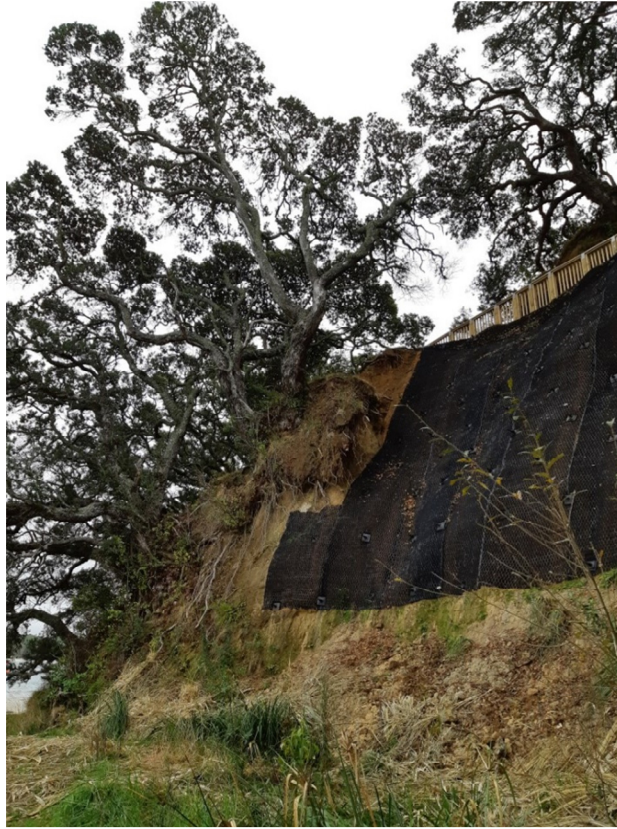
- It also appears that the trees are supported by the slope at the base and there are large roots visible extending above the trees into the soil however on the western side there are many small diameter roots which appear to have little support and are overhanging the slope.

Photograph 1 - Photo of tree and exposed lower roots

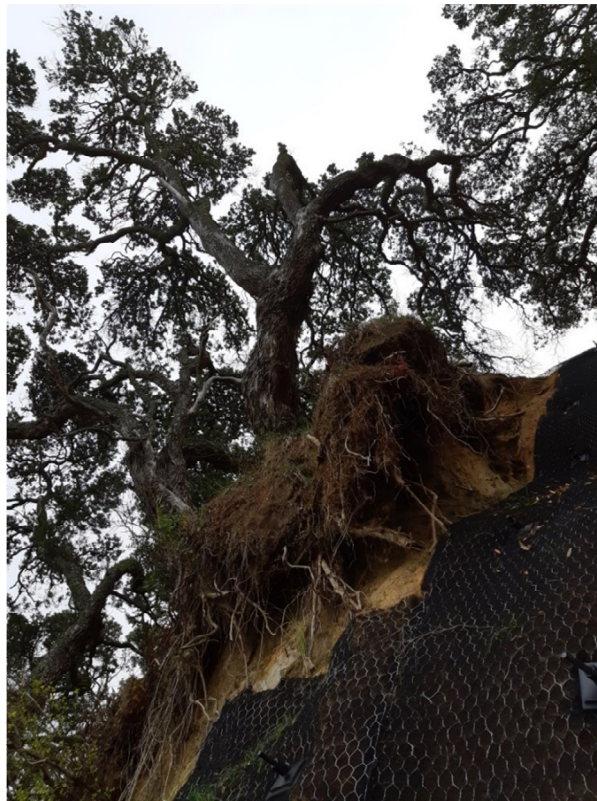
Photograph 3 - As above close up

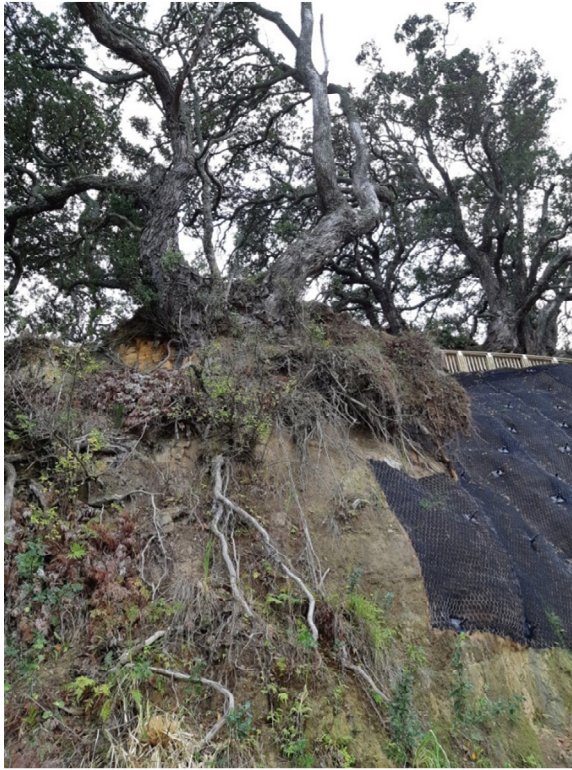
Photograph 4 - Front of promontory

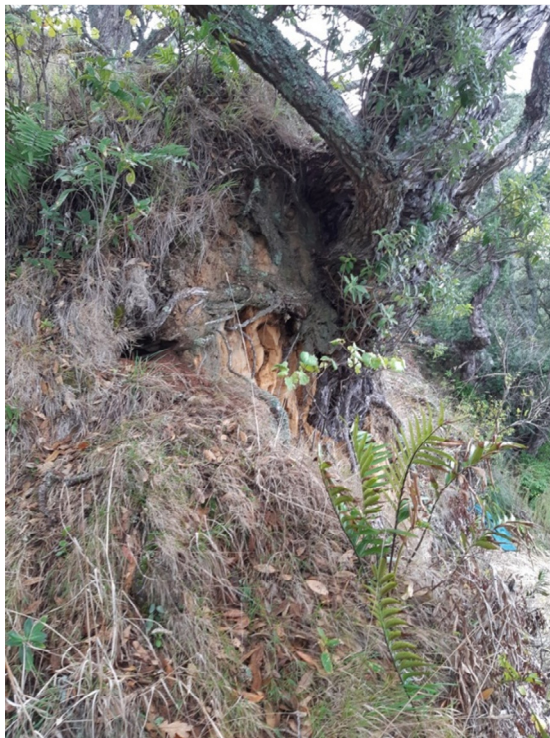
- The base of the promontory predominantly comprises a hard-brown ash typical of Te Puna Ignimbrite and below the base of the Pohutukawa tree are interbedded layers of hard volcanic tephra (Matua Subgroup).
- The soil supporting the tree appeared to be hard and weakly welded on the surface where exposed.

Photograph 5 - Hard bedded tephra surrounding tree

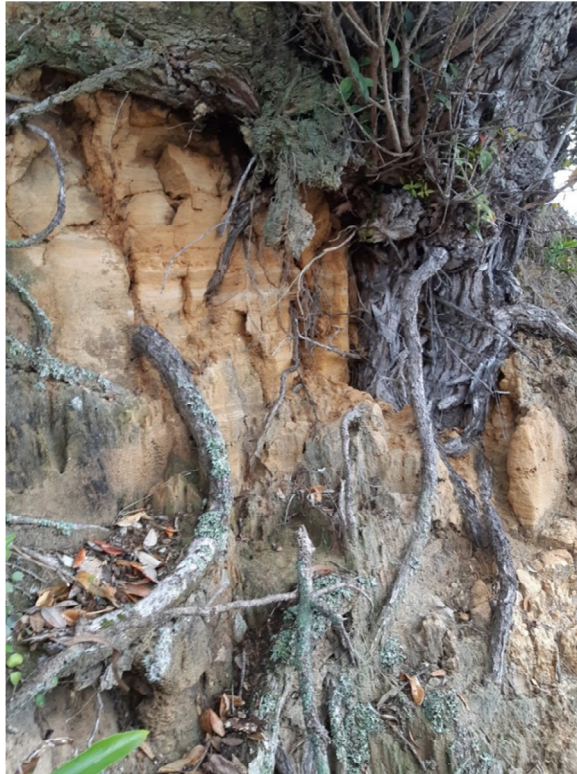
Photograph 5 - Close up view of soils supporting tree

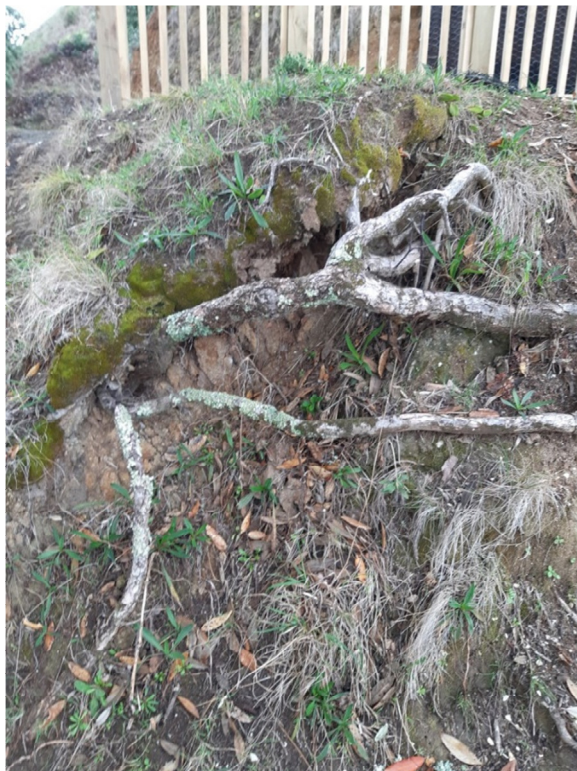
- The tree comprises two main trunks which have diameters of approximately 0.8 to 1.0m respectively.
- At about 2.5m from the site fence there is a 1.2m vertical drop down to a flattish terrace which the tree is sitting on. The terrace is bounded to the east by the slip scarp of the original slip which occurred in 2017 and by the original slope to the west.

That said, if a failure occurred along a tension crack at the top of the lobe where it drops down 1.2m, then the current track would still be approximately 2.5m away from the failure surface, however a larger, deeper failure surface may still be possible which could encroach into the current track alignment. We have sketched these scenarios on the attached annotated drawings C01 and C22. Although it is hard to predict the depth of the failure surface, we believe failure surface B which could affect the track would be much less likely than A.

Photograph 6 - 1.2m scarp at top of promontory

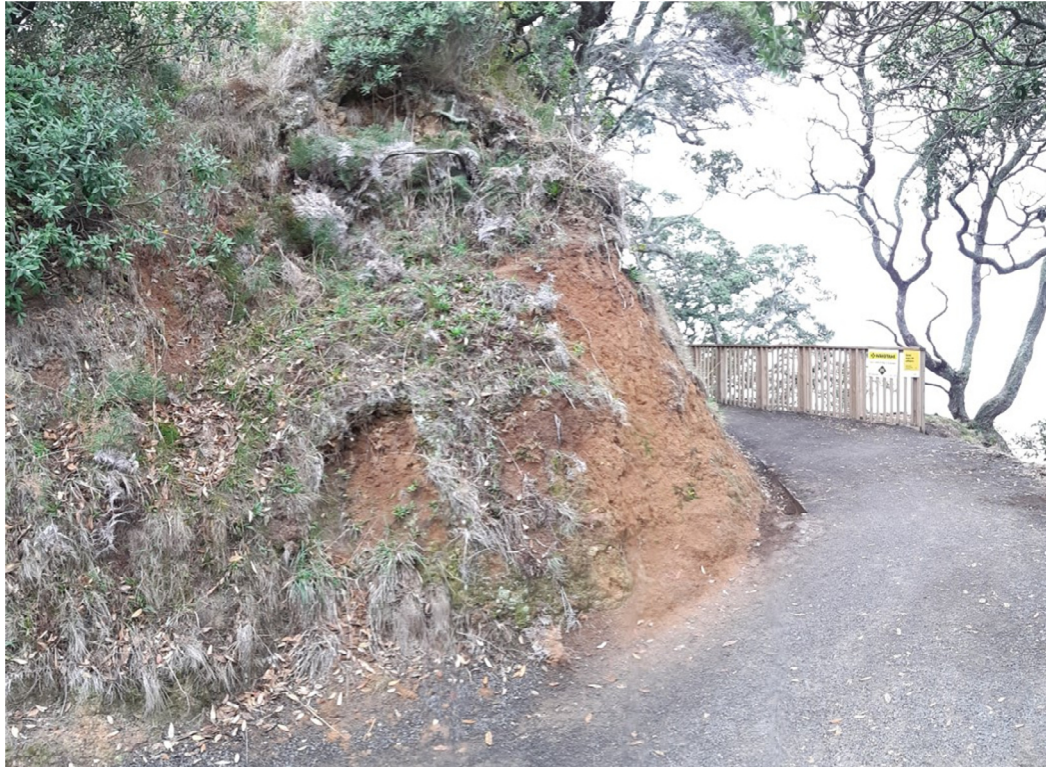
Photograph 11 – Bank opposite promontory

This option would involve trimming the bank opposite the location of the promontory. This would enable the track to be moved further away from the tree location outside the influence of a future slip. This option would be a medium cost option and would require consultation with stakeholders and the closure of the track while the work is undertaken. Also, consideration of where the soil could be disposed should be given for this option.

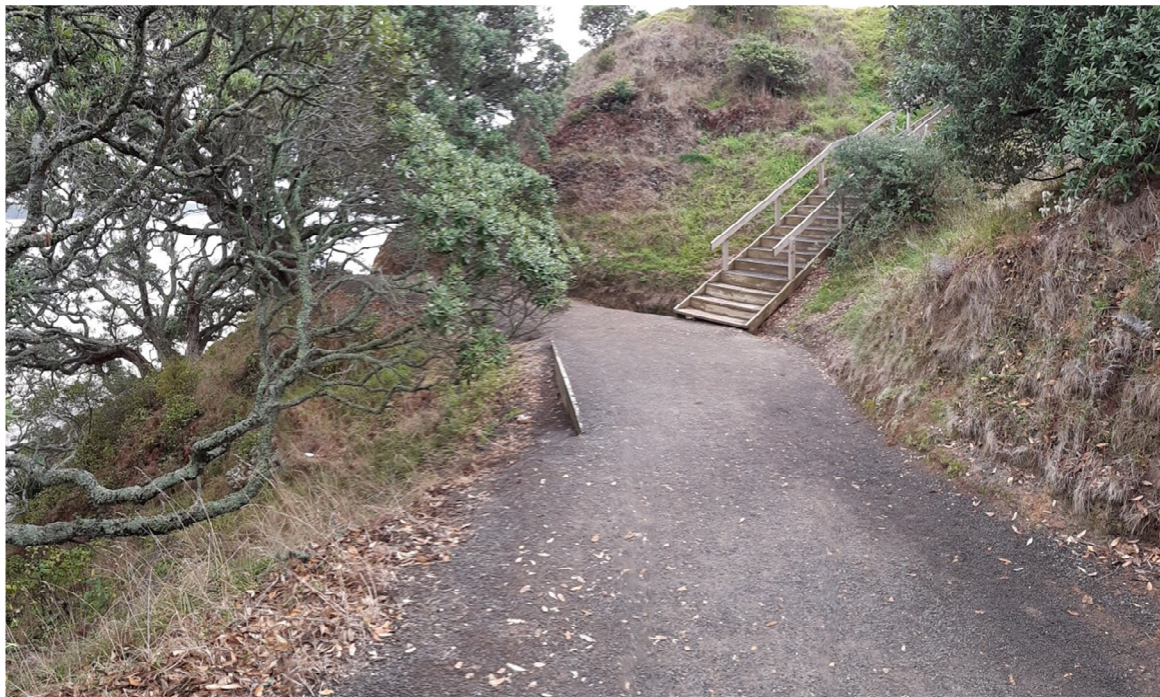
Photograph 12 – Gully to the west

As per our previous memo dated 26 February 2020 regarding the cracking observed on the western side of the slip repair we would recommend the installation of bored drains below the track to mitigate pore pressures building up in the slope. The drainage would need to be designed and the stability of the gully modelled to determine the effectiveness of such drains.

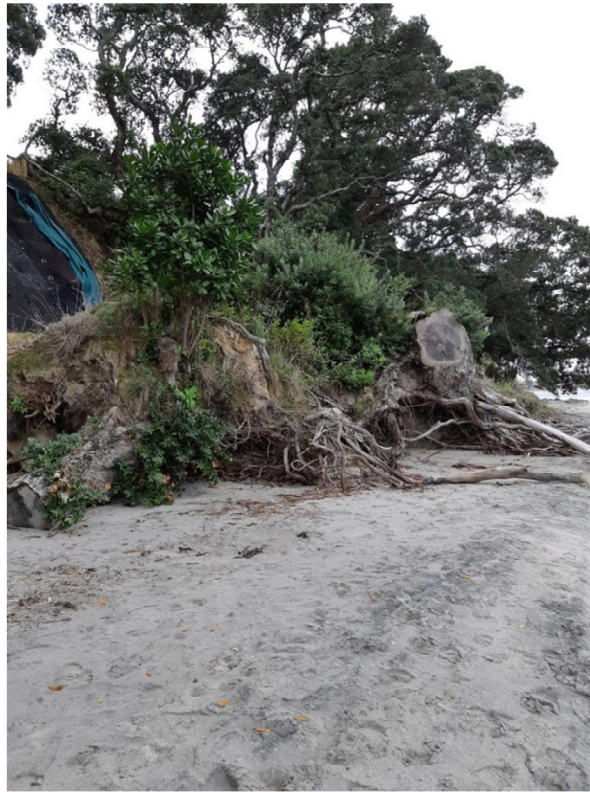
Photograph 13 - Failed Pohutukawa on Foreshore
