**Archaeological Site Condition Monitoring
Report
Mauao Historic Reserve, Tauranga**

20 August 2018

Prepared for: Tauranga City Council
P O Box
TAURANGA

Prepared by: InSitu Heritage Ltd.
P O Box 710
WHAKATANE 3158

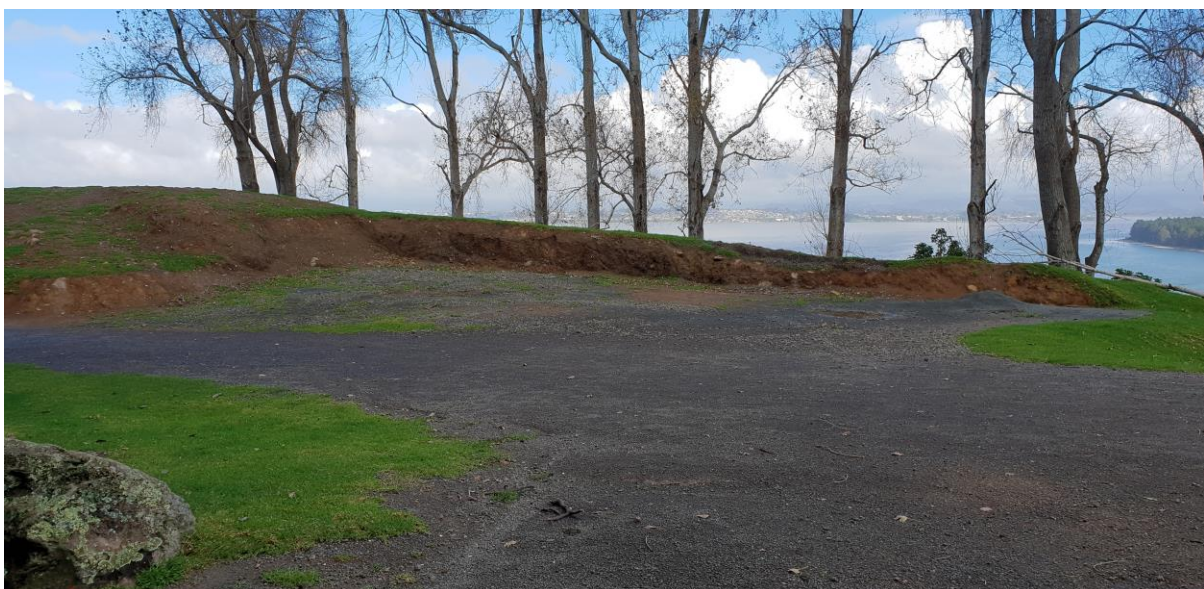
December 2017 – Archaeological monitoring of the removal and repositioning of the slip debris spoil heap near the water reservoir; this included the removal of material that had been recently dumped adjacent to the 4WD track. There was no impact on any intact archaeological features. During the same visit repairs to a retaining wall in the motor camp were also inspected and a work plan was made to ensure that there would be no impact on intact archaeological features.

Figure 3: Slip debris spoil stock pile after restacking and shaping (InSitu Heritage Ltd April 2018).

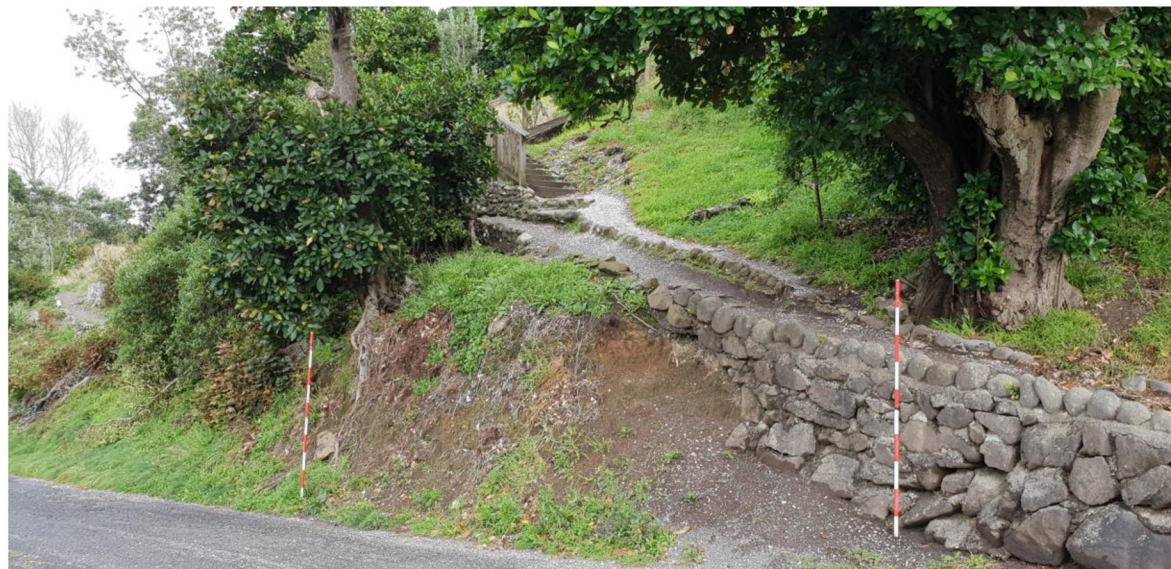
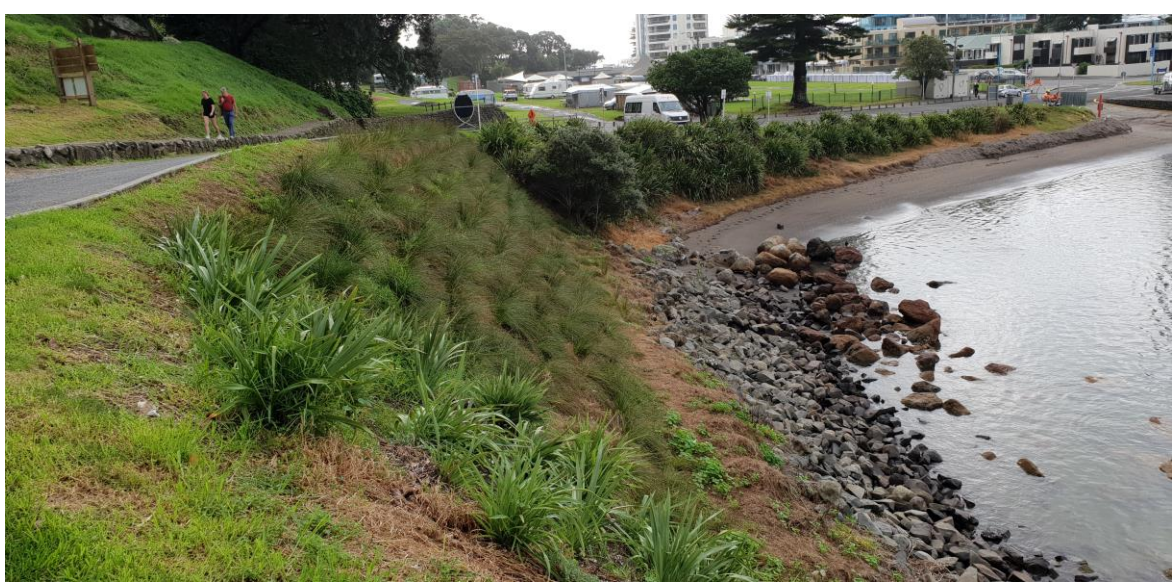
Monitoring point 1

Description: Stone Jetty surrounds – stone walls

Notes: Recent vegetation clearance completed. Constant on-going minor erosion of midden evident. Suggest that it is monitored for 2 years to see if we can establish if intact midden is eroding or whether it is previously displaced shell that is washing off the track surface. The stone jetty itself is stable, it would be good to establish the antiquity of the associated stone walls in this area and establish how much pre-1900 fabric remains.

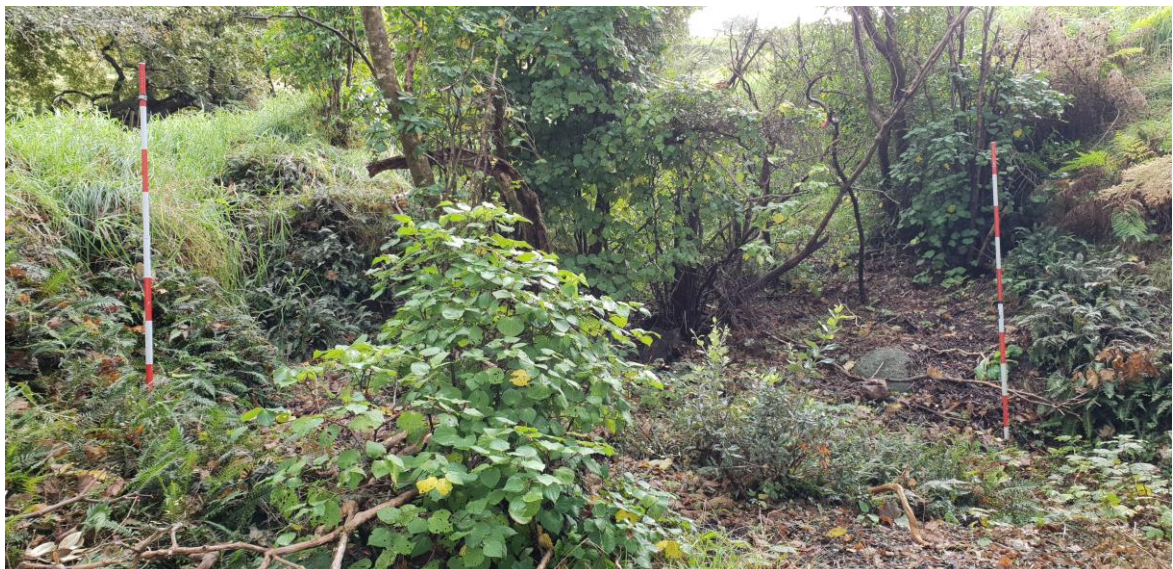
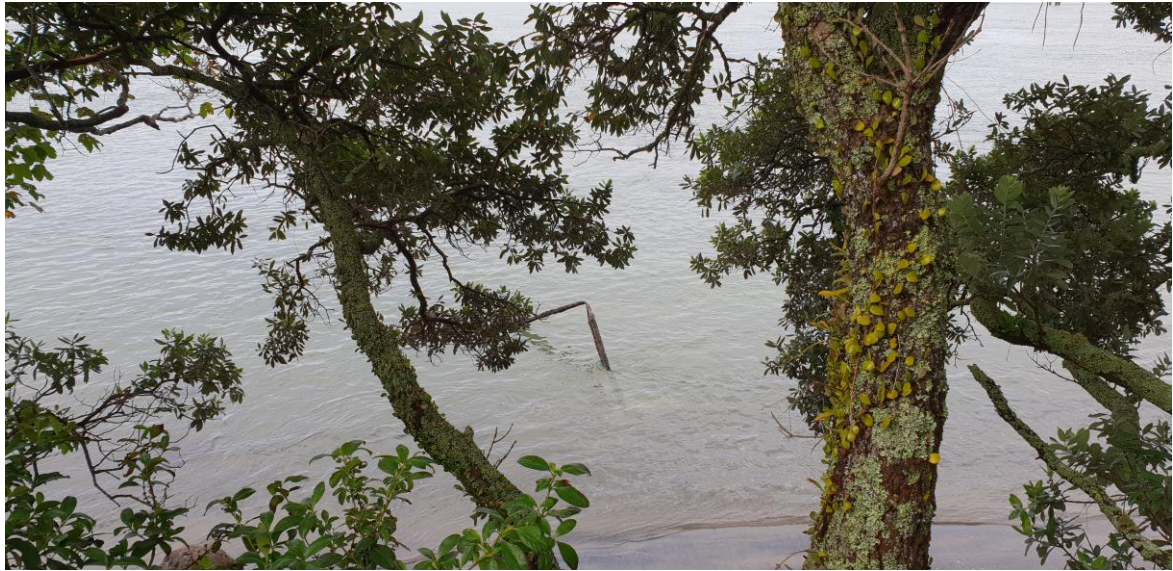
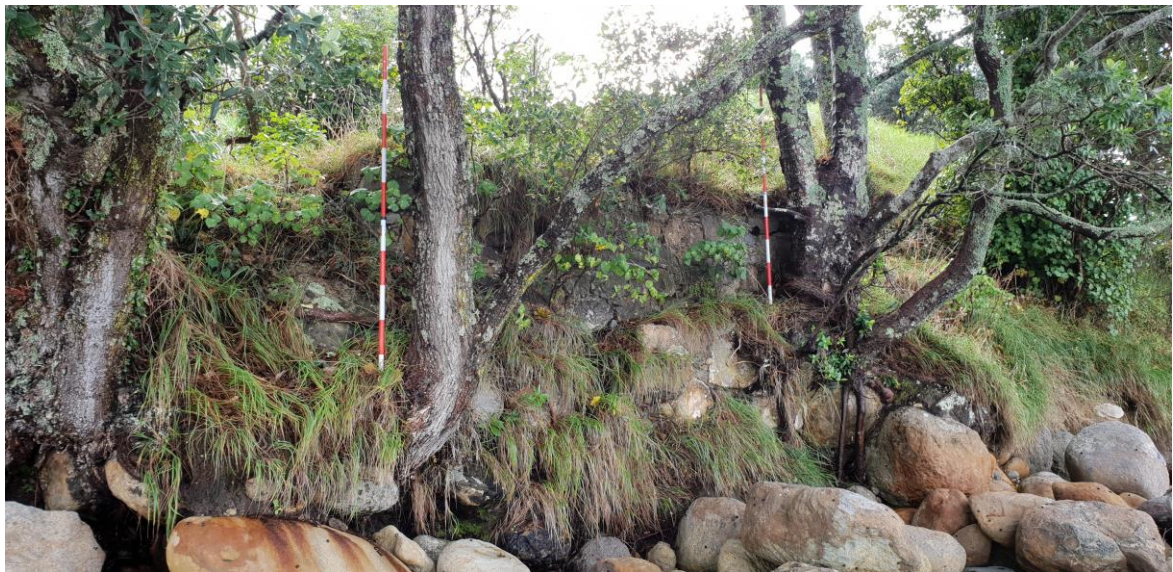
Monitoring point 2

Description: Iron Jetty and surrounds

Notes: Vegetation clearance is required including pohutukawa growing on the stonework face of the jetty. Possible interpretation could be developed at the jetty. It should be maintained in low vegetation/ferns/rank grass, with periodic weed eating. The view shaft to the iron debris offshore should be opened and maintained.

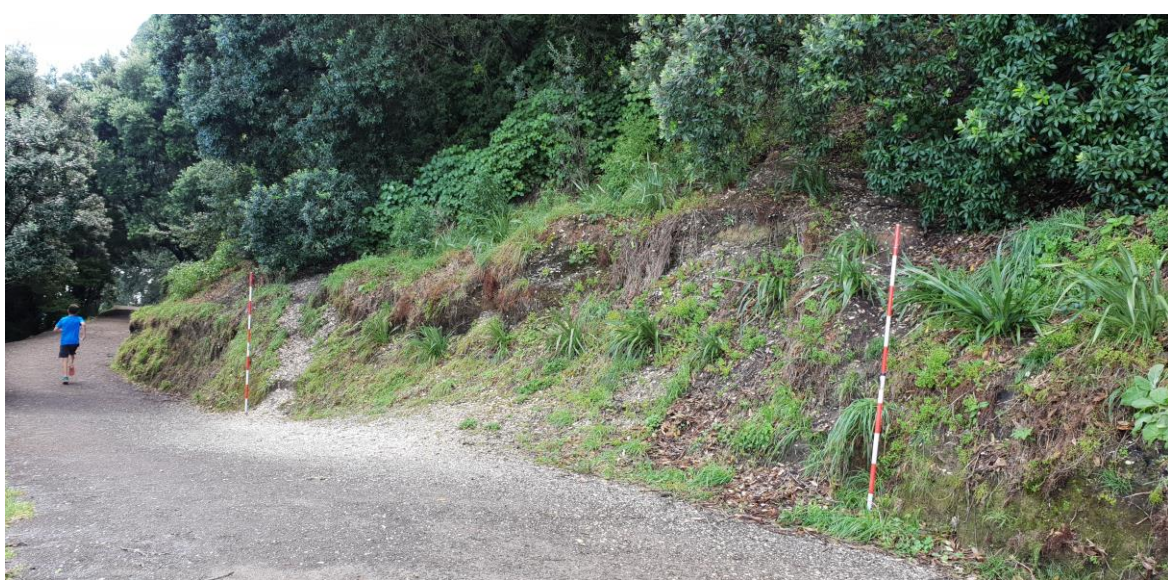
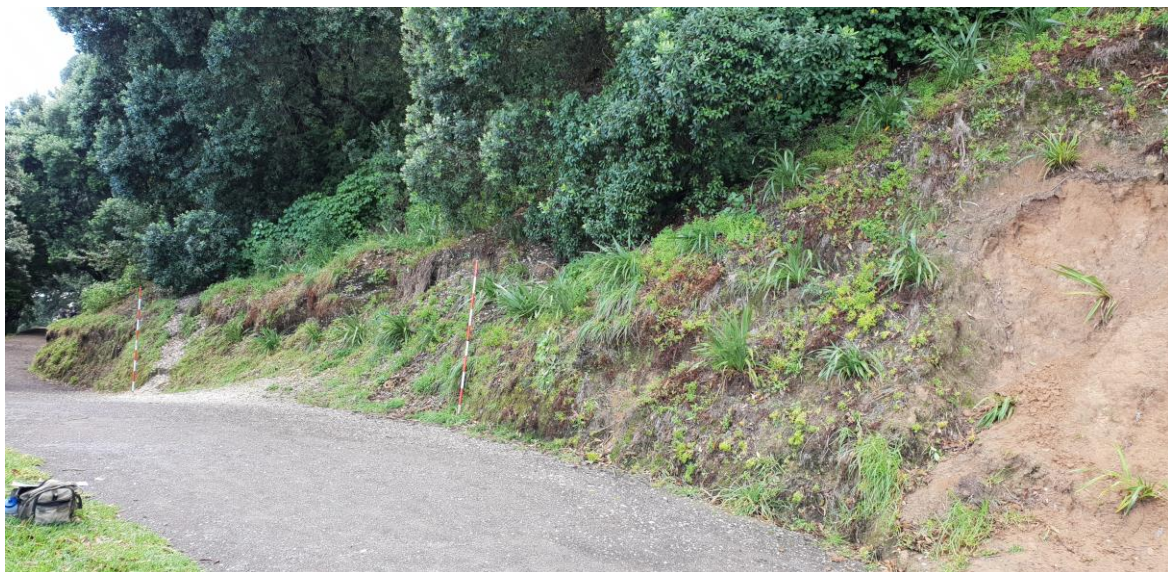
Monitoring point 3

Description: Base track midden erosion.

Notes: This is potentially stabilising based on observations at previous visits, possibly as a result of less rabbit browse. There has been some recent planting in the vicinity. Monitor for 2 years and then reassess.

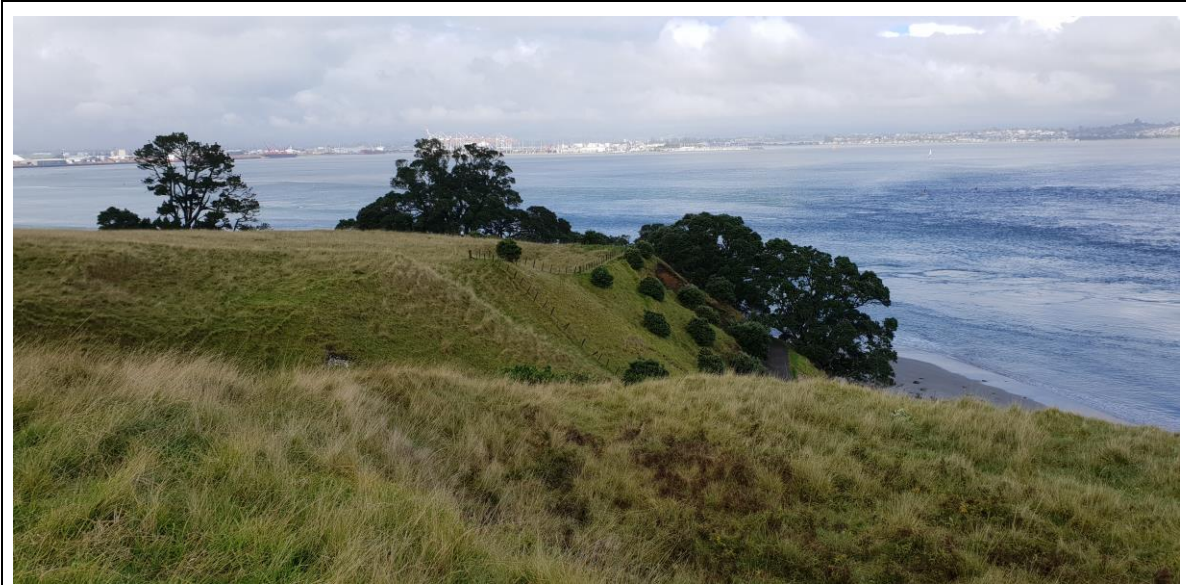
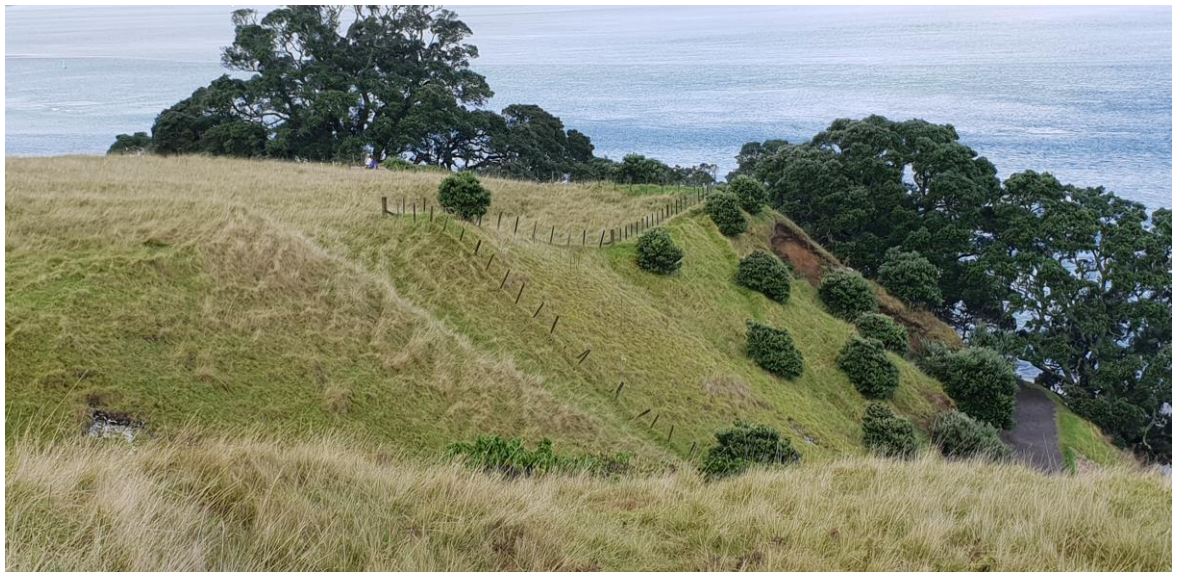
Monitoring point 4

Description: Fence placement, rabbit browse and slope stability

Notes: Fence alignment is on the edge of archaeological features, but there is no other practical fencing alignment available. The aim is to stabilise the slope below the features to prevent their loss due to landslip. There is more growth appearing on the slope since rabbit numbers were reduced. Midden is less visible.

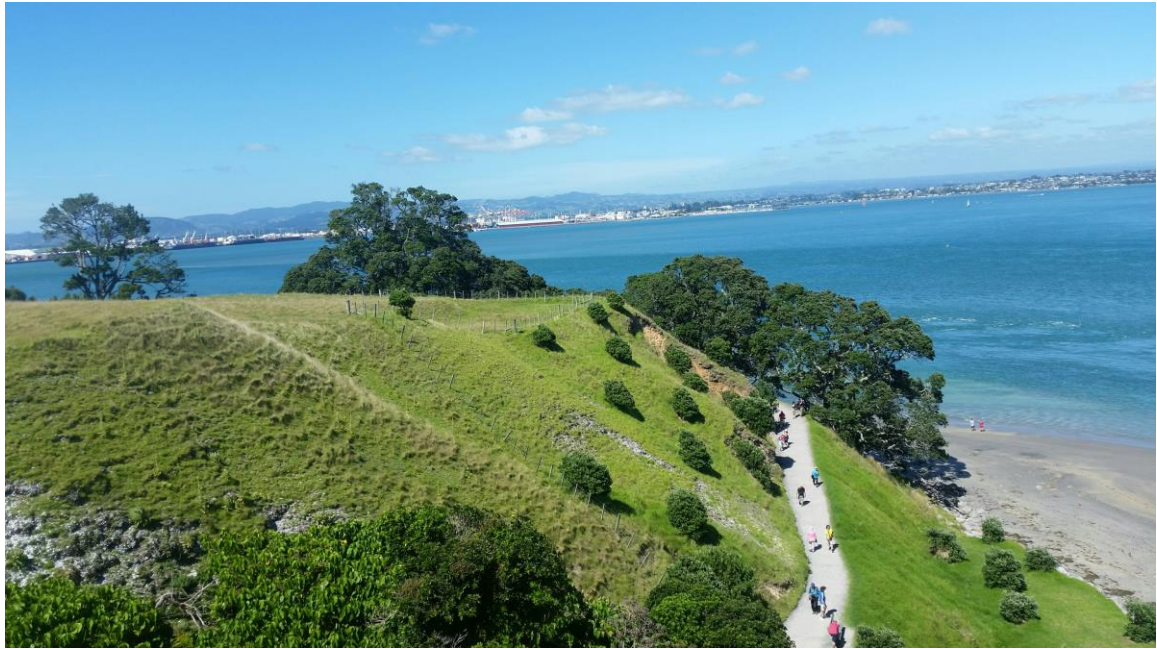
By comparison photograph (above) was taken in February 2016, showing midden exposure on the slope.

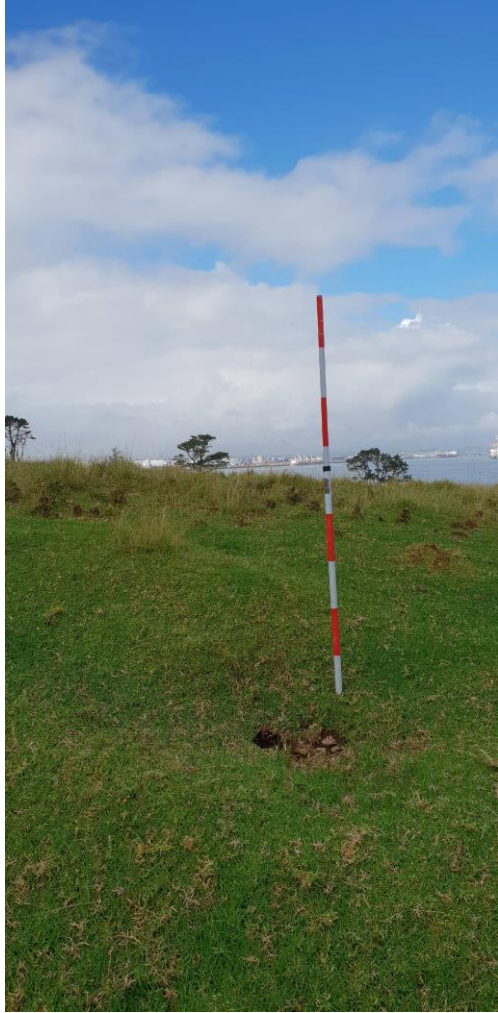
Monitoring point 5

Description: Rabbit damage (inactive)

Notes: Old rabbit damage, visibility decreasing.

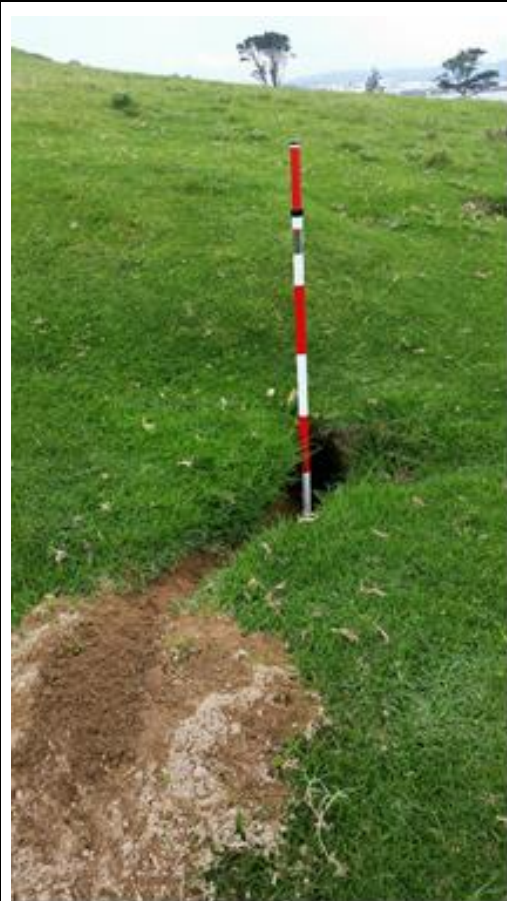
Comparison photography (above) taken in February 2016 when rabbit burrow was active.

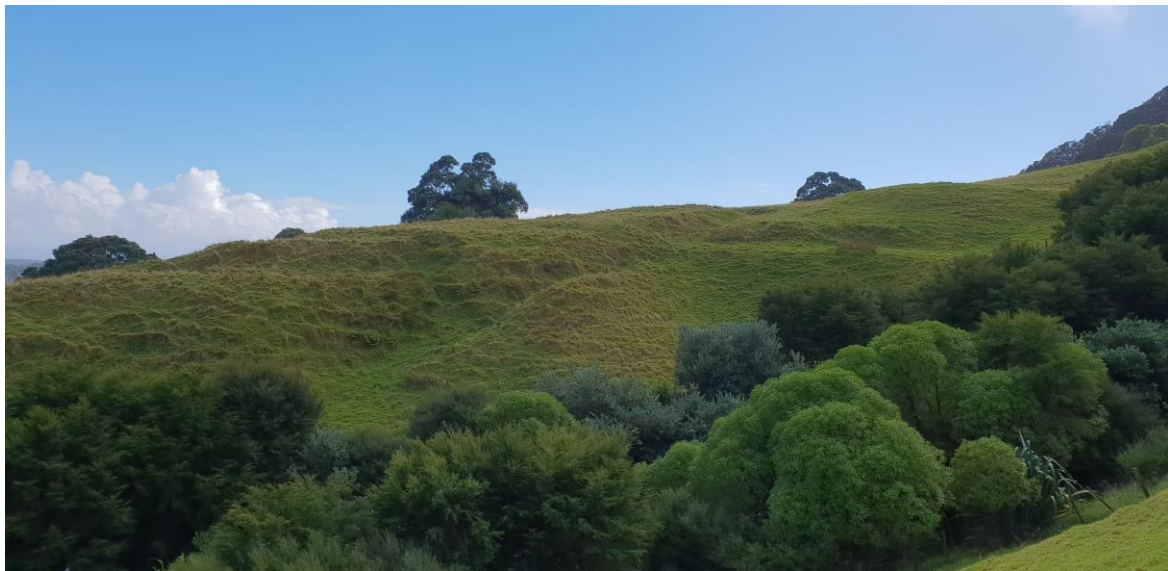
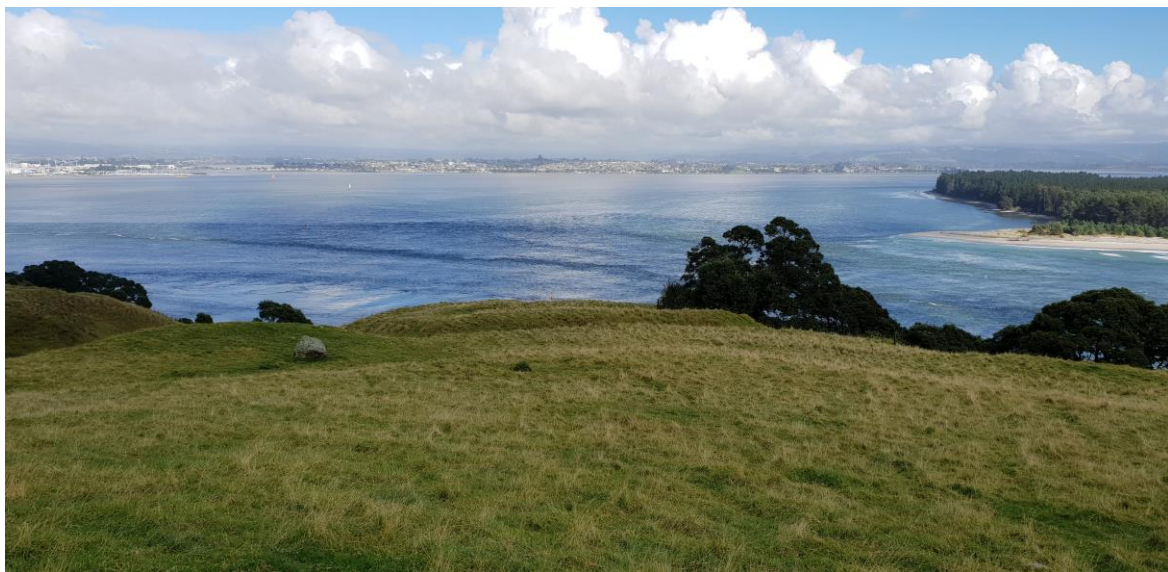
Monitoring point 6

Description: Pa U14/173 condition/grass cover

Notes: General views across pa to demonstrate grass cover.

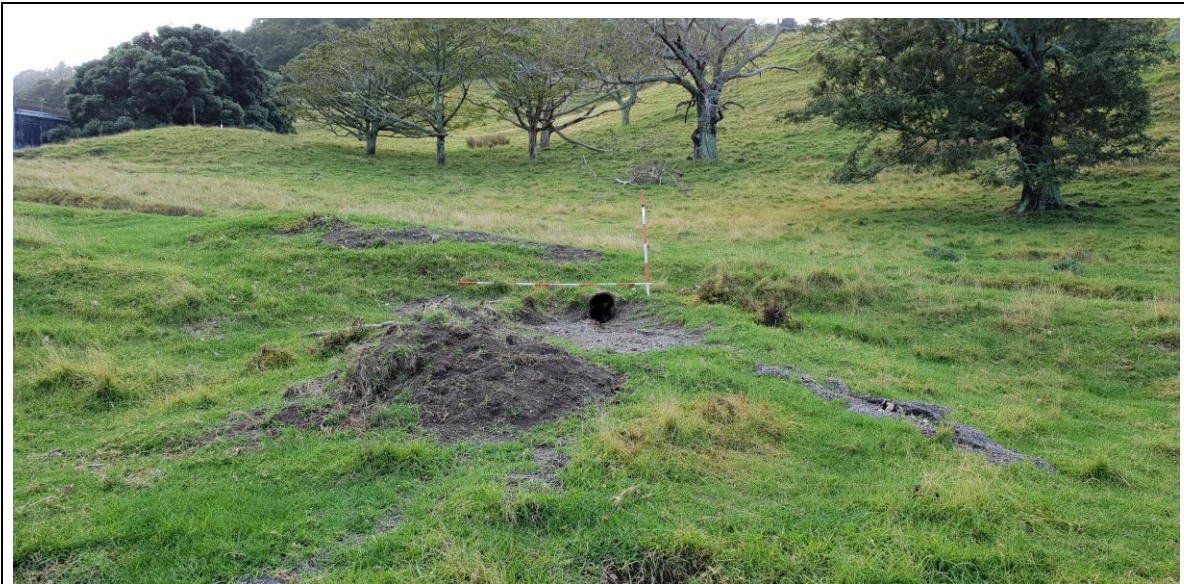
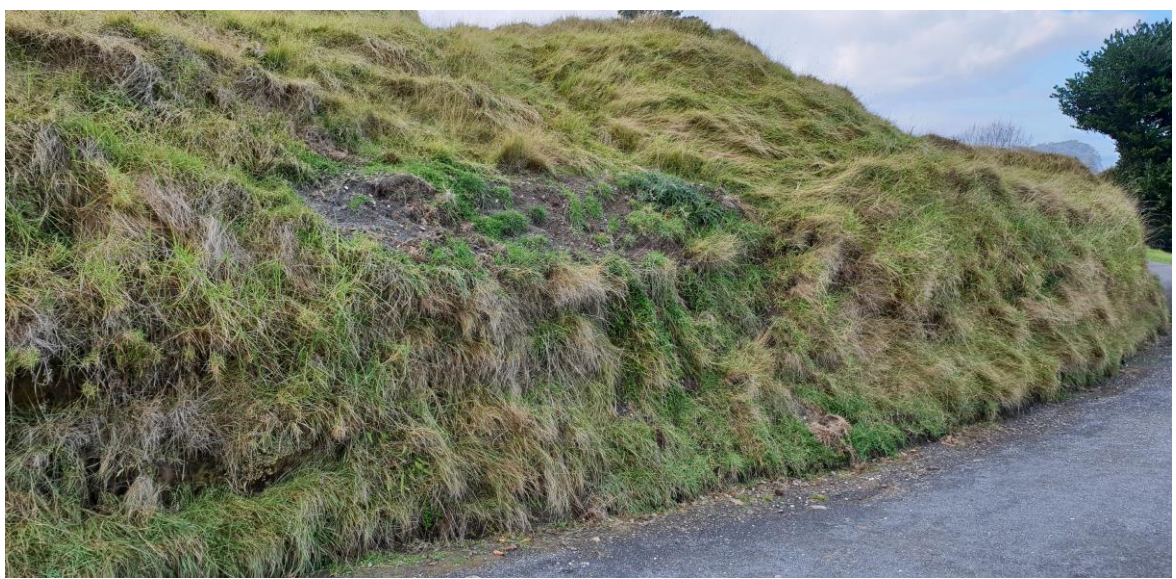
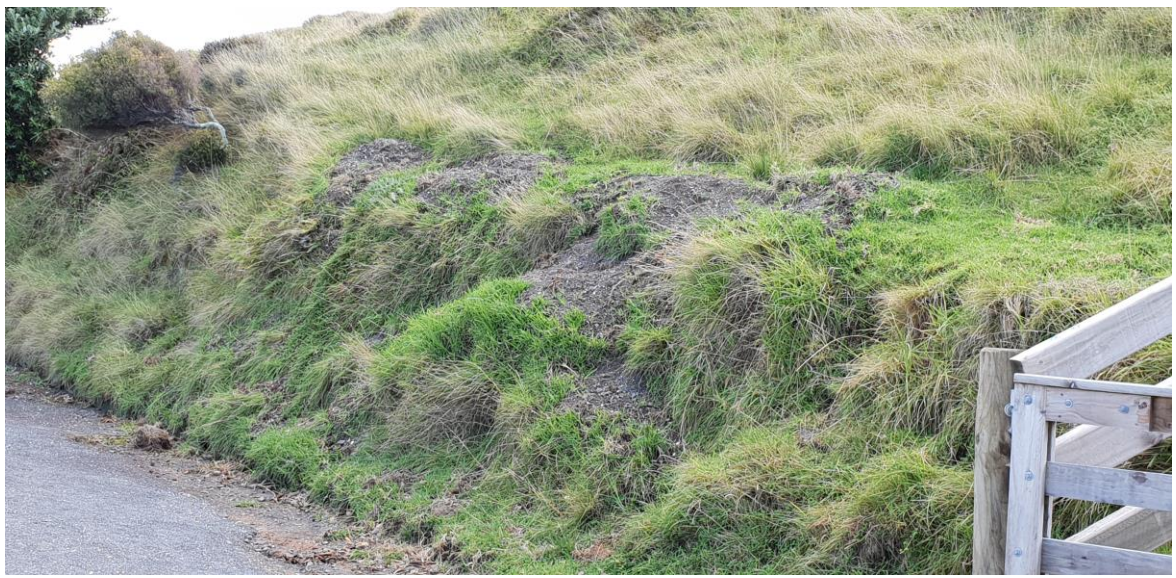
Monitoring point 7

Description: 4WD track maintenance issues – tailings management

Notes: 4WD maintenance routine is causing an on-going issue of tailings clearance. Artificial build up of material is 'creating' features adjacent to the track. Tailings should be removed off site to the stockpile by the reservoir. Remedial and maintenance issues relating to the 4WD track are on-going and have not been adequately addressed since the conservation plan was prepared in 2004. The distance between culverts, their function and the treatment of tailings needs to be improved.

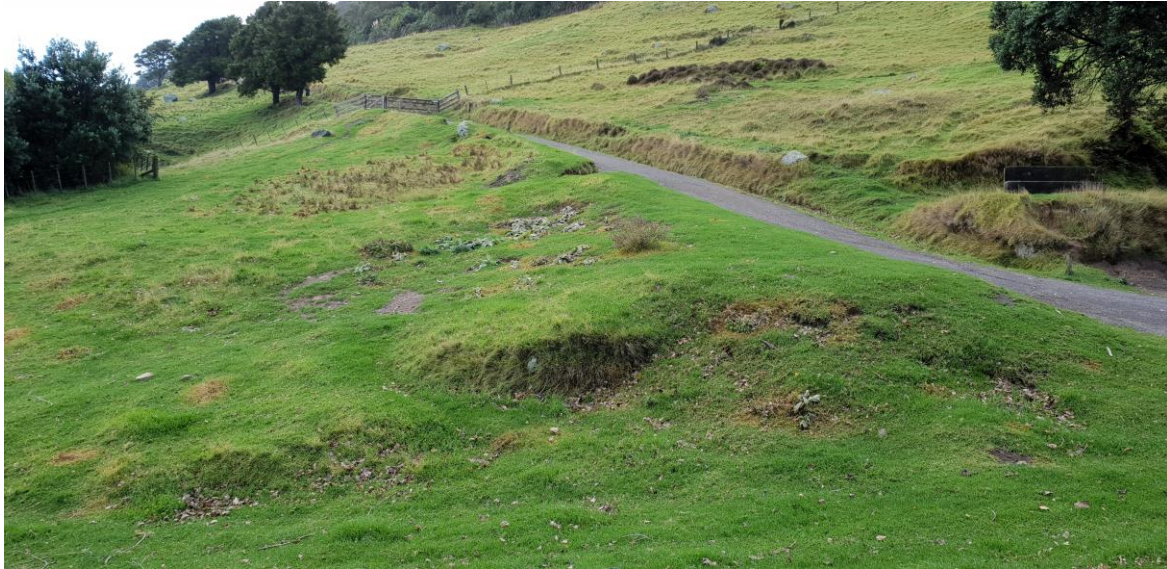
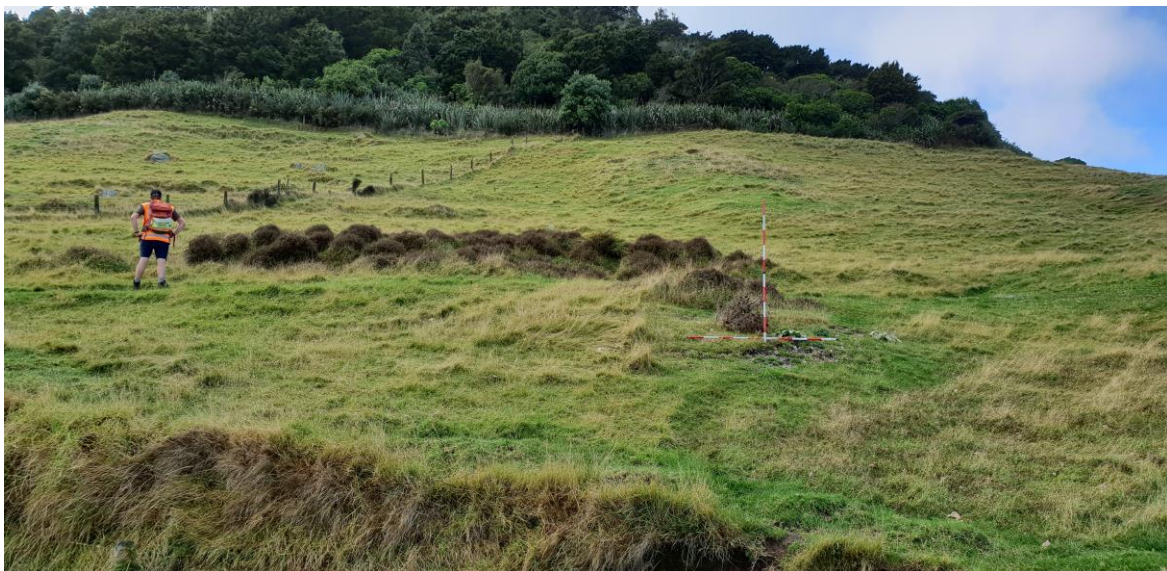
Monitoring point 8

Description: Midden and vegetation management – mingimingi growth

Notes: Midden mound above water reservoir has good cover of mingimingi and it is gradually spreading to other mounds as sheep numbers have been reduced. Monitor spread and condition.

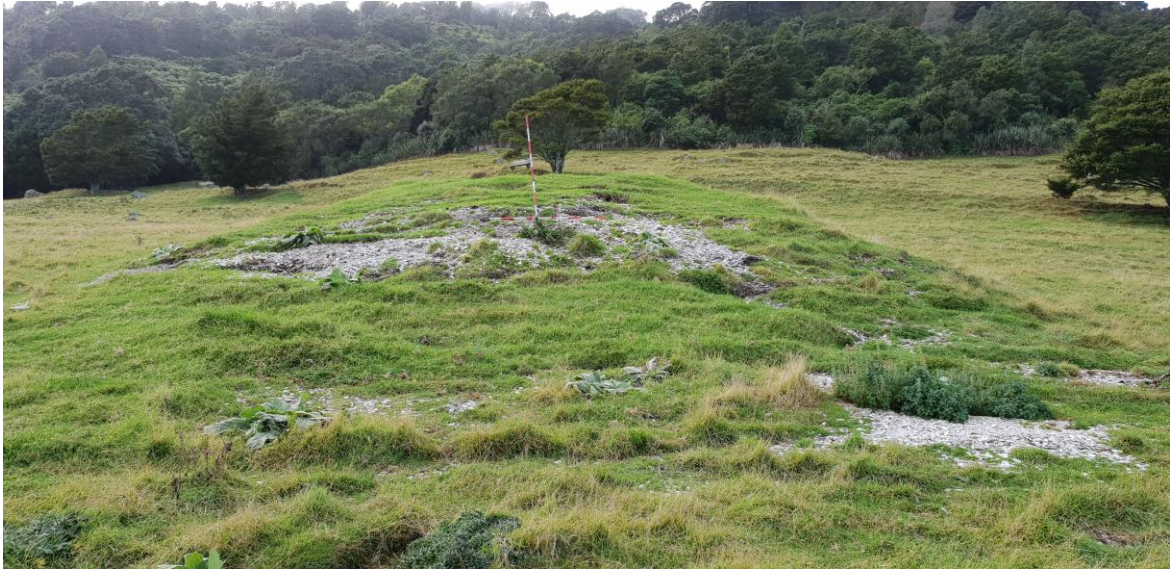
Monitoring point 9

Description: Erosion on shell mound – stock and vegetation management

Notes: Develop sheep exclusion trial and monitor results.

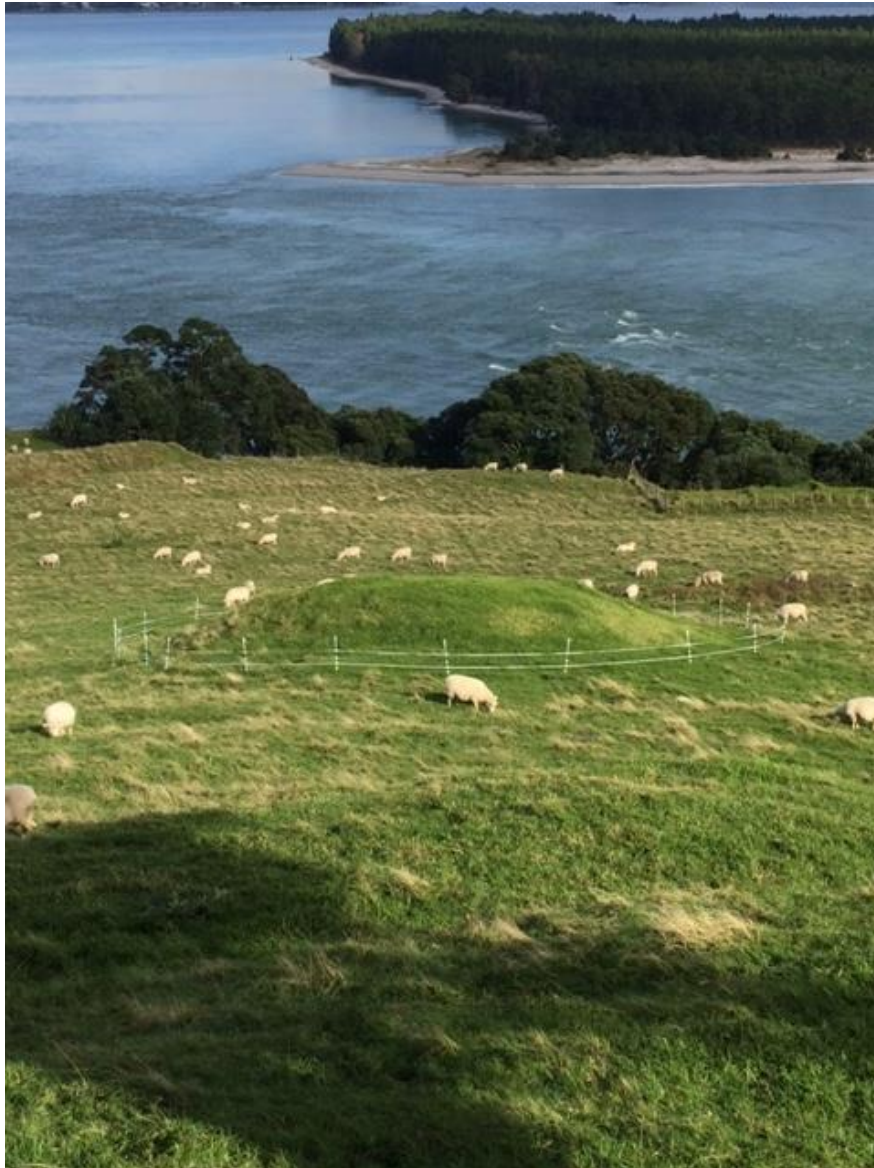
Sheep exclusion trial June 2018.

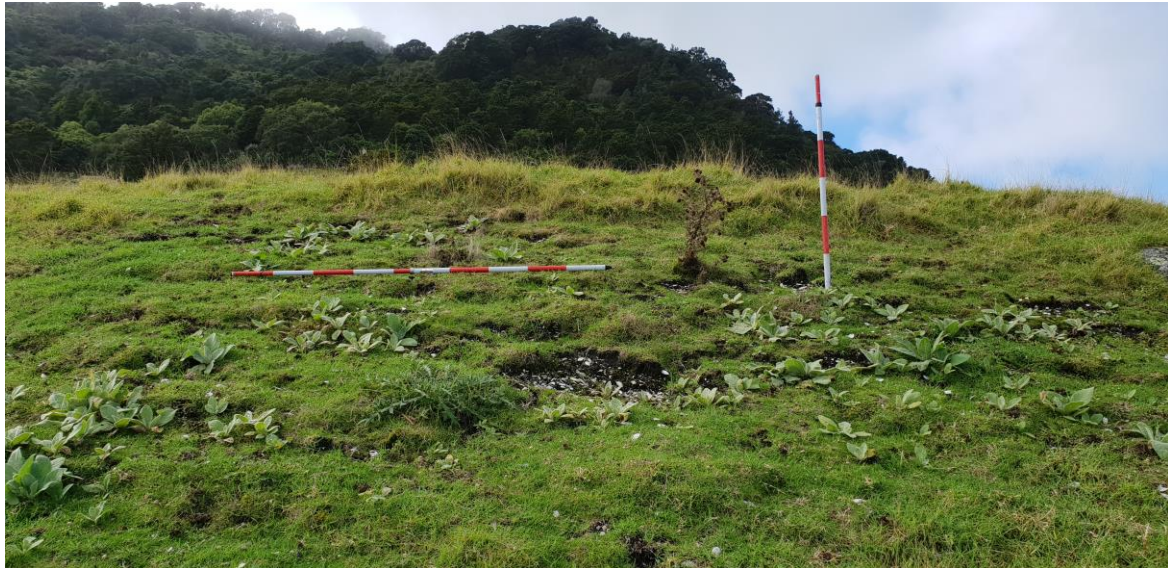
Monitoring point 10

Description: Rabbit damage (active)

Notes: Monitor condition of site after on-going rabbit control.

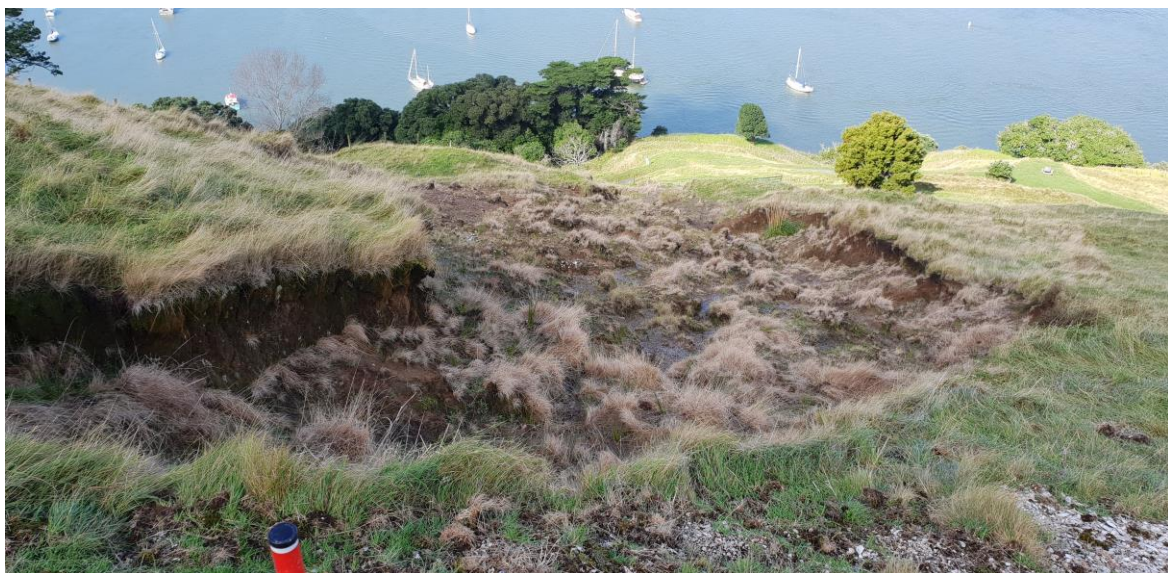
Monitoring point 11

Description: Land slip on southern slope

Notes: Recent planting of slip scar completed. Monitor stability/recovery of area.

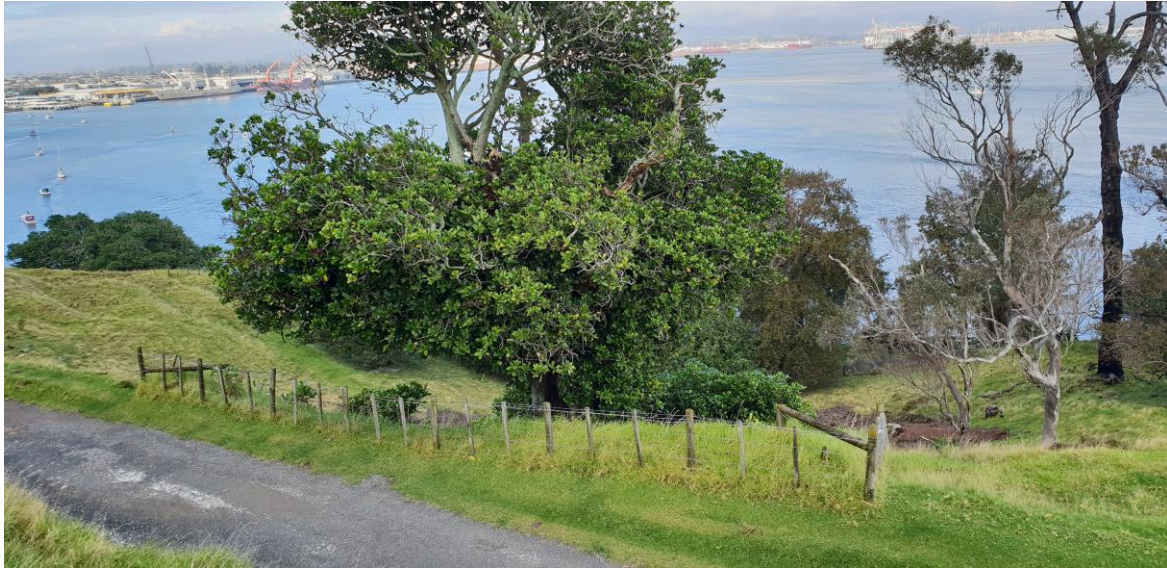
Monitoring point 12

Description: Fence around middens on southern slope

Notes: Fence around middens is not required and should be removed. It was installed in

approximately 2003, ground has since stabilised. Remove fence and monitor result.

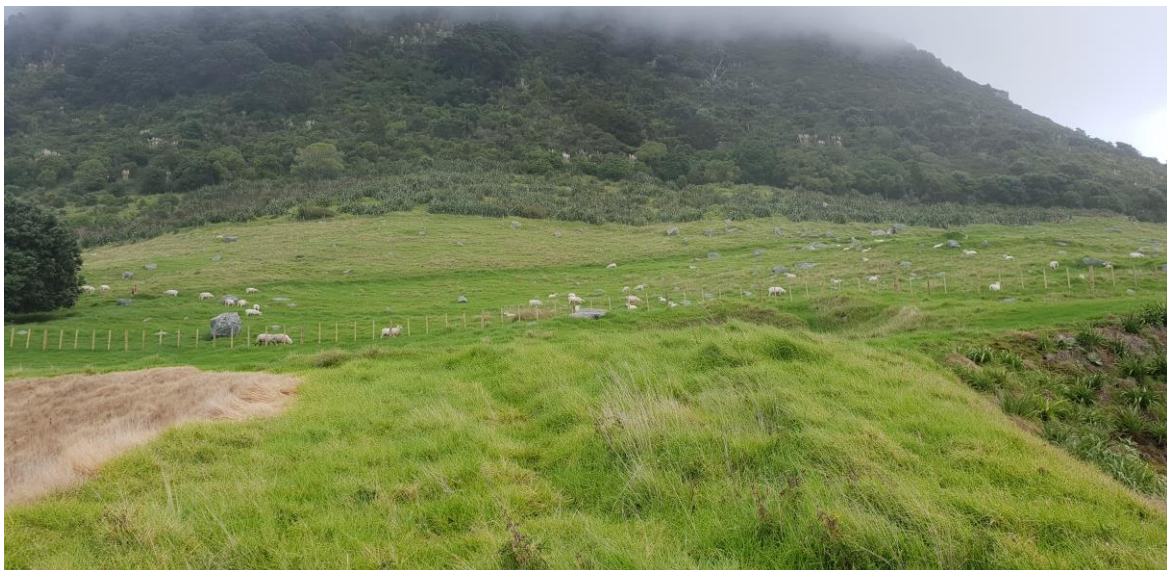
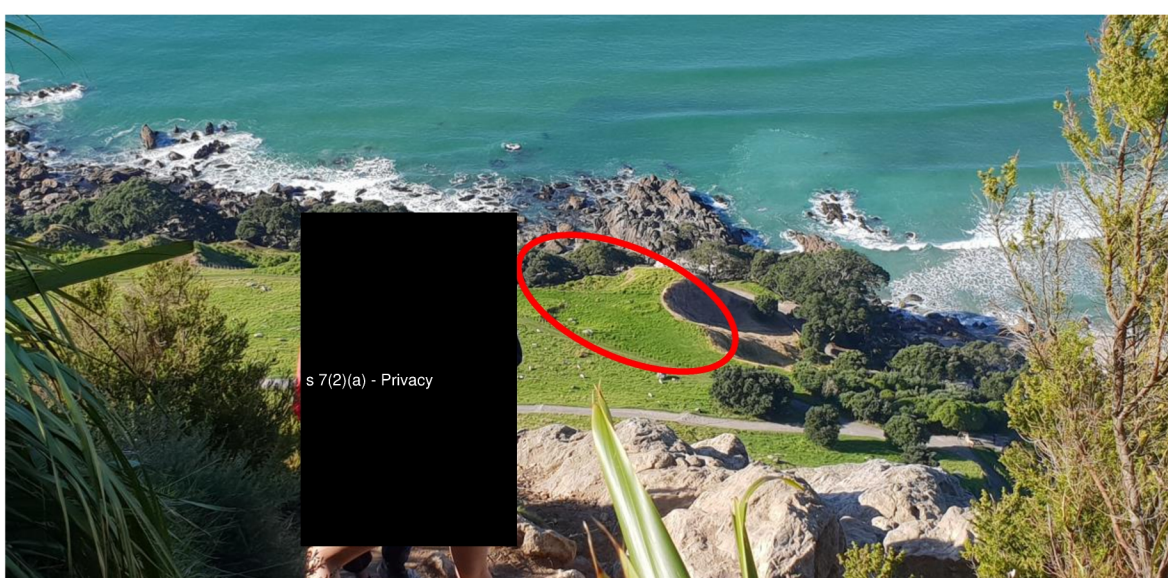
Monitoring point 13

Description: Area of military camp, helicopter pad, pits and terraces, recently retired from grazing.

Notes: Monitor for stability and visibility following cessation of grazing.

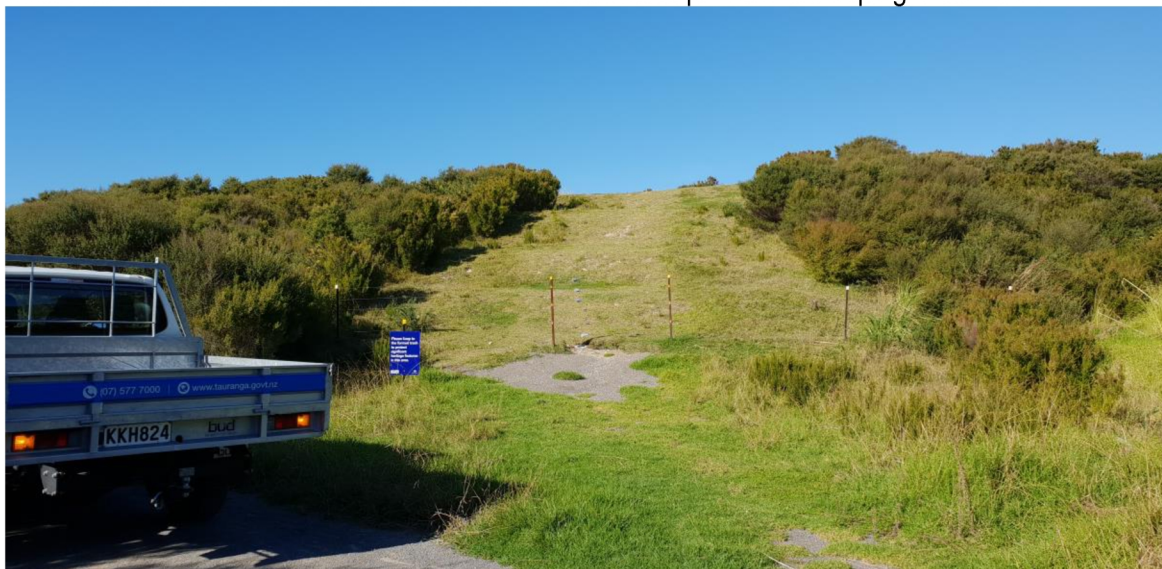
Monitoring point 14

Description: Repair to summit terraces

Notes: Repair to terraces completed in 2013. The aggregate at the base of the slope needs to be removed. Fence at the base should be better reinstated to prevent developing desire line.

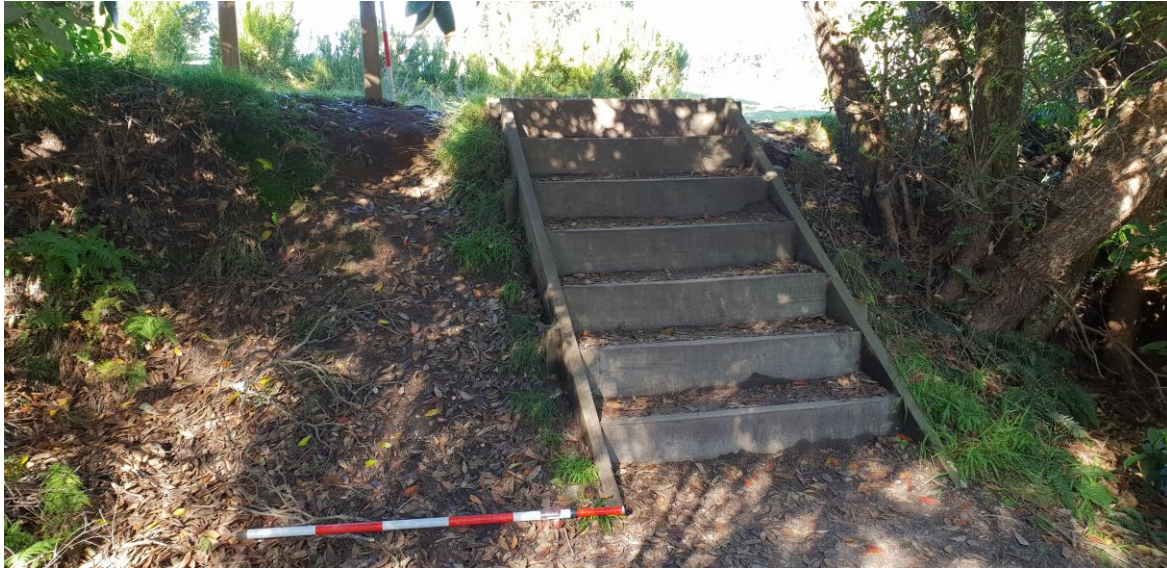
Monitoring point 15

Description: Repair to bank on summit and steps installation

Notes: Monitor the developing desire line/wear next to steps and act to block access if required.

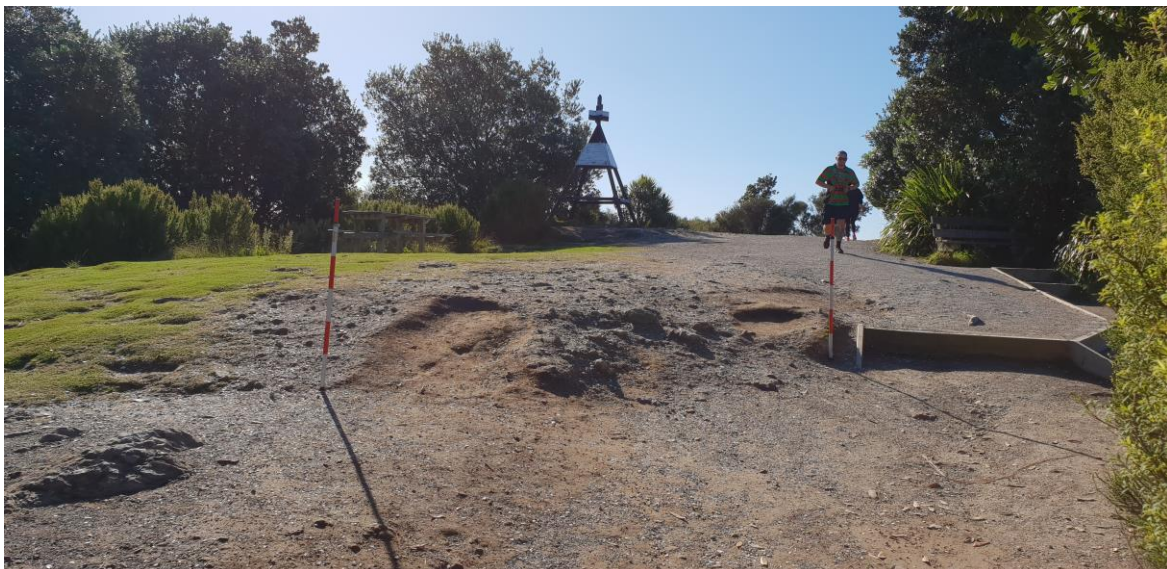
Monitoring point 16

Description: General monitoring of summit wear

Notes: Monitor wear of imported armouring material on summit and recap as/when required by bringing in additional material.

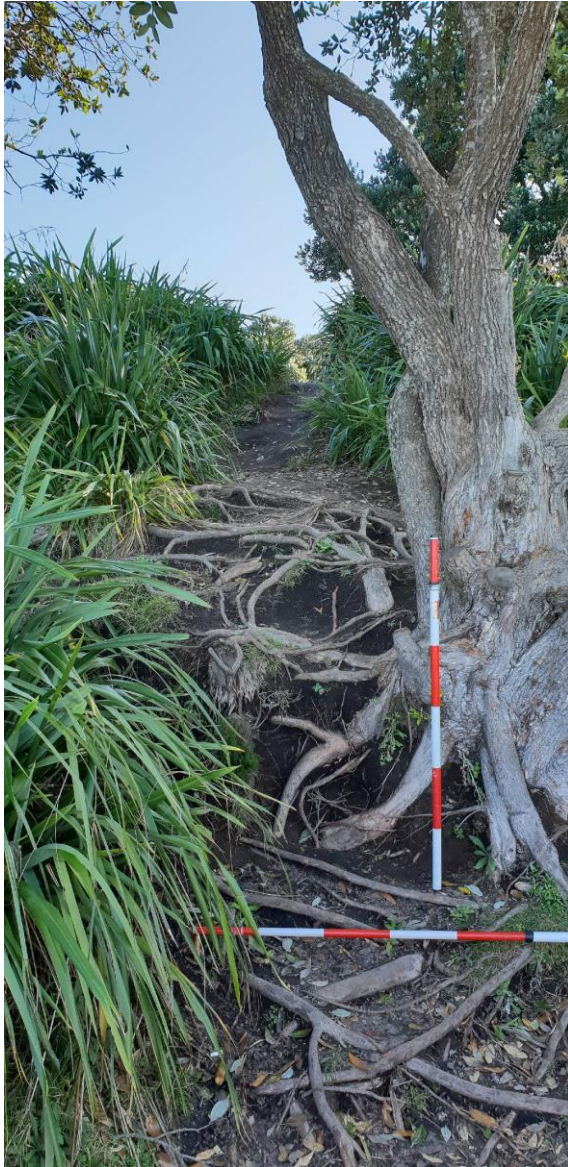
Monitoring point 17

Description: Desire line track on summit

Notes: Developing desire line is causing wear to intact archaeological deposit. Monitor and act to block if wear continues.
