**Archaeological Site Condition Monitoring
Report
Mauao Historic Reserve, Tauranga**

20 August 2018

Prepared for: Tauranga City Council
P O Box
TAURANGA

Prepared by: InSitu Heritage Ltd.
P O Box 710
WHAKATANE 3158

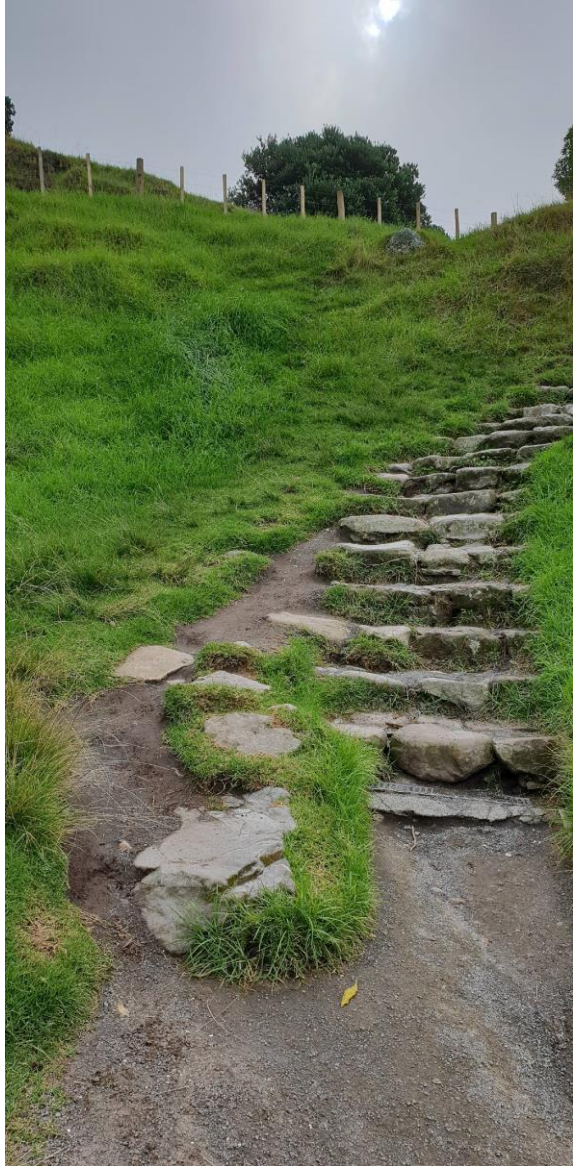
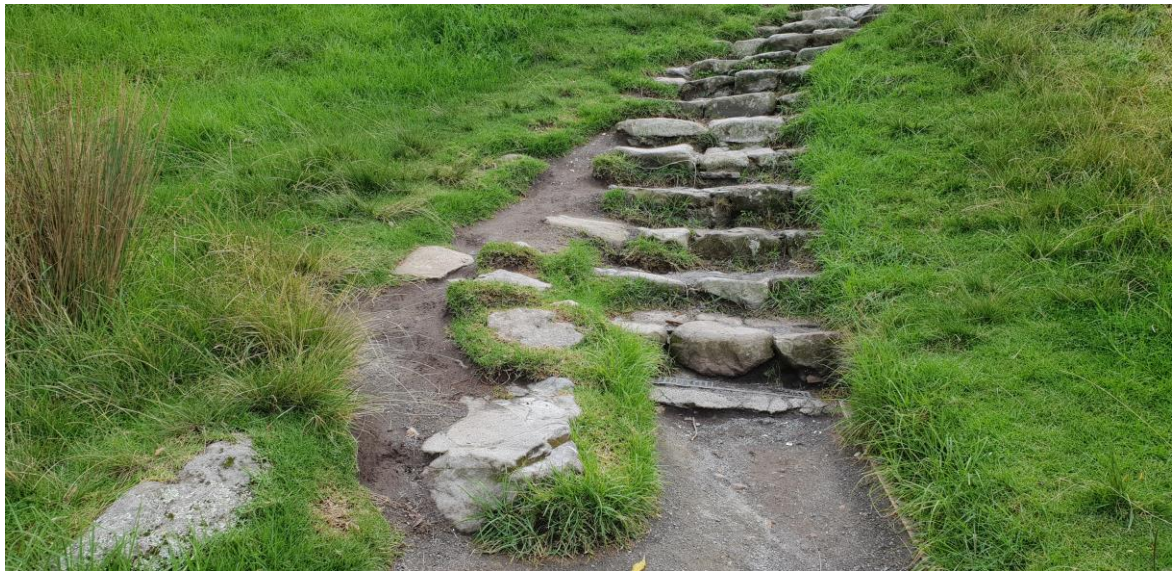
Monitoring point 18

Description: Stone steps condition and erosion

Notes: Monitor condition of stone work and desire line wear.
