Archaeological Site Condition Monitoring Report –
Authority no. 2023/244
Mauao Historic Reserve, Tauranga

ARCHAEOLOGICAL SITE
CONDITION MONITORING REPORT
AUTHORITY NO. 2023/244
MAUAO HISTORIC RESERVE
TAURANGA

29 February 2024

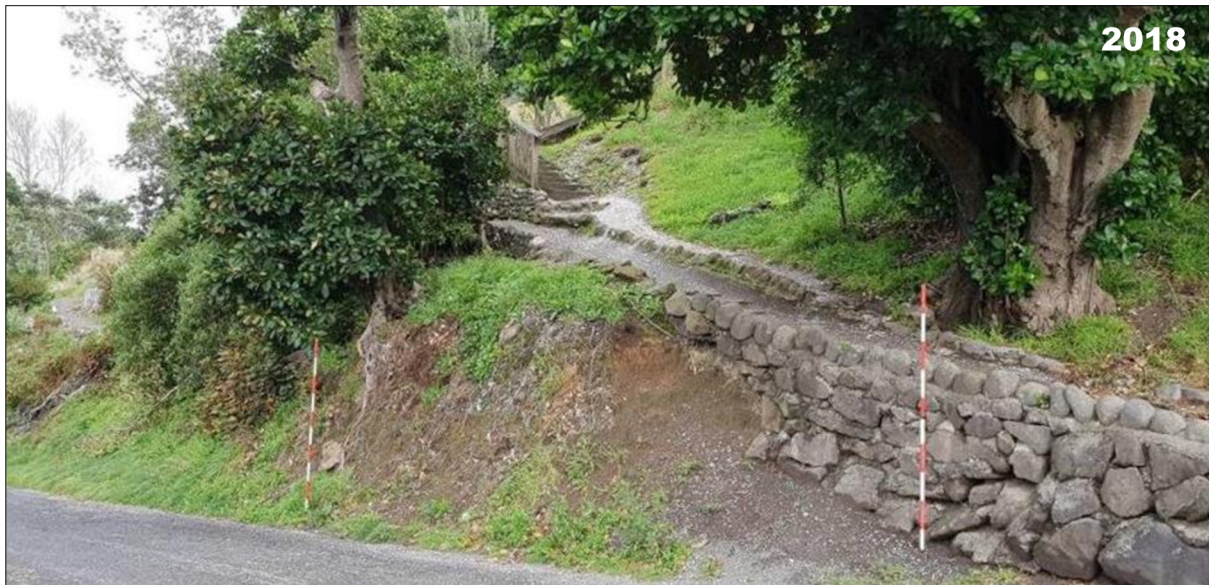
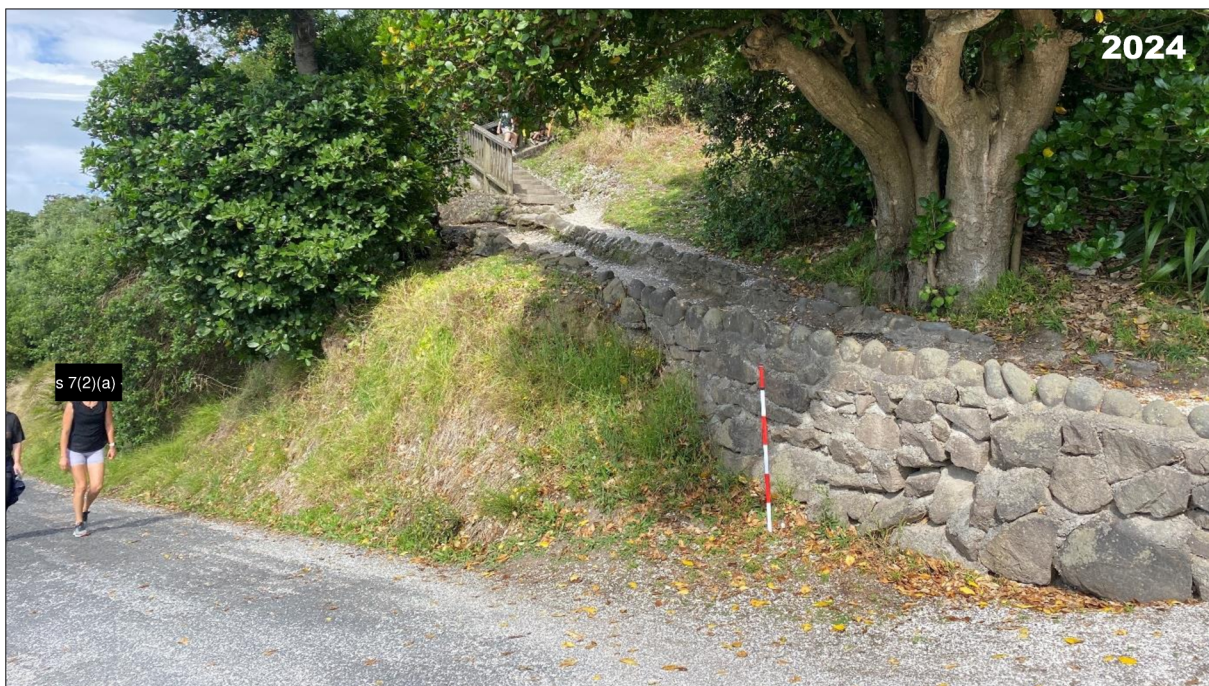
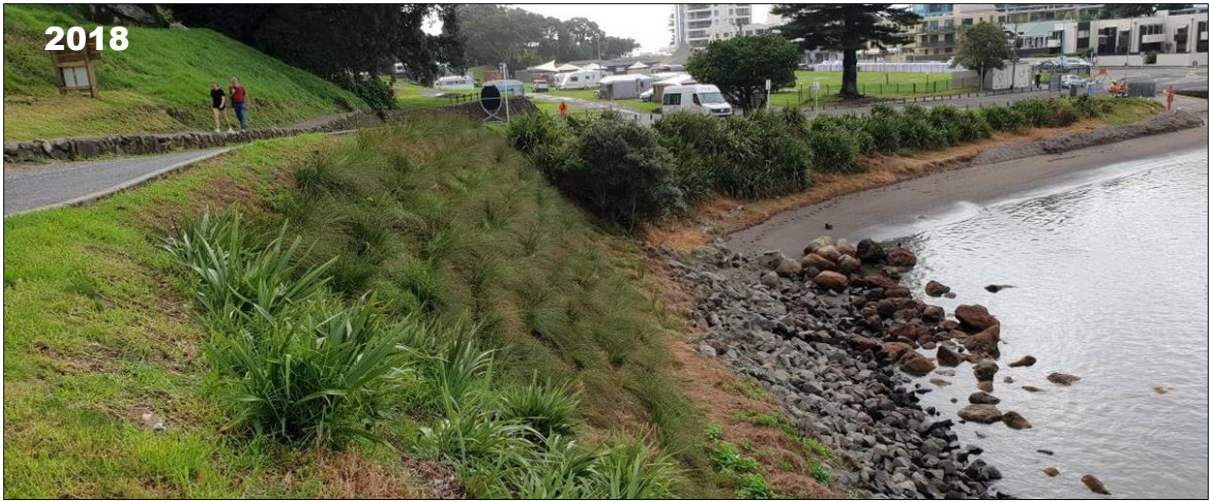
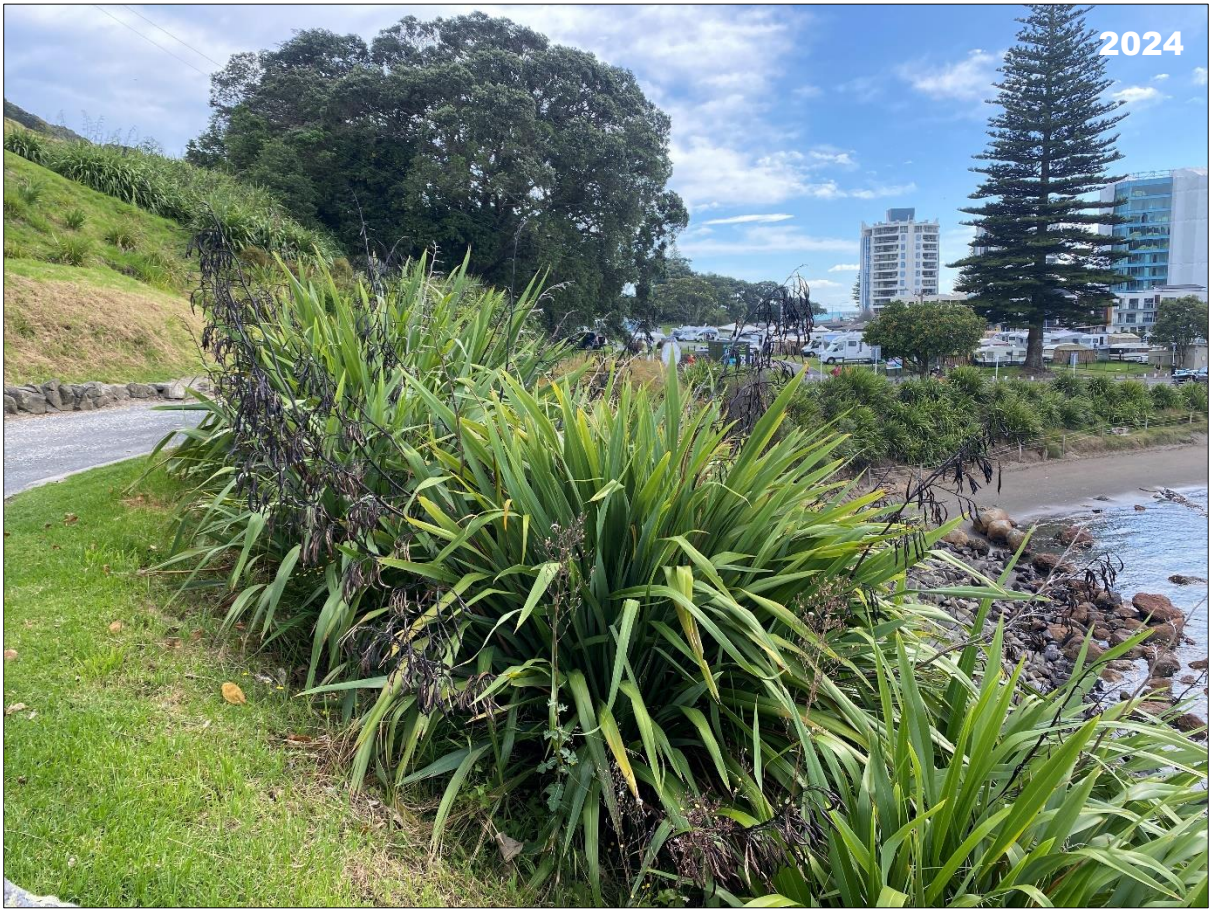
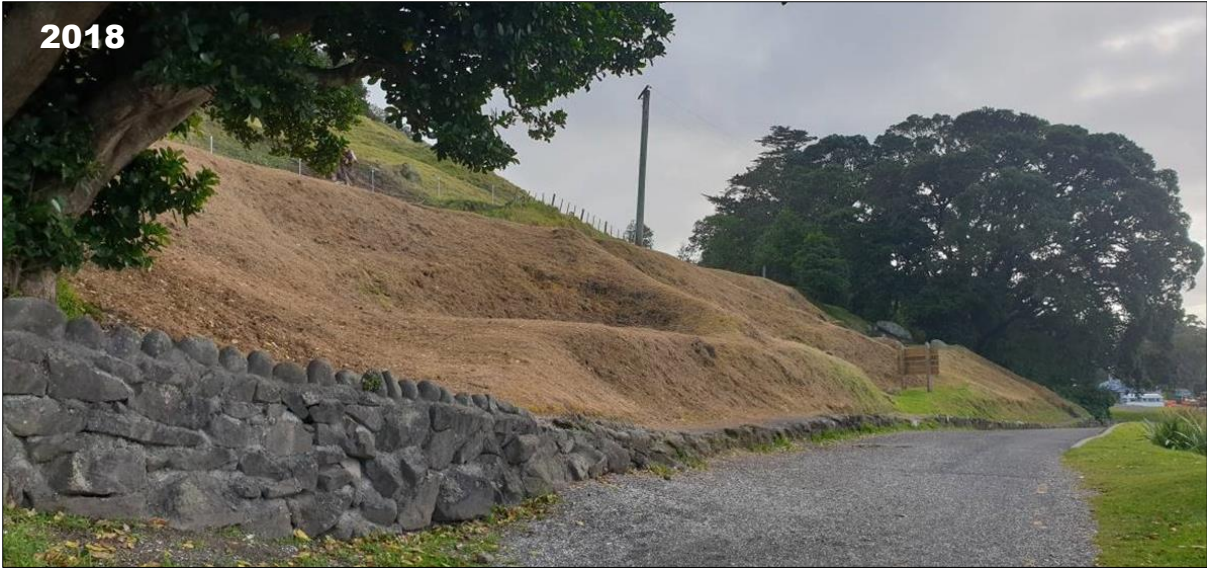
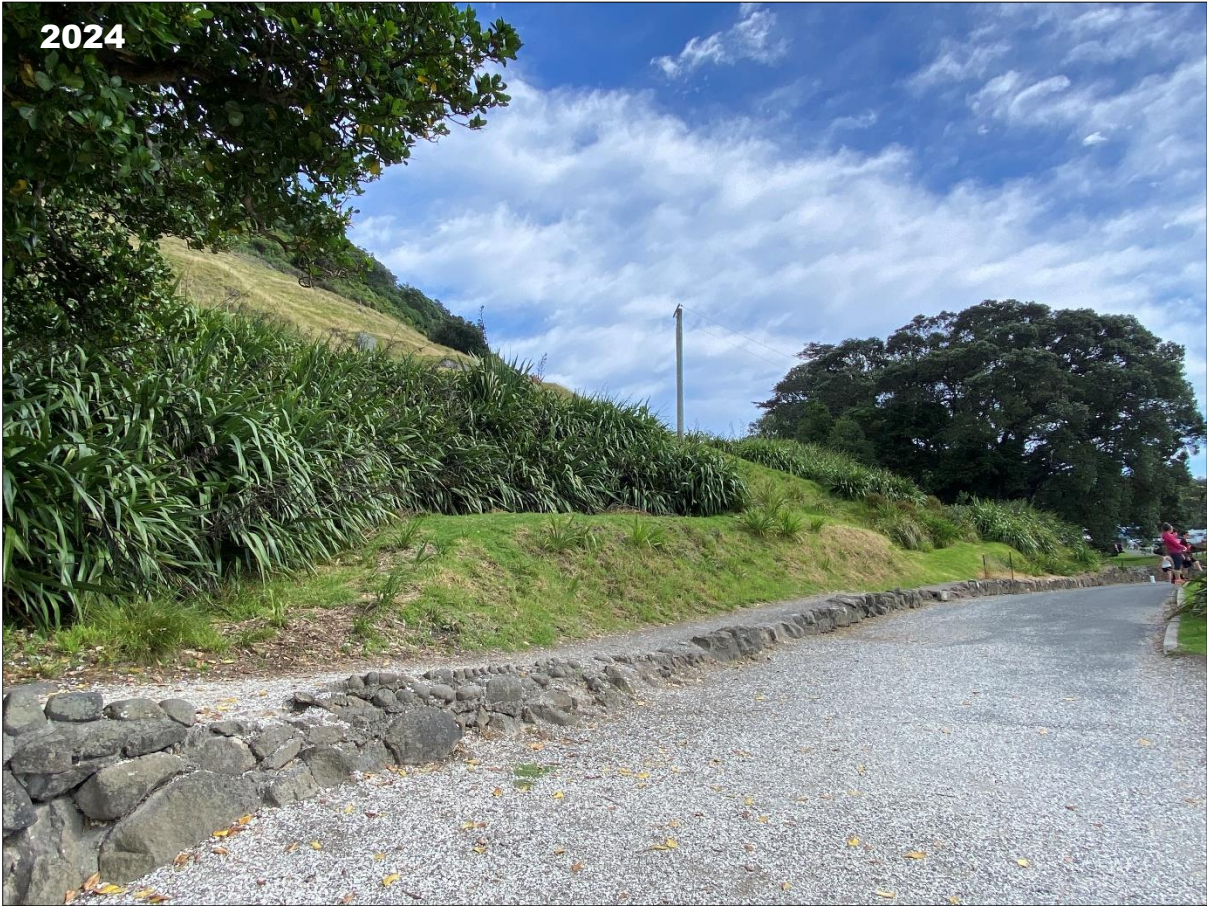
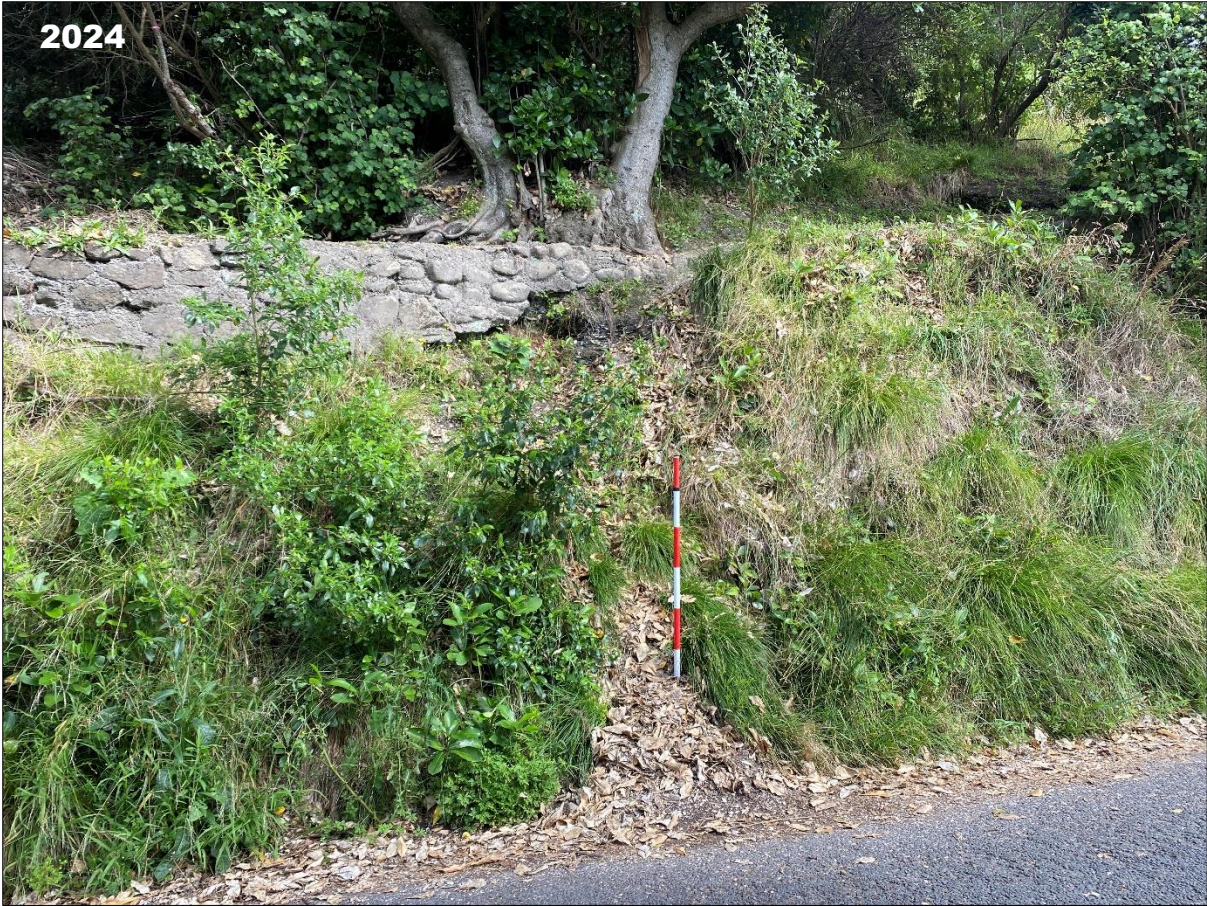
Monitoring Site 1

Stone Jetty surrounds – stone walls

Notes: The monitoring site has been extended to include the walkway connection to the 4WD track, as there is some exposed midden which requires monitoring. Monitoring site also includes the bank down to the jetty steps entrance, which now has a well-established sward of flax. Grass and other vegetation cover significantly advanced since 2018. The karaka tree may need to be reduced in weight if it becomes an issue. Wall condition has significantly stabilised since 2018.

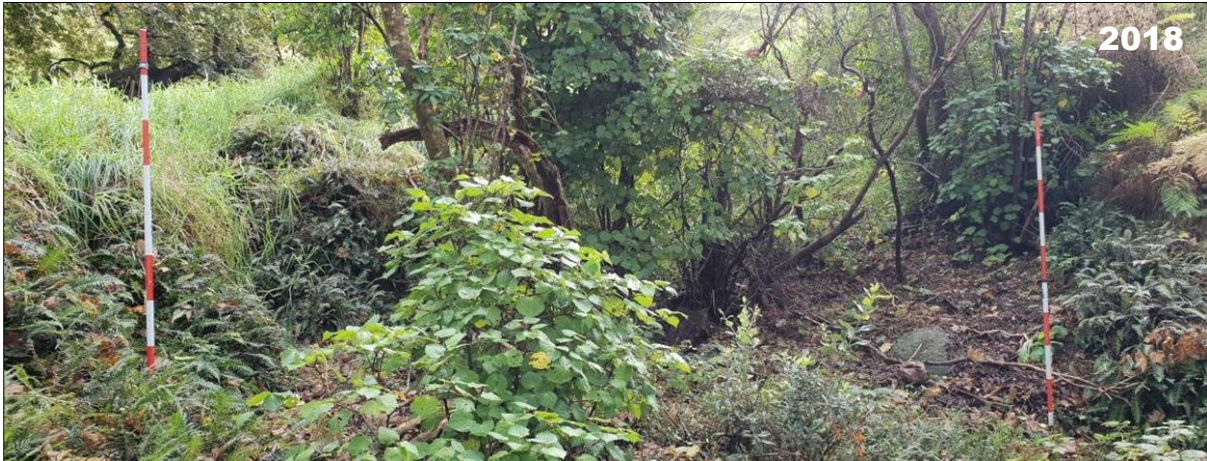
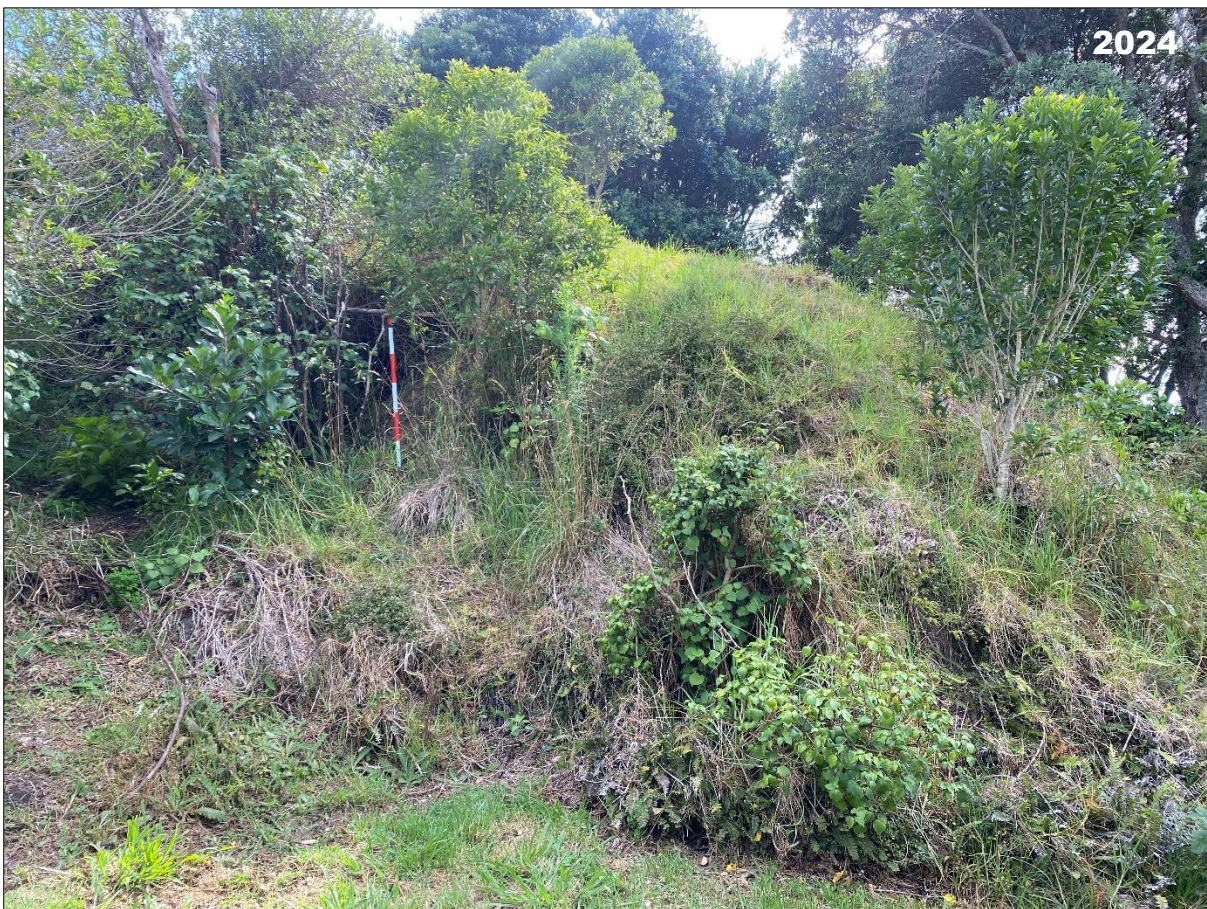
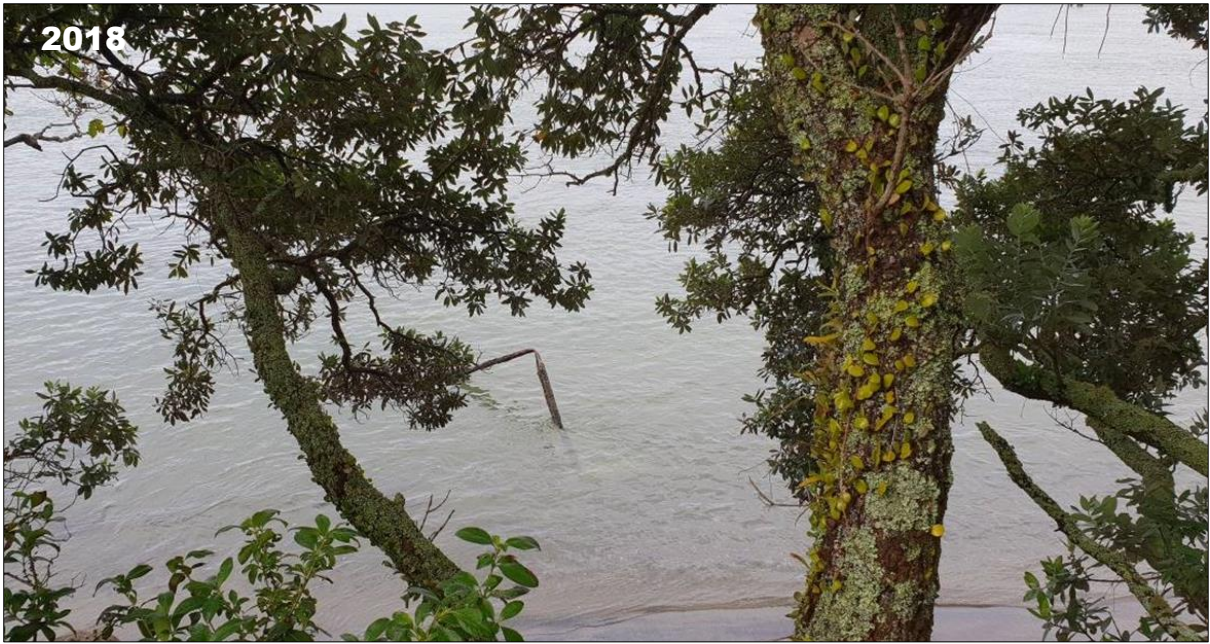
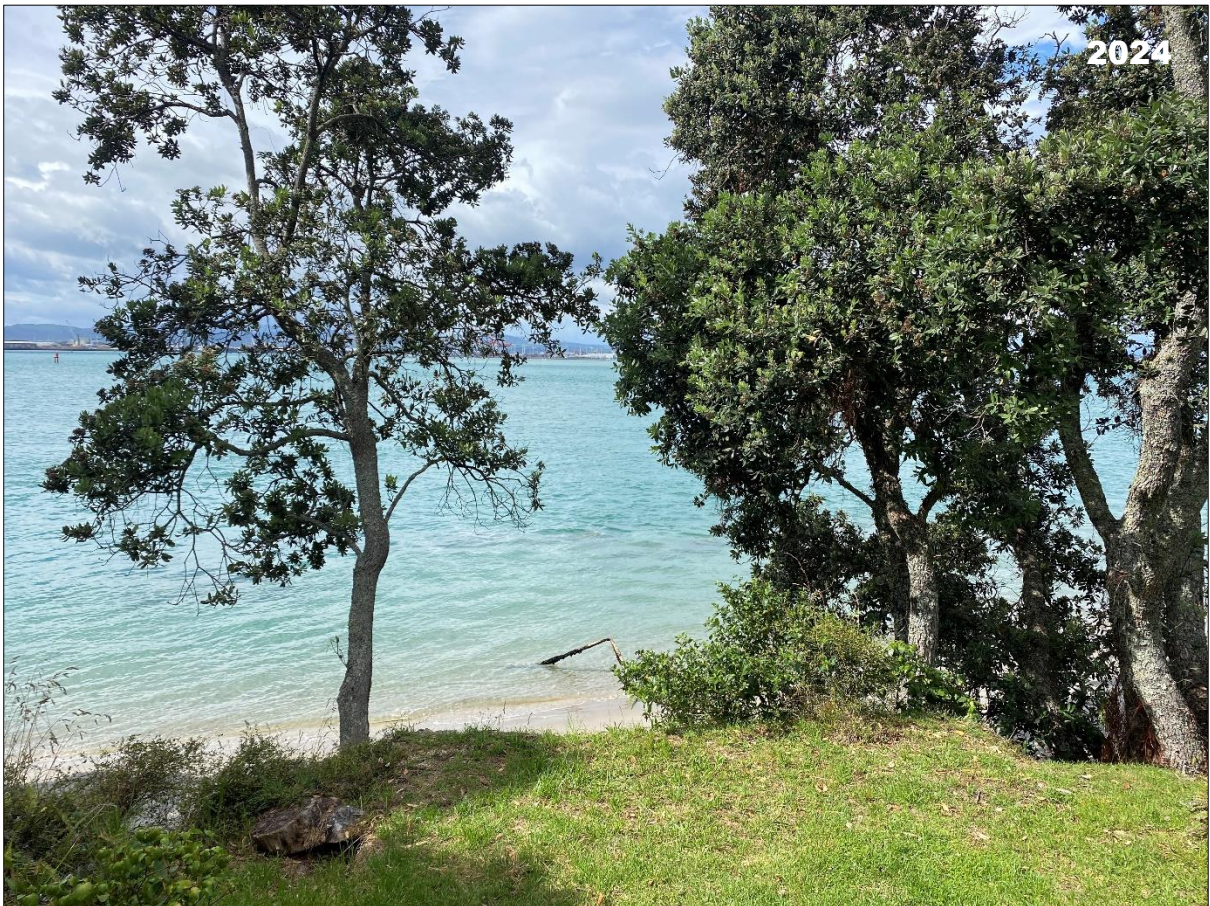
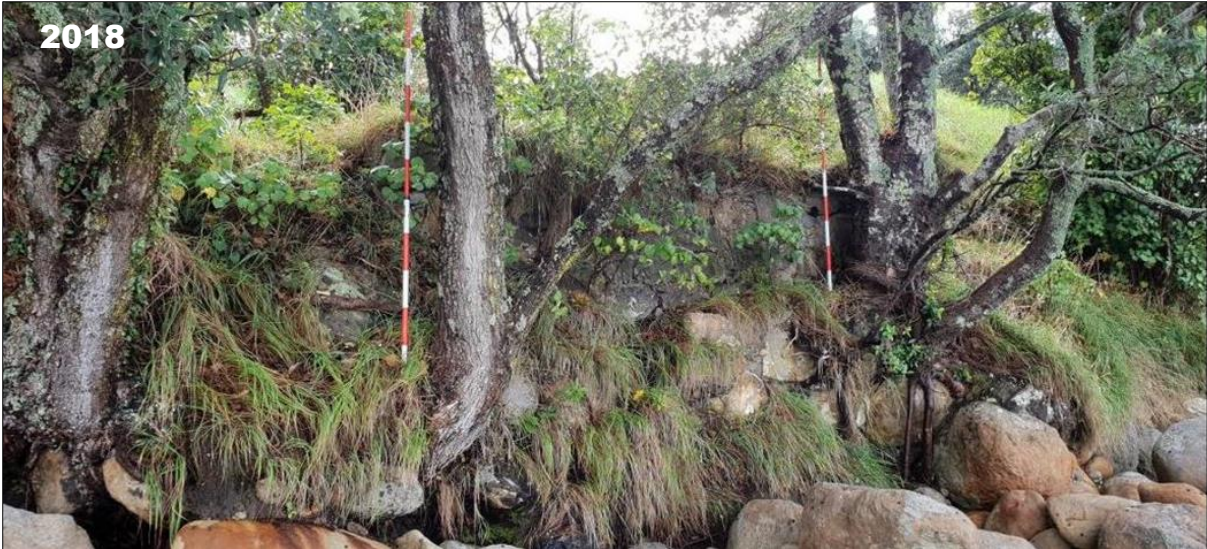
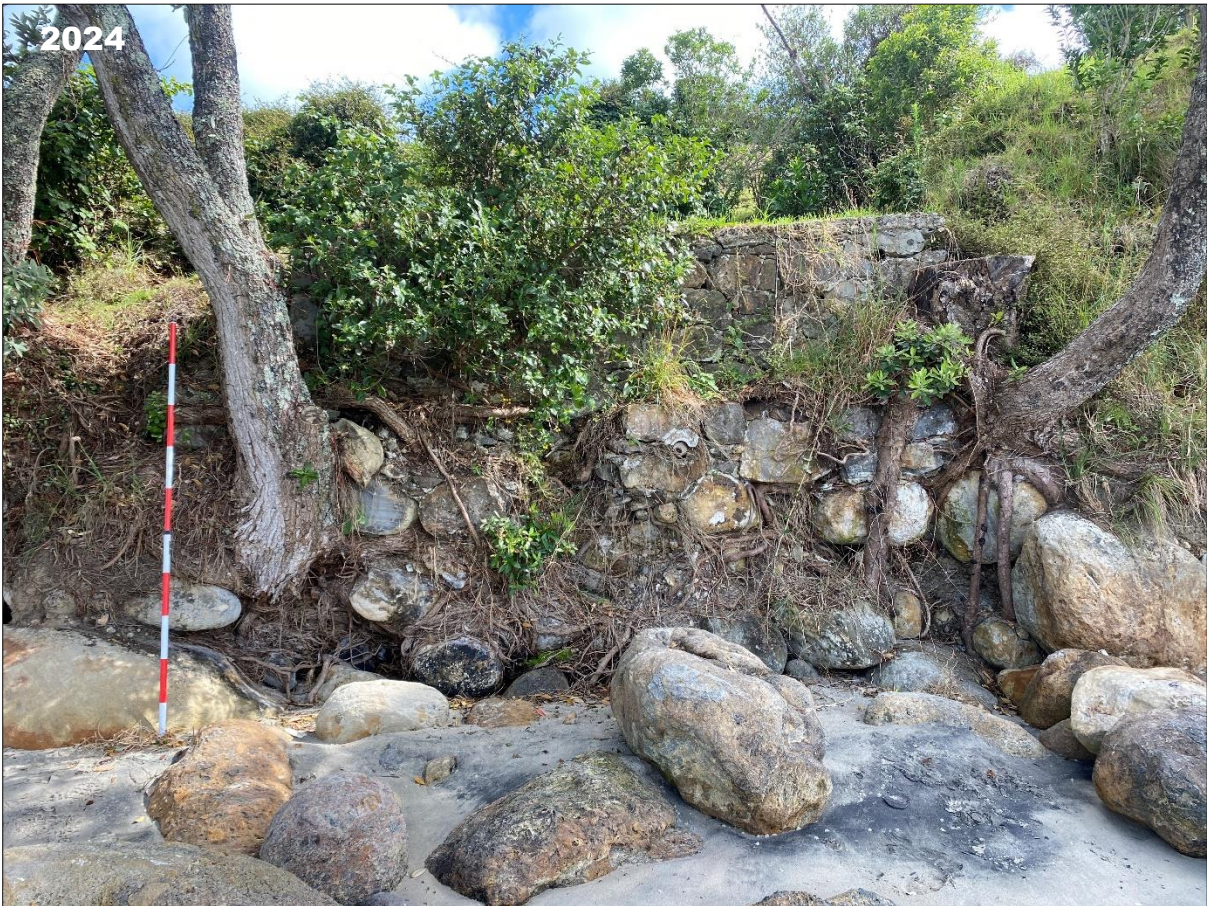
Monitoring Site 2

Iron Jetty and surrounds

Notes: Vegetation on the bank has reduced, but there is on-going invasion by sycamore as well as rabbit burrowing activity (location of survey pole in 2024 image), karaka growth has improved. On going active management of the trees on the concrete face of the jetty is required, although much improved since 2018. The view shaft to the iron debris has been well maintained.

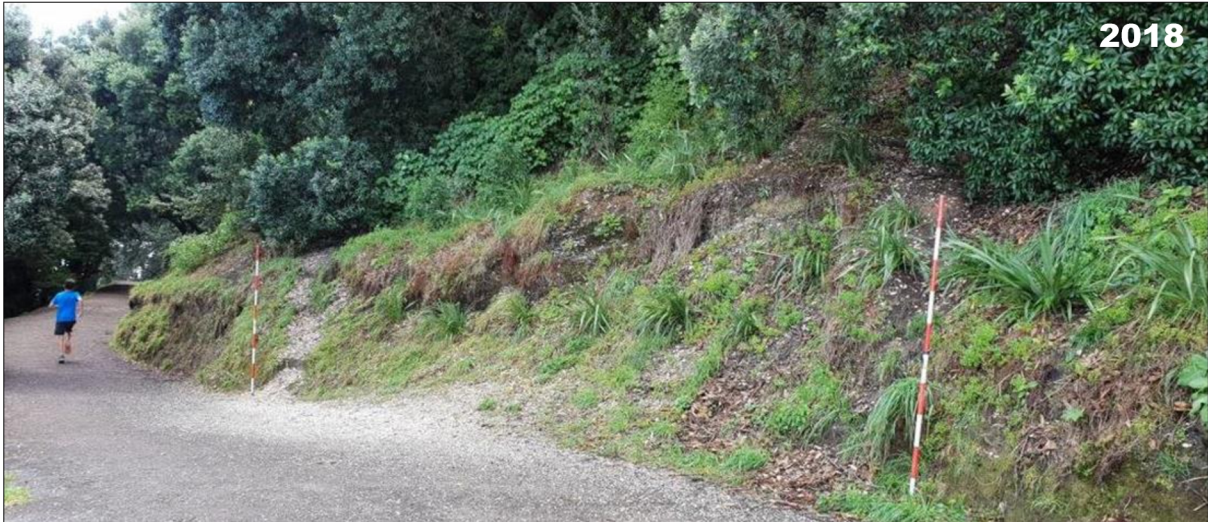
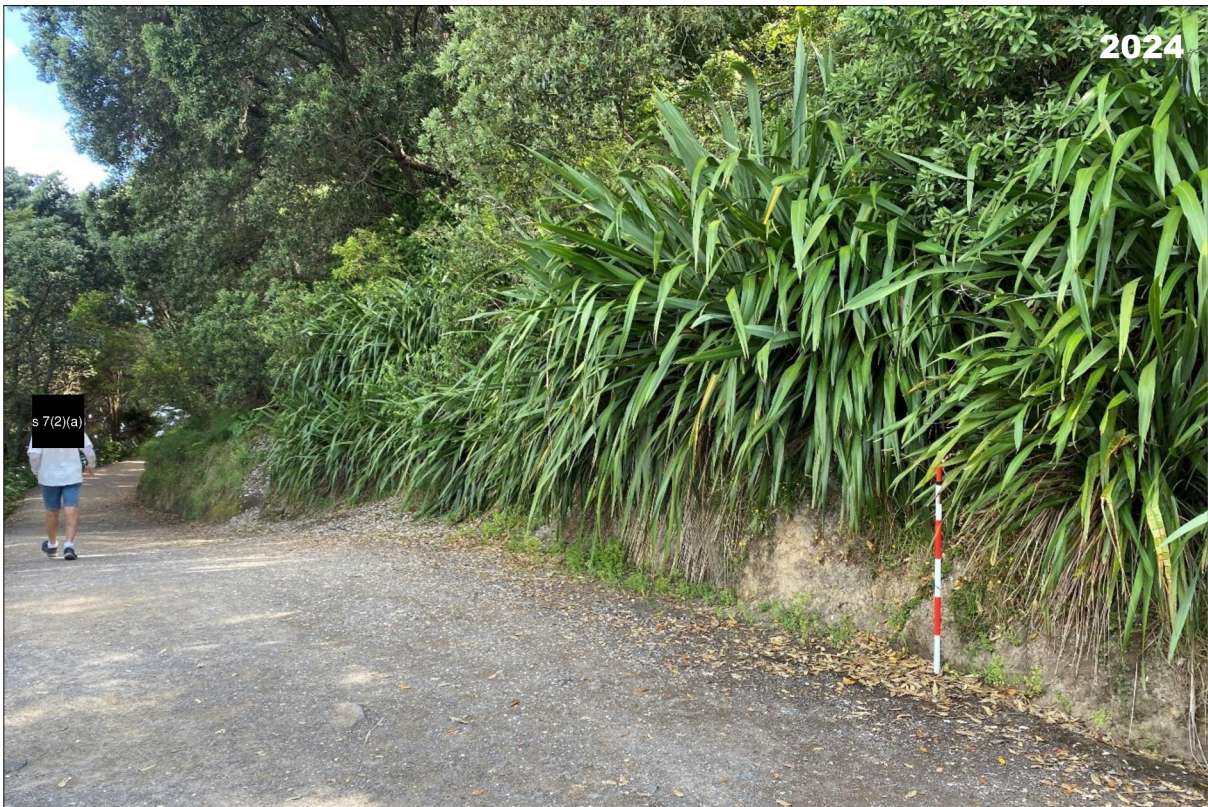
Monitoring Site 3

Base Track midden erosion

Notes: Significant advance in vegetation cover over the monitoring period and the eroded face is covered by flax. Very little shell is actively eroding onto the path. The weight of the flax should be monitored.

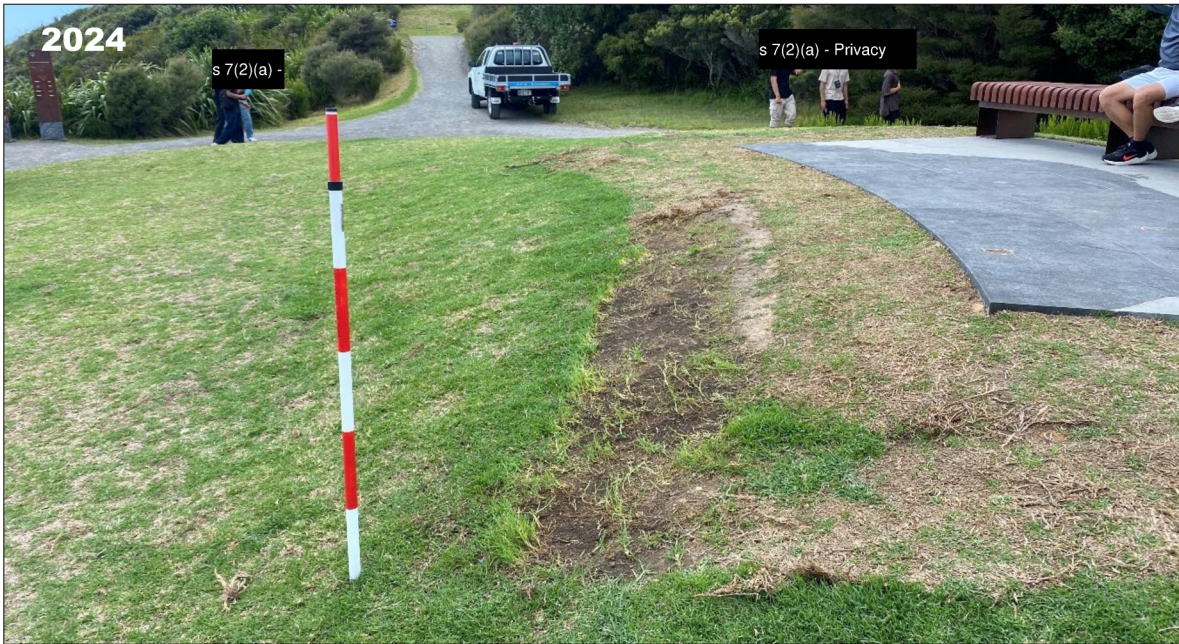
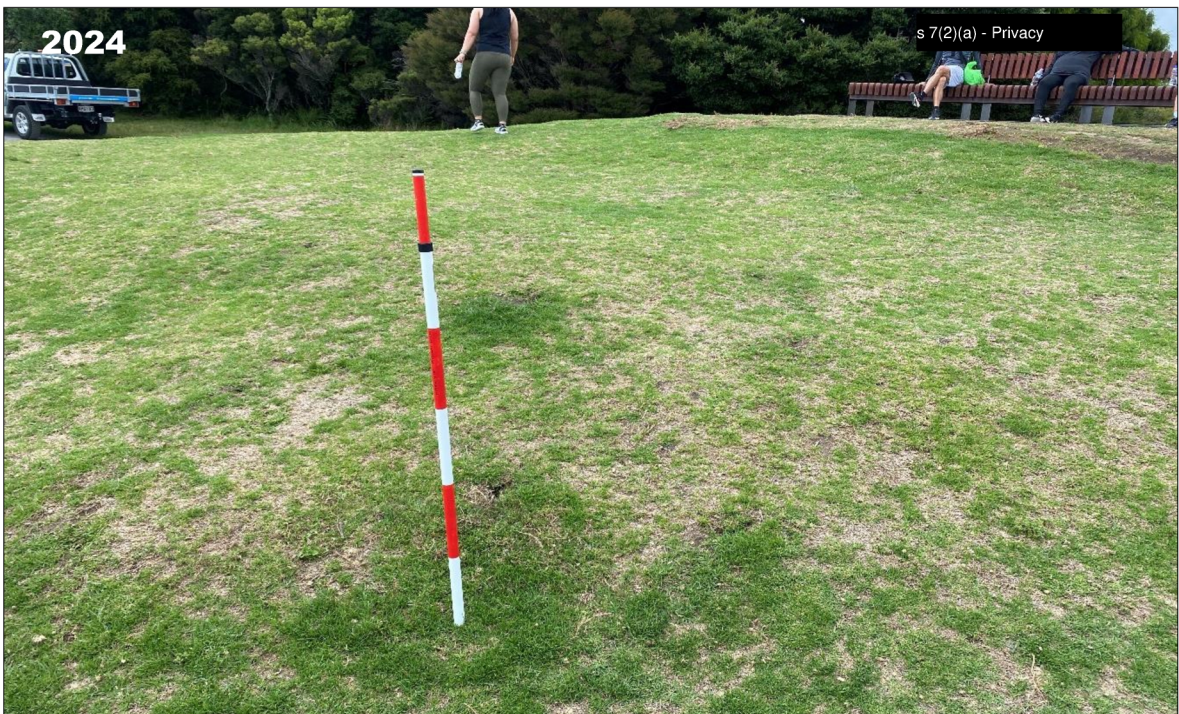
Monitoring Site 4

The Lower Summit

Notes: Newly added monitoring point. Interpretation place on lower summit. There is some wear on the grass from informal visitor tracks to get to the bench, as well as rabbit damage in the grass and some loss of the capping material which has exposed the edge of the concrete plinth.

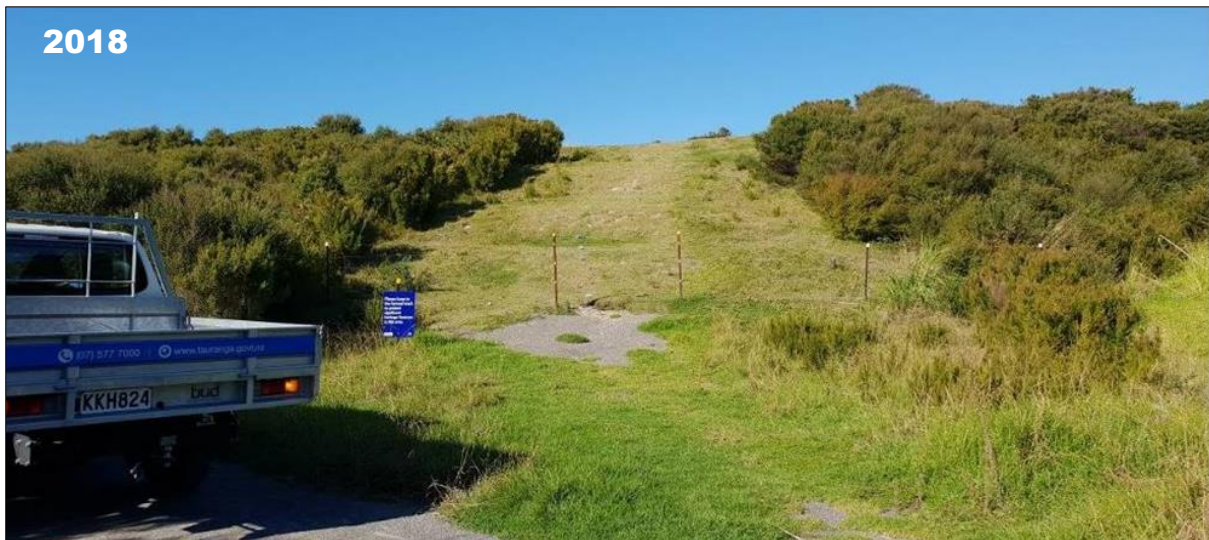
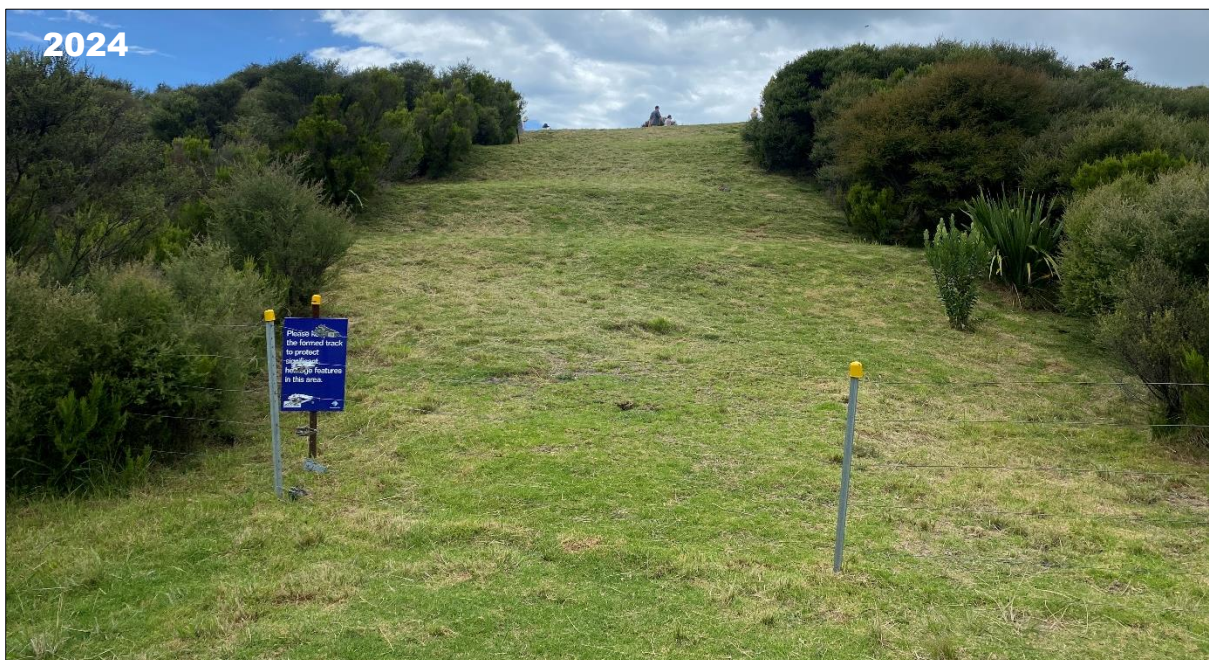
Monitoring Site 5

Repairs to summit terraces

Notes: Repair to terraces completed in 2013. The aggregate at the base of the slope was not moved as recommended as in 2019 but is now less visible. Grass cover much more robust than in 2018. Encroaching vegetation has been managed to keep terraces visible but requires on-going monitoring. There is evidence of rabbit damage which will require active management.

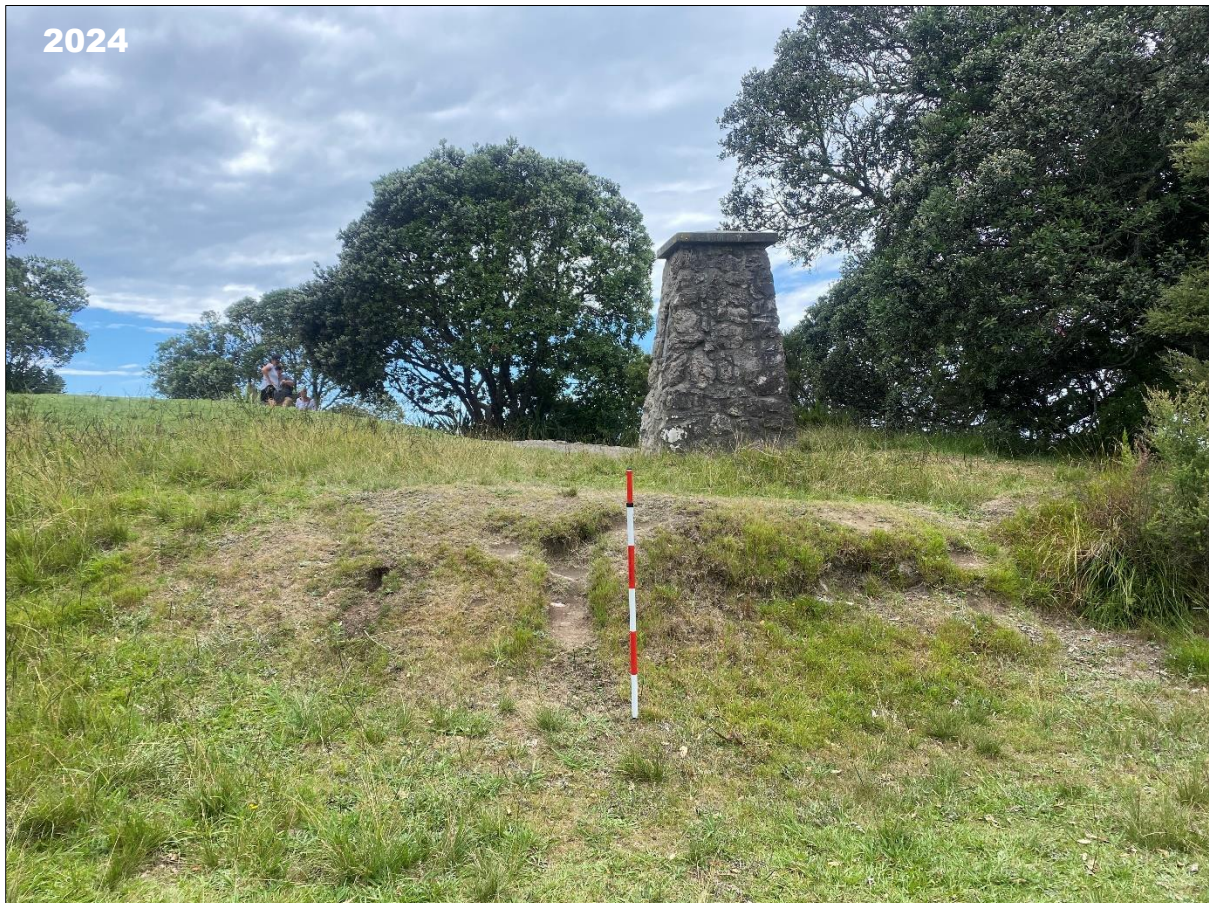
Monitoring Site 6

Terrace back scarp on summit

Notes: Newly added monitoring point. Monitoring the capping, as the terrace back scarp has visitor wear and there is also rabbit damage.

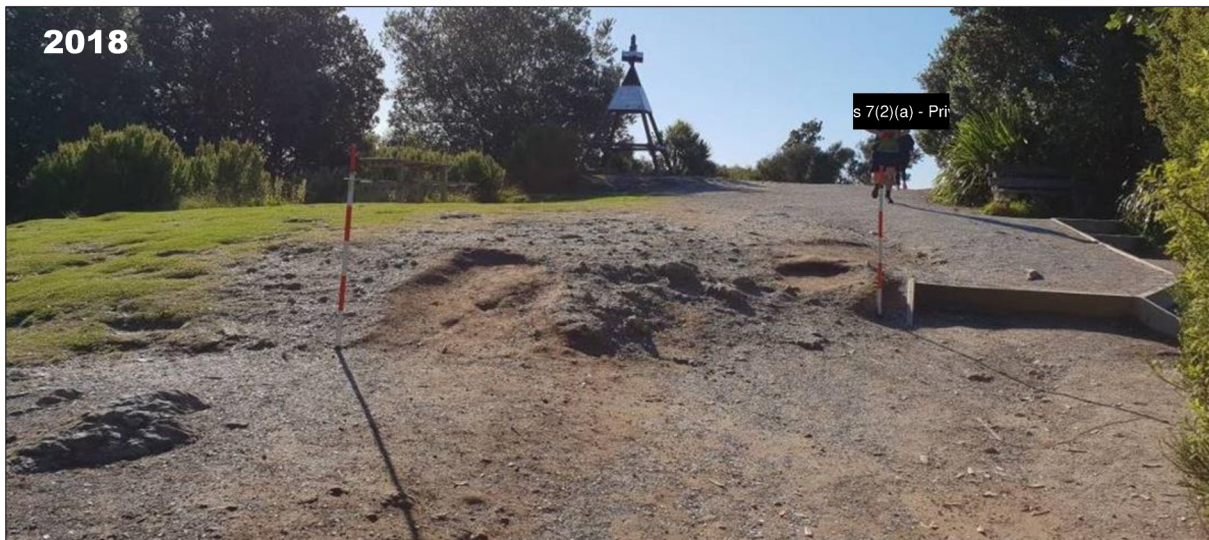
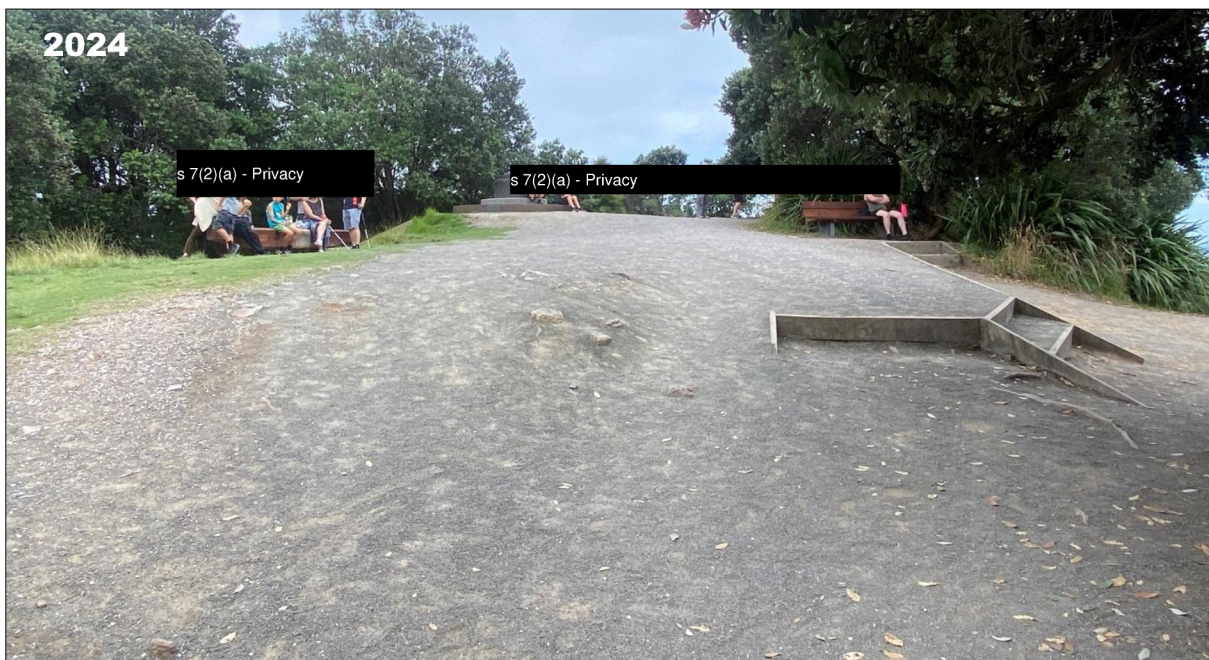
Monitoring Site 7

General monitoring of summit wear

Notes: The summit area has been redeveloped as part of the interpretation and placemaking project and has resulted in greater ground cover, but there is on-going wear of the imported armouring material on the summit and on-going recapping is required by bringing in additional material from the stockpile. Monitoring should continue. Trig was removed in June 2021, replaced with touchstone.

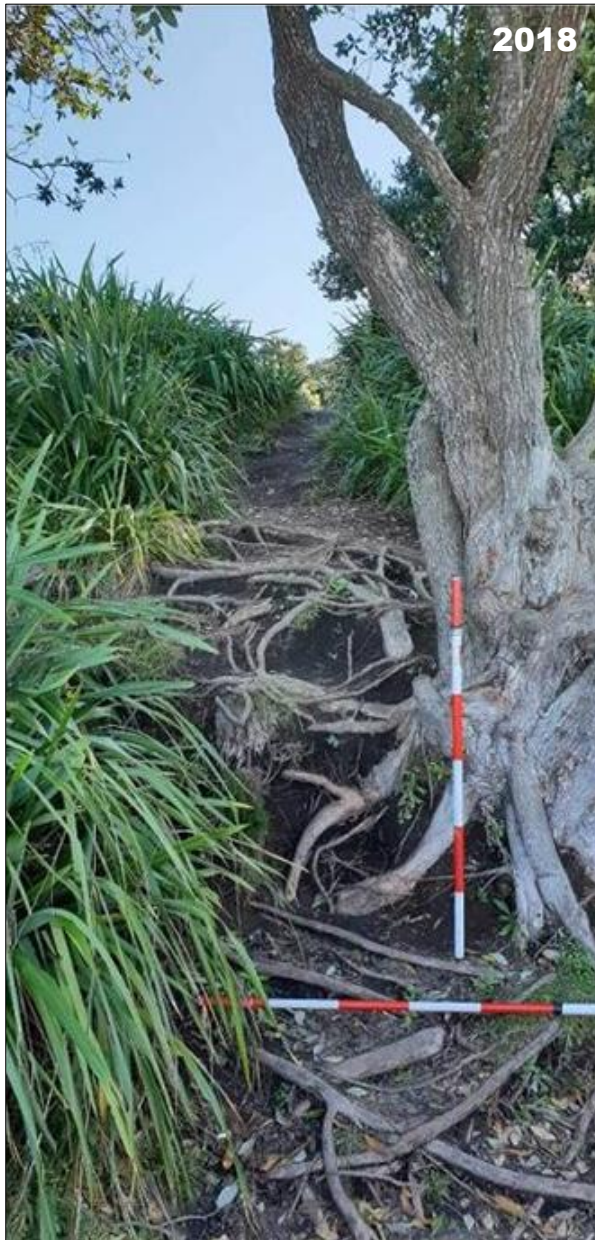
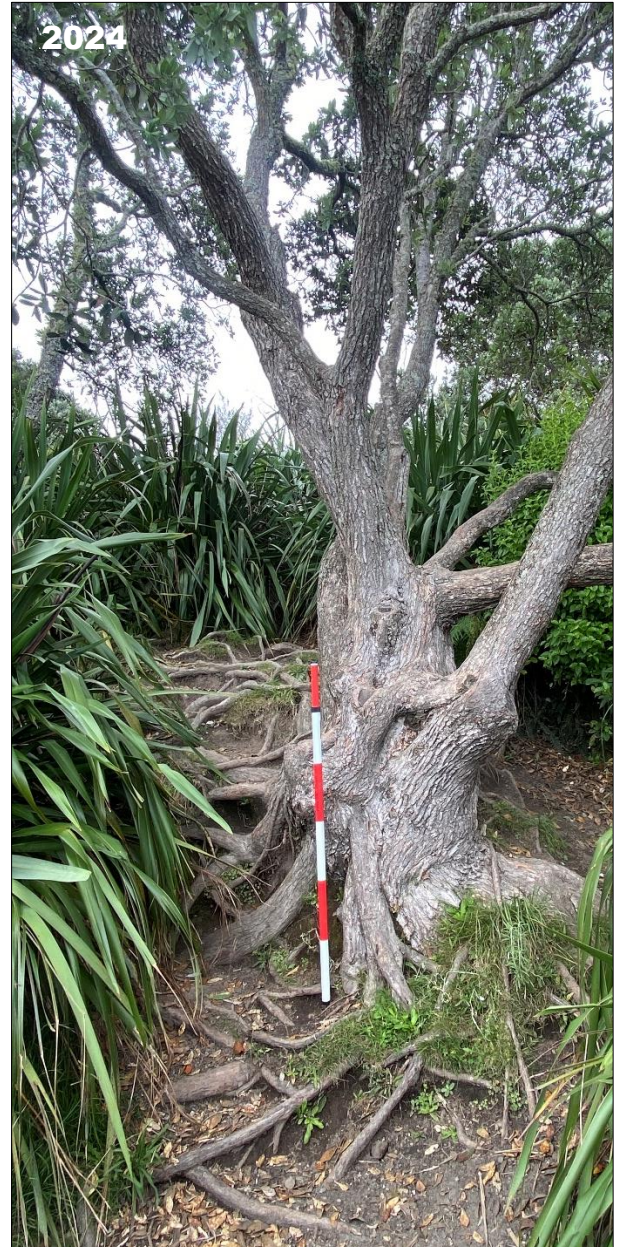
Monitoring Site 8

Desire line tracking on summit

Notes: Action to block access with planting and a fence installed in 2023 has seen a significant reduction in wear to the intact archaeological deposit. Additional fill material which was placed around the tree remains intact.
