Archaeological Site Condition Monitoring Report –
Authority no. 2023/244
Mauao Historic Reserve, Tauranga

ARCHAEOLOGICAL SITE
CONDITION MONITORING REPORT
AUTHORITY NO. 2023/244
MAUAO HISTORIC RESERVE
TAURANGA

29 February 2024

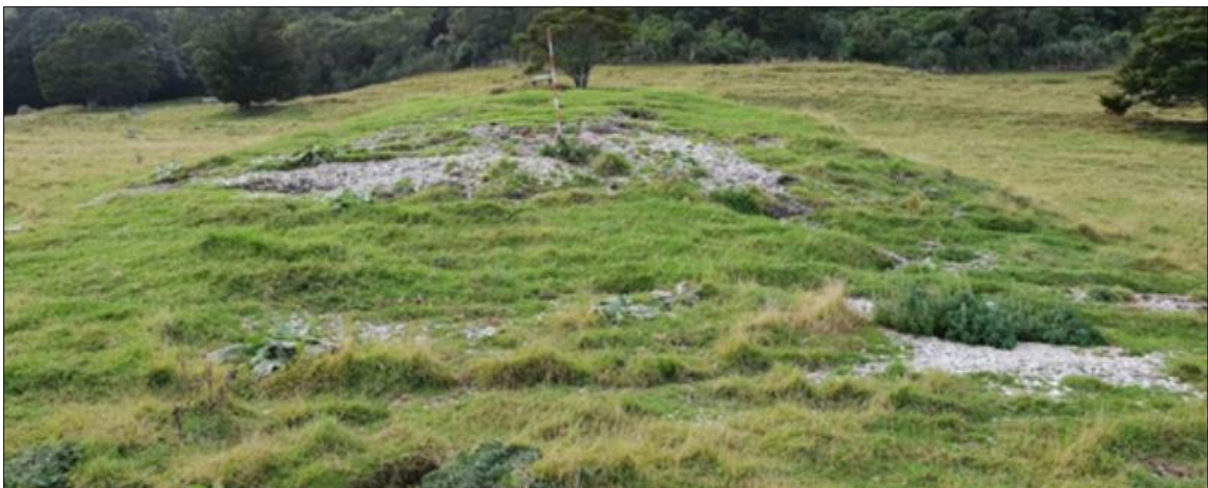
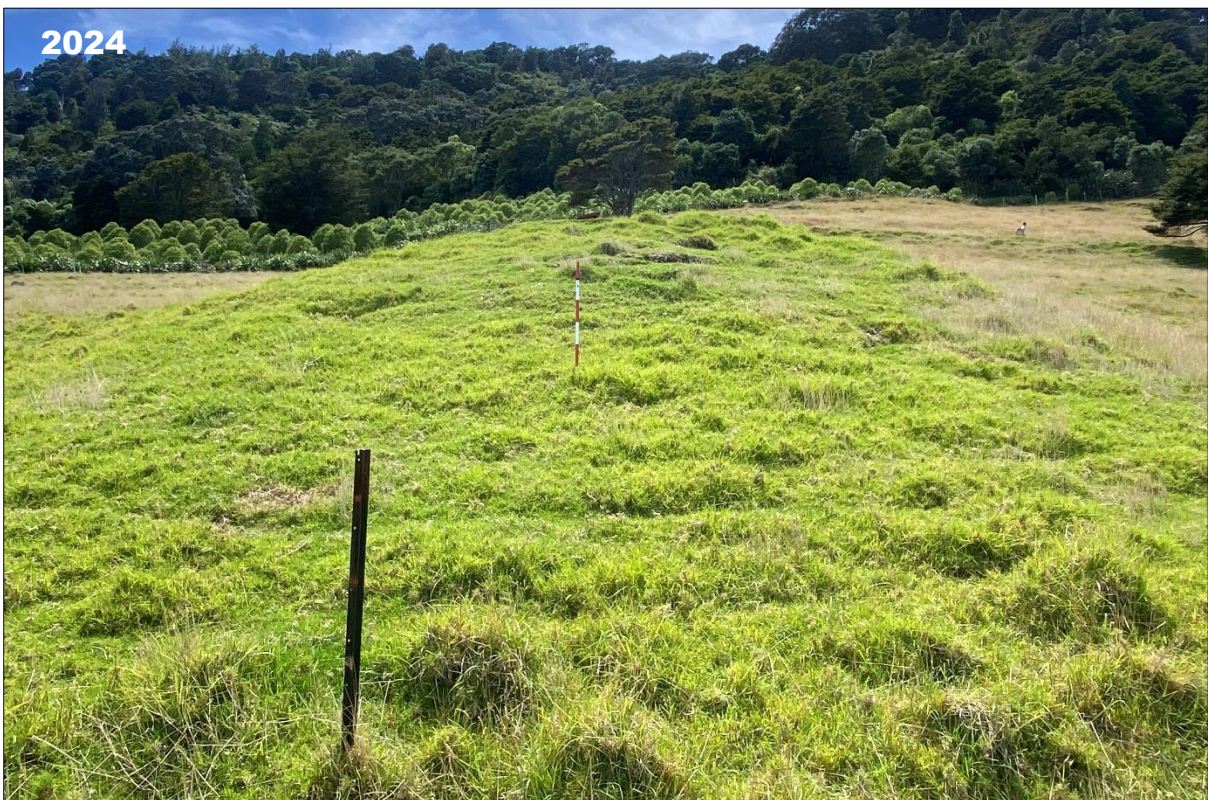
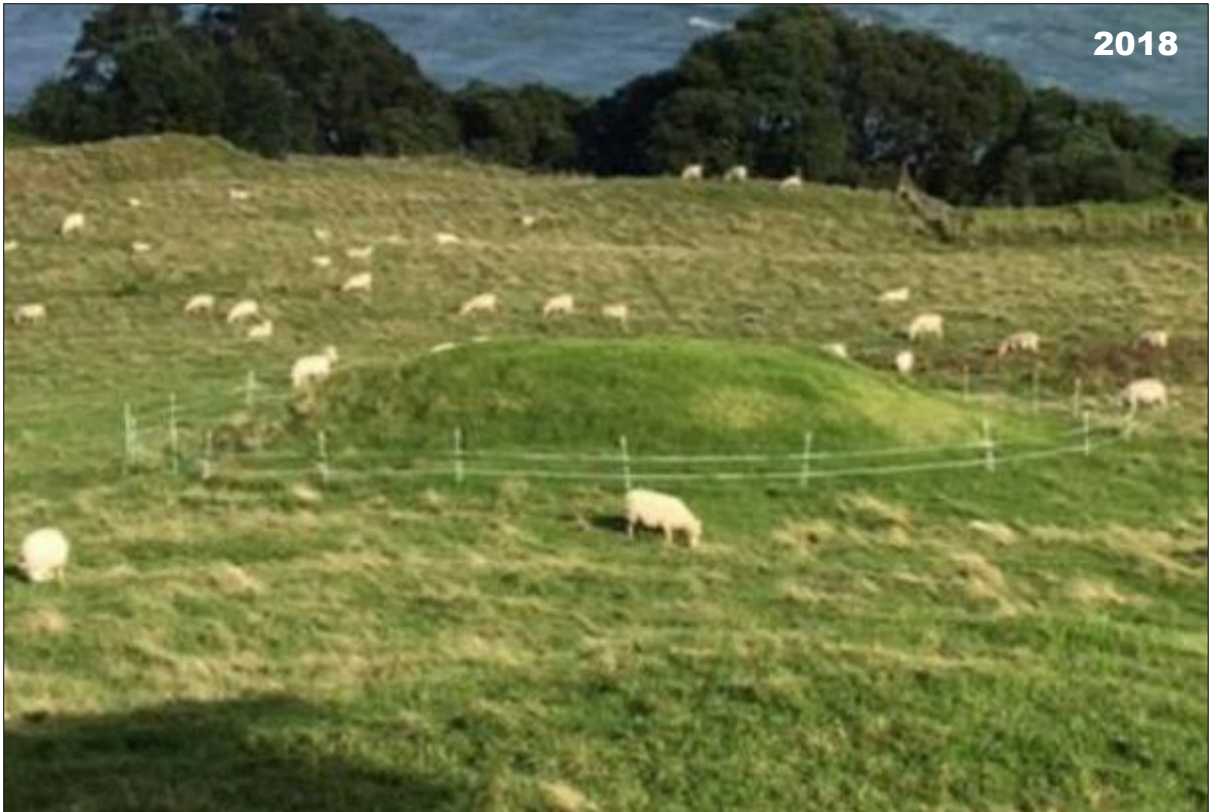
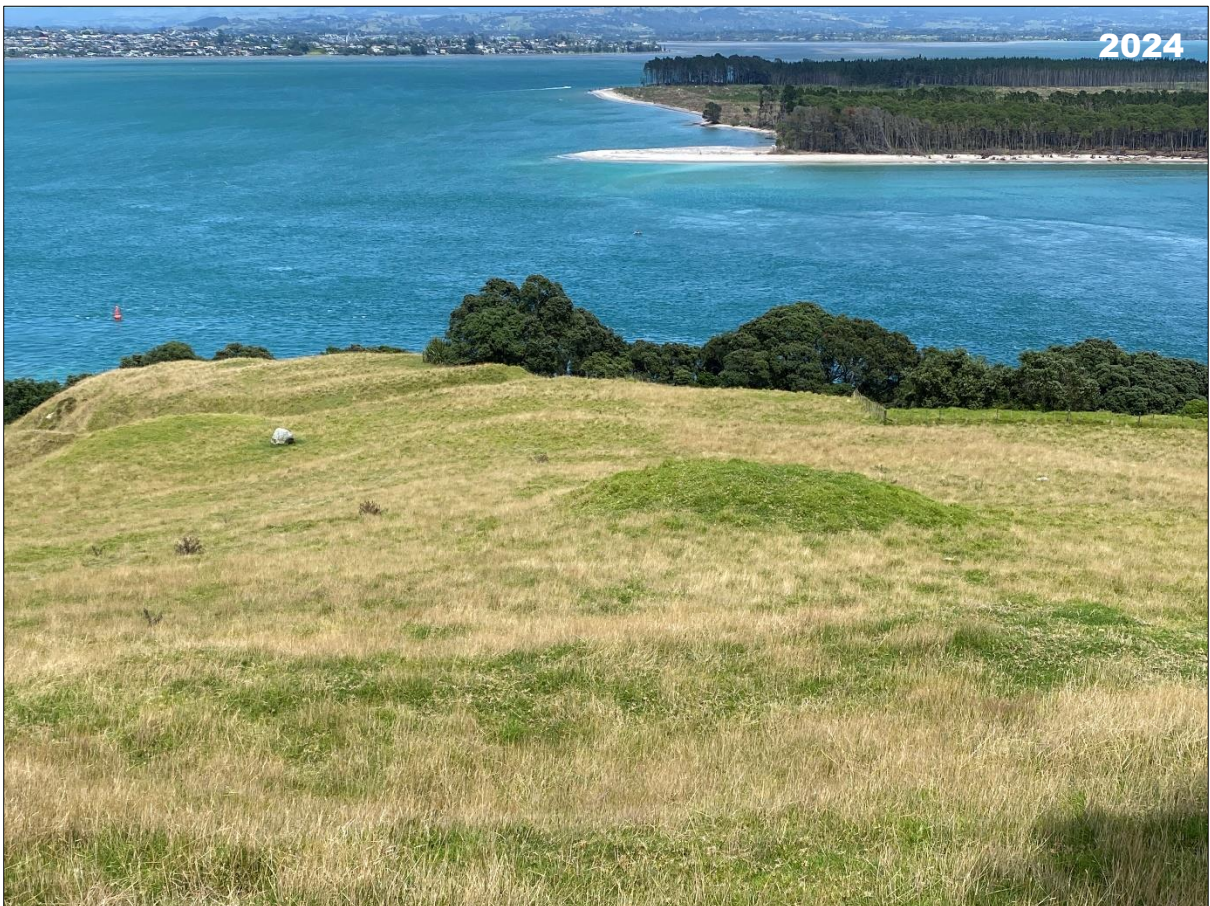
Monitoring Site 9

Erosion on Shell Mound – Stock and Vegetation Management

Notes: The temporary exclusion of stock from the shell mound in 2019/20 successfully established a good grass sward which has been maintained. The mound is significantly more stable now than when monitoring started in 2018. Rabbits are attracted to the shell, and so it is important that the dense sward and low numbers of rabbits are maintained.

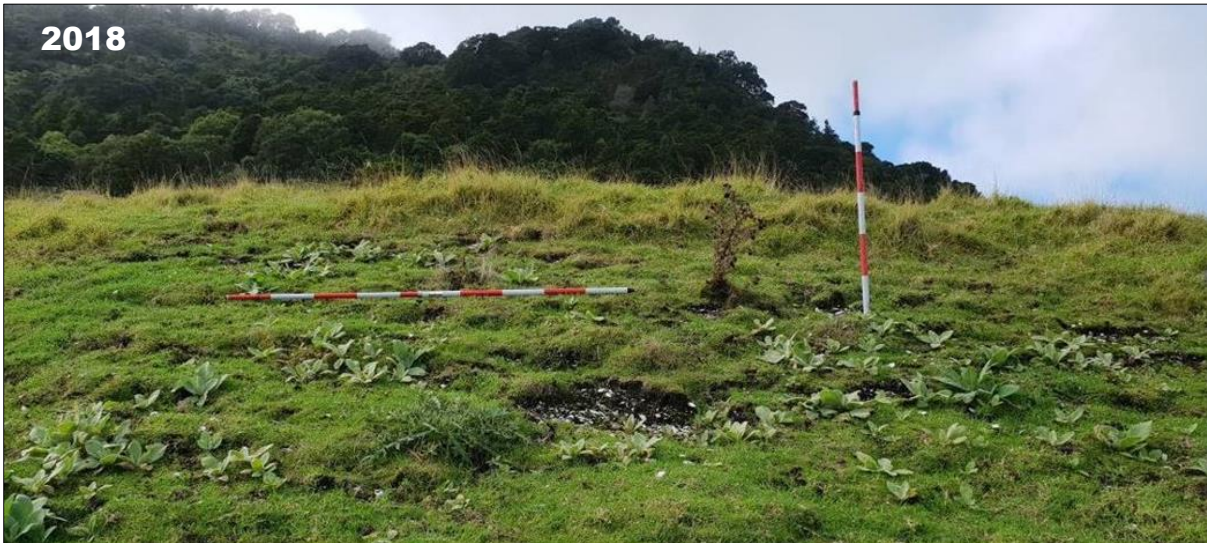
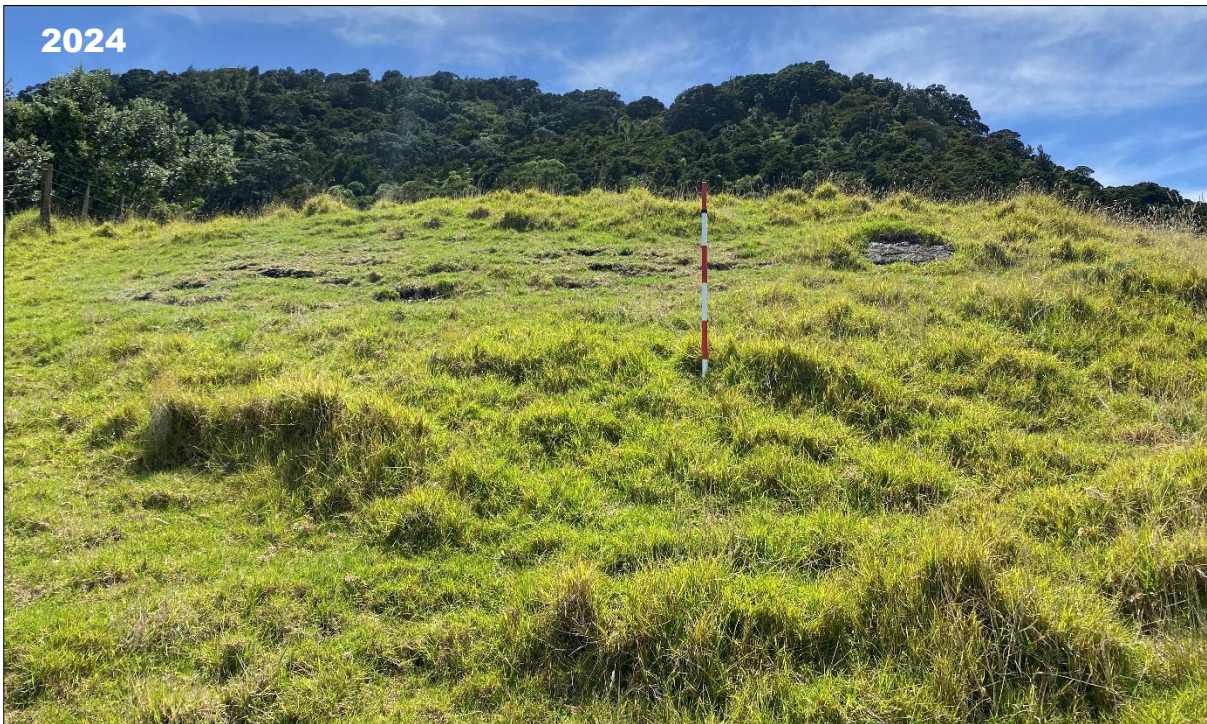
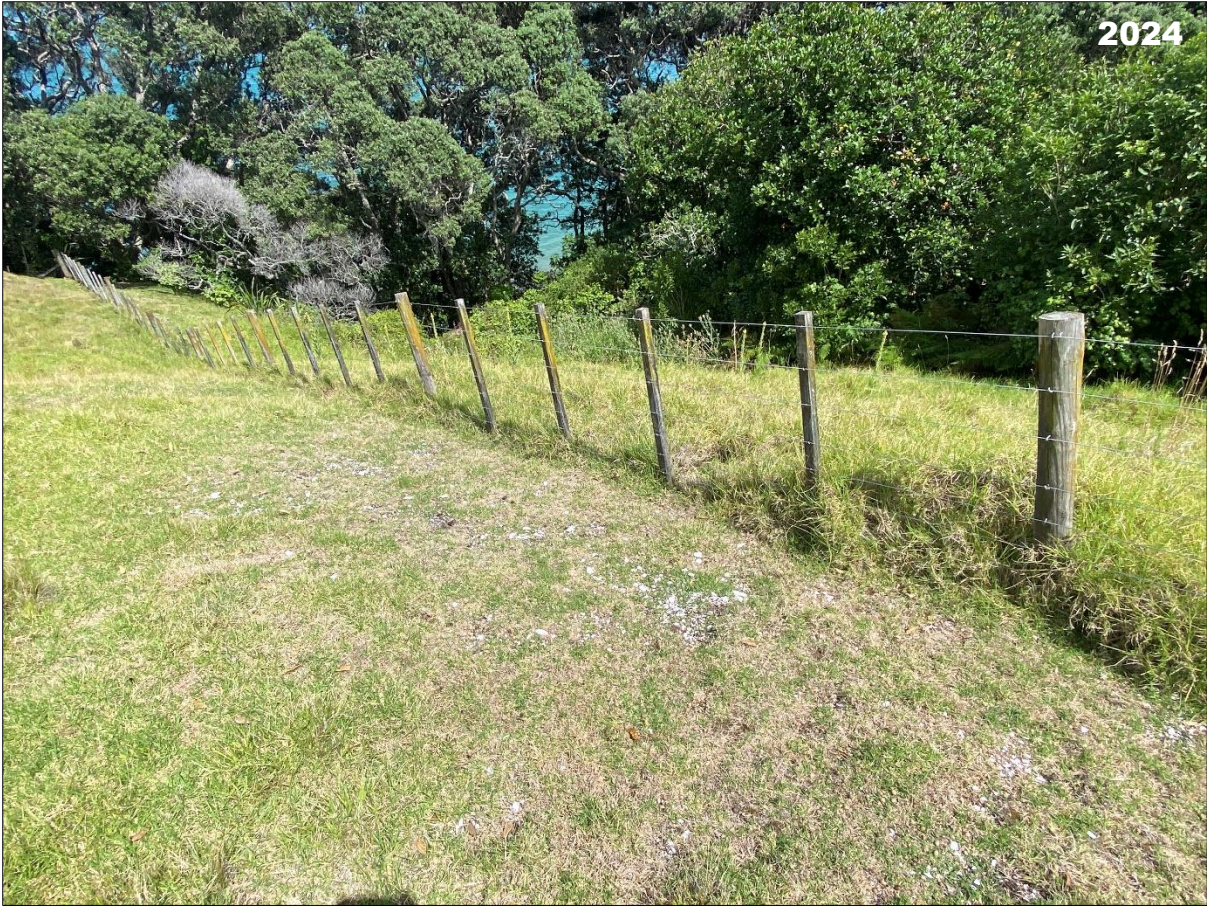
Monitoring Site 10

Rabbit Damage (active)

Notes: Vegetation cover has improved as greater rabbit control measures are in place, but this should be closely monitored as there are still active rabbit burrows and accessways visible along the fence line which has exposed midden. Monitoring should be ongoing as rabbit control is still required.

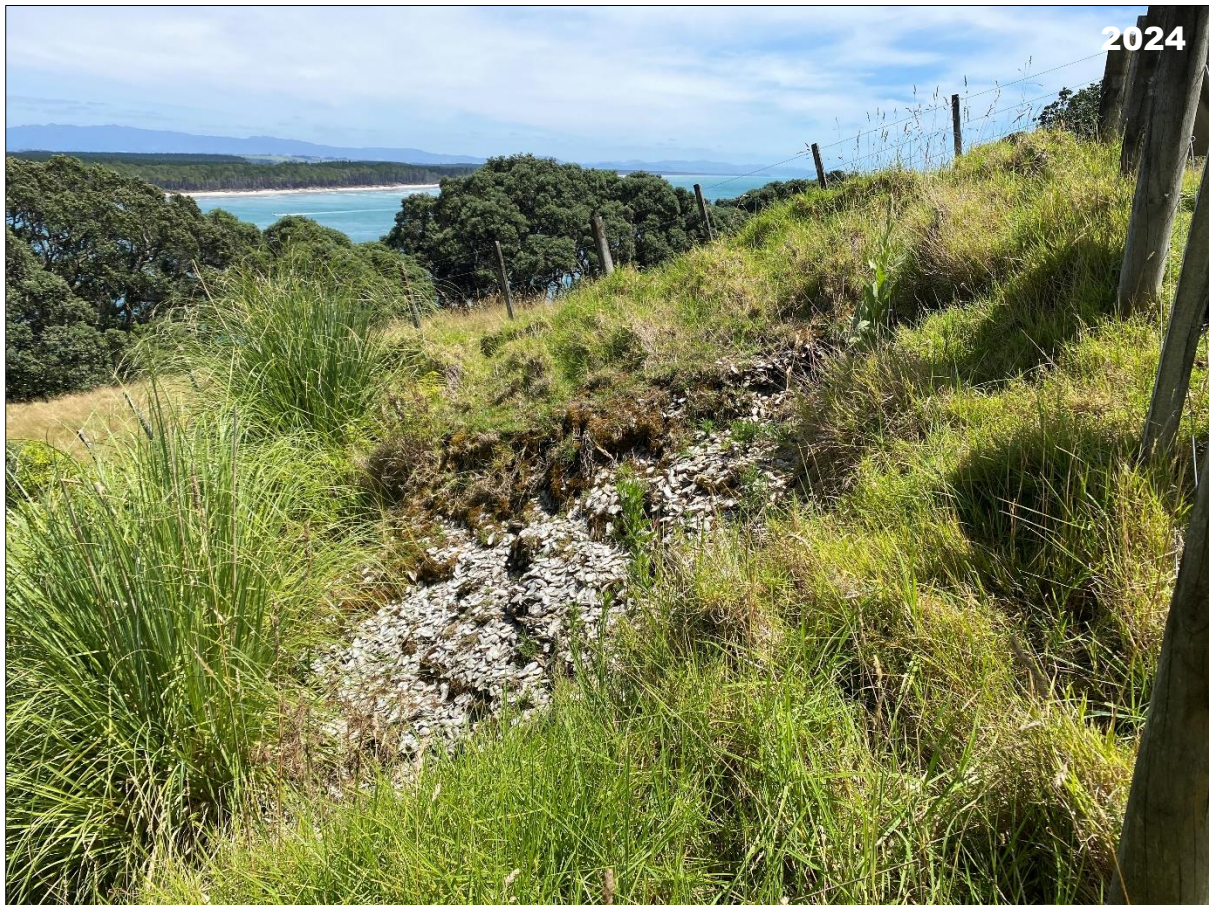
Monitoring Site 11

Midden exposure west end of the Ditch

Notes: Newly added monitoring point. There is a large midden exposure at the western end of the ditch on site U14/173 (Pā). There is active exposure and slope erosion, possible slope failure risk.

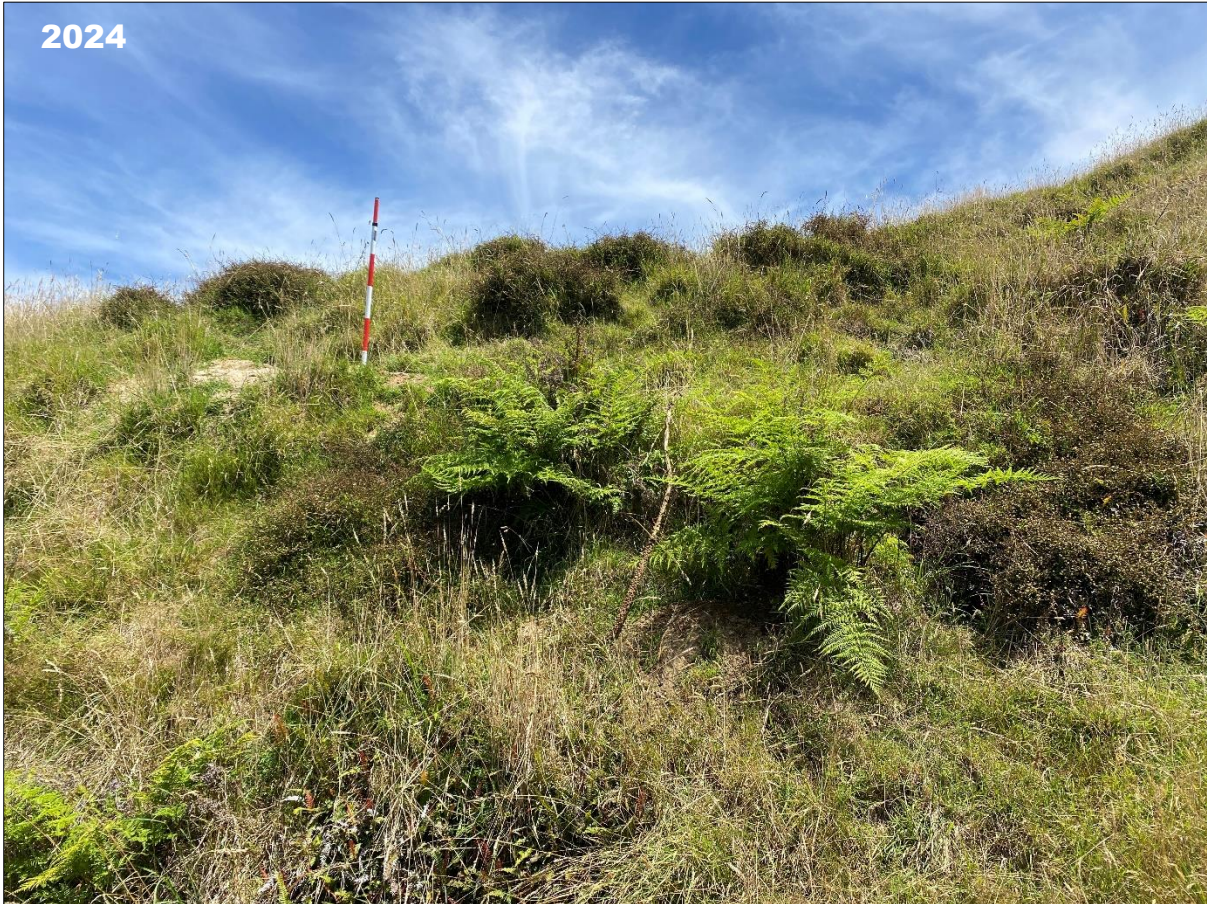
Monitoring Site 12

Rabbit damage eastern slope of Pā

Notes: Newly added monitoring site. Rabbit damage (burrows and accessways) on eastern slope of site U14/173 (Pā), in location of survey pole. Further rabbit control needed and will require monitoring to its conclusion.

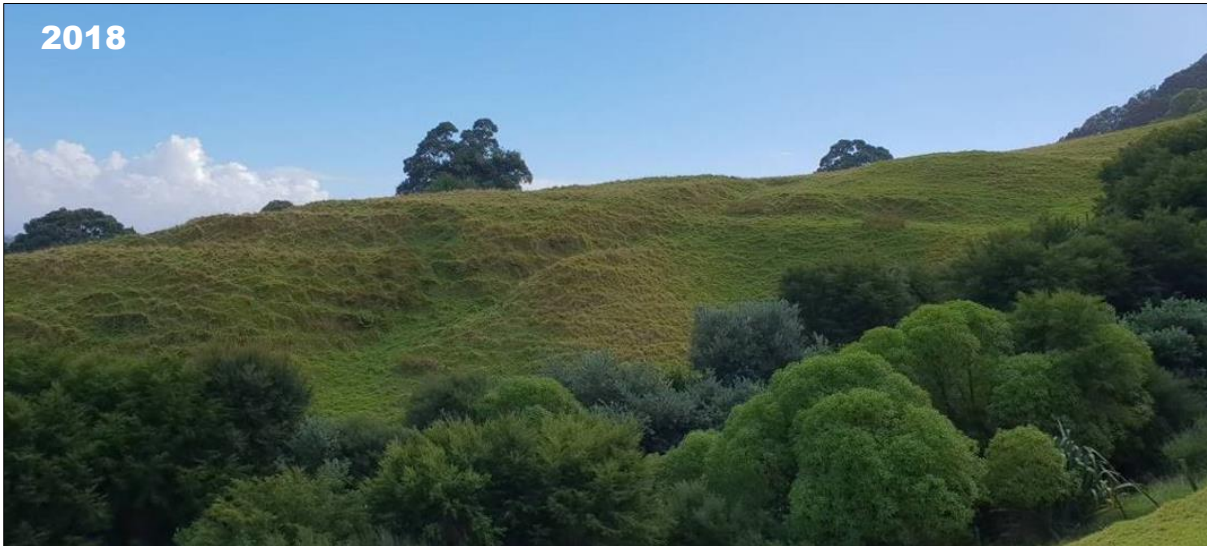
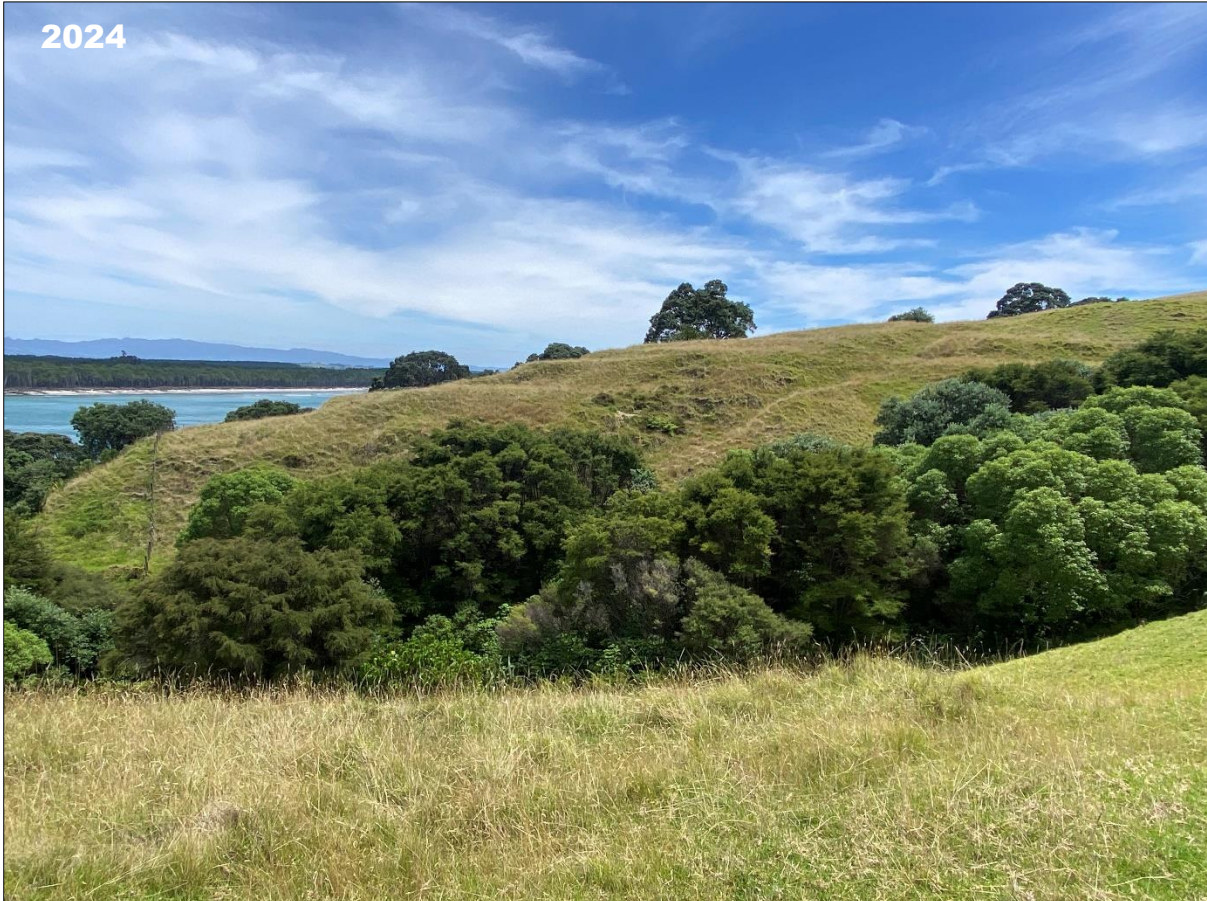
Monitoring Site 13

Pā U14/173 condition/grass cover

Notes: General views across pā to demonstrate grass cover. Site is stable with good ground cover being maintained. Rabbits are active on the eastern side of the pā, requires monitoring and control.

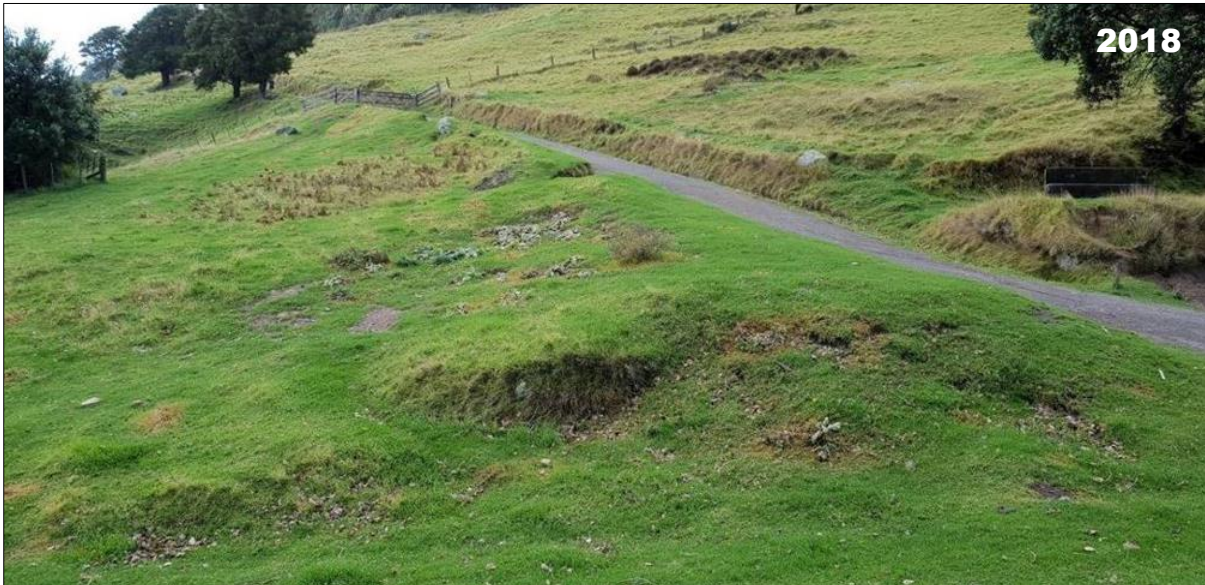
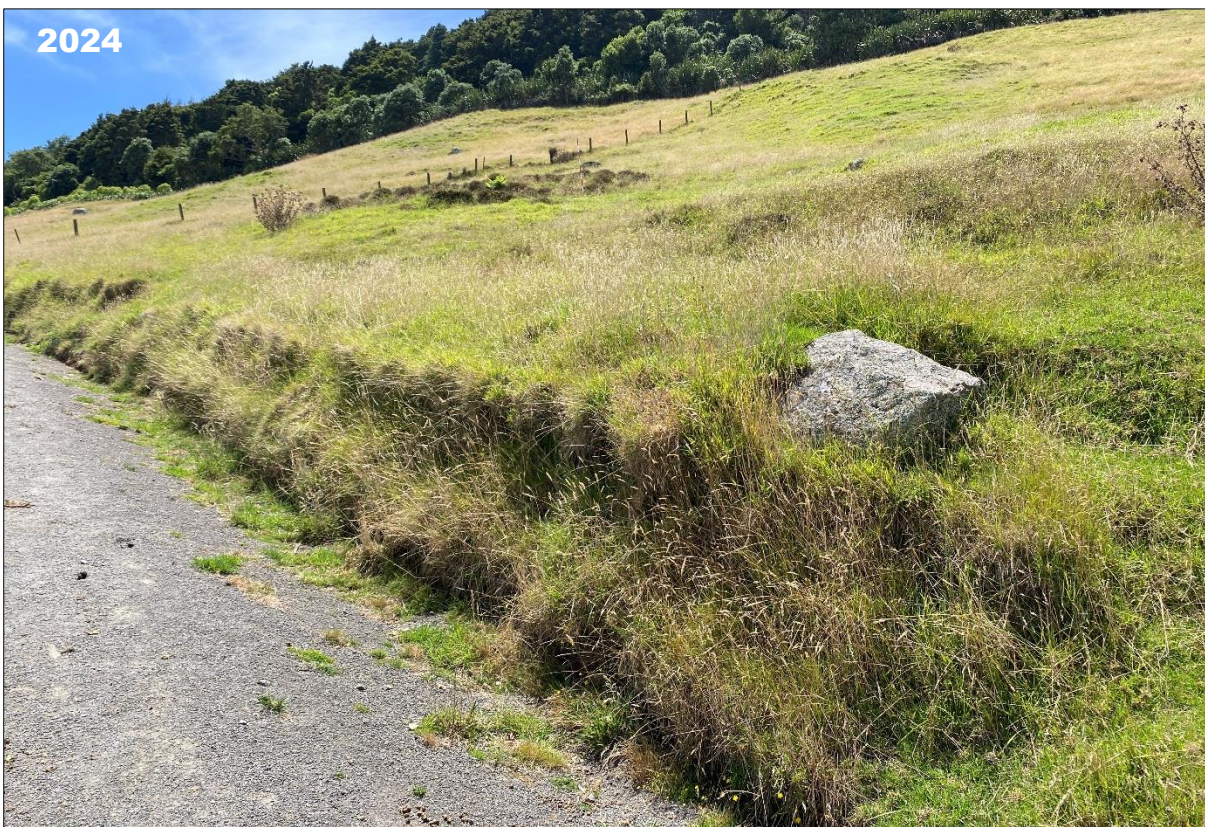
Monitoring Site 14

Midden and vegetation management – Pōhuehue growth

Notes: Pōhuehue cover on midden mounds above water reservoir is stable but has not spread to other mounds since monitoring began in 2018. The grass sward is kikuyu; stock have had access to the mound since December 2019. Stock numbers should continue to be closely monitored and reduced if necessary.

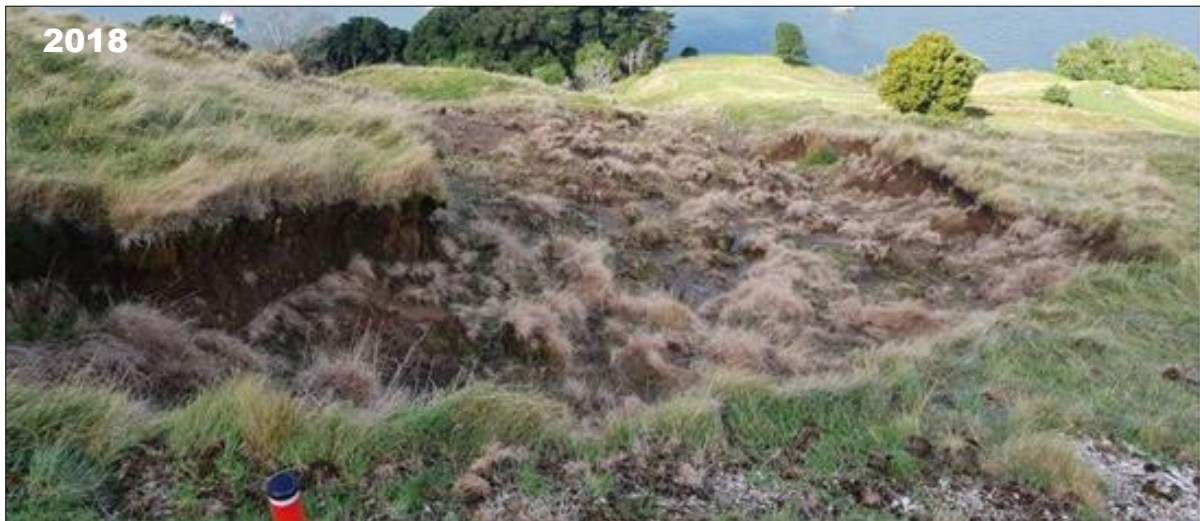
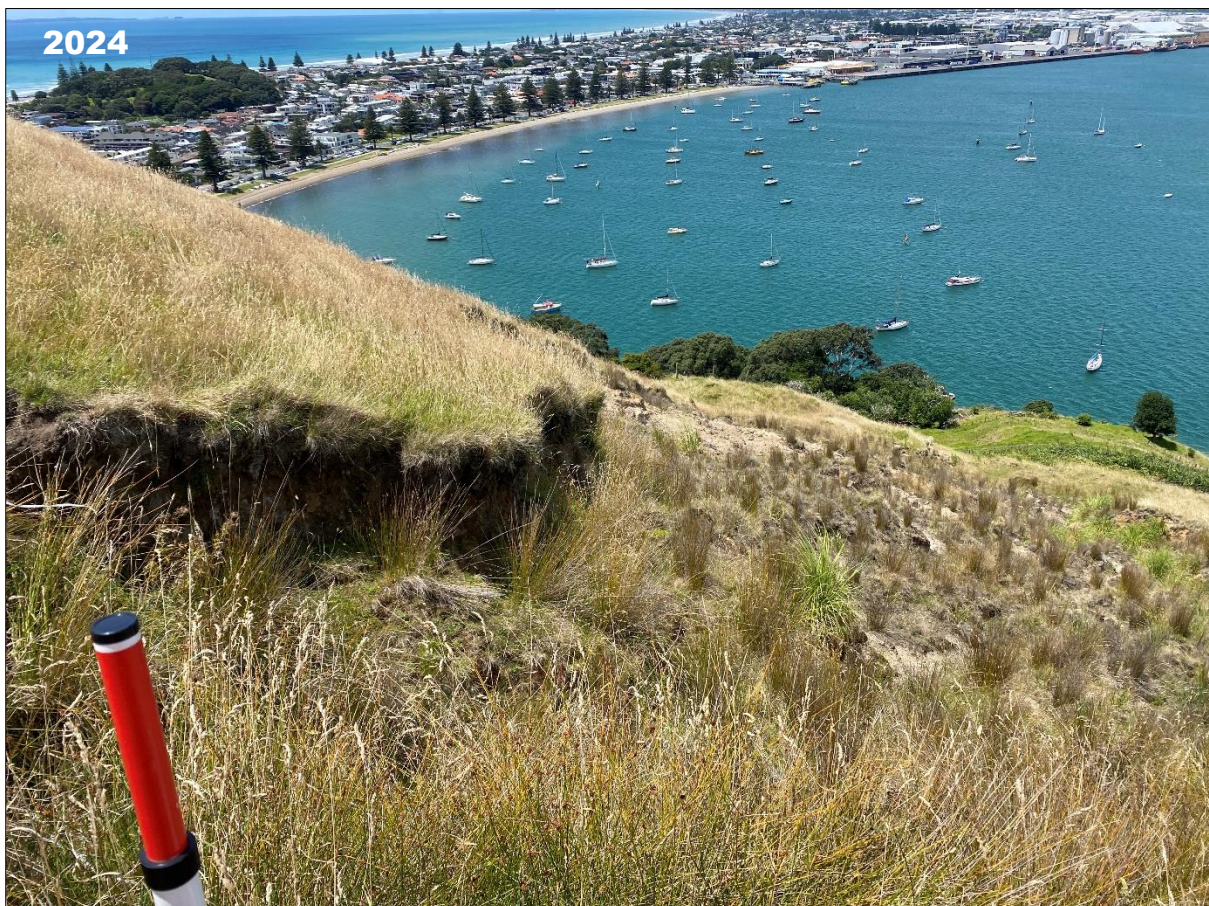
Monitoring Site 15

Land slip on southern slope

Notes: Temporary fencing has failed, the midden is still exposed and the erosion is still active, but not significantly different from the erosion and exposure seen in 2022. Recommend trying netting fencing. Rabbits have damaged parts of features nearby, including in a kūmara pit, needs control.

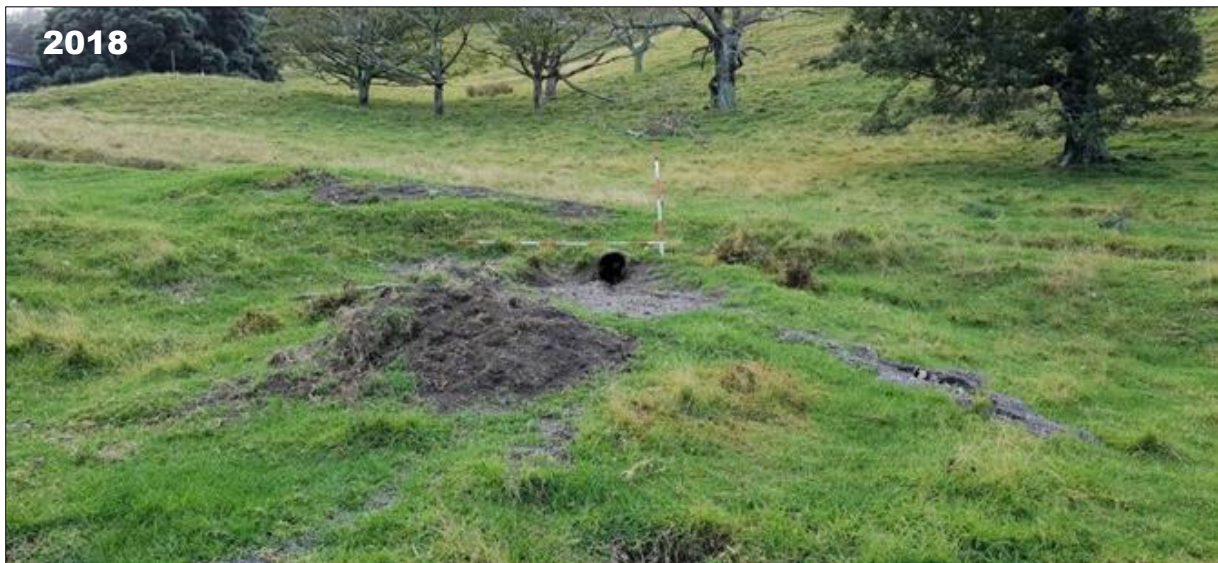
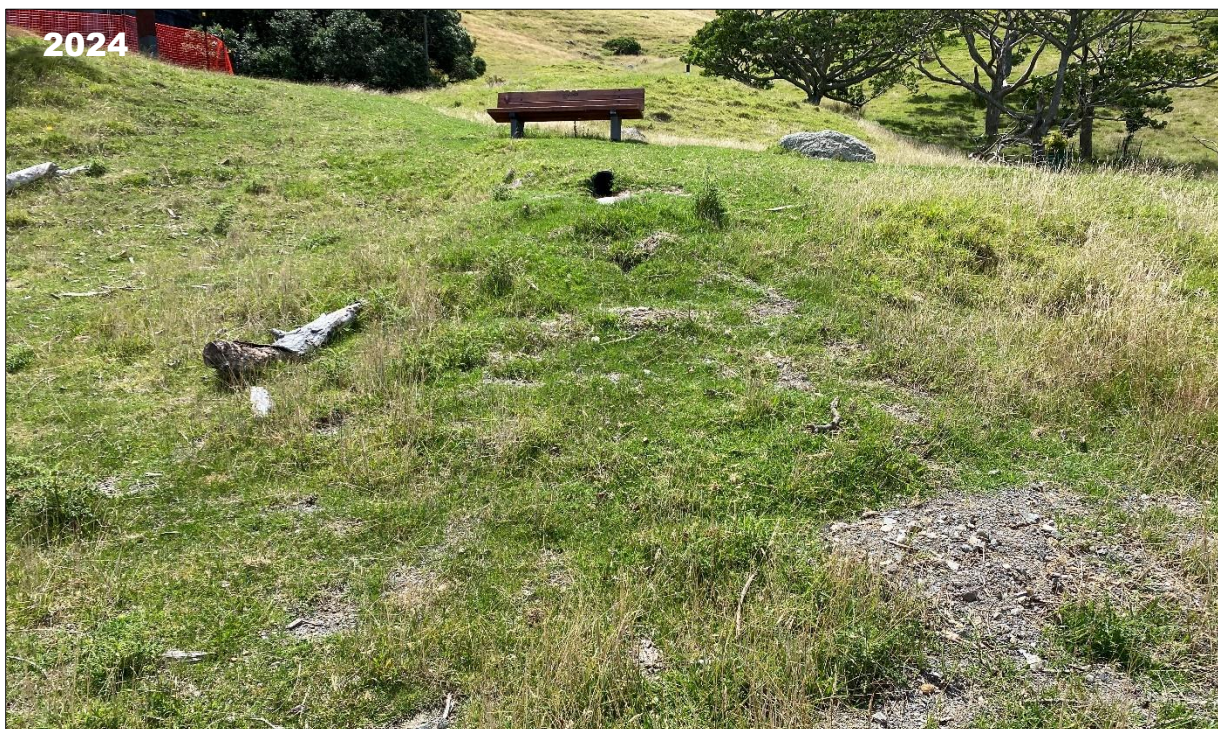
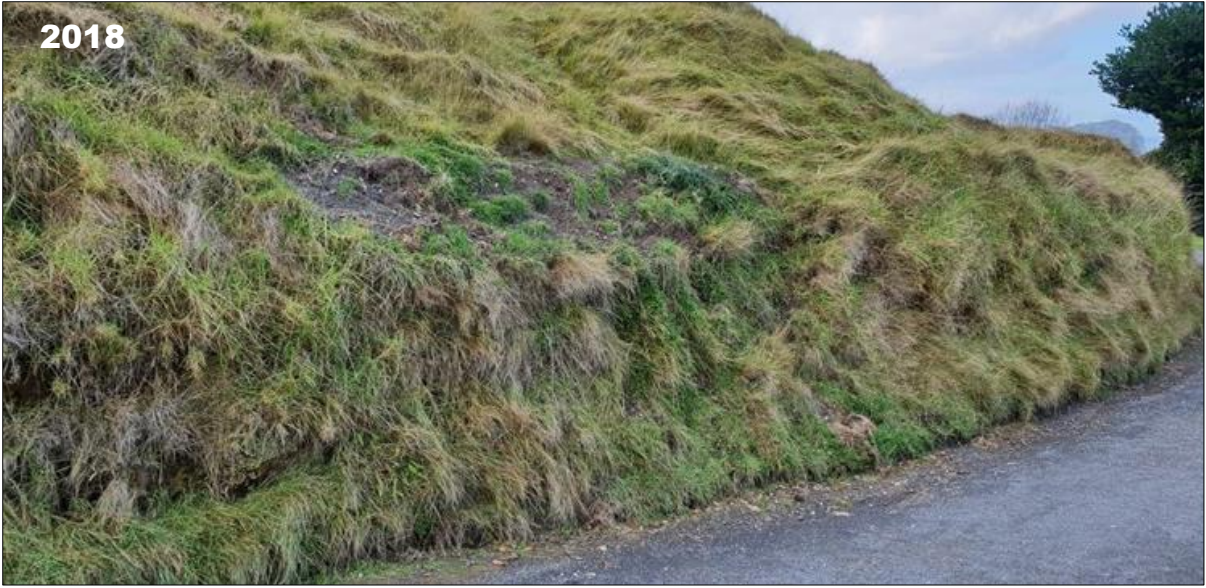
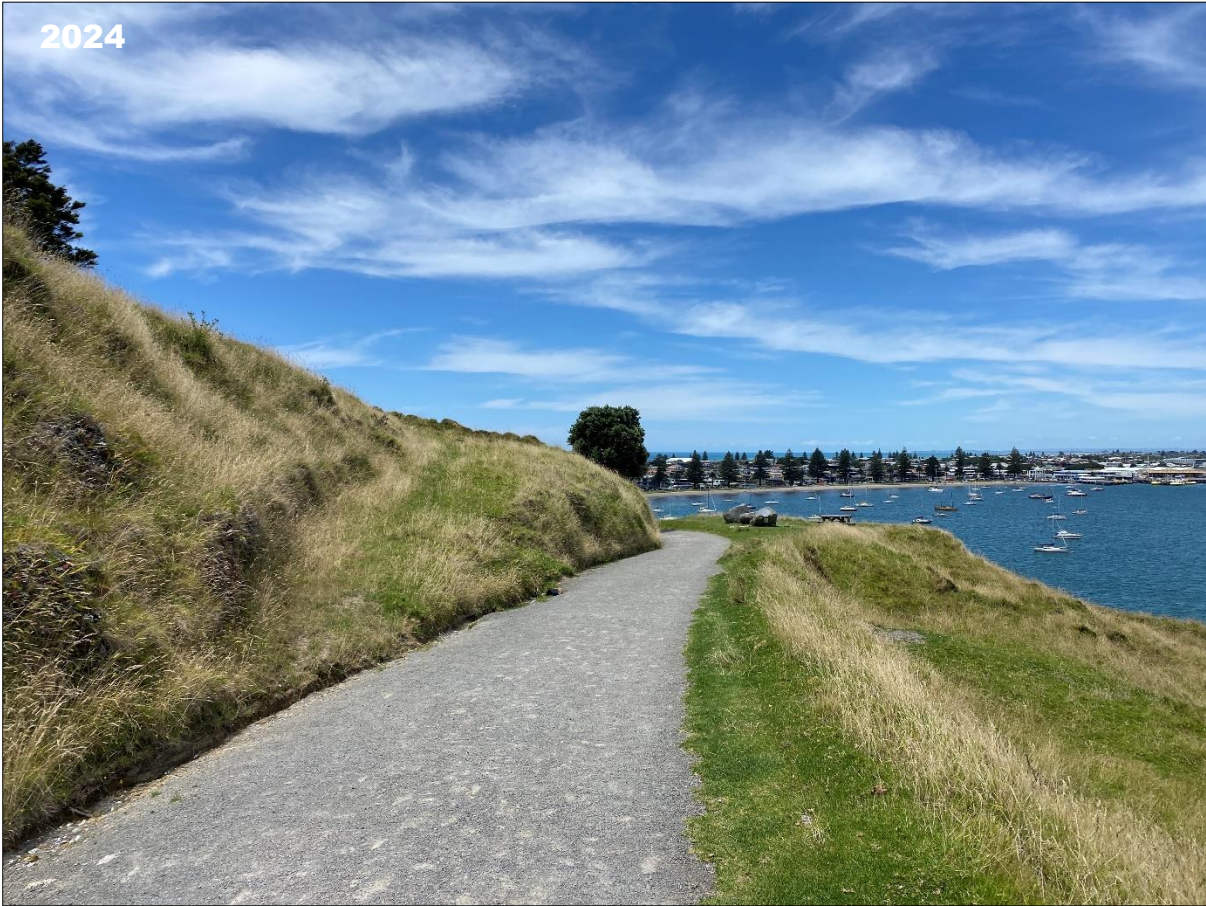
Monitoring Site 16

4WD Track maintenance issues – tailings management

Notes: Built up tailings were removed from terraces with archaeological supervision, although there is still a significant issue with road metal being distributed onto terraces below the track and on-going archaeological monitoring and metal removal is required. The distance between culverts, their function and the treatment of tailings needs further management attention.

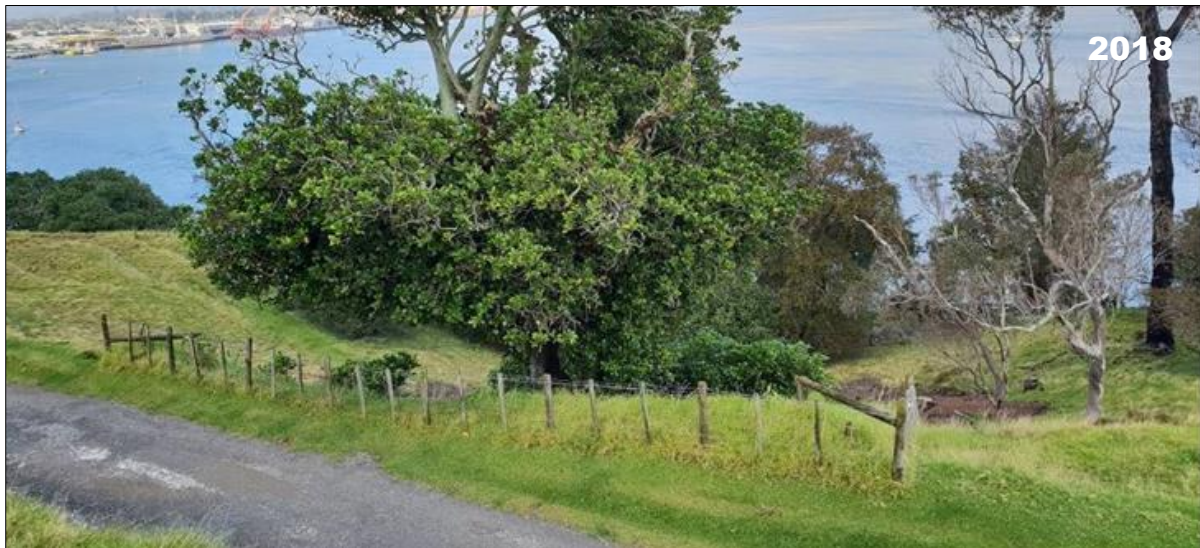
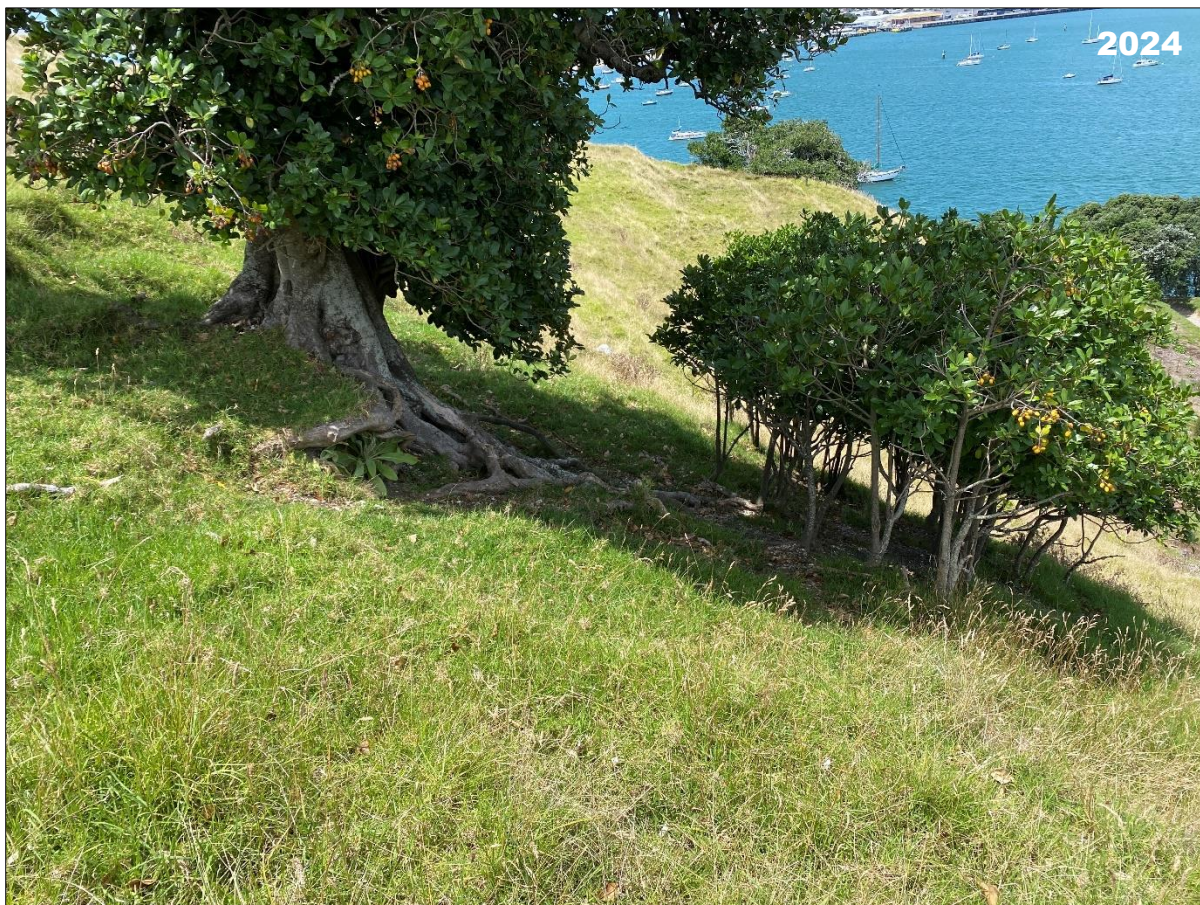
Monitoring Site 17

Fence around Midden on southern slope

Notes: Fence around midden that was installed in 2003 was removed in 2018. Ground cover around karaka and midden on slope well developed.

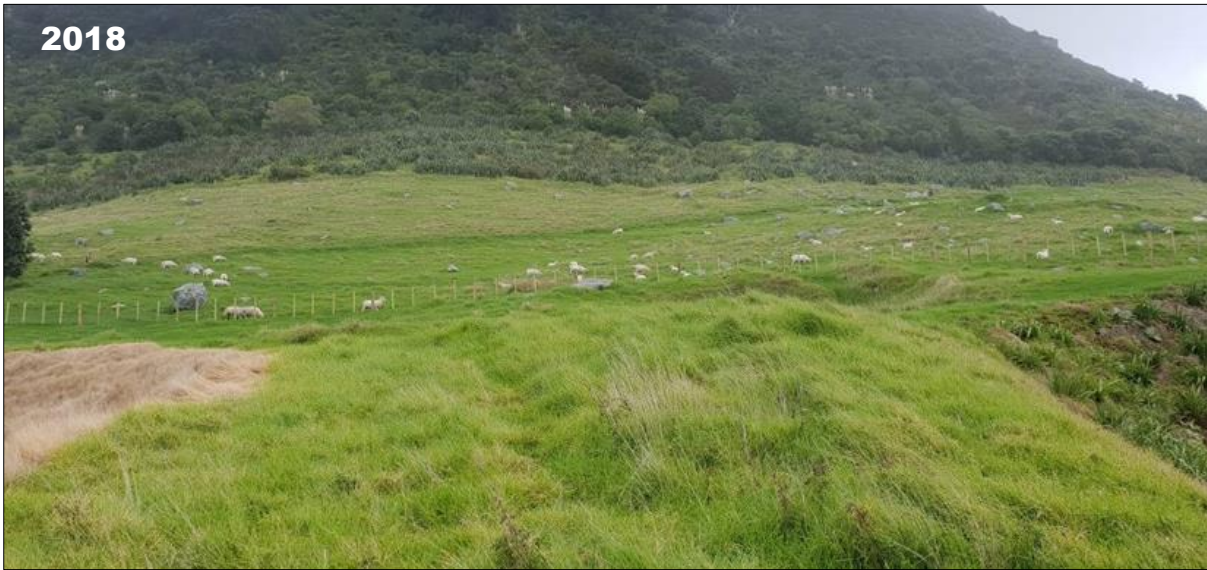
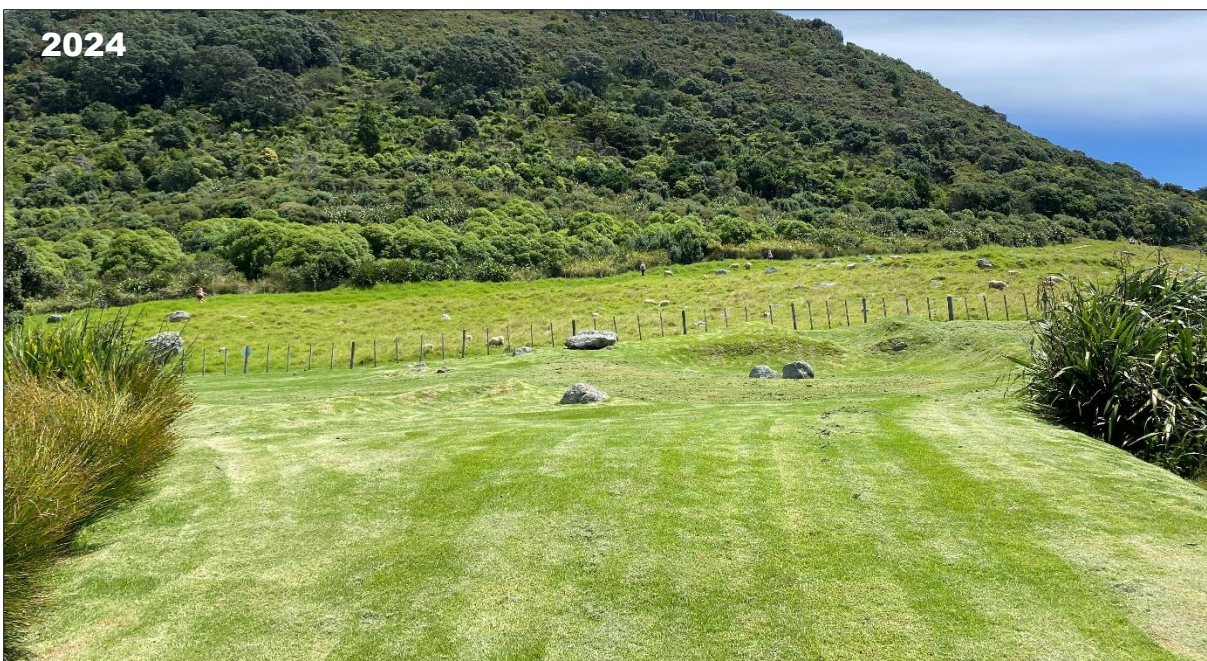
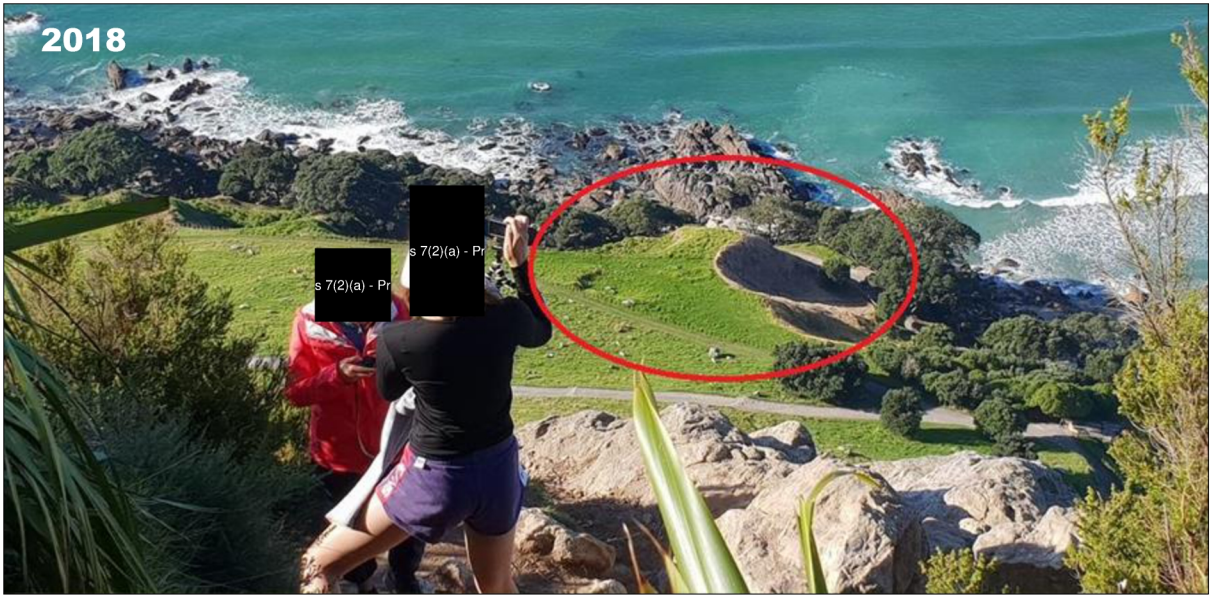
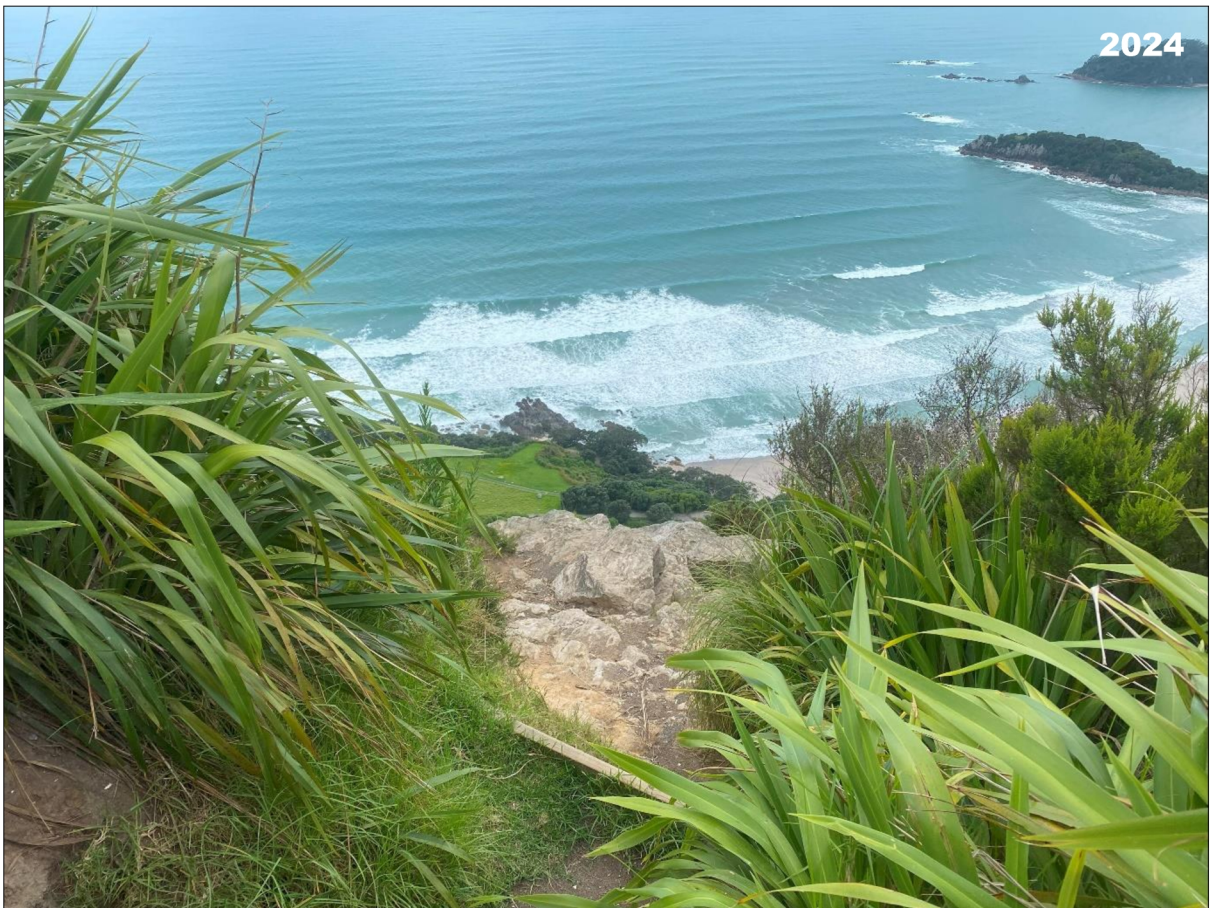
Monitoring Site 18

Area of Military Camp, helicopter pad, pits and terraces retired from grazing in 2018

Notes: Management of vegetation and site visibility has significantly improved following cessation of grazing. The length of weed eating needs to be monitored especially in summer as patches of the grass sward on the pit are broken by 'scalping'.
