Archaeological Site Condition Monitoring Report –
Authority no. 2023/244
Mauao Historic Reserve, Tauranga

ARCHAEOLOGICAL SITE
CONDITION MONITORING REPORT
AUTHORITY NO. 2023/244
MAUAO HISTORIC RESERVE
TAURANGA

29 February 2024

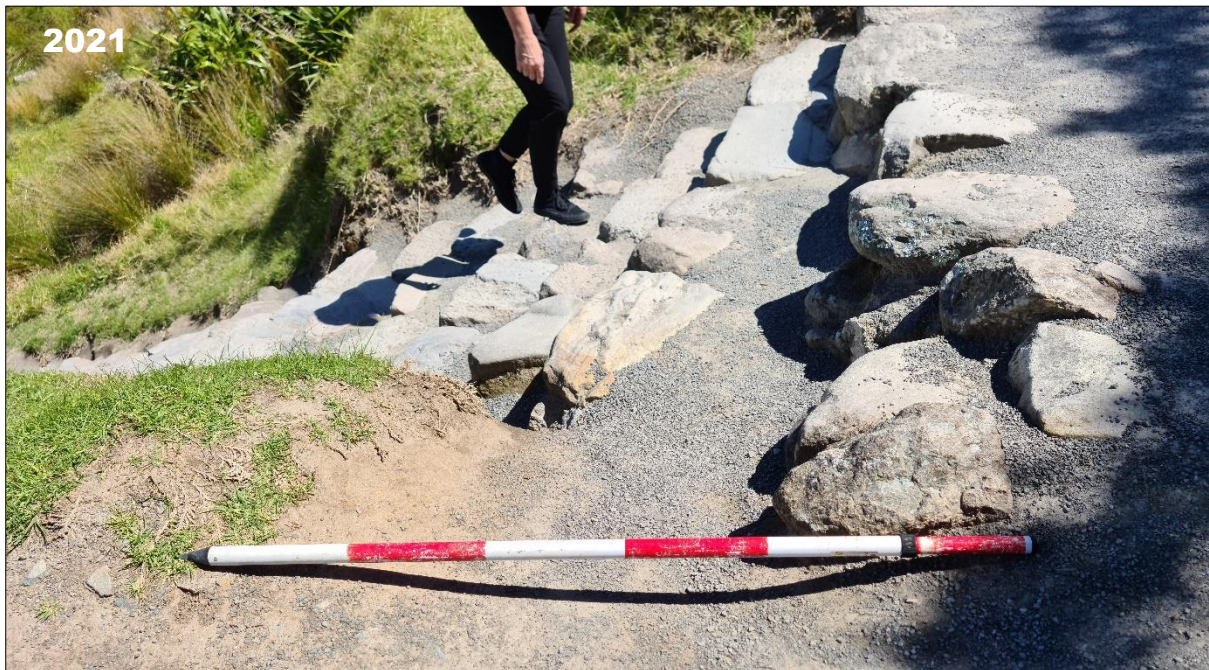
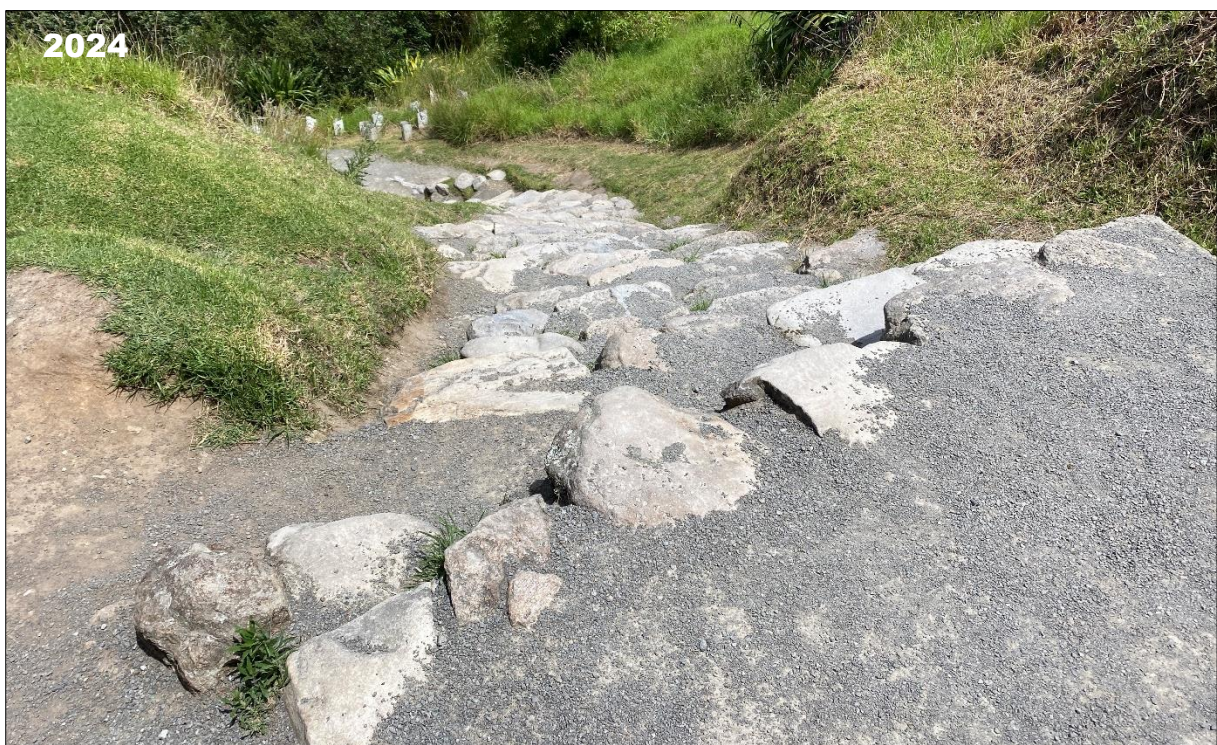
Monitoring Site 19

Stone Steps condition and erosion

Notes: Stonework stable at present, but erosion from desire line is still apparent. Weed spraying corridor needs to be reduced as this is encouraging desire lines. Action needed at the top of the stairs to reduce water flow and erosion, which was resolved in 2021 but has re-occurred.

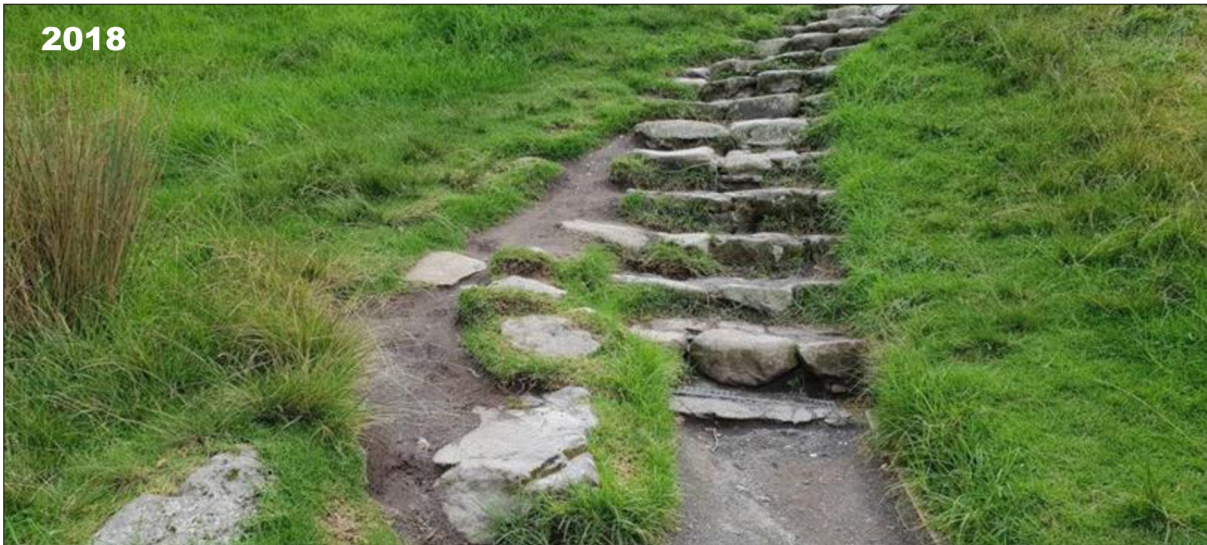
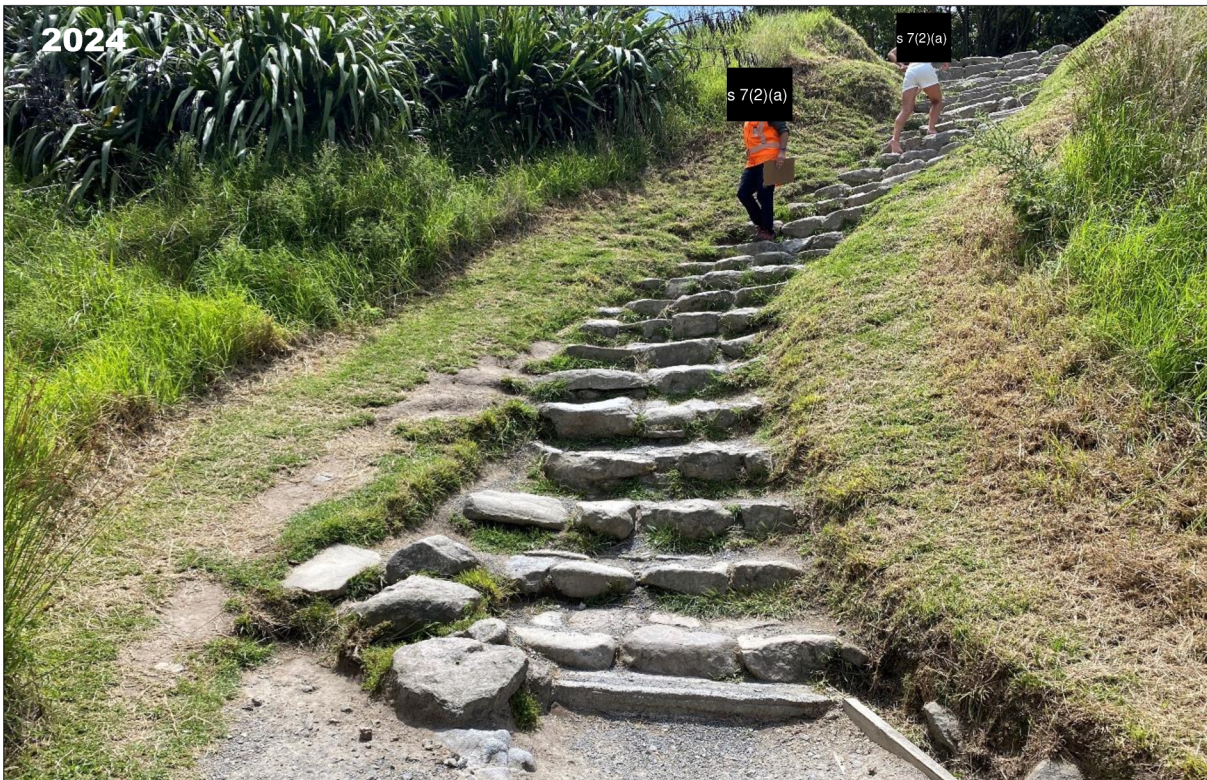
Monitoring Site 20

Base of Stone Steps condition and erosion

Notes: Stonework stable and erosion from desire line is still apparent but improved since 2018. Weed spraying corridor needs to be reduced as this is encouraging desire lines. Down-stream effects of the water flow and erosion needs to be monitored and managed.
