Contract: TC1/14
Reserves Walkways Maintenance
Tauranga City Council

Monthly Report
July 2017

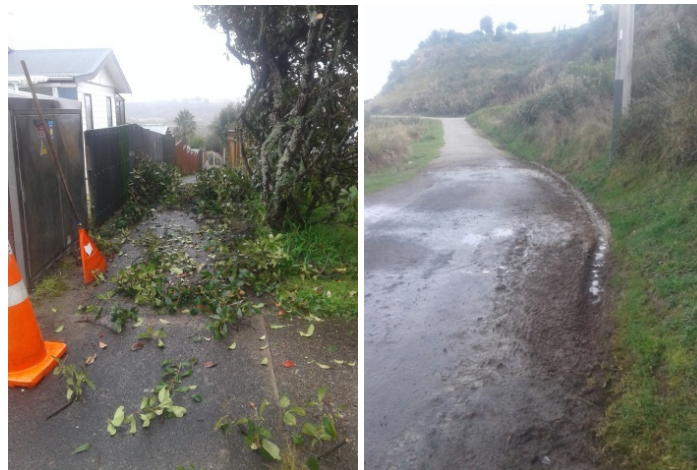
July has brought the start of a new financial year but really this has not meant any change what so ever on the ground as the maintenance and unscheduled teams continued to be busy. With the maintenance staff, focus has been on the drainage again with the continued heavy downpours of rain meaning blockages can occur quickly with either branches and vegetation, or mud and silt causing problems. The below photo shows the team digging a drain line back in at Gordon Carmichael which had lost all functionality. RS are actually looking at all of the open drain lines in a large part of the network and thinking they really need to be dug out a lot deeper with a digger to work as they need to and not block up so quickly. RS will discuss this with council. The second photo shows the other maintenance job RS wants to make headway on before Spring which is cutting back branches that are near or entering the track envelope. The second photo below shows York Park but there are many other access and entrance ways that will be worked on that are similar to this. The Daisy Hardwick to Coach Road section was a much larger scale vegetation clearance job RS a lot worked on cutting and chipping small branches where possible with bigger material going to green waste.

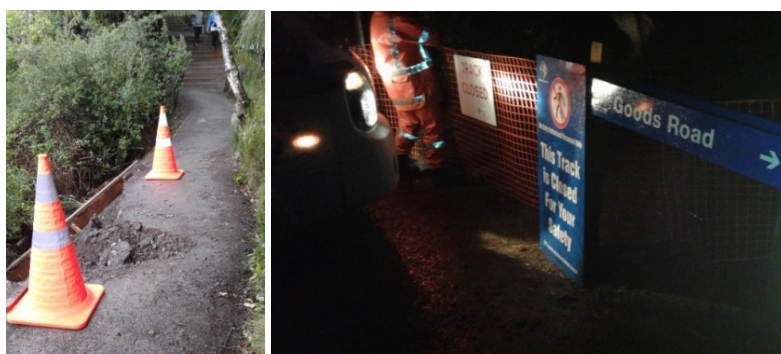
With typical winter weather bringing heavy rain and strong wind at times the below photos show some of the work that was required either repairing damage or closing tracks for public safety. The first photo below shows the damage to the Waikorire track on the Mount with a section of edging coming away that needed to be re installed with more pegs and aggregate filled and shaped to allow better water runoff. The second photo shows an evening track closure put in place at both ends of McCardles bush for a tree that was dangerous and needed removal from an arborist the next day. RS worked in with the arborist in the morning to make sure everything ran smoothly and there were no communication issues with re opening the track. This was important with this section of track being such a busy one for public use.

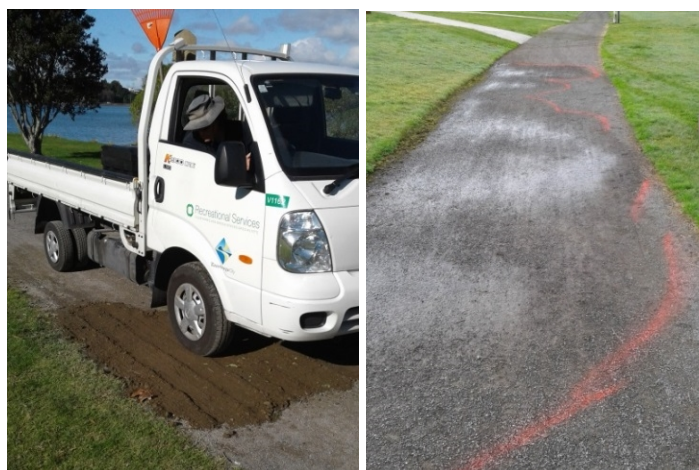
Wet winter weather is always a good time to understand where low spots are that need filling in or track re surfacing required. The first photo below shows an example of the maintenance team at Waikareo foreshore filling in low spots and compacting with the truck. Where the truck can't get to an area to fill in one of either the gator, plate compactor or the hand tamper will be used. With 2017 being so wet low spots have been a real problem through the Papamoa drainage reserves network. In some areas a layer of silt and mud will form as the track has sat under water for considerable time due to the high water table sitting in the waterways. RS decided to go through the whole network while it was raining and ground conditions saturated to understand where the low spots and work was required. Dazzle was used to identify spots to work on (see second photo) with a plan to then come through and apply aggregate to these spots and correctly shape them for water runoff. Once this process was completed RS realised the scale of the work required was huge. The process has started at Beachwaters Reserve and Topaz with drains installed as part of this work where needed but RS will discuss with council what sections should be prioritised to work on over the coming months, and what may be able to be left for near future renewals work.

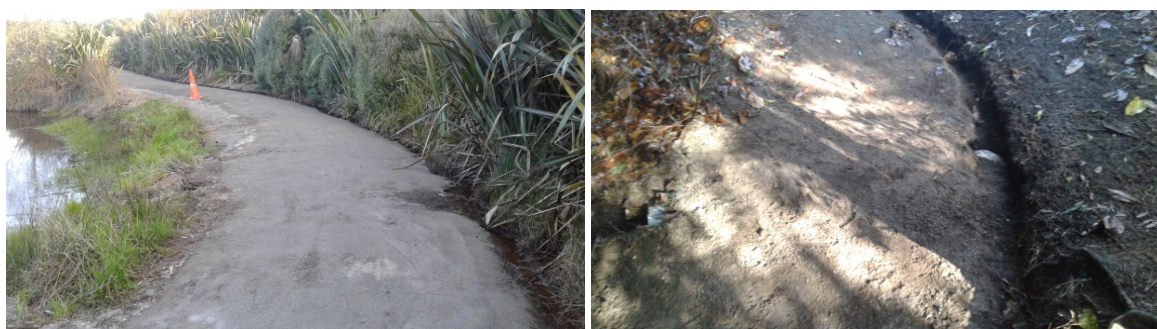
Yatton Park has had drains installed (see photo below) for localised wet areas needing water diverted away from the track. The bigger job was at Matua Saltmarsh where various sections needed more drainage and re surface from recent scouring after heavy rain (see second photo below). The digger was used to dig one dish drain much deeper to allow for water flow and to also store water when the tide is high and it can't escape. This just helps keep the surface from potential damage and drier for users of the track. There are sections of track however that needs significant building up or boardwalks installed as they are too low and constantly get affected by surface water.

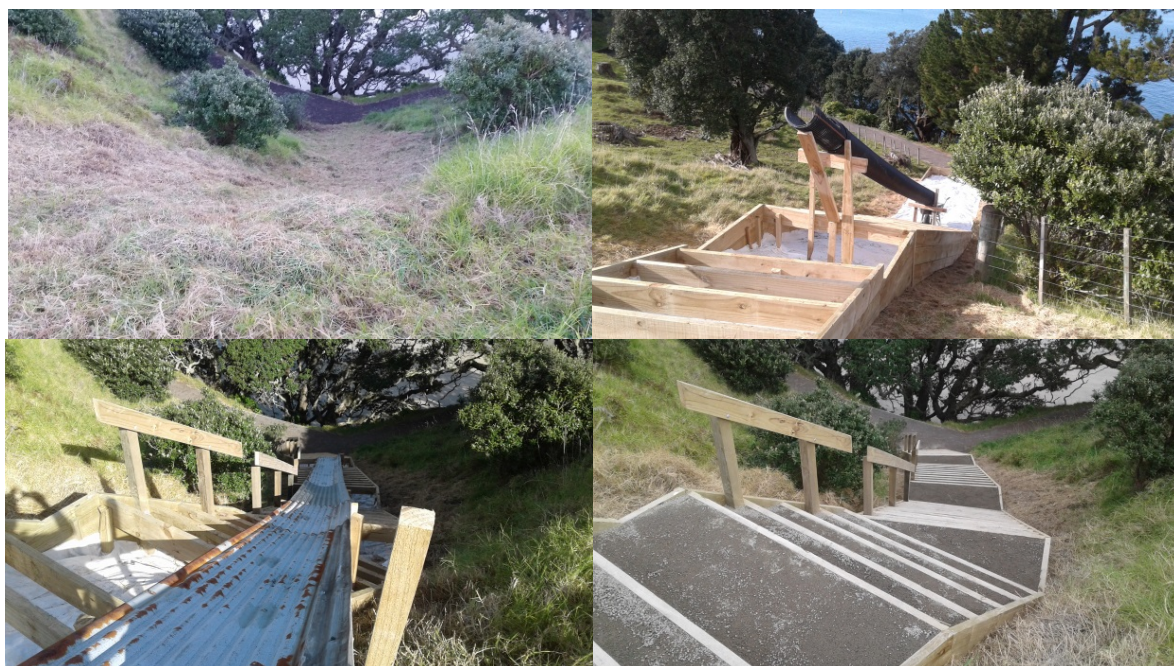
The big unscheduled job for the month has been re directing the Mount base track where it was closed off from the slip in Autumn. This was a difficult job with the area to re direct the track to being a significant archaeological area which meant the track had to be built on the top of the ground as much as possible to avoid any damage. An archaeologist and an Iwi member were part of the plan

and the stand over of the job itself. The Iwi were really happy with the way the job went and were hoping the track could stay in place for the future with the structure being built so well and the great view that people could get from the top of the steps. The photos below show the starting point for installing one side of the track with a steep section of land to work with. This meant thinking of innovative ways to get aggregate to this set of steps and the other side which can be seen in photos 2 and 3 where roofing iron and drainage pipe worked well. The fourth photo shows the excellent result that was achieved.

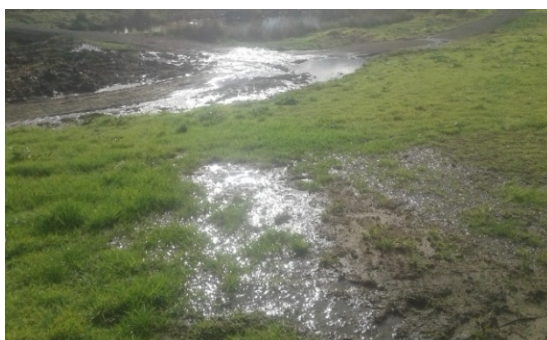
- Matua Saltmarsh has a section of track that is now always under water on or near high tide.
- Mauao's Waikorere track has a section at the Bluff which is very narrow and has a straight drop. This really needs attention and ultimately some kind of safety railing installed for everyone's safety.
- The flaxes growing on the track at Gordon Carmichael and other tracks mentioned to Council have still not been removed as well as other areas now becoming an issue.
- K Valley has had damage from contractors working on certain sections. The photo below shows the Tom Muir side of the valley not looking to good.

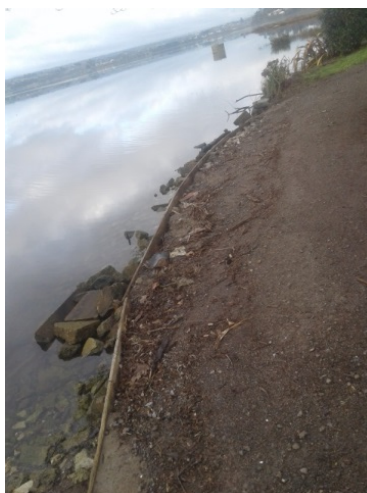
- Waikareao Foreshore Bridge is constantly having aggregate being washed out of the edge of it. The bridge needs extending and possible lifting to remove this issue
- Wild Ginger has been seen growing near the tracks at Waioraka, Rotary Park and Taipari - particularly the new section.
- The Gordon Carmichael steep track up the hill has scouring all through it. Needs to be resurfaced with possible lumps required like on the Mauao 4 wheel drive track to slow down and divert water to the sides.
- The edging on a section of track at 18th Ave needs looking at as not very stable and aggregate is being washed away (see photo below).
