**MAUAO, MOUNT
MAUNGANUI**

**GEOHAZARD
REVIEW REPORT**

PROJECT NO: HD3639
TAURANGA CITY COUNCIL
REFERENCE: CAR
6 JUNE 2025

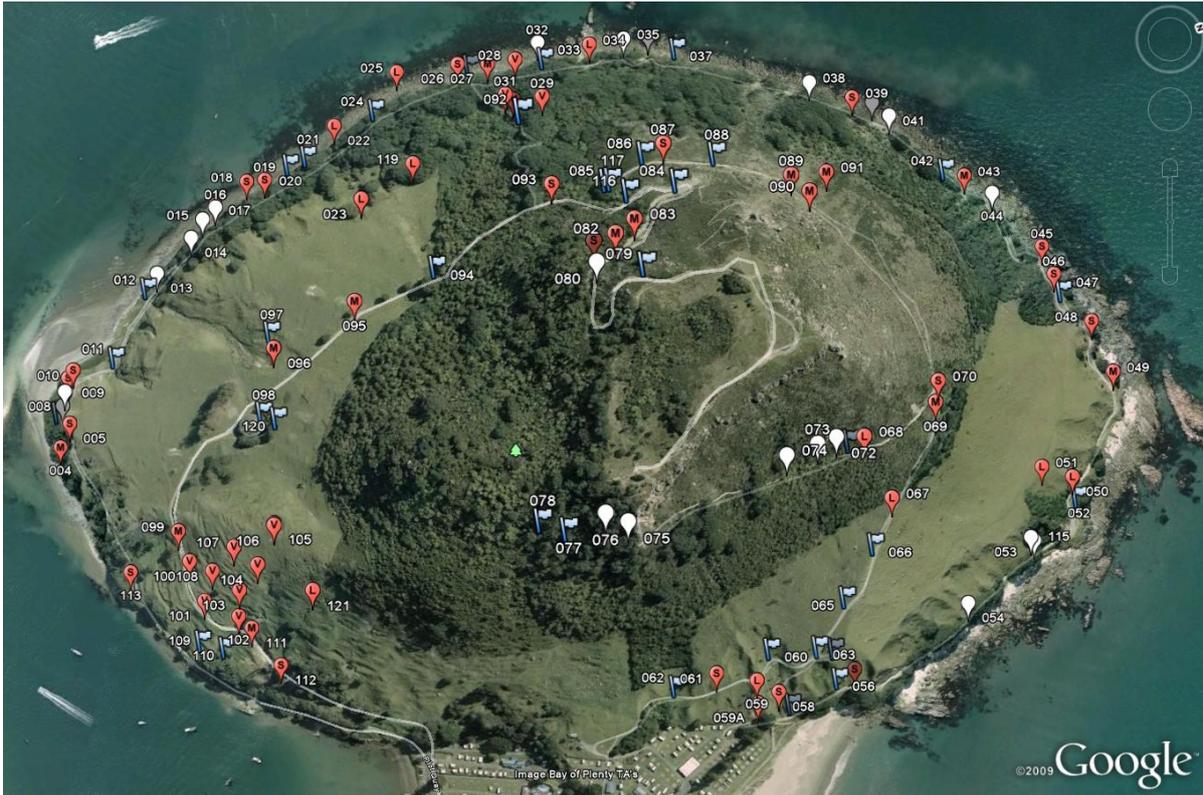
- Up to 80 individual landslides occurred, triggered by the 2011 rainfall event
 - 8 large landslides recorded (6 x impacting base track, 2 x impacting 4 wheel drive track)
 - 20 medium landslides recorded
 - 50 small scale landslides/wash outs
- Landslide failure mechanisms were restricted to shallow soils with few rockfalls
- Landslide debris impacting the tracks was removed and the tracks reopened
- A google earth image with assumed landslide and rockfall locations from 2011 event is shown in Figure 1 below.

Figure 1: A google earth aerial image of the Mauao with 2011 landslide event/feature locations, extracted from TCC PowerPoint slides, date unconfirmed, no legend available.

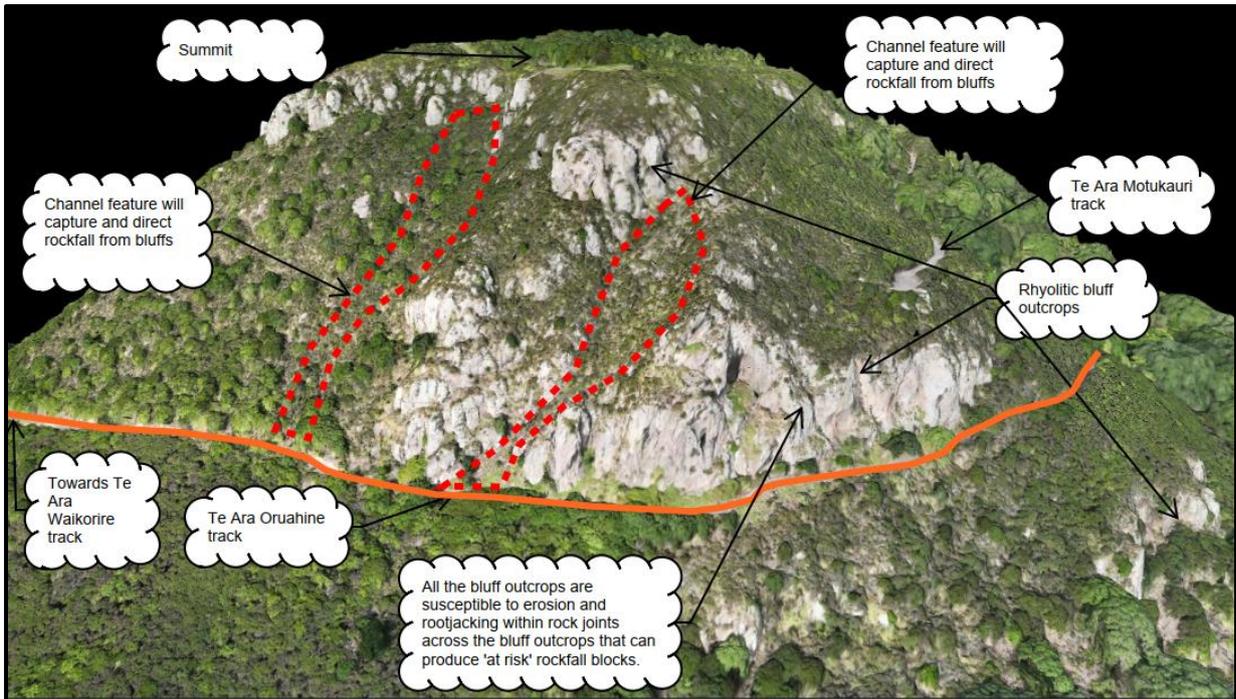
Figure 3: Annotated drone model of north-western/western Mauao looking south-east, date taken 02/05/25.

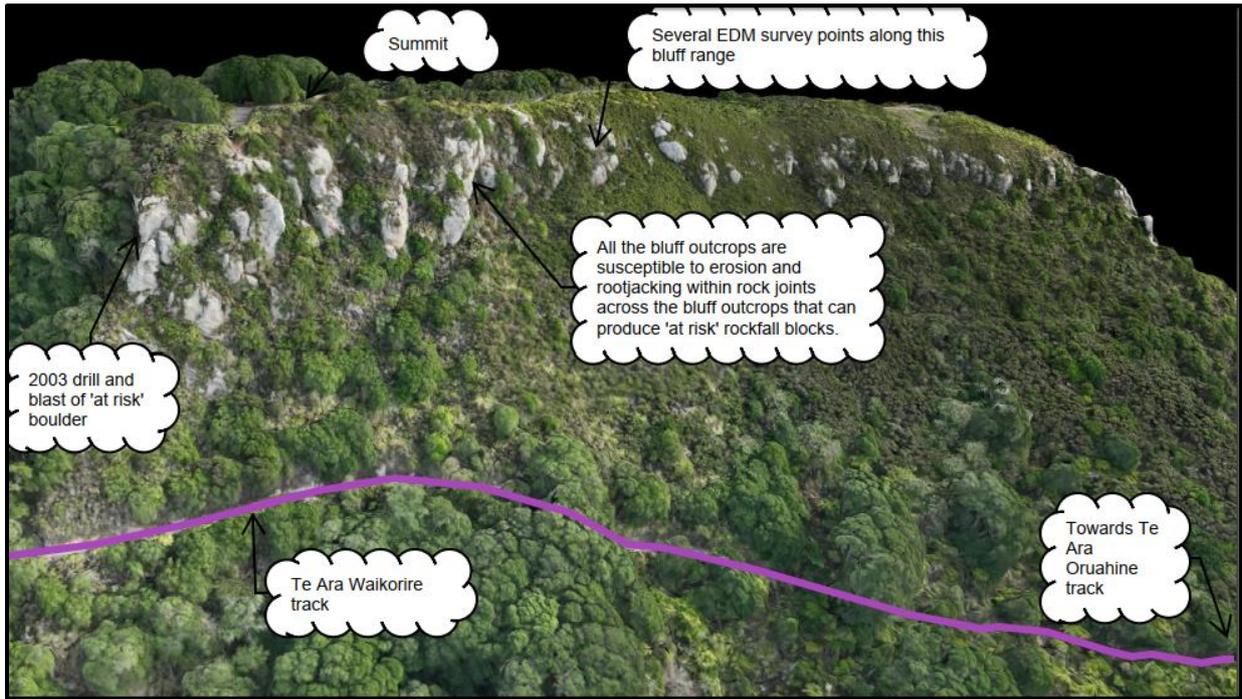
Figure 4: Annotated drone model of eastern Mauao looking north-west, date taken 02/05/25.

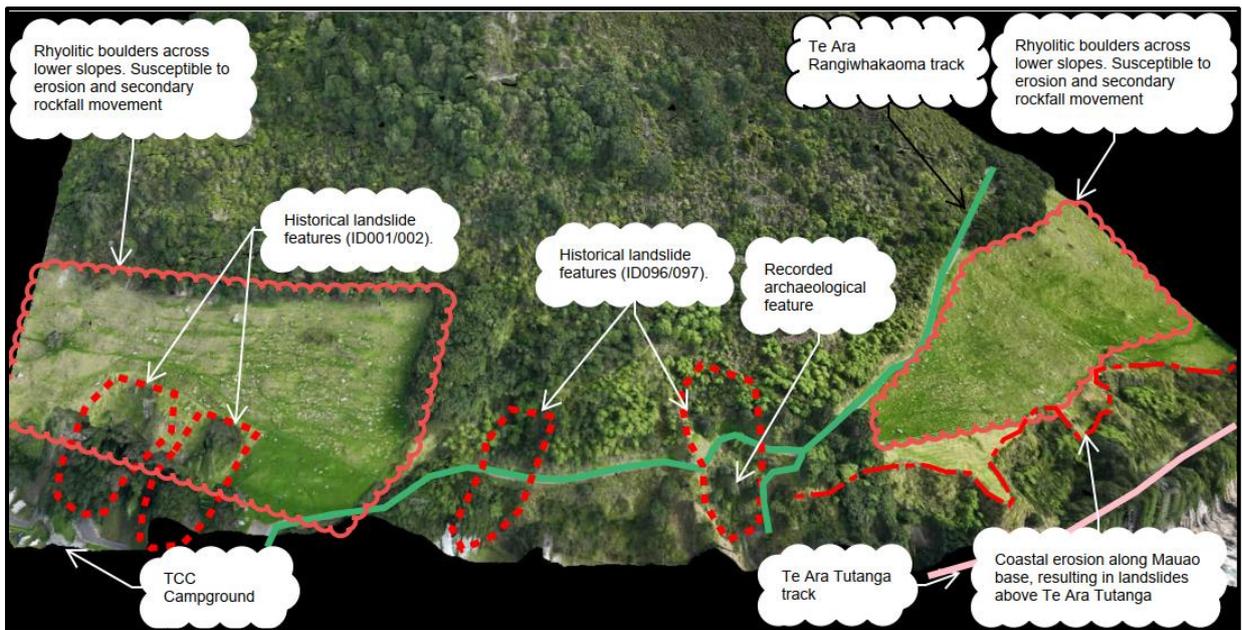
Figure 5: Annotated drone model of eastern lower slopes, looking west, date taken 02/05/25.

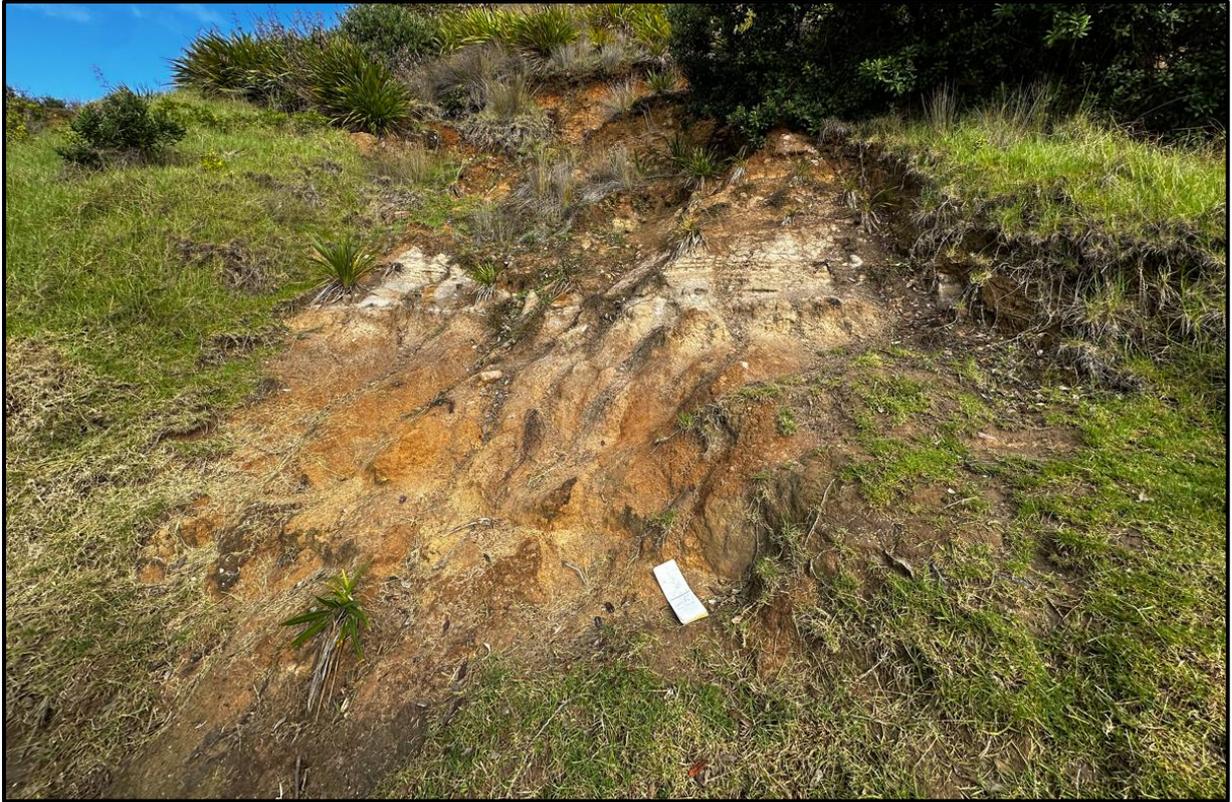
Figure 6: Existing translational landslide above Te Ara Tutanga track (ID043), date taken 02/05/25.

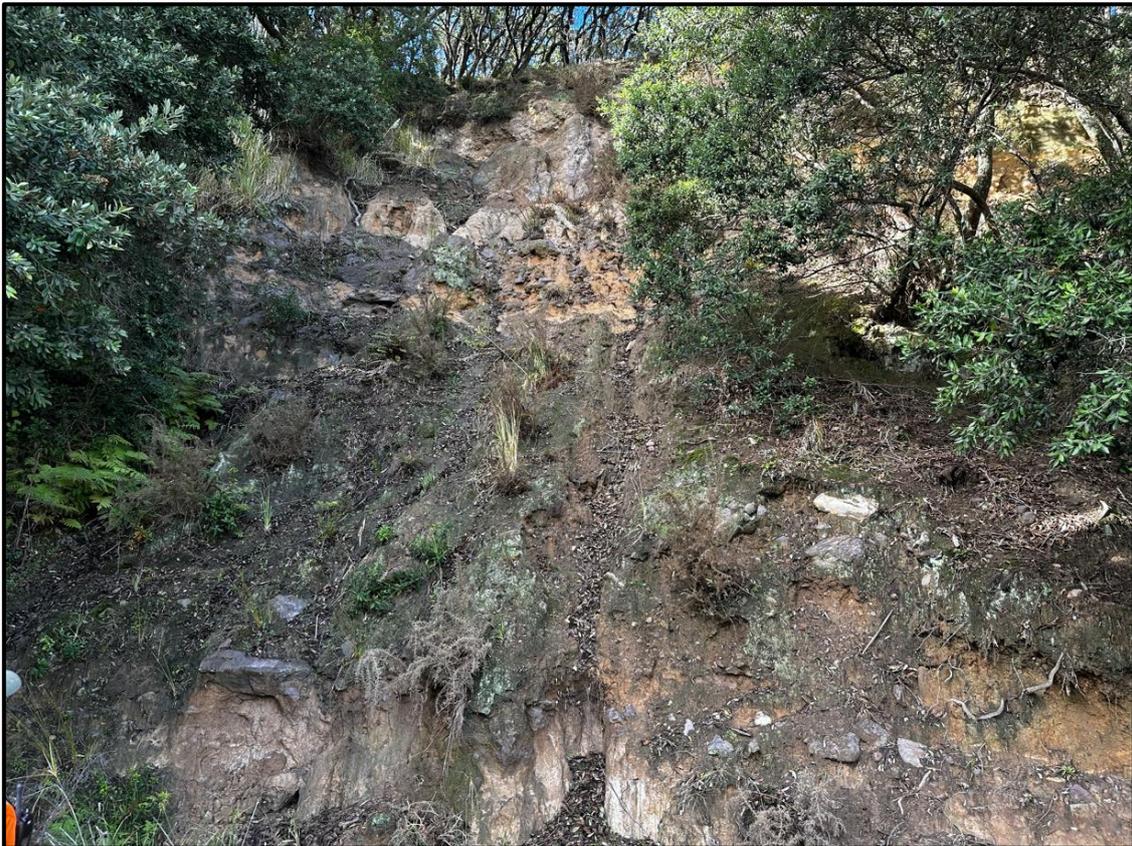
Figure 7: Existing translational landslide above Te Ara Tutanga track (ID032), date taken 02/05/25.

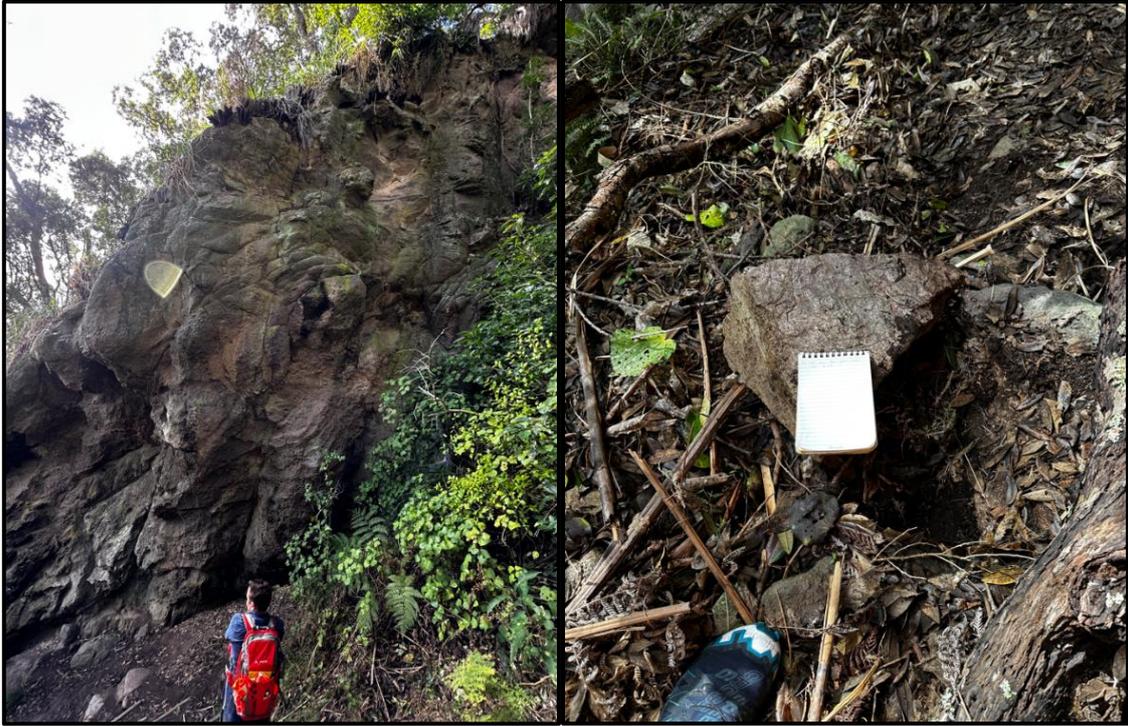
Figure 8: Recent rockfall block identified on Te Ara O Tutauaroa track (ID094), date taken 02/05/25.

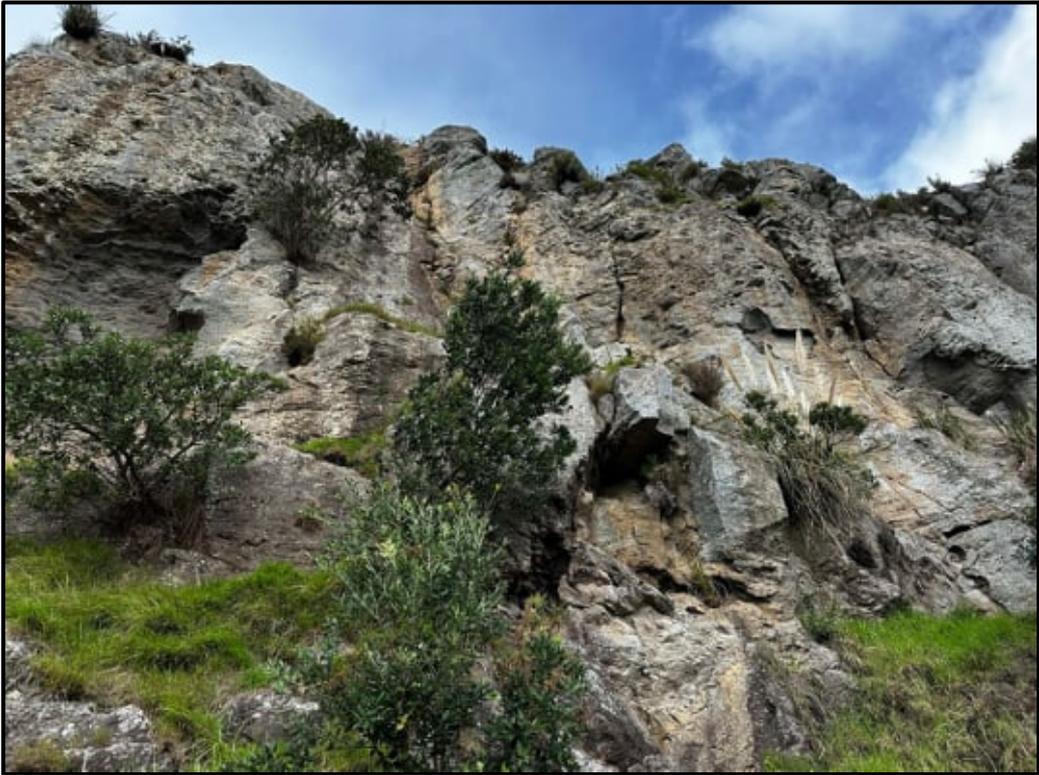
Figure 9: Susceptible joints and blocks identified on bluff outcrop above Te Ara Oruahine track, date taken 02/05/25.

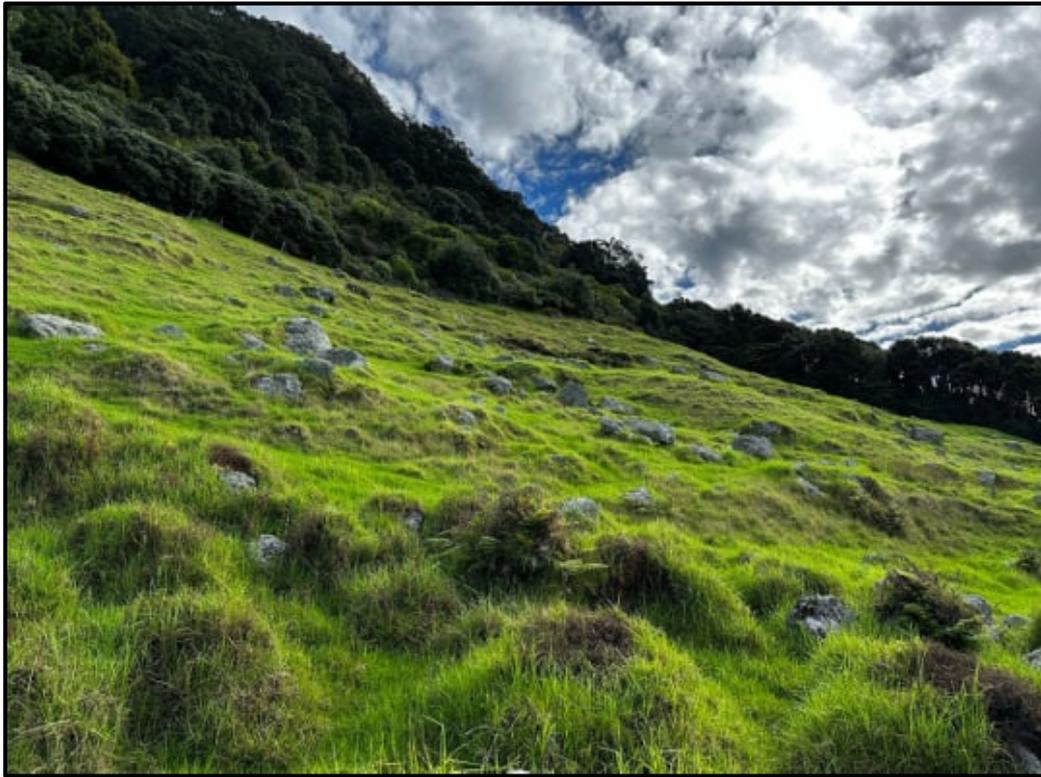
Figure 10: Numerous previous rockfall boulders across steep eastern slopes above campground (ID064), date taken 02/05/25.

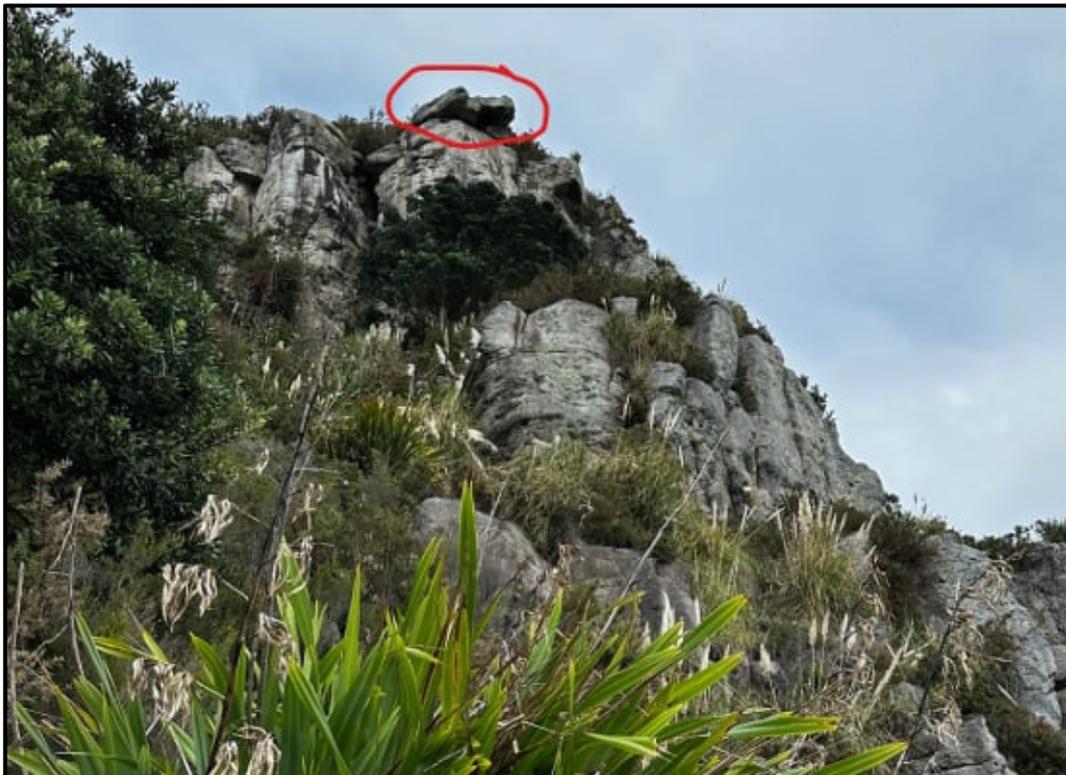
Figure 11: Susceptible overhang on bluff top, above Te Ara Oruahine track, date taken 02/05/25.

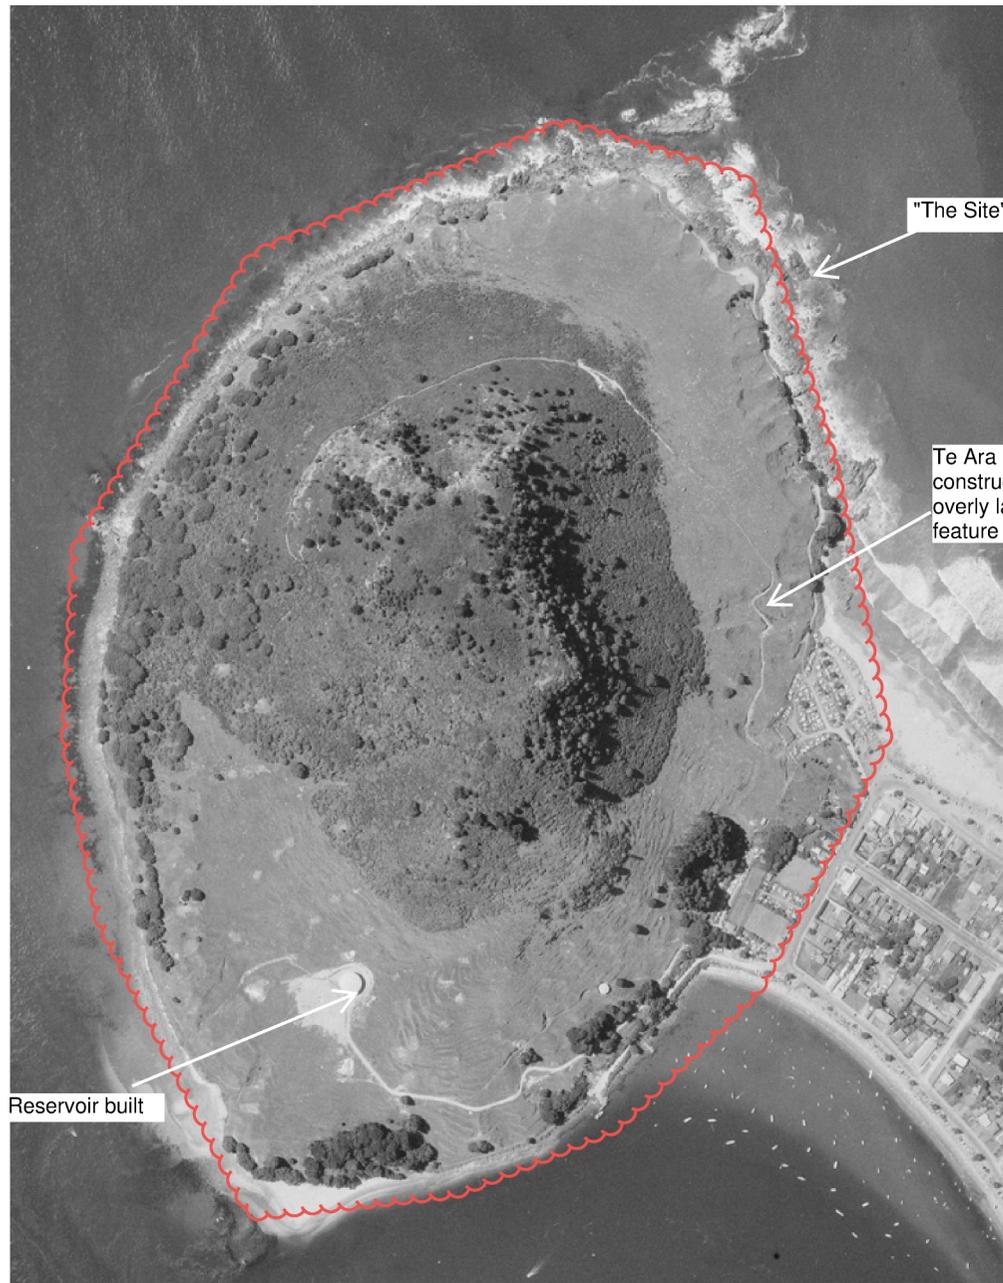
Te Ara Rangiwhakaoma track constructed, appears to overly landslide morphology feature

Reservoir built
