Project Number: 2-9B577.00

Tauranga City council Assets - Natural Hazard Risk Assessment Mount Holiday Park

1 December 2023

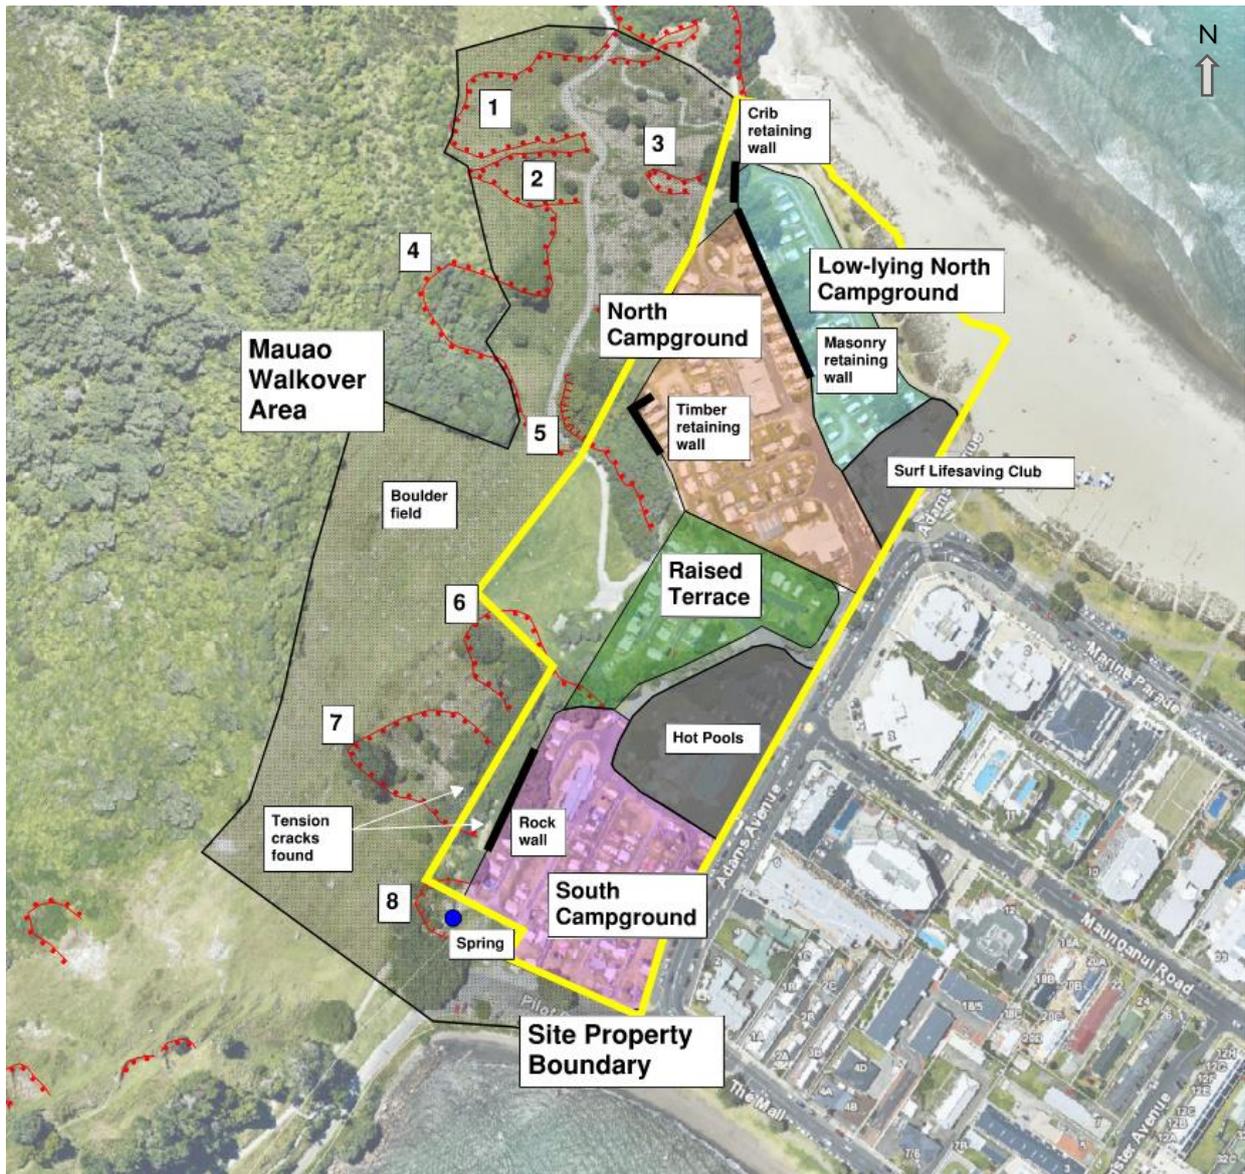
Figure 6. Annotated figure showing features identified during the site walkover. Numbers denote identified historic landslides that have runout zones extending into the site grounds.

OBSERVATION	DETAILS
Areas vulnerable to flooding and overland flow.	<ul style="list-style-type: none"> • Low-lying basin-shaped area within the northern campground (Figure 6). • Sections of the south campground area near to Pilot Bay.
Steep slopes, banks and cut faces vulnerable to slope failure	<ul style="list-style-type: none"> • Many of the steep slopes along the toe of Mauao, with some appearing to be comprised of historic landslide debris (e.g., Landslide 5 in Figure 6). • Steep natural slopes and cut faces along the raised terrace. Slopes are particularly steep on the south of the terrace area. Shallow soil erosion and undercutting of the ground surface is evident in this area (figures 9 to 13 in Appendix B).
Historic Landslides	<ul style="list-style-type: none"> • Eight landslides were identified via GIS data and inspected during the walkover for signs of instability and/or ongoing movement e.g., tension cracks, slumping, presence of soft ground.

OBSERVATION	DETAILS
	<ul style="list-style-type: none"> • None of the landslides investigated showed signs of imminent failure or significant movement. Scarps showed signs of “healing” where topography has smoothed over and vegetation is returning. • Landslide 7 shows minor tension cracking within the leaf litter in the centre of the slide scarp (Figure 24 in Appendix B). A previous tension crack formed adjacent to the landslide scarp along an access path has slumped slightly (Figure 22 in Appendix B).
<p>Qualitative inspection of retaining walls</p>	<ul style="list-style-type: none"> • It was observed that many of the retaining walls have been constructed below historic failures (Figure 6). It is assumed that each was built in response to a landslide event. Some of the retaining structures show degradation: <ul style="list-style-type: none"> Crib wall: <ul style="list-style-type: none"> • Located above a recently active series of slope failures that begin above the base track and continue downslope. The scarp above indicates failure was relatively recent (Landslide 3 in Figure 6). The wall shows signs of damage to the concrete and to the soils behind it. Very large void spaces and piping structures are present where water has flowed through the wall, removing sediment. Large masonry retaining wall: <ul style="list-style-type: none"> • Signs of minor degradation to the masonry (Figure 32 in Appendix B). Very slight forward rotation occurring at the northern end of the wall. Timber retaining wall: <ul style="list-style-type: none"> • Constructed in response to landslide failures within this area. Historic slips can be seen in the field and within the GIS datasets. Cabins are located very close to the wall and may be vulnerable to future landslide hazards. Gabion rock wall <ul style="list-style-type: none"> • Appears to have been built in response to the large failures in this area. Some metal wires of the basket structure are rusted away (Figure 31 in Appendix B).

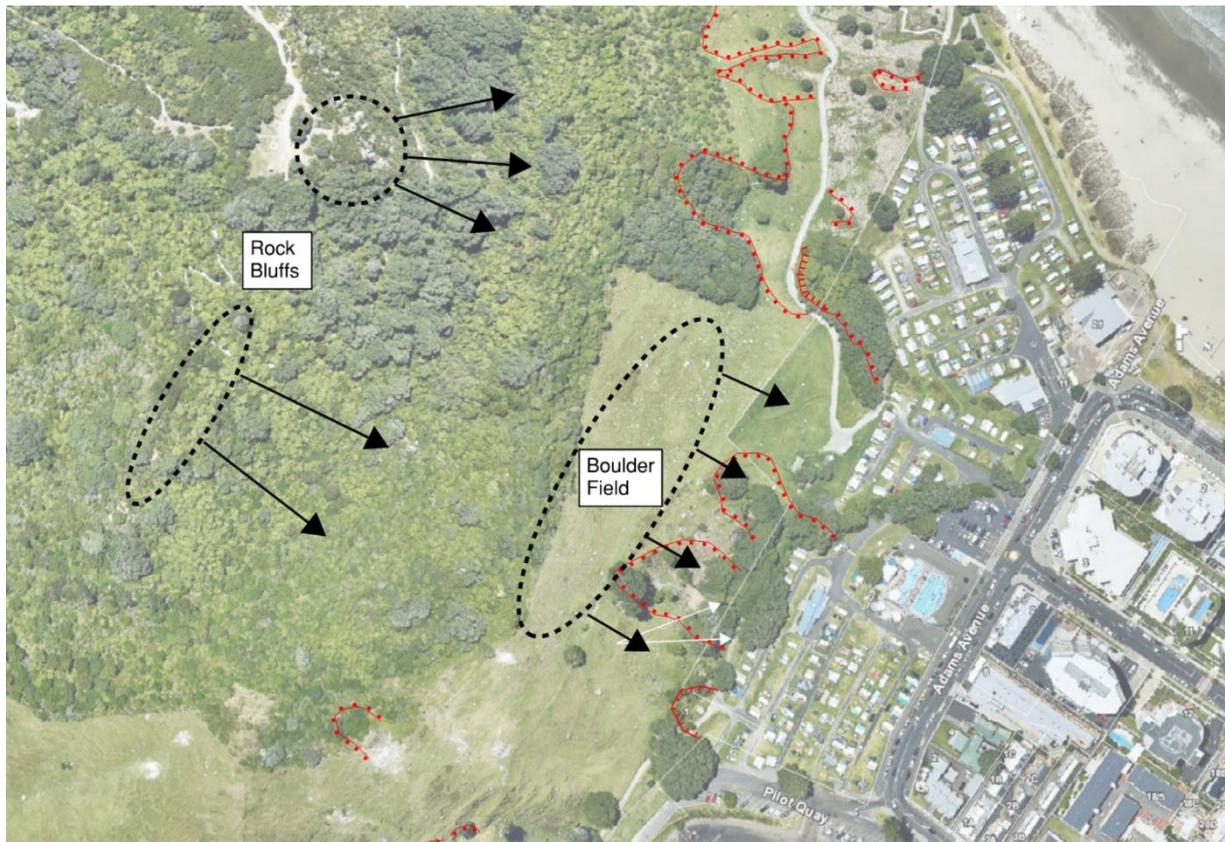
Using GIS data and observations during the site walkover, three potential sources of rockfall hazard for the site have been identified (Figure 9).

Figure 9. Aerial view of the site with indicated rockfall source areas and travel paths. Vegetation cover between the source and the site is important for providing protection.

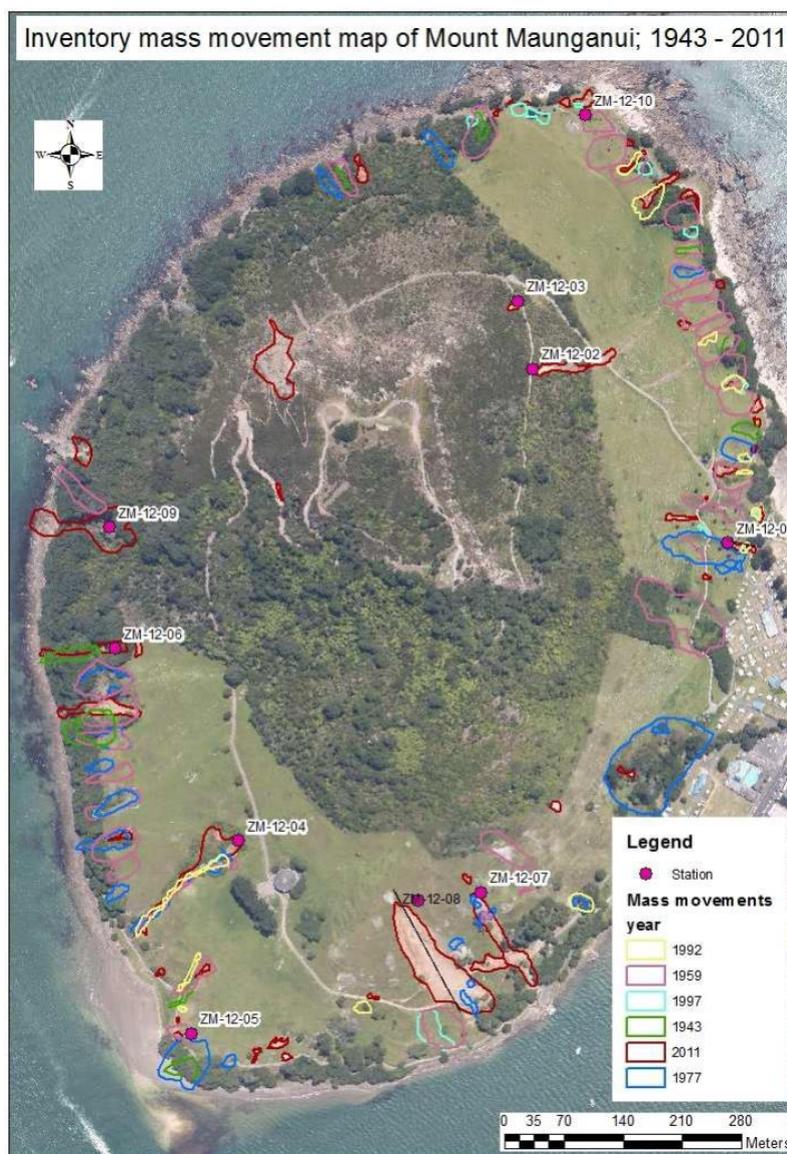
Figure 10. Spatial distribution of landslides on Mount Maunganui between 1943 and 2011. Multiple mapped landslides are present immediately above the site grounds. Source: Martin and Brideau, 2014.

Based on our slope failure map, a proportion of the site is within the runout zone. Particularly vulnerable areas include the campsites adjacent to the toe of Mauao. Much of these areas are within the runout areas of historic landslides. Reactivation of these failures is possible during heavy rainfall (e.g., Figure 10 above).

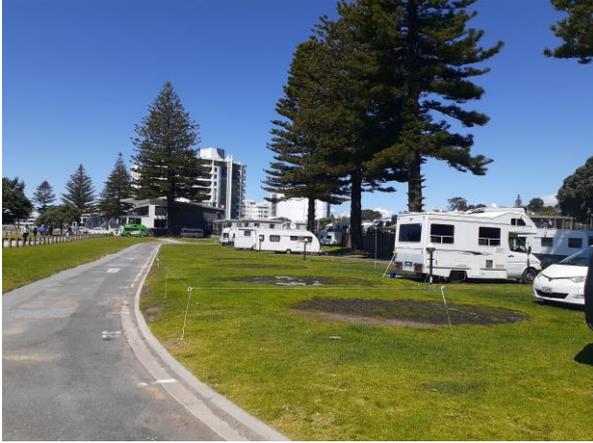
Figure 1. Low-lying north campground.

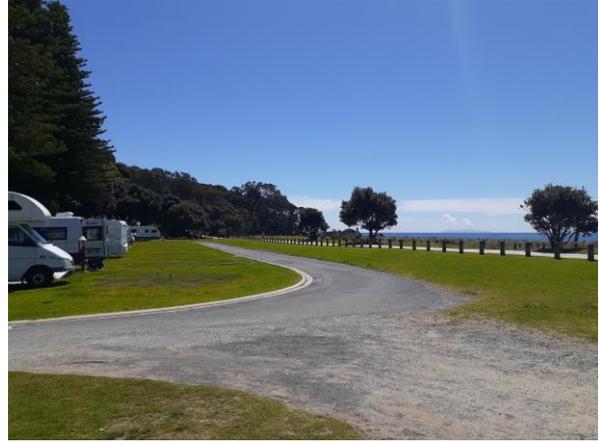
Figure 2. Low-lying north campground.

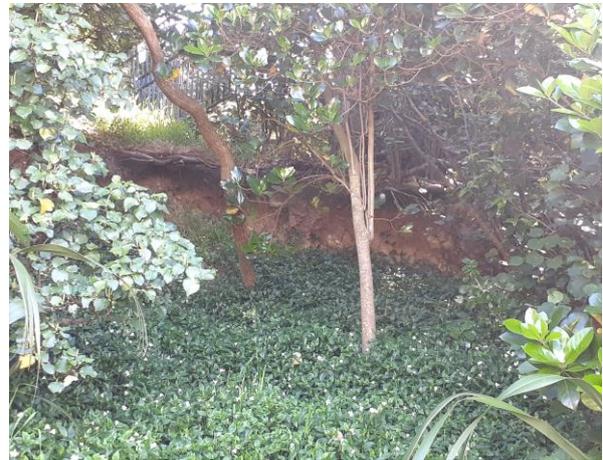
Figure 10. Eroded, exposed soils in steep banks of raised terrace.

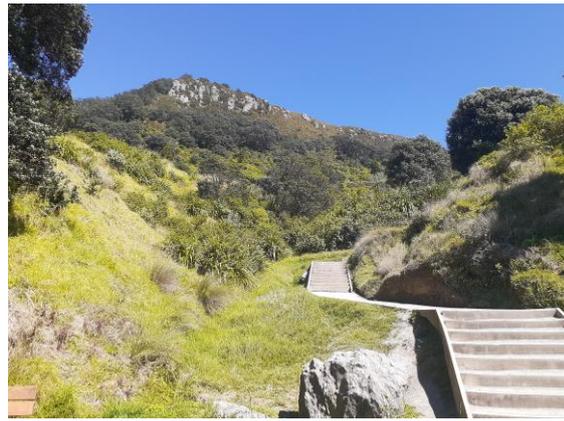
Figure 14. Landslide 1 looking upslope from base track stairs.

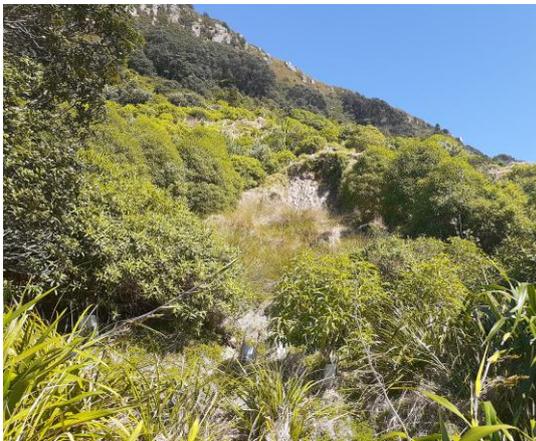
Figure 15. Landslide 2 looking upslope. Outcrop represents former scarp face.

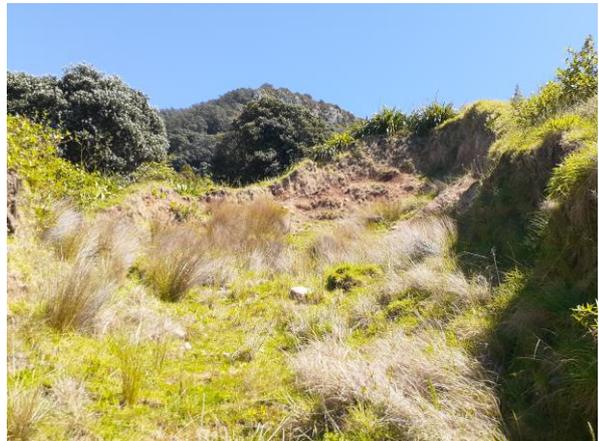
Figure 16. Landslide 3 head scarp.

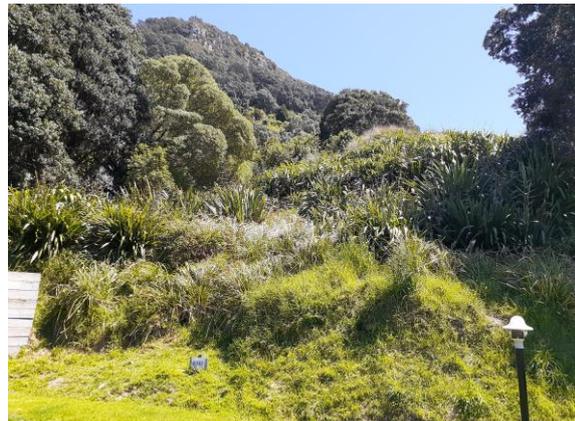
Figure 18. landslide 4 toe next to timber retaining wall.

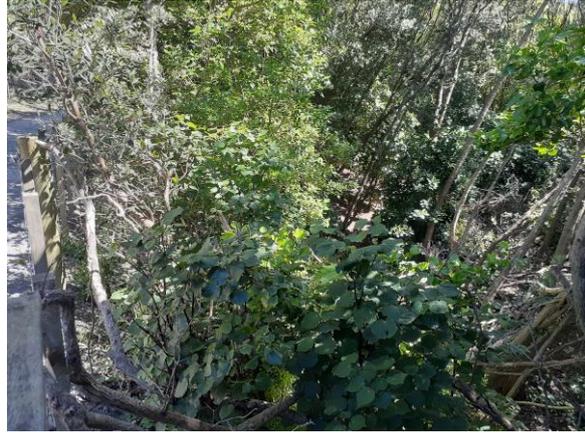
Figure 20. Landslide 5 looking downslope from base track. Vegetation hides the very steep slope profile.

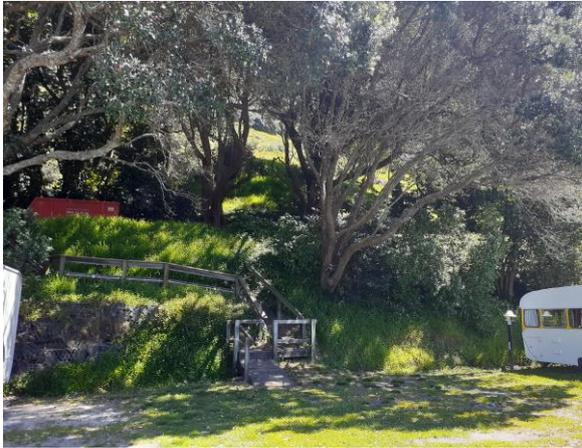
Figure 21. Landslide 6 toe from southern campground.

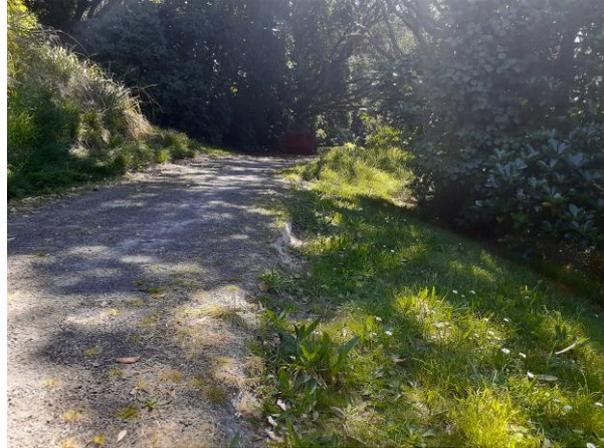
Figure 22. Tension crack formed in January 2023.

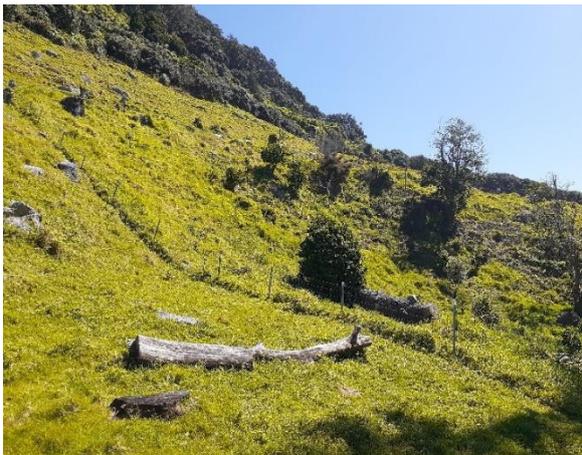
Figure 23. Landslide 6 scarp.

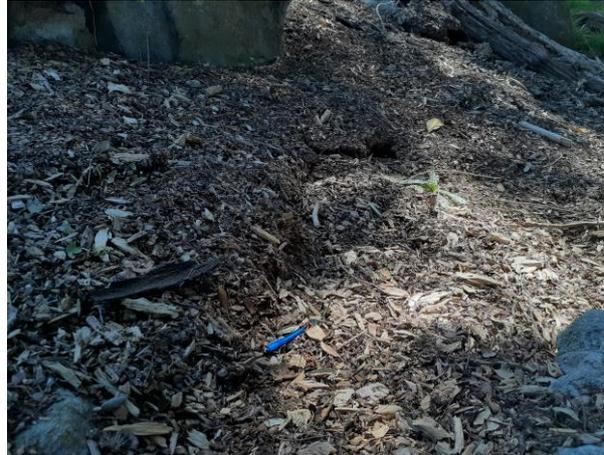
Figure 24. Landslide 7. Area within debris pile (above skip location) shows some minor tension cracking.

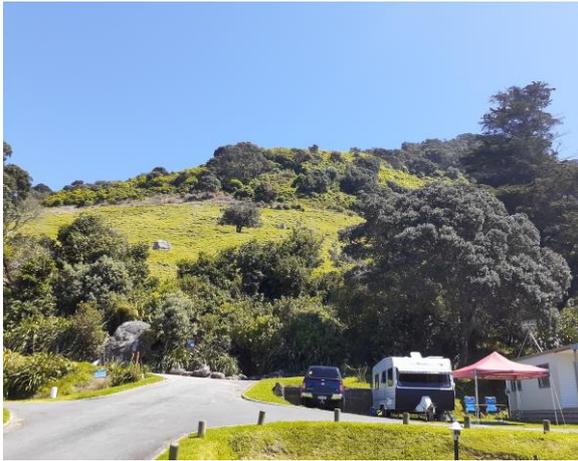
Figure 25. Landslide 8 (vegetated area). Spring down the centre of axis at toe.

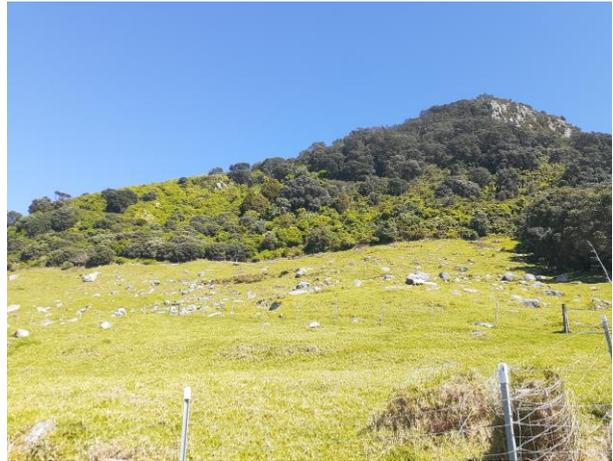
<p>Boulder fields on the grassed slopes of Mauao</p>	<ul style="list-style-type: none"> • Many scattered boulders that have been transported from upslope and deposited on the lower grassy slopes above the site. Some of the boulders appear only loosely attached to the soils and it is possible that heavy rainfall or seismic shaking will cause them to be remobilised.

Figure 26. Boulder field. View from central terrace area.

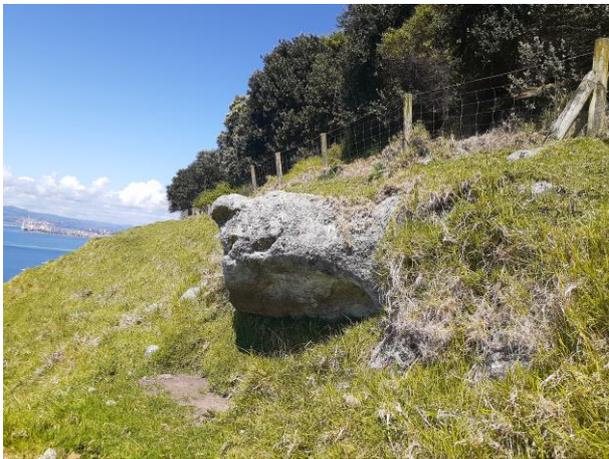
Figure 27. Example of boulder vulnerable to dislodgement.

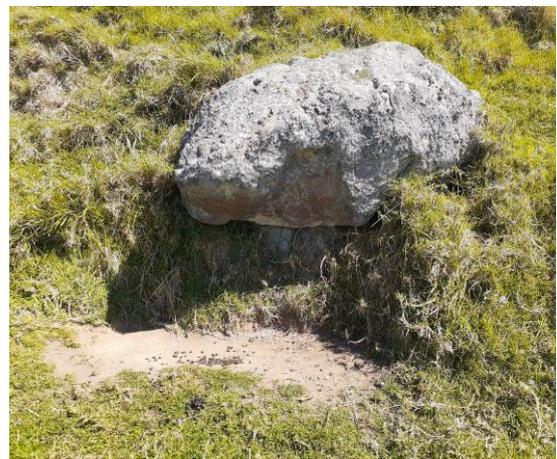
Figure 28. Example of boulder vulnerable to dislodgement.

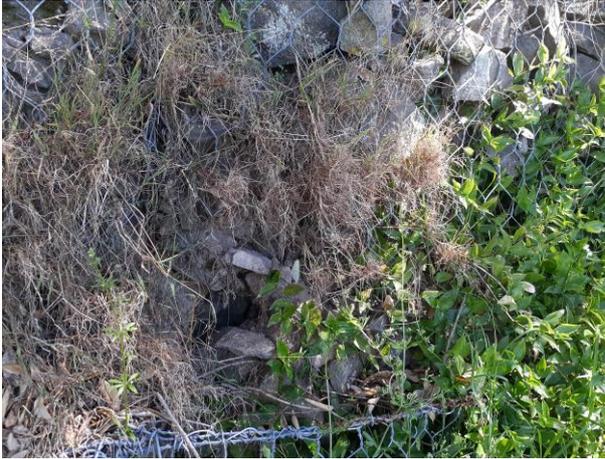
Figure 31. Damage to metal wires in gabion wall.

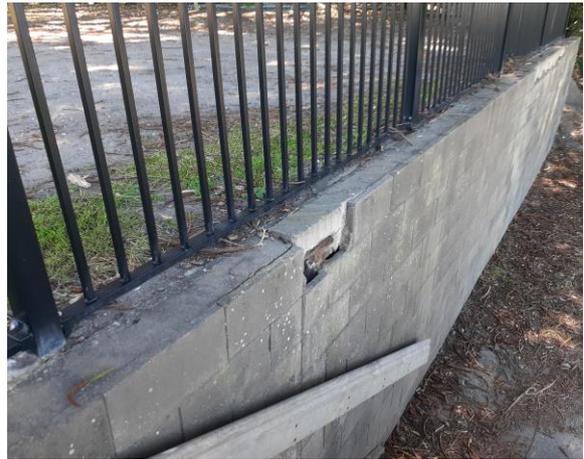
Figure 32. Damage to masonry wall in northern campground.

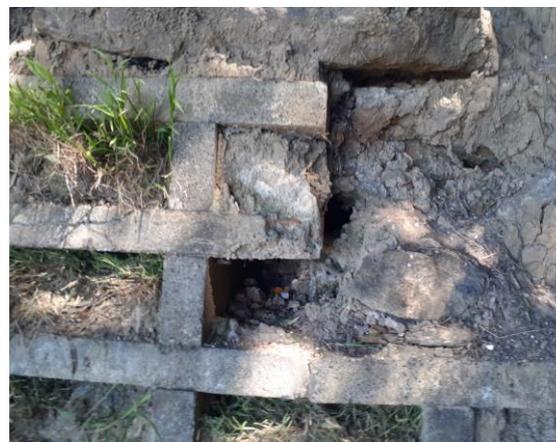
Figure 38. Voids and piping structures within crib wall.
