Tauranga District Council  
Private bag 12022  
Tauranga

26 July 2007

**Mauao Slopes; Monitoring Report; July 2007**

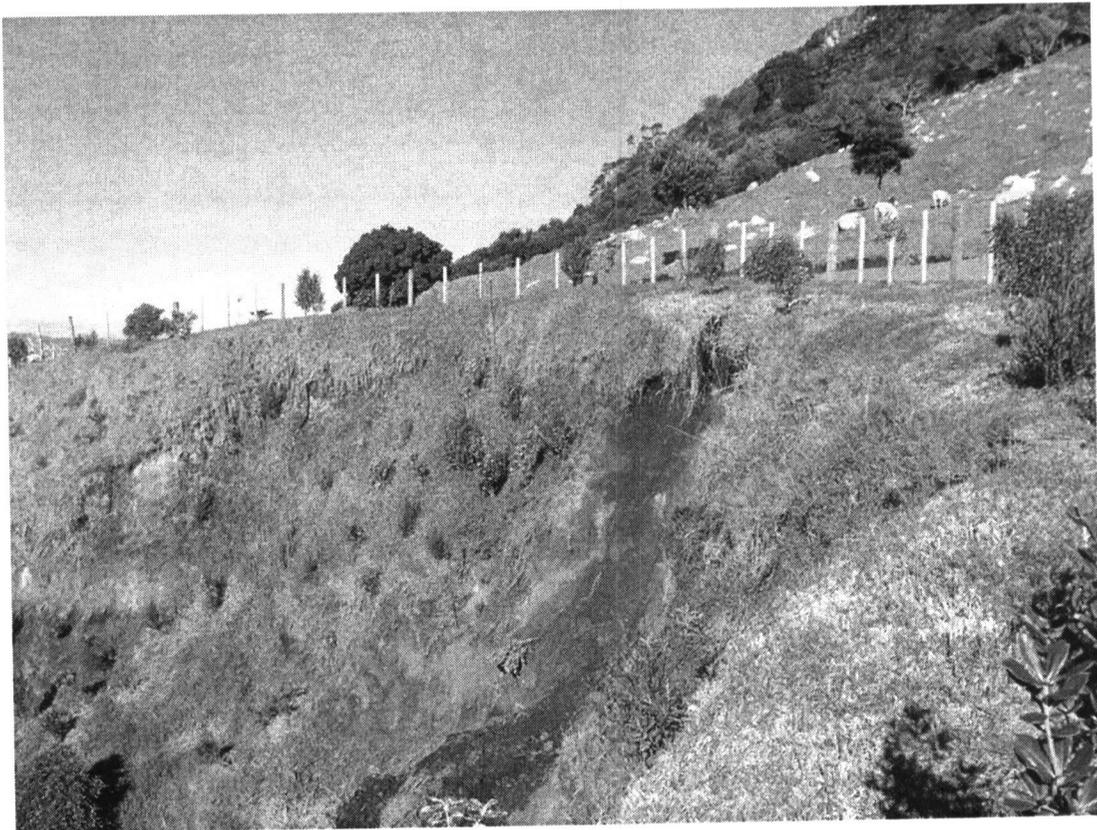
*Photograph 1; Minor shallow slipping continues (slip 34)*

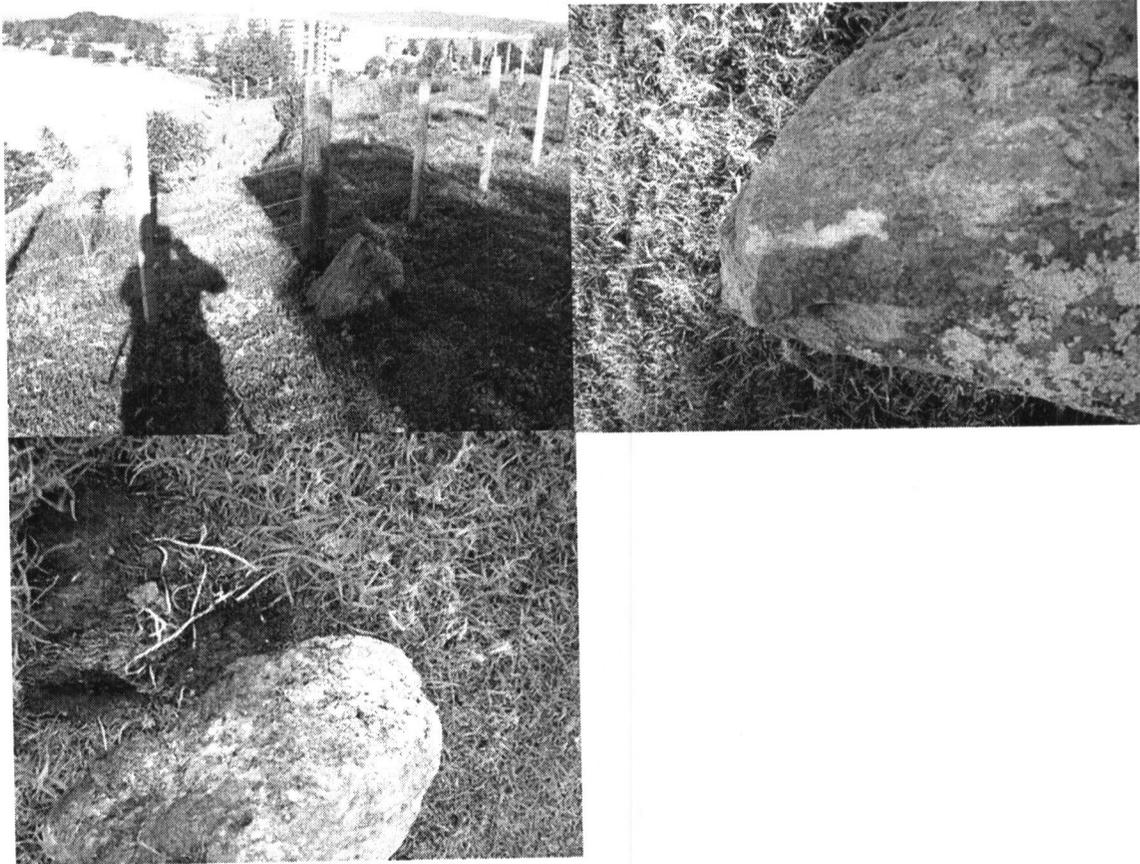
*Photograph 2 (a,b,c); Surface boulder above slip 34 shows signs of impact and has decaying grass underneath.*

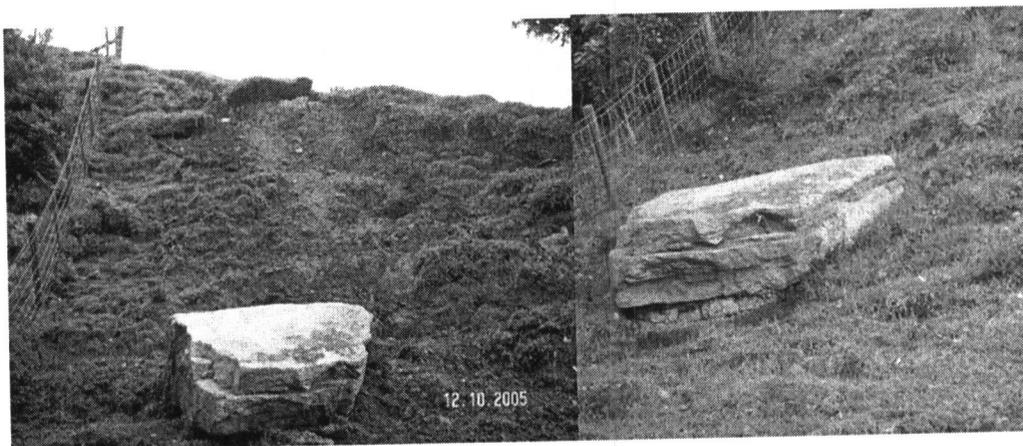
*Photograph 3 (a & b); 18 months after moving 10m this boulder is well embedded again.*

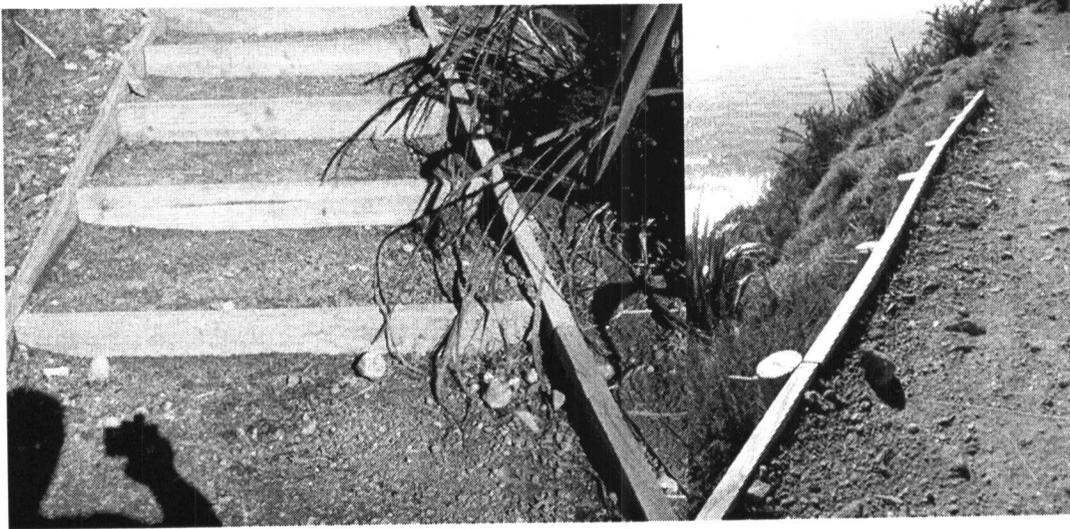
The rockfall hazard probably continues to be highest in the northern areas where rock climbers exiting from the top of routes will walk over unstable slopes from which any disturbed rock freefalls onto the Oruahine with no warning. This hazard is exacerbated by the fact that peak climbing activity will coincide with track walking (ie; at weekends during fair weather).

*Photograph 4 (a & b); Small rocks on the Oruahine track appear likely to have fallen from above.*

- It is recommended that rockfall mitigation options be considered for the North West Oruahine Track, the highest risk area. Measures could include access restriction, rock scaling and possibly the consideration of small catch fences.*
- The hazard to the Campground is likely to be most cost effectively mitigated by monitoring and controlled scaling at the rockfall source areas (if and when necessary) although catch fences continue to be an option. The landslip hazard may present a greater overall threat here (than rockfall).*

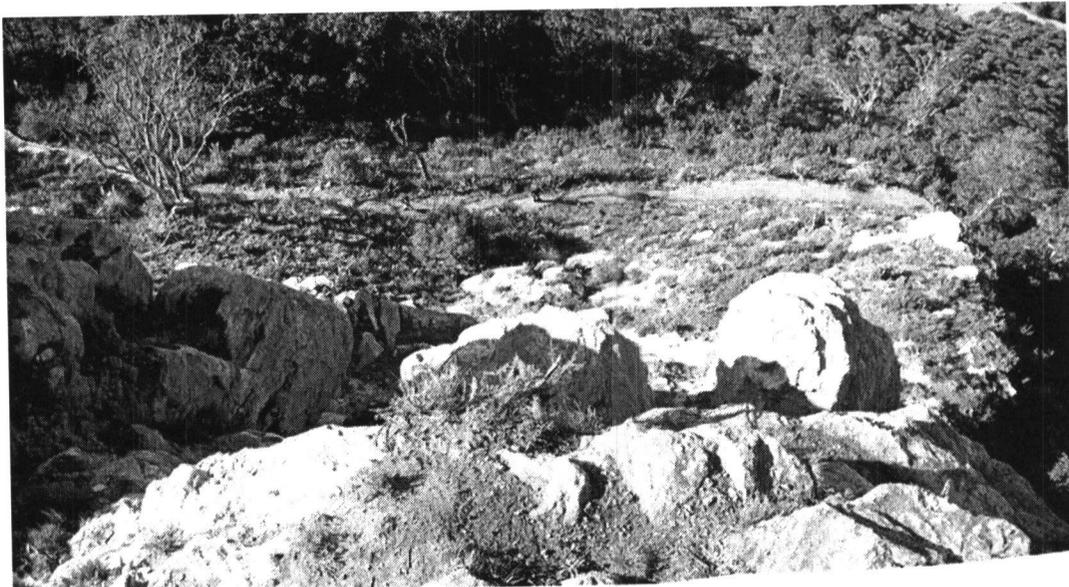
Scour of sand from non-vegetated patches has continued as previously and certainly has been the source of much minor rockfall, however, as reported previously the majority of this will have occurred during inclement weather, at which times there are

*Photograph 5 (a & b); Ongoing scour on the camp bluff.*

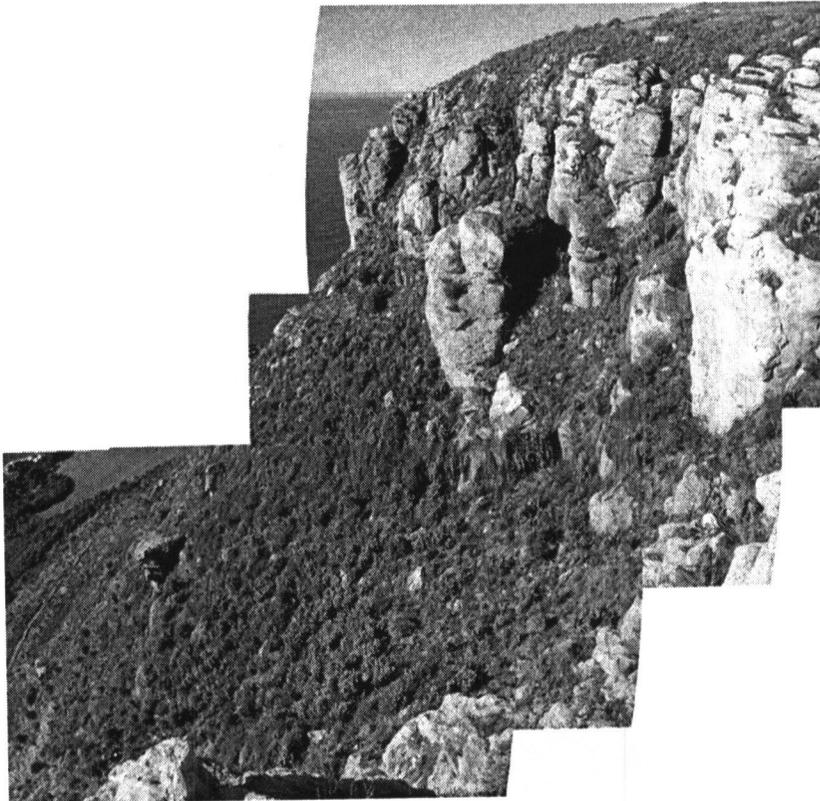
In the period since the herbicide spraying programme has been 'on hold', vegetation continues to re-establish. Although the fastest growth has been in some weed species, they are beneficial from a geotechnical point of view in reducing scour and increasing stability.

*Photograph 6; Vegetation re-establishing on the North Western slopes.*

- *TDC's planting and weed control programme should give priority to establishing grass to help stabilise the loose colluvium.*
- *Public off track access to the steep upper slopes should be prohibited.*
- *Effective track closures must be in place before any TDC staff or contractors access the steep upper slopes off track. Any persons entering these areas must be suitably experienced, competent, trained, equipped, insured etc.*
- *Monitoring and inspection should continue six monthly.*
- *Annual rock scaling is recommended.*
