Tauranga District Council  
 Private bag 12022  
 Tauranga

7 August 2020  
 Avalon Project #20149

## Mauao Slopes; Monitoring Report for August 2020

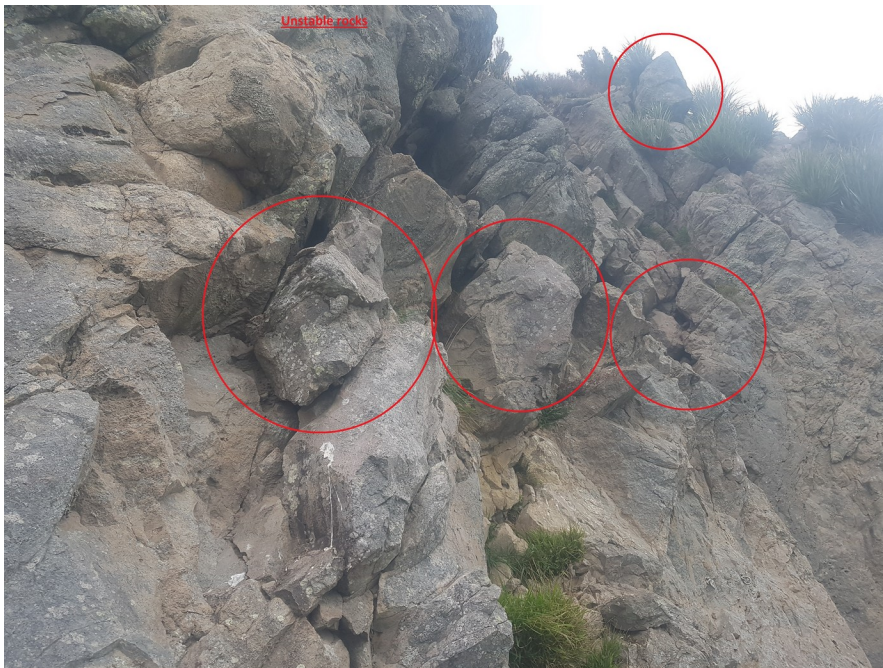
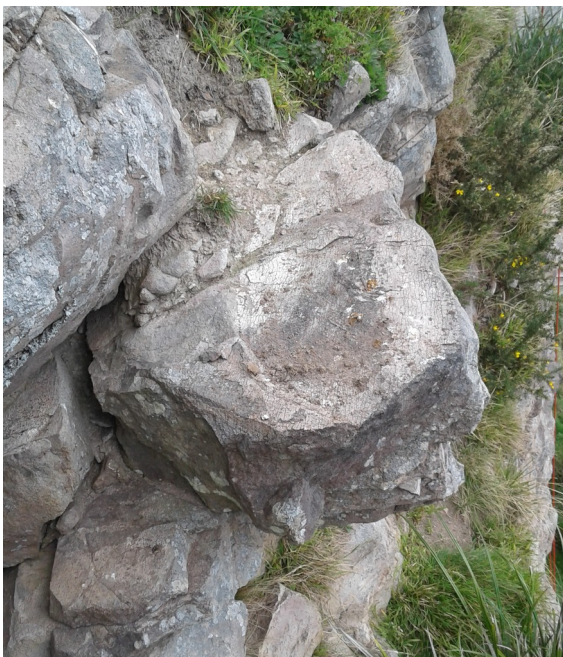
In 2017 Avalon provided a team of two technicians to assist with vegetation survey work above the Oruahine track. During that work the team came across a number of unstable areas of rock face.

Some larger unstable boulders were found, indicated in the following photos. These could not be scaled at the time with the resources available. We recommend these hazards be scaled. Track security would be required.

Loose rock identified on the bluffs above the Oruahine track.

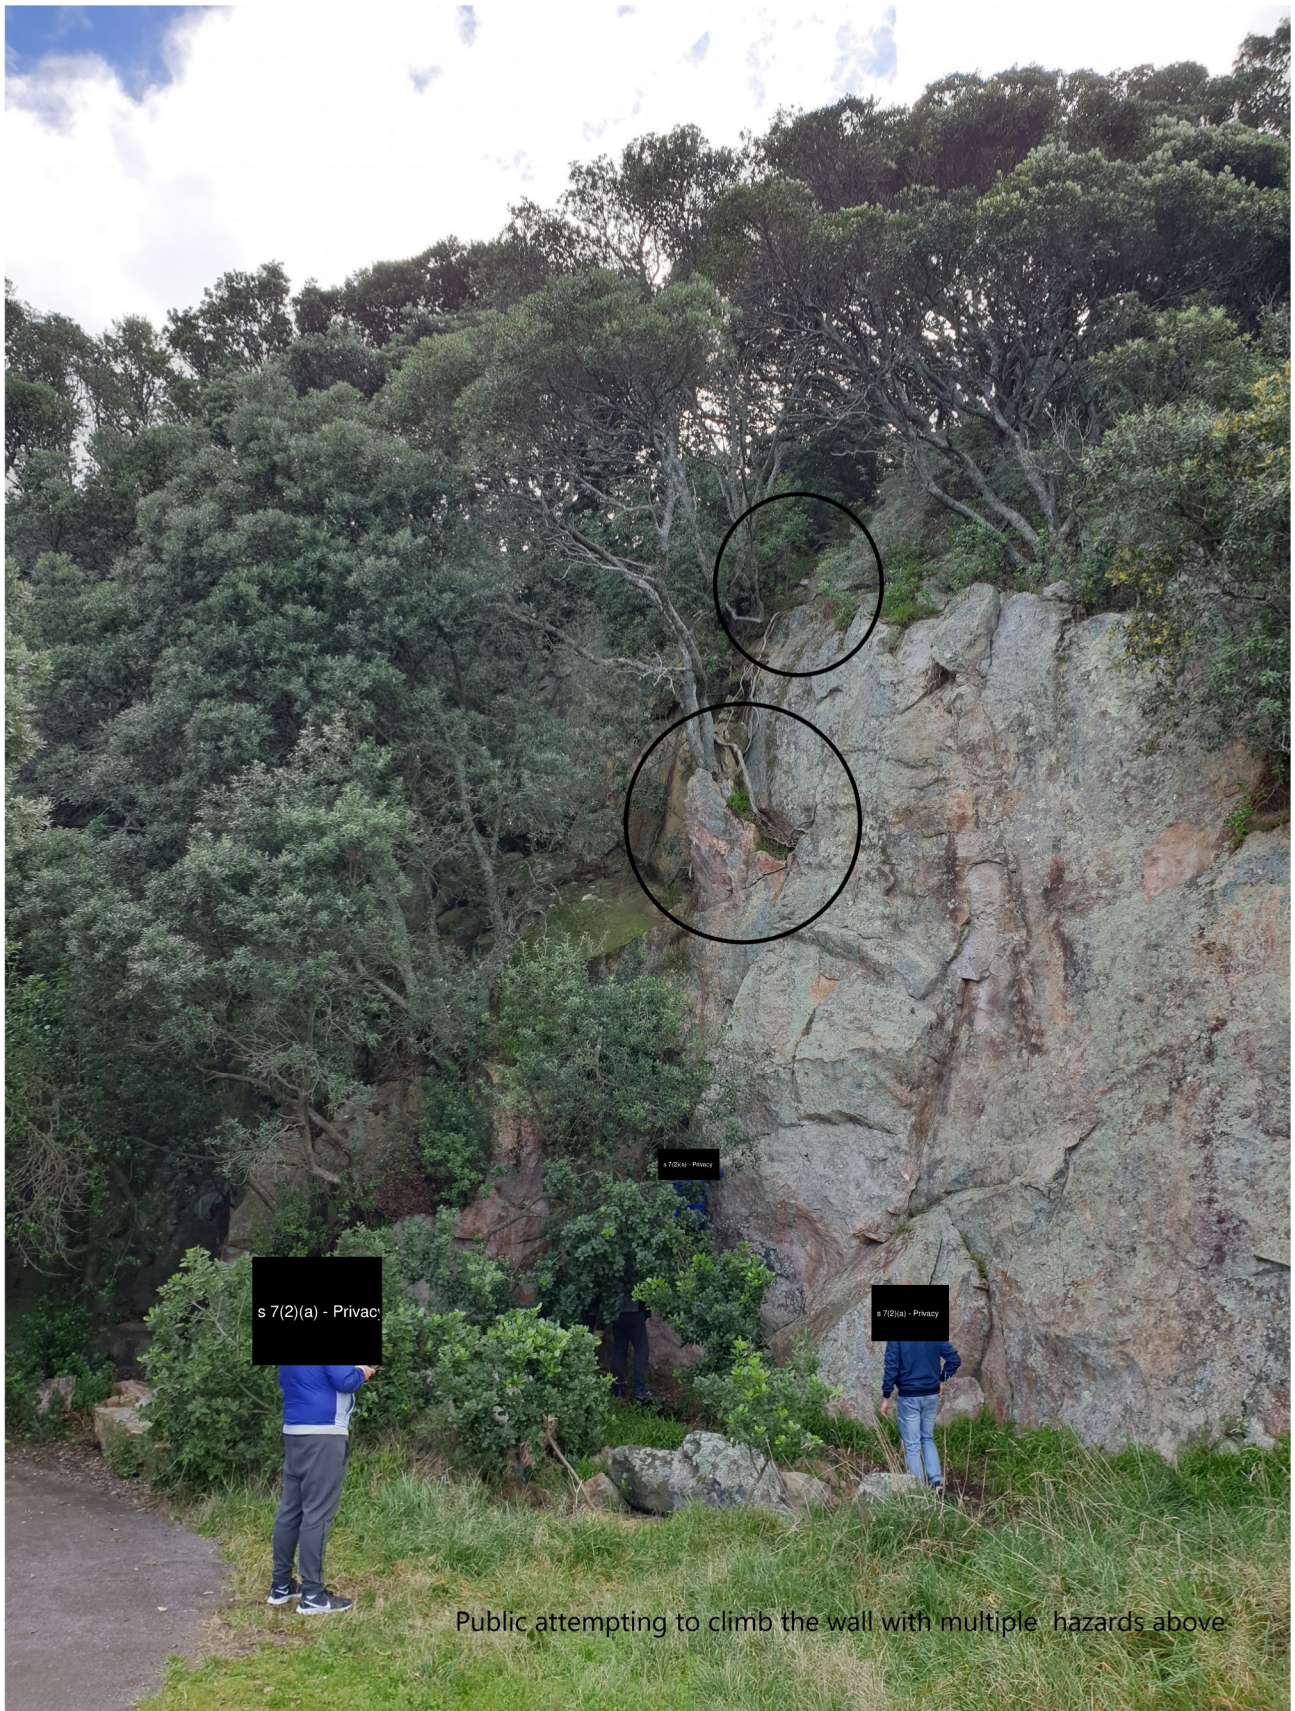
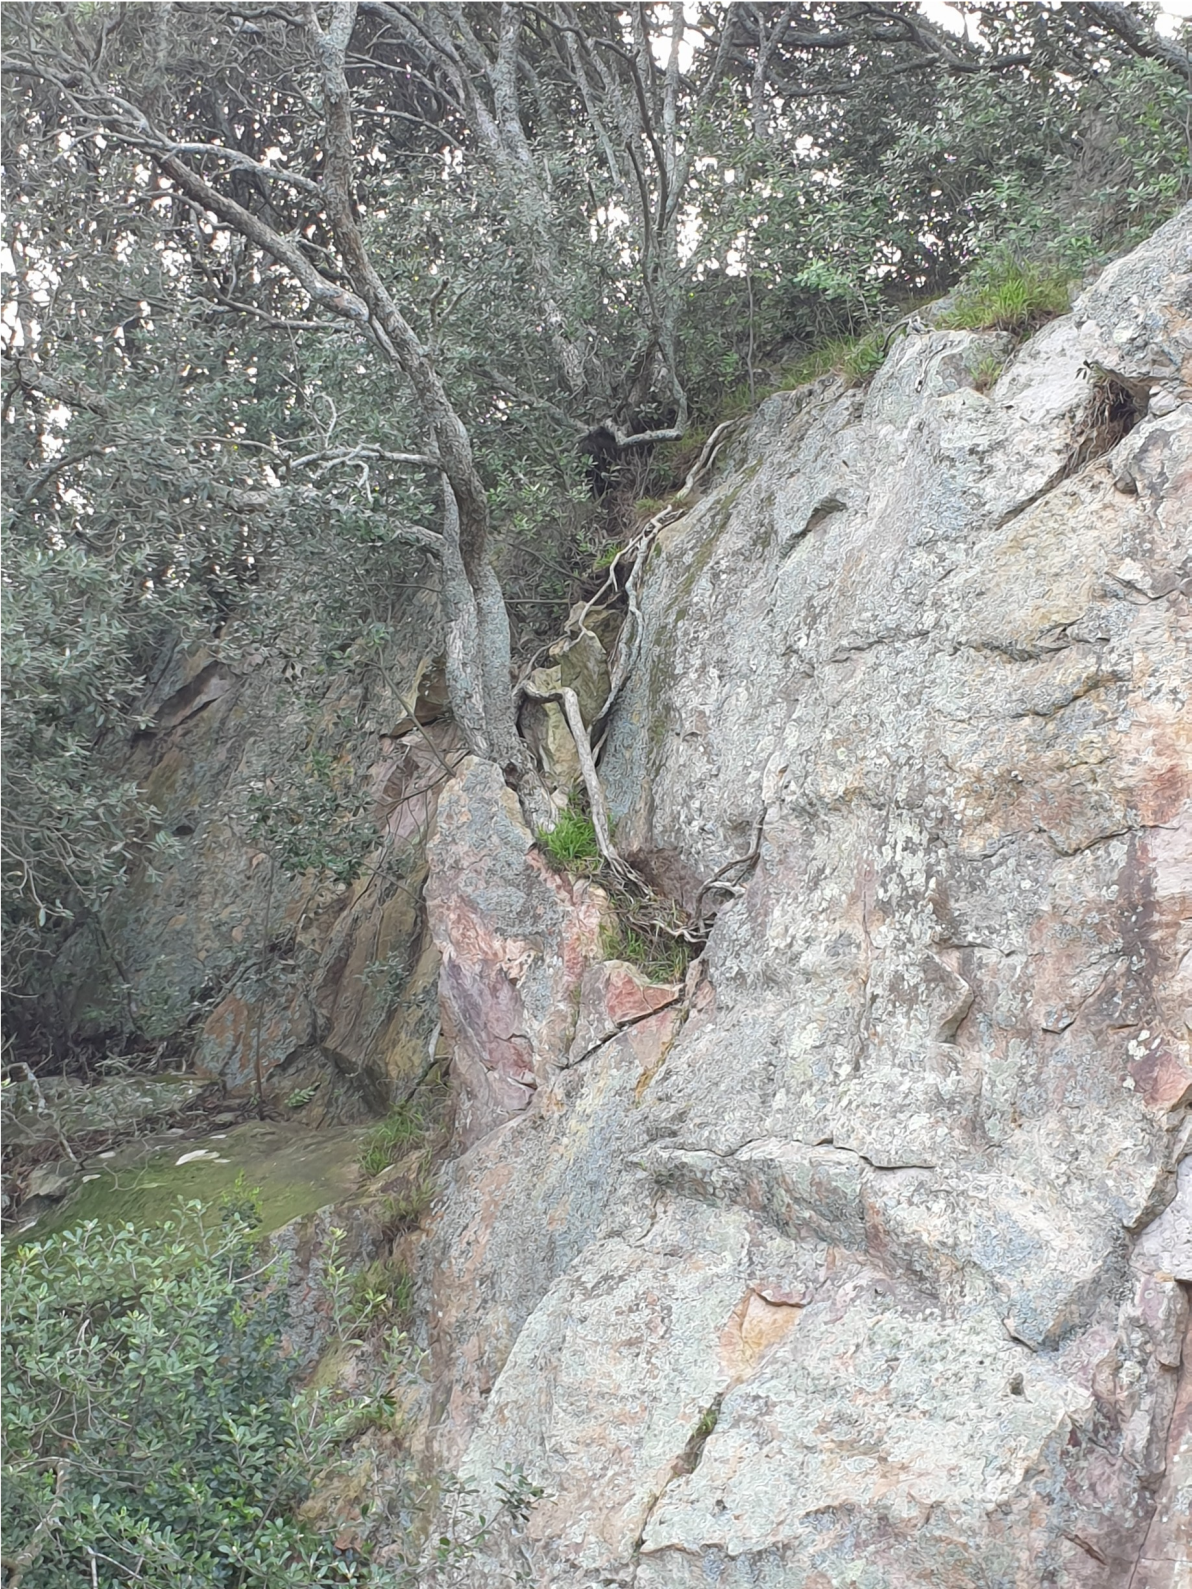
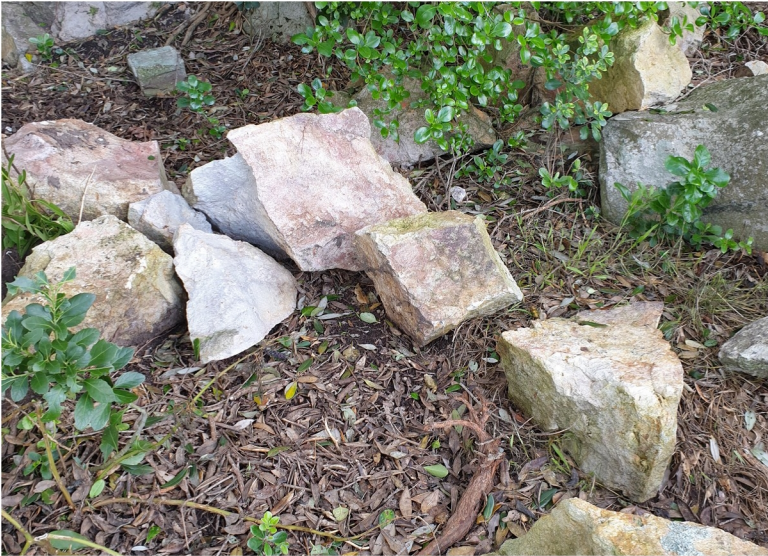
Whilst on a recreational visit to Moturiki island one of Avalon's technicians identified evidence of rockfall and persons rock climbing on a face with a number of obviously marginally stable areas.

Evidence of recent rockfall was found immediately below

We would recommend a close inspection and light scaling operation to reduce the rockfall hazard in this vicinity
