Mauao slopes 2005; Zone 6

Southern campground and hot pools

Rockfall hazard & risk assessment

Avalon Report No: 0534 A (Issue 2)

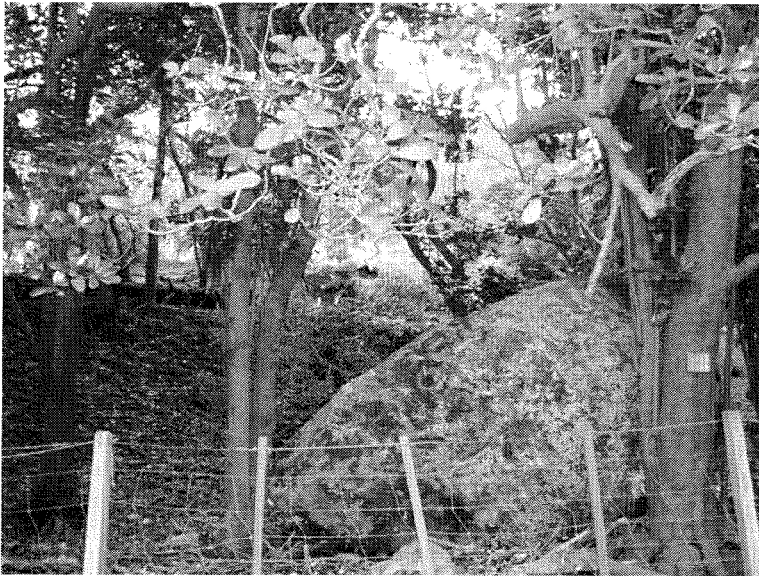
Photograph 1. Main boulder at rest adjacent to campground fence.

The boulder can be seen in the foreground of photograph 1 at rest behind the fence above camp site location No 98.

Prior to failure the main boulder appears to have been shallowly embedded and sat above a rotted out tree stump.

Shell middens were found backed up against and around the sides of the boulder and some shells were found below, indicating the boulder had probably moved post Maori occupation.

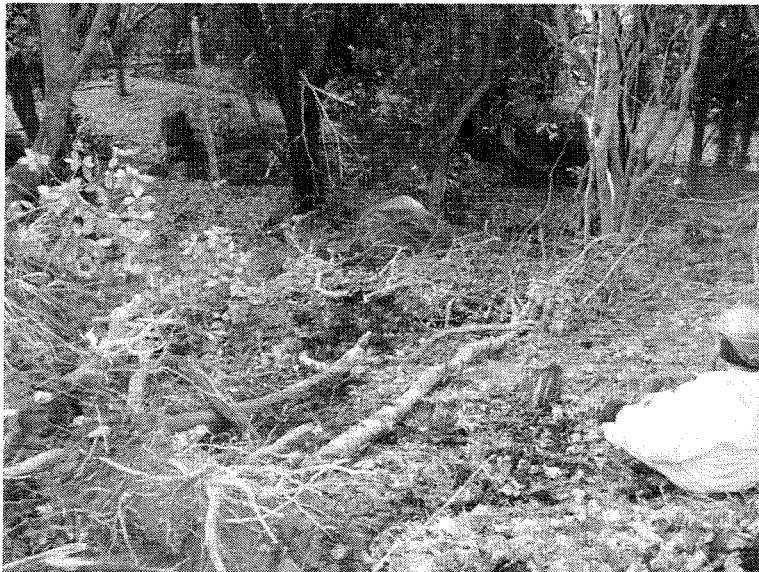
Photograph 2. View down fall line from source location.

The failure was from approximately the position of the photographer in photograph 2, 25m up the slope which lies at approximately 30°. The boulder was well rounded and approximately 2 to 3m in diameter.

A few metres down slope it collided with the small trees in the foreground of photograph 2 and then continued to roll through a few more trees before, approximately two thirds of the way down its track, striking a glancing blow to and dislodging a second boulder. This second boulder was approximately 1.5 to 2m in diameter and rocked forward approximately 1m and came to rest against a tree.

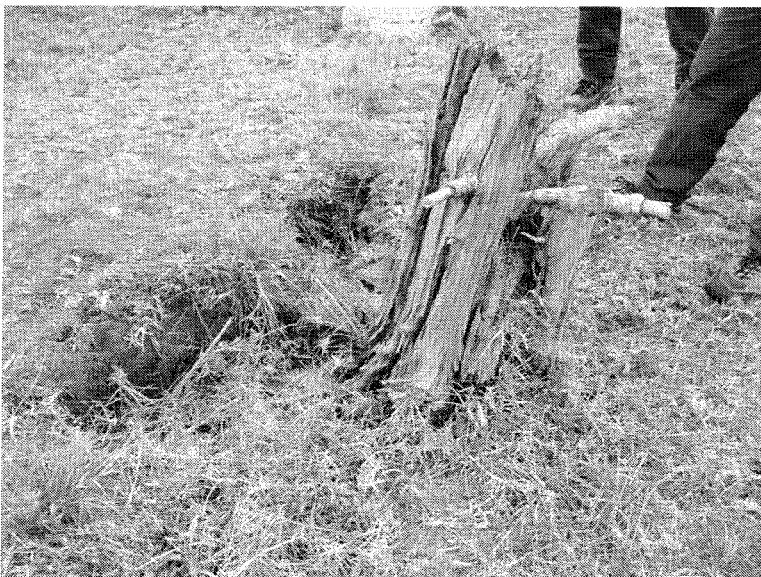
The slopes in this vicinity contain many highly rotted stumps. The decay of roots is causing localised subsidence as can be seen in photograph 3 below.

Photograph 3. Localised subsidence due to decaying root systems.

The main triggers for the boulder failure appears to have been localised ground movement due to the saturation of decayed tree root systems in conjunction with minor surface erosion and increased ground water pressure due to the extreme rainfall.

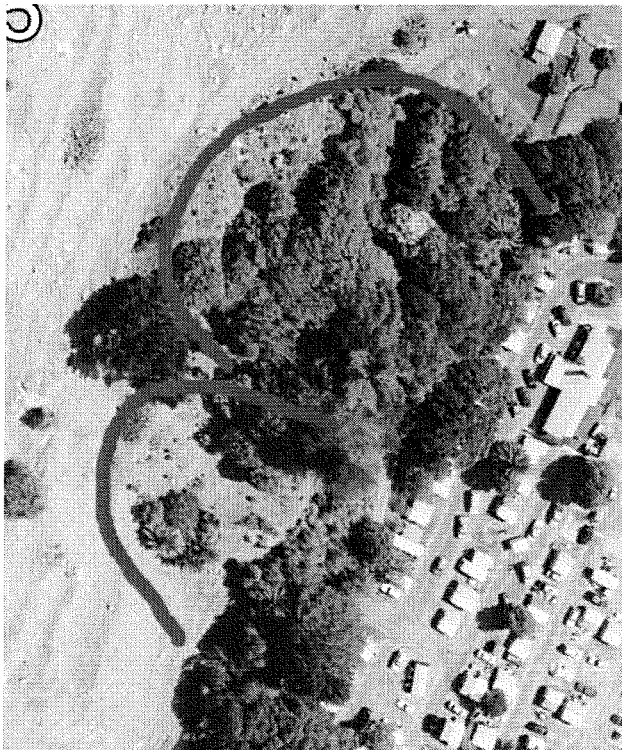
Photograph 6; Very approximate locations of two typical historical mass slips.

Photograph 6 indicates historical circular mass slips in the colluvial slopes immediately above the campground (others are also present). These events appear likely to have been over five times larger than the 18th May 2005 slip on the south western slopes and probably released a fast liquefied debris flow.

Should such an event now occur above the campground the consequences could be extremely serious.

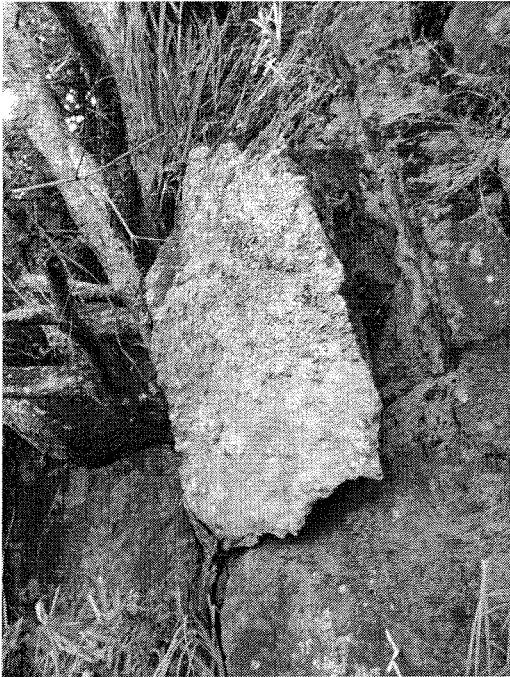
3.6.1 **6a**; detached boulder on face of outcrop

A broken bluff up to 4m in height runs from 6a to 6b and 6c. At 6a a 'flake' of rock approximately 1 x 1 x 0.4m has become detached, mostly due to root jacking. The rear joint is open over 100mm. Very marginally stable. The disc shape could allow this boulder to roll a considerable distance.

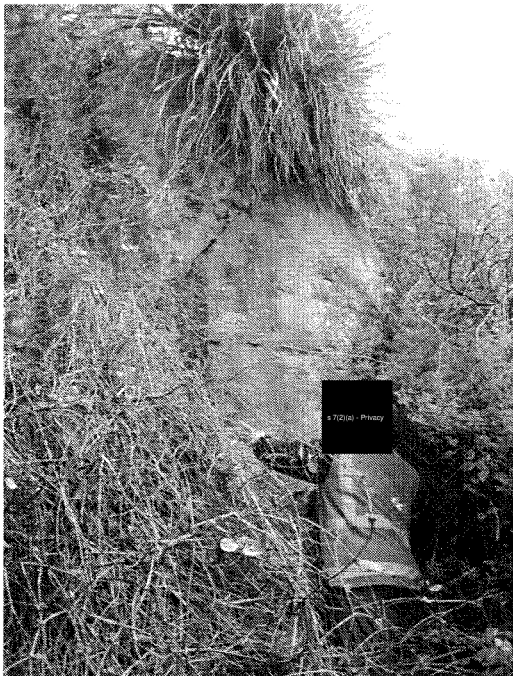
3.6.2 **6b**; detached boulder forms face of outcrop

The lower area of this outcrop shows very fresh looking stress fractures. A 'flake' approximately 2.5 x 2 x 0.5m is marginally stable. The rear joint is open 30-50mm and seeping water. Freshness of fractures suggests they could have formed in last year's earthquake event.

Appears likely to split on failure but main piece would remain disc shaped.

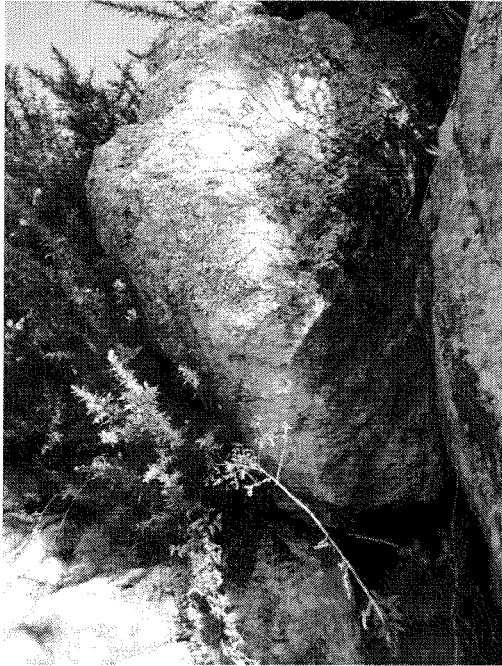
3.6.3 6c; detached boulder on top of outcrop

A relatively small boulder, 1 x 0.5 x 0.5m. Detached and temporarily wedged but root jacking could destabilise.

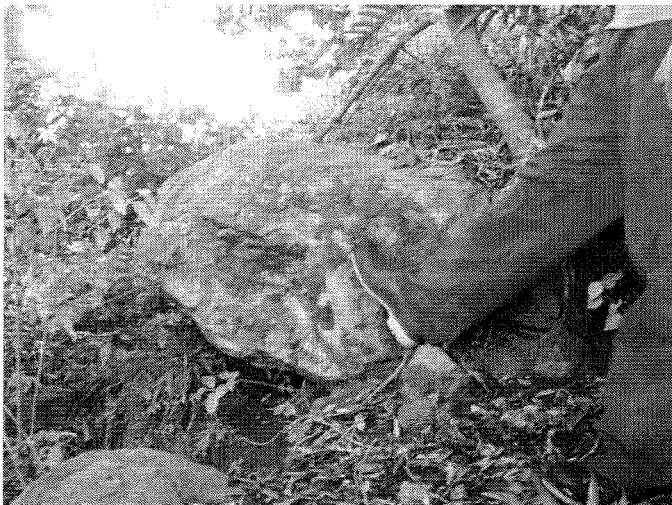
3.6.4 6d; surface boulder

Approximately 1.2 x 1.0 x 0.8m. Toe undercut by erosion but relatively stable in the short term. Further erosion and growth of tree behind could further destabilise.

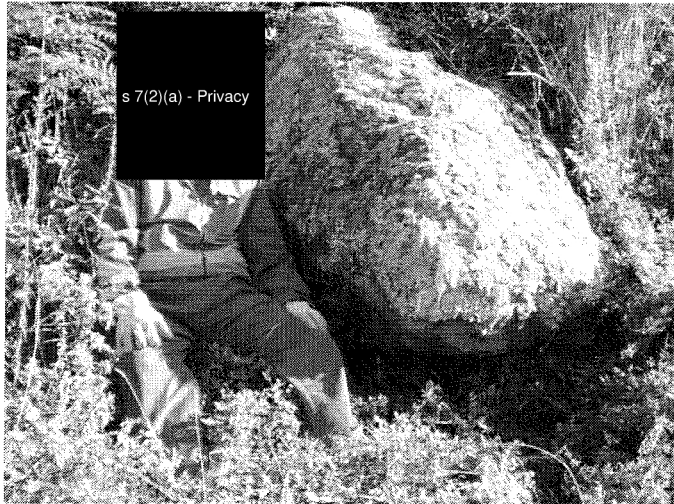
3.6.6 6f; surface boulder

Approximately 1.2 x 0.8 x 0.8m. Toe undercut by erosion. Further erosion could destabilise. Ground immediately below is very steep.

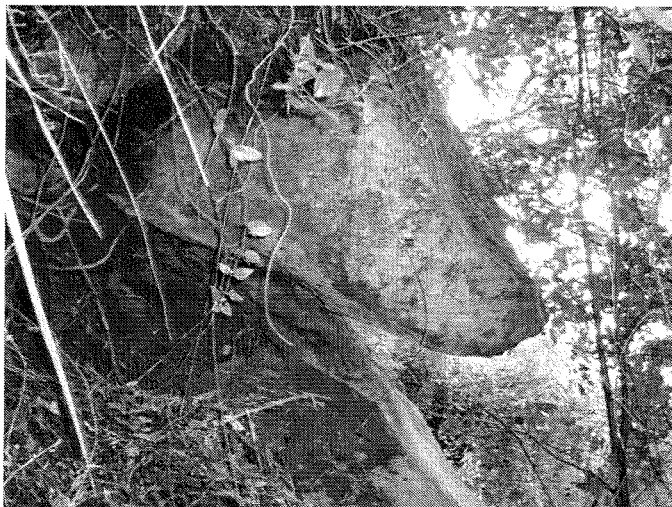
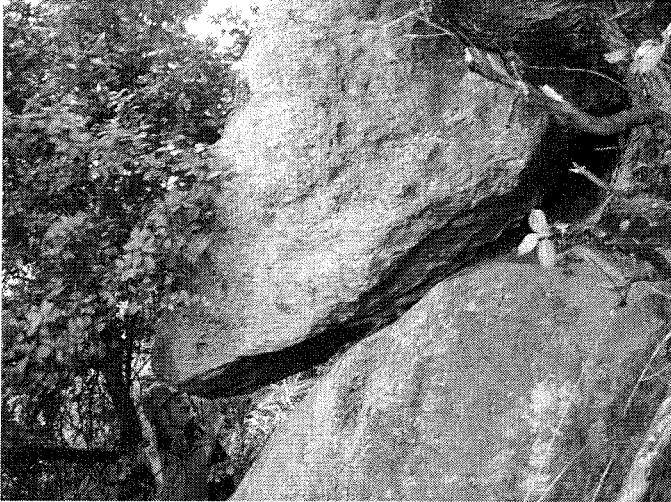
3.6.7 6g; weathered outcrop with detached boulder on top

A relatively severe hazard, appears to have very marginal stability. Approximately 2 x 3 x 1.2m. Tree behind is jacking the upper block forward. Steep slope immediately below.

Wedge shape will resist rolling but mass of boulder and steepness of ground are not favourable.

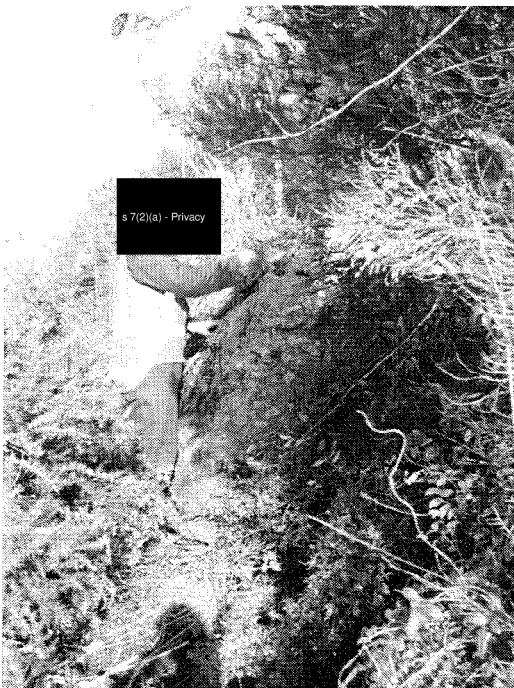
3.6.9 **6i**; surface boulder

1.5 x 1.5 x 1m. Moderately eroded and undercut base. Steep ground below but relatively stable in the short term.

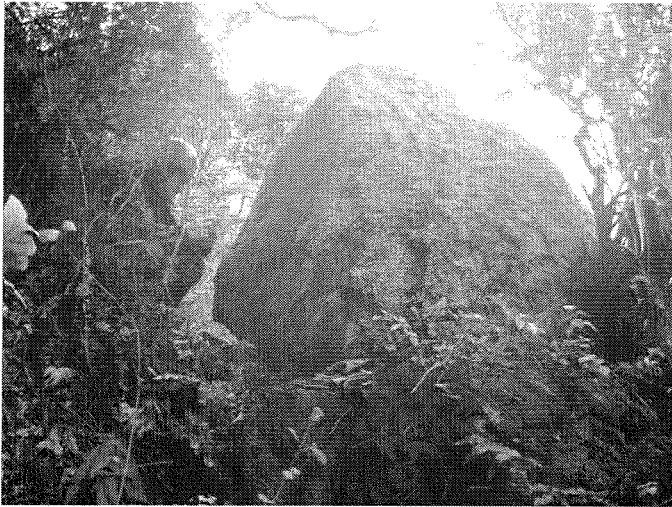
3.6.11 **6k**; large outcrop boulder

5 x 5m outcrop with boulder of 1.5 x 2 x 2m resting on top. Low angle contact between boulder and outcrop is stable regarding erosion but potentially becomes a hazard given seismic loading.

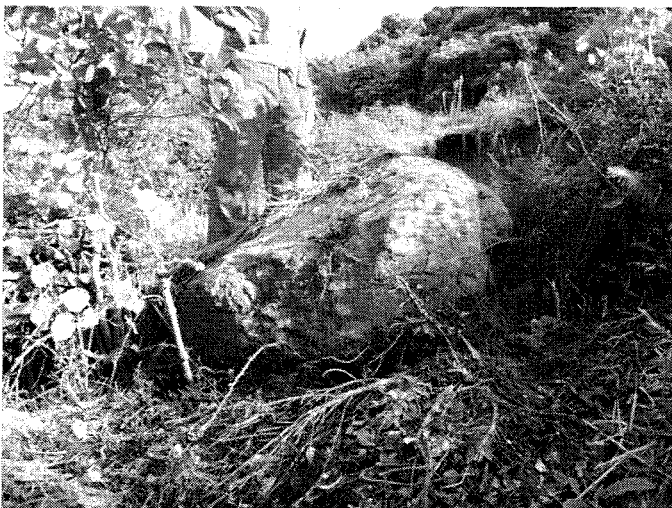
3.6.13 **6m**; surface boulder disturbed by recent mass slip (slip item 9).

1.2 x 1.2 x 0.6m. Has been rolled to a relatively stable position.

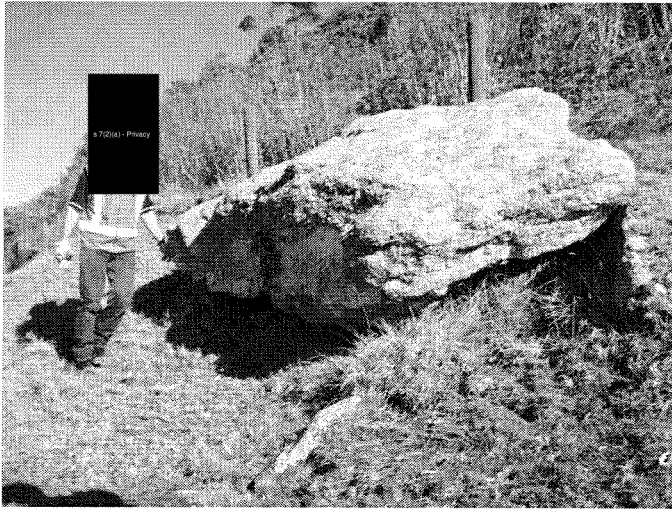
3.6.14 **6n**; surface boulder in paddock

2 x 2.5 x 0.8m. Moderately stable in short term but on steep ground and with potential for erosion below. Hazardous in earthquake. Could split into two on rolling.

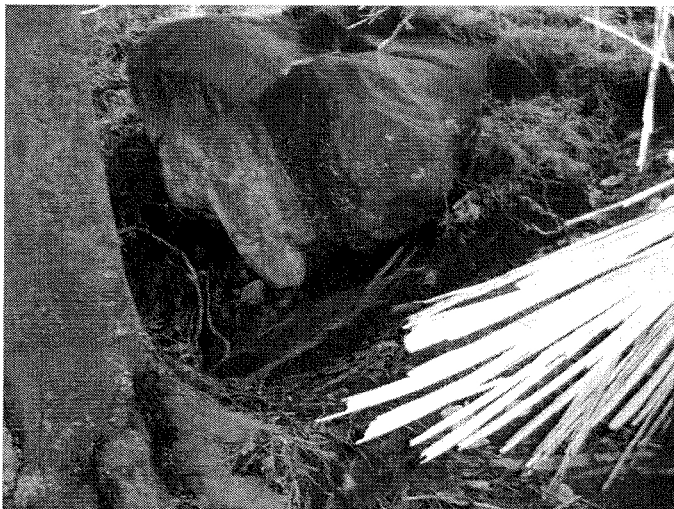
3.6.17 **6q**; surface boulder on margin of historical mass slip

2 x 1.5 x 1m. Embedded in top of steep historical mass slip scarp. Moderately stable in the short term but eroding slowly below.

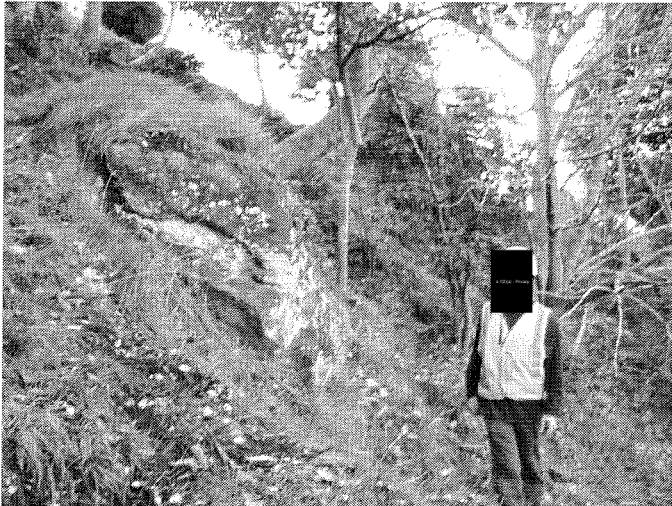
3.6.18 6r; surface boulder on margin of historical mass slip

2 x 2m. Embedded in steep historical slip scarp. Stable in short to medium term.

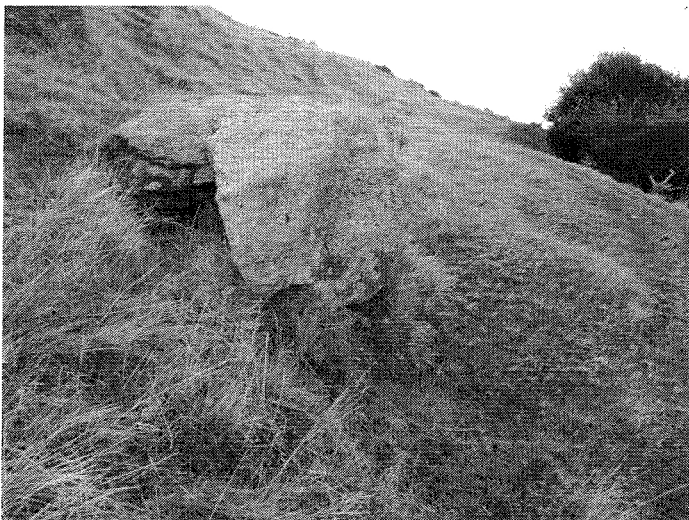
3.6.19 6s; surface boulder in paddock

1 x 0.8 x 0.6m. Embedded and moderately stable in the short term.

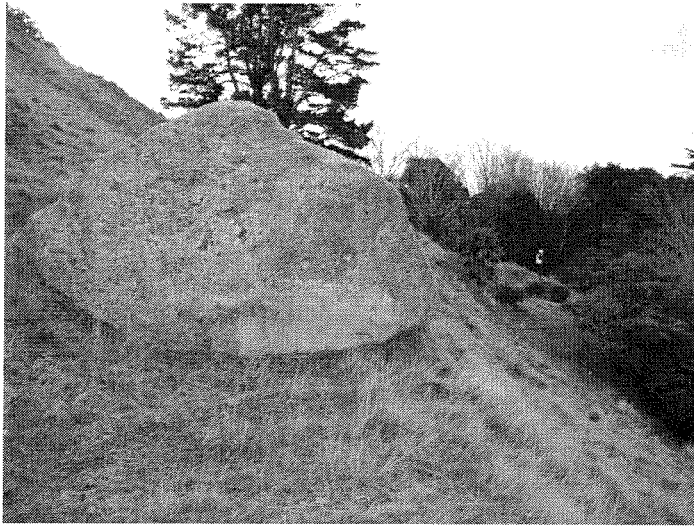
3.6.20 6t; surface boulder in paddock

2 x 2 x 1.5m. Stable in short term but potentially hazardous should steep soil slope drop out from below.

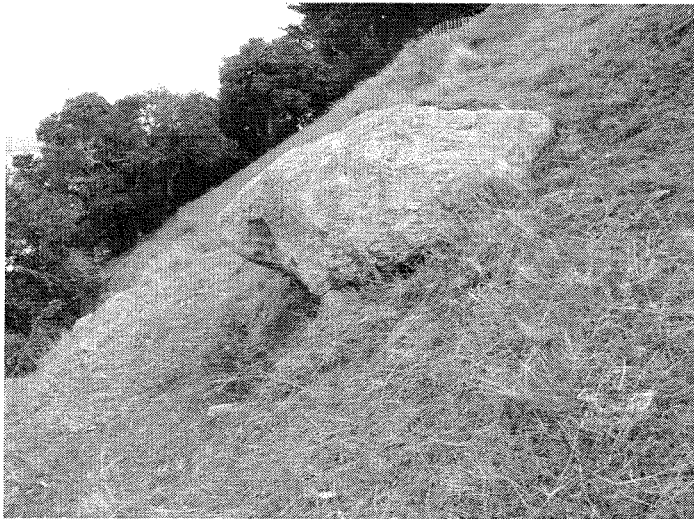
3.6.21 6u; surface boulder in paddock

2 x 1.5 x 1.5m. Moderately stable in the short term but undercut and on very steep ground.

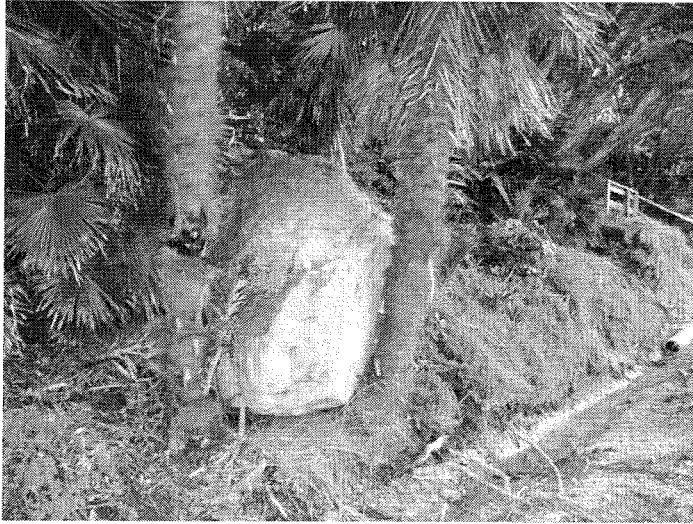
3.6.22 **6v**; surface boulder at campground boundary

1.5m diameter. No significant hazard but appears likely to have been creeping down cut slope. Now bearing on the small palm trees.
