## GEOTECHNICAL

### **Mauao Slopes; Monitoring Report; 29 November 2007**

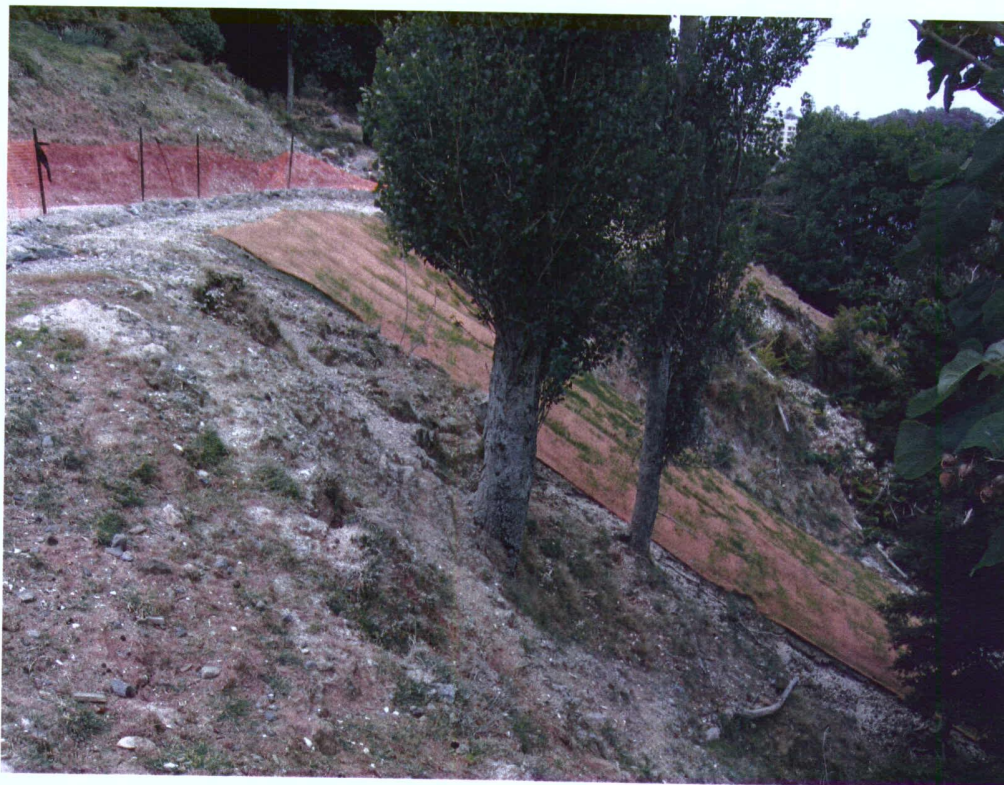
*Photograph 1; Repair completed to dropout on lower 4WD track.*

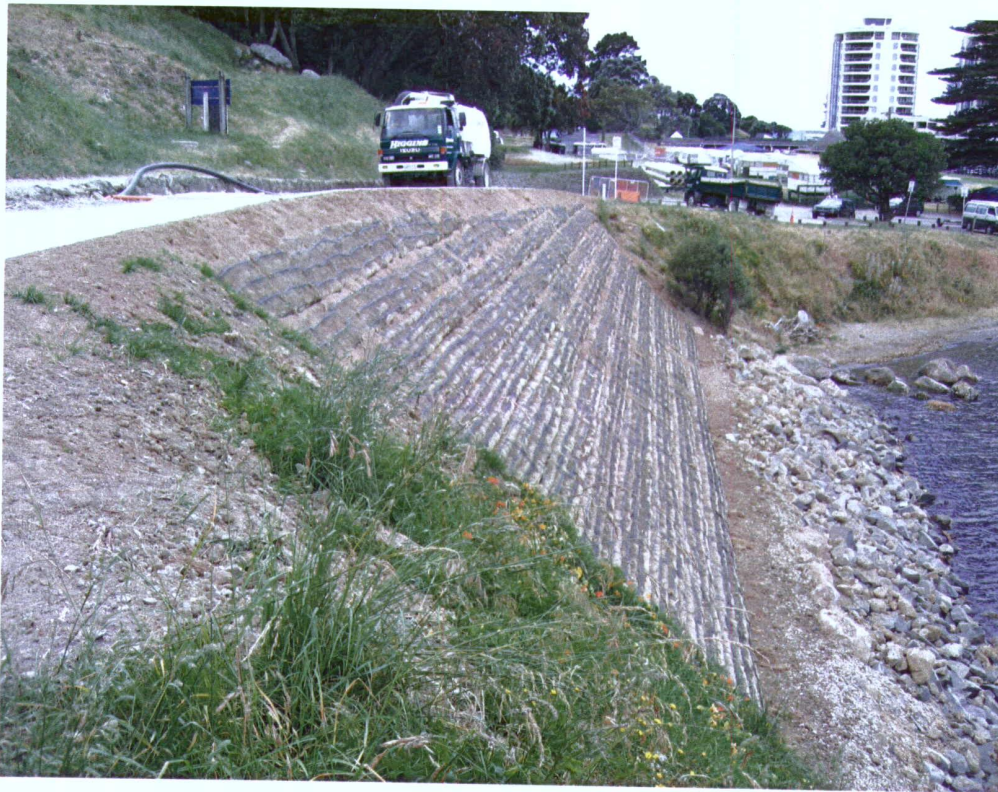
*Photograph 2; Repair completed to dropout wharf access road.*

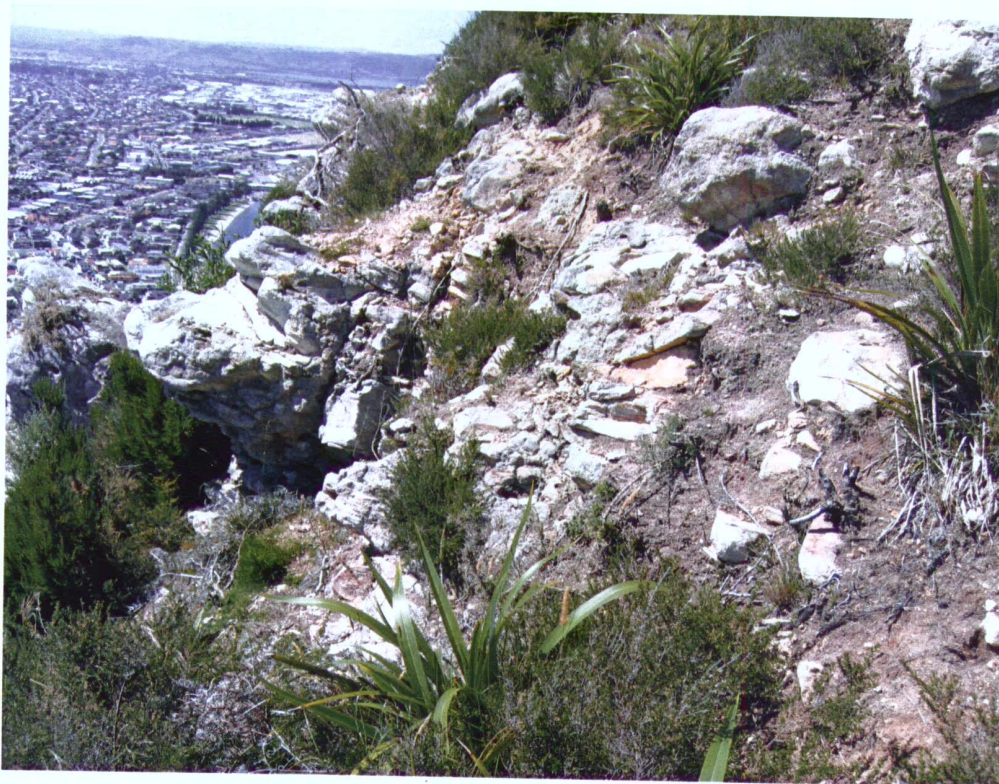
Scour of sand from non-vegetated patches has continued and has been the source of minor rockfall. As reported previously the majority of this will have occurred during inclement weather, at which times there are few persons on the tracks. The majority of the rock likely to fall from these loose surfaces is in the smaller size range (say <150mm).

*Photograph 3; Ongoing scour.*

Vegetation continues to re-establish. As previously recognised any weed spraying must be extremely targeted to not leave loose sandy areas prone to scour.

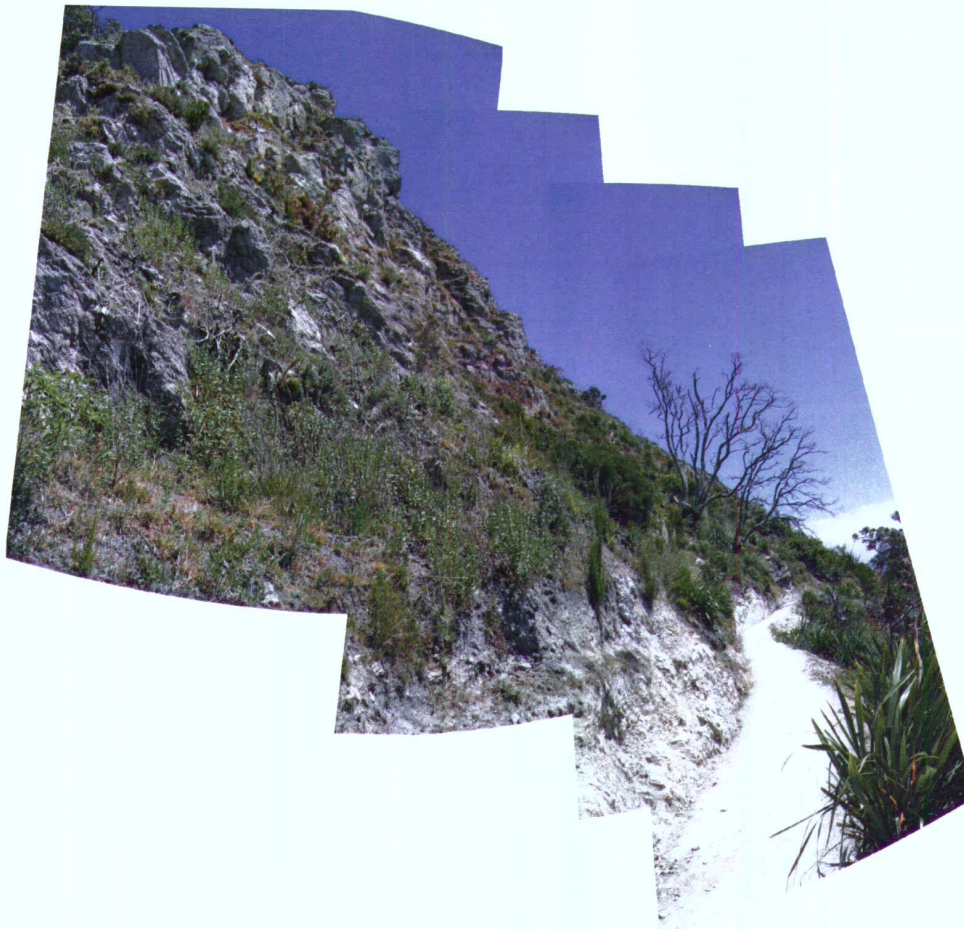
*Photograph 4; Example of new monitoring point on Waikorere track.*
