17 December 2007

Our Ref: 3203964/100
T1:71117-ST57DL02.DOC

Mt Maunganui Beachside Holiday Park Slip Assessment

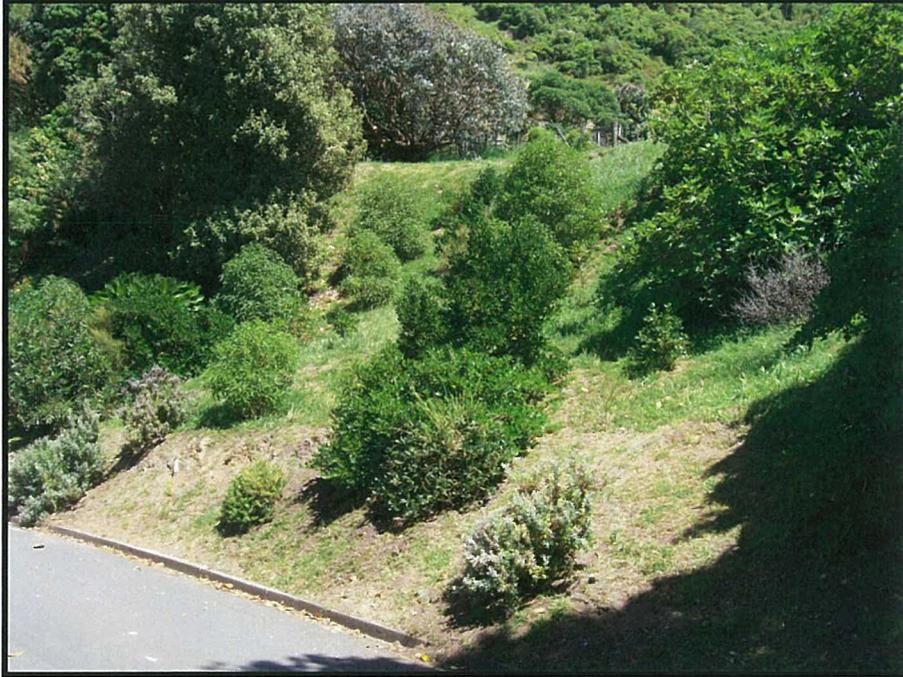
The upper section of the slope has slumped with a vertical headscarp forming along the top of the slope. No evidence of movement has been noted within the lower section of the slope.

- The observed instability appears to be confined to the upper slope area, and to have caused the crest of the slope to recede by around 0.5 m.
- There is evidence of near surface instability, ie localised small slumps and soil creep, within the surrounding steeply sloped areas.
- A scarp was observed along the top of this slope, indicating around 50 mm to 100 mm of vertical movement.
- The slope surface is mantled in variable fill materials. Assorted debris, including concrete blocks and plastic, plus topsoil was noted within this fill.
- The remainder of the slope area is variably covered in grass, bushes and small trees.

Photo 1: Looking across the slope from the eastern side.

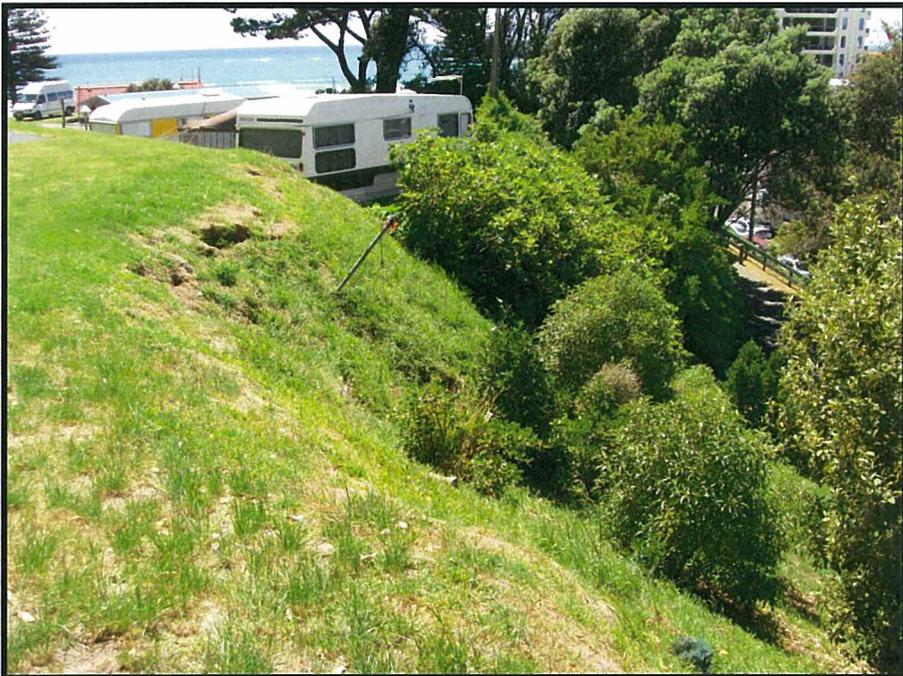
The observed instability appears to be confined to the fill materials that overlay the stiff in situ soils encountered on this slope. These materials have likely been placed as a part of localised earthworks to form a platform for a caravan site, and appear to have been compacted poorly and with unsuitable materials used.

Instability of a similar type to that observed is likely to continue in the future. These future episodes will continue to cause the crest of the slope to retreat, potentially by an additional 1 m to 2 m. A large scale and deep seated movement appears unlikely given the stiff in situ soils encountered below the fill.

Photo 1: Looking along the top of the failure slope from the western side, recent movement indicated by the near vertical scarp.

The recommended immediate action is to restrict access to the crest of the slope in the short term and until a remedial option has been selected, keeping campers and vehicles clear of the slope crest.

A suitable measure to restrict access includes placing large painted rocks or installing posts a minimum of 2 m from the crest of the slope.

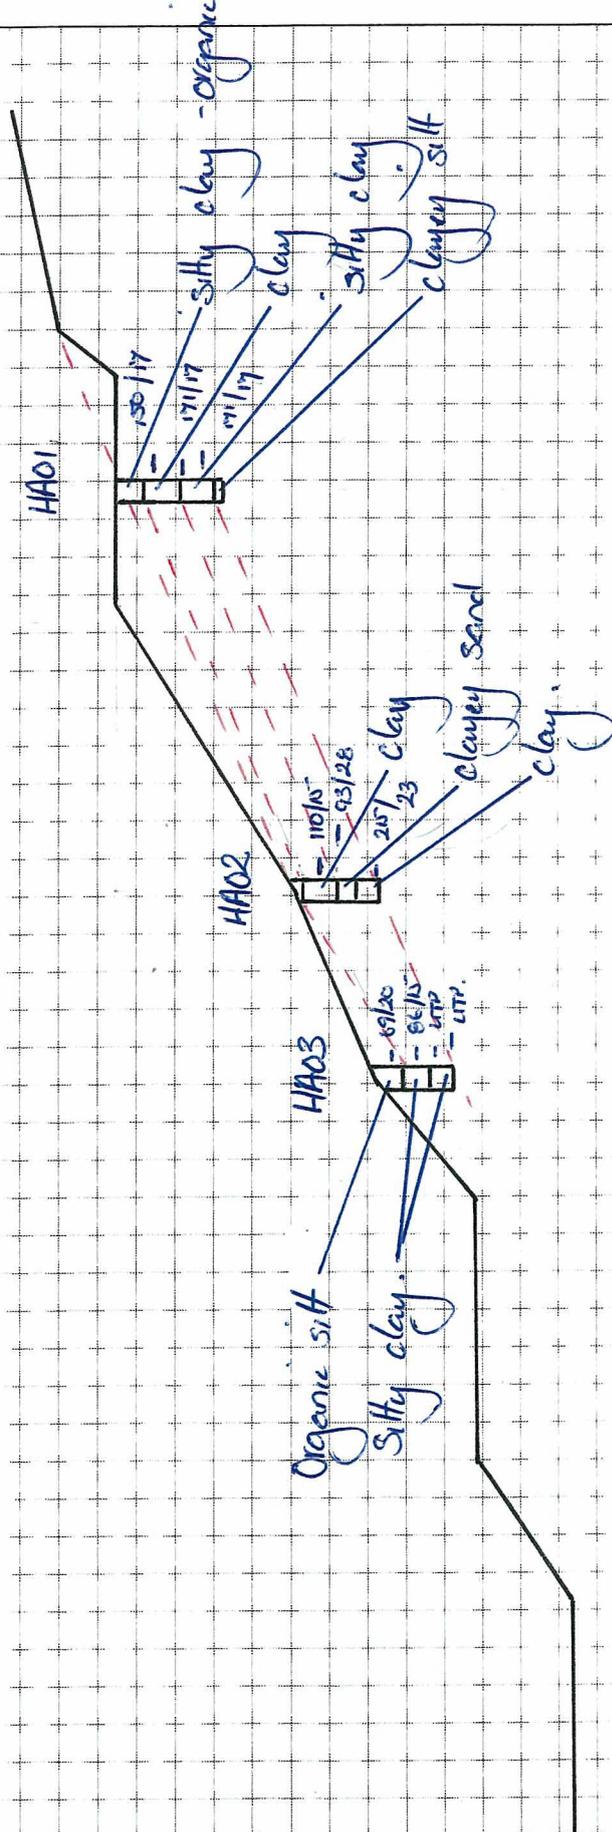
Job name: *Mauvo Slip*
Subject: *Geological cross-section*
By: *s 7(2)(a)*

The soil profile encountered with the hand augers consisted of silty clay that overlays weathered rhyolite (see attached cross-section). The hand augers show that the upper 1 m of the upper section of the slope consist of fill material (silty clay with organic material),

while the upper 0.7 m of the lower section consists of cohesive fill materials containing plastic, glass and charcoal and other debris.

The in situ materials encountered had shear strengths in the range of 50kPa to over 150kPa. No groundwater was encountered within the hand auger holes.
