GEOTECHNICAL

3 December 2018
Avalon Project #19145

Mauao Slopes; Monitoring Report for November 2018

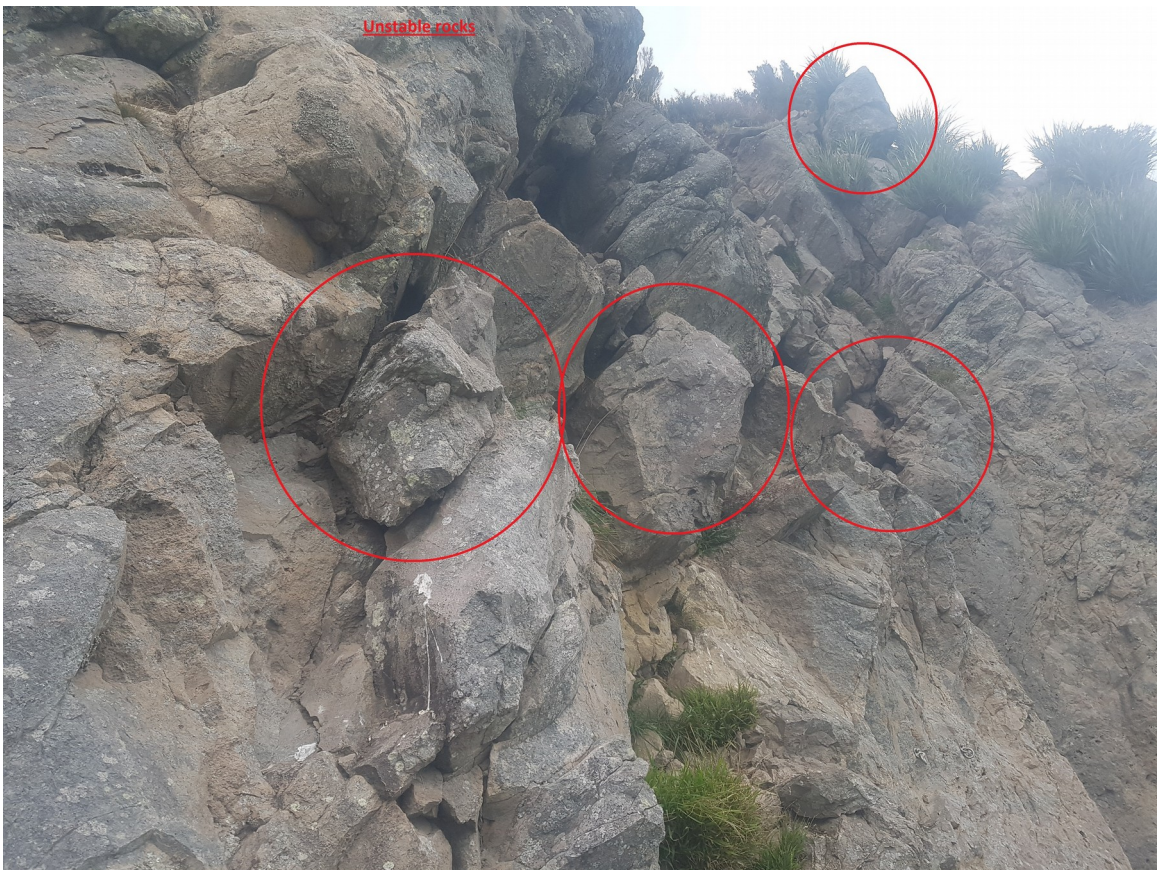
Some significant larger unstable boulders were also found, indicated in the following photos. These could not be scaled in the time available.

Photo 1. Areas identified on the bluff above the Oruahine track.

We recommend these hazards be scaled. Track security would be required.

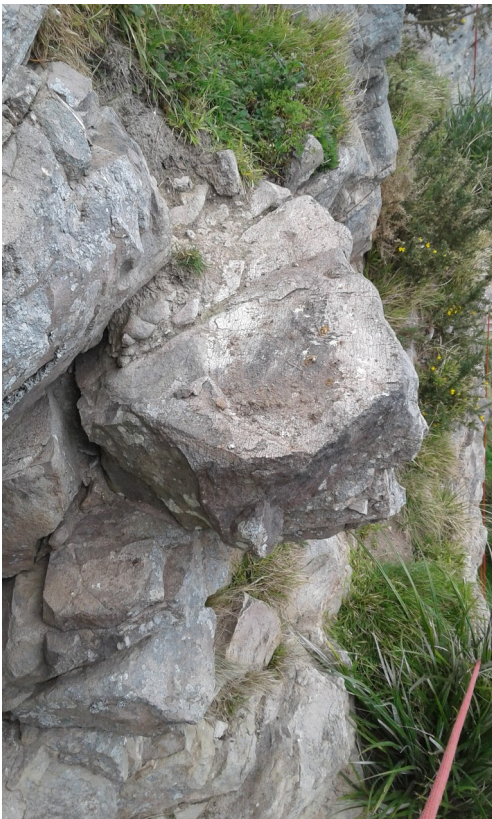
Photo 2. Loose rock previously identified above the Oruahine track.

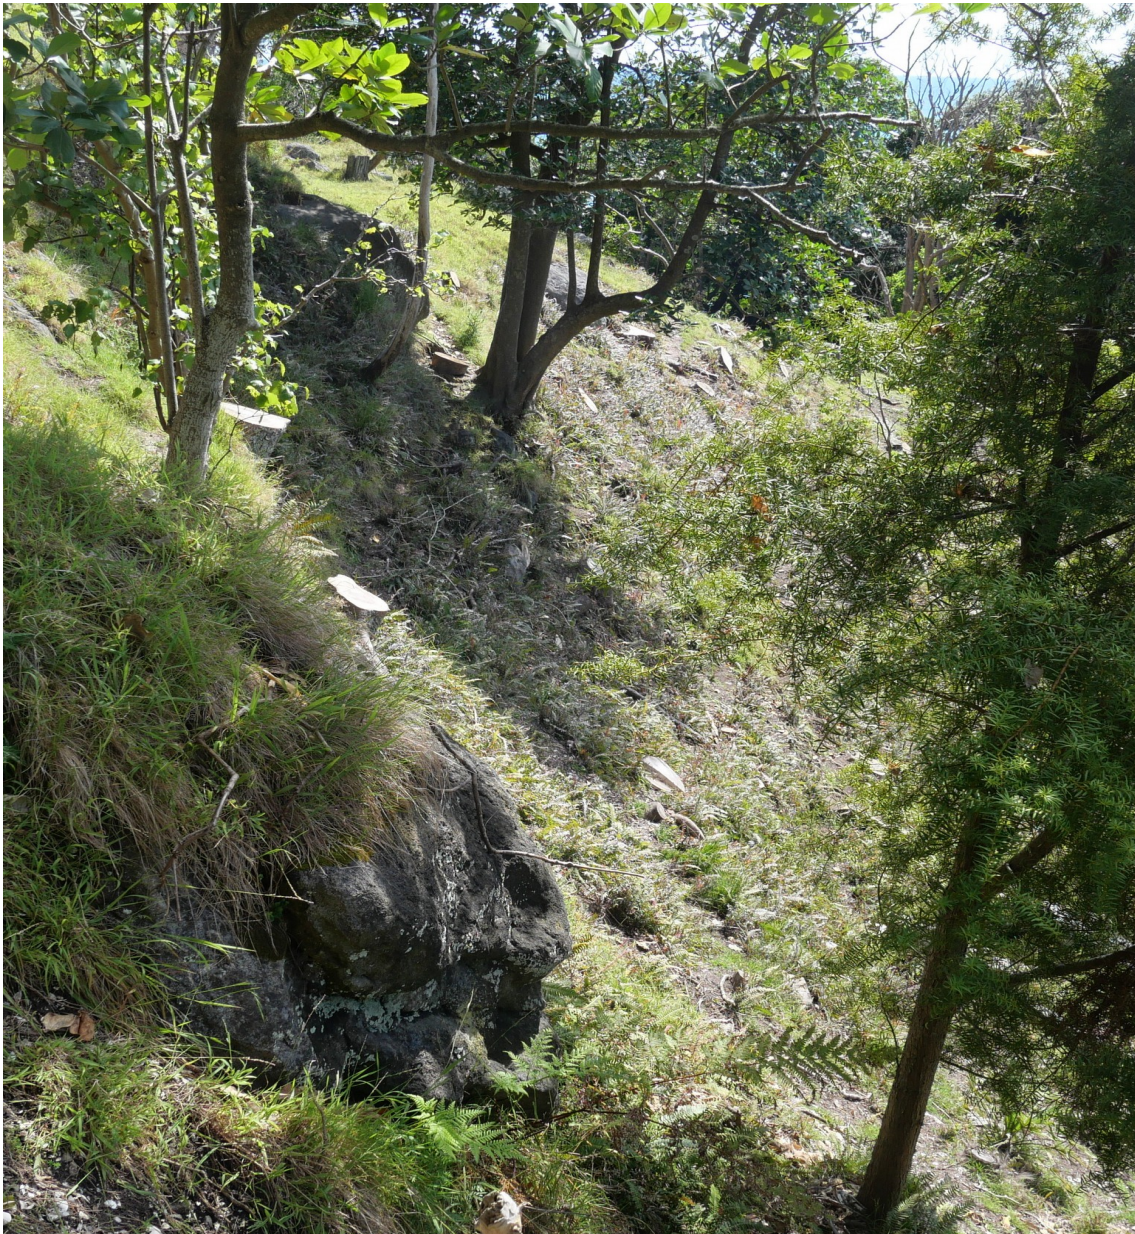
Previous experience on Mauao has shown, in similar locations nearby, that as dead tree roots decay this is detrimental to local slope stability, particularly where boulders are loosely embedded in the surface of steep slopes, as is the case in this recently cleared area.

The removal of the trees also leaves the slopes more exposed to wind and rain erosion and surface runoff tends to channel around boulders. A number of potentially affected boulders are shown in the following photos.

Photo 3. Boulders in the steep slope behind the southern area of the campground.

It would be advisable to probe around these boulders to better determine the size and shape and where necessary safely scale them. This should be able to be achieved relatively quickly and at minimal cost. Additional security guards would not be necessary.

Small patches of erosion control mat could be pinned to any resulting scars on the slope.

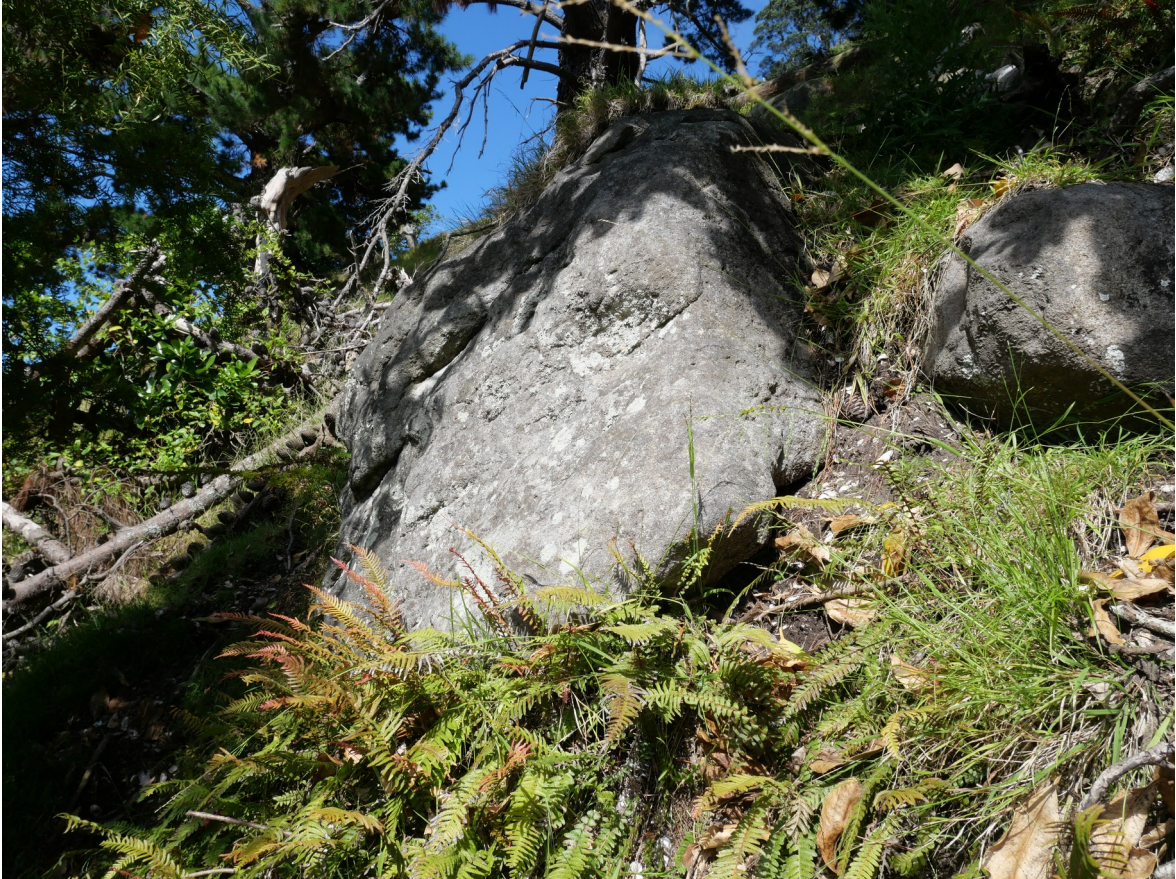
Photo 4. Boulders in the steep slope behind the southern area of the campground.

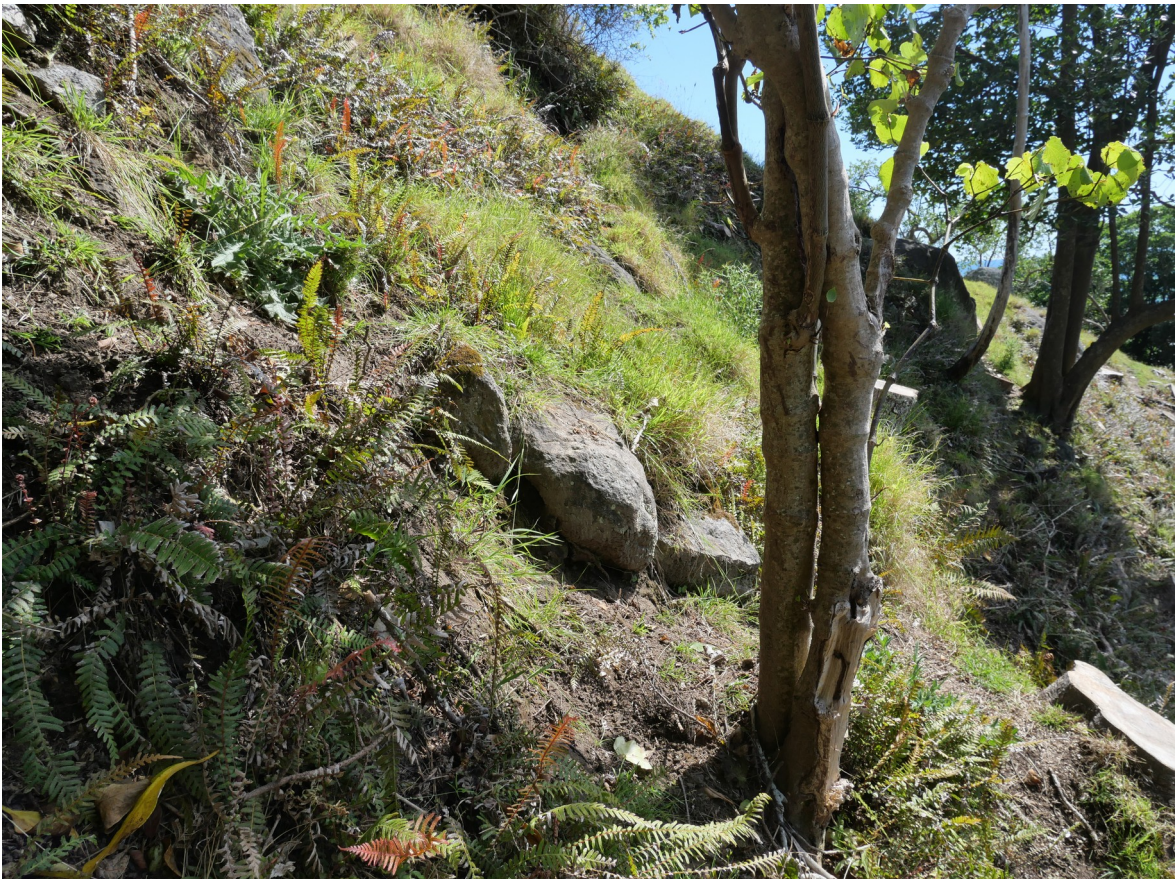
Photo 5. Boulders in the steep slope behind the southern area of the campground.

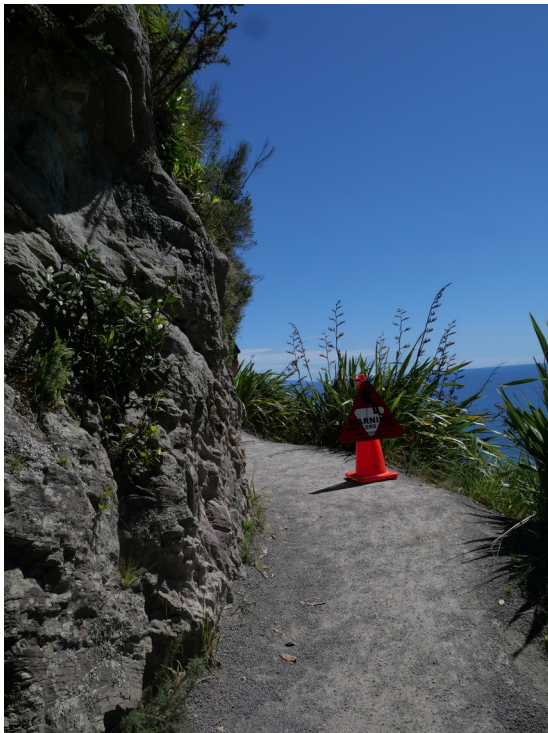
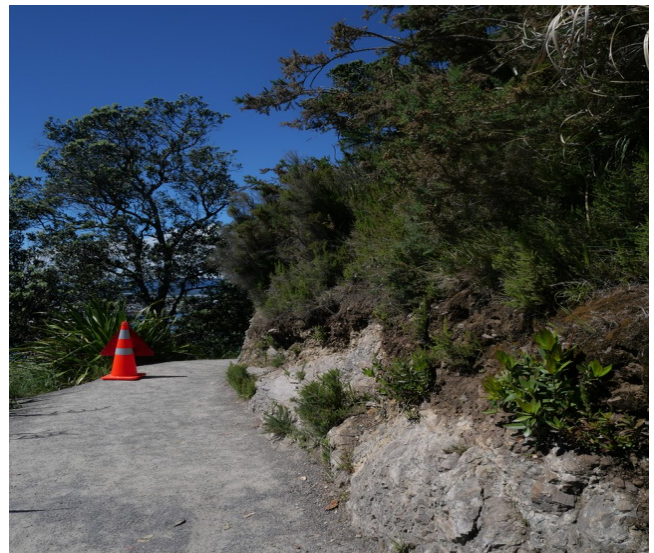
Photo 6 and 7. Sharp bend on the Waikorere track.

As known, the drop off at this location is very steep and hazardous and the potential for runners to collide is clear.

The rock corner could be reprofiled and cut back to improve the sight line. Signage and or a guardrail could also be considered. At your request Avalon would be happy to work on proposals for this work.

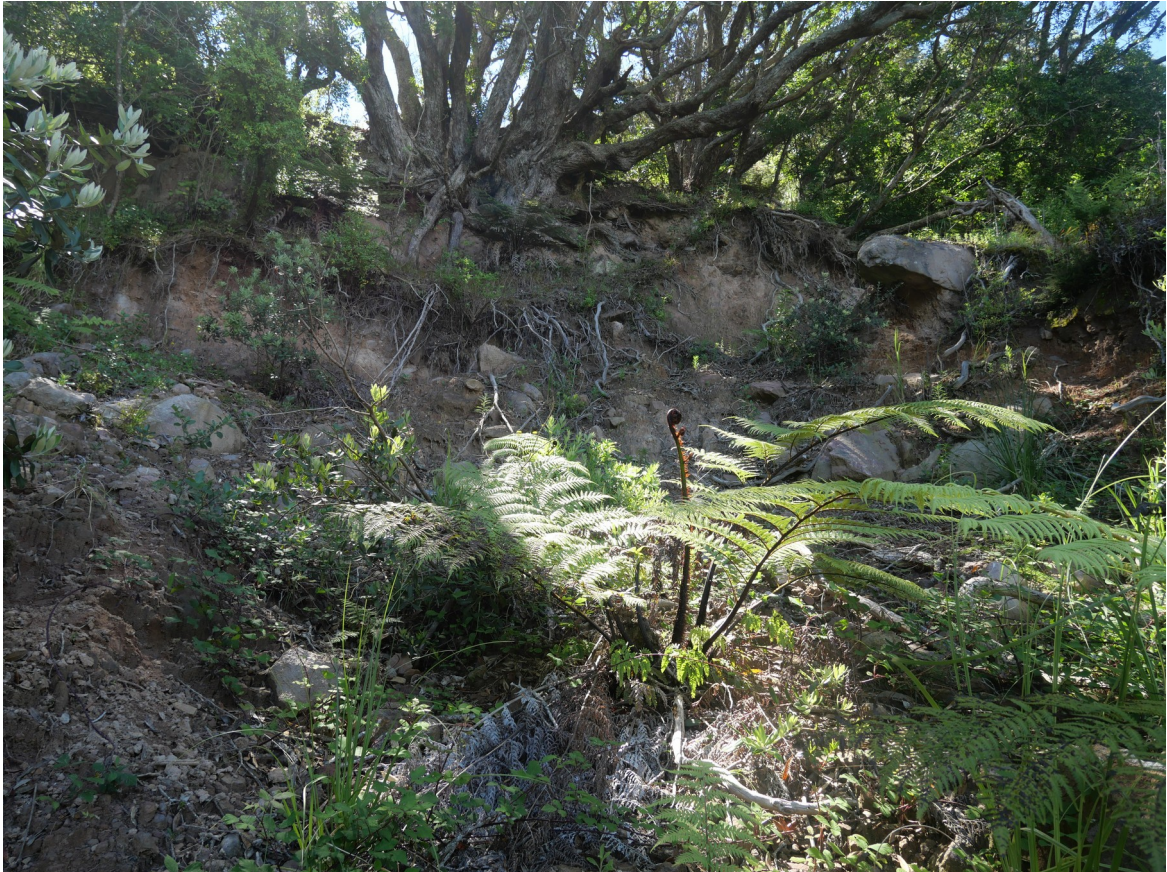
Some of the hazards are clear in the following photo.

Photo 8. Active slip slope above the Goat track.

It is recommended that this active slip slope should be scaled prior to the track being fully reopened to the public.

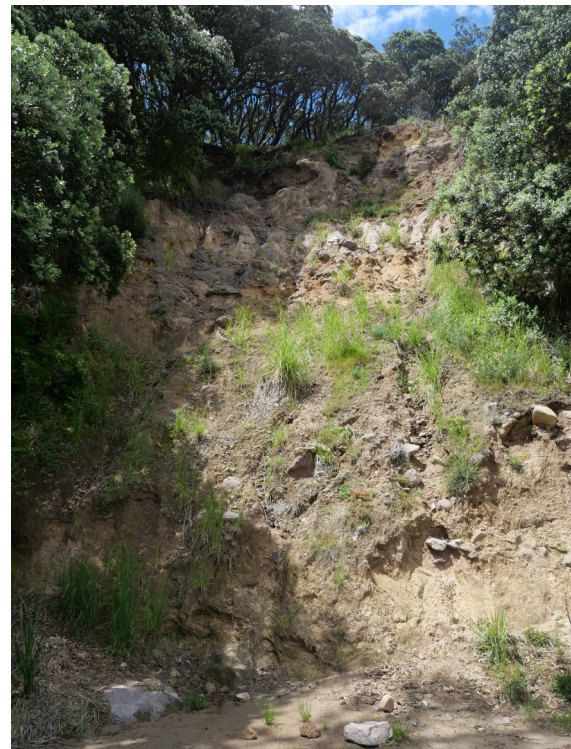
Photo 10. Current.

As expected the surface of this slip continues to actively erode. The minimum recommended hazard management measure would be to scale the surface every two or three years and/or following major and prolonged storms. A catch fence or slope erosion control mesh/mat would be higher level options.

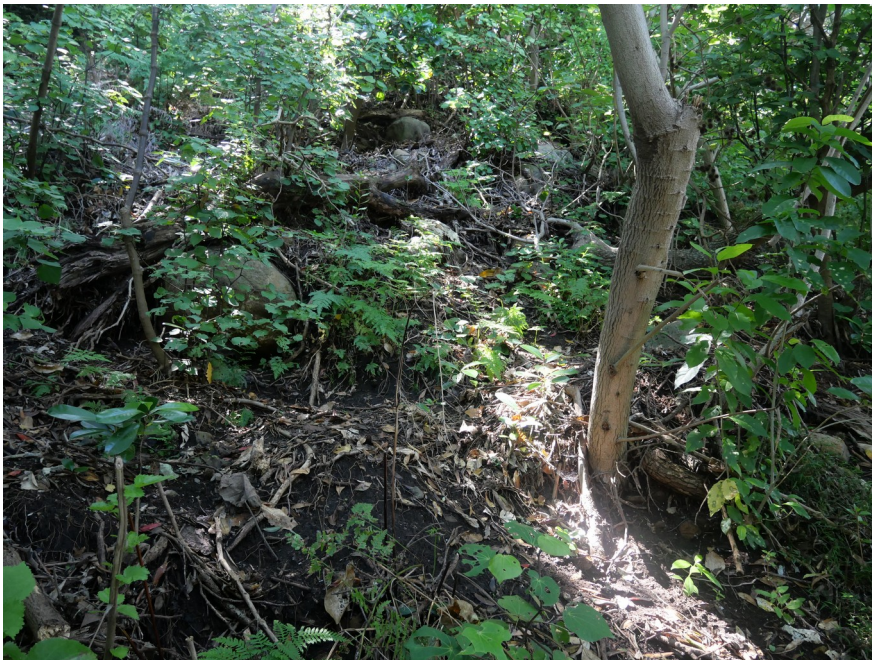
Photo 11. Boulders on the slope surface above the southern base track

This location has been reported previously but has never been worked on.

Many large rounded boulders are loosely embedded in the sandy soil which in places lies at a steep slope angle. The slopes in this vicinity are heavily vegetated which tends to hide the hazard although the roots also help stabilise the slope.

Some of the worst of these hazards could be scaled relatively easily.
