5 December 2019
Avalon Project #20149

Mauao Slopes; Monitoring Report for December 2019

The six monthly rock bluff survey benchmark monitoring and site geotechnical walkover was carried out on the 3rd and 4th December, in conjunction with rock scaling and weed spraying of an ongoing scouring slip face above the western base track.

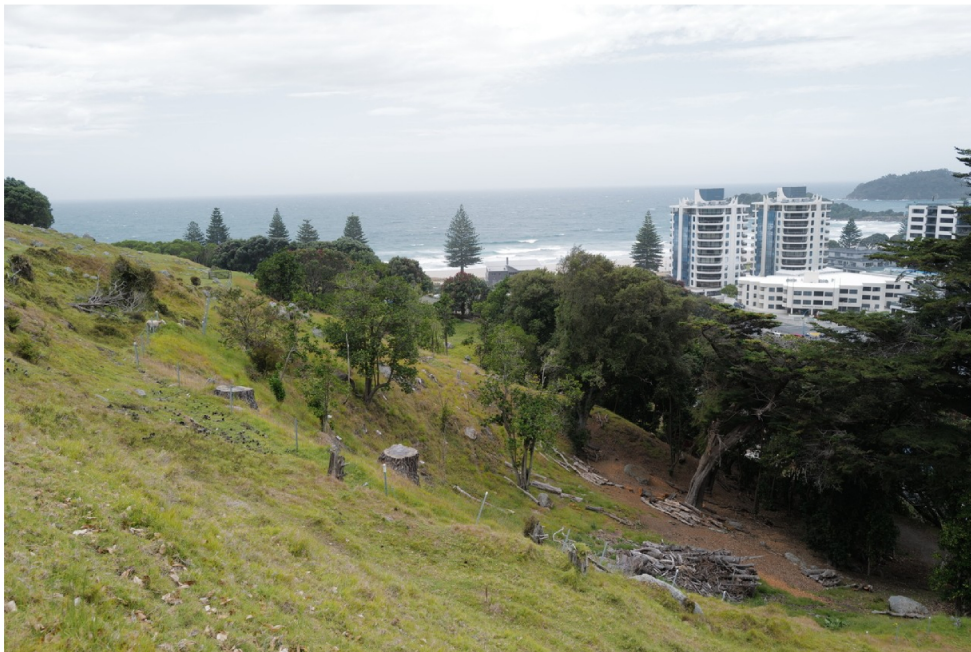
2.1 Non native tree removal has been completed on lower slopes above the campground.

Photo 1. Tree felling completed.

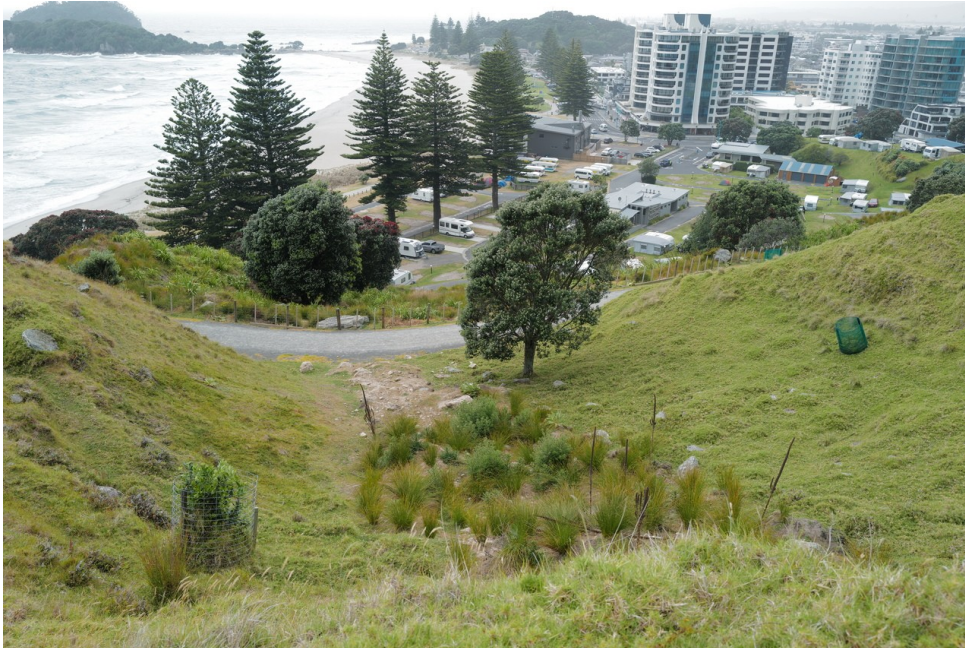
Recent erosion control planting was noted to small slip scars on the lower slopes above the base track and in the vicinity of the campground. This should be effective in helping stabilise the slip surfaces.

Photo 2. Recent erosion control planting.

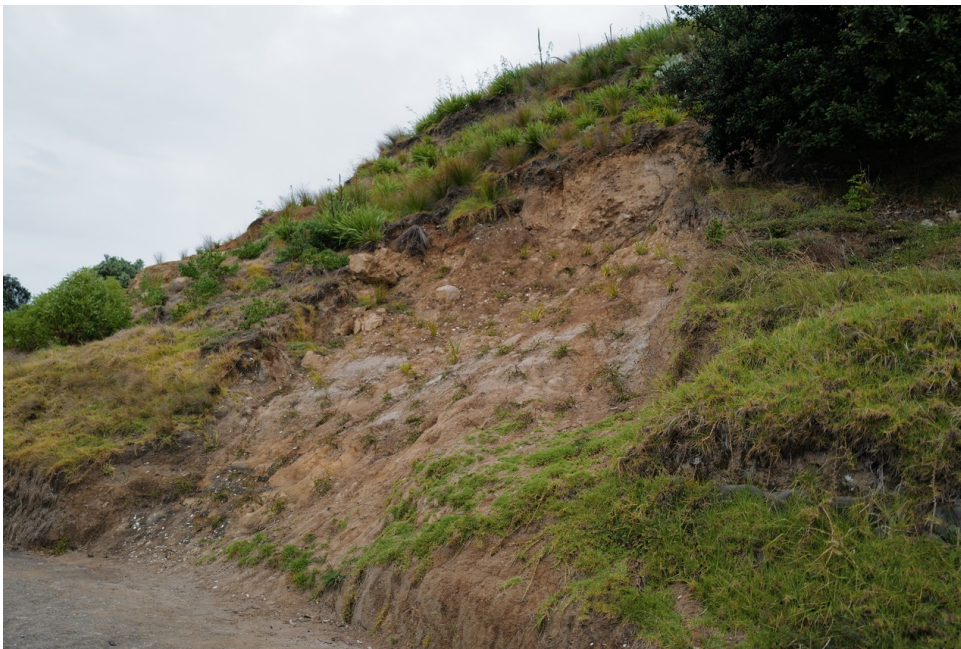
Photo 3. Recent erosion control planting.

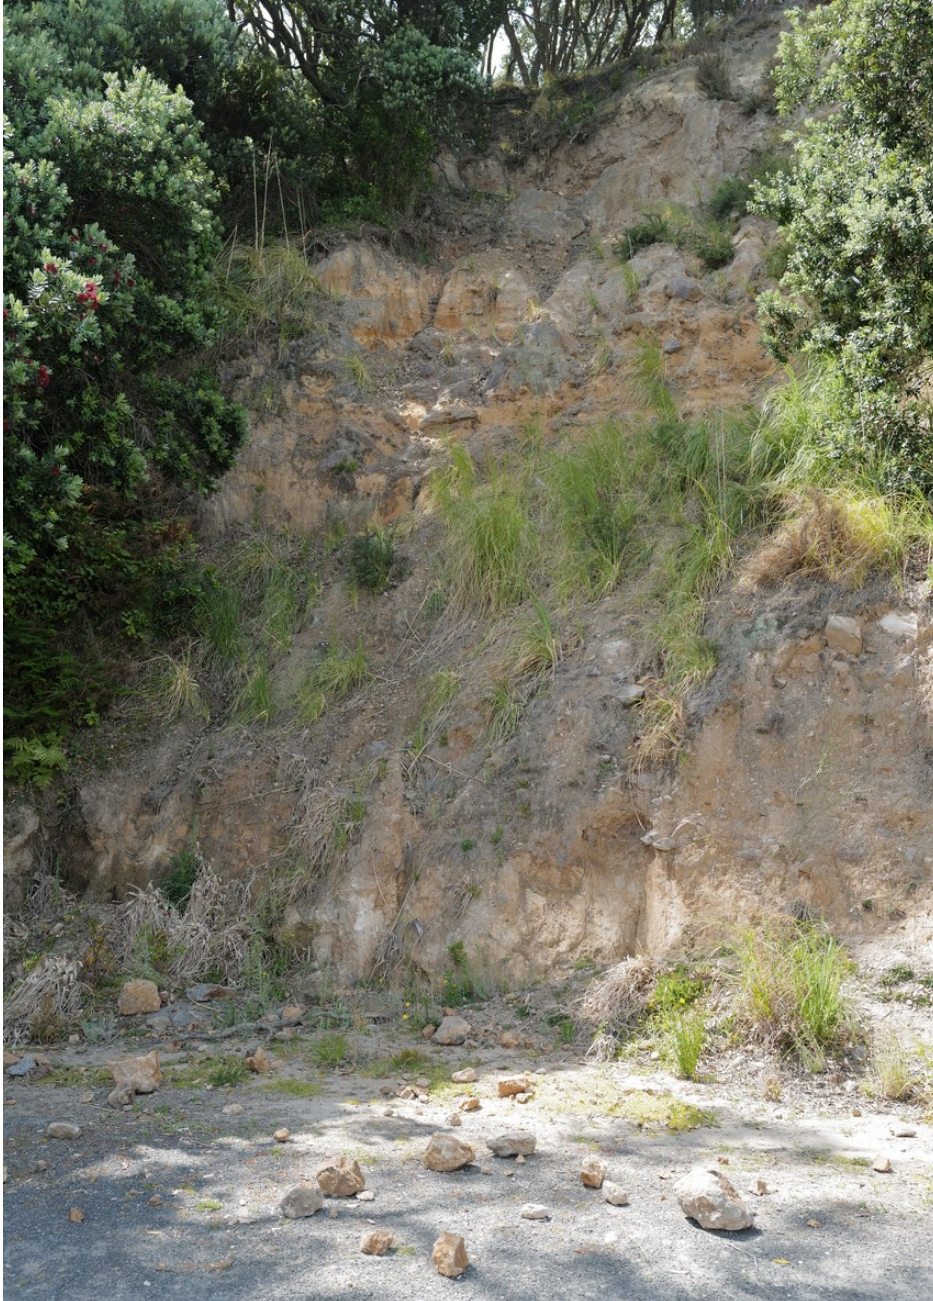
These slips continue to actively erode and scour results in exposure of new surface rocks. The minimum recommended hazard management measure would be to scale the surface every two or three years and/or following major storm events.

Photo 4. Scaling and weed spraying was completed on 3 December 2019.

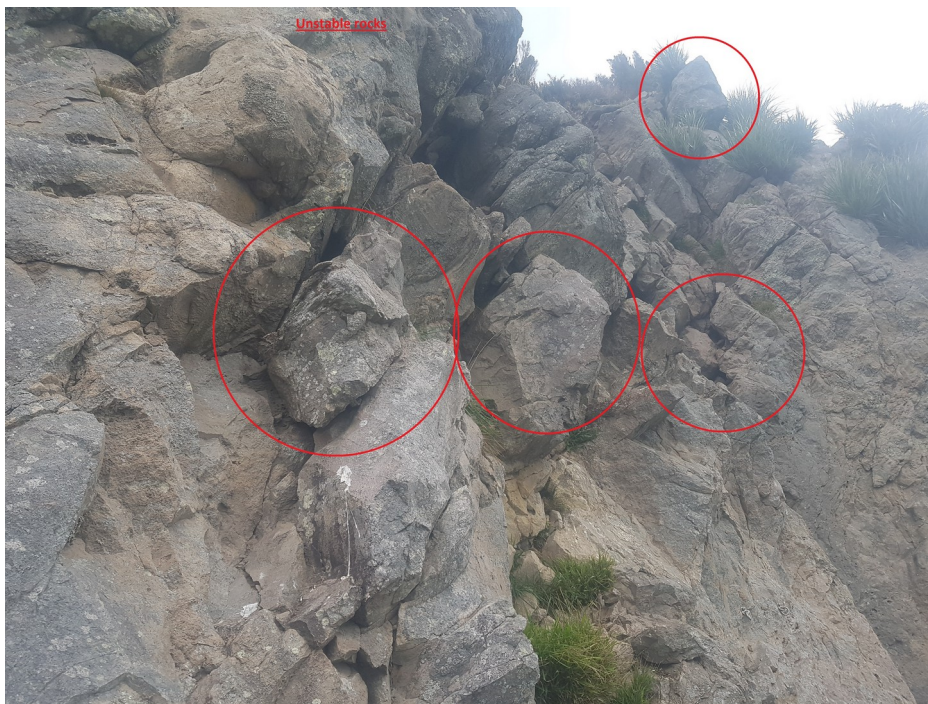
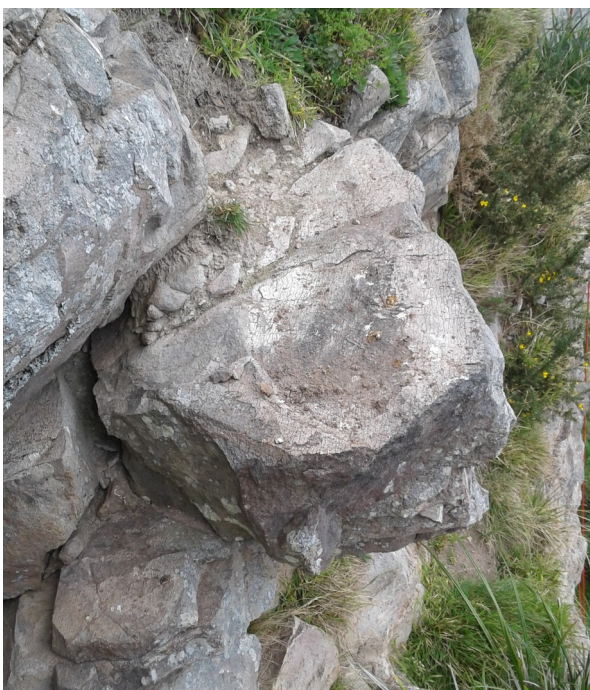
In 2017 Avalon provided a team of two Technicians to assist with vegetation survey work above the Oruahine track. During that work the team came across a number of unstable areas of rock face.

Some larger unstable boulders were found, indicated in the following photos. These could not be scaled at the time with the resources available. We recommend these hazards be scaled. Track security would be required.

Photo 5 and 6. Loose rock identified on the bluffs above the Oruahine track.

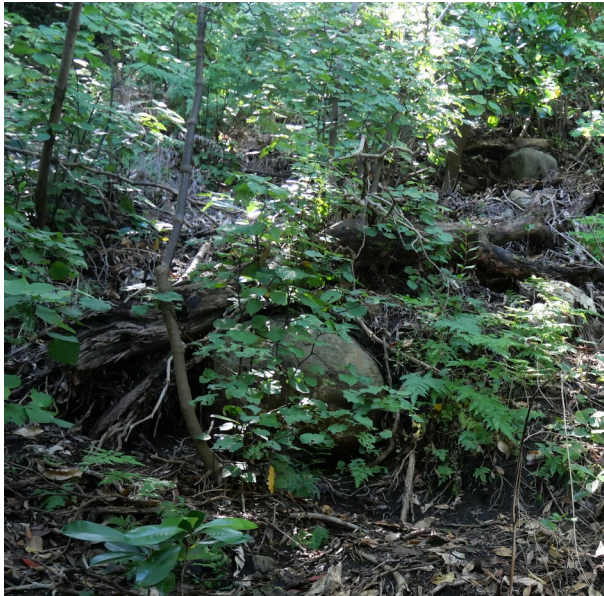
This location has been reported a number of times previously but has never been looked into in more detail. The slopes in this vicinity are heavily vegetated which tends to conceal the hazard. Many large rounded boulders are loosely embedded in the sandy soil which in places lies at a very steep slope angle.

Photo 7. Boulders on the slope surface above the southern base track

We would recommend a rope access inspection to take a closer look. Some of the worst of these hazards could be scaled relatively easily.

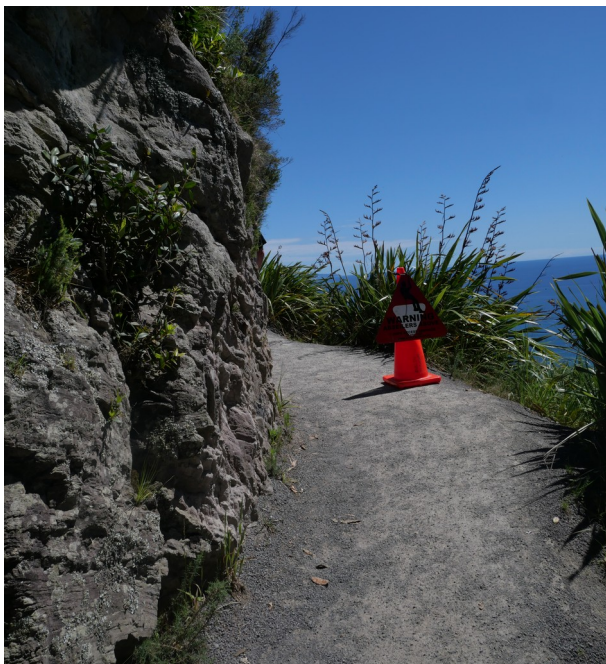
Photo 8. Sharp bend on the Waikorere track.

The drop off at this location is very steep and hazardous. The potential for joggers to collide is clear.

The rock corner could be reprofiled and cut back to improve the sight line. Signage and or a guardrail could also be considered.

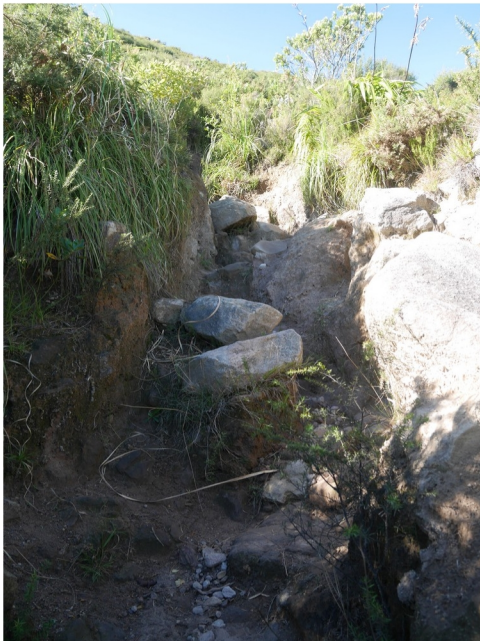
The steep Goat track connects the hairpin on the 4WD track with the south summit. The track is not visually obvious and is not officially open but it is used regularly by locals.

It becomes a surface water channel during heavy rainfall and is currently deeply scoured out.

Photo 9. Scour on Goat track.
