Tauranga District Council
Private bag 12022
Tauranga

Mauao Slopes; Monitoring Report; 17 June 2009

Thanks for your help last week (17 June) with the ongoing slope inspection/rockfall monitoring program.

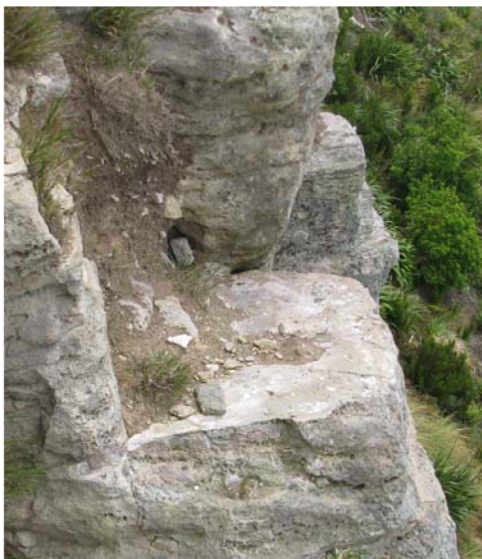
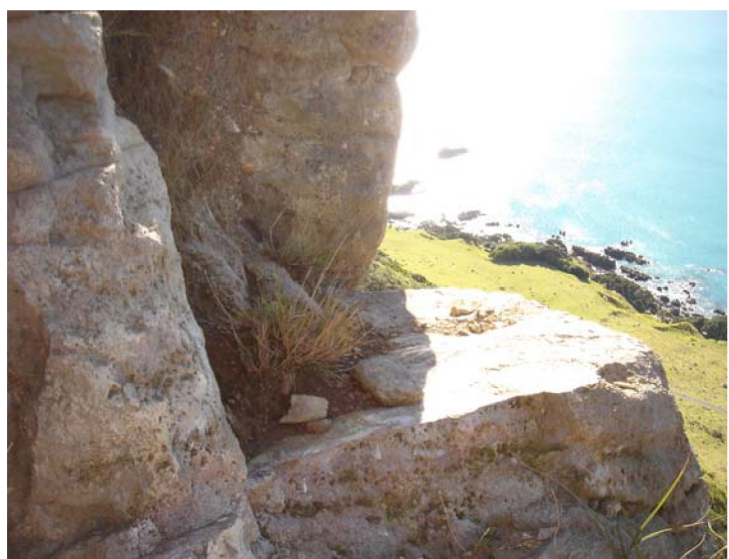
Photograph 1; The small ledge we monitor on the camp bluff.

Small rocks and soil piles continue to move around. This is the natural weathering process but illustrates that rockfall must be frequent.

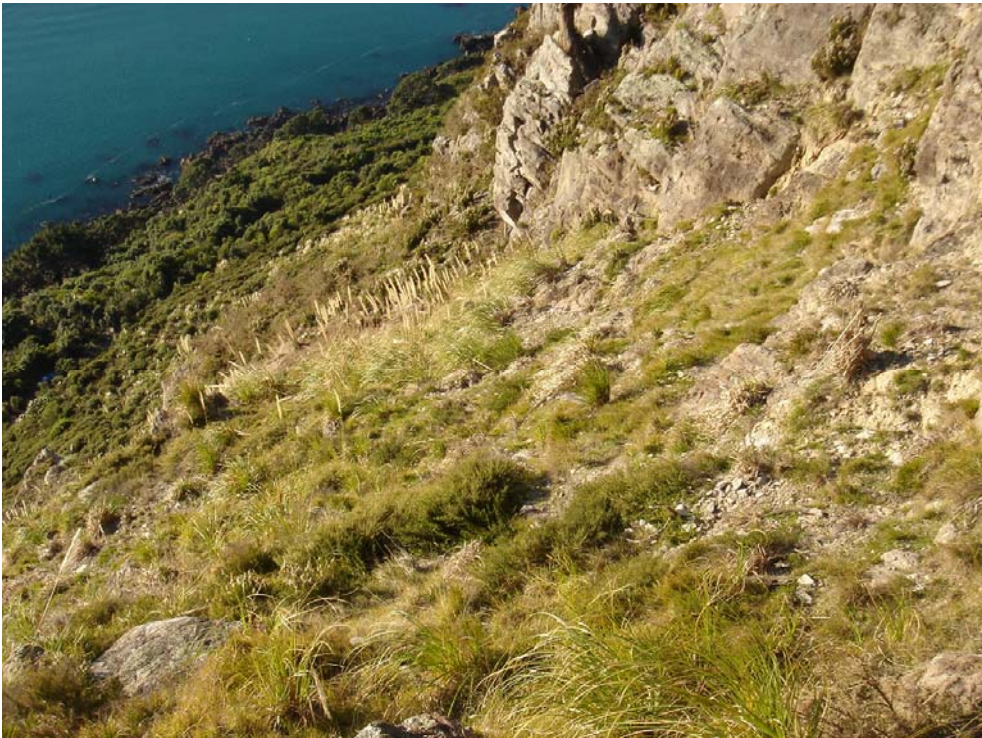
Photograph 2; Northern slopes; vegetation is becoming well established.

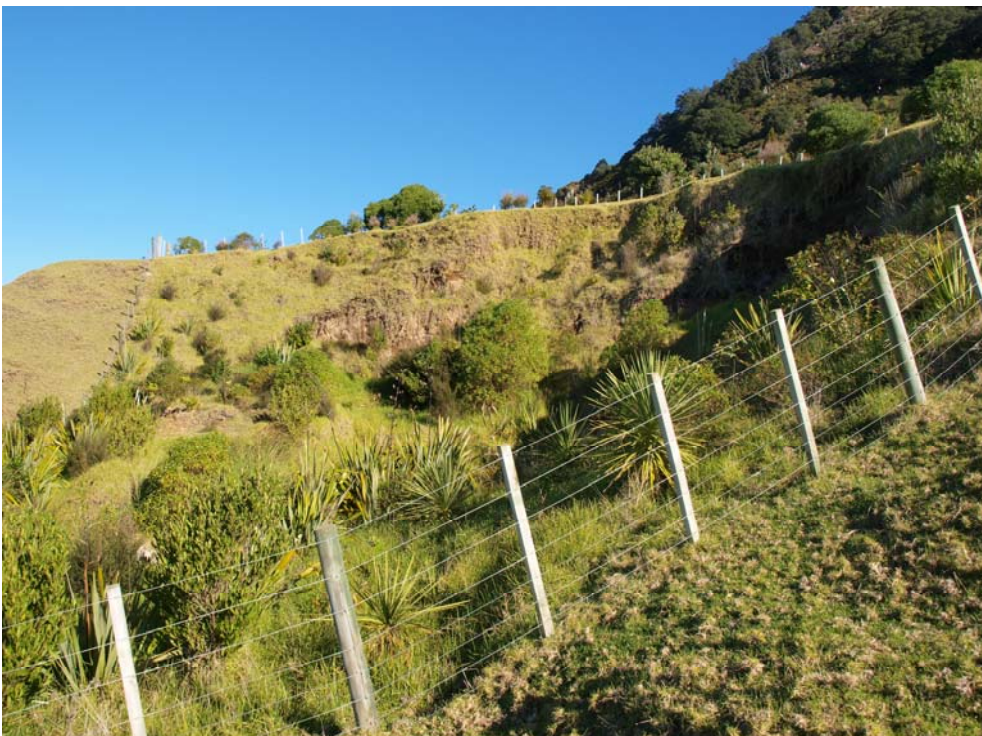
Photograph 3; Slip scar on lower slopes above eastern campground; vegetation is now becoming well established.

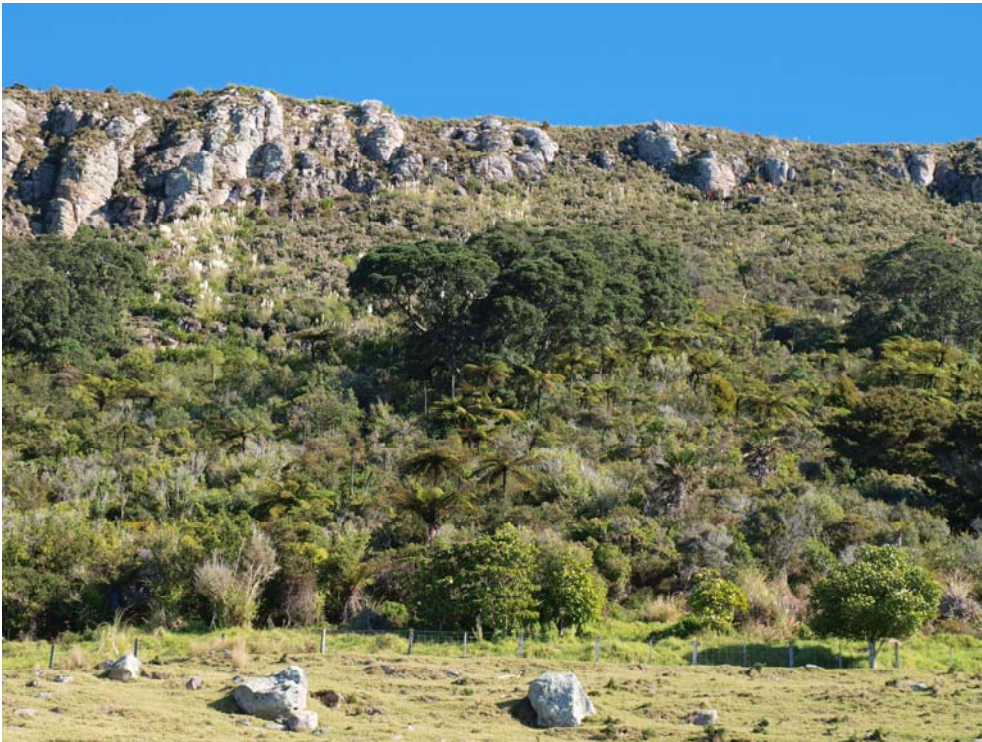
Photograph 4; Slopes to the north of the camp bluff now show little evidence of the 2003 fires.

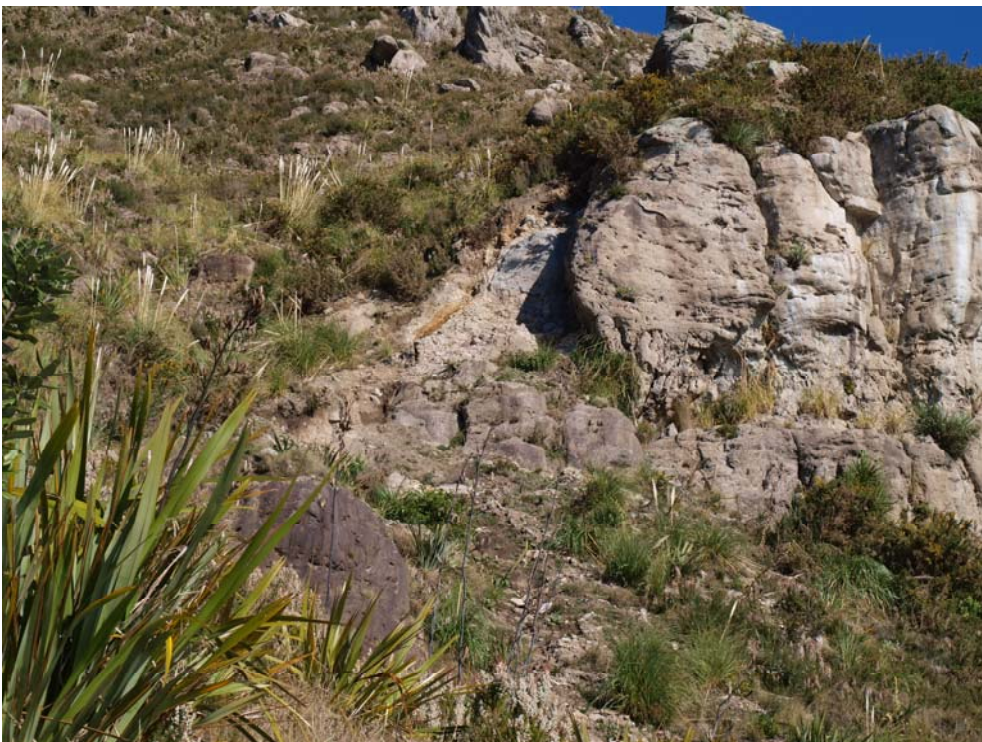
5. The May 2005 flood event slips now appear to have locked up and are re-vegetating.
 6. The area blasted in June 2007 was re-checked and is now acceptably stable.

Photograph 5; The site of last years blast scaling; acceptably stable.

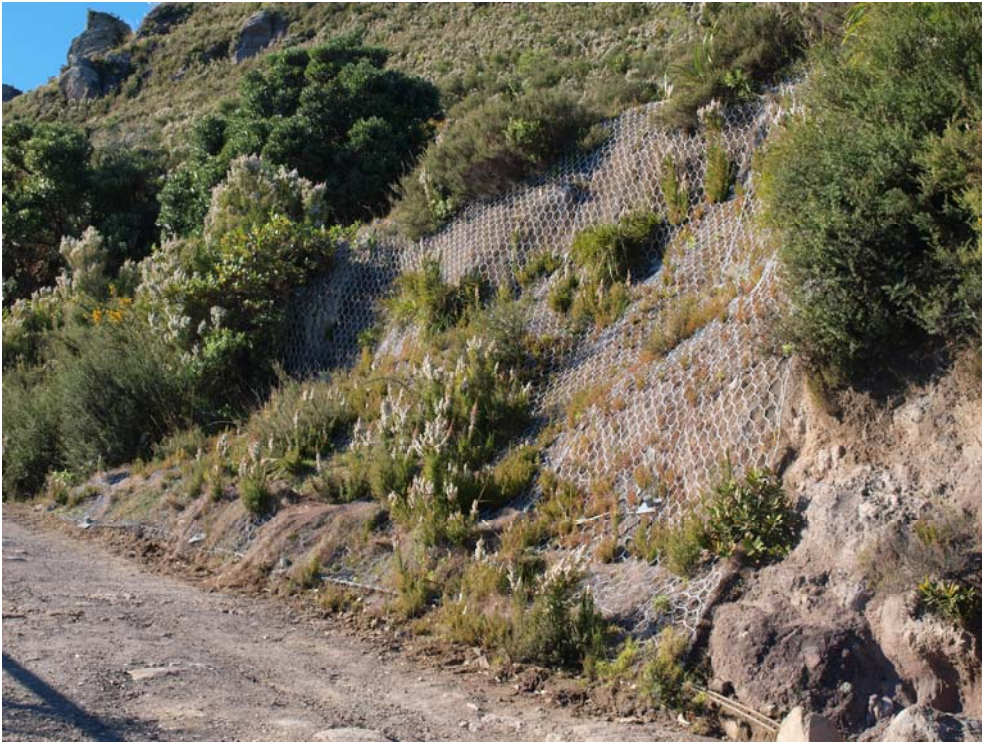
Photograph 6; The small patch of soil nails and mesh installed in 2005 to stabilise the 4WD track hairpin; performing well.

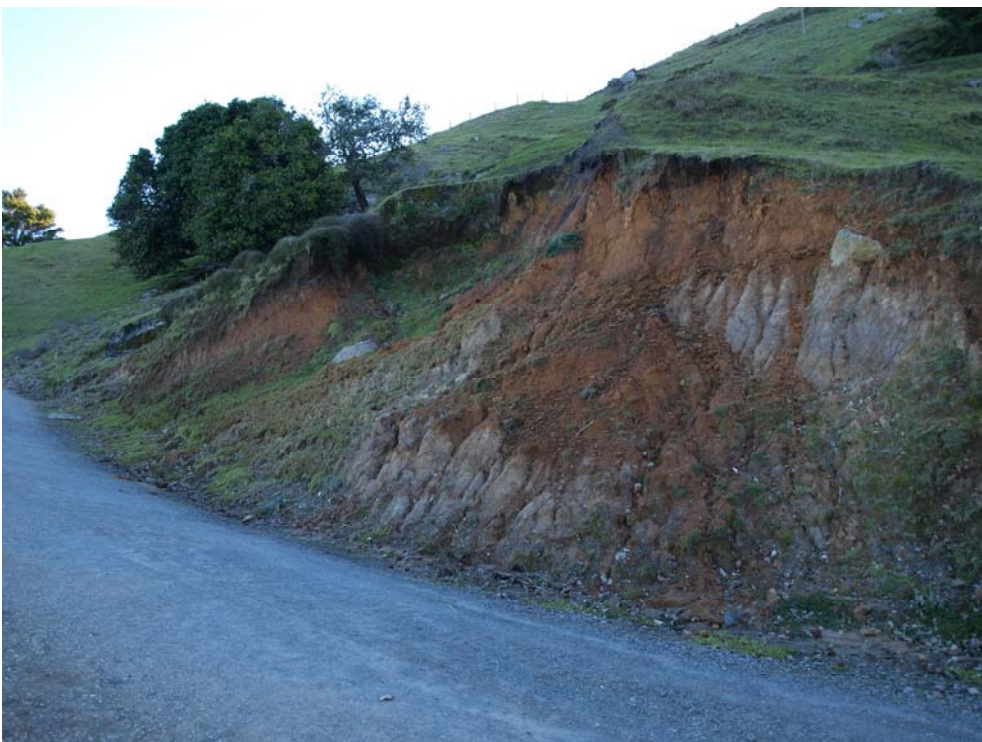
Photograph 7; Slip scars are still present in places above the lower 4WD track.

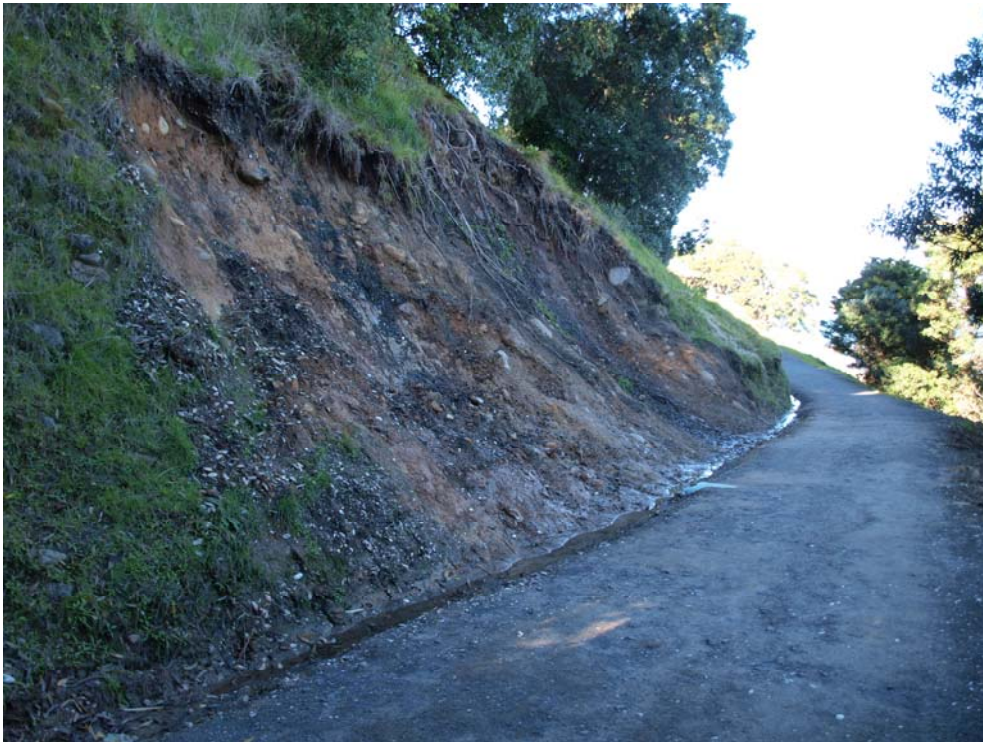
Photograph 8; Slip scars are also still present in places above the base track.

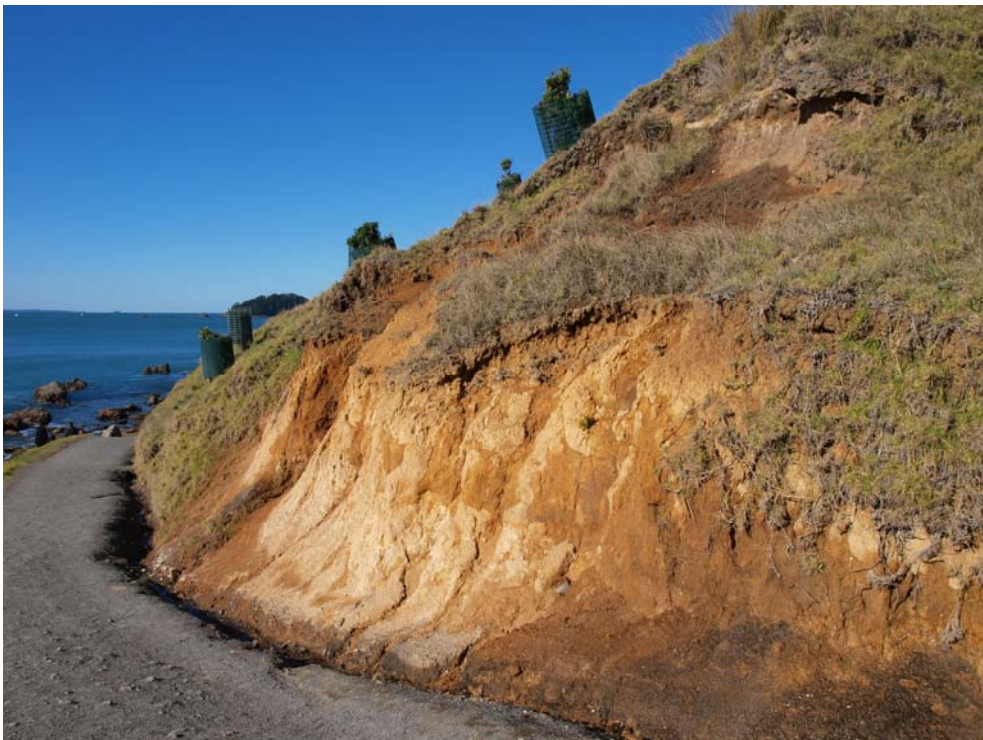
Photograph 9; Another slip scar above the base track.

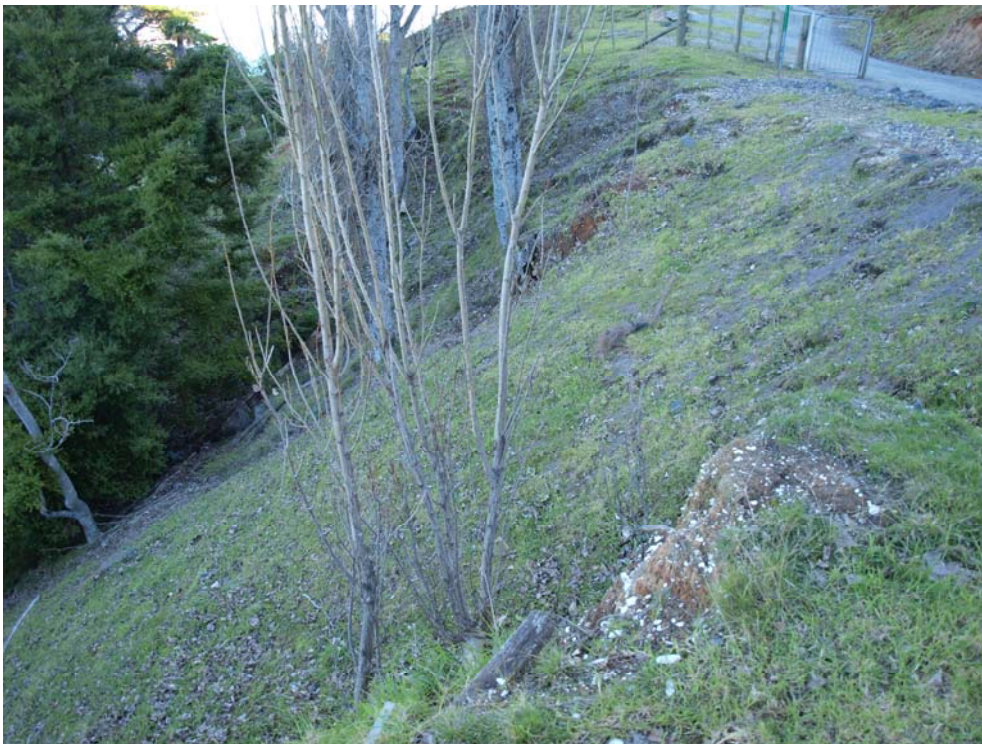
Photograph 10; Good remedial repair to a dropout below the lower 4WD track.

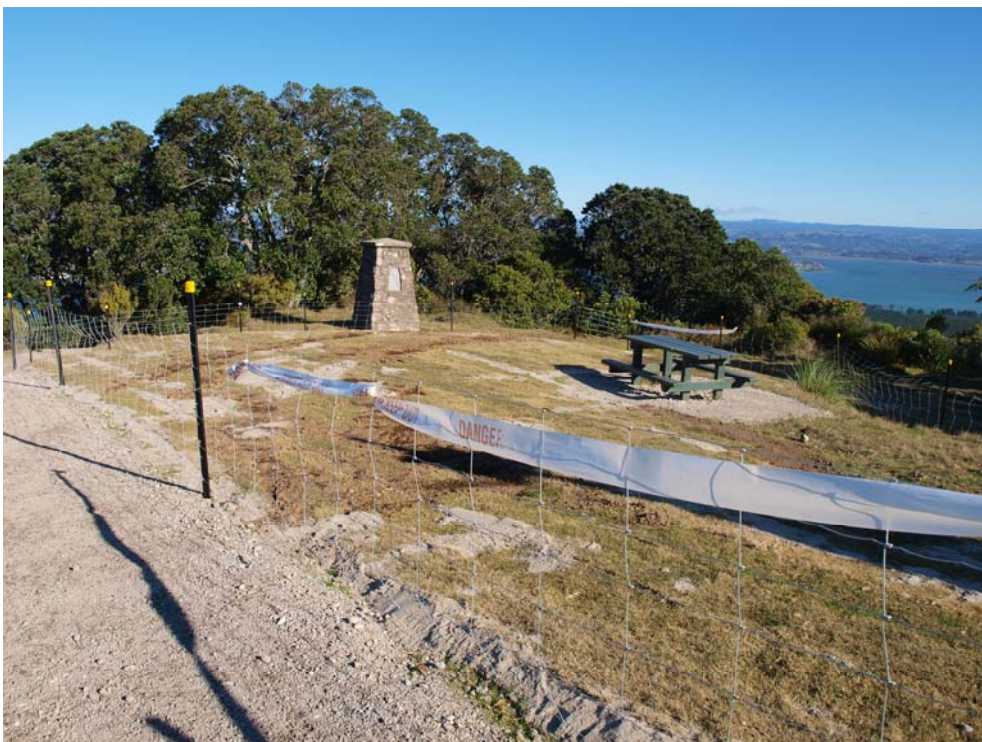
Photograph 11; Erosion control work on summit.
