Project Number: 2-9B463.00

# Mauao Base Track Reinstatement

18 December 2019

Design Report

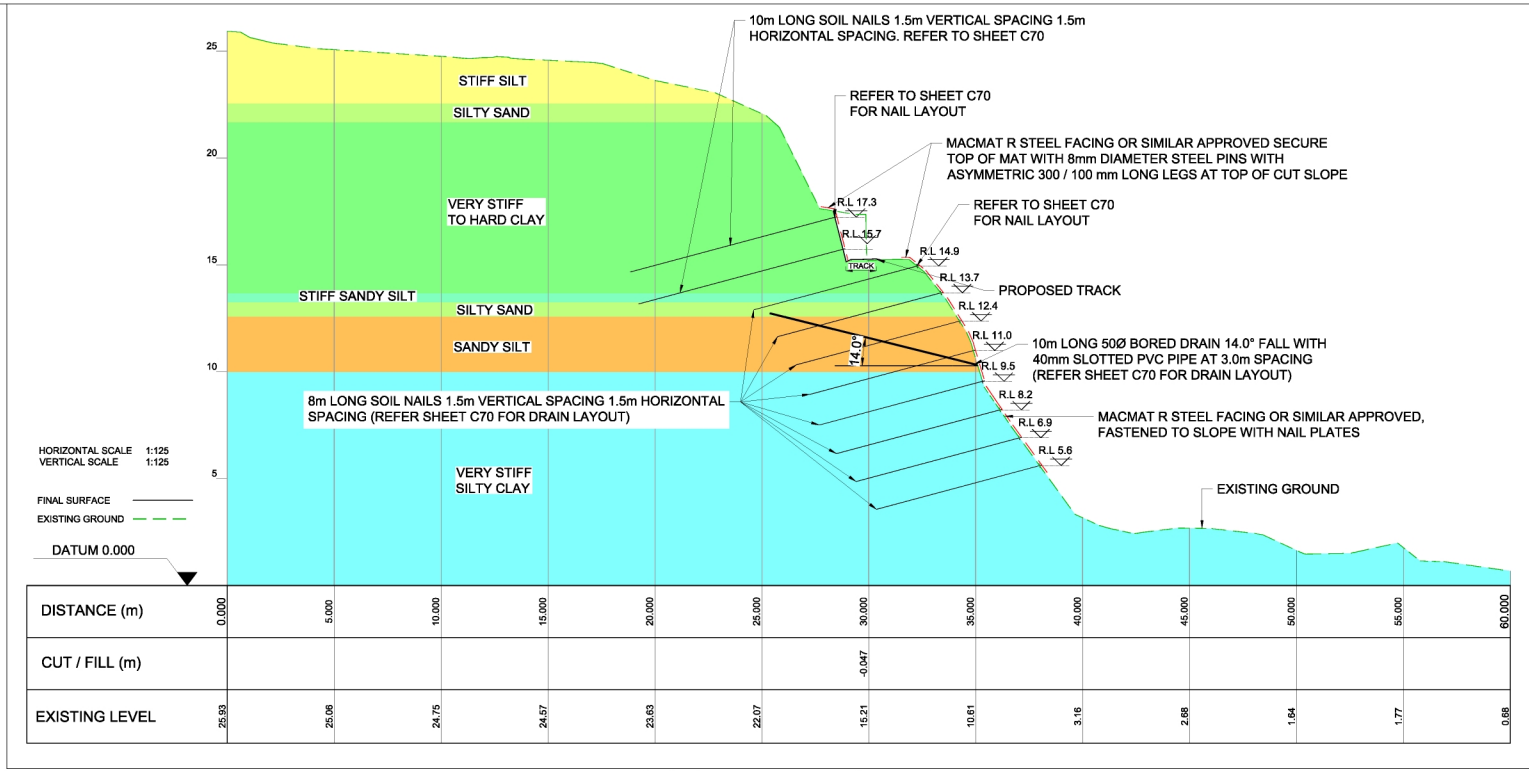
SECTION A - A DETAIL - SHEET C70  
Scale 1:125 (A1) 1:250 (A3)

An interpretation of the geological profile is shown on the annotated section shown on sheet C71 of the design drawings contained in Appendix A.

The soil nails will be installed in a grid pattern within the proposed cut face above the track and below the track within the existing slip face. The soil nails will be installed in a nail staggered pattern. The soil nail design is summarised in Table 4 below. Further details can be found in the appended design drawings in Appendix A and specification in Appendix D.

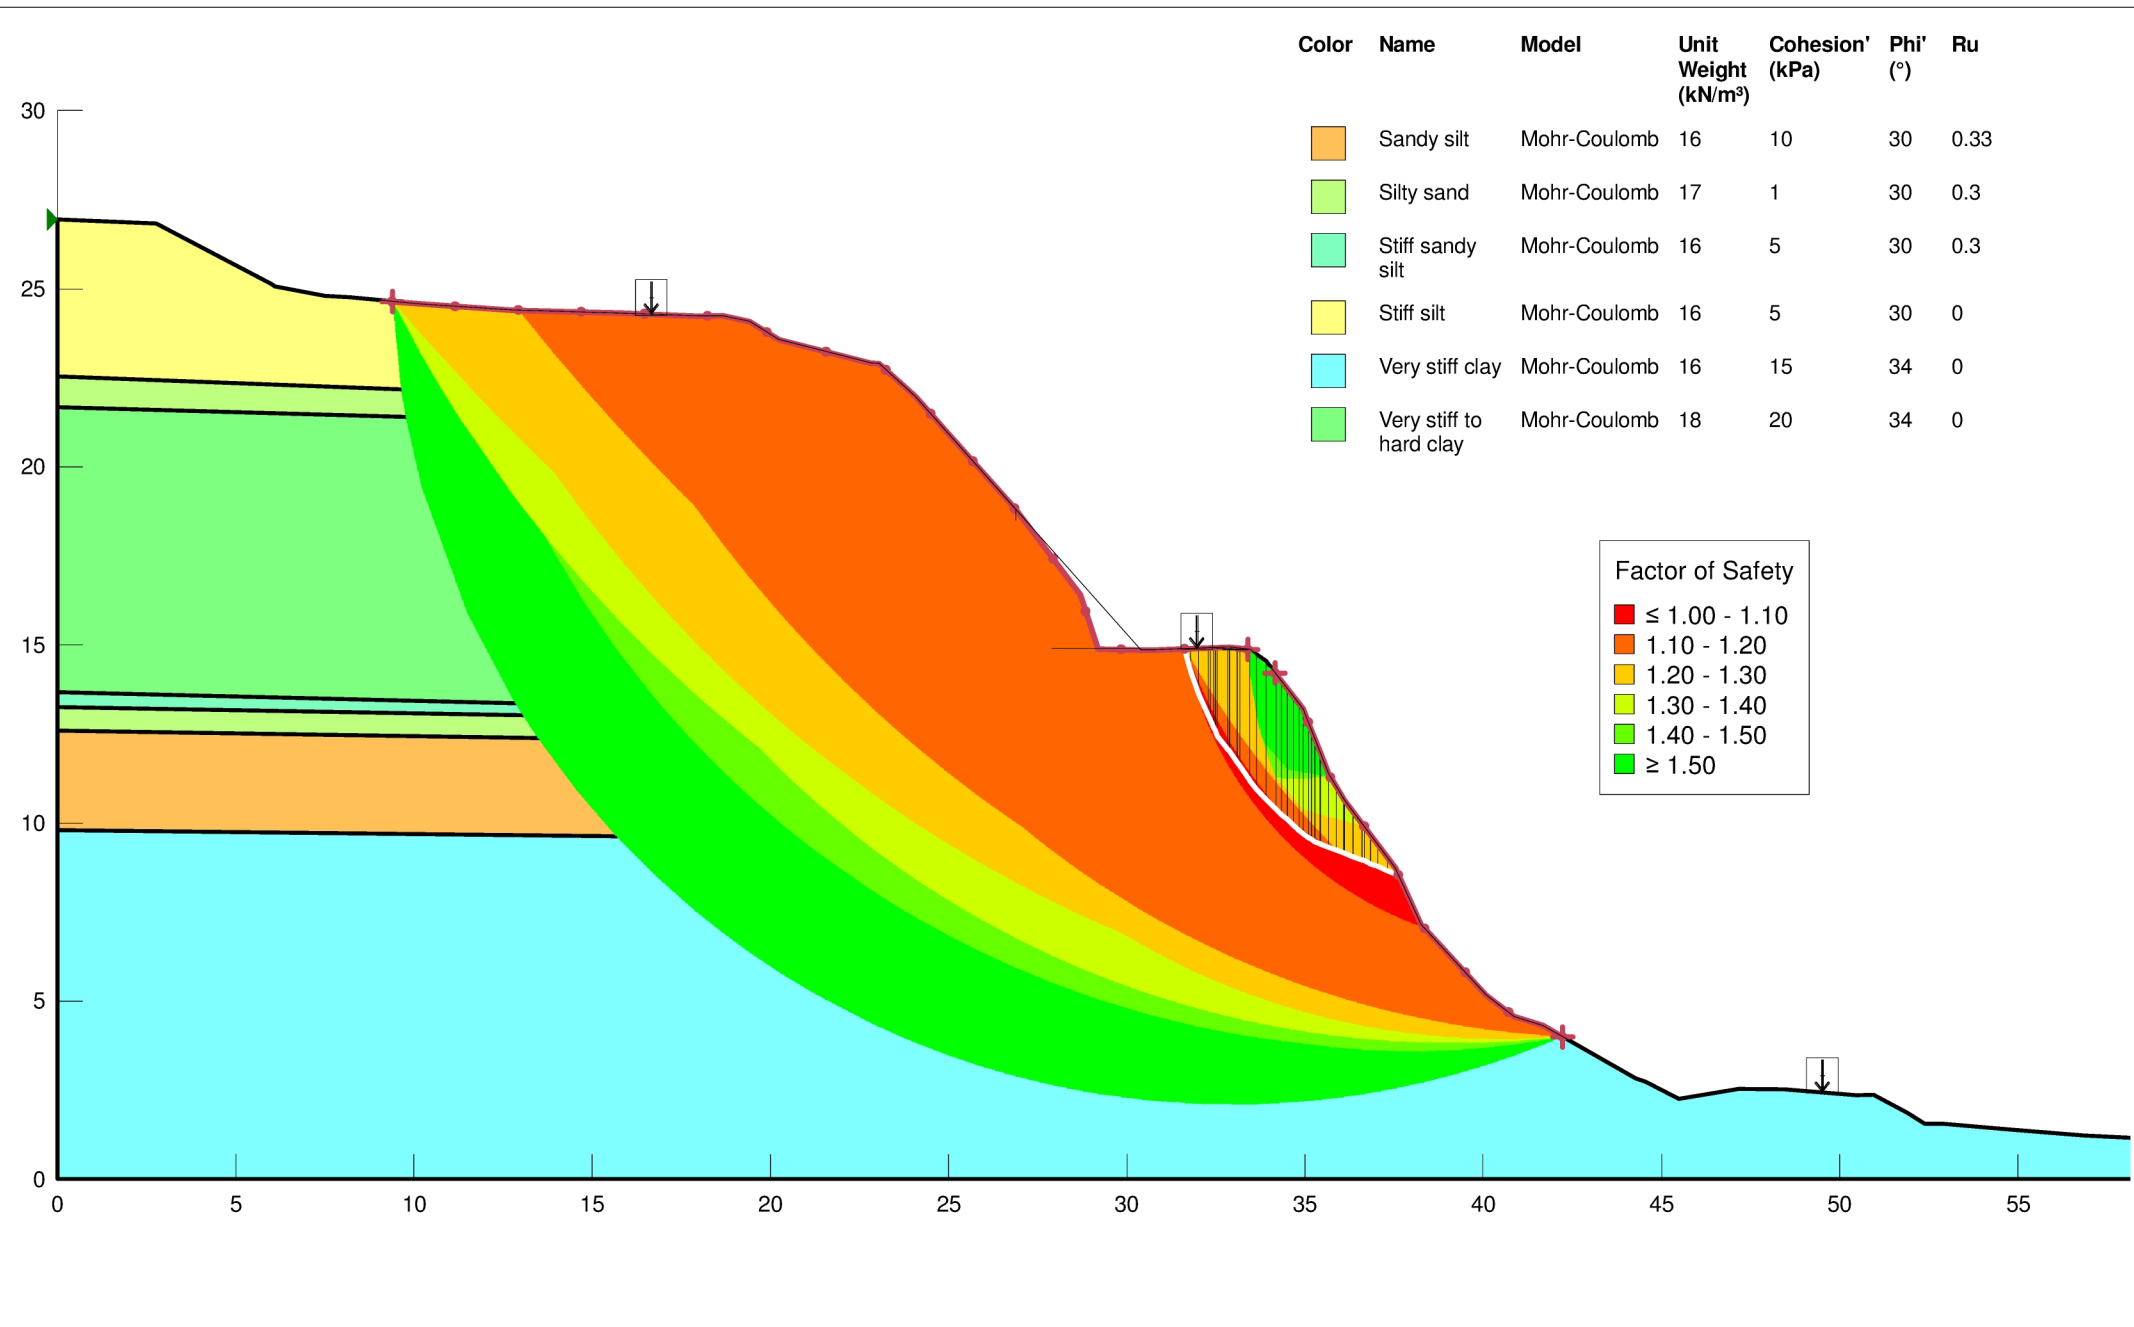
Project: <b>2-9B463.00 - Mount Base Track</b> Analysis: <b>CH37.5_Final Model 141119 back analysis</b> Modelled By: § 7(2)(a) - Privacy Checked By: § 7(2)(a) - Privacy	Model	SLOPE/W	Proj No.	2-9B463.00
	Method	Morgenstern-Price	Date:	10/12/2019
	PGA	g	Scale	1:150
	FOS	1.01	Sheet No.

Analysis Case	Factor of Safety Achieved	Target Factor of Safety
Before Slip (back analysis)	1.01	-
Proposed Nailing (stage 1 nails installed in upper slope only static condition)	1.22	1.20
Proposed Nailing (stage 2 all nails installed transient groundwater condition $R_u=0.3$ )	1.19	1.20
Proposed Nailing (stage 2 all nails installed long term static condition)	1.31	1.35
Proposed Nailing (stage 2 all nails installed seismic condition)	1.01	1.00

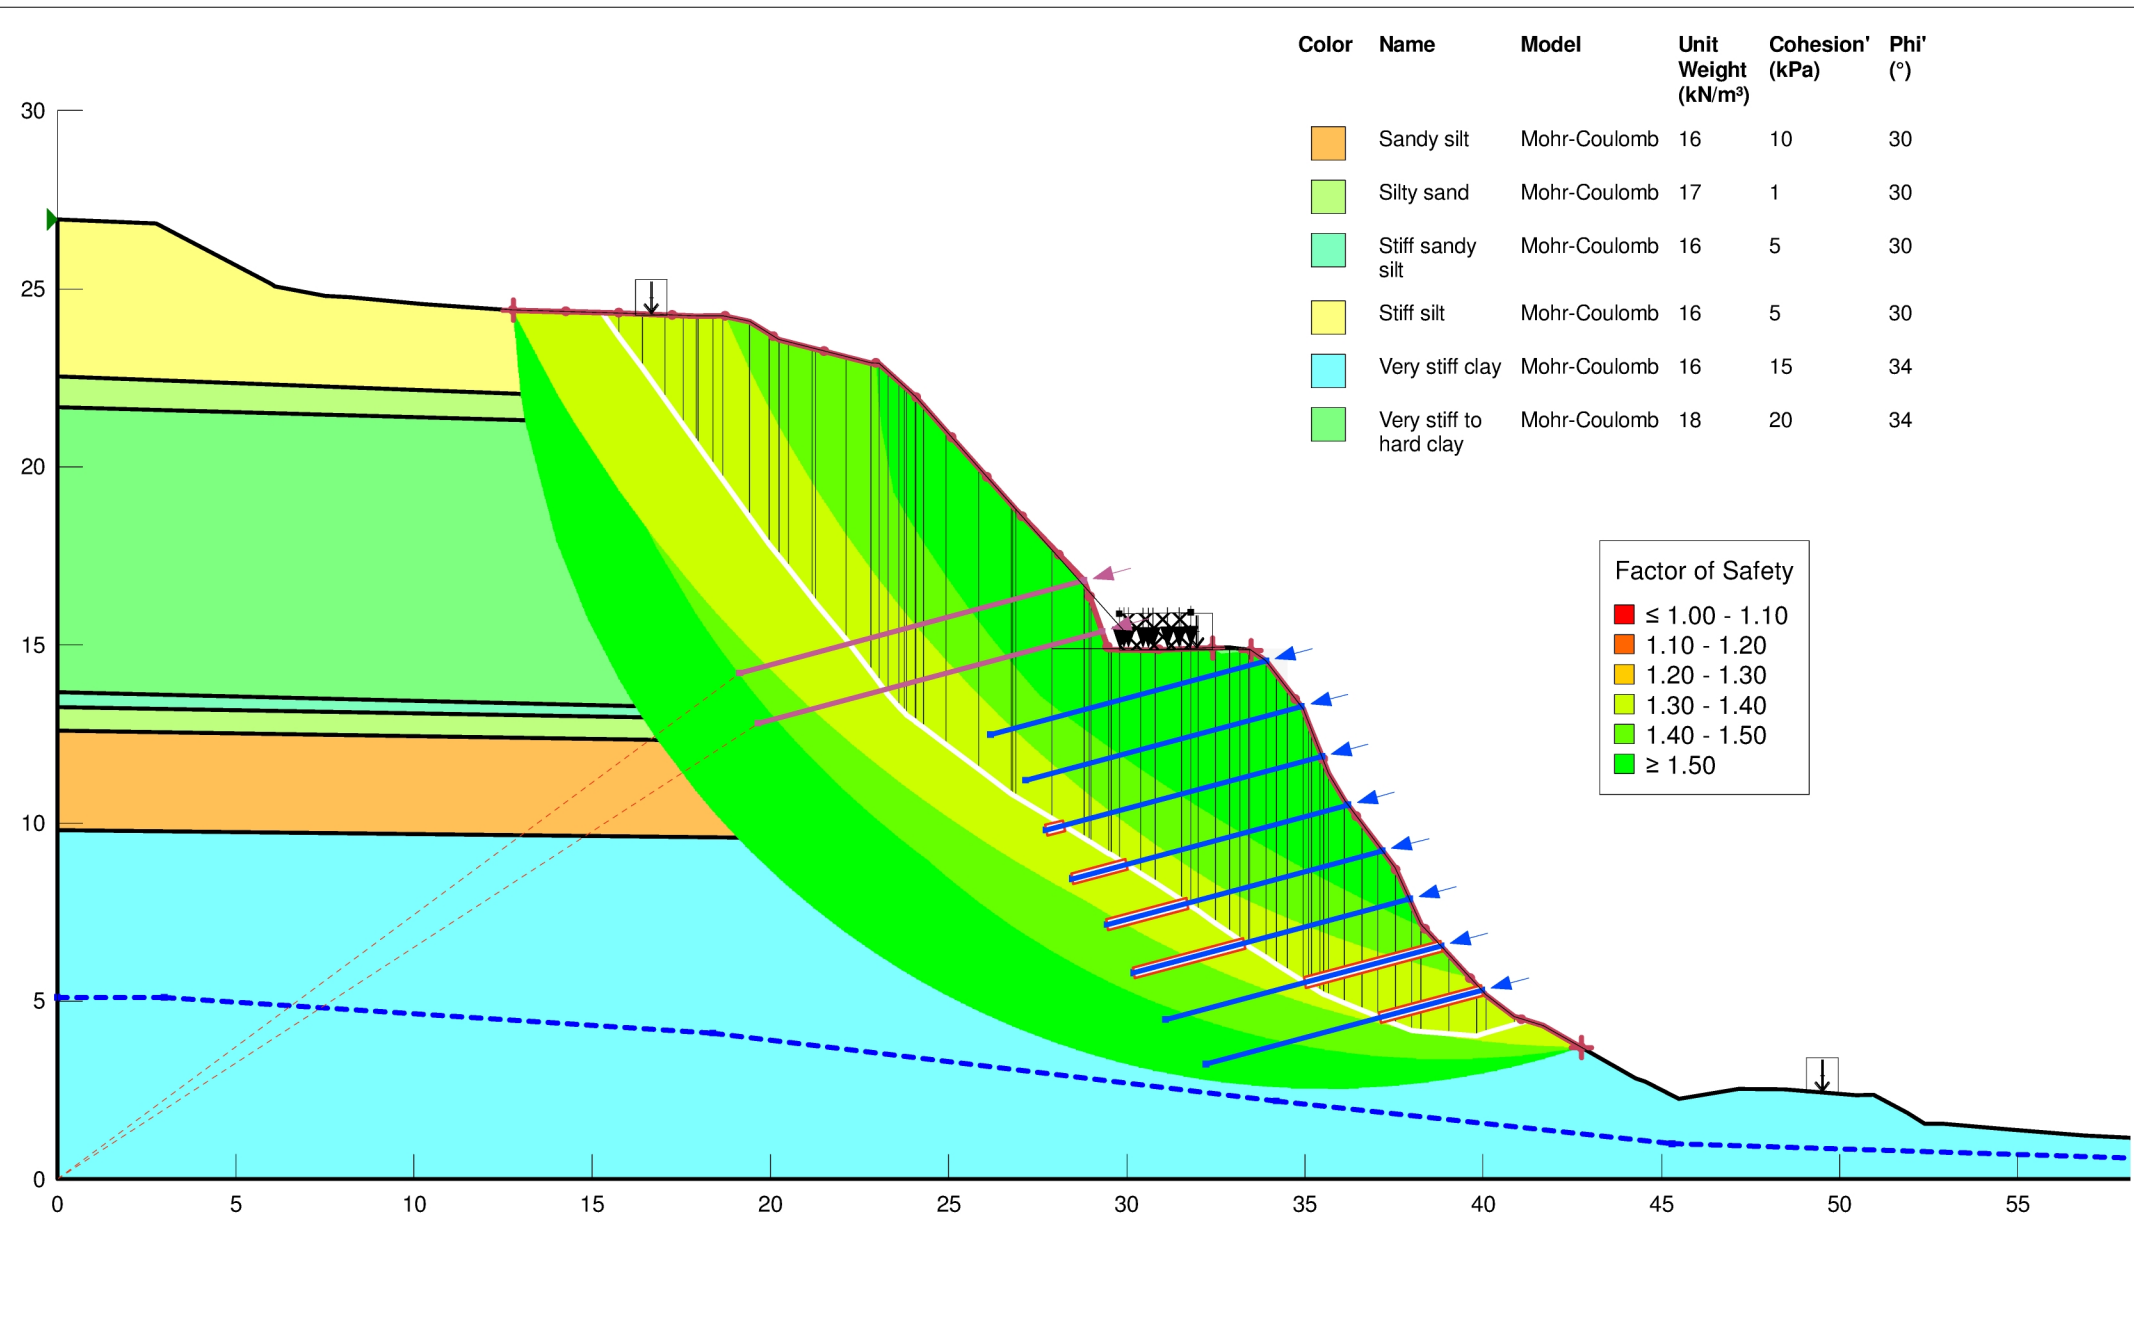
Analysis: **CH37.5\_Soil Nail Design Rev.A Normal GW all nails**

Model	SLOPE/W	Proj No.	2-9B463.00
Method	Morgenstern-Price	Date:	10/12/2019
PGA	g	Scale	1:150
FOS	1.31	Sheet No.

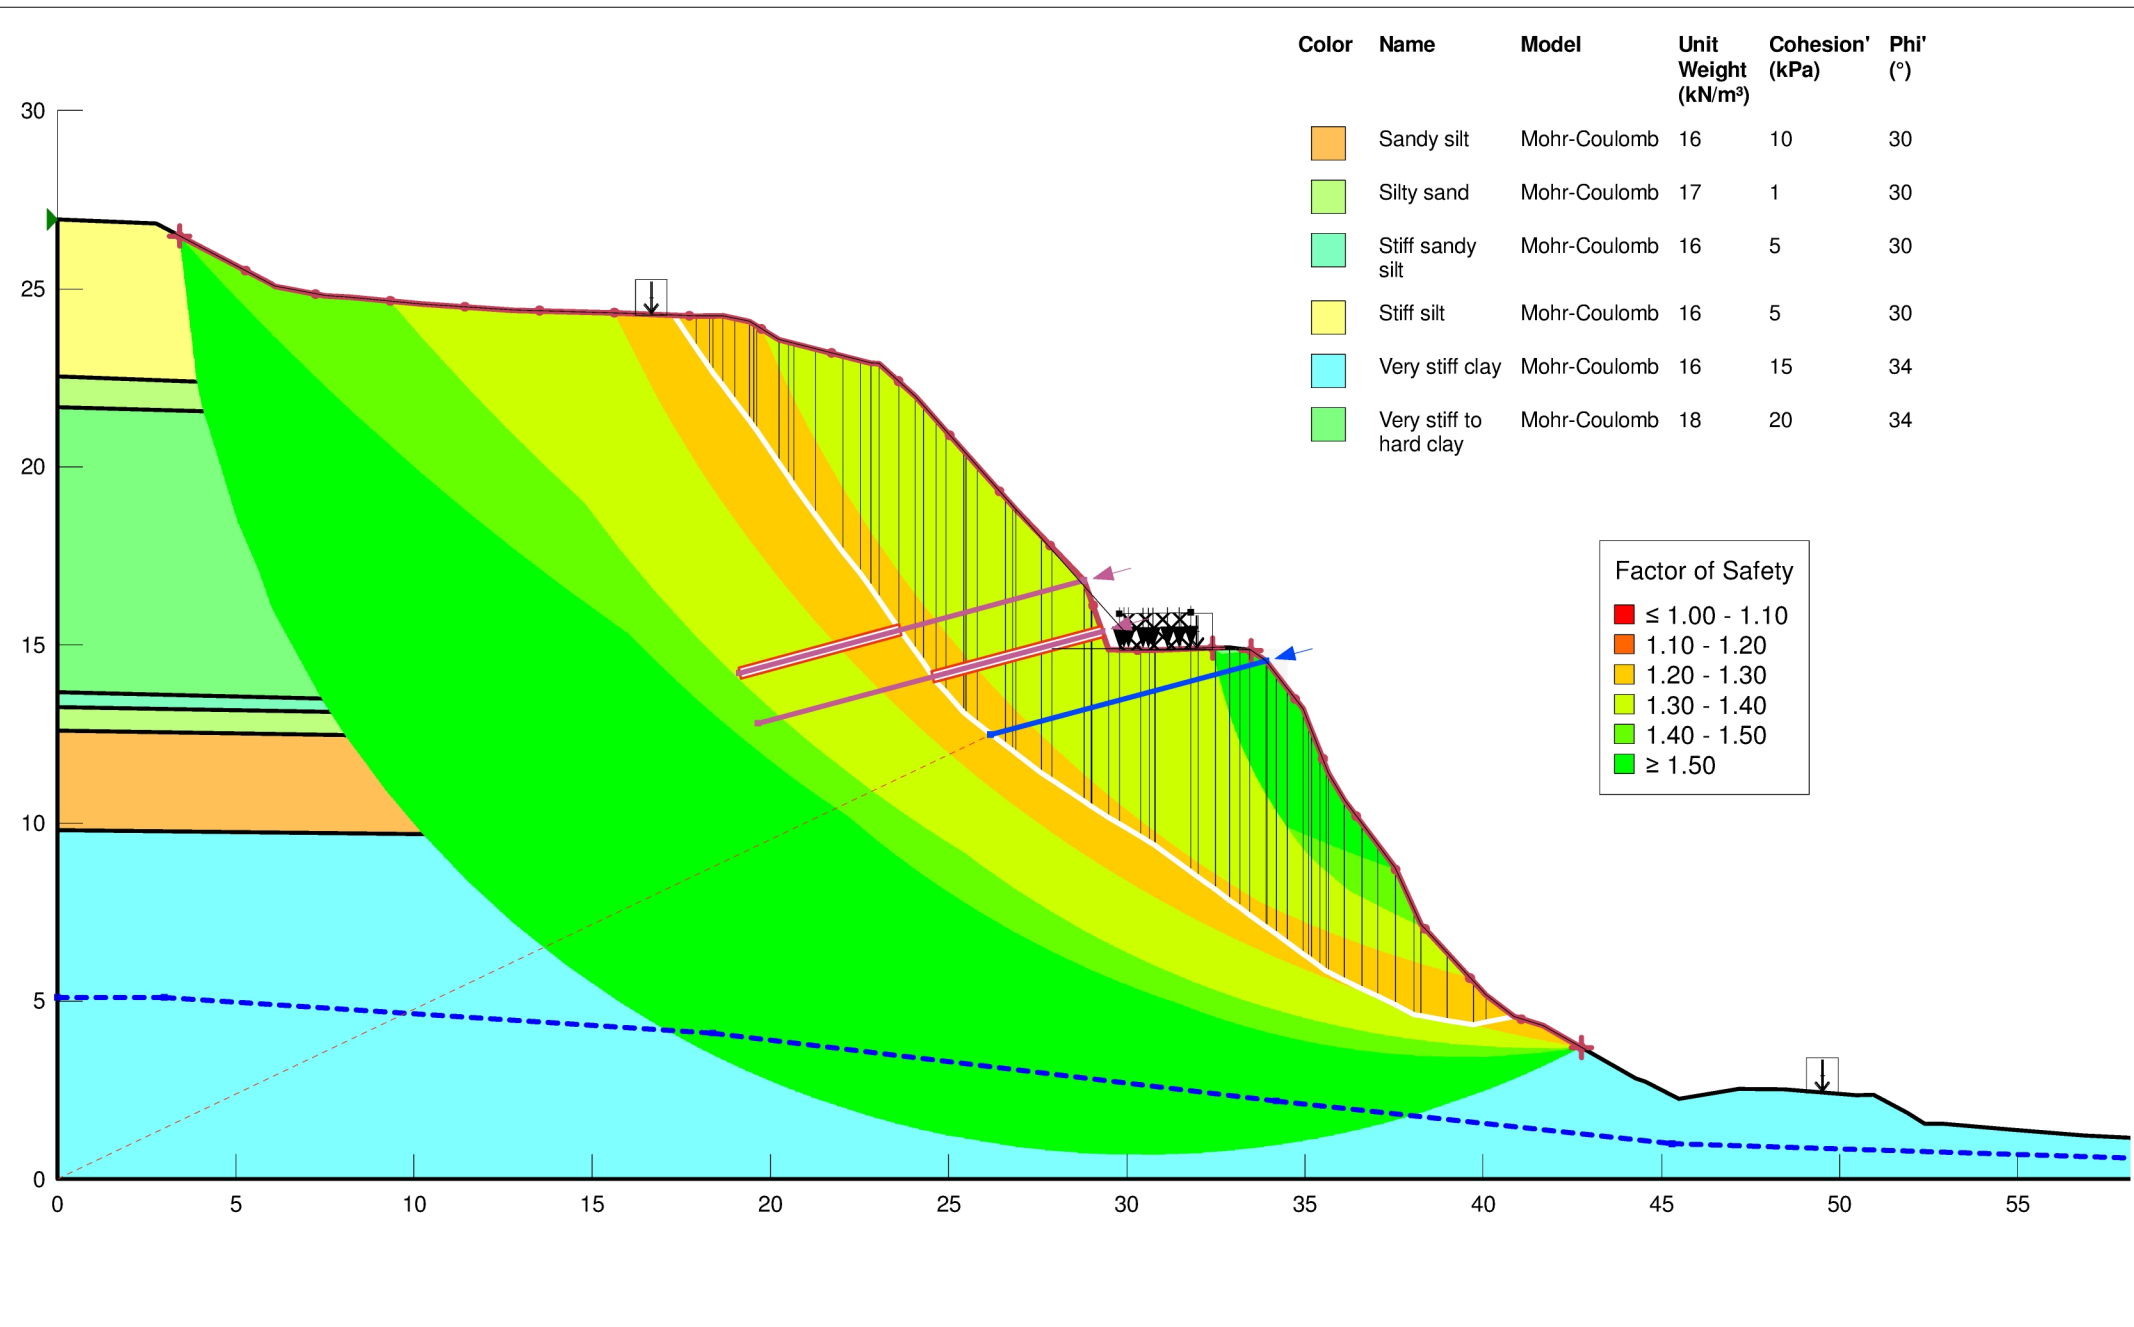
We note that this staging leaves the slope vulnerable to adverse weather conditions until all nails have been installed below the track. We understand that the Client accepts this risk to have an operative track over the Christmas break. Therefore, we recommend that regular visual inspections are conducted to assess the track condition over this period as recommended in our options report.
