30 August 2022
Avalon Project #23043

Mauao Slopes;

Routine slope monitoring report August 2022 + Suspect boulder inspection above campground + New spring & adjacent boulder inspection

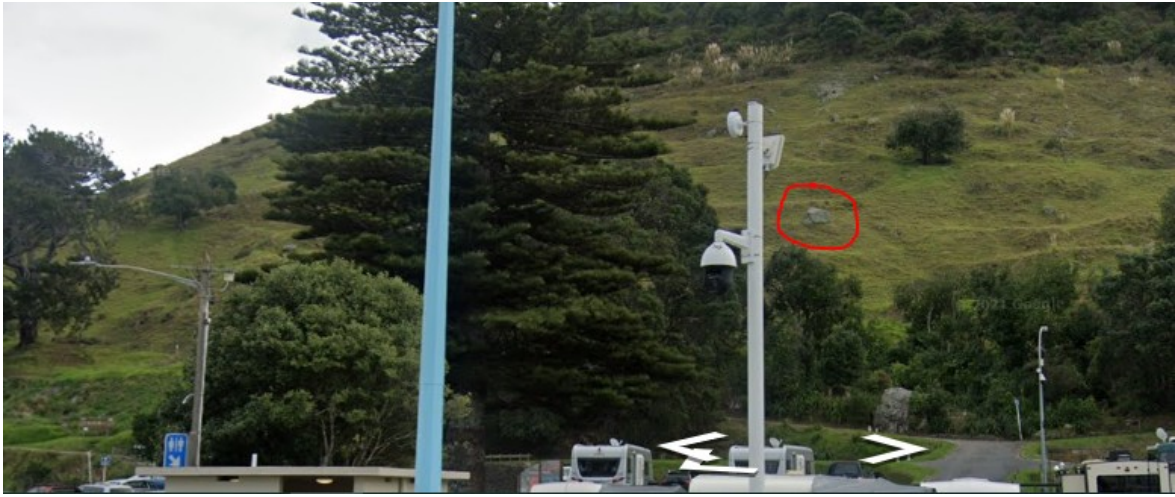
The boulder above the campground highlighted indicated in photo 1 does not appear to have moved recently. There is no indication of any recent disturbance in the soil or lichen.

Photo 1; Suspect boulder location above campground.

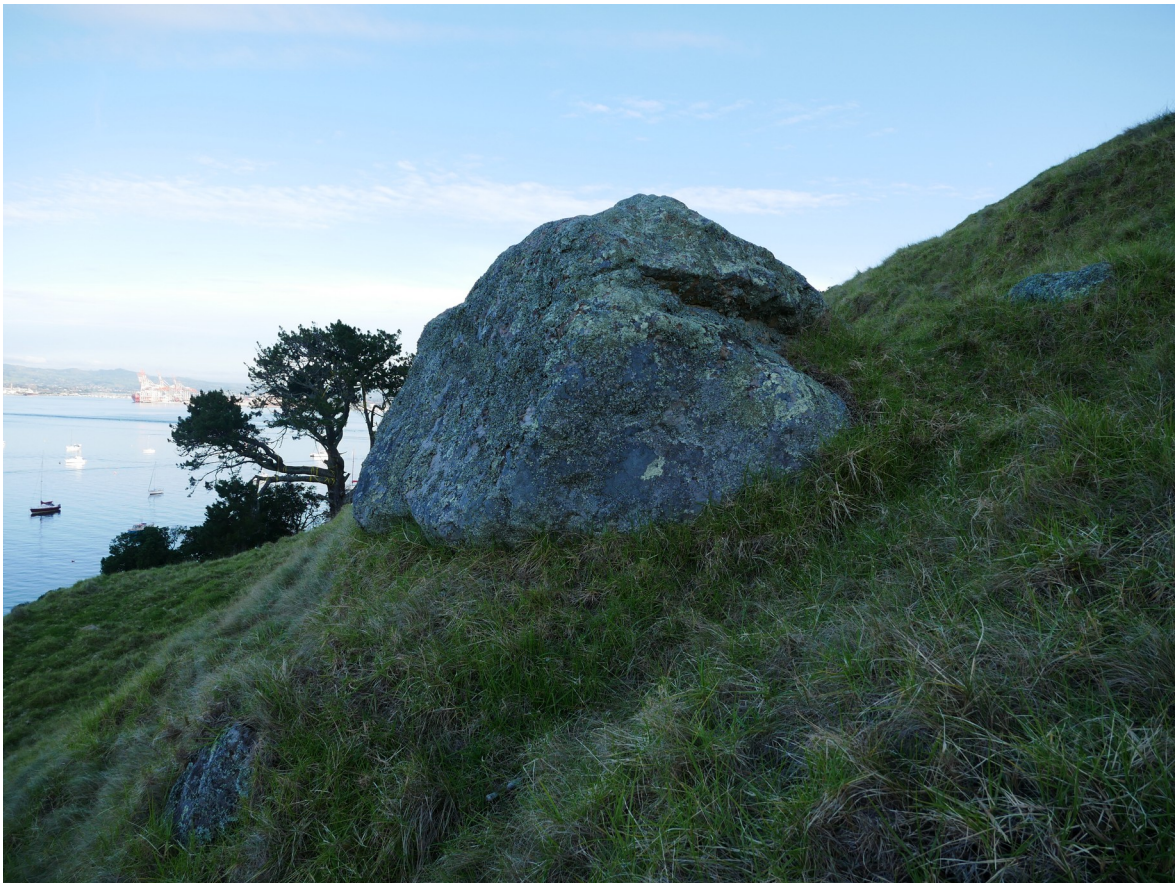
Photo 2; The boulder appears stable at present and has not moved recently.

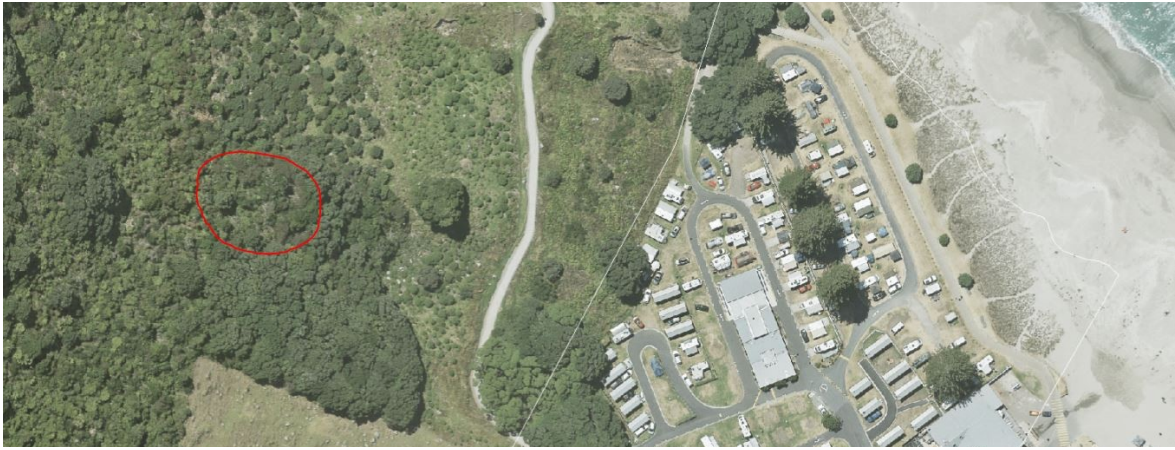
Approx. Location = 1880181 5830443 or -37.630513, 176.174827

The spring had opened up following storms in the week of 11 July. It was noticed by TCC staff on July 13. TCC Staff excavated around the spring to ensure it was not coming from a water main or artificial land drain.

Photo 3; Location of the new spring & boulder.

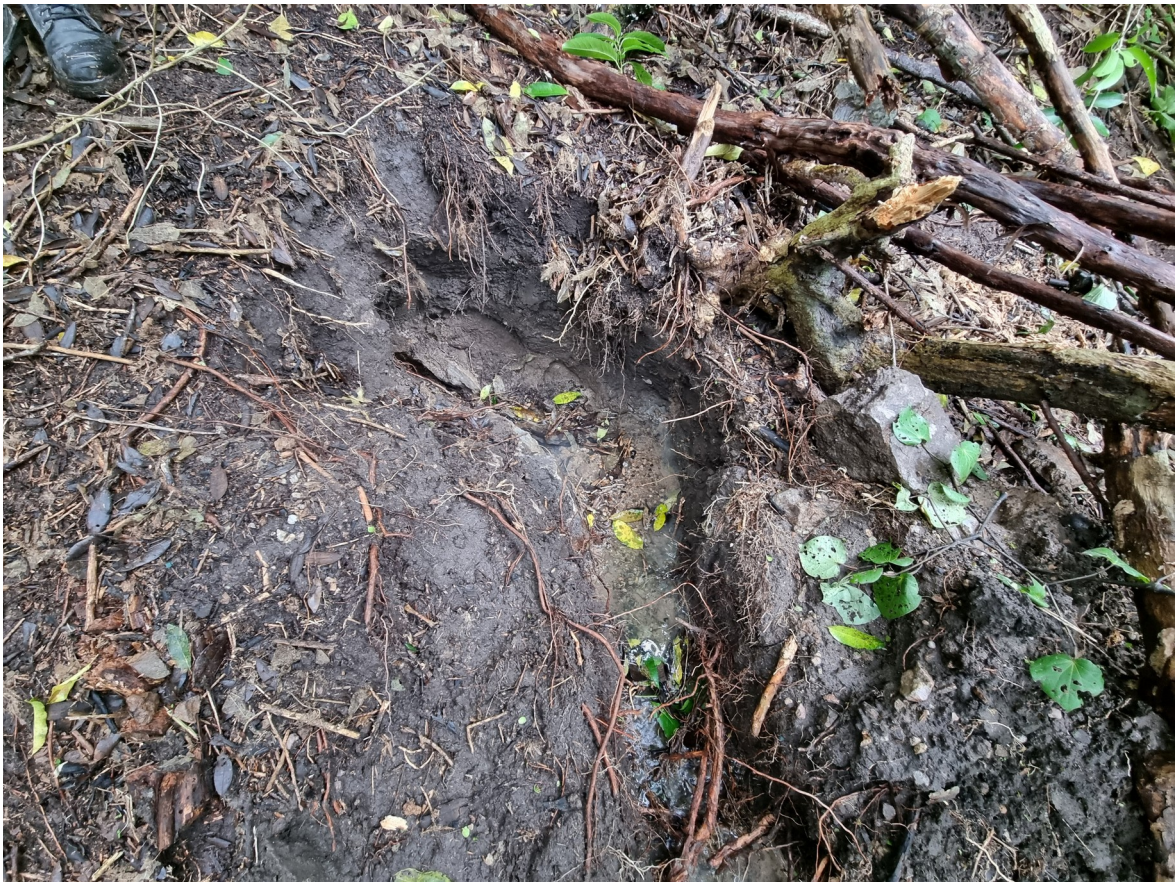
Photo 4; Spring (after excavation to investigate).

Water flow had reduced down to a trickle at the time of our inspection on 19 July but there was scour and evidence that a significant amount of water had sprung and flowed down the gully below. There was vegetation damage and leaf litter washed out downstream.

Over 20 almost years of monitoring we have seen ongoing evidence of the ways underground water flows through the lower soil slopes of Moau and the occasional opening and blocking of springs is consistent with previous observations.

Water flows through the permeable layers and is blocked and redirected by the impermeable layers. Backing up of water can lead to significant hydrostatic/pore water pressures, which will be a contributing trigger to soil slips.

The smaller of the underground flows probably change course relatively often as new flow paths form and others become blocked, particularly following intense and prolonged rain events.

We will include the spring as part of future monitoring visits.

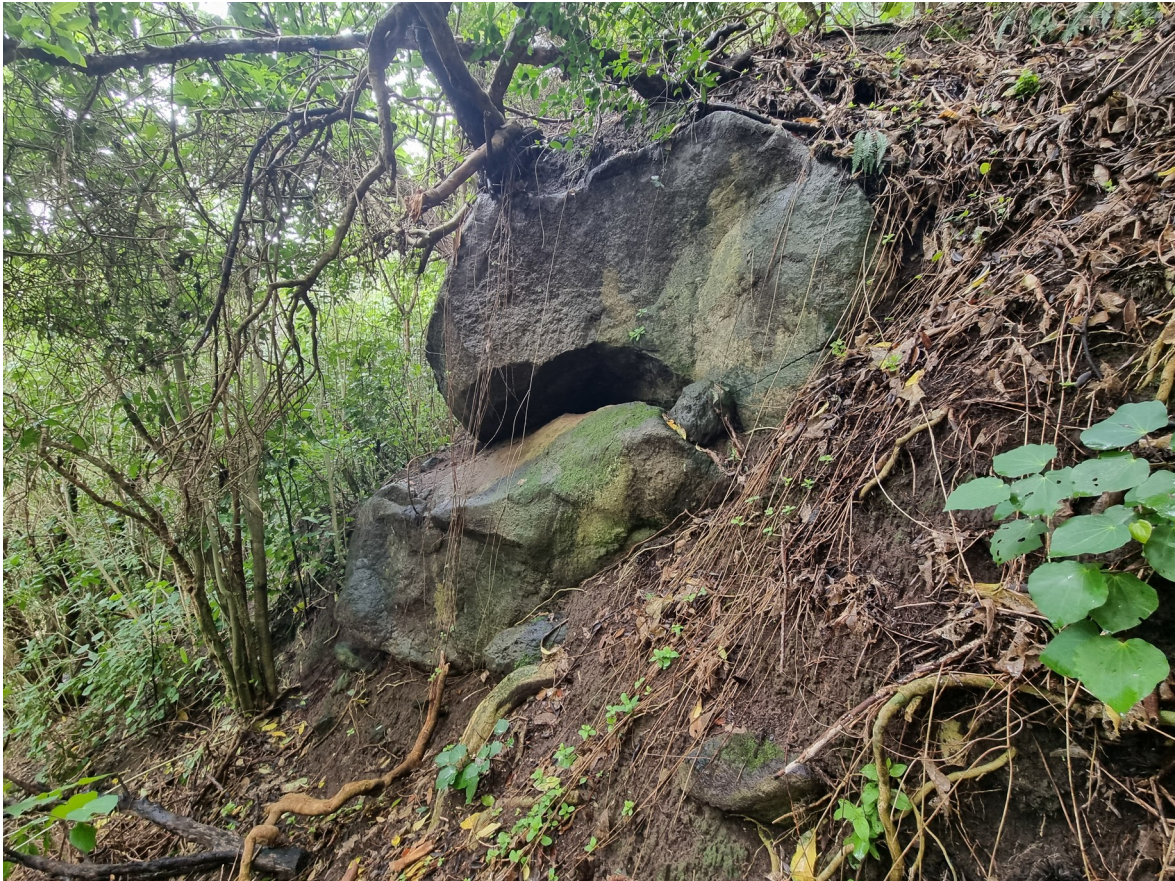
The adjacent boulder lies immediately above the spring.

Photo 5; Boulder near spring.

The boulder appears well seated and it's stability is not currently being affected by the new spring. It appears stably seated with no evidence of significant scour or washing out under or around the boulder

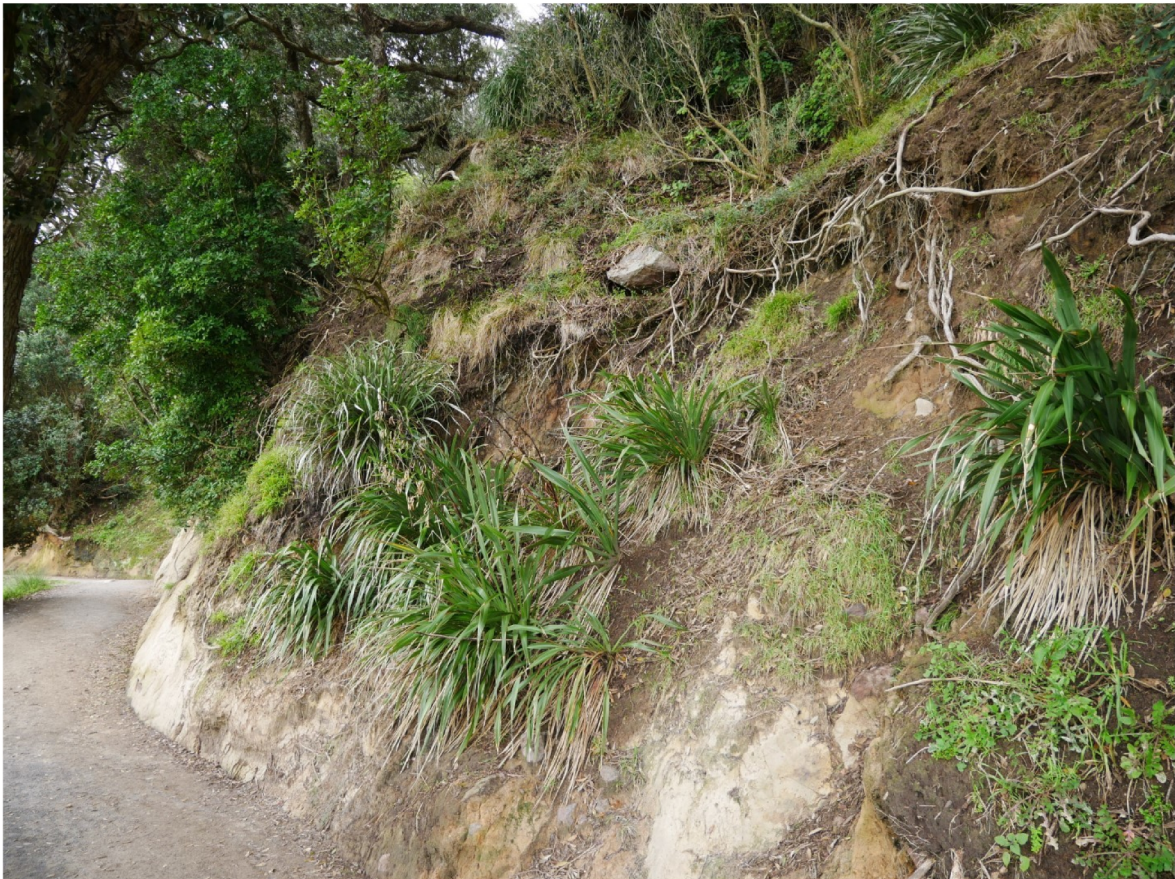
NZ Topo50 E:1879442 N:5830500

A relatively small rock been exposed by erosion. As it is immediately above the base track and clearly likely to fall soon it would be worth scaling to eliminate any hazard.

Photo 6; Small rock above base track

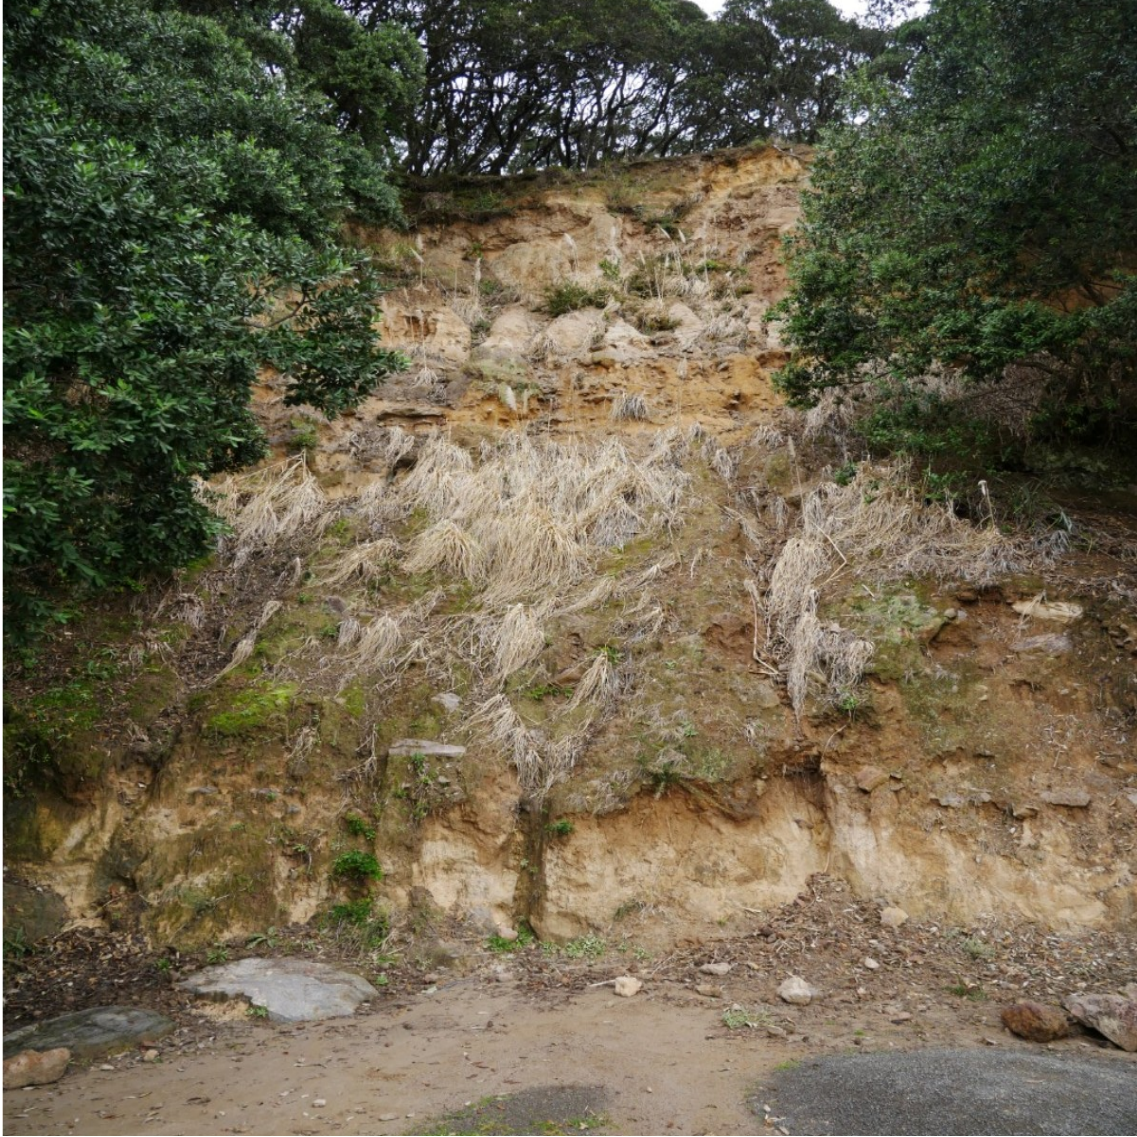
The same location as Section 6 of August 2021 report. This face has been scaled a number of times previously.

There is some new evidence of recent rockfall at the base. Ongoing erosion is evident on the face.

Photo 6; Eroding face above base track

Recommend continue monitoring, worth considering for some scaling after significant rain fall or when a scaling team is on site for other works.

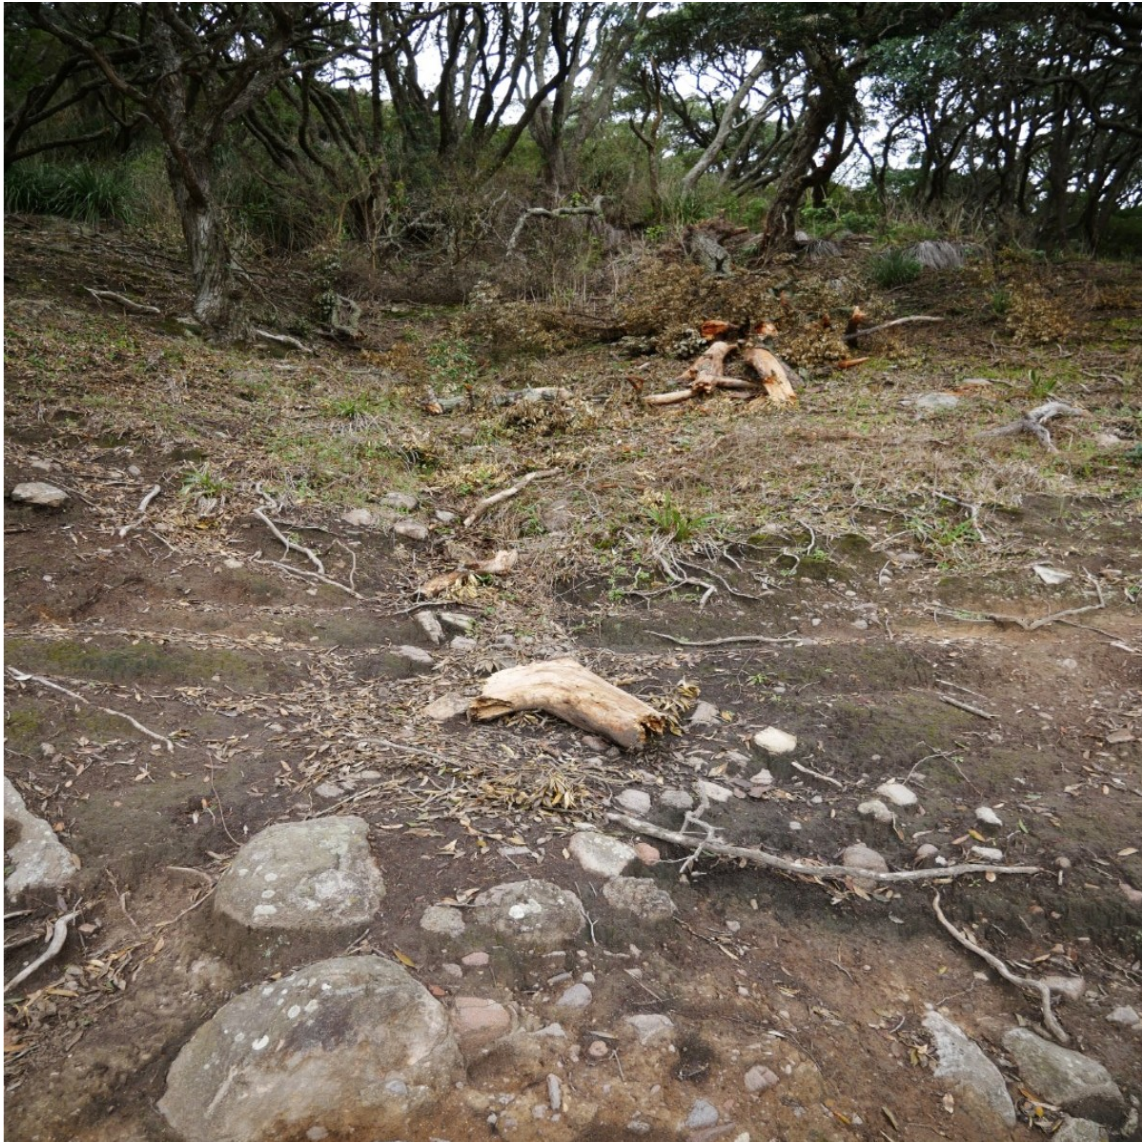
There is evidence of recent treefall in various places, but no evidence of significant associated rockfall in these locations.

Photo 7; Treefall.

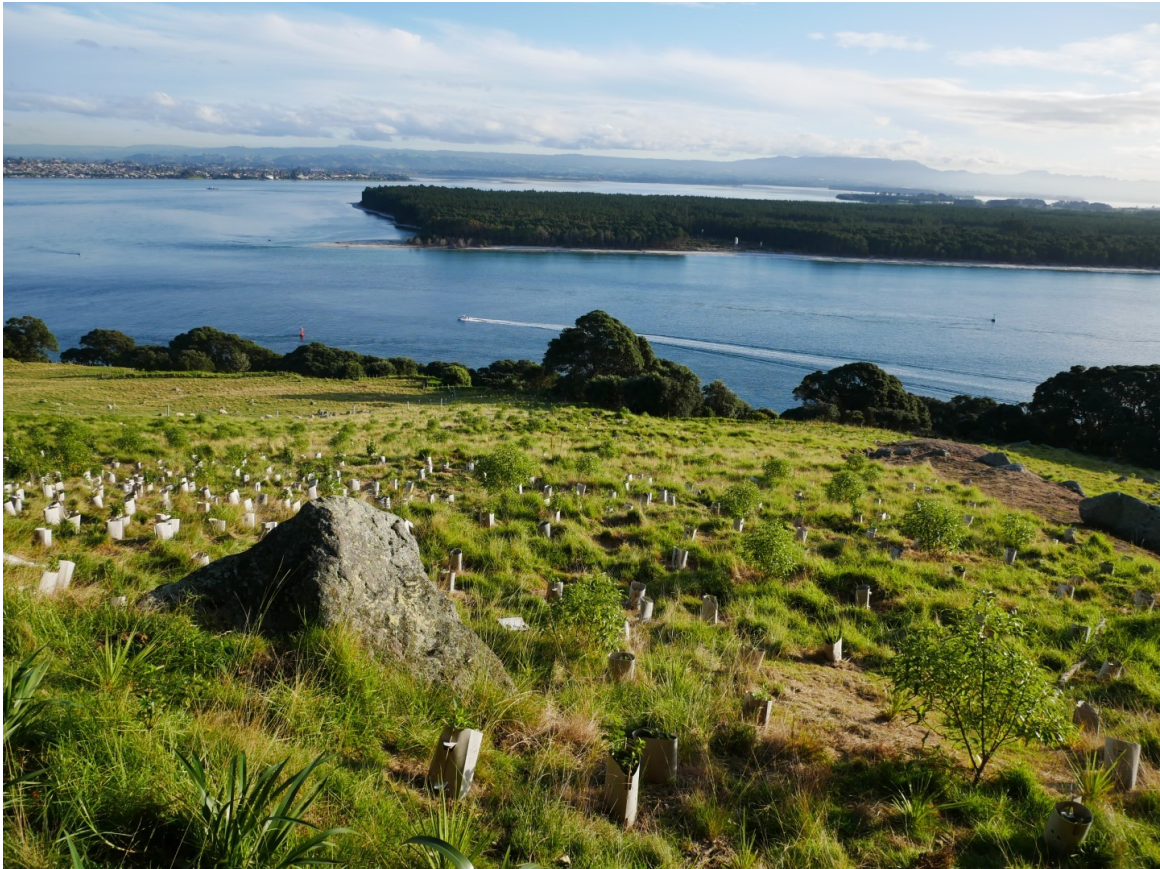
Recent planting noted in 'top paddock'

Photo 8; Recent planting

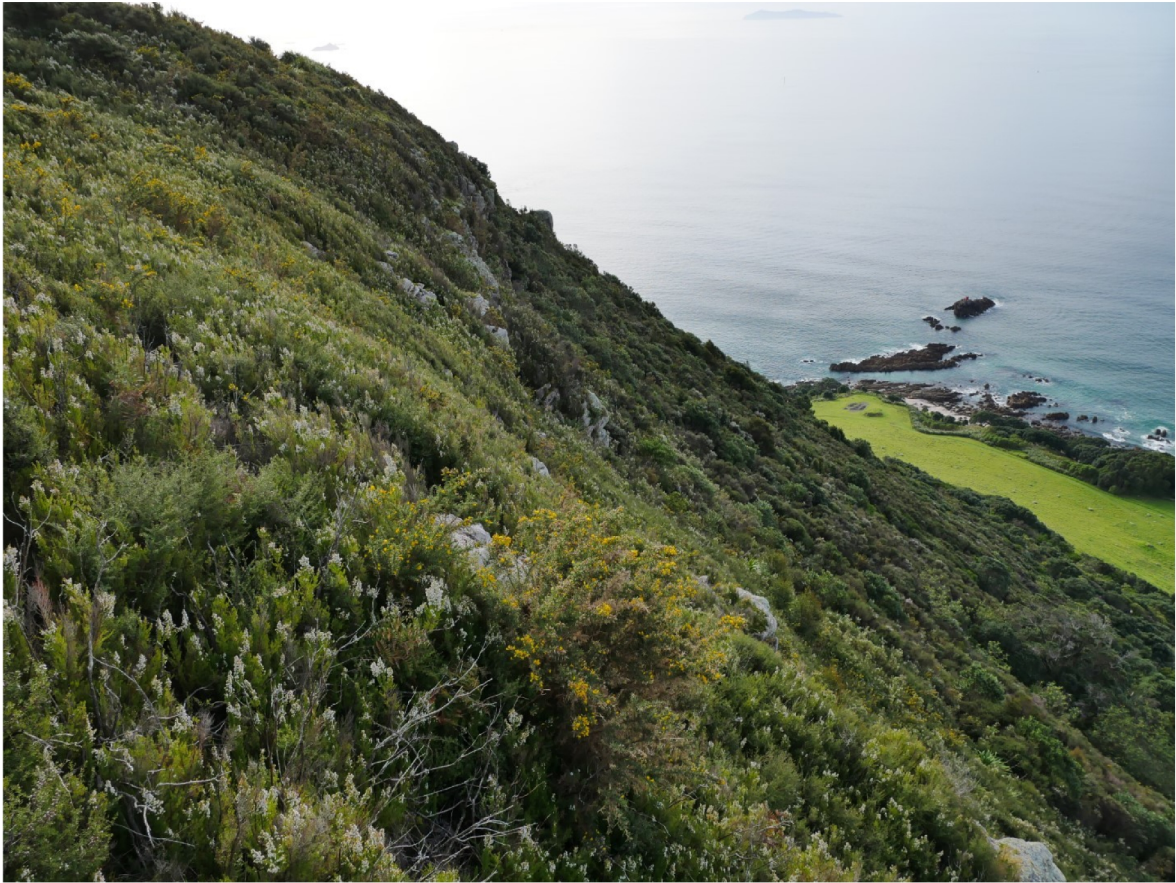
Previous monitoring locations A to M were photographed for the final time. No visual evidence was found of recent movements or rockfall activity.

These locations have been used since 2002 but will no longer be used due to vegetation growth now obscuring most items of interest on the slopes.

Photo 9; Vegetation well established and now concealing slope areas previously being monitored.
