GEOTECHNICAL

15 April 2021
Avalon Project #21212

Mauao Slopes; Final Report for March 2021

The rock bluff survey benchmark monitoring was carried out on the 23rd March.

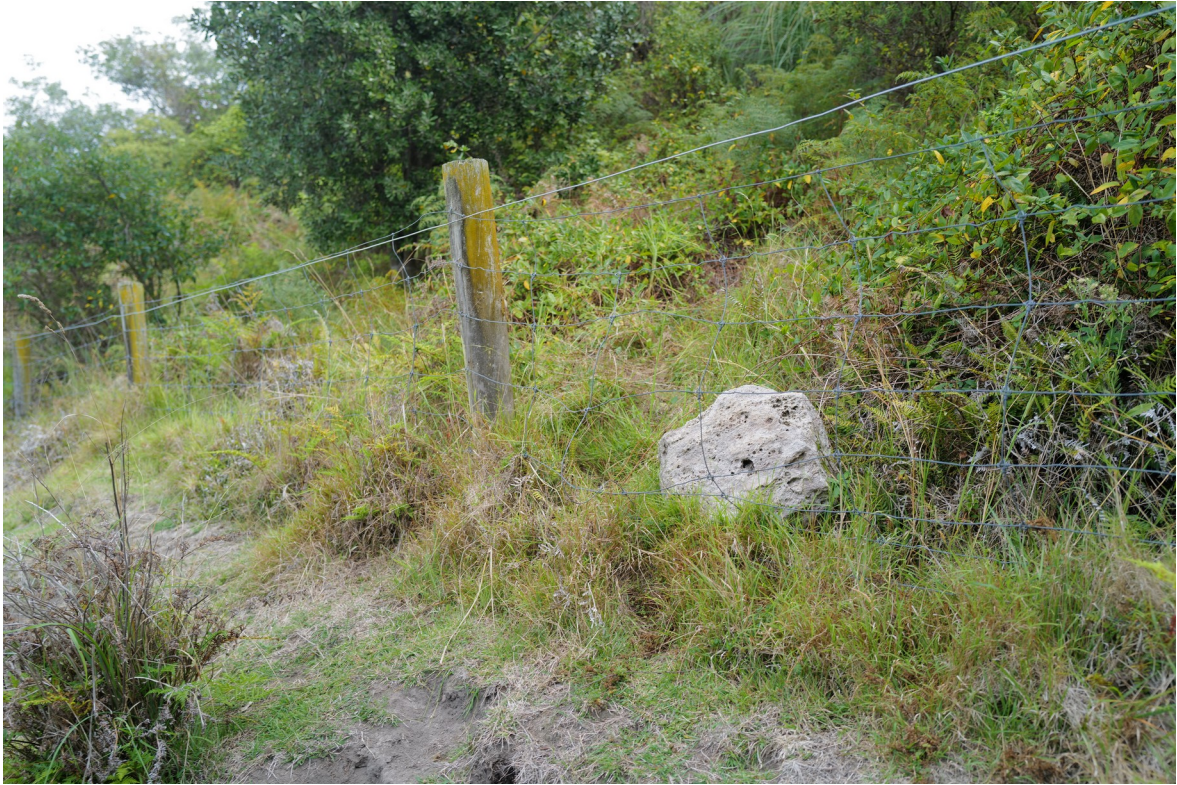
Photo 1; Rock against fence at 70m contour above the Campground.

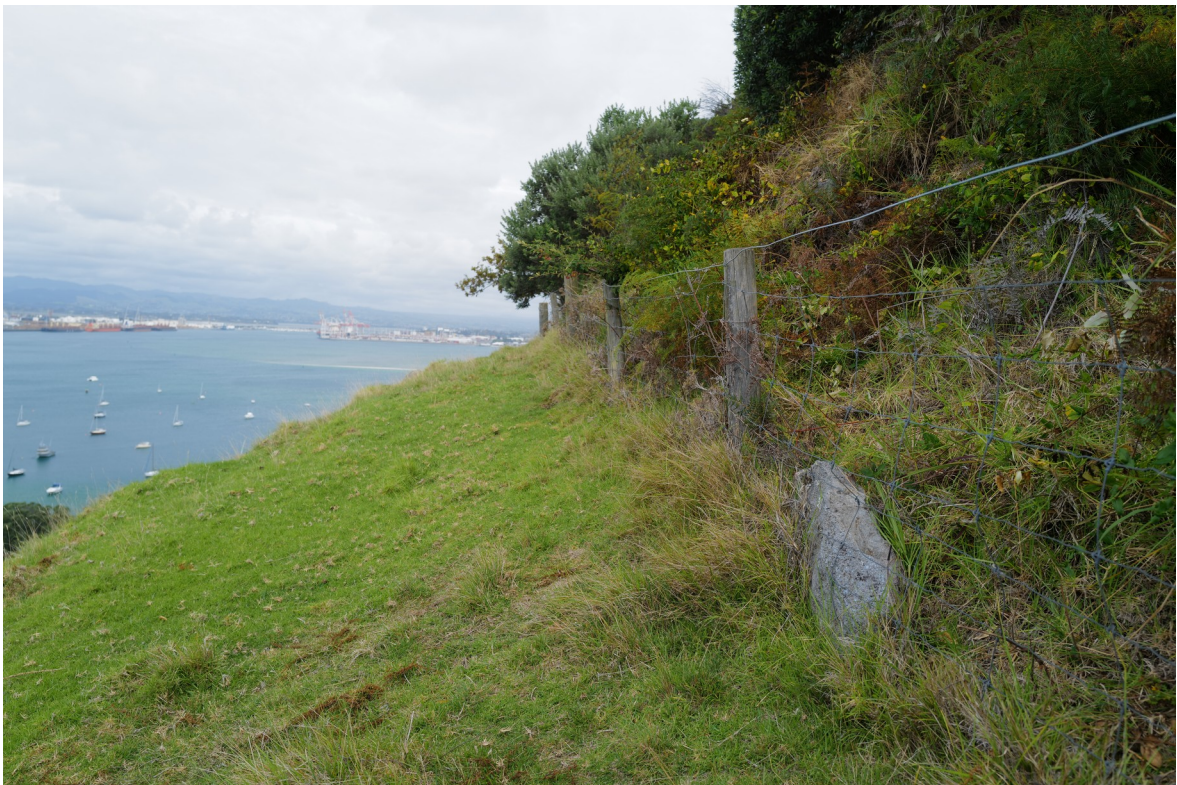
Photo 2; Second rock against fence at 70m contour above the Campground.

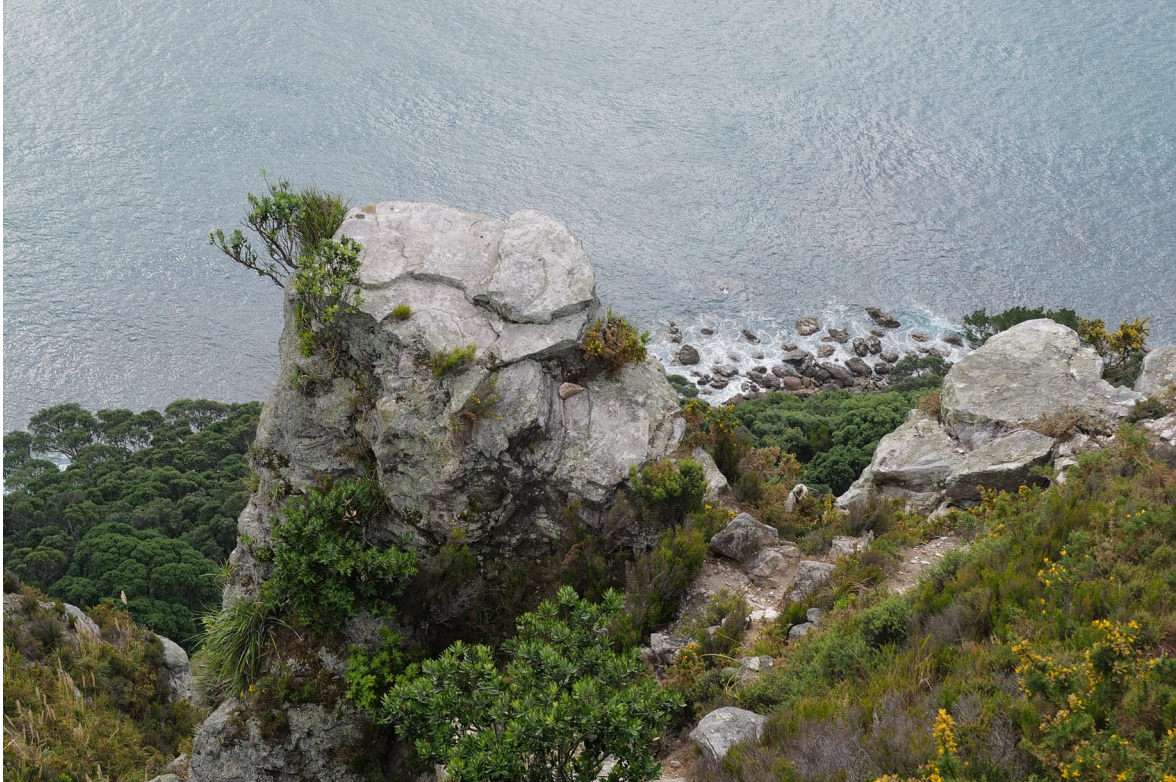
Rocks going over the edge in this location could pose an **extreme hazard** to anyone on the Oruahine track below. Rock here can impact the track from freefall.

Photo 3; View down from bluff crest to top of a rock column.

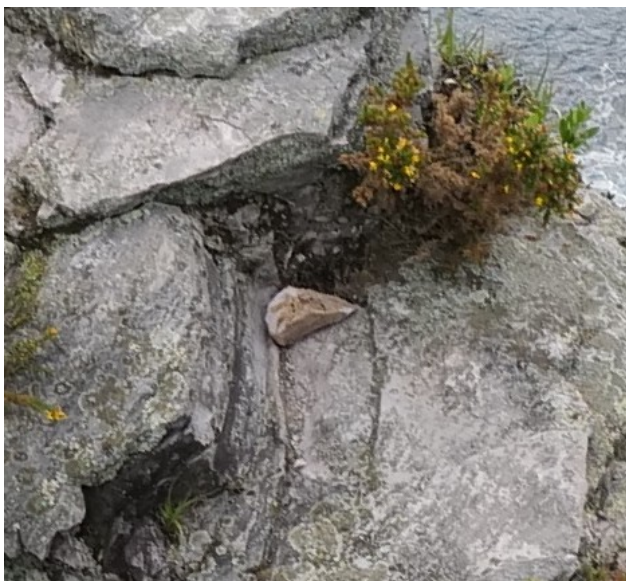
Photo 4; Fresh rock on top of column – detail in centre of photo 3, above.

It appears very likely that rocks have been dug from the crest and deliberately thrown to target landing on top of the column!

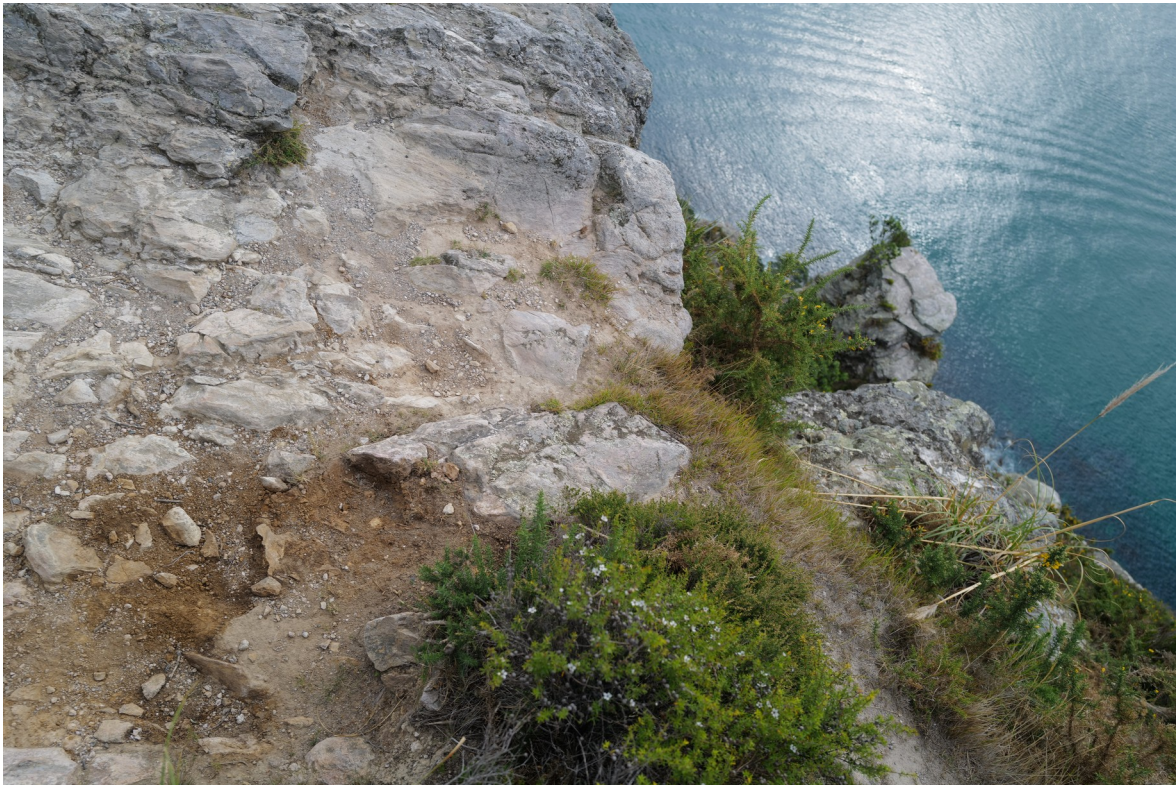
Photo 5; Fresh digging at crest. Column top in 3. is visible centre right.

A number fresh looking empty alcoholic drink cans were littered in the vicinity.

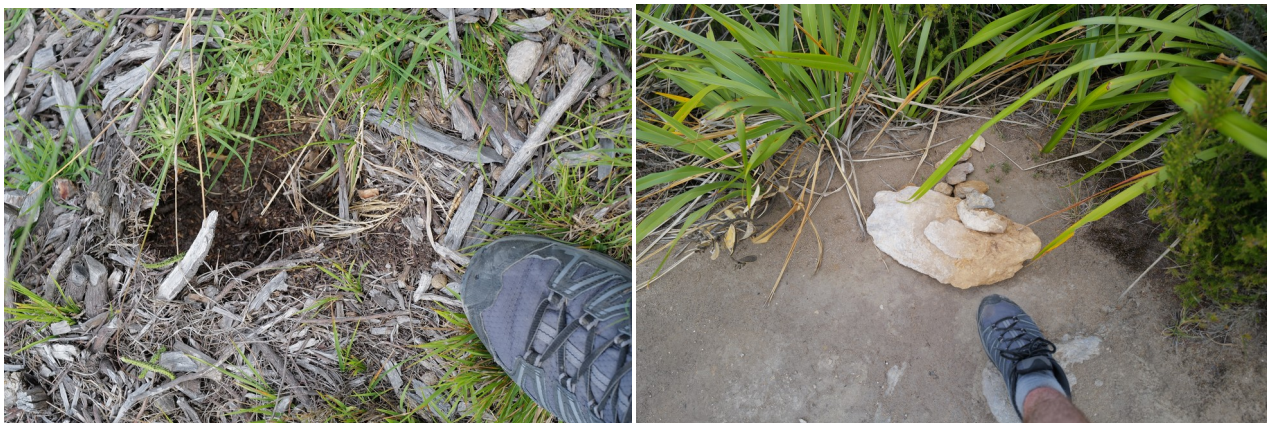
We have previously seen collected piles of rocks and scars where rocks may have been dug but this is the first time since 2003 that we have come across such clear evidence of persons having been stupid enough to deliberately thrown rocks over the high bluffs!

Photo 6; Scar from dug rock and a small collected group of rocks as found.

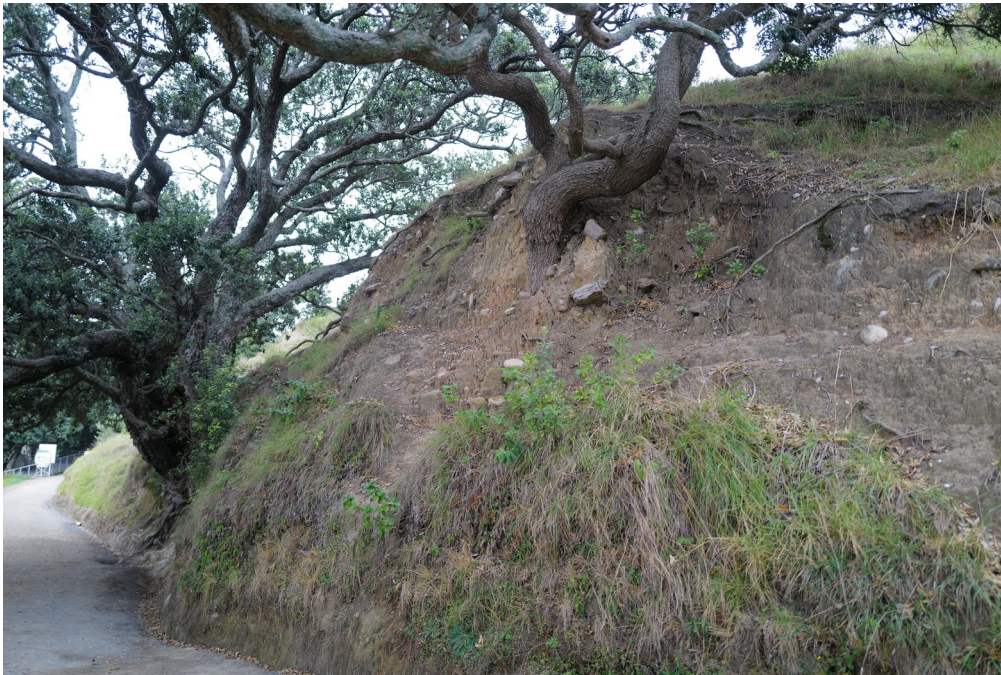
Around the Base Track there are a number of locations where small cut slopes have relatively small rocks exposed in marginally stable positions a few metres above the track.

Photo 7; Small rocks immediately above the Base Track.

This occurs as part of the natural erosion process and although they do not present a great hazard they are relatively very easy to scale. Very targeted light hand scaling is recommended occasionally to eliminate the worst of these.

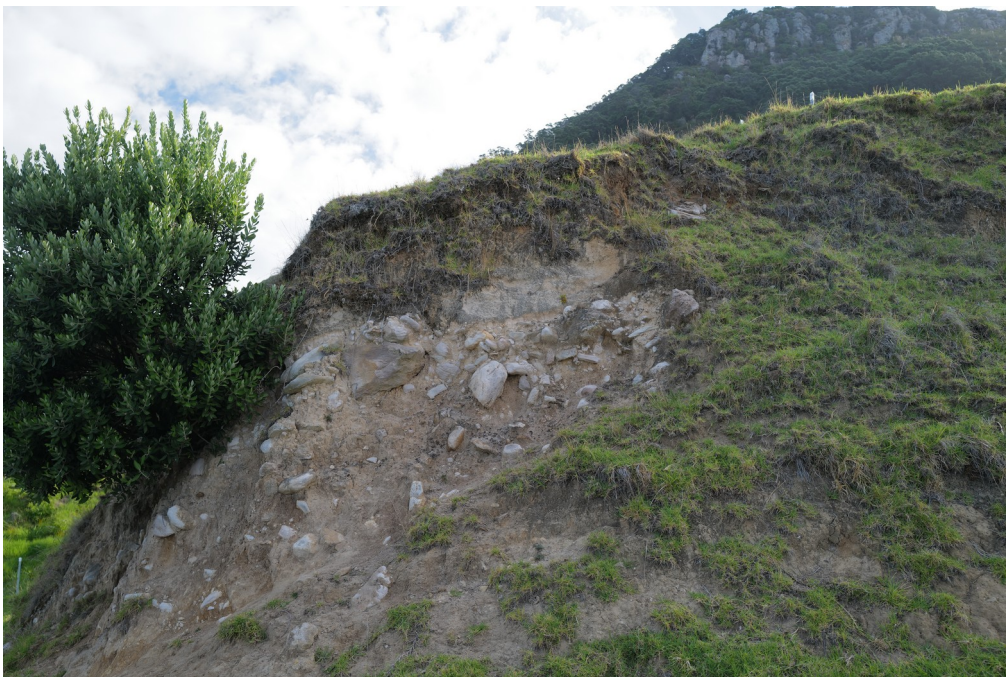
Photo 8; Small rocks immediately above the Base Track.

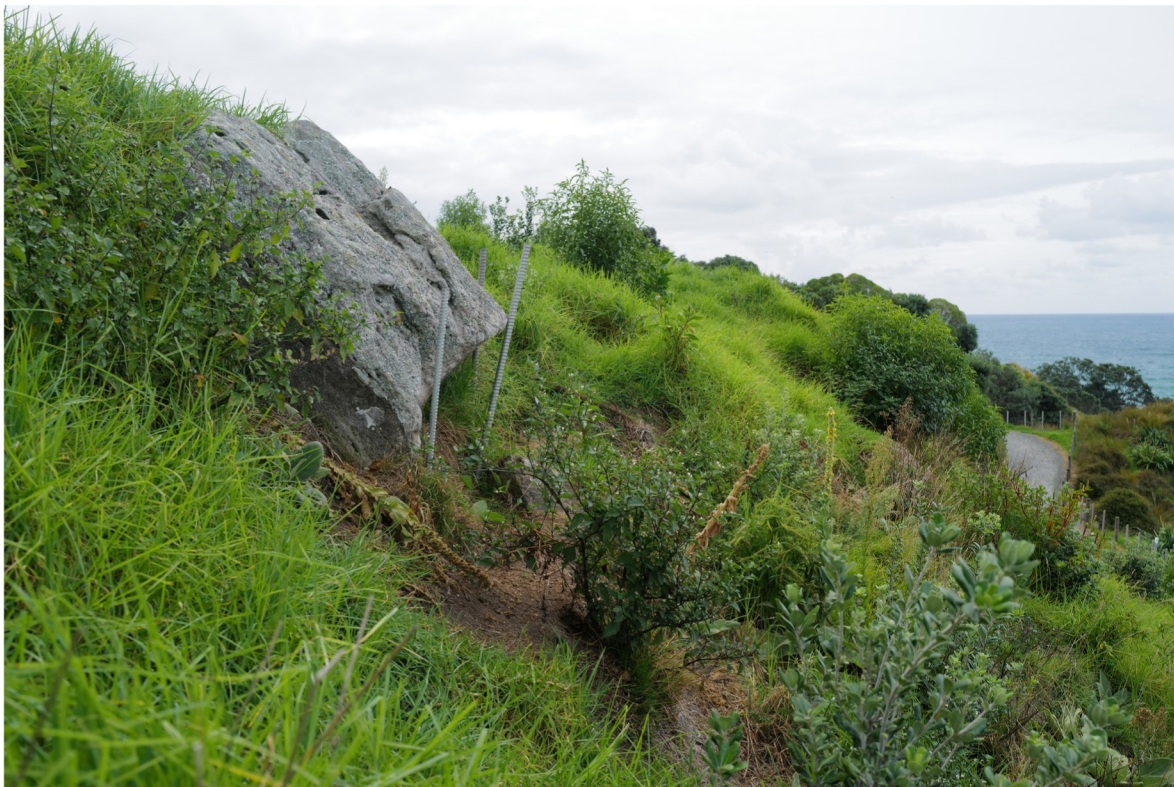
In December 2020 s 6 - Maintenance of I reported a boulder in a marginal looking location above the Northern Campground area, around the 25m height contour.

Photo 9; 3m long 25mm diameter pins driven in front of boulder.

As part of this monitoring visit we installed three RB25mm driven bars, each 3m in length. These will indicate if there is any movement and help to stop movement. They will be checked at future monitoring visits.

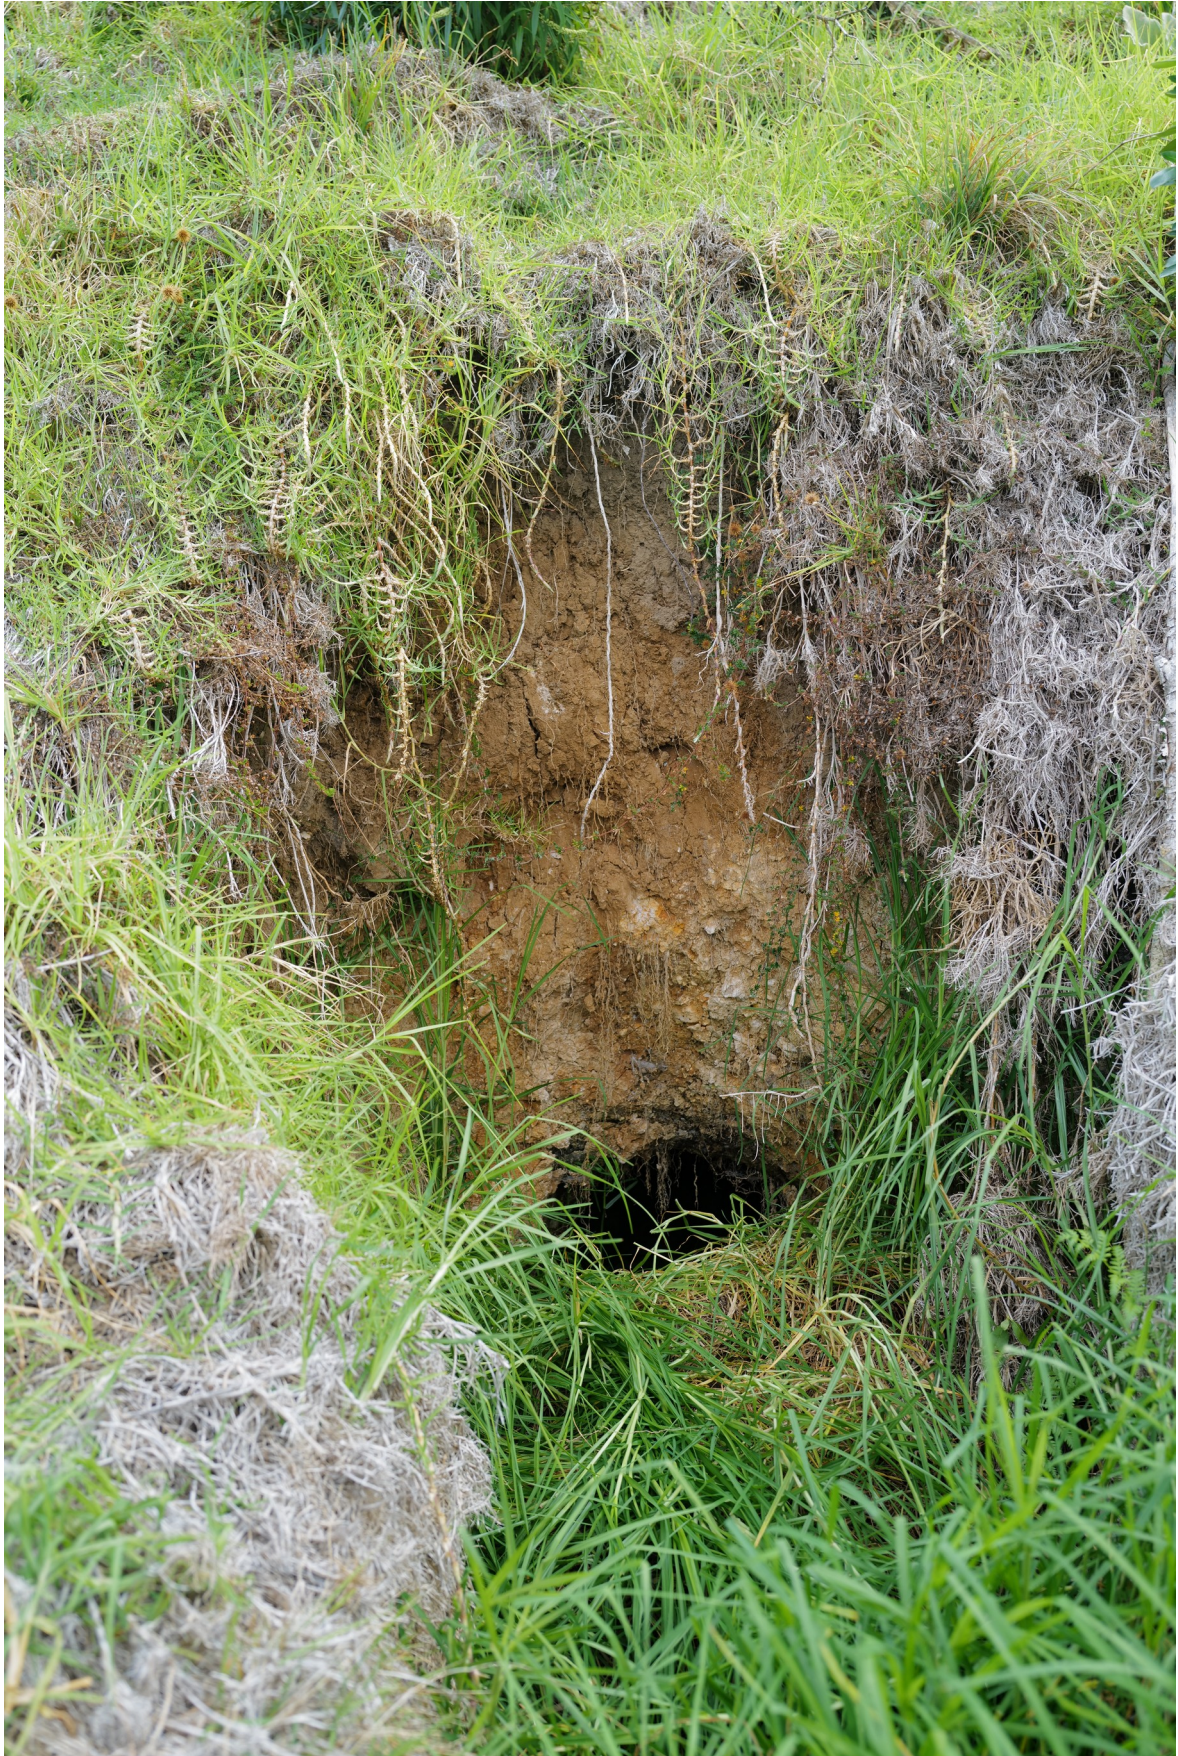
Around 7m south of the boulder reported in 8, above, there is a collapsed sinkhole / void, around 2m in depth, 1m in diameter.

Photo 10; 2m deep 'sinkhole' / void collapse

What has created this feature is unknown. There were no signs of flowing water or animal tracks.

The springs that issue from the lower colluvial slopes around Mauao indicate widespread underground water movement. Underground drainage routes will tend to form at levels where sandy, relatively permeable colluvium, overlies impermeable clay (weathered volcanic ash) layers.

It is possible that the 'piping' effect, scouring out sand, has created open 'pipes', 'passages'.

We have observed this soil scarp feature on past visits but it appears recently enlarged. It was previously assumed to be a surface feature, possibly above a spring though we never moved vegetation to inspect its base in detail.

The general location is a revegetating slope, separated from the public by a new fence line, however, being relatively close to the campground it is possible that children could find it. Attempting to enter it obviously would present a very serious hazard.

We would recommend we revisit and use an inspection camera (on extendable fibreglass poles) to determine if the tunnel continues beyond that currently visible and then temporarily block it to prevent entry.

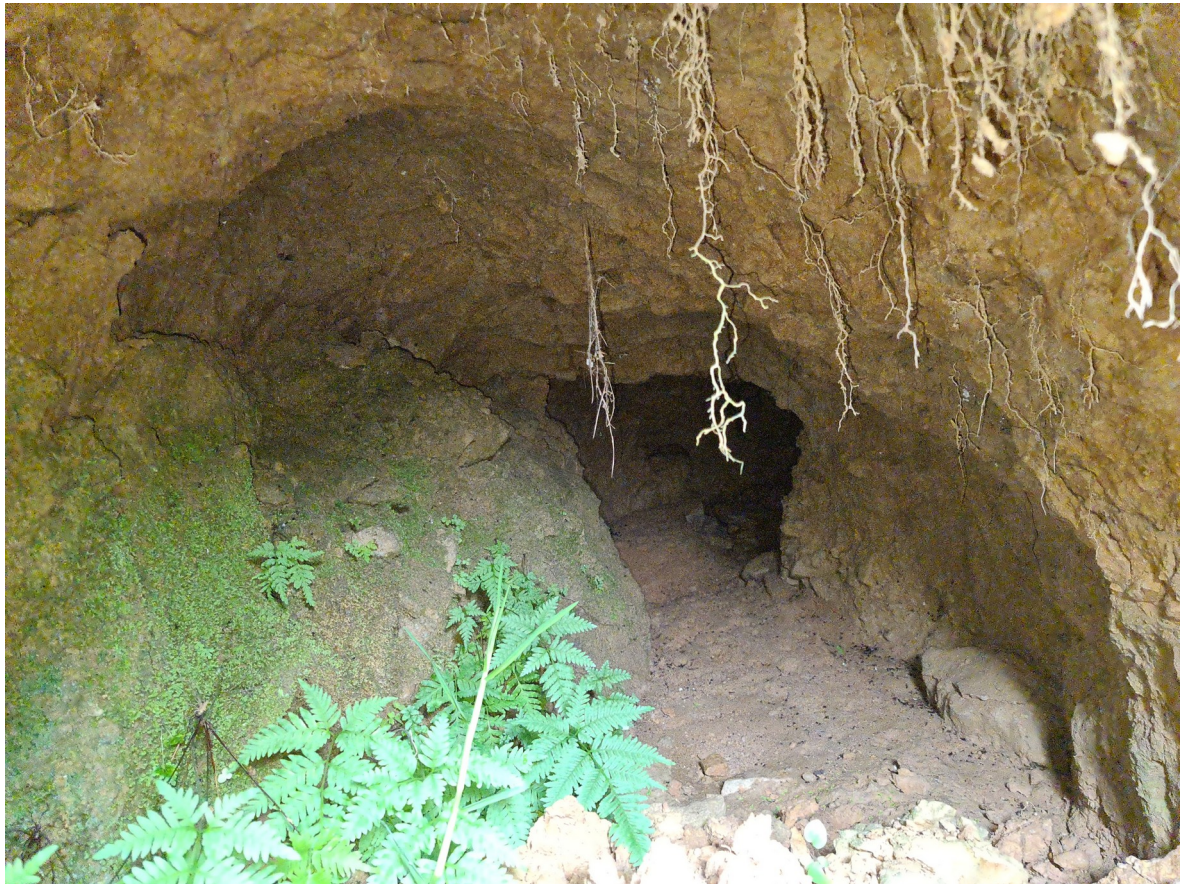
Inspecting the base of this void there appears to be a continuation into the colluvial slope, around 0.4m high by 0.4wide.

The continuation appears to turn right approximately 2m in, possibly also continuing to the left

Photo 11; 'Tunnel' into slope from base of collapse hole.

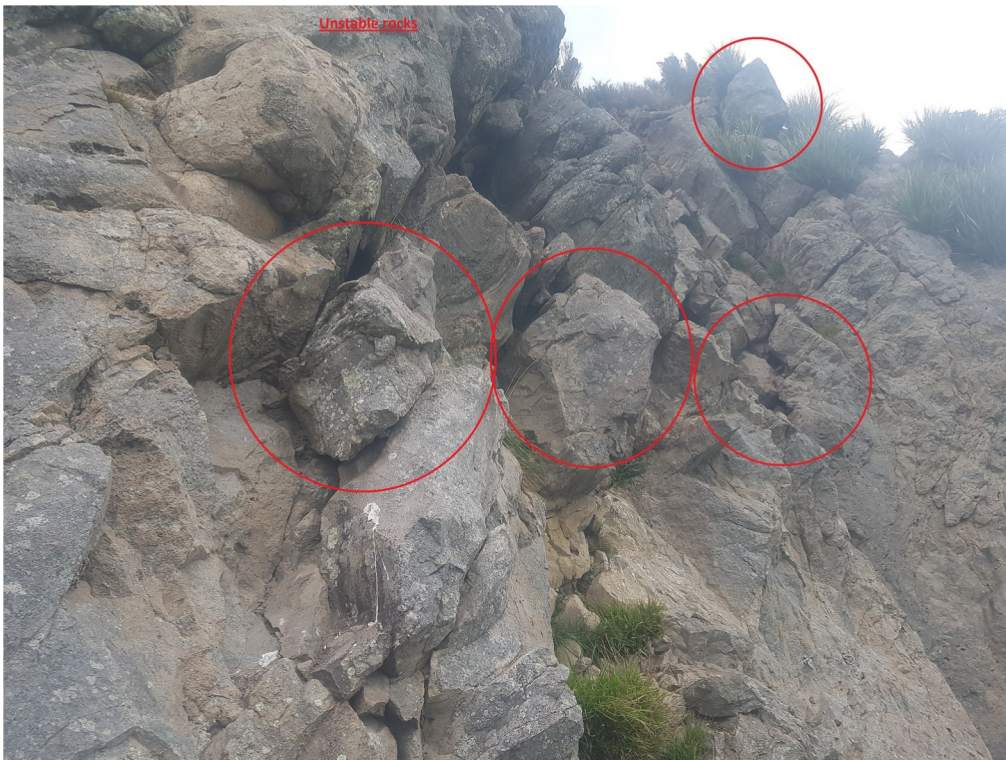
Photo 12; Marginally stable rock above the Oruahine track has now been removed.

In November 2020 at s 6 - Maintenance of request Avalon successfully scaled an area above the Oruahine Track known to be particularly hazardous since 2017.

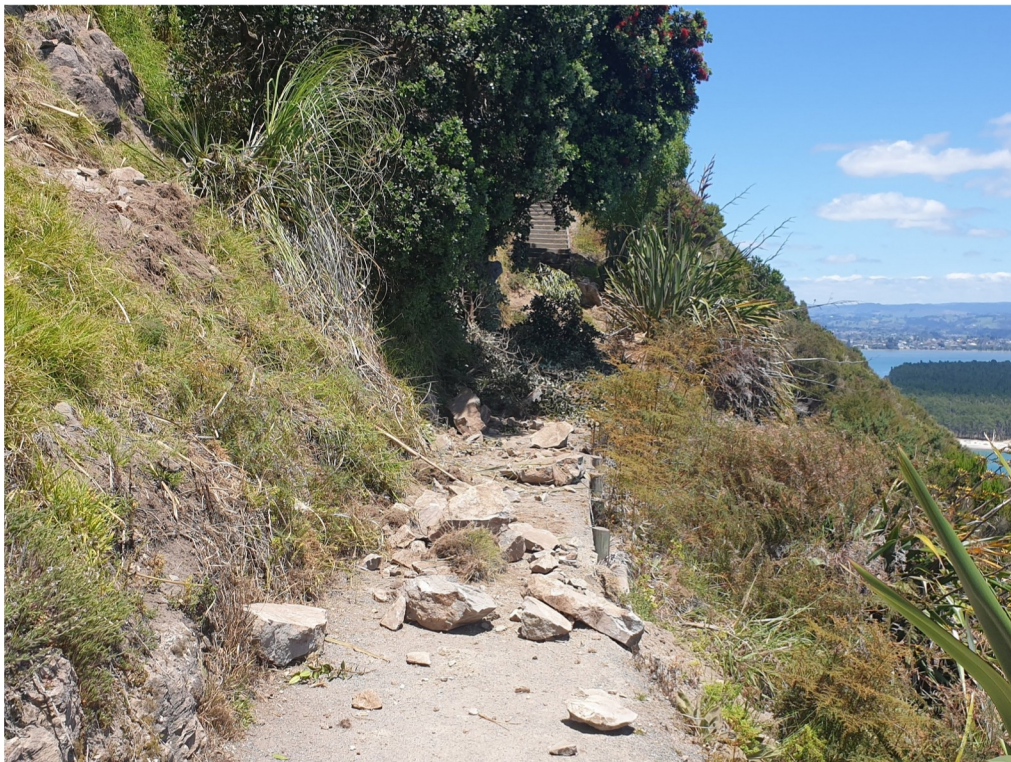
Photo 13; Some of the rock in Photo #12 stopped on the Oruahine track.

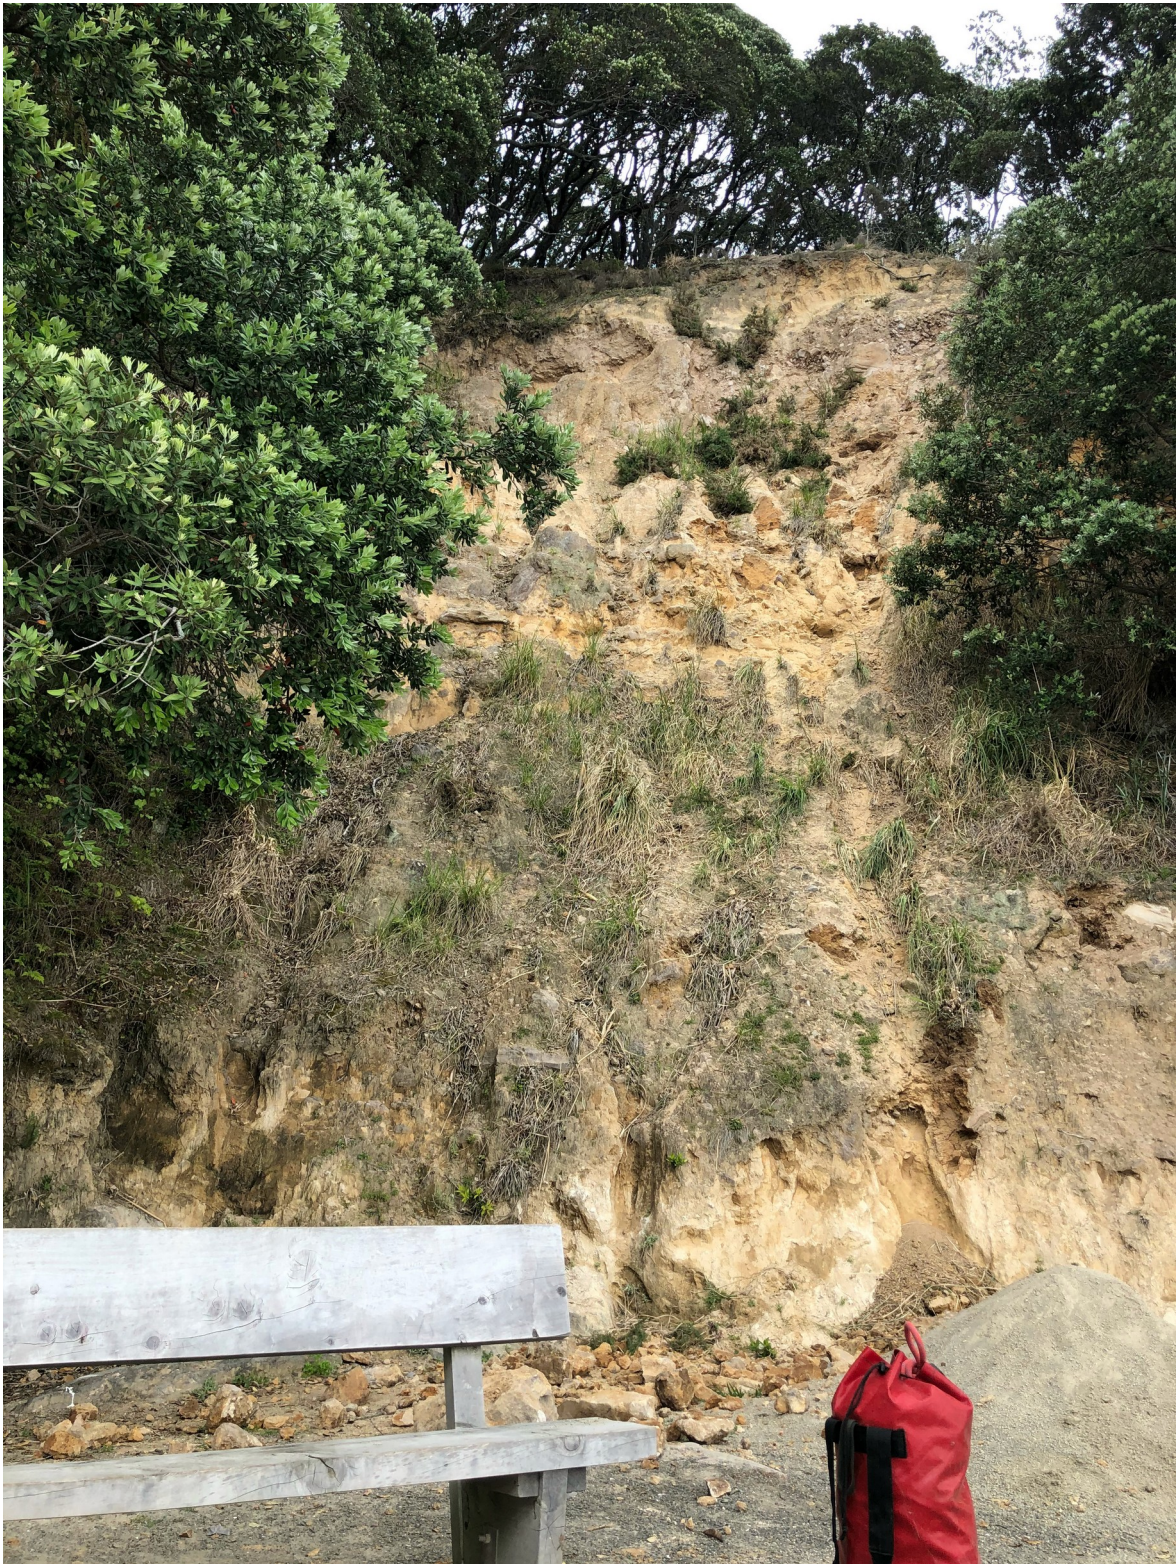
Photo 15; Scoured slope face above the Western Base Track.
Fresh rocks are regularly exposed on this slope as the natural weathering process proceeds.

Avalon's team cleared the least stable, 'loose' surface rock.

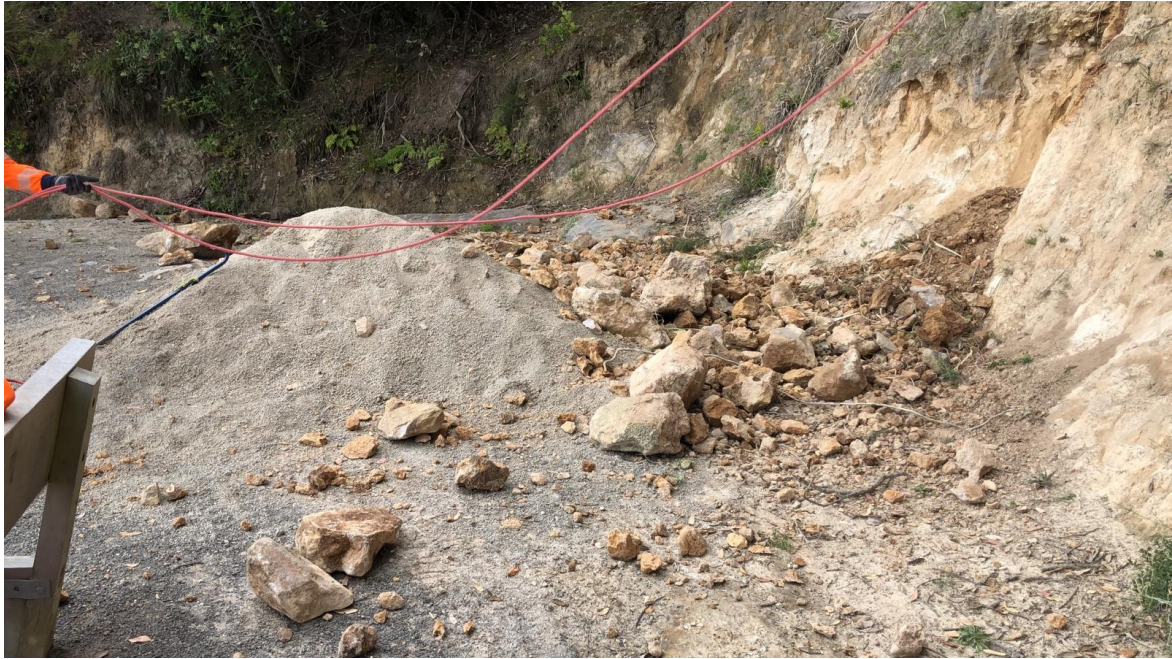
Photo 16; Rock removed from scoured slope face above the Western Base Track.

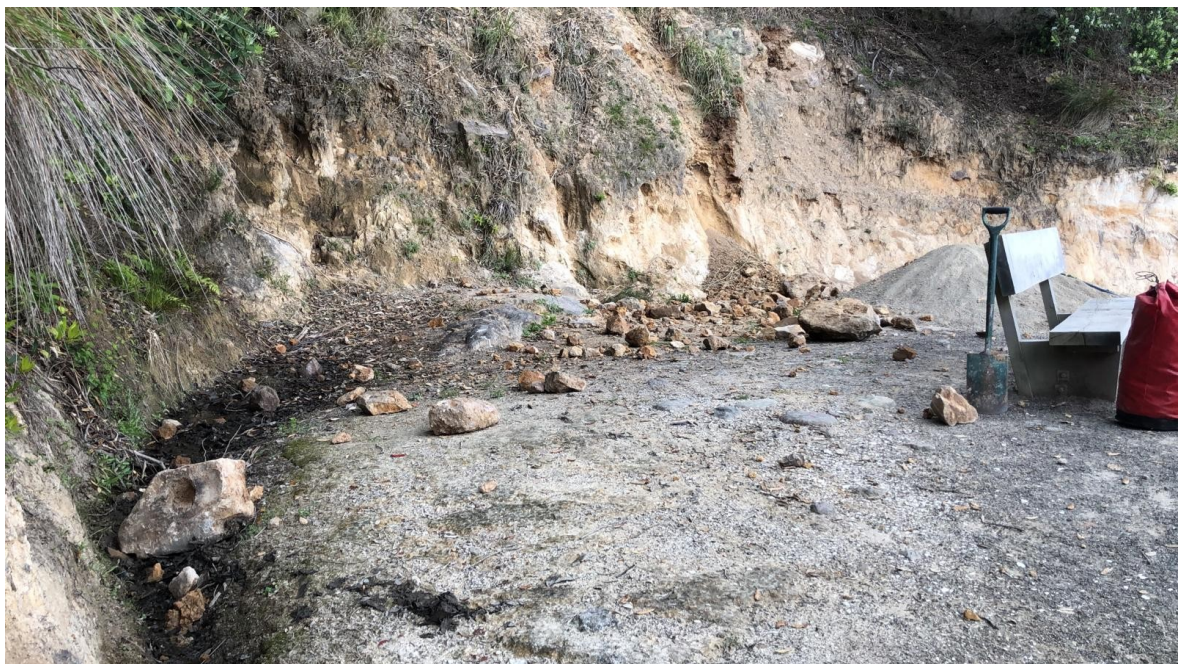
Photo 17. Rock removed from scoured slope face above the Western Base Track.

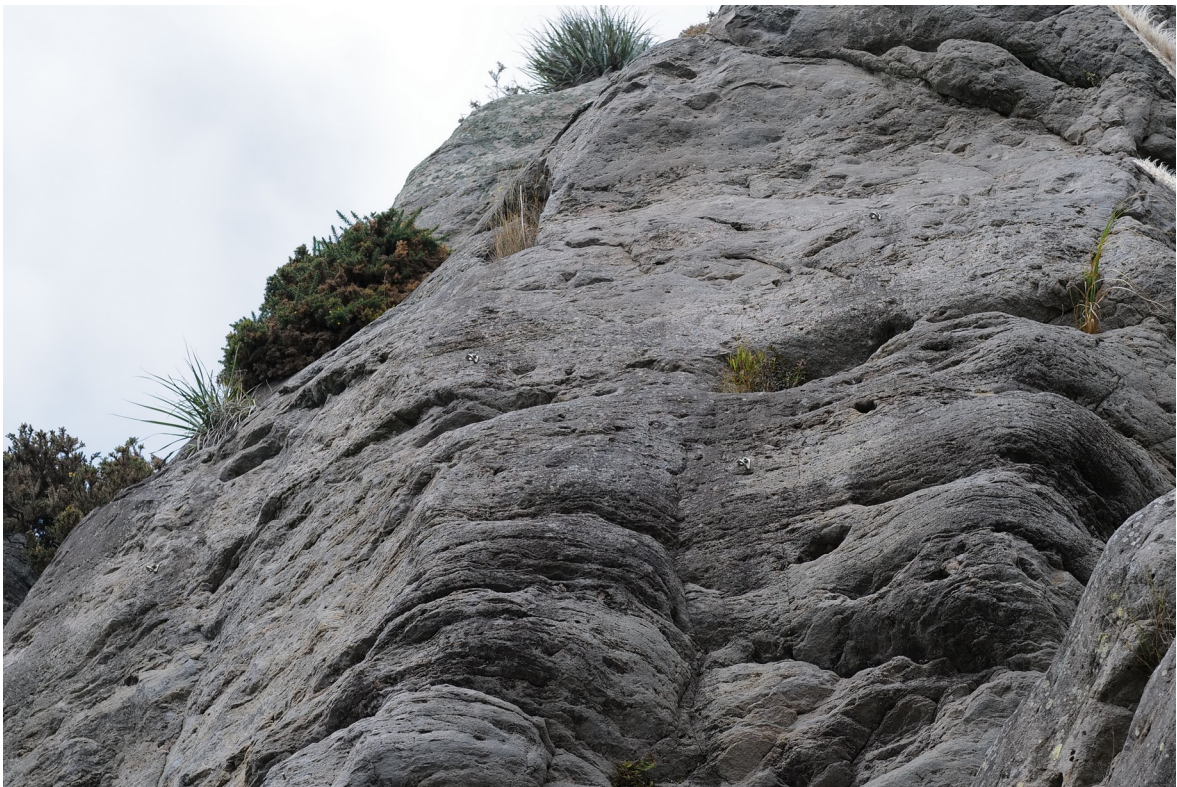
The rockfall triggered by climbers disturbing the loose rock in this vicinity has long been identified as likely to be one of the higher rockfall risks on Mauao.

Photo 28; Climbing routes with hangars still in place on 8 April.

During this inspection we noted that hangars still remained on some climbing routes, particularly on the Southern Oruahine Bluffs

We understand that TCC very recently used an arborist company to remove the "hangars" and disable the protection anchors on these rock faces to discourage future climbing.
