SITE VISIT RECORD

Contract: Mauao Base Track Geotechnical Monitoring

Inspection No: 7

Work Site: Mt Maunganui Base Track

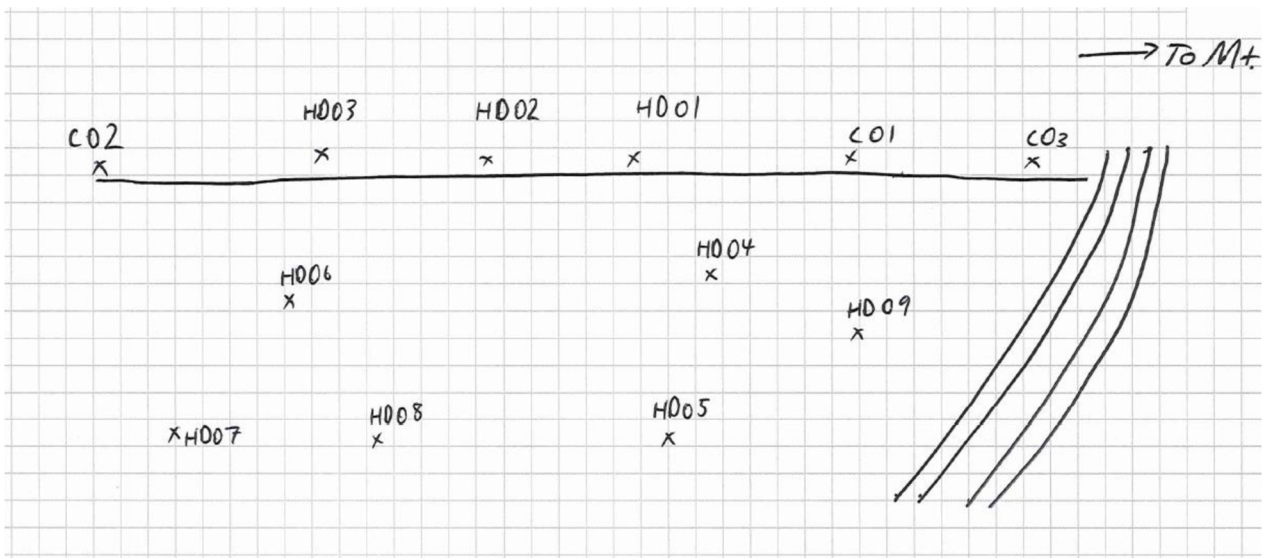
Figure 1 - diagram of site

- Horizontal drains HD01 - HD03 (Figure 1) on the slope above the repaired track were checked. All drains were dry.
- The scour around drain HD03 has been remediated by the installation of a horizontal coil drain by council contractors on 09/11/2020 (Photographs 19-22).
- At the bottom of the slope the only horizontal drain that was dripping was HD07.

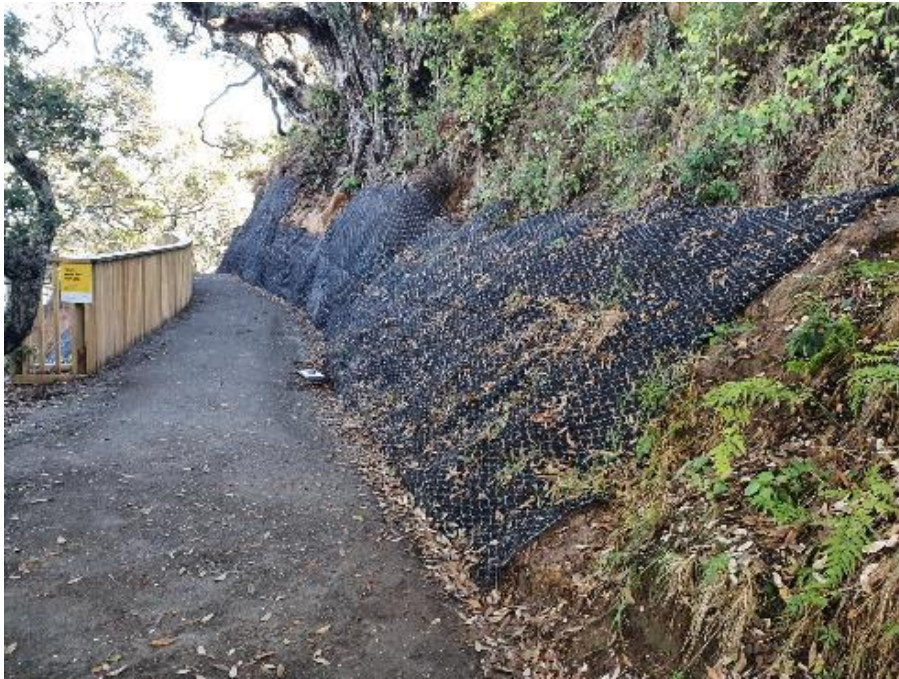
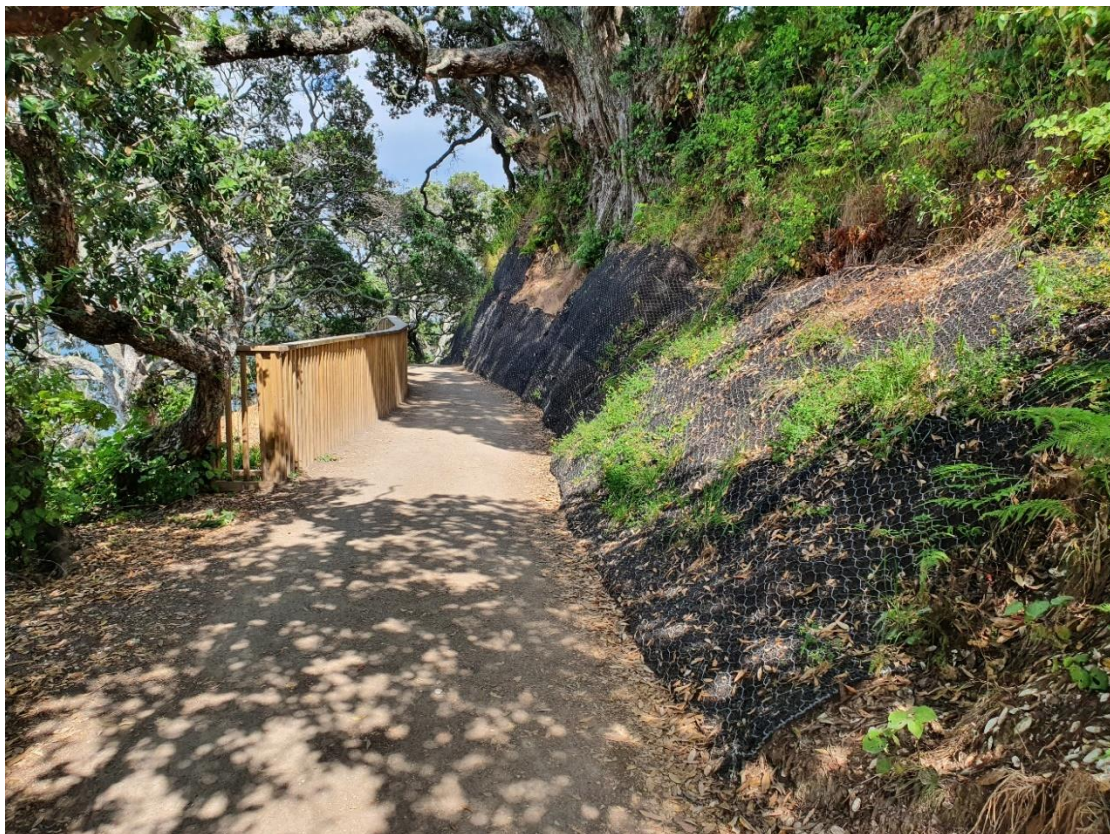
Photograph 1 & 2

Photograph 1 (top, taken on 02/06/20) compared to the most recent visit on 14/01/21- At the start of the track looking west

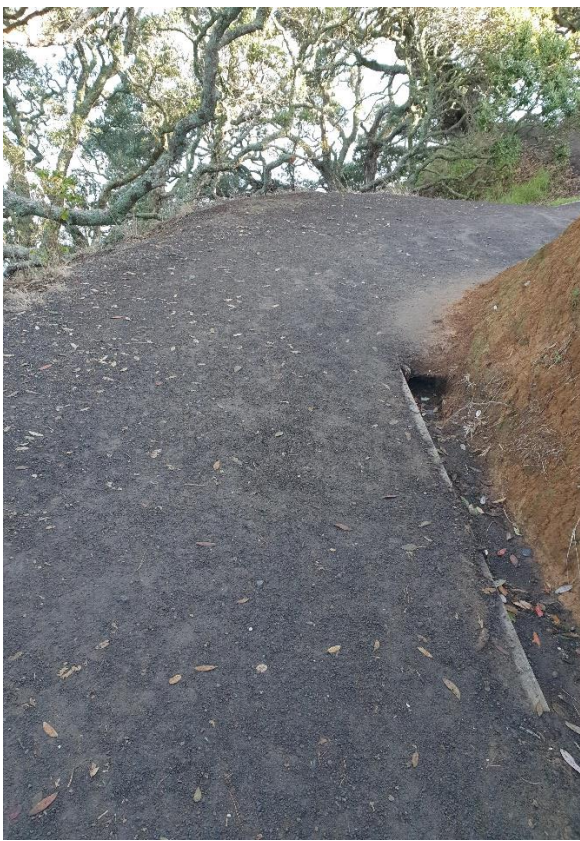
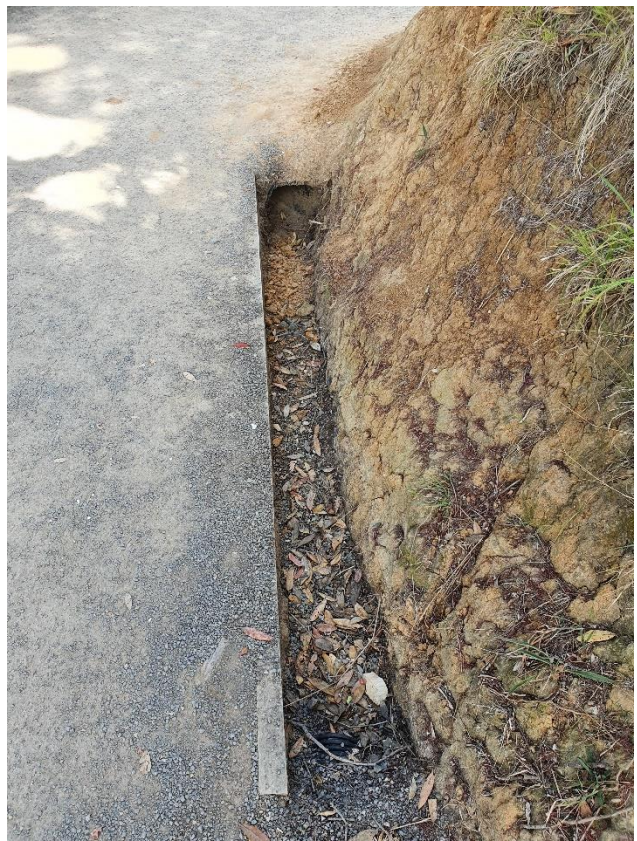
- Culverts 01 and 03 were clear, with the exception of a covering of leaves (Photographs 3 - 4). Culvert 02 is clear (Photograph 4).

Culvert 02 at west extent of track repair. Photograph 3 (above, left) was taken during the initial inspection on 02/06/20 and Photograph 4 (above, right) taken on 14/01/21.

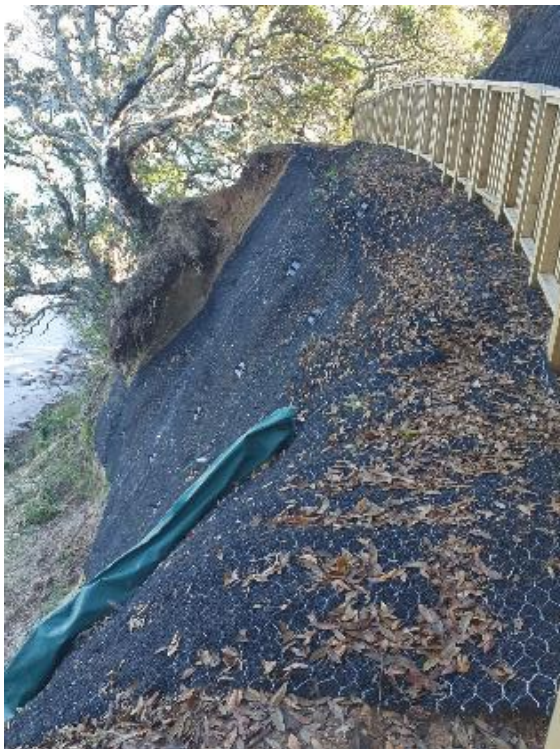
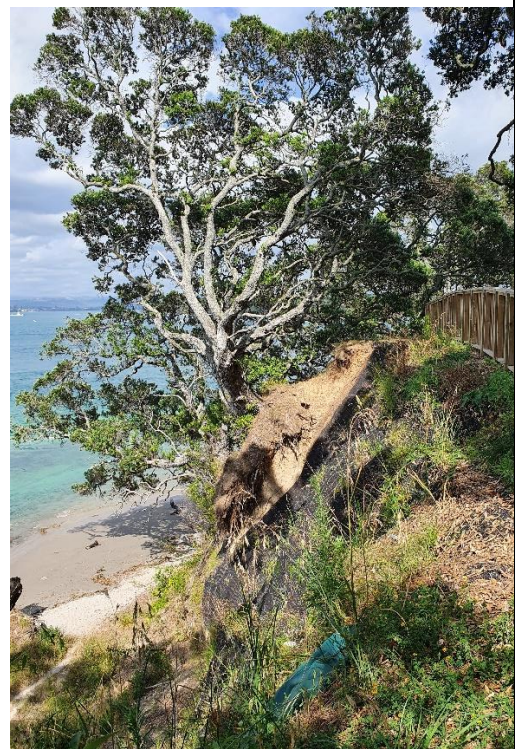
View of slope looking west. Photograph 5 (left) taken on 02/06/20, compared to Photograph 6, taken on 14/01/21.

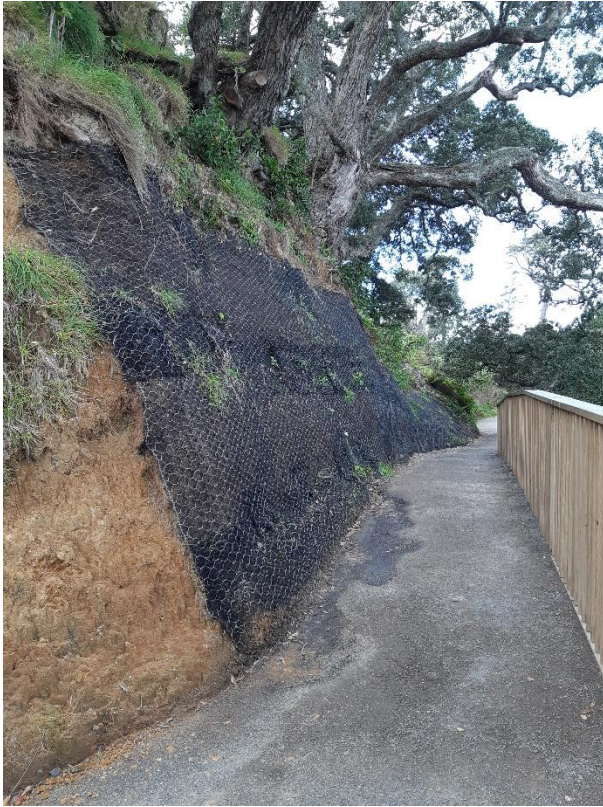
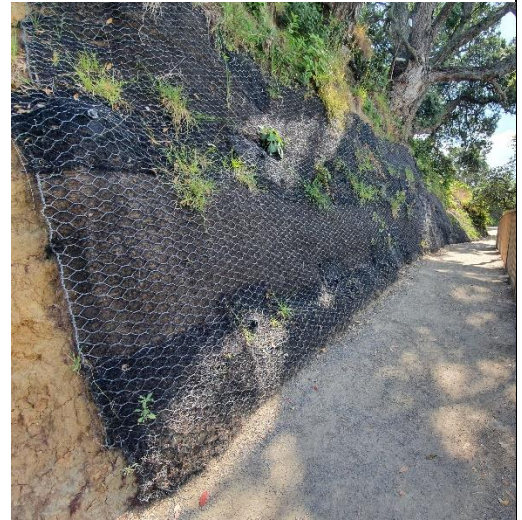
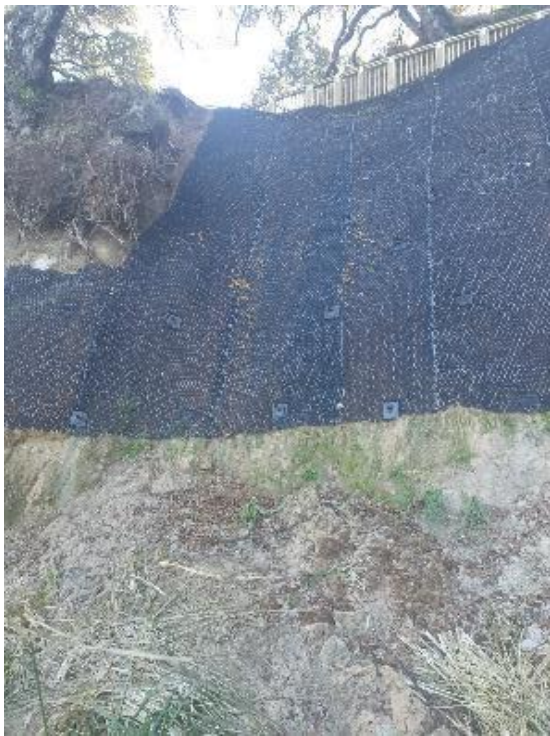
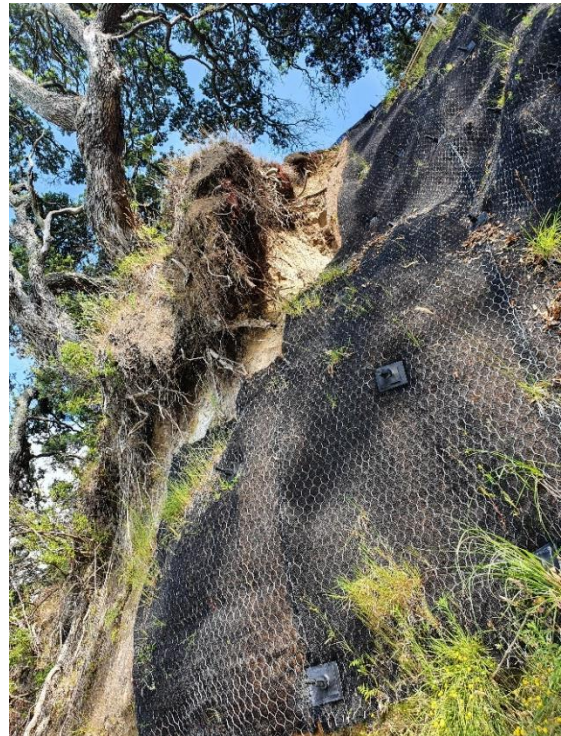
Photographs 7 - 10

Photograph 7 (top left, taken on 27/08/20) and Photograph 8 (top right, taken on 14/01/21) showing the minor amount of scouring that occurred below horizontal drain 3 during the month of September. Photograph 9 (bottom left) and Photograph 10 (bottom right) show that scour has gradually occurred since the beginning of monitoring to the present.

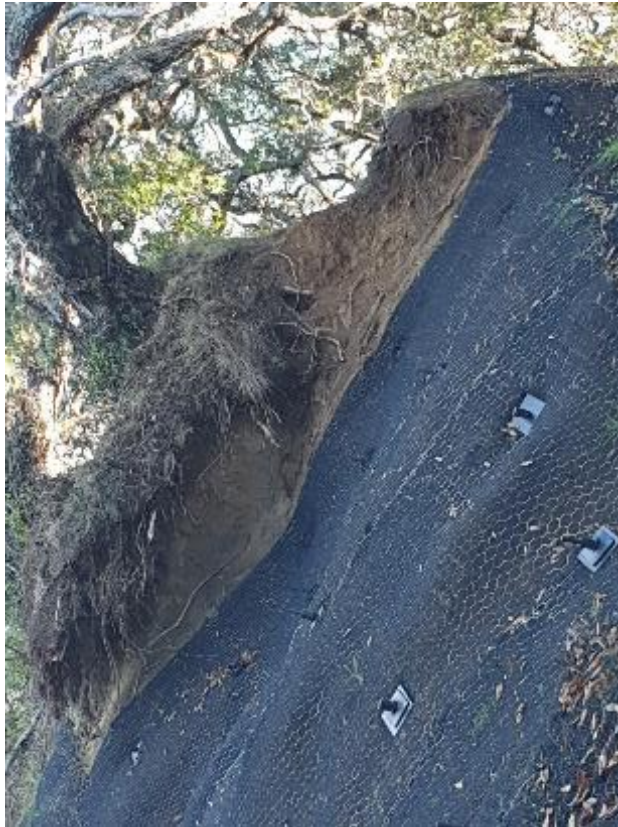
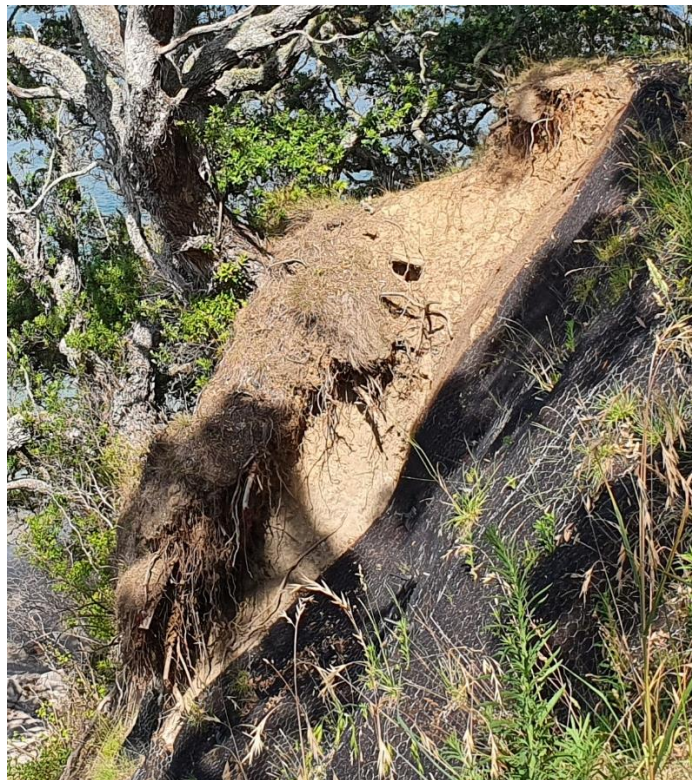
Photographs 11 - 12

- A minor amount of erosion around the Pohutukawa tree at the western edge of the slip has occurred since we started monitoring in June 2020. Pohutukawa stabilisation works are planned to being in April 2021.

Photograph 11 (top), taken on 02/06/20) and Photograph 12 (bottom, taken on 14/01/21).
Looking west across slip face towards the Pohutukawa tree.

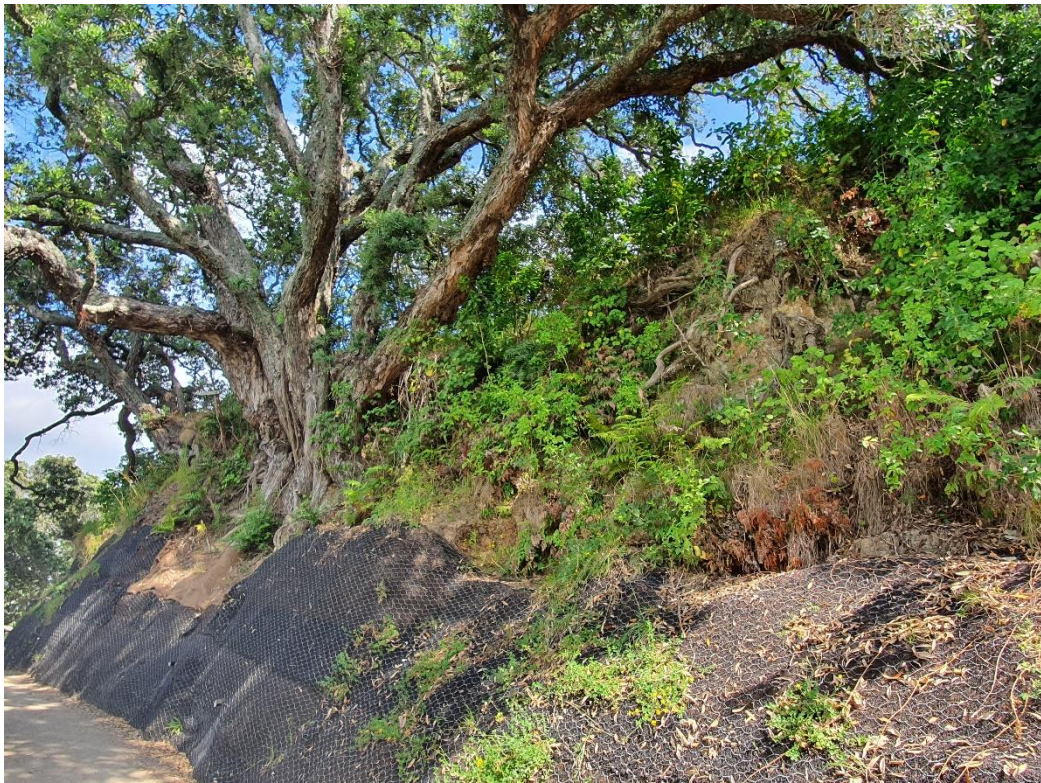
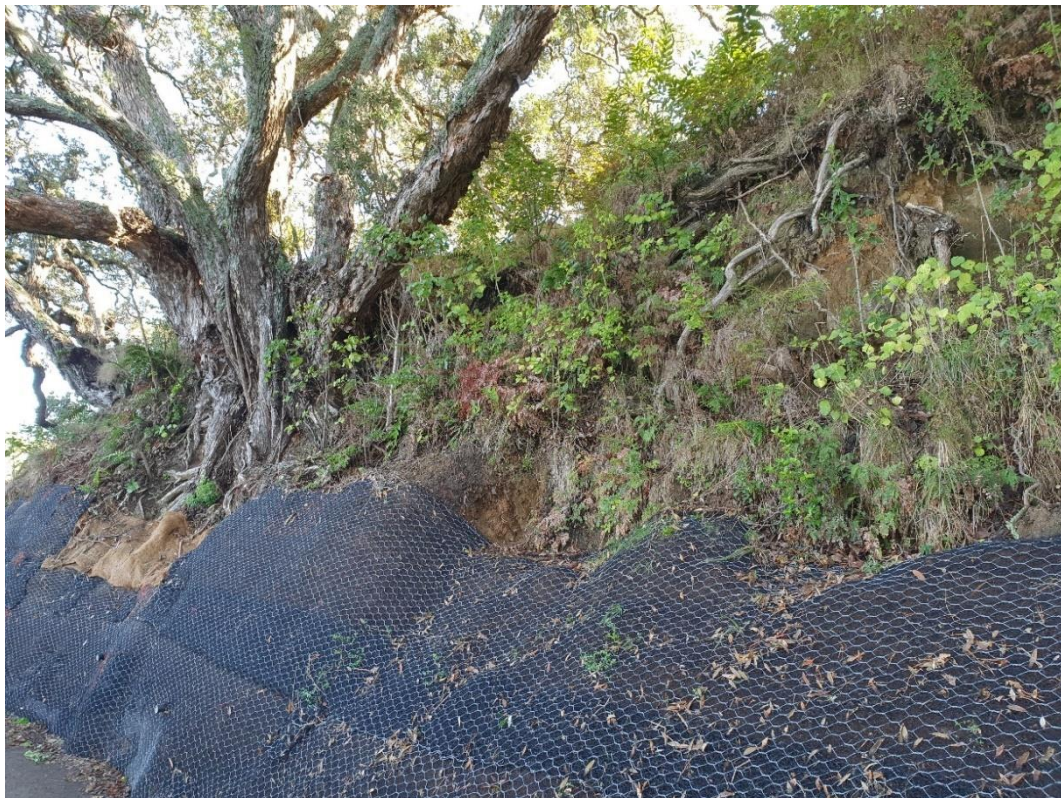
Photographs 13 & 14

Photograph 13 (top, 02/06/20) and Photograph 14 (bottom, 14/01/21) – slope above track.

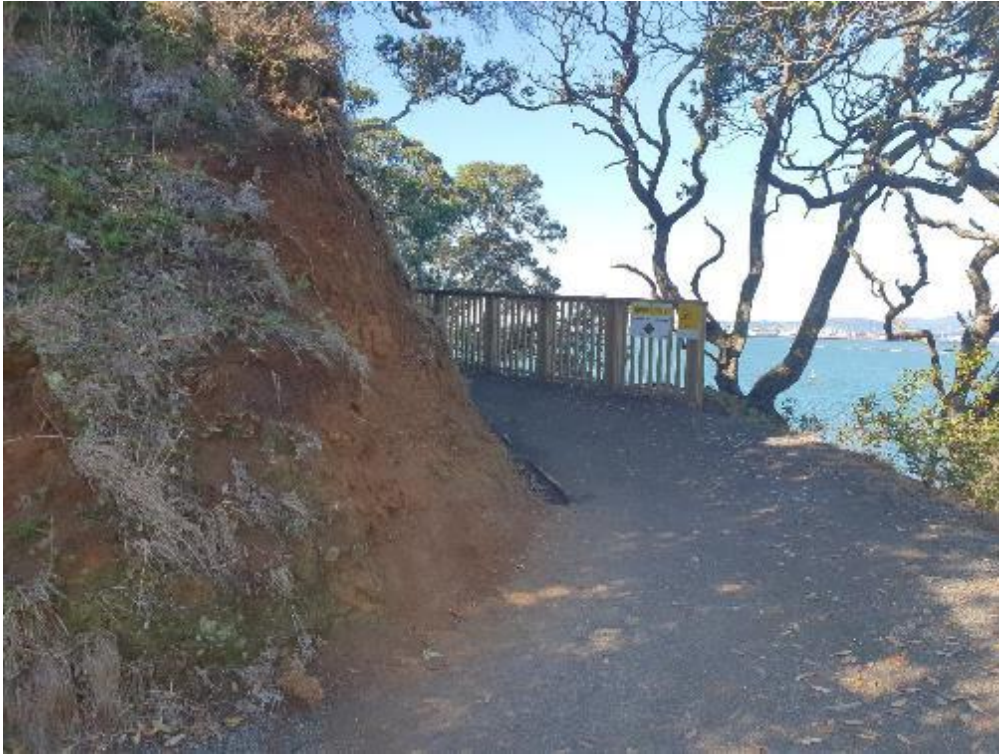
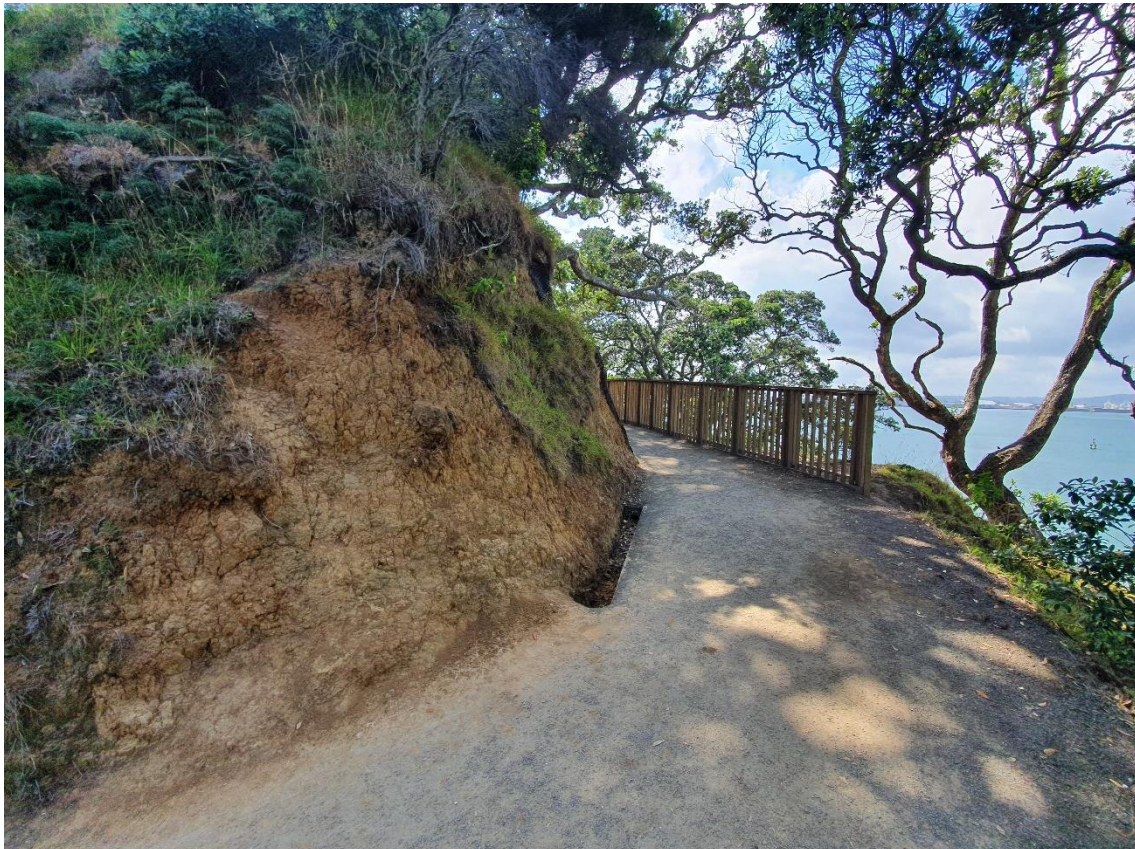
Photographs 15 & 16

Photograph 15 (top, 02/06/20) and Photograph 16 (bottom, 14/01/21). Looking towards the track from the western end.

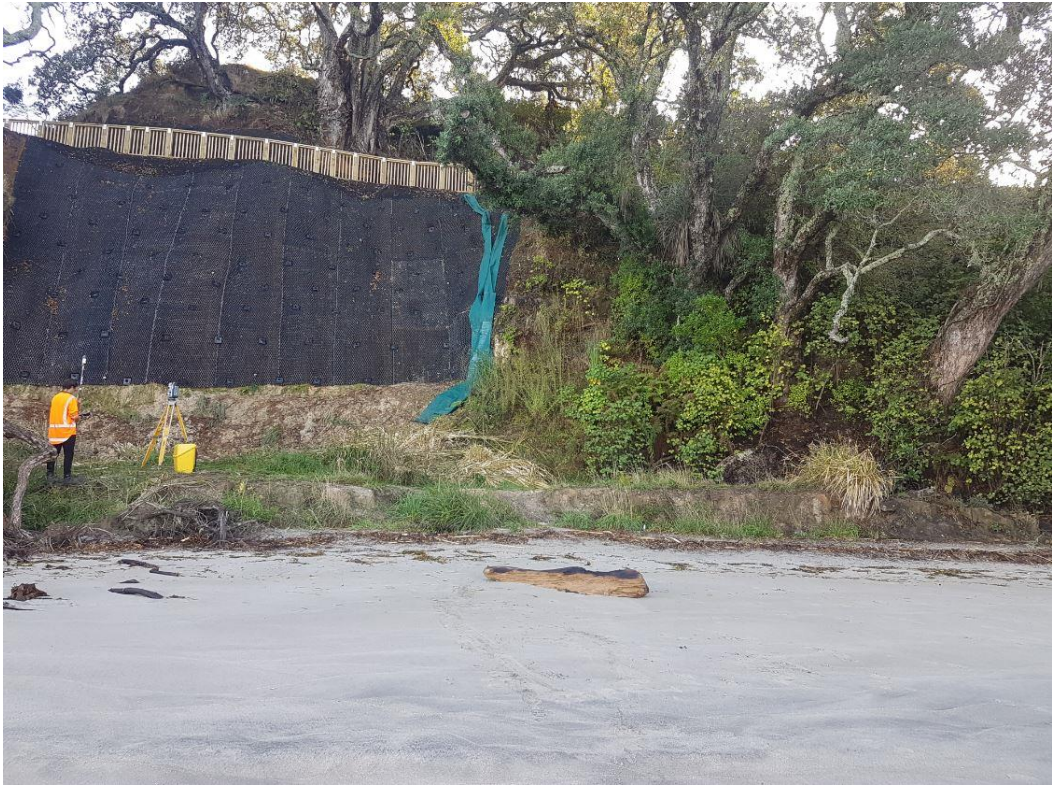
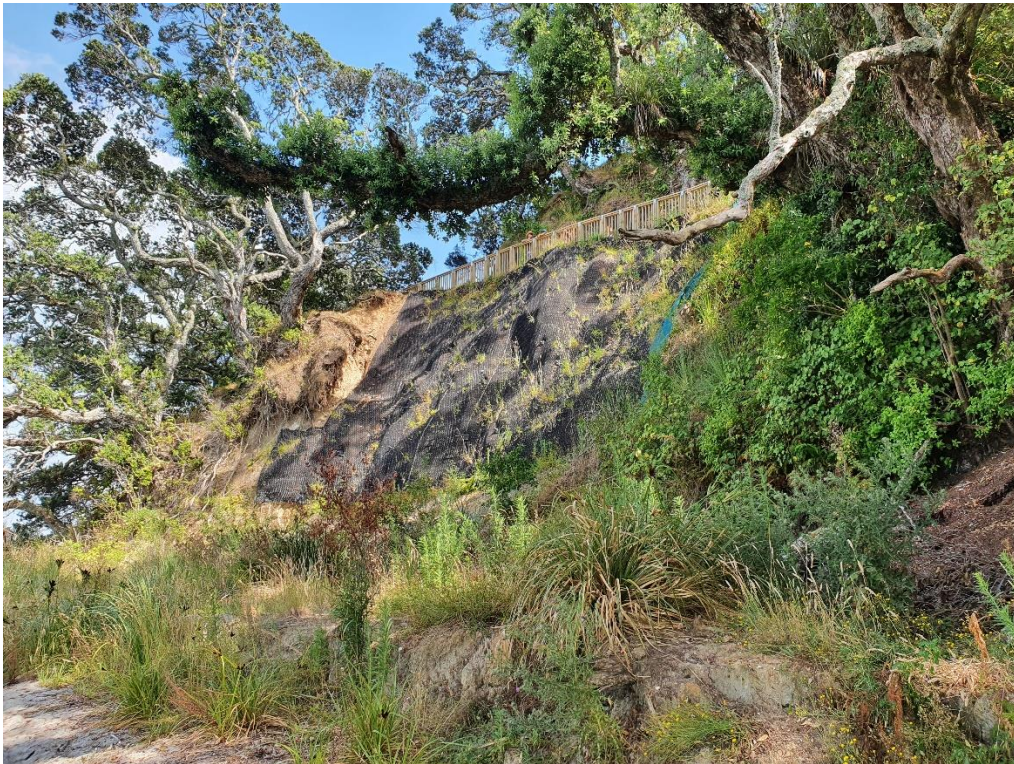
Photograph 17 & 18

- On the slip scarp itself there were no signs of soil nail deformation / movement.
- The grass covering growing through the coconut mat has increased.

Photograph 17 (top, 01/06/20) and Photograph 18 (bottom, 14/01/21). Looking up to the slip face.

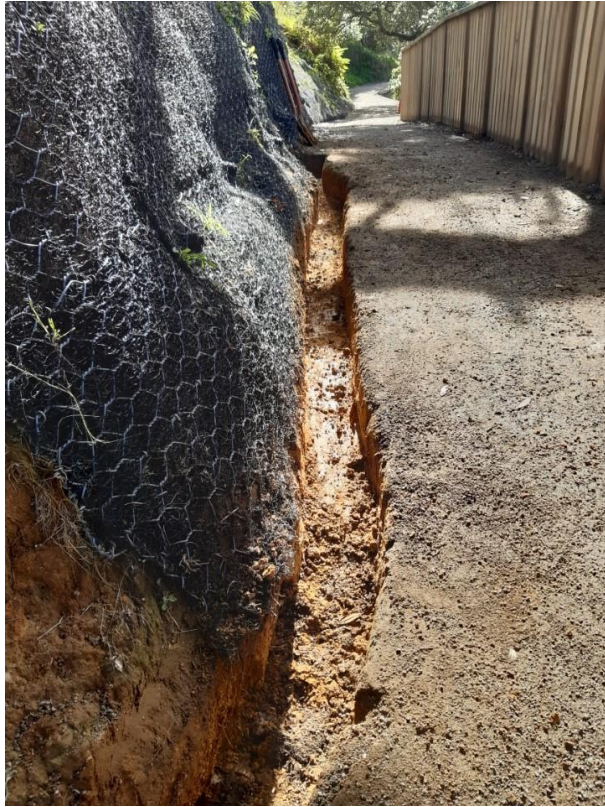
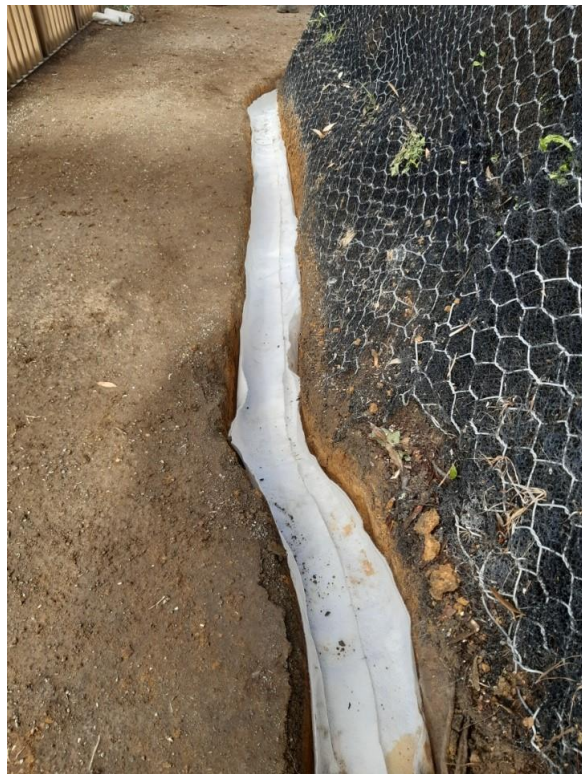
Photograph 19 & 20

Photograph 19 (top) and Photograph 20 (bottom). Drain install detail below HD03 on 09/11/20

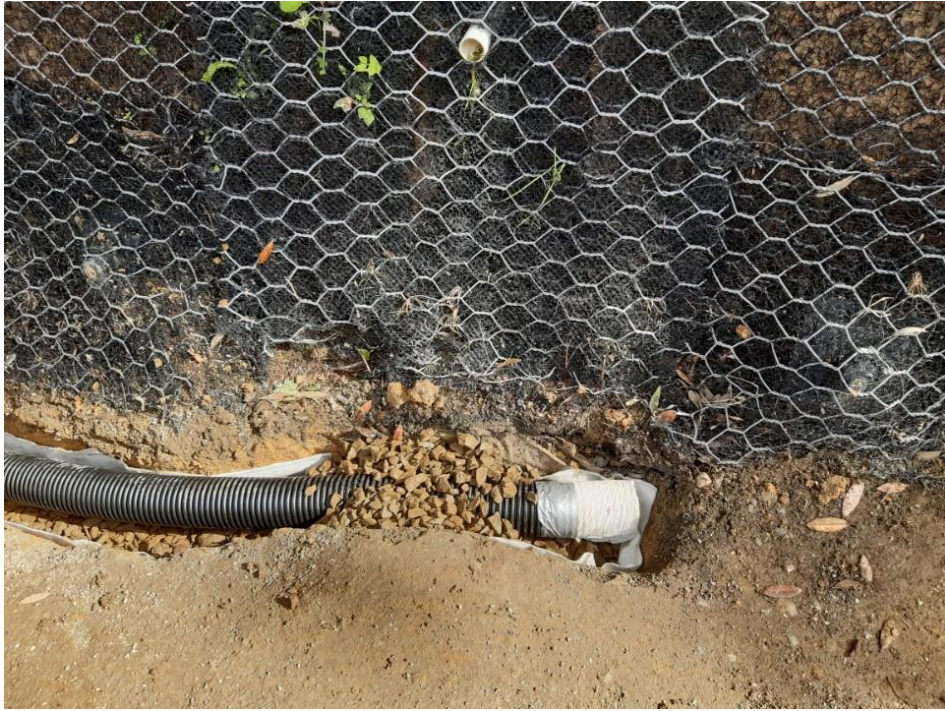
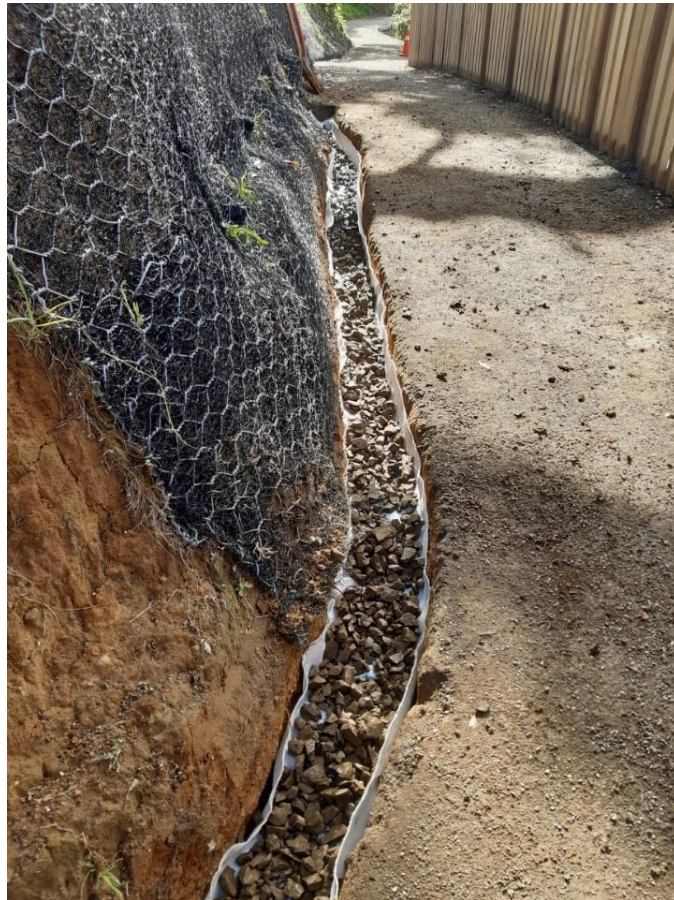
Photograph 21 & 22

Photograph 21 (top) and Photograph 22 (bottom). Drain install detail below HD03 on 09/11/20
