# SITE VISIT RECORD

Contract: Mauao Base Track Geotechnical Monitoring

Inspection No: 5

Day & Date of Visit: 28/09/20

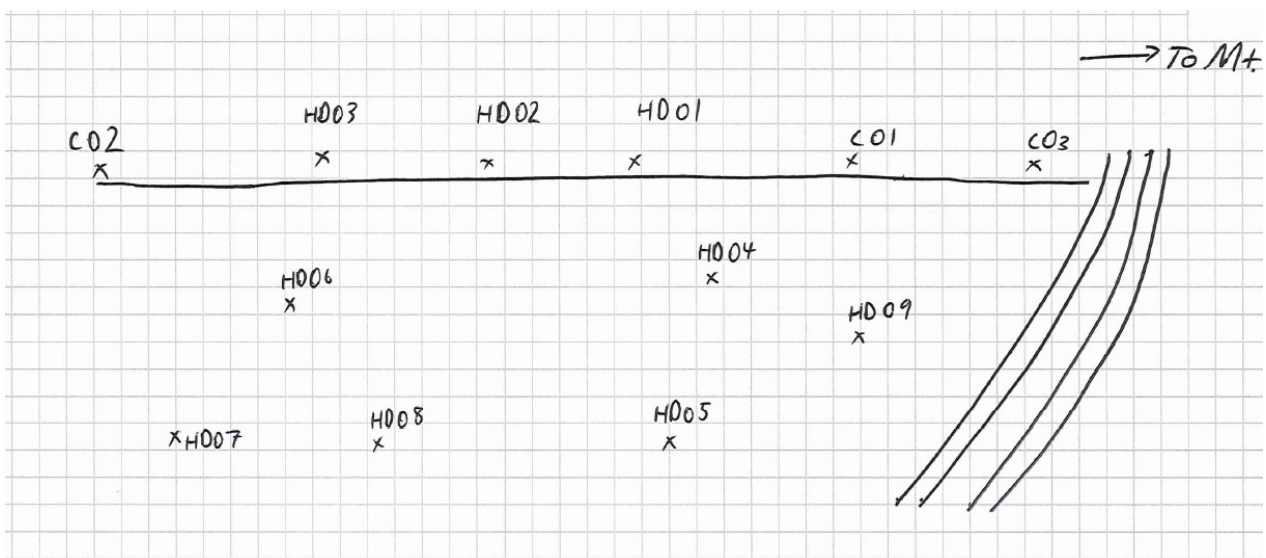
Figure 1 - diagram of site

- Horizontal drains HD01 - HD03 (Figure 1) on the slope above the repaired track were checked. There was a steady stream of water coming out of HD01 (Photograph 10). Horizontal drain 02 was dripping at a rate of about 1 drip per second (Photograph 11). Horizontal drain 03 had a steady stream of water (Photograph 12) flowing out of it. A small amount of algae indicated that water flow from the drain has been relatively constant.
- The scour around drain HD03 appeared to be in the same or similar condition as when last checked on 28/08/20; the slope around the drain was wet and weak. A minor amount of erosion has occurred. It was difficult to assess how much of the slope was affected due to the geogrid covering. Recommendations regarding this issue are outlined below.
- At the bottom of the slope HD05 and HD07 were both dripping steadily, while HD04, HD06, HD08 and HD09 were not dripping.

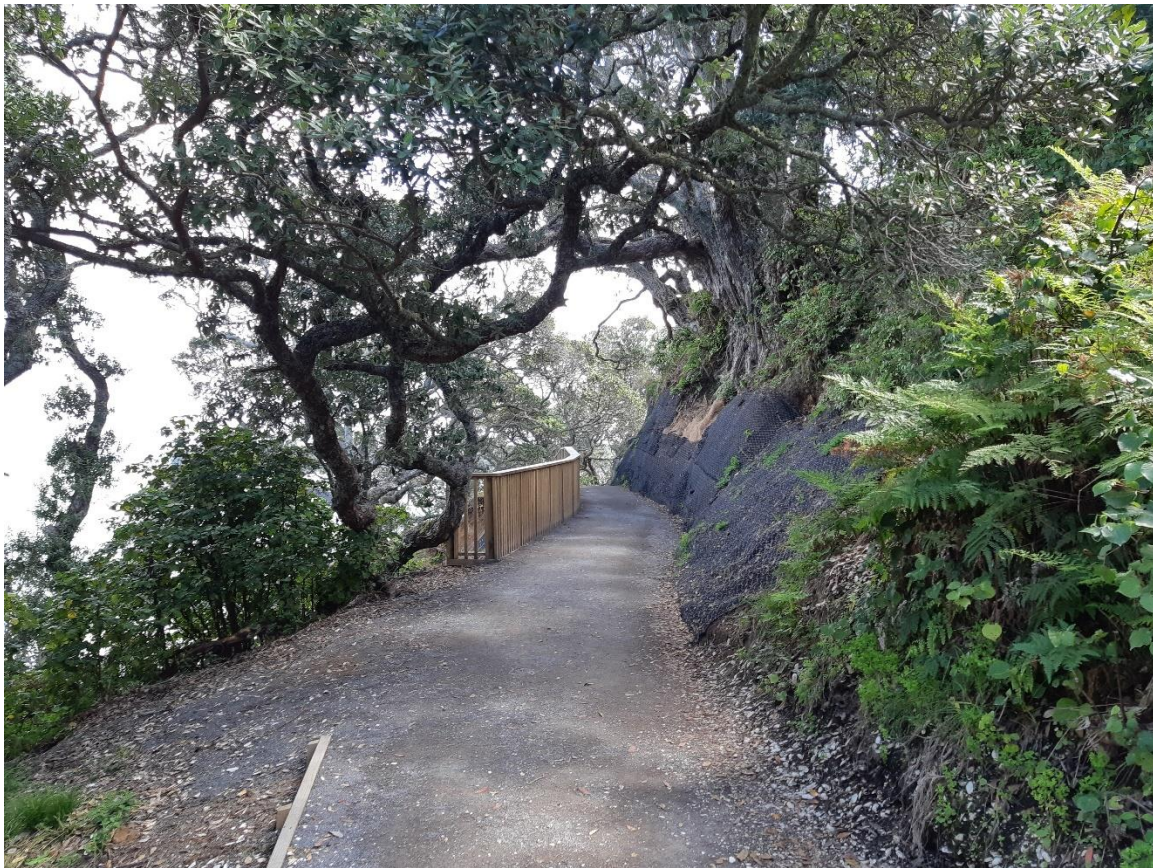
Photograph 1 & 2

Photograph 1 (top, taken on 02/06/20) compared to the most recent visit on 28/09/20 -  
At the start of the track looking west

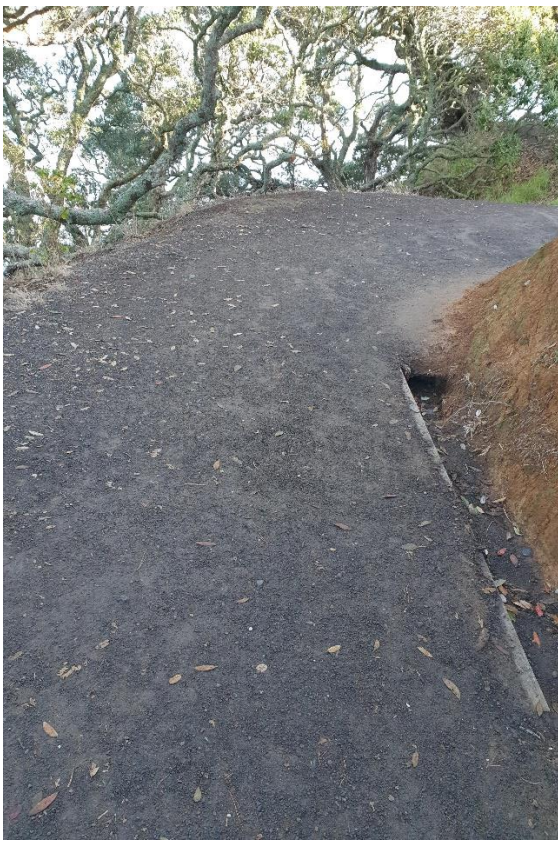
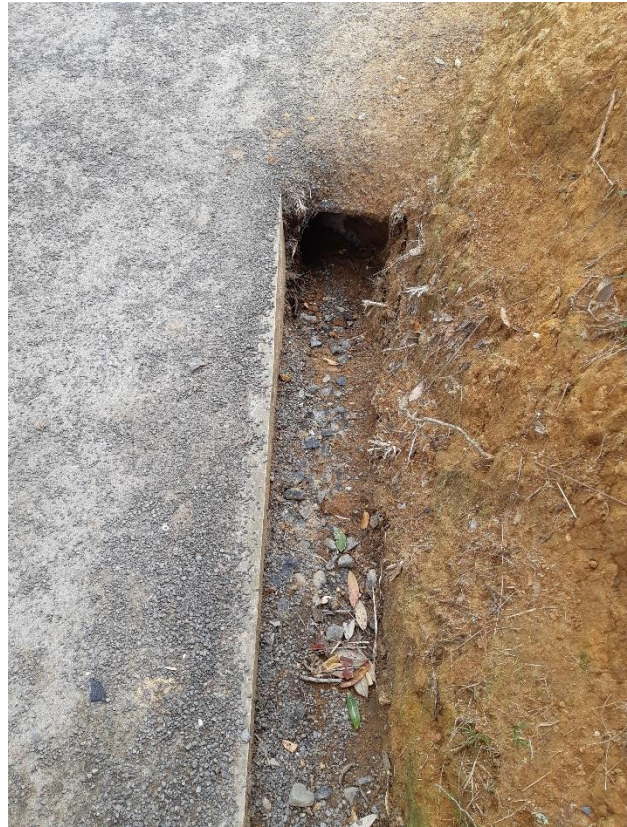
- All grates (Culverts 01 - 03) were clear, with the exception of a covering of leaves (Photographs 3 - 4).

Culvert 02 at west extent of track repair. Photograph 3 (above, left) was taken during the initial inspection on 02/06/20 and Photograph 4 (above, right) taken on 28/09/20.

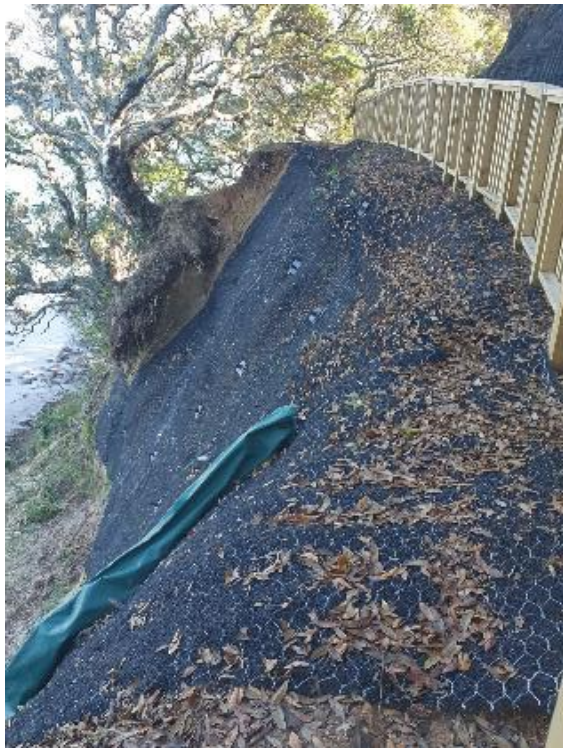
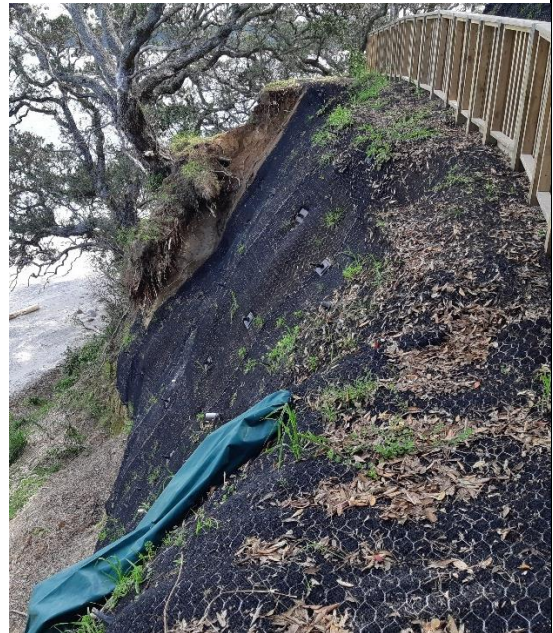
View of slope looking west. Photograph 4 (left) taken on 02/06/20, compared to Photograph 5, taken on 28/09/20.

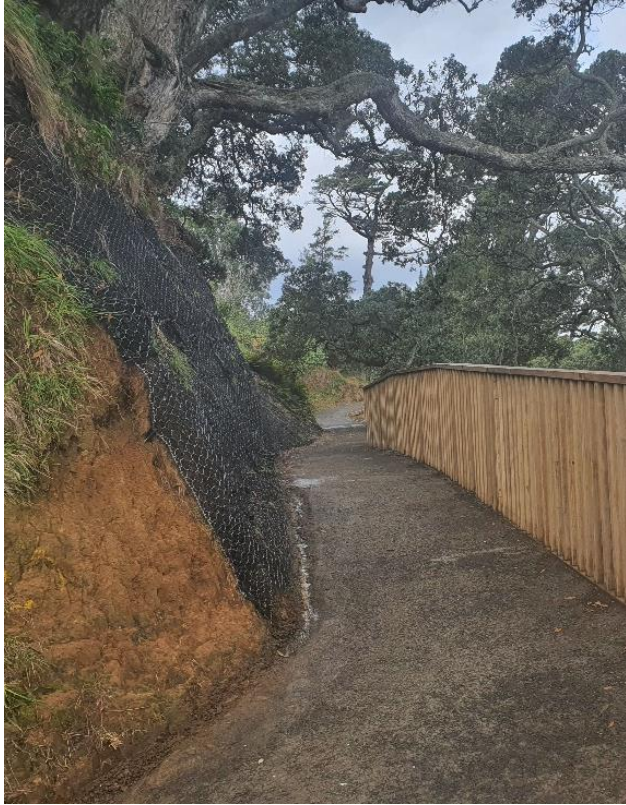
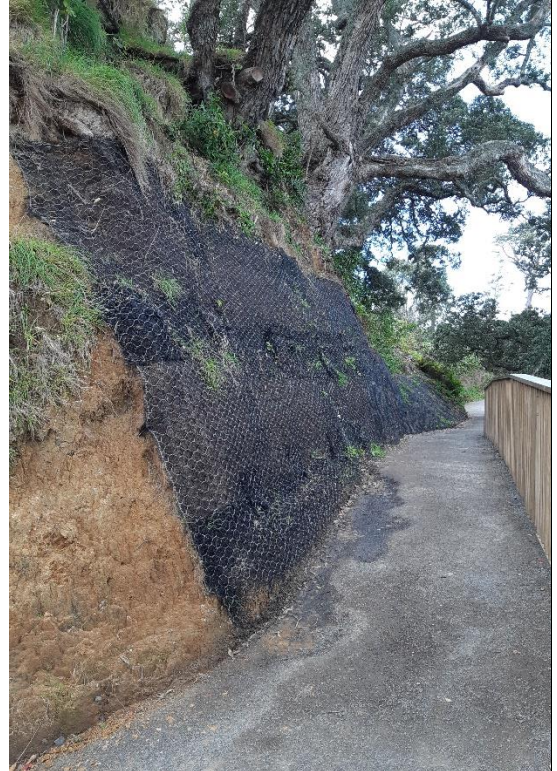
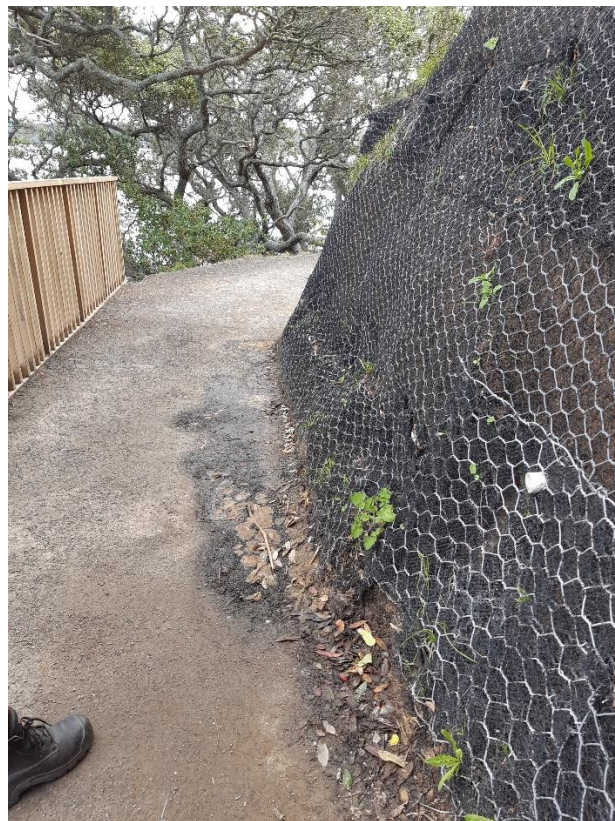
Photographs 7 - 9

- The repaired track was moist after rain on the morning of the 28/09/20. The minor amount of scour is at the western end of the repaired track. This scour occurred sometime during September, as it was not present during the previous site visit on 27/08/20 (Photographs 7 - 9). The scour looks to be associated with drainage from horizontal drain 03 (HD03) (Photographs 7 - 9).
- The scour is likely caused by excess water seeping from the slope around horizontal drain 03. This has been monitored in previous site inspections. This seepage has caused minor erosion of the slope around the end of the drainage pipe (horizontal drain 03).
- Recommendations for the remediation of this scour and erosion are presented in the recommendations section below.

Photograph 7 (top left, taken on 27/08/20) and Photograph 8 (top right, taken on 28/09/20) showing the minor amount of scouring that has occurred below horizontal drain 3 during the month of September. Photograph 9 (bottom) shows the scour looking west from horizontal drain 3 (28/09/20).

- To remediate the scour and prevent further erosion of the track below horizontal drain 03, we recommend to hand dig a subsoil drain and connect the outlet to the existing culvert located at the western end of the prepare. A detail for this drain is outlined in Figure 2 (attached) and comprises a 100mm drain coil encased in drainage aggregate and bidim geotextile cloth. We have also indicated the extent of the drain required on the attached plan C73.
- In addition, the slope around horizontal drain 03 is seeping more than expected. We need to assess the condition of the slope around the drain to assess whether another horizontal bored drain is necessary at this location. We recommend that the geogrid be pulled back around this area during an additional site visit to assess the condition of the slope.

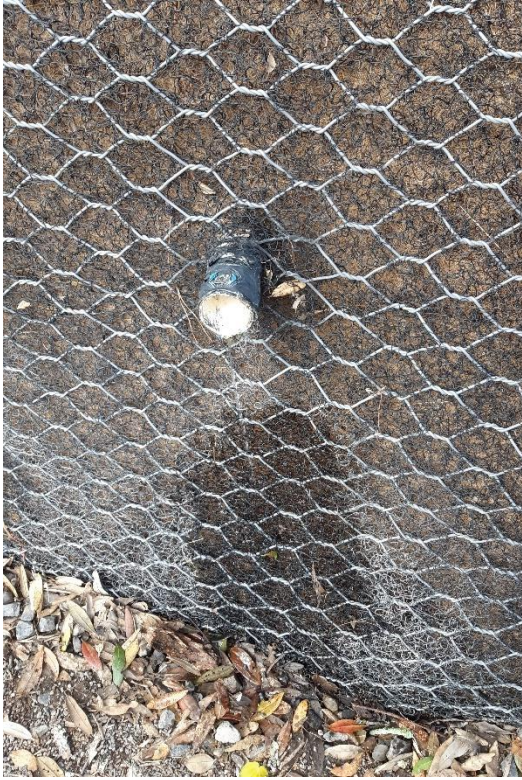
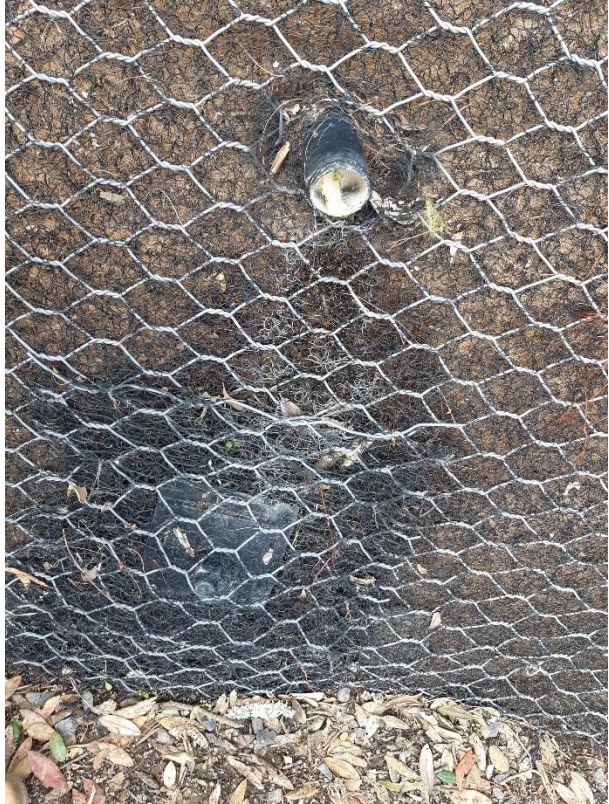
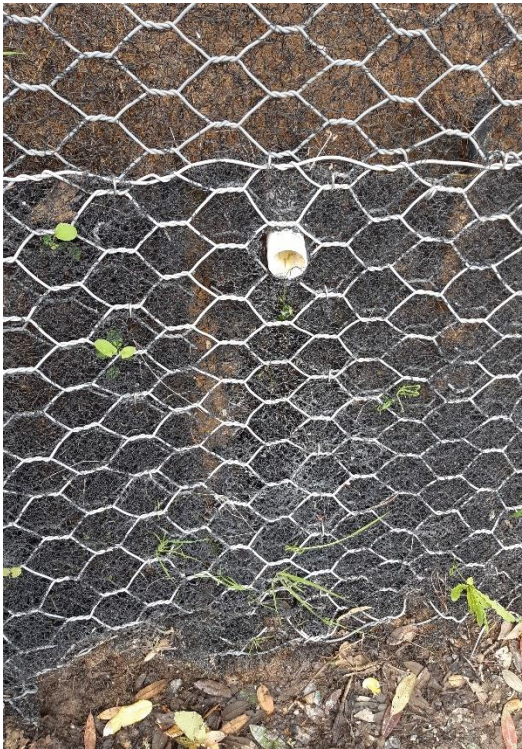
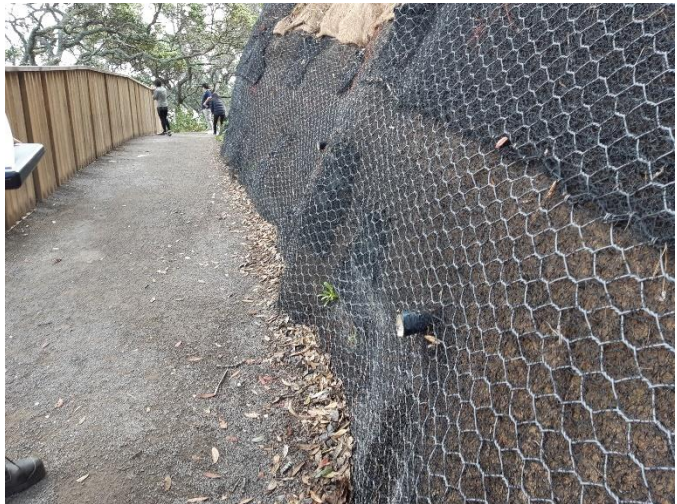
Photographs 10 - 13

Photograph 10 (top left): Horizontal drain 01. Photograph 11 (top right): Horizontal drain 02. Photograph 12 (bottom left): horizontal drain 03. Photograph 13 (bottom right): looking towards the west end of the repaired track from horizontal drain 01. All photos were taken on 28/09/20.

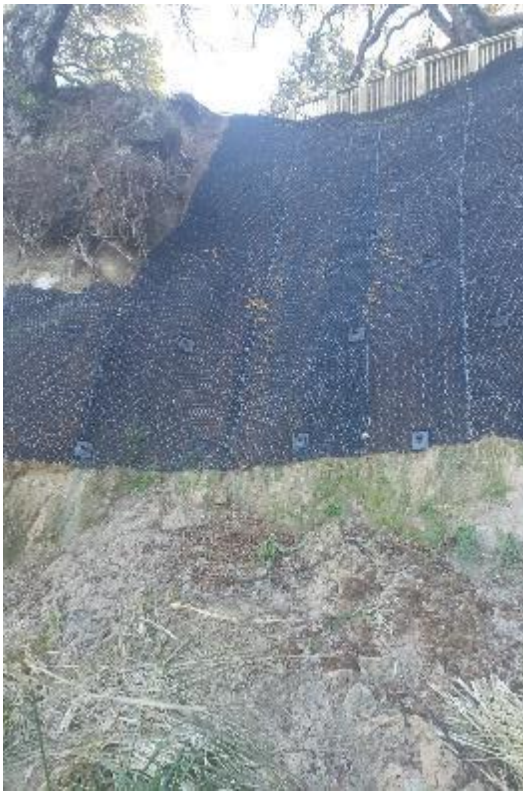
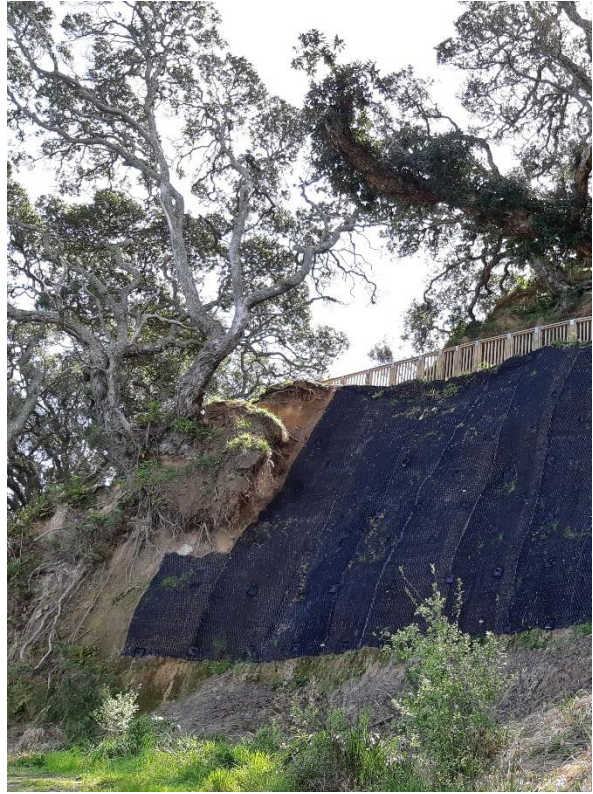
Photograph 14 (left, 02/06/20) and Photograph 15 (28/09/20) - View looking upslope

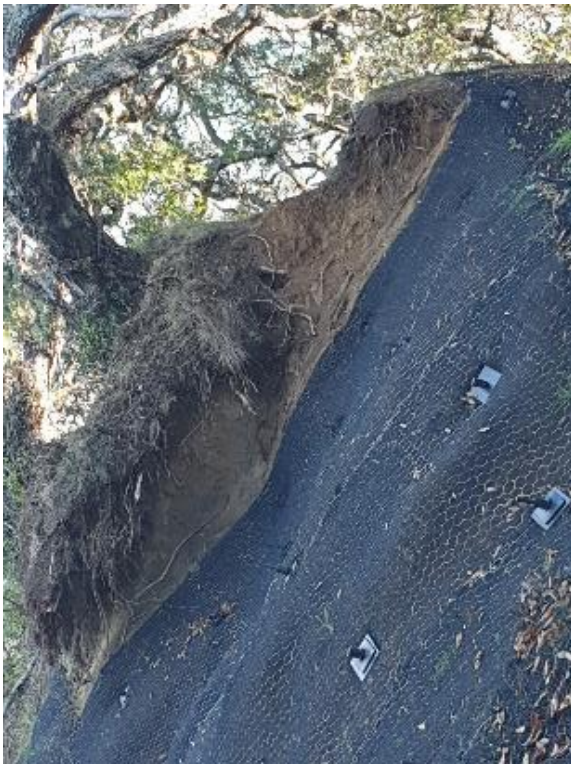
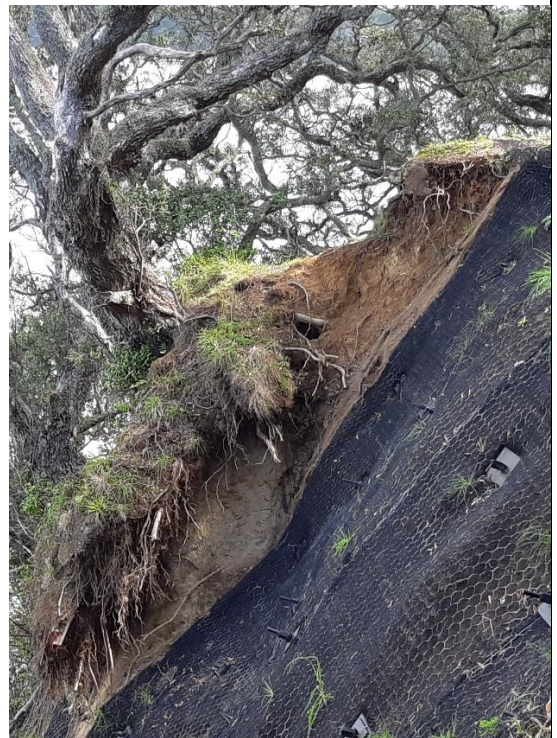
- The minor amount of scour around the roots of the Pohutukawa Tree at the western edge of the slip appears to be stable - erosion of this area has not increased despite recent heavy rain (Photographs 16 - 17).

Photograph 16 (left, taken on 02/06/20) and Photograph 17 (right, taken on 28/09/20).  
Looking west across slip face towards the Pohutukawa tree.

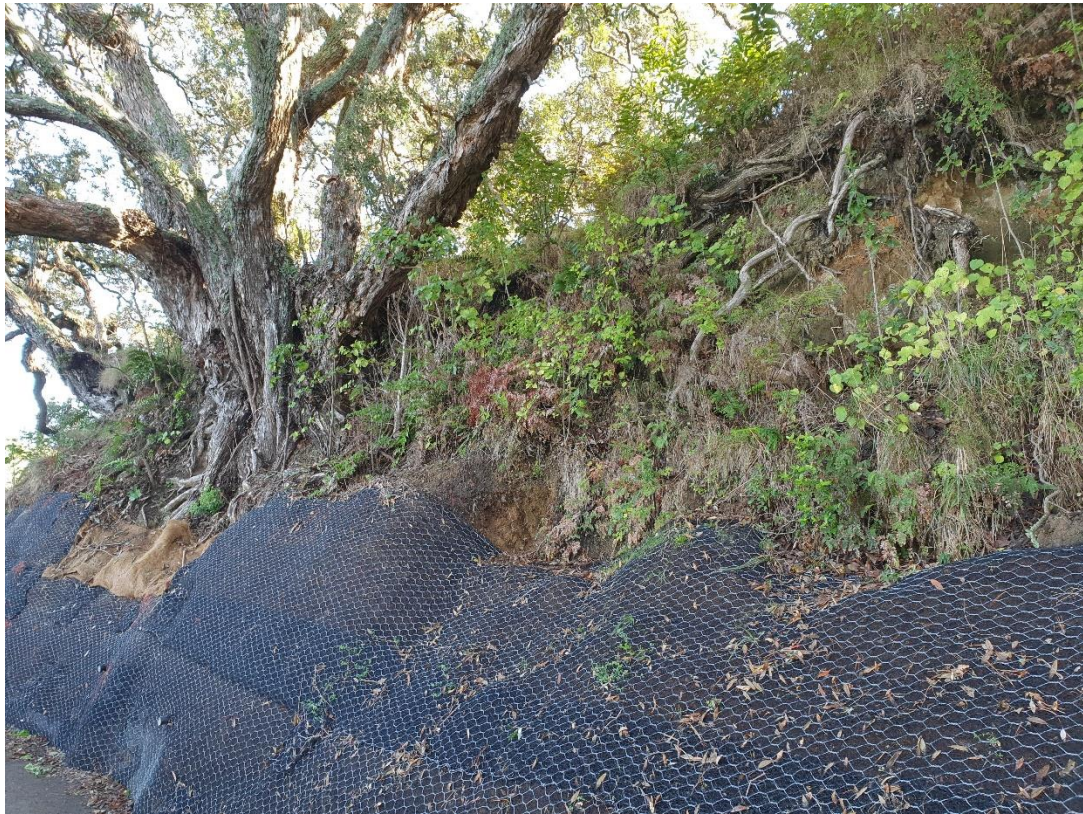
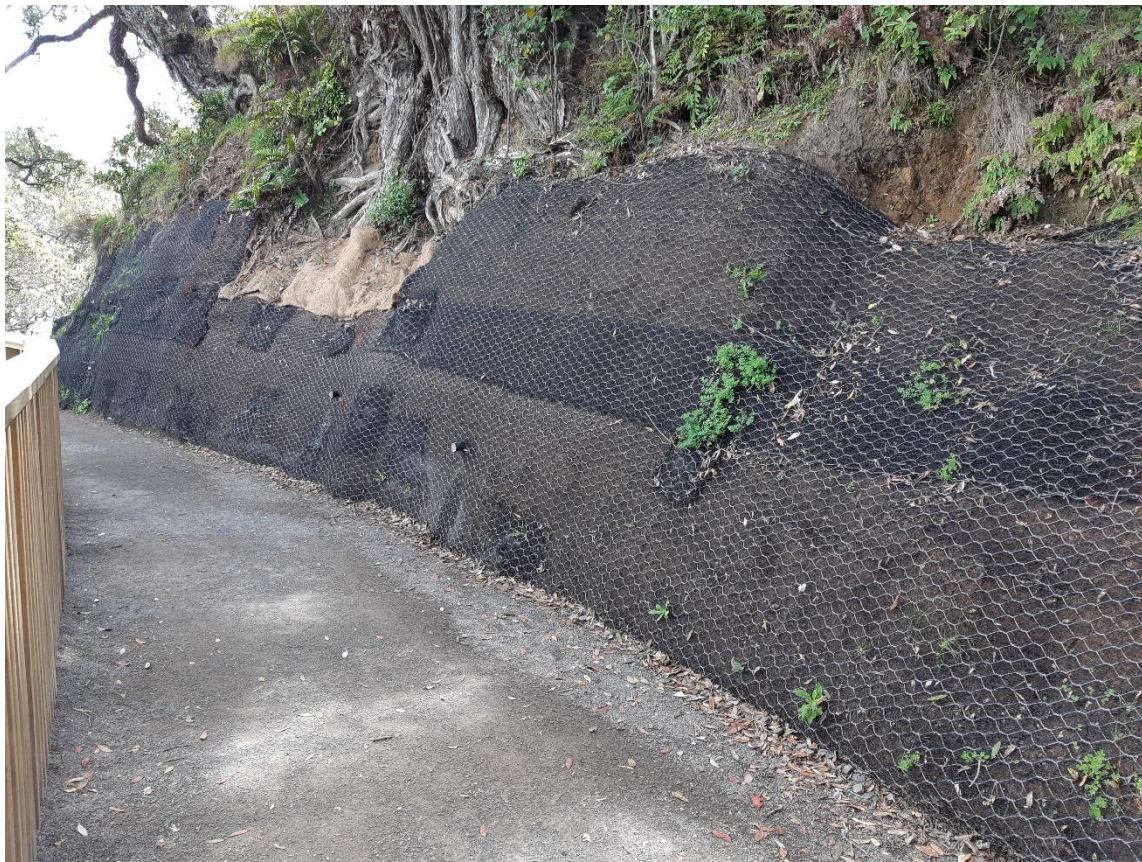
Photographs 18 & 19

Photograph 18 (top, 02/06/20) and Photograph 19 (bottom, 28/09/20) - slope above track.

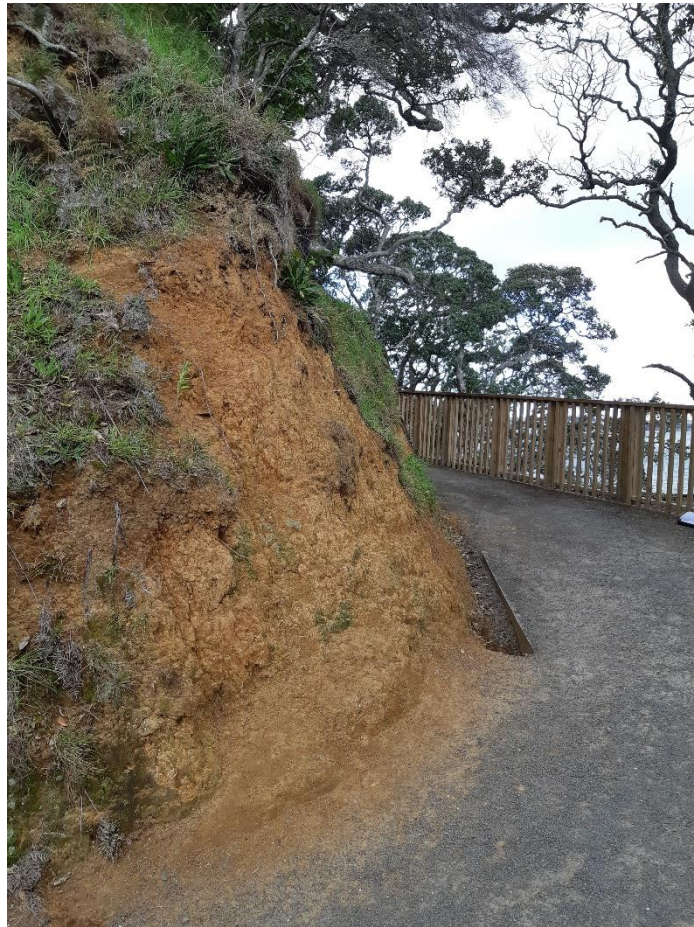
Photographs 20 & 21

Photograph 20 (top, 02/06/20) and Photograph 21 (bottom, 28/09/20). Looking towards the track from the western end.

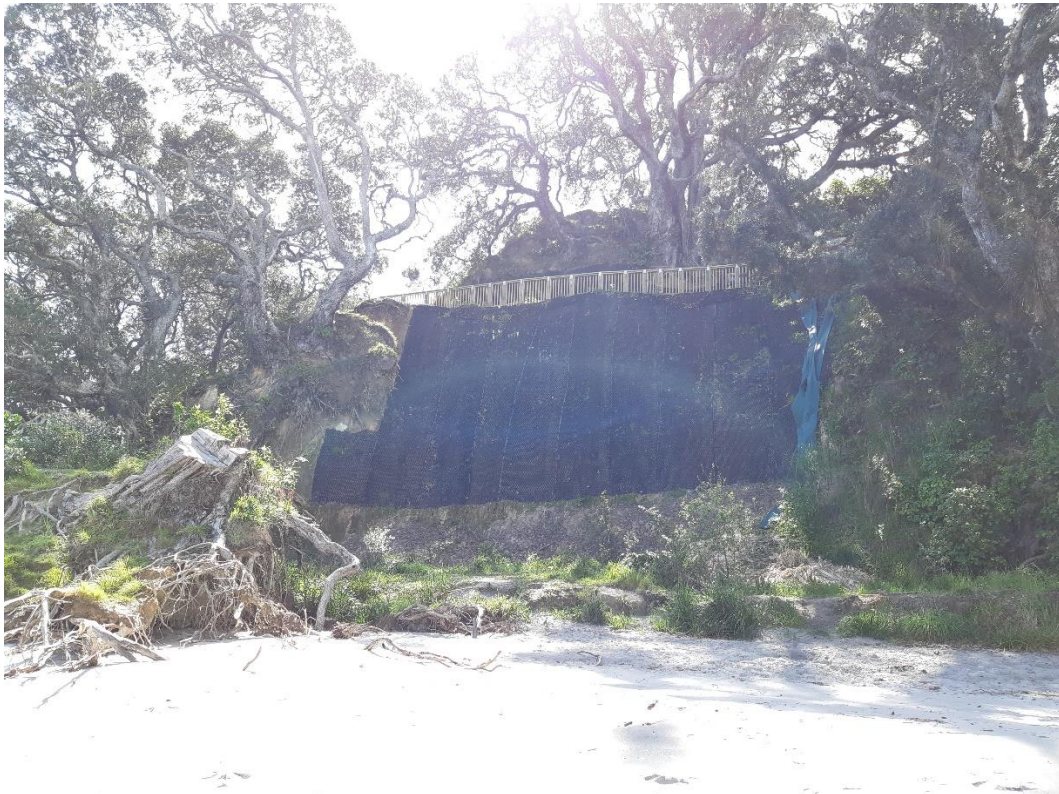
Photograph 22 & 23

Photograph 22 (top, 01/06/20) and Photograph (bottom, 29/06/20). Looking up to the slip face.
