# SITE VISIT RECORD

Contract: Mauao Base Track Geotechnical Monitoring

Inspection No: 4

Work Site: Mt Maunganui Base Track

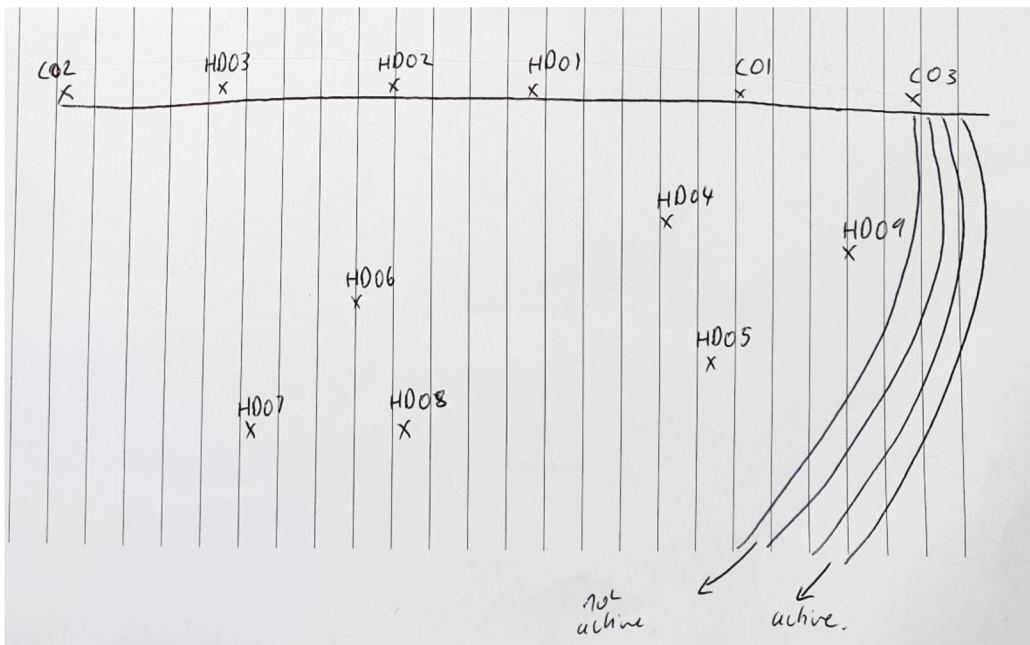
Figure 1 - diagram of site

- Refer to Figure 1 for locations of drains / culverts.
- The track condition was overall in the same condition as the previous visit on 02/08/20, with the exception of minor ponding on the track slightly east of the slip (Photograph 1), and drain clearing around Culvert 02 (Figure 1, Photograph 2).
- The culvert at the western end of the track has been dug out recently (Photograph 2) as recommended in the previous site inspection. This will allow better flow through the culvert.
- Overall, the drainage system appears to be performing well. Water is being efficiently drained from the slope above the track to the culvert beside the track. The green filter socks collecting this water at the base of the slip were draining efficiently.
- Photos from this inspection and the first inspection (02/06/20) are compared to monitor changes in the attached site photographic record.

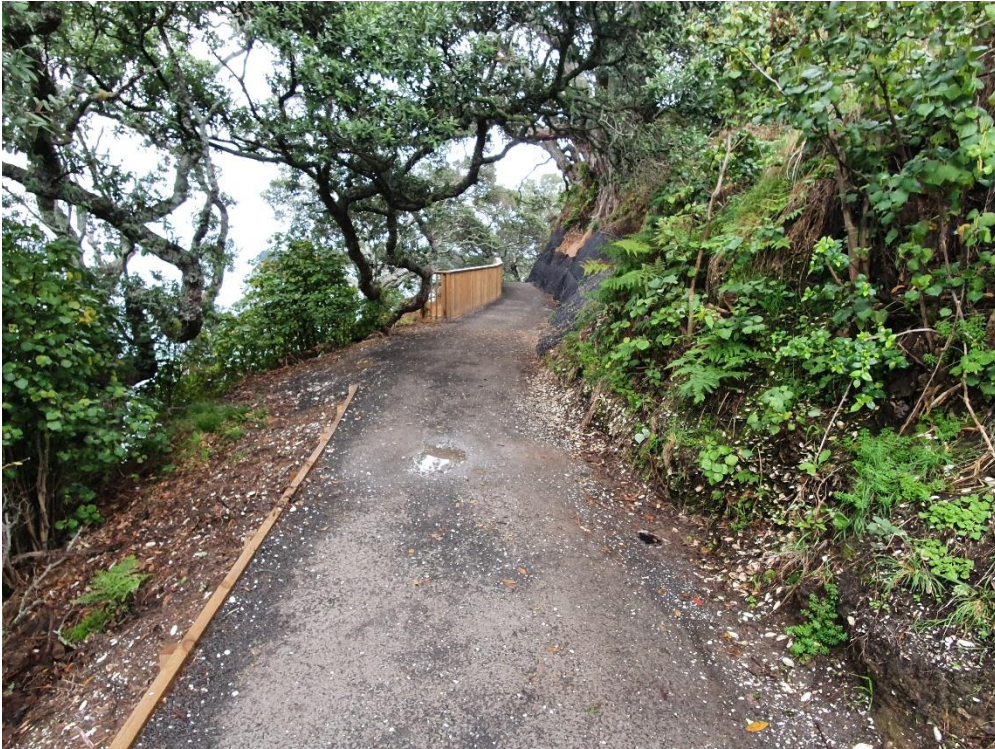
- The repaired track was moist, while the drain running below the cut slope was wet, showing that water is being efficiently collected in the culvert and not accumulating on the track. No ponding was observed except for minor amount just to the east of the slip on the repaired track (Photograph 01).
- The geometry of the track still has a reverse grade to the swales that lead to the culvert inlets. No cracking or deformation was observed on the track.
- There were no changes to the slope above the repaired track, with the exception of the small amount of erosion occurring around horizontal drain 3 (HD03, Figure 1). The level of erosion around this pipe has not changed since the last site inspection on 02/08/20.

Photograph 1 - At the start of the track looking west - minor ponding on the track.

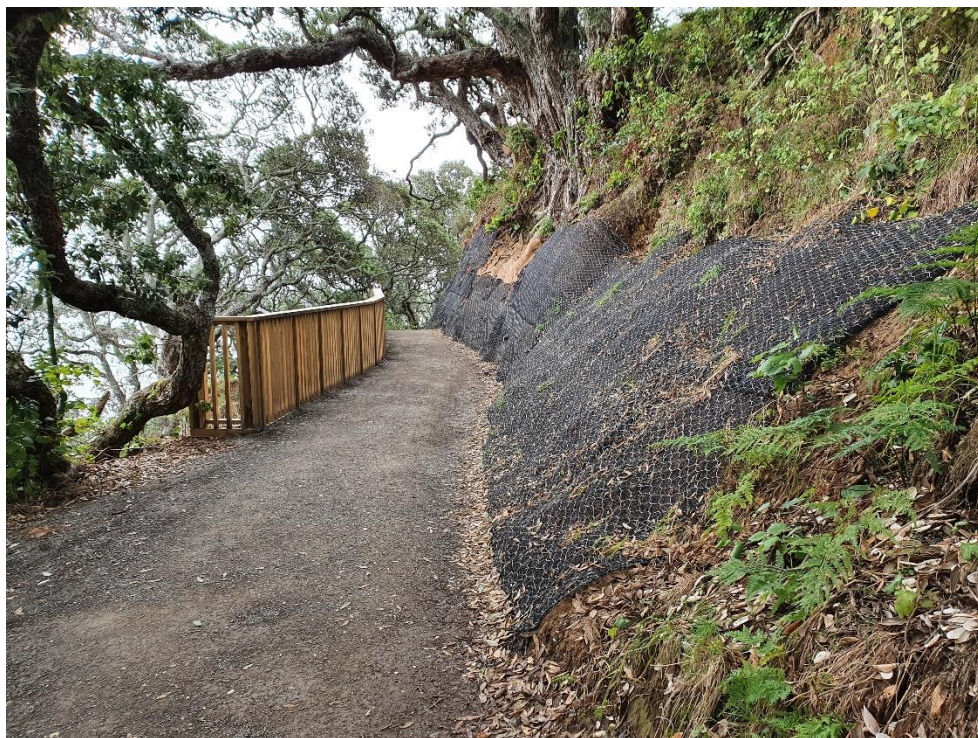
At the start of the track looking west. Photograph 1 (top) was taken on 27/08/20. Photograph 2 (bottom photo) was taken during the first inspection on 02/06/20.

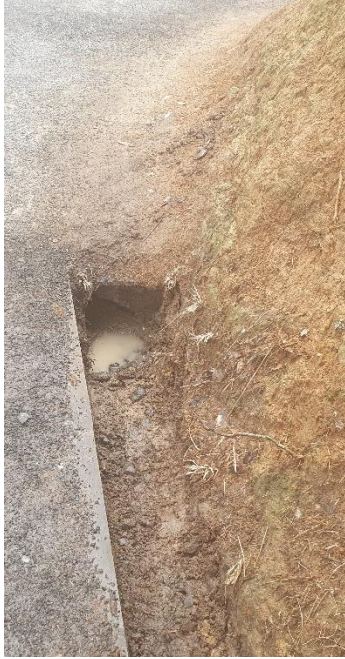
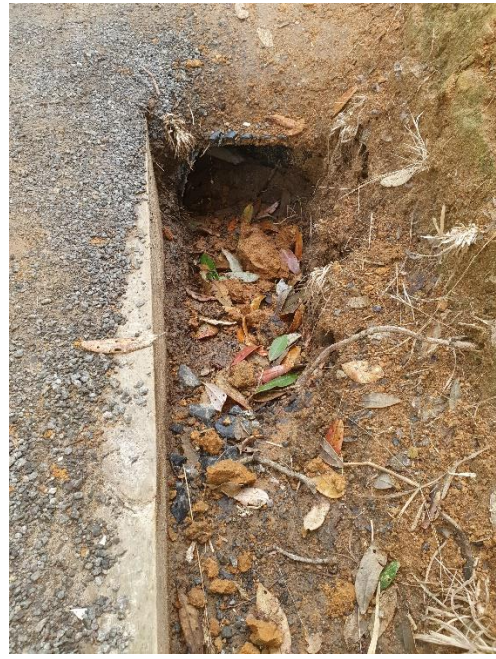
- All drains appear to have been cleared recently, most likely following heavy rain on the 23rd August. Culvert 02 has been cleared of silt material that was observed in previous site visits. All grates entering the culverts were clear.

Photograph 3 (top left, taken on 27/08/20) and Photograph 4 (top right, taken 02/08/20) showing Culvert 02 (C02, Fig. 1).

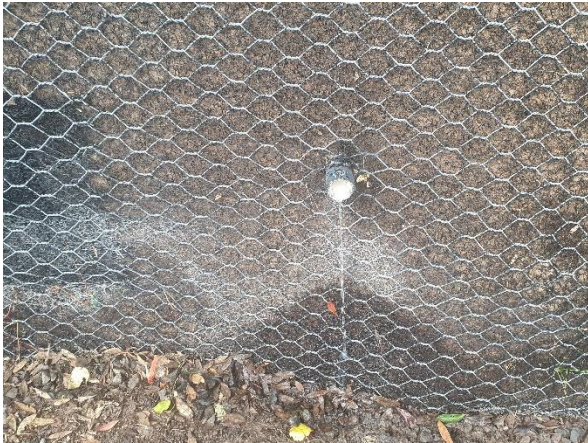
- Horizontal drains HD01 - HD03 (Figure 1) on the slope above the repaired track were checked. There was a steady stream of water coming out of HD01

Photograph 5 (left): Water steadily flowing from horizontal drain 01 (HD01). Photograph 6 (right) horizontal drain 02 (HD02) dripping steadily.

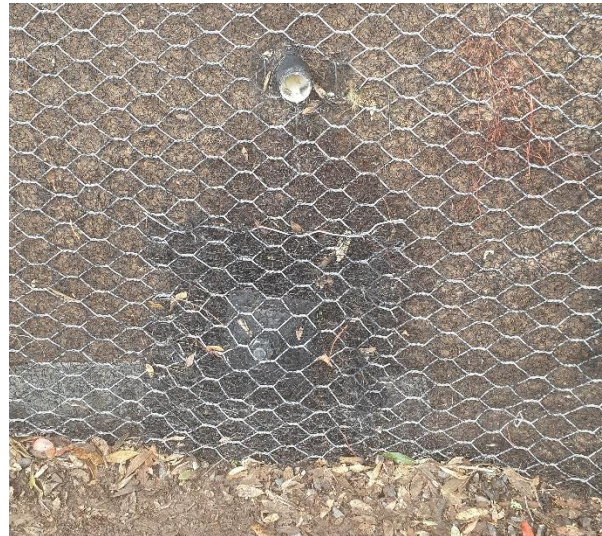
(Photograph 5). Horizontal drain O2 and O3 (HD02 and HD03, Figure 1) were both dripping / streaming steadily (Photographs 6 - 8).

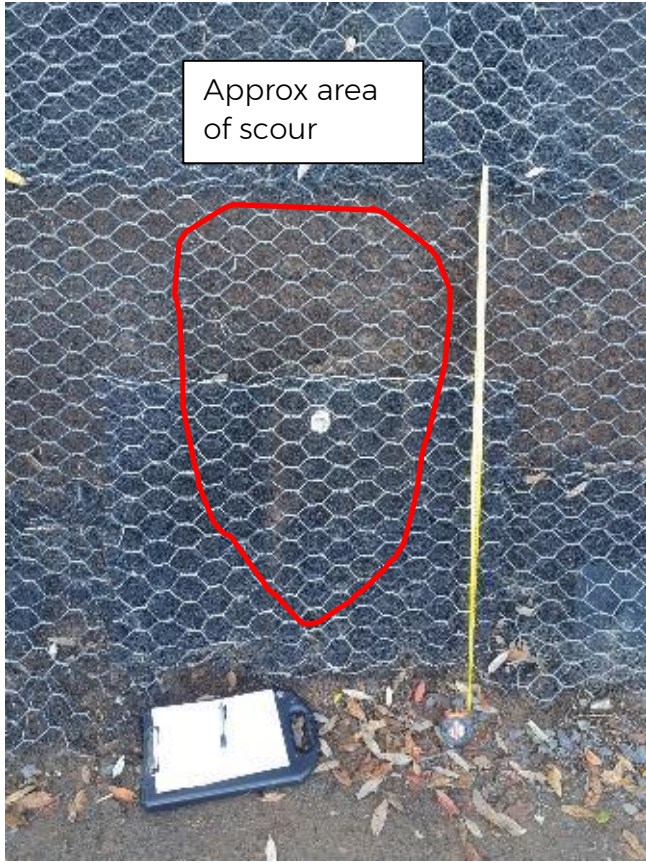
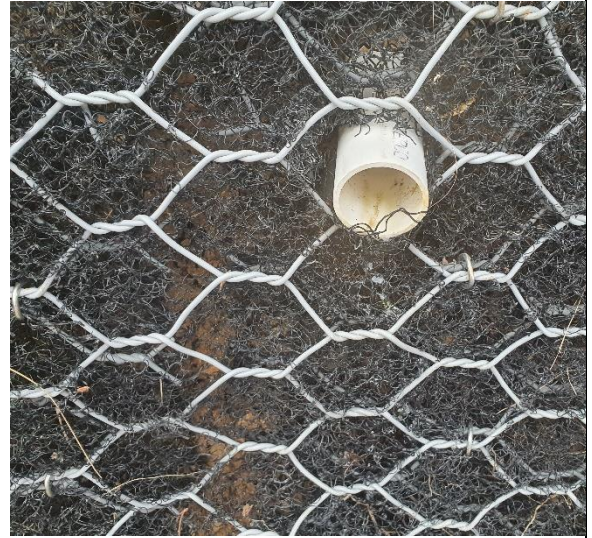
- The scour around drain HD03 appeared to be in the same or similar condition as when last checked on 02/08/20. We will continue to monitor and will complete a site visit next month to determine whether the geogrid needs some extra pins so that it is attached to the soil face (preventing further erosion).
- At the bottom of the slope HD05 and HD07 were both dripping steadily, while HD04, HD06, HD08 and HD09 were not dripping.

Photograph 7 (above left) horizontal drain 03 (HD03) and approximate area of scour associated with it. A zoomed in picture of the drain is shown in Photograph 8 (above right).

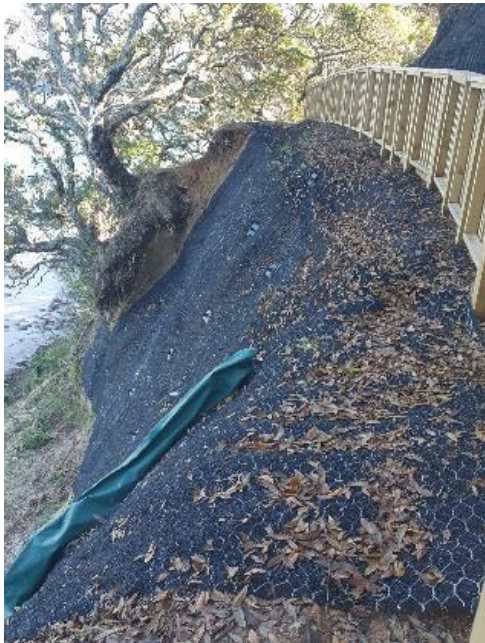
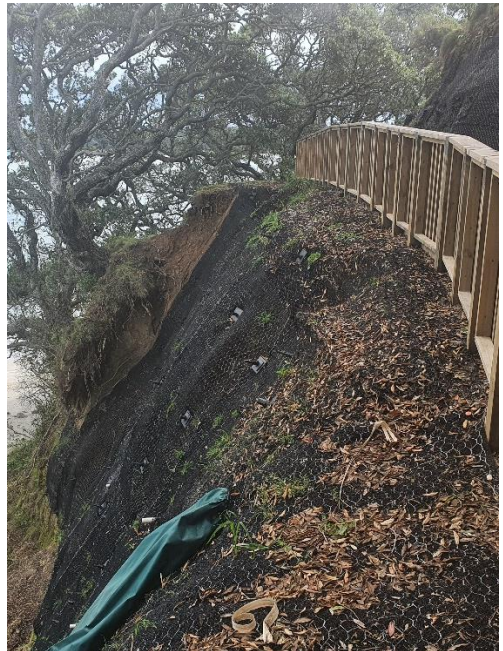
- The minor amount of scour around the roots of the Pohutukawa Tree at the western edge of the slip appears to be stable - erosion of this area has not increased despite recent heavy rain (Photographs 9-10, 14-15).

Looking west across the slip face. Photograph 9 (above left) – taken during the first inspection on 02/06/20. Photograph 10 (above right) was taken on 27/08/20.

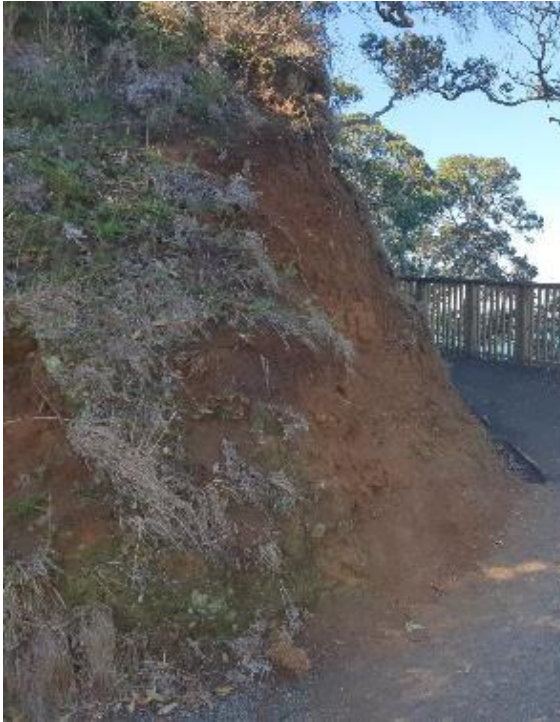
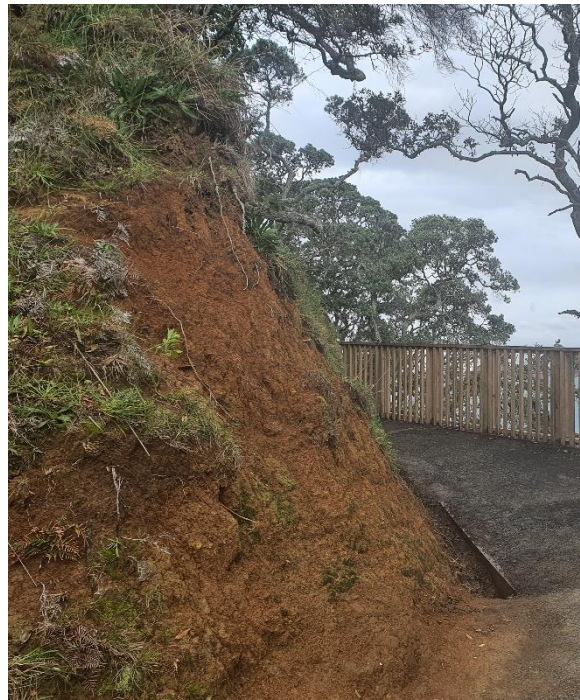
Looking at the bare face at the western end of the track. Photograph 11 (above left) - taken during the first inspection on 02/06/20. Photograph 12 (above right) was taken on 27/08/20.

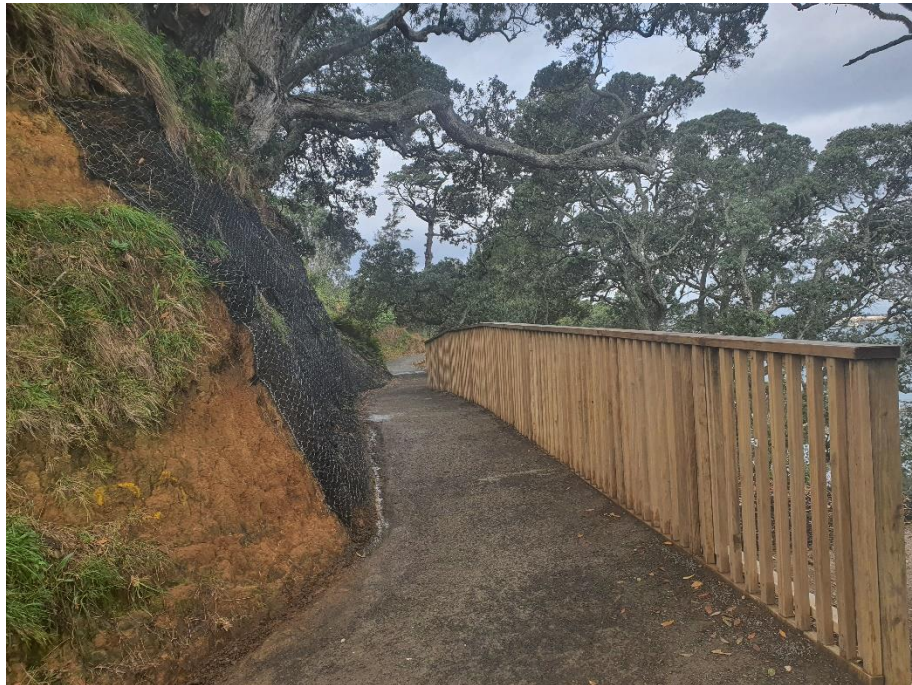
Photograph 13 - looking from the west side of the reformed track to the eastern end of the track.

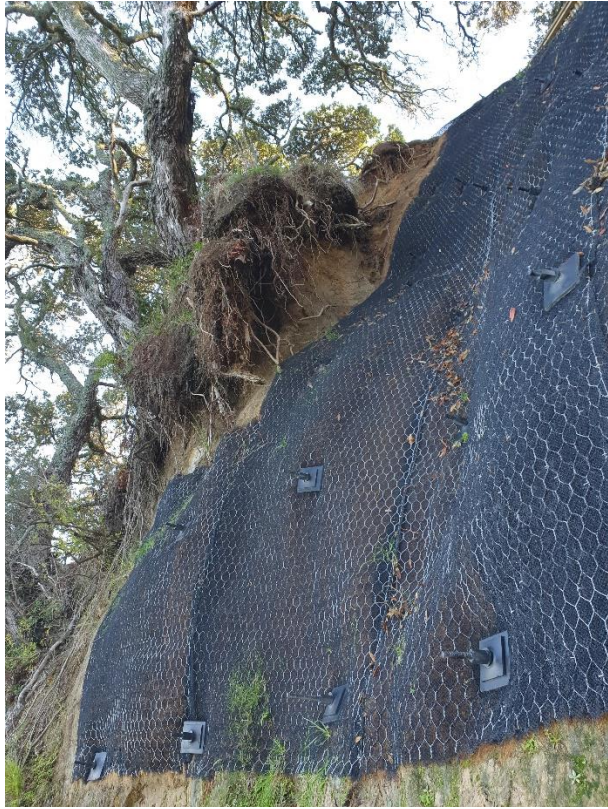
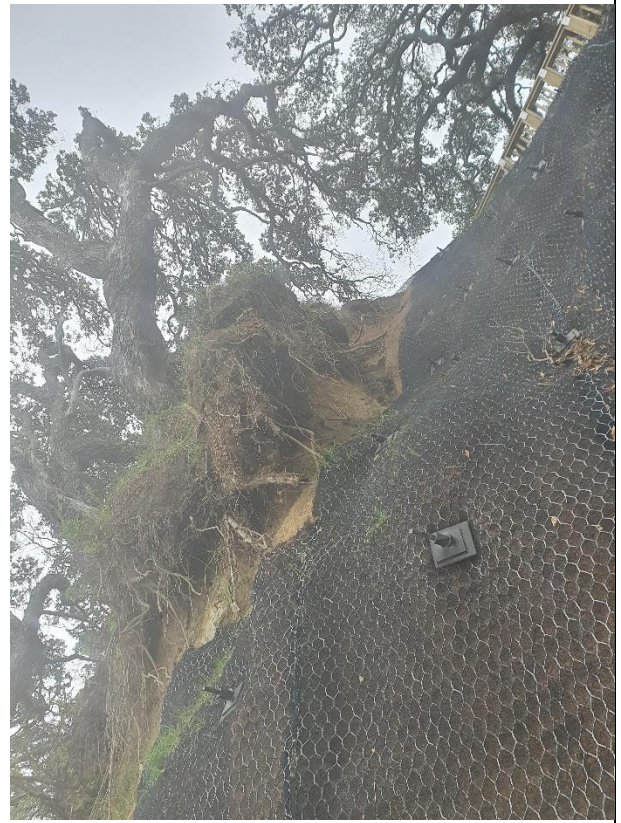
Photograph 14 (left, 29/06/20) and Photograph 15 (right, 27/08/20).  
Looking up from the base of the slip towards the Pohutukawa tree.

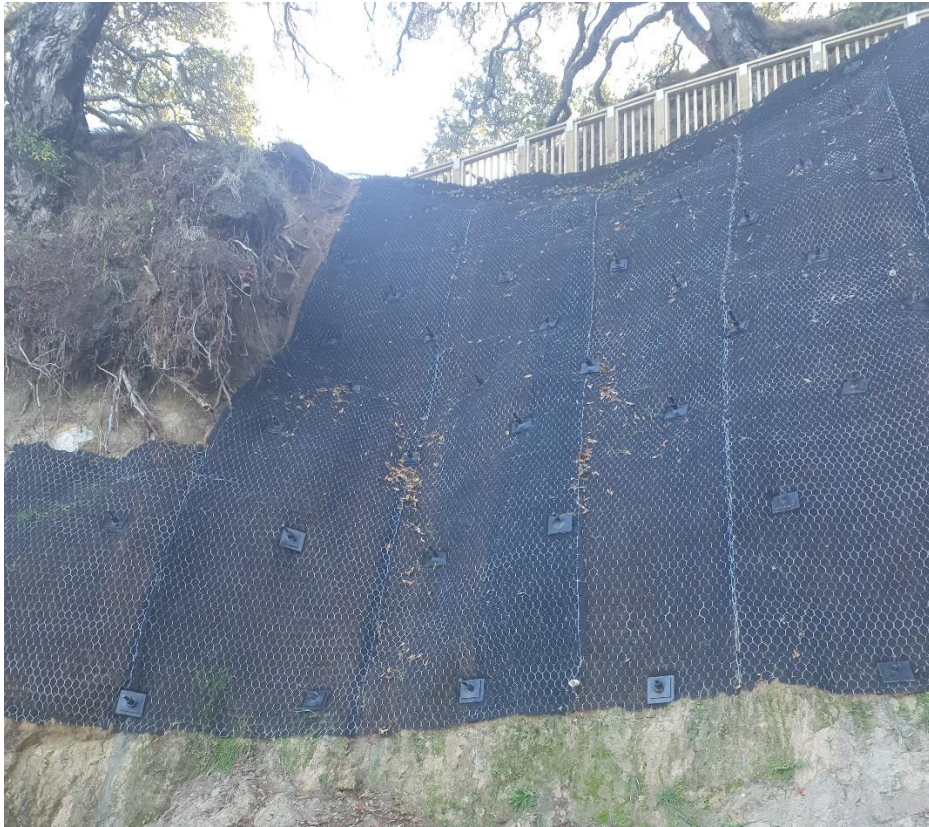
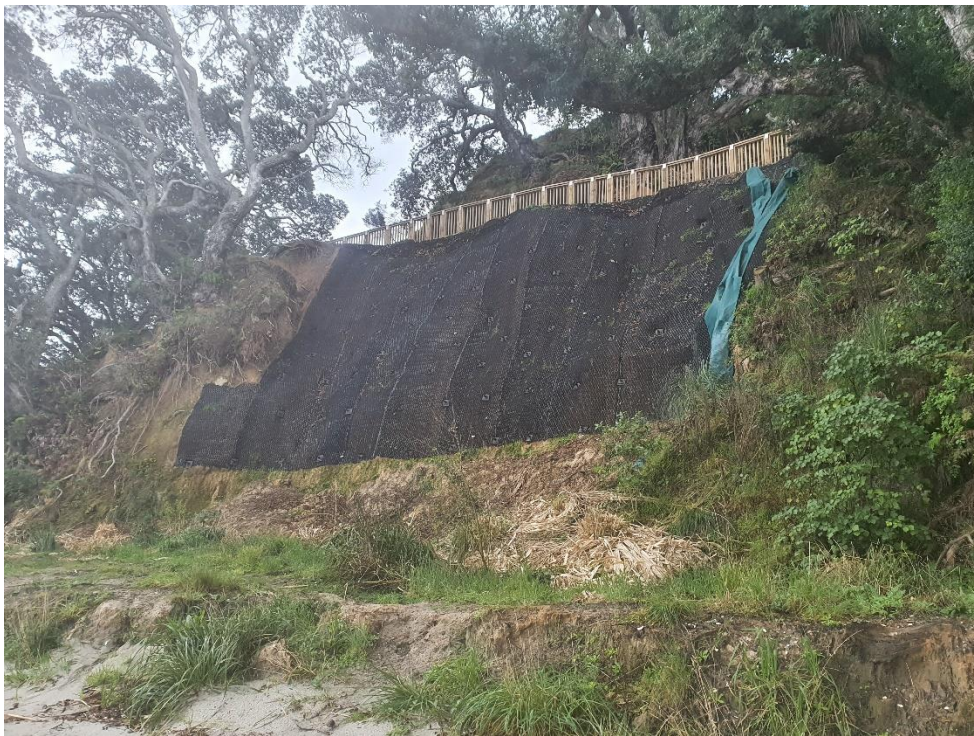
View of slip face from bottom of slope. Photograph 16 (top) was taken during the first inspection on 02/06/20. Photograph 17 (bottom) was taken on 27/08/20.

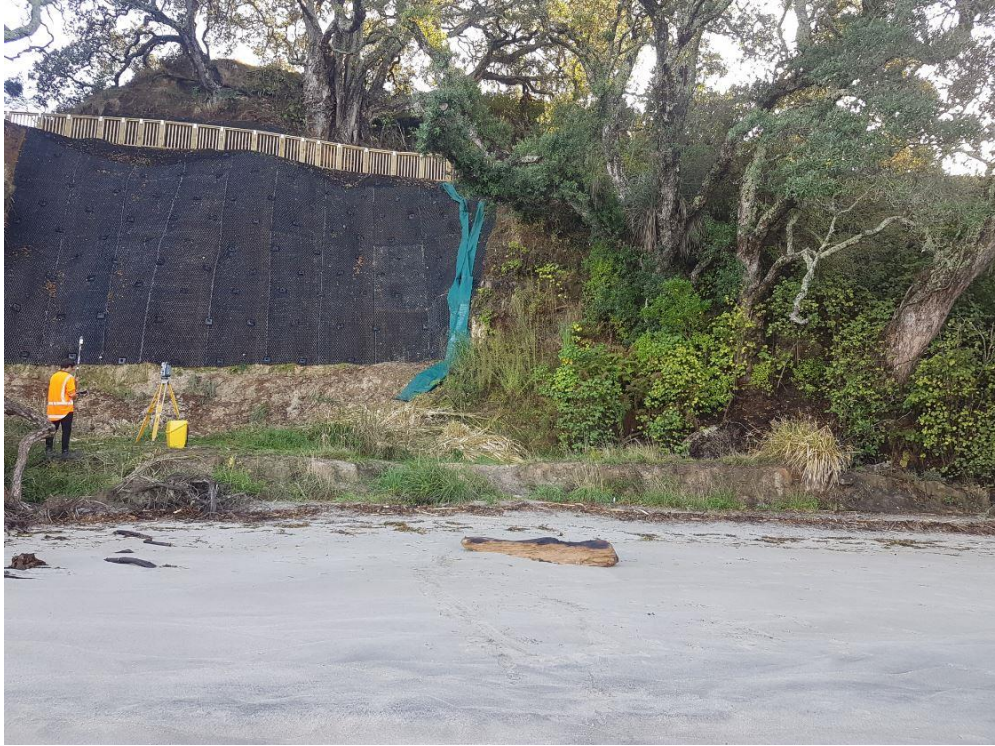
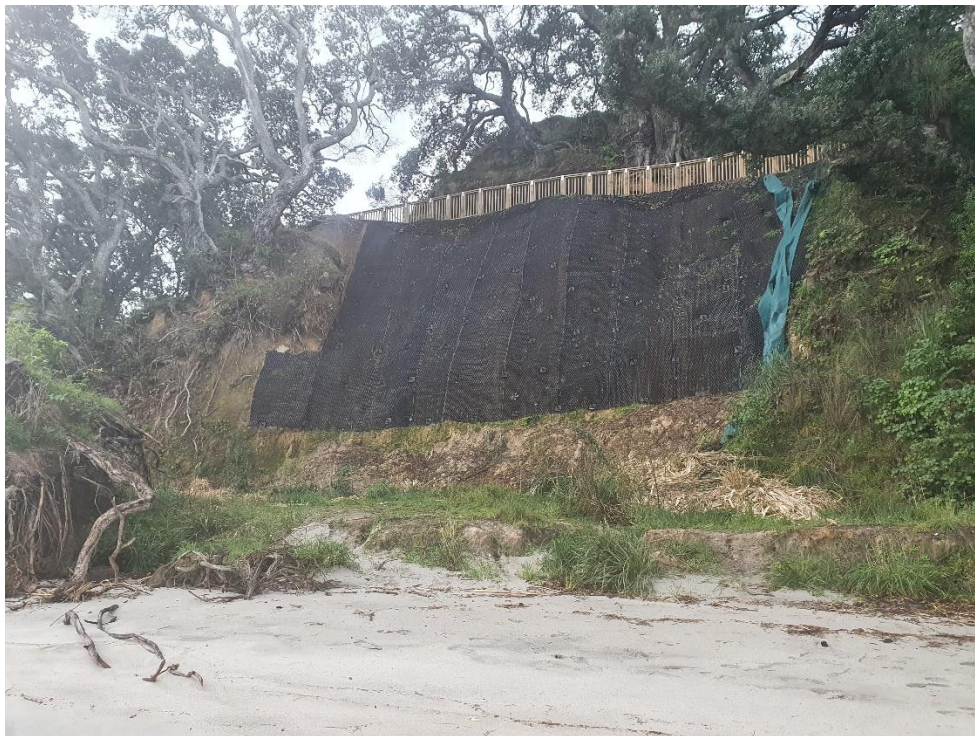
Looking towards the slip from the tidal platform. Photograph 18 (top) was taken during the first inspection on 02/06/20. Photograph 19 (bottom) was taken on 27/08/20.
