SITE VISIT RECORD

Contract: Mauao Base Track Geotechnical Monitoring

Inspection No: 3

Project Number: 2-9B463.01

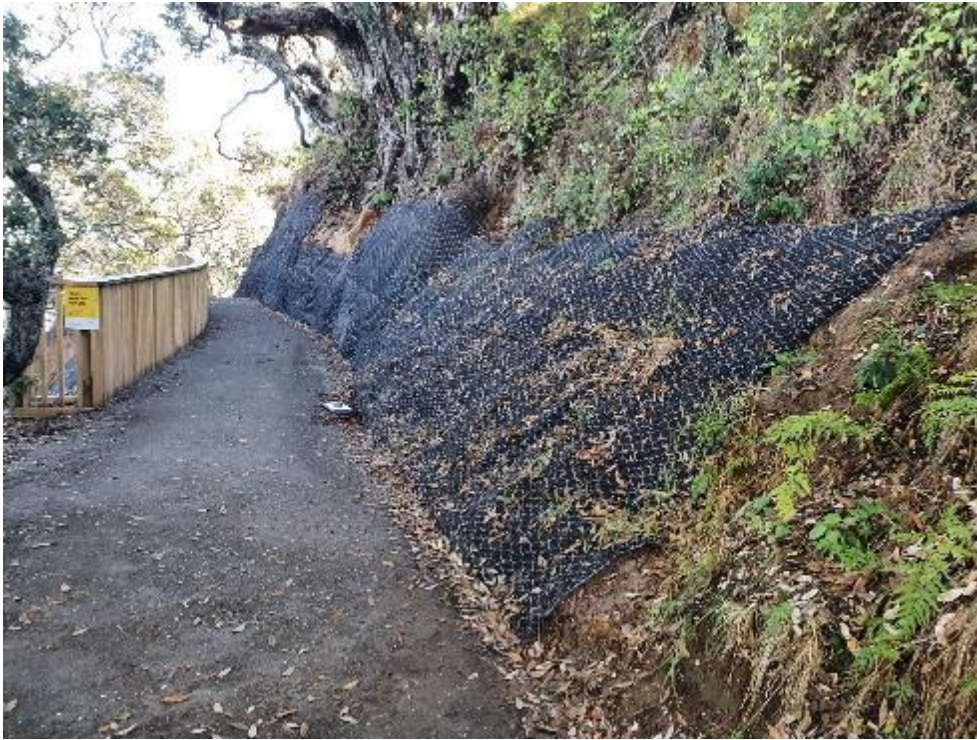
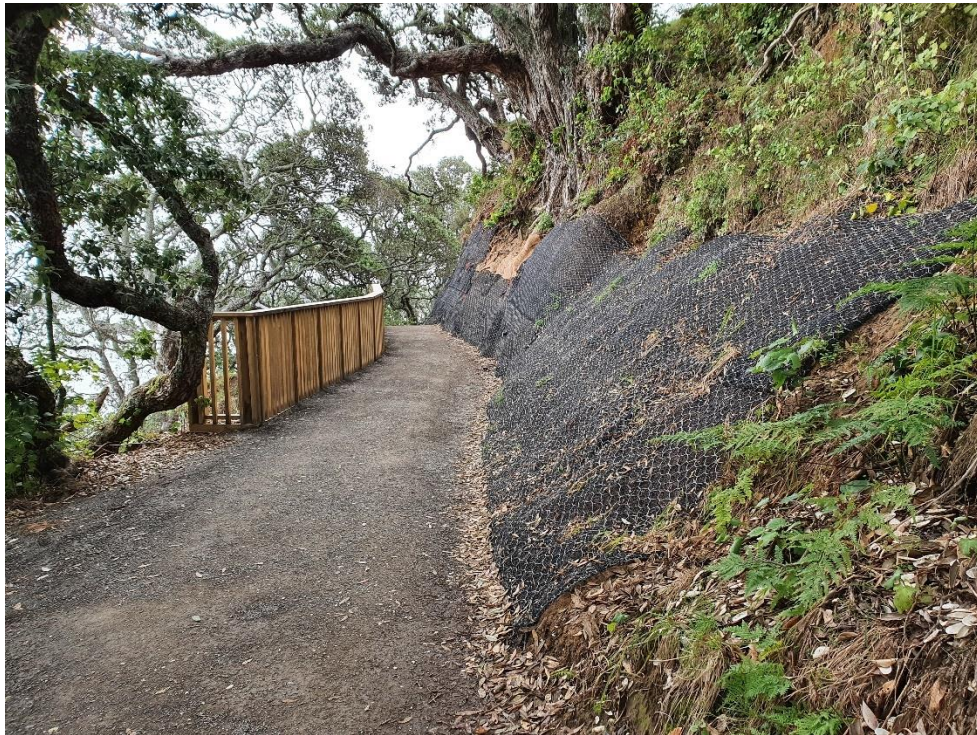
Photographs 1 & 2

- The repaired track was moist, but there was no ponding, erosion, or deformation / cracking observed on the track itself (Photographs 1 & 2).
- There were no changes to the slope above the repaired track, with the exception of the small amount of erosion occurring around horizontal drain 3 (HD03, Figure 1). This is discussed below.

At the start of the track looking west. Photograph 1 (top) - taken during the first inspection on 02/06/20. Photograph 2 (bottom photo) was taken on 02/08/20.

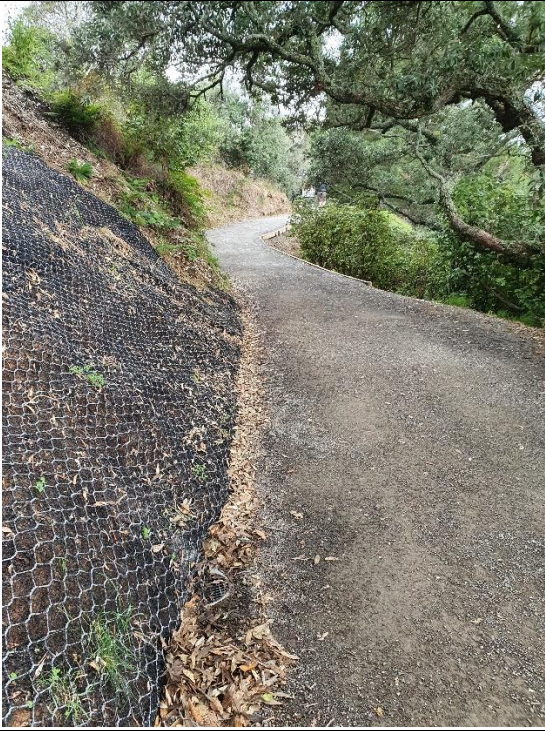
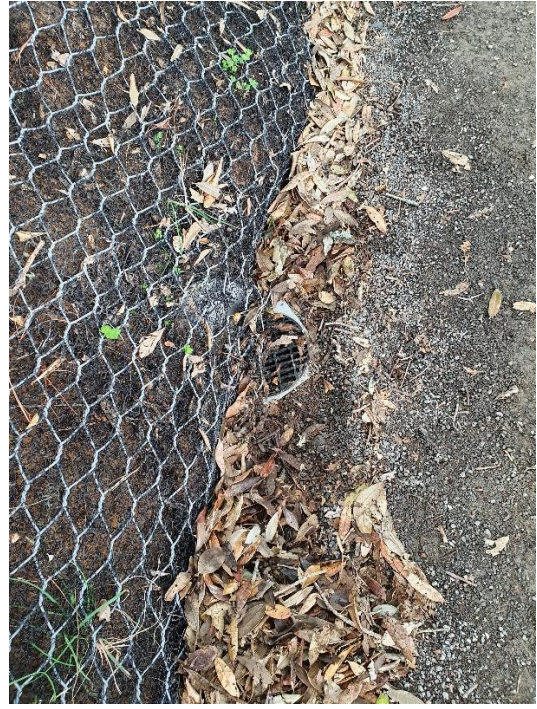
- All grates entering culvert inlet at the north side of the track on the eastern side of the repair were clear - however they were covered with leaves (Photographs 3 and 4). The green drainage socks that collect water from these culverts and outlet at the bottom of the slope were checked. A small amount of water was flowing from the drain furthest to the east.
- The culvert at the west end of the repaired track (C02, Figure 1) was still mostly clear with the exception of leaves/ silt build-up (Photographs 11-13). This material is being eroded on the adjacent slope above the track at the western end (Photographs 16 and 17).
- The geometry of the track still has a reverse grade to the swales that lead to the culvert inlets.

Photograph 3 (top left) and Photograph 4 (top right) showing Culvert 01 (C01, Fig. 4).

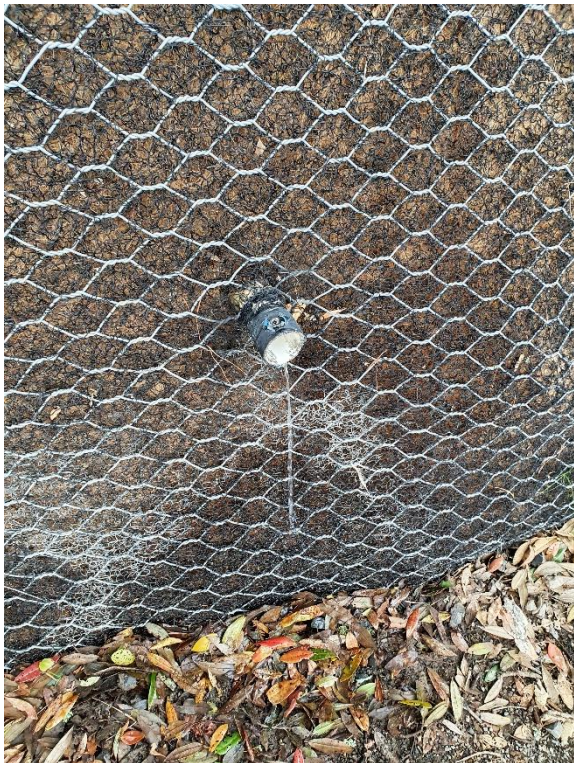
- Horizontal drains HD01 - HD03 (Figure 1) on the slope above the repaired track were checked. There was a steady stream of water coming out of HD01 (Photograph 5). Horizontal drains 02 and 03 (HD02 and HD03, Figure 1) were both dripping steadily (Photographs 6 and 8).

Photograph 5 (left): Water steadily flowing from horizontal drain 01 (HD01). Photograph 6 (right) horizontal drain 02 (HD02) dripping steadily.

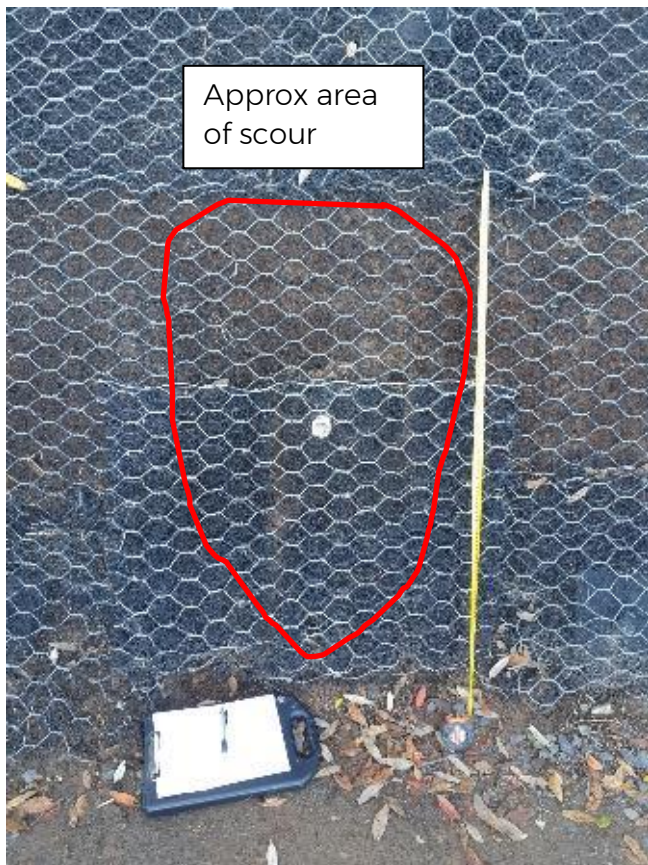
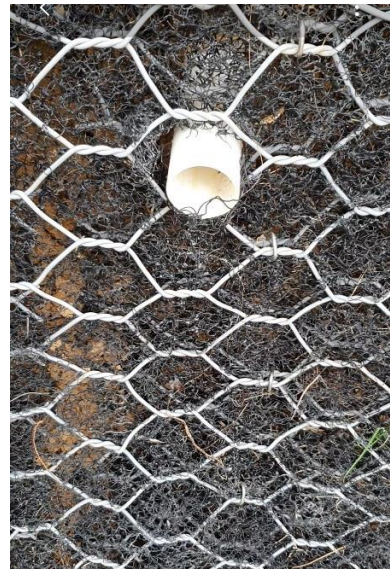
- The scour around drain HD03 appeared to be in the same or similar condition as when last checked on 29/06/20. It is difficult to tell the extent of the scour due to the black mesh covering. The soil around the pipe was still wet and quite weak. The geogrid was not attached to the slope face in the vicinity around the drain (Photographs 7 & 8). We think this may need to be addressed by pinning the geogrid back onto the slope around the vicinity of the drain.
- At the bottom of the slope, horizontal drains on the slope face were checked (H04 - HD09, Fig. 01).
- HD04, HD06 and HD09 were not dripping.
- A small amount of water was dripping from HD07 - about 1 drip every 5 seconds.
- HD08 felt wet inside but was not actively dripping.
- HD05 was dripping at a rate of 1 drip per second.

Approx area of scour

Photograph 7 (above left) horizontal drain 03 (HD03) and approximate area of scour associated with it. A zoomed in picture of the drain is shown in Photograph 8 (above right).

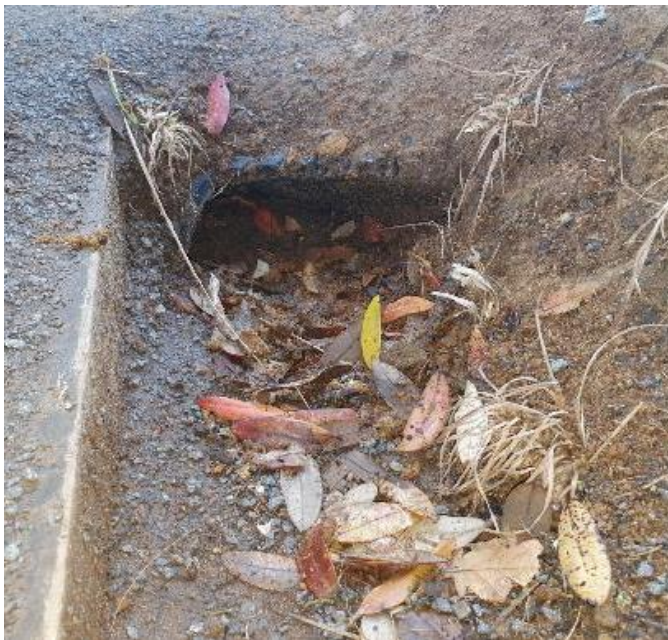
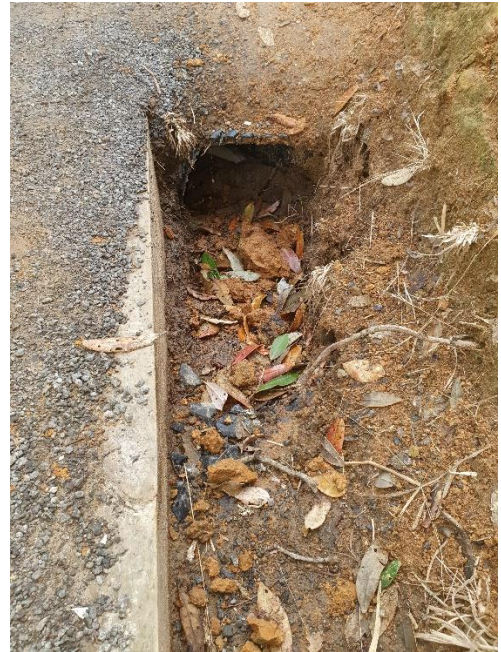
A comparison of Culvert 2 as initially inspected on 02/06/20 (Photograph 9 - above, left) and on 02/08/20 (Photograph 10 - above right). Material from the slope above the drain has been collecting in the slope side of the drain.

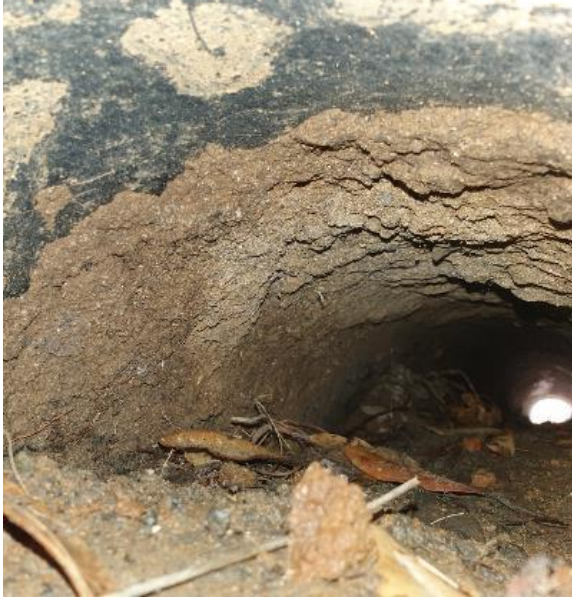
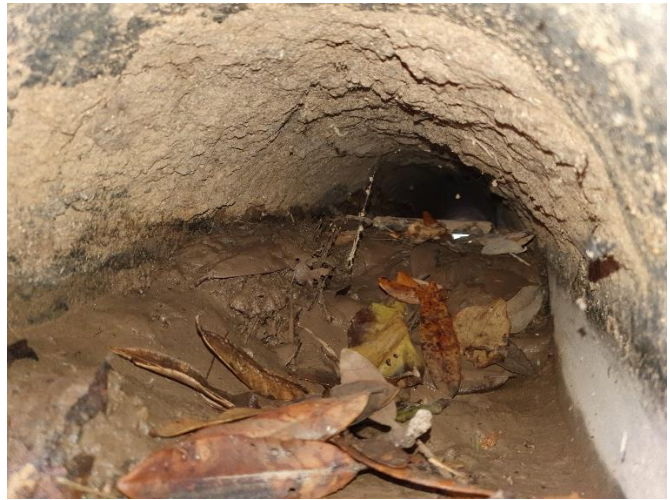
A comparison of Culvert 2 as initially inspected on 02/06/20 (Photograph 11 - above, left) and on 02/08/20 (Photograph 12 - above right). Buildup of material has nearly blocked the drain at the track end.

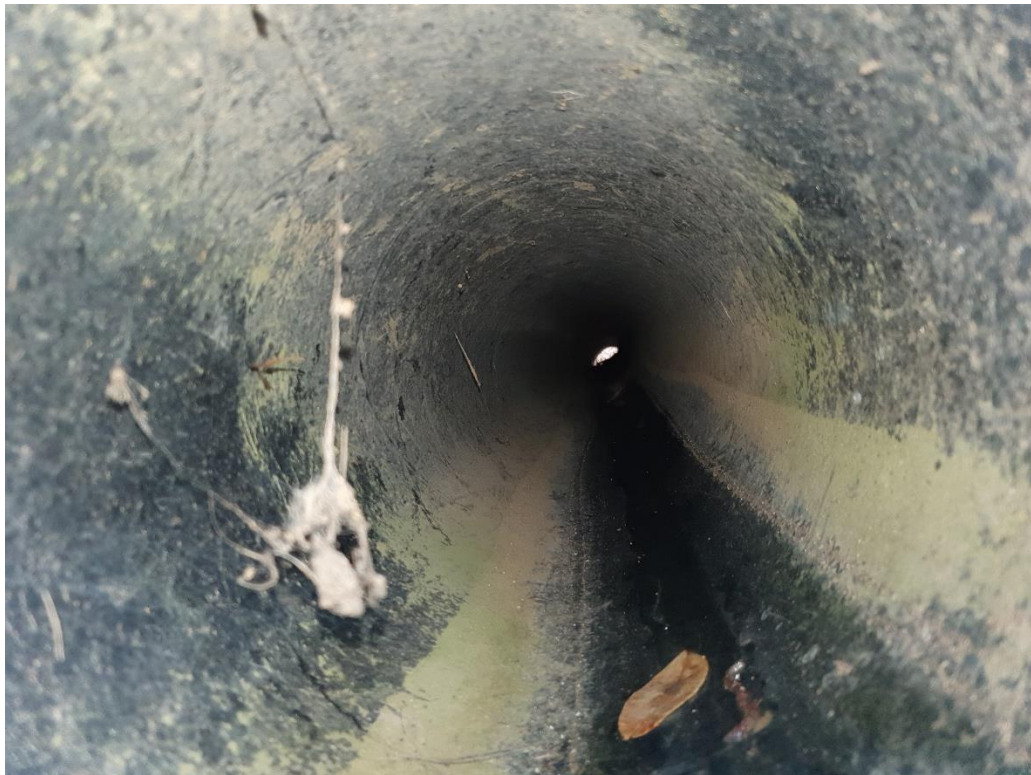
Photograph 13 - culvert O2 looking from the slip side of the track to the slope side of the track. The material has only accumulated at the slope side of the culvert.

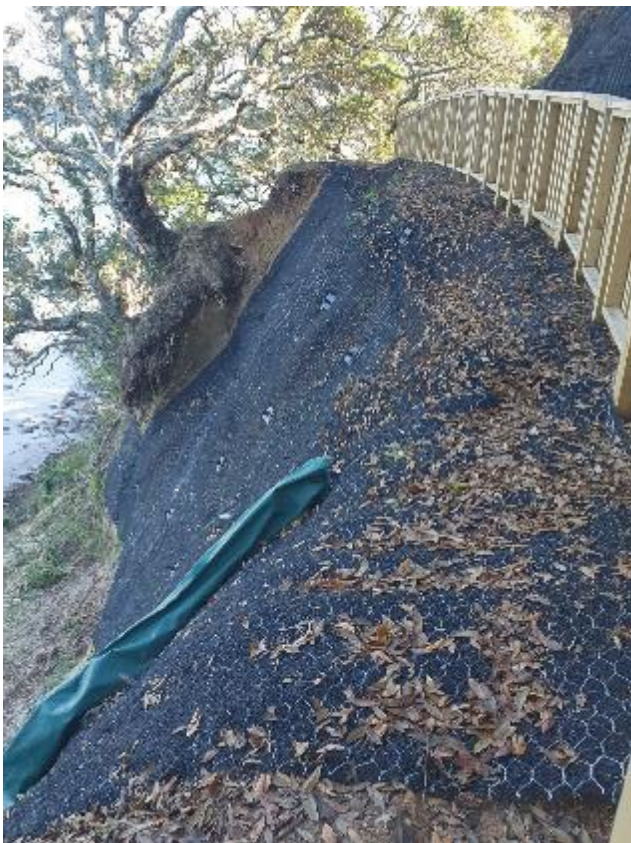
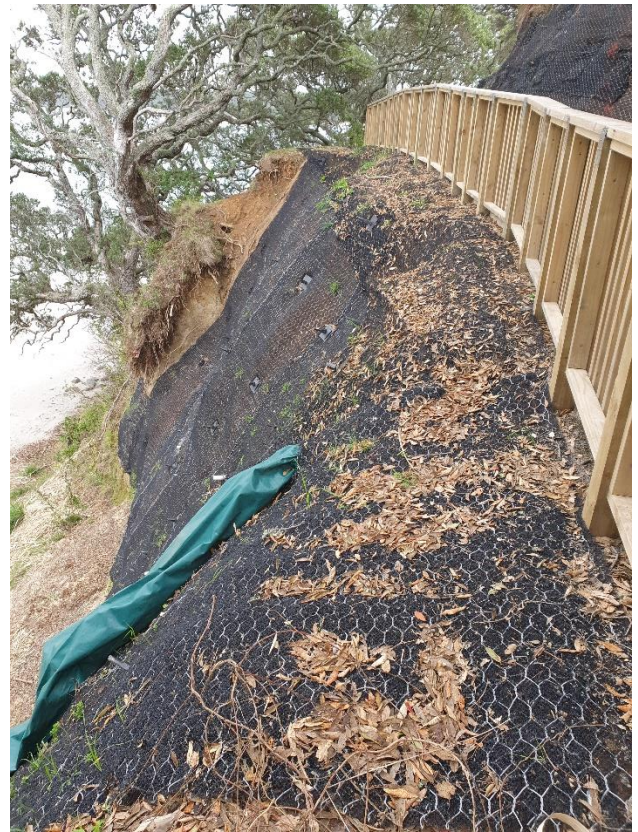
Photographs 14 - 17

Looking west across the slip face. Photograph 14 (above left) – taken during the first inspection on 02/06/20. Photograph 15 (above right) was taken on 02/08/20.

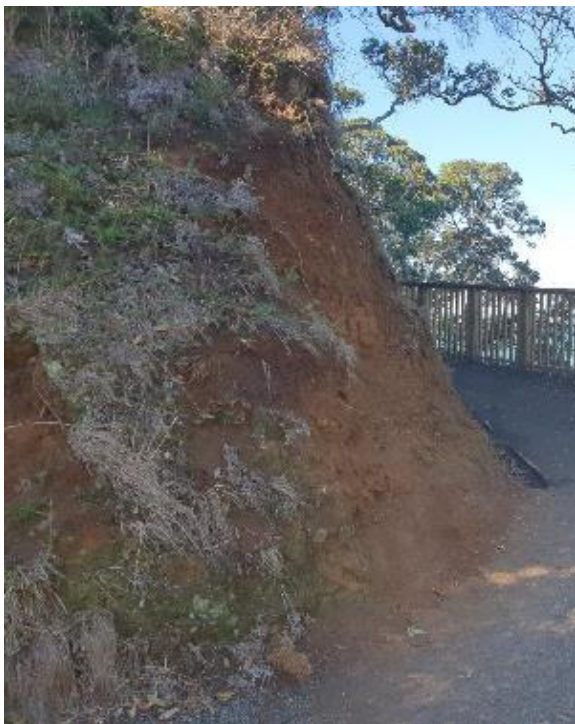
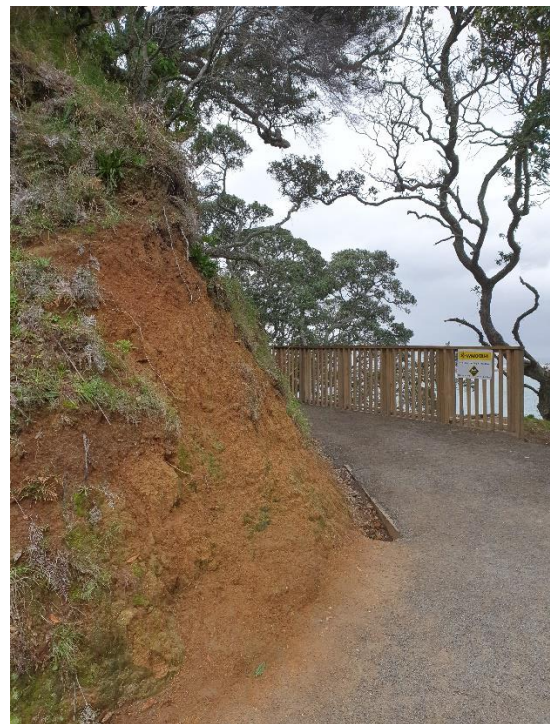
Looking at the bare face at the western end of the track. Photograph 16 (above left) – taken during the first inspection on 02/06/20. Photograph 17 (above right) was taken on 02/08/20.

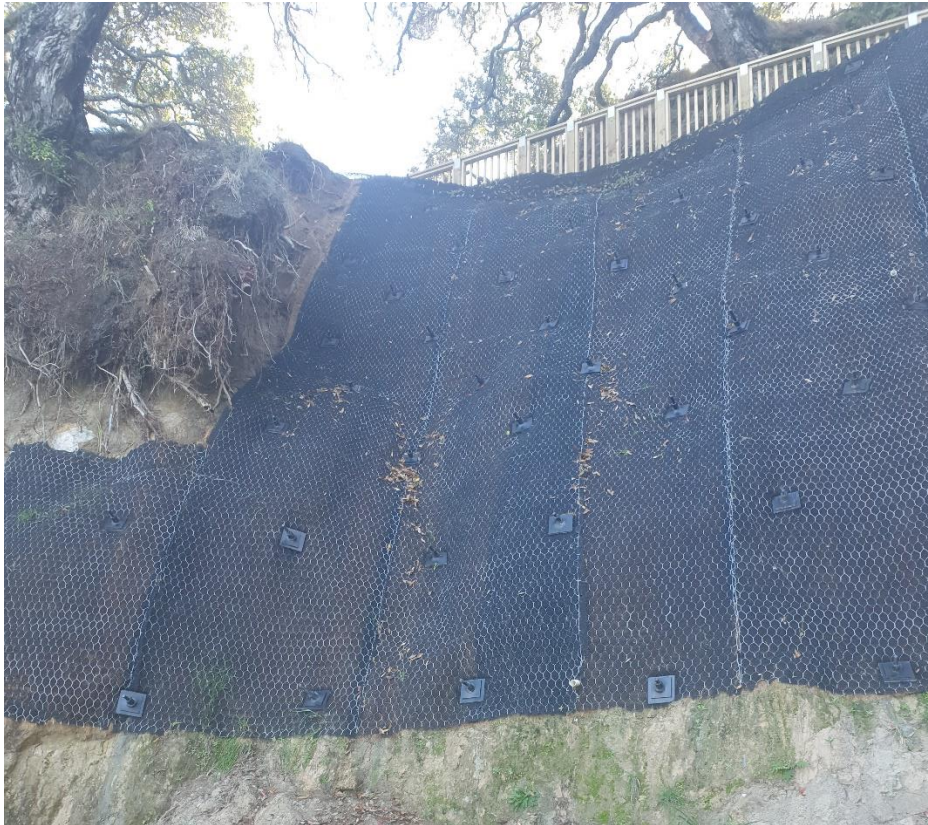
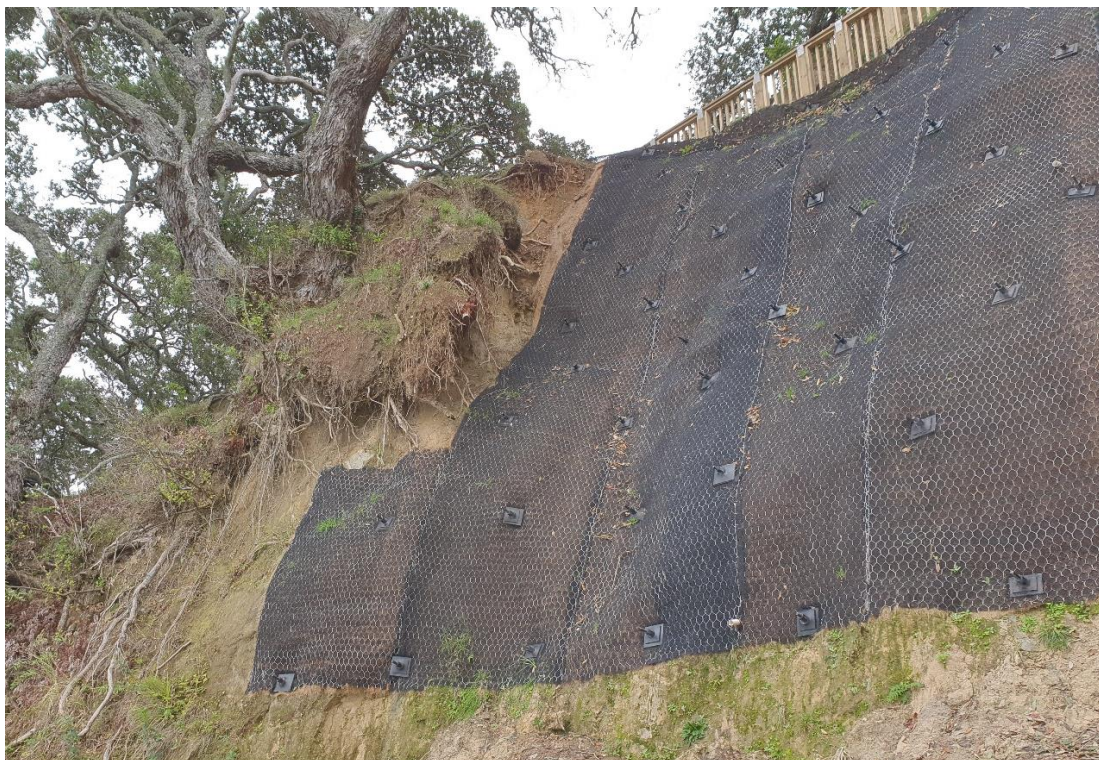
Photographs 18 & 19

- The minor amount of scour adjacent the Pohutukawa tree on the western side of the slip looks the same as the last site visit i.e. no further scouring has occurred (Photographs 18-19).

Looking up towards the Pohutukawa tree on the western side of the slip. Photograph 18 (top) was taken during the first inspection on 02/06/20. Photograph 19 (bottom) was taken on 02/08/20.

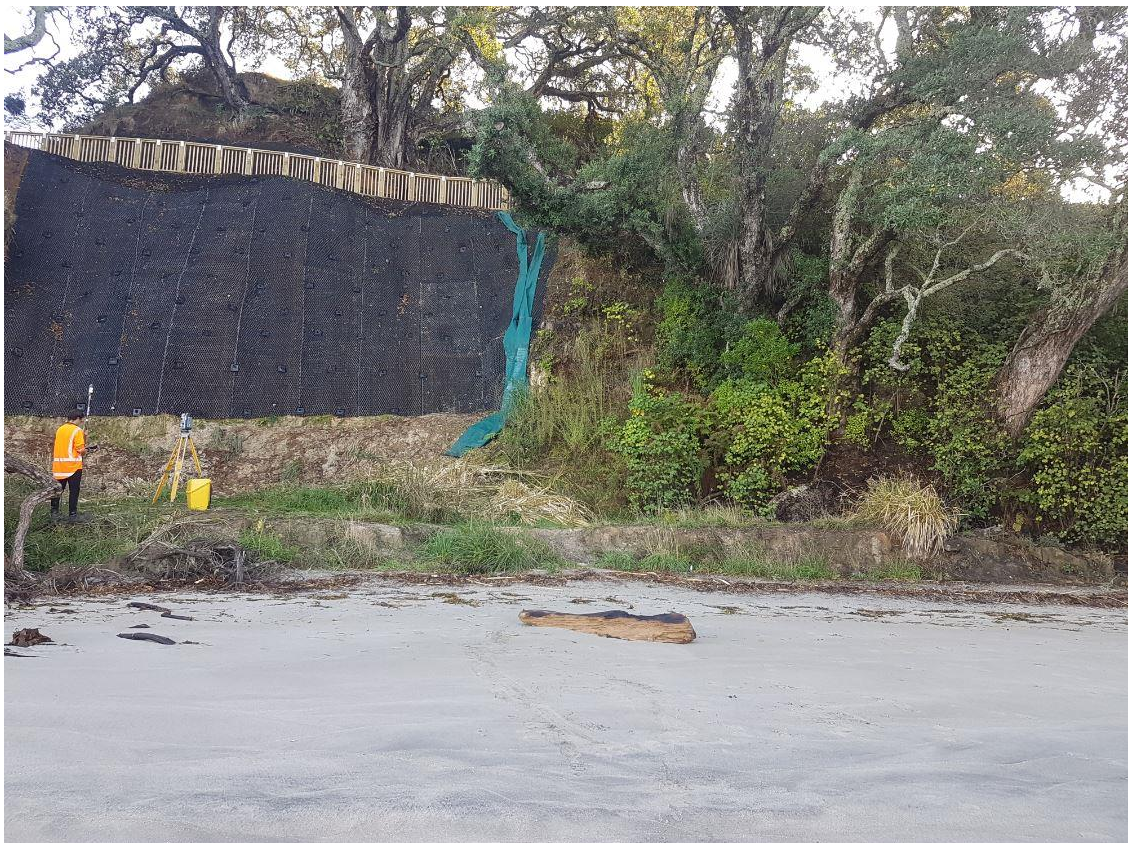
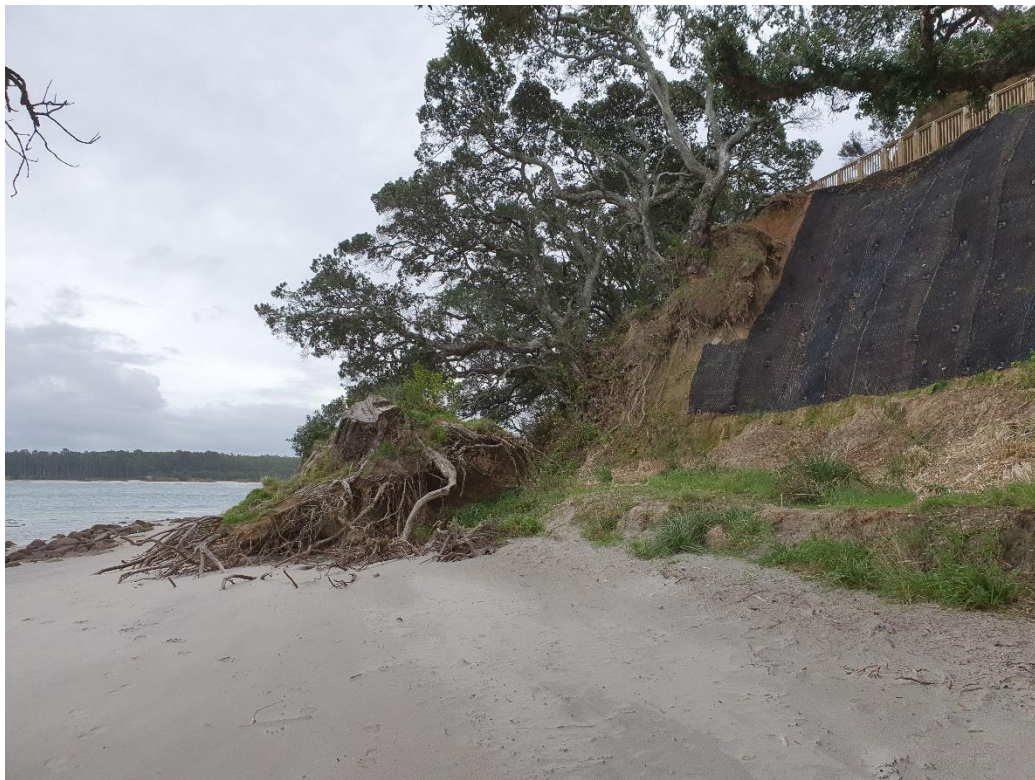
Photographs 20 & 21

- There were no signs of wave / water erosion of the toe of the slope or between the toe of the slope and debris remains (Photographs 20 and 21).

Looking towards the slip from the tidal platform. Photograph 20 (top) was taken during the first inspection on 02/06/20. Photograph 21 (bottom) was taken on 02/08/20.
