SITE VISIT RECORD

Contract: Mauao Base Track Geotechnical Monitoring
Project Number: 2-9B463.01

Inspection No: 2

Work Site: Mt Maunganui Base Track

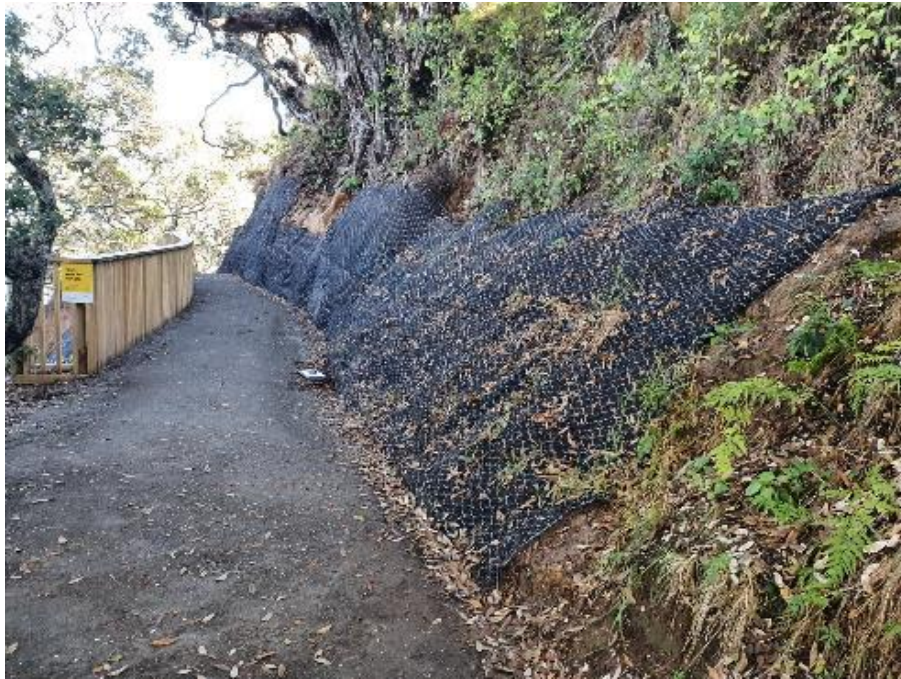
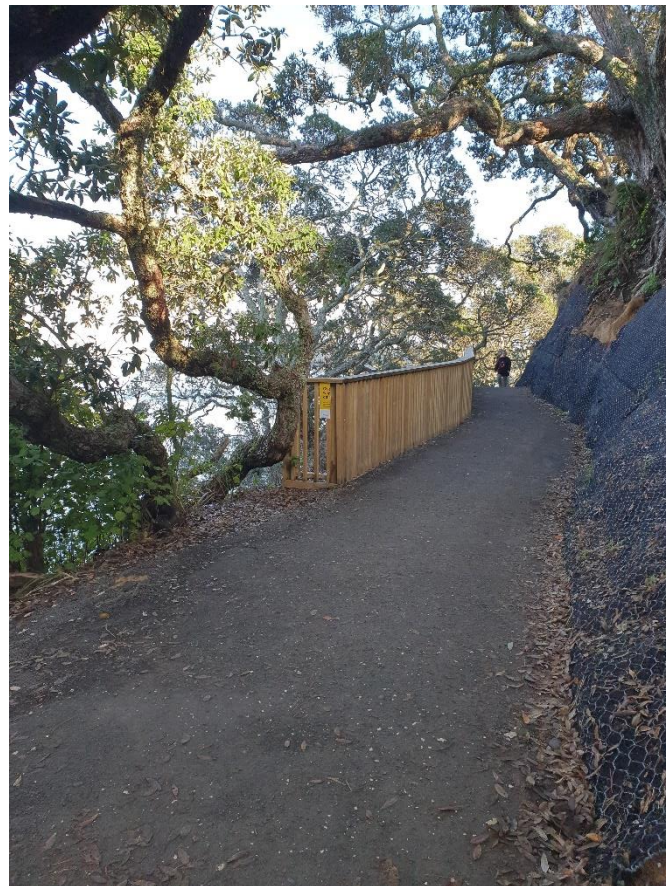
Photograph 1 & 2

- All grates entering culvert inlet at the north side of the track on the eastern side of the repair were clear - however they were covered with leaves (Photographs 1 and 2). The green drainage socks that collect water from this culvert and outlet at the bottom of the slope had a small amount of moisture in them, indicating that water had been flowing overnight but had since stopped. There was no water draining from these socks when observed.
- The geometry of the track still has a reverse grade to the swales that lead to the culvert inlets.

Photograph 1 (top, taken on 02/06/20) compared to the most recent visit on 29/06/20 - At the start of the track looking west

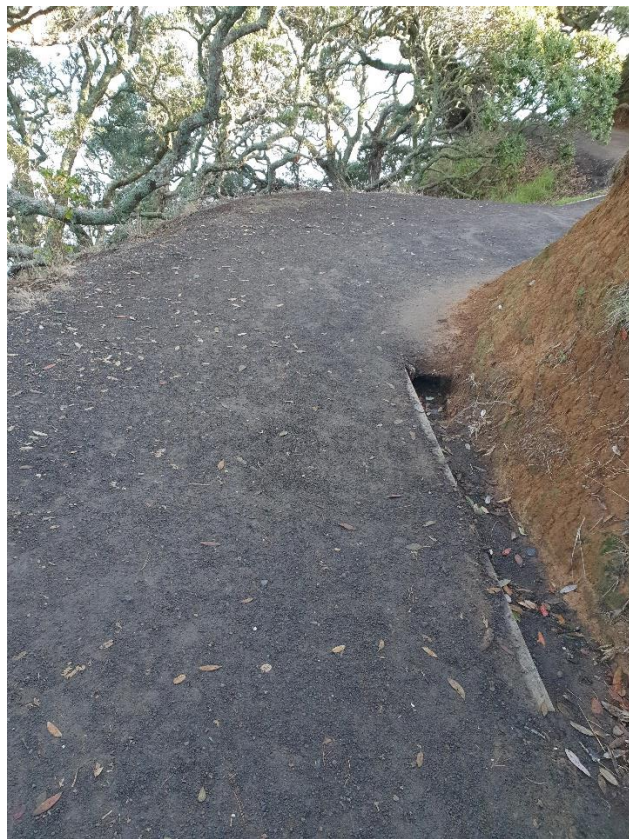
Photograph 3 - Culvert 02 at west extent of track repair

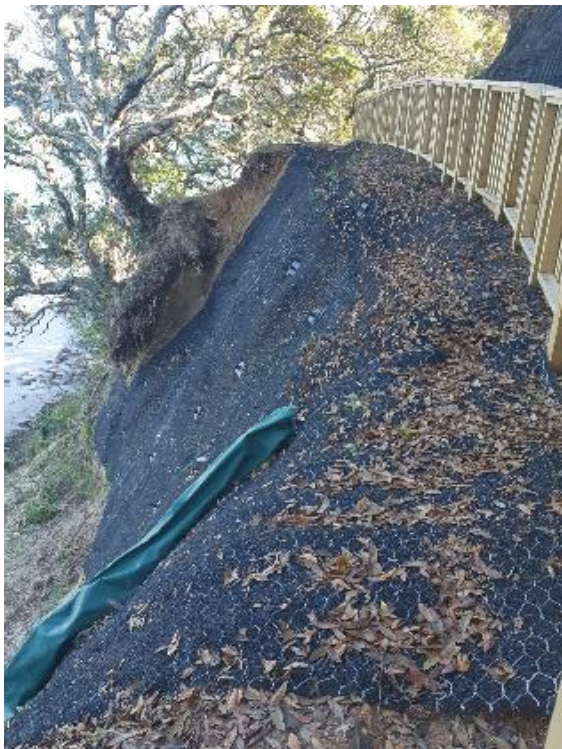
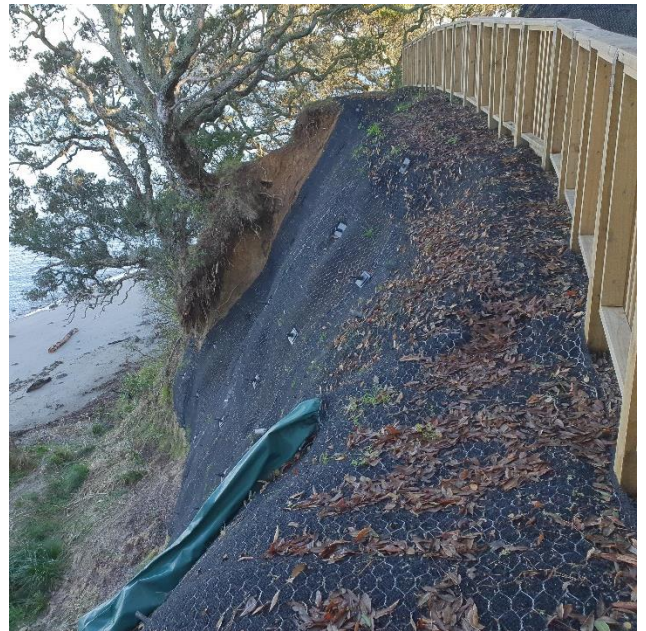
- It appears that a small amount of scour has occurred adjacent the Pohutukawa Tree at the western edge of the slip (Photographs 4-5, 8 - 11).

View of slope looking west. Photograph 4 (left) taken on 02/06/20) compared to Photograph 5, taken on 29/06/20.

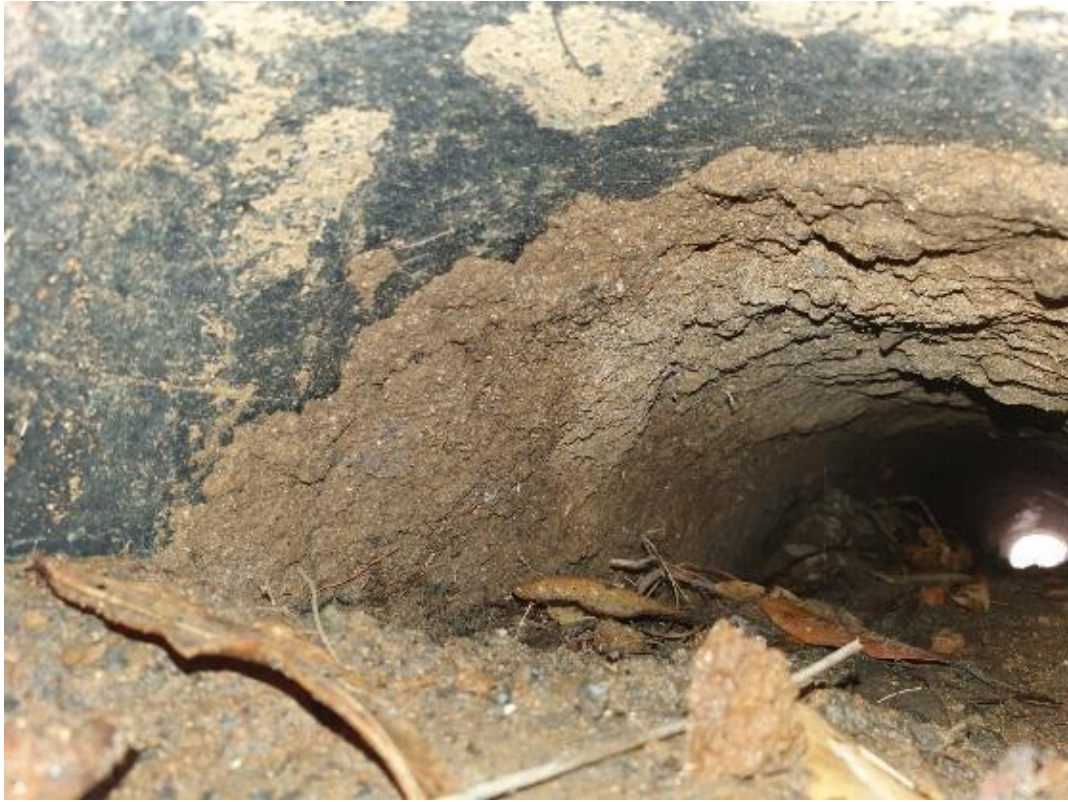
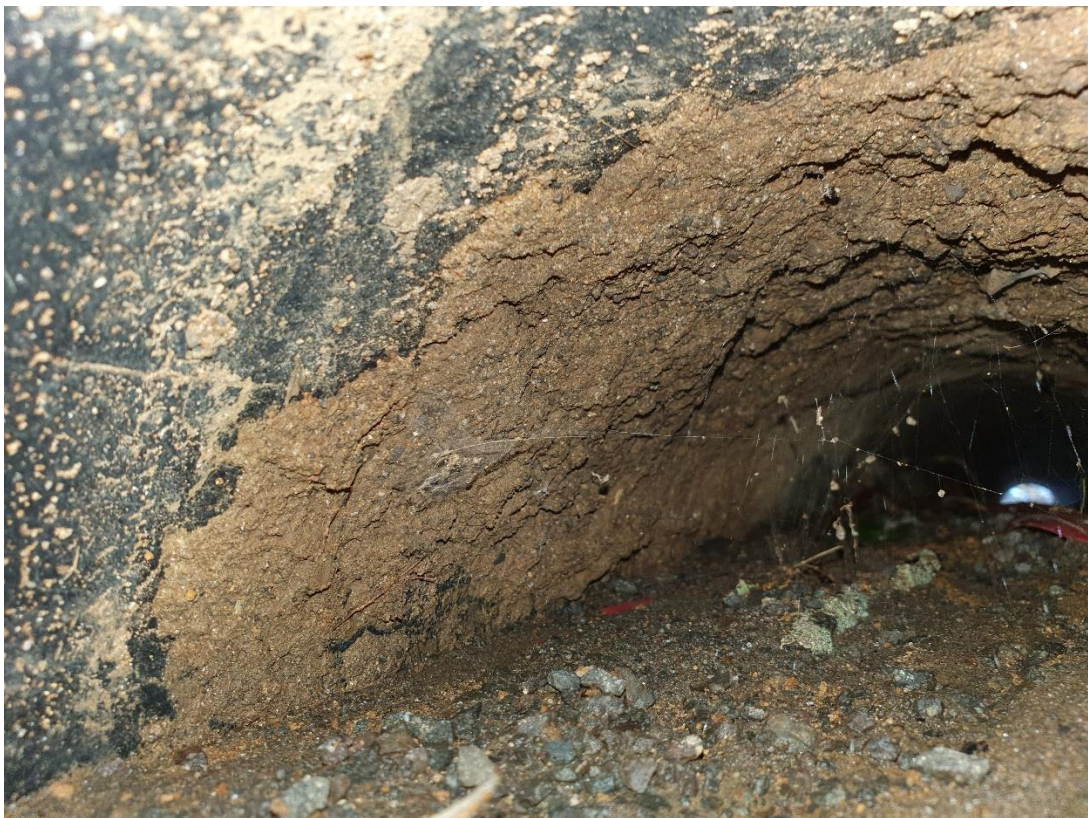
Photographs 6 & 7

- The culvert at the west end of the repaired track (C02, Figure 1) was still mostly clear with the exception of leaves/silt build-up (Photographs 6 and 7).
- At the bottom of the slope no water was observed dripping from horizontal drains on the slope (H04, H05, H06, H07, HD08).

Photograph 6 (top, from 02/06/20), and Photograph 7 (bottom, from 29/06/20). A comparison of the view inside Culvert 2, from track to edge of slope.

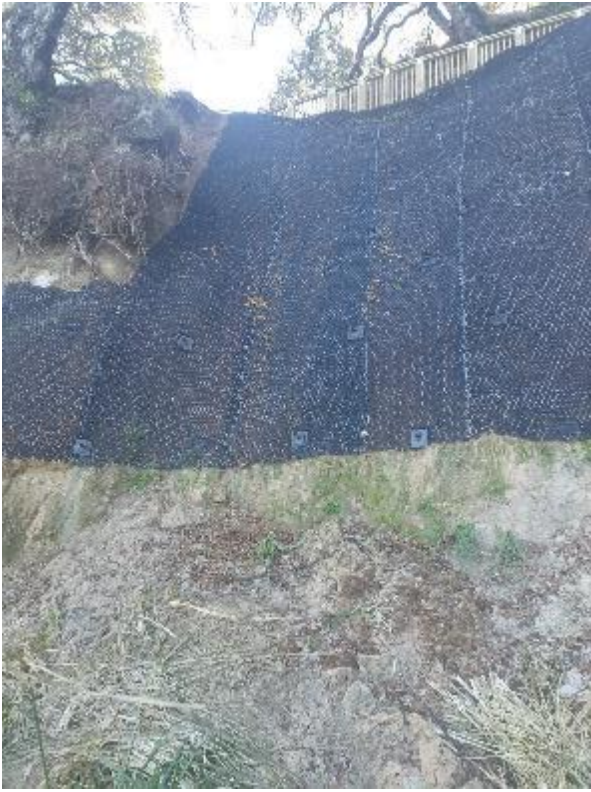
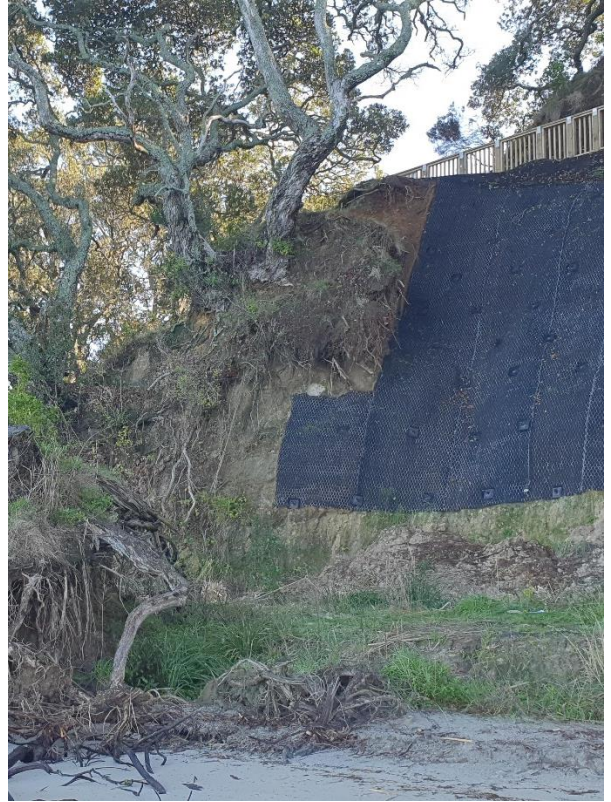
Photograph 8 (left, 02/06/20) and Photograph 9 (29/06/20) - View looking upslope

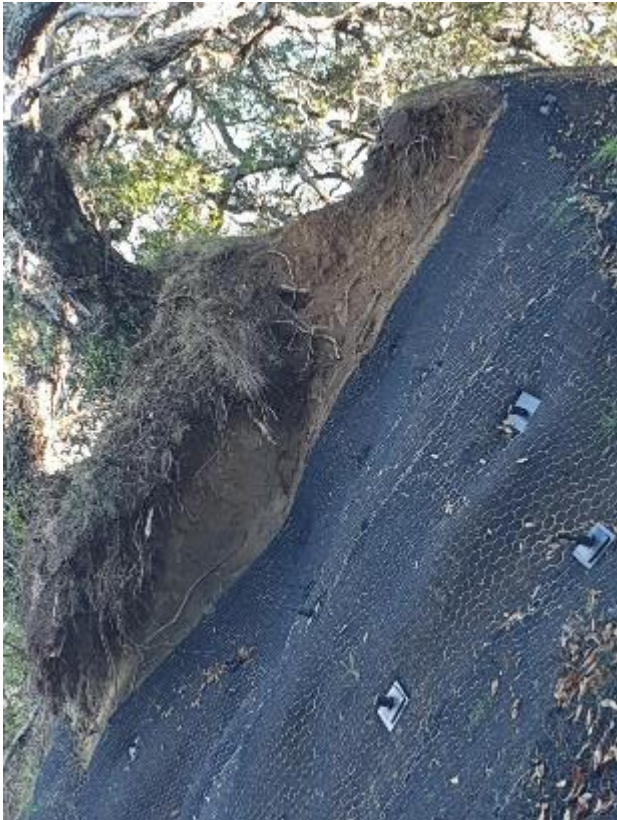
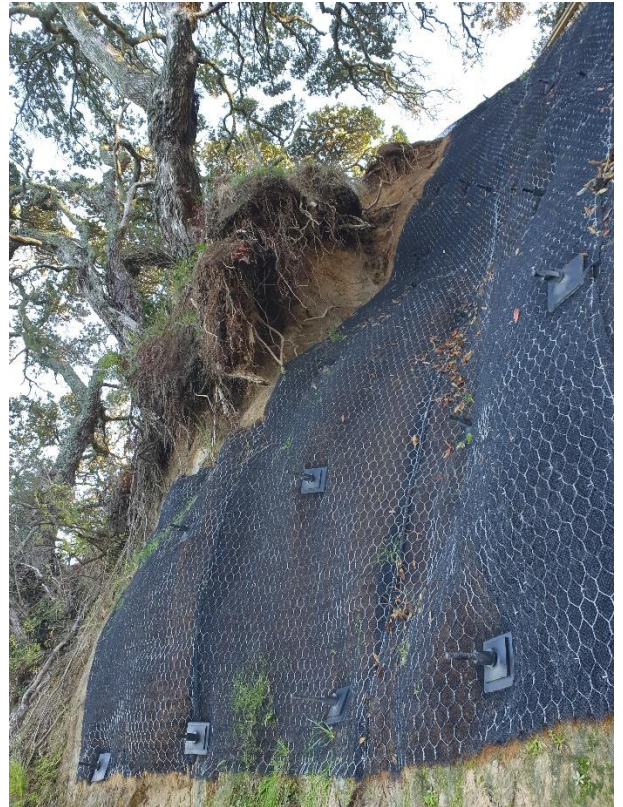
Photograph 10 (left, 02/06/20) and Photograph 11 (right, 29/06/20).
Looking west across slip face towards the Pohutukawa tree. It appears that slightly more scour adjacent the tree has occurred following heavy rain.

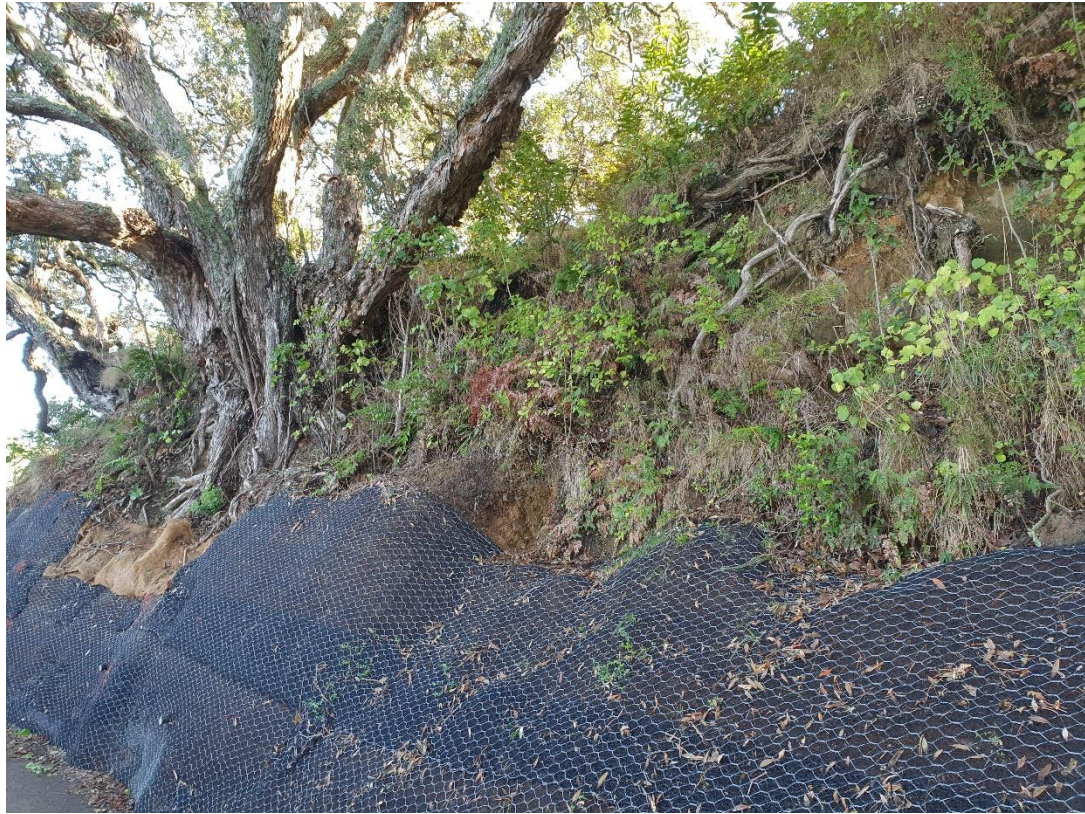
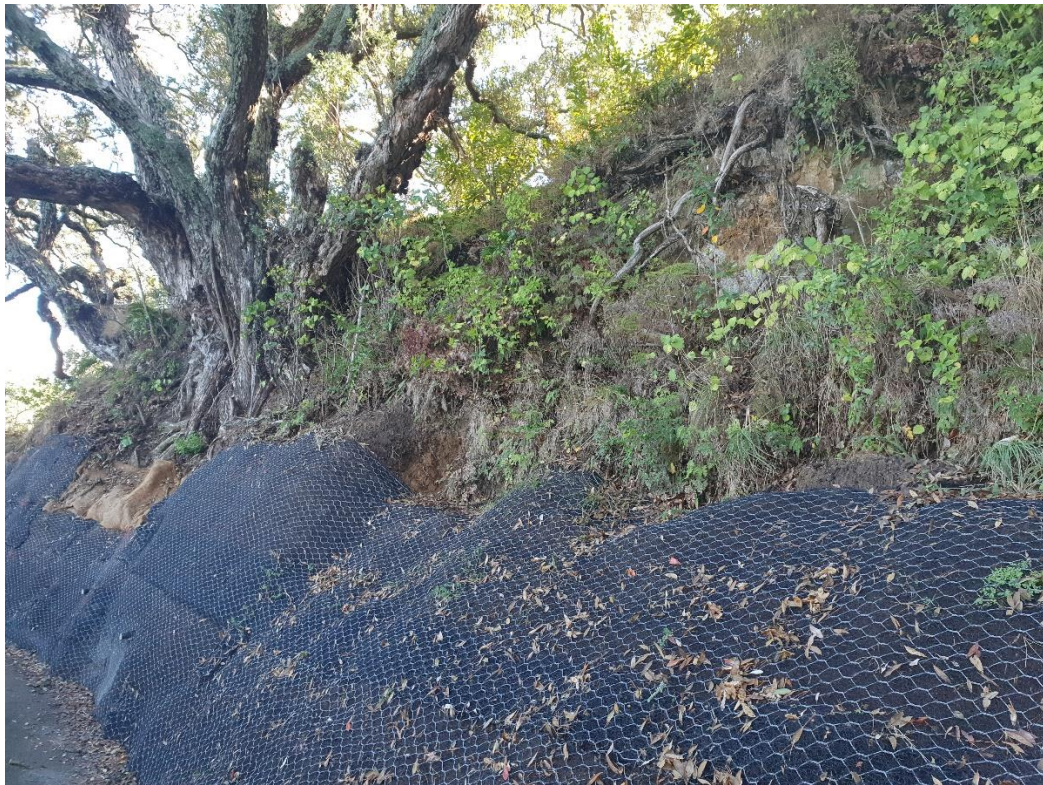
Photographs 12 & 13

- The repaired track was wet but there was no ponding, erosion, or deformation / cracking observed on the track itself.
- There was no change to the slope above the repaired track (Photographs 12 and 13).

Photograph 12 (top, 02/06/20) and Photograph 13 (bottom, 29/06/20) – slope above track.

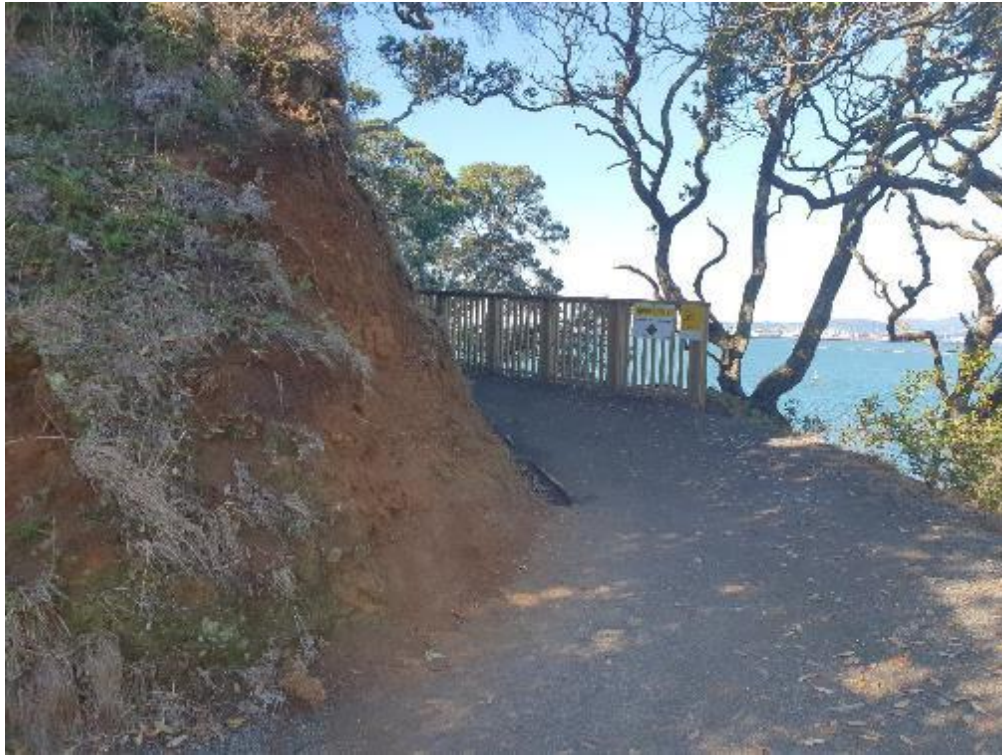
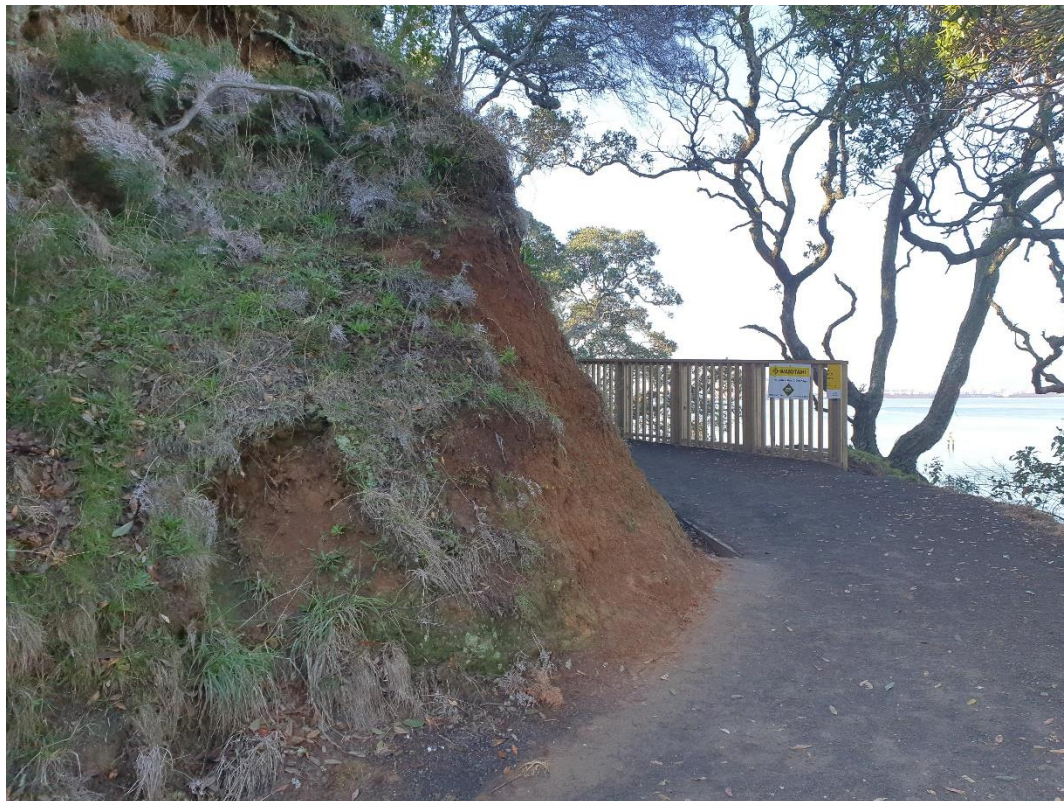
Photographs 14 & 15

- The track condition was overall in the same condition as the previous visit on 02/06/20.
- The cut slope above the track just beyond the west edge of site looked to be eroding slightly (See Photographs 14 and 15).
- Refer to Figure 1 for locations of drains / culverts.
- Photos from this inspection and the previous inspection are compared to monitor changes.

Photograph 14 (top, 02/06/20) and Photograph 15 (bottom, 29/06/20). Looking towards the track from the western end.

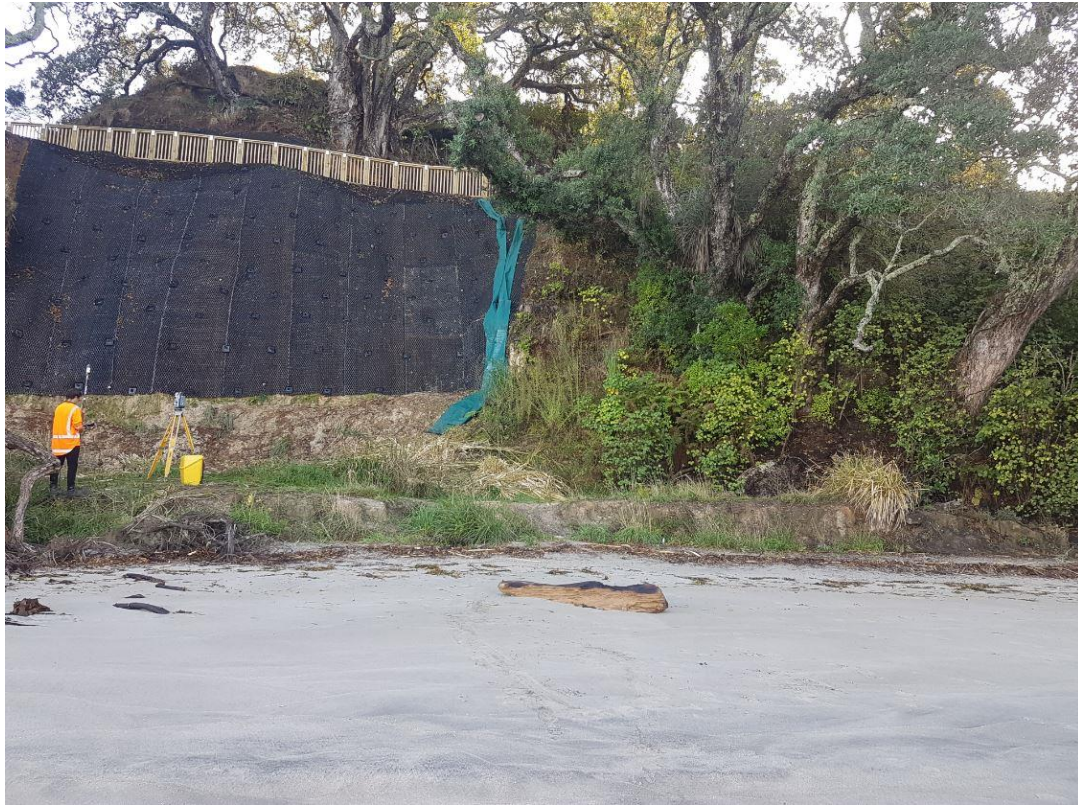
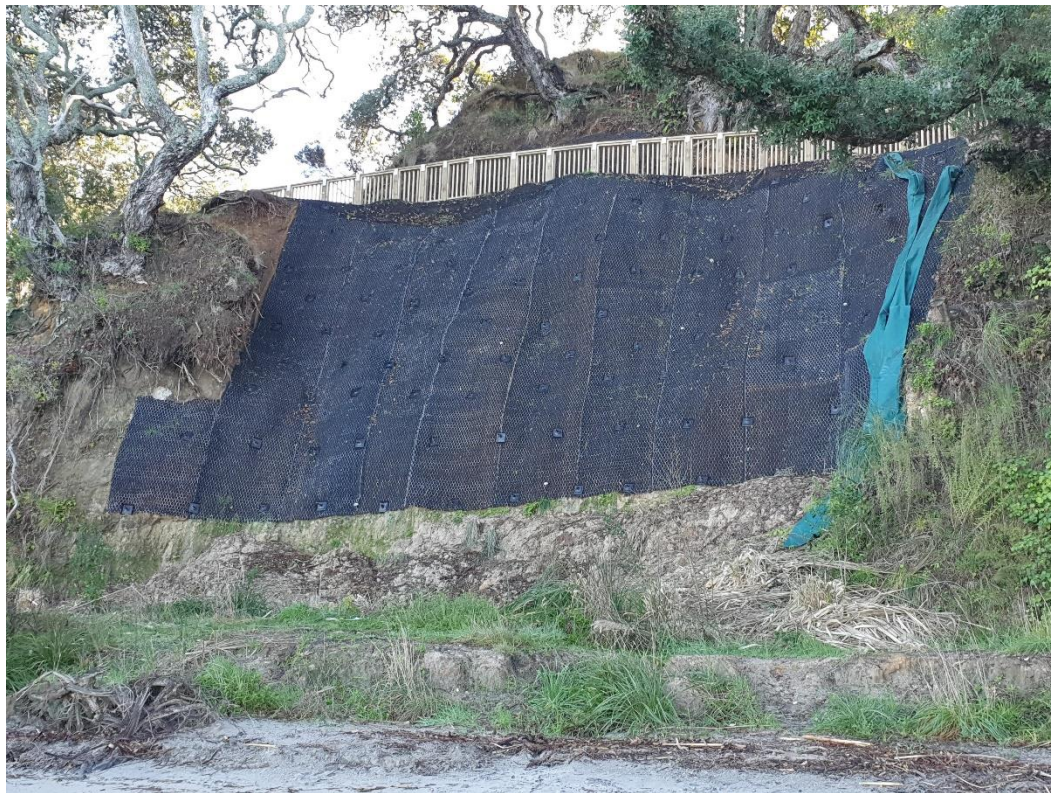
Photograph 15 & 16

Photograph 15 (top, 01/06/20) and Photograph 16 (bottom, 29/06/20). Looking up to the slip face.
