Tauranga City Council

Mount Maunganui Landslide, Tauranga January 2026

Preliminary Geotechnical Appraisal Report – Mount Maunganui Beachside Holiday Park Landslide

16-03-2026

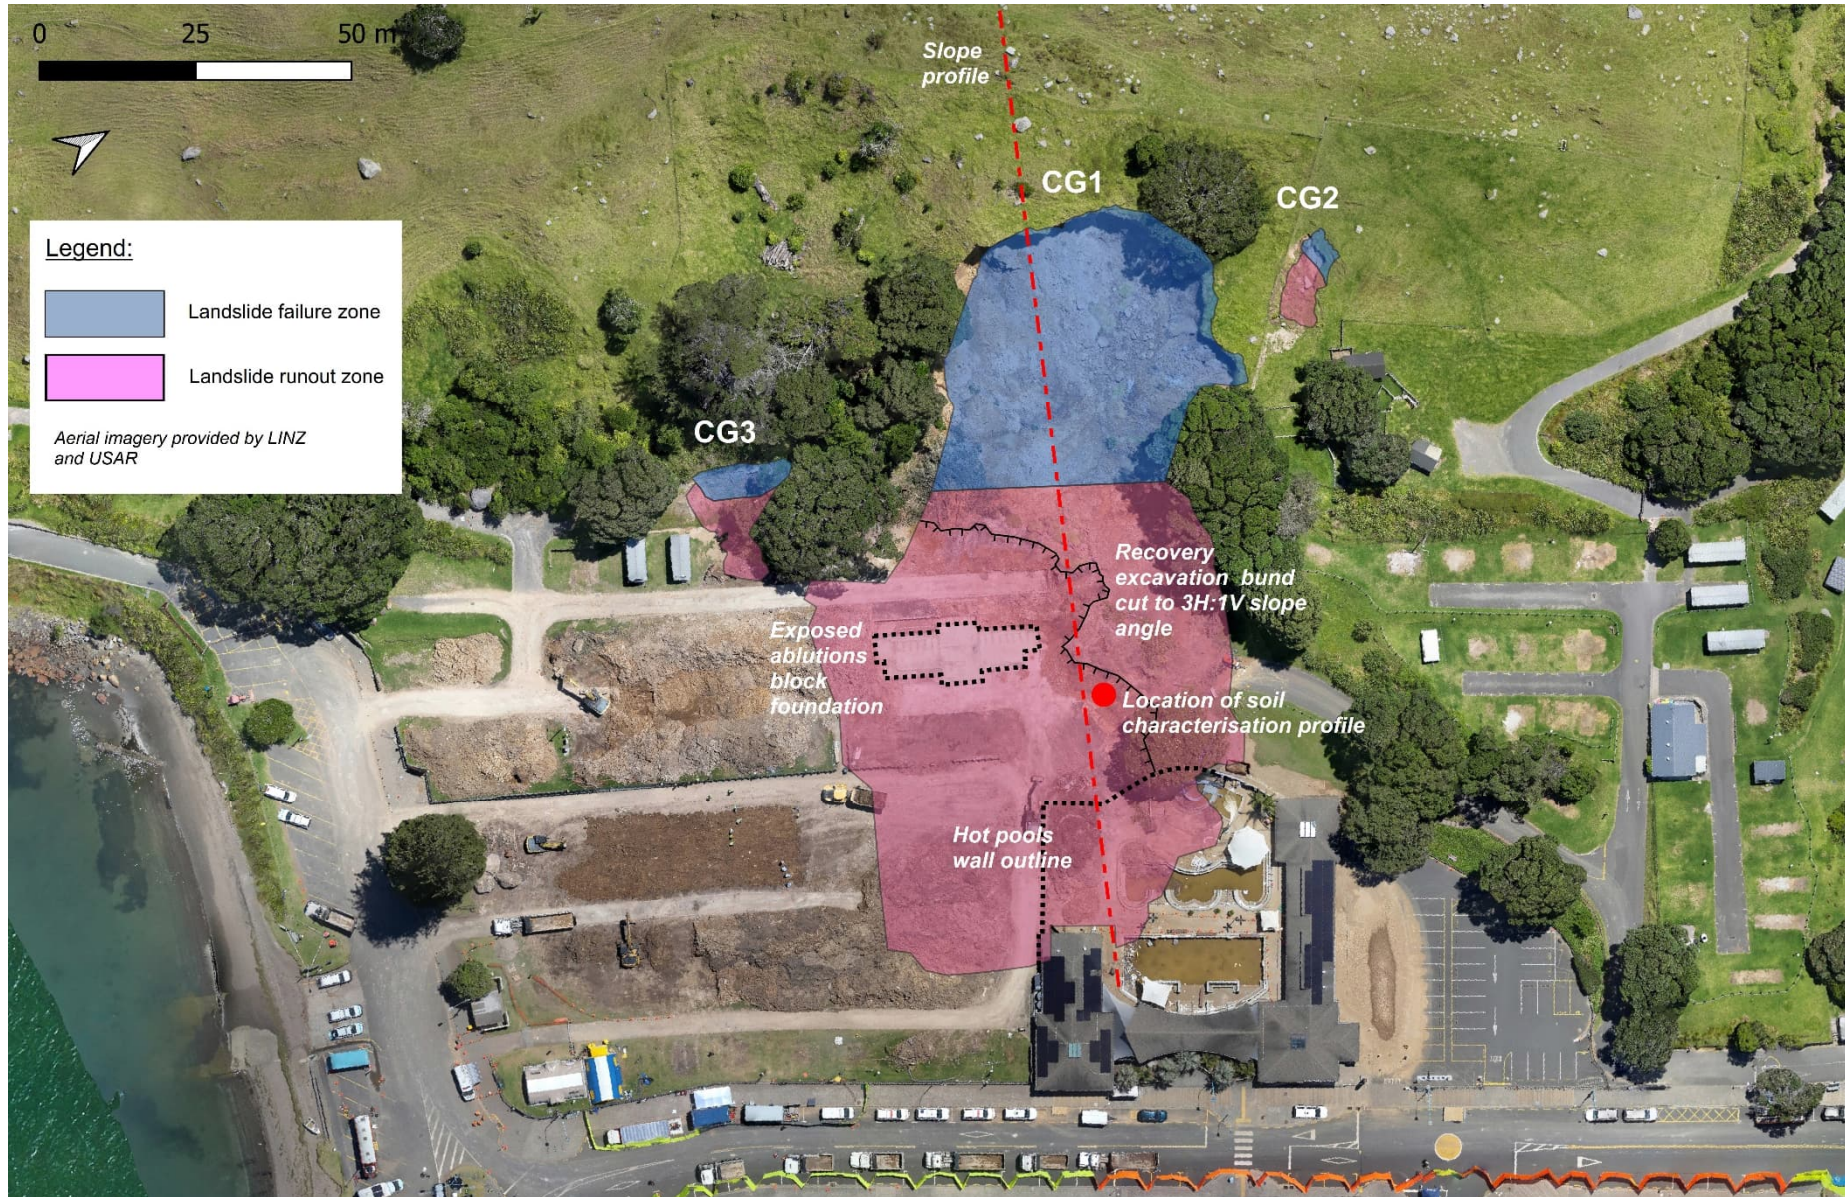
- Based on the aerial imagery, the landslide produced a scarp approximately 40 m wide and 20 m high, with the debris running out approximately 125 m from the top of the head scarp (see CG1 below, Figure 1). The landslide debris material comprised predominantly soils, with several metre-sized boulders, and produced an estimated 2 to 4 m thick deposit, with an estimated

volume of greater than 10,000 m³. Two smaller failures also occurred within the site, including a small translational slide to the north (CG2) and a small rotational slump to the south (CG3) of the main scarp area (CG1).

Figure 1. Site plan showing location of landslides that occurred on 22 January 2026 within the Harbour Side of the Holiday Park. Adapted from LINZ and USAR aerial imagery (dated 30 Jan 2026).

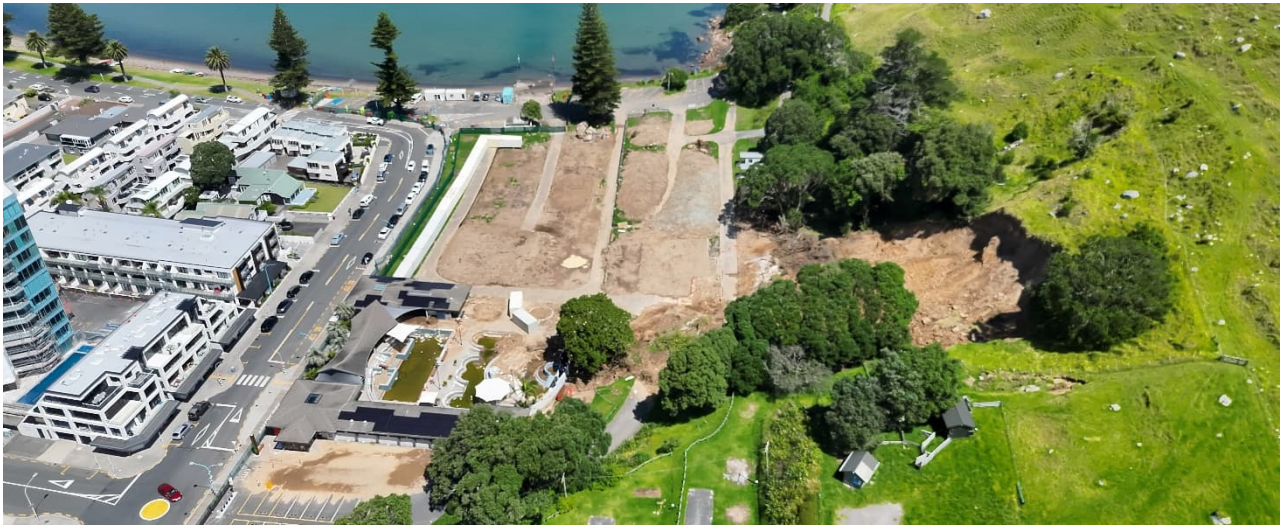
ID	Description	Dimensions	Runout Distance	Other Comments
CG1	Observation of the scarp indicate a deep-seated rotational failure approx. 8m thick. The scarp is concave which suggests an initial rotational slump failure, however observations and examination of video footage suggest the debris moved as a translational mass to the east with little rotation. Debris material is comprised of a thick succession of soils containing weathered tephra, sediments, colluvium, midden layers, organic soils and interspersed rockfall boulders. The debris has a fine-grained tephra surface at its base with limited deformation of the soil layers within. The failure initiated between two relict slip scarps (“Bull Nose”) and incorporated the thin triangular wedge of soil between them.	Failure Zone: 20 m elevation change in head scarp 40 m wide, 45 m long Area of ~1650 m ² Debris Zone: 60 m wide, 80 m long Area of ~4100 m ²	125 m horizontal distance from head scarp to debris toe. Water and slurry runoff extends up to 50 m from the debris and follows a drainage path around the Hot Pools and along Adams Avenue.	Slumping of very saturated toe/cut face (evident in public sourced media) observed prior to main failure. 150 mm PE water main was exposed and severed with an unknown contribution to failure mechanics and timeline. Multiple examples of water flowing/seepage from the exposed scarp face suggests significant sub-surface flow prior to and during failure.

Figure 2. Aerial UAV photograph of the main slip CG1 looking south.

- Prior to the heavy rain event, the previous slope was generally dry and in an unsaturated state, with the sudden and heavy rainfall causing a reduction in suction and loss of apparent cohesion within the upper soil profile.
- Heavy rainfall resulted in raised groundwater levels and reduced shear strength of the soils. It is assumed that water from rainfall is stored and transported within fracture networks within the rhyolite rock further upslope, with hydraulic head building up and eventually driving flow through the subsurface soil profile. As the failure occurred after peak rainfall, there was a delayed response, and pore pressures would have likely increased progressively until failure. Strong seepage flows observed immediately after the landslide are evidence that high porewater pressures were occurring at depth and were released upon exposure of the slip surface.

- The site is located within a zone of historic failures with permanent springs and seeps that daylight nearby. Springs/seepages continued to flow at various locations within the main failure surface (CG1) and within the smaller translational slide to the north (CG2) for up to a week following the failure with pooling of water in the debris immediately below the scarp also noted. The landslide debris is interpreted to have been transported along a fine-grained rhyolitic tephra layer, possibly the Pahoia Tephra as this was observed at the base of the landslide deposit (see Figure 6 above. This will need to be confirmed with borehole investigations and laboratory testing in vicinity of the failure scarp to determine the spatial extent of these deposits.

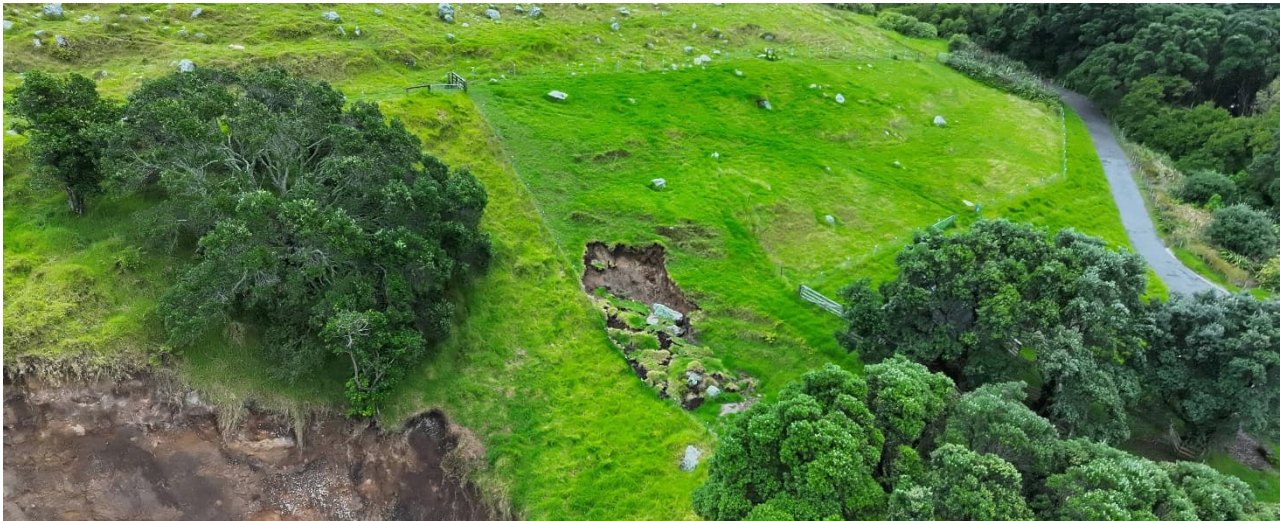
CG2	A shallow, translational earth slide that has occurred upslope 20 m north of the main slip CG1. Excavated soils comprise weathered tephra and organic soils. Occurs within a historically defined failure zone.	Failure Zone: ~1 m tall head scarp 6 m wide, 4 m long Area of ~25 m ² Debris Zone: 5 m wide, 10 m long Area of ~55 m ²	15 m horizontal distance from head scarp to debris toe. Water and slurry runoff extends up to 15 m.	Several tomos are present below the base of the topsoil that extend an indeterminate distance back into the slope, suggesting significant subsurface flow.

Figure 3. Aerial UAV photograph of CG2 looking north. Main slip in lower left of image.

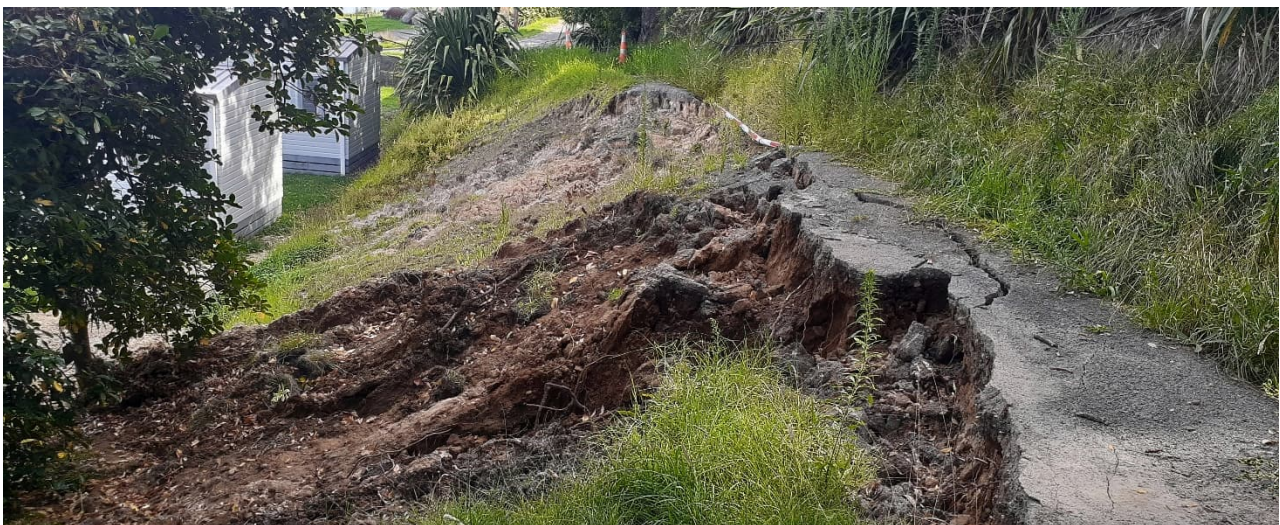
CG3	A small rotational earth slump within a cut-bank at the toe of the southern end of the campground. The head scarp has intersected the old walking track. Multiple small, slumped blocks have rotated downslope. Occurs within a historically defined failure zone.	Failure Zone: ~20 m wide 5 m tall scarp Area of ~70 m ² Debris Zone: ~ 20 m wide Area of ~100 m ²	10 m horizontal distance from head scarp to debris toe. Water and slurry runoff extends up to 10 m.	Occurring within cutbank at base of Mauao. Reoccurring failure that occurred before October 2025. Tension cracks present along walking path and slumping of slope were documented in 2023.
------------	--	---	--	---

Figure 4. Photograph of CG3 slump looking southwest.

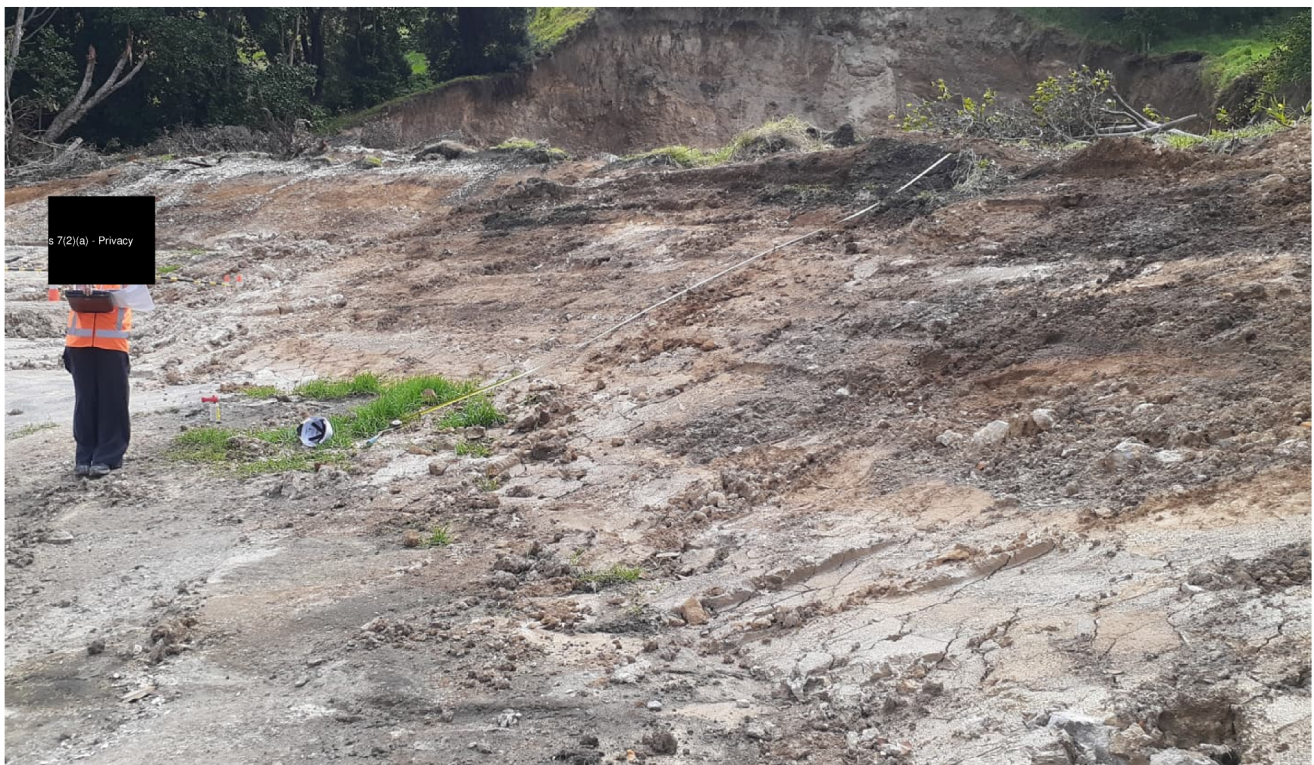
The following soil profile was obtained from an approx. 2.5 m high slope batter exposure (at 3H:1V angle) near the centre axis of the landslide debris and 80 m from the head scarp. See Figure 1 above for location of slope profile, Figure 5 below for a photograph of the batter, and Figure 6 for the slope profile with an annotated soil profile.

Unit	Unit Thickness (approx.)	Description	Residual Moisture
Topsoil and Midden / Shells	0.5 m	Dark brown SILT containing abundant intact bivalve seashells such as Pipi.	Moist
Orange-Brown Tephra	0.45 m	Brownish orange SILT with minor clay, minor fine to coarse sand and minor angular gravel and cobble-sized angular clasts. Moderately plastic when wet.	Moist to wet
Colluvium / Landslide Deposit	0.25 m	Yellowish orange-grey cobbly fine to coarse gravel within a sand and silt matrix. Poorly sorted with angular to rounded clasts comprised of fresh and weathered rhyolitic/dacitic lava. Matrix is moderately plastic when wet.	Mosit to wet.
Orange-Brown Tephra	0.5 m	Brownish orange SILT with minor clay and minor fine to coarse sand. Trace gravel and cobble-sized clasts. Moderately plastic when wet. Grades into bright orange with pockets of brown mottles throughout with gravels and cobbles absent. Appears as nearly solely silt and clay ash. Highly plastic.	Mosit to wet

Figure 5. Photograph showing the batter slope excavated through the landslide debris during recovery efforts which provides an insight into the soil units within the failure. The main slip scarp can be seen in the upper background of the image.

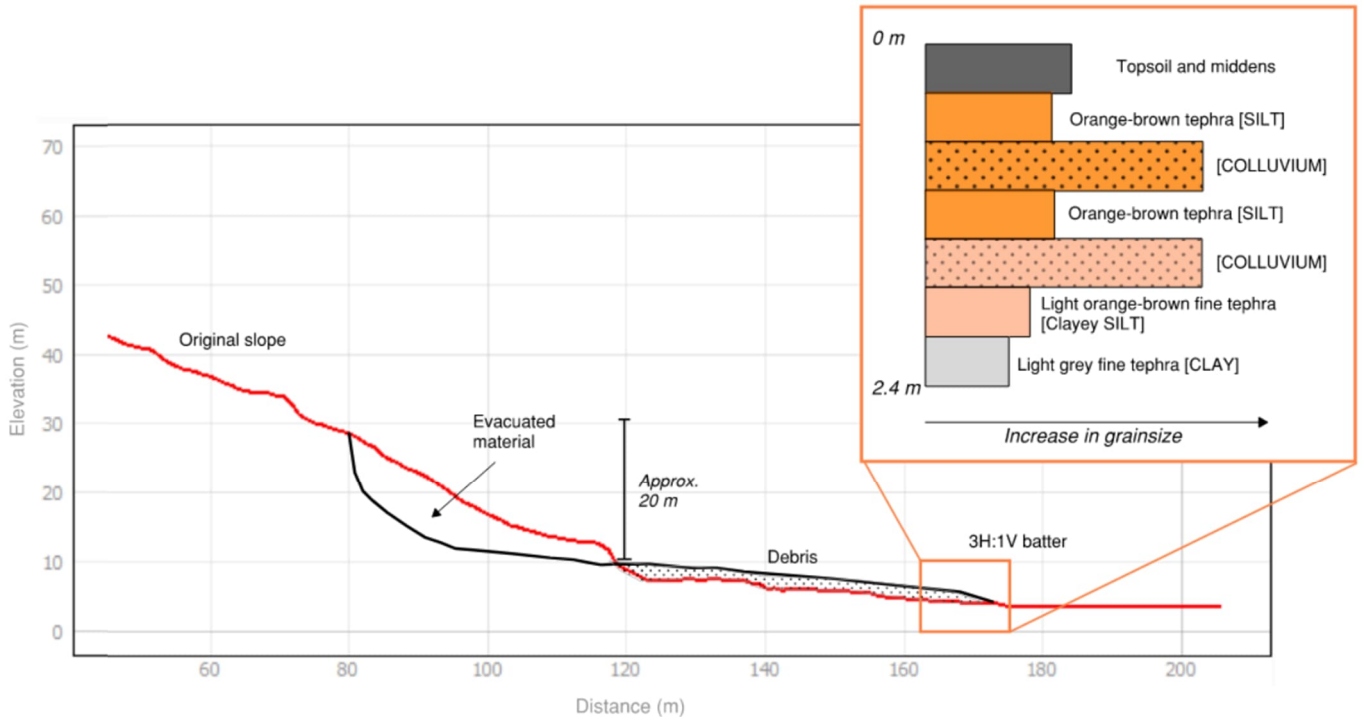
Figure 6. Slope profile showing landslide failure zone of CG1. Simplified soil profile obtained from cut batter shown in top right inset.
