SITE VISIT RECORD

Contract: Mauao Base Track Geotechnical Monitoring
Project Number: 2-9B463.01

Inspection No: 1

Work Site: Mt Maunganui Base Track

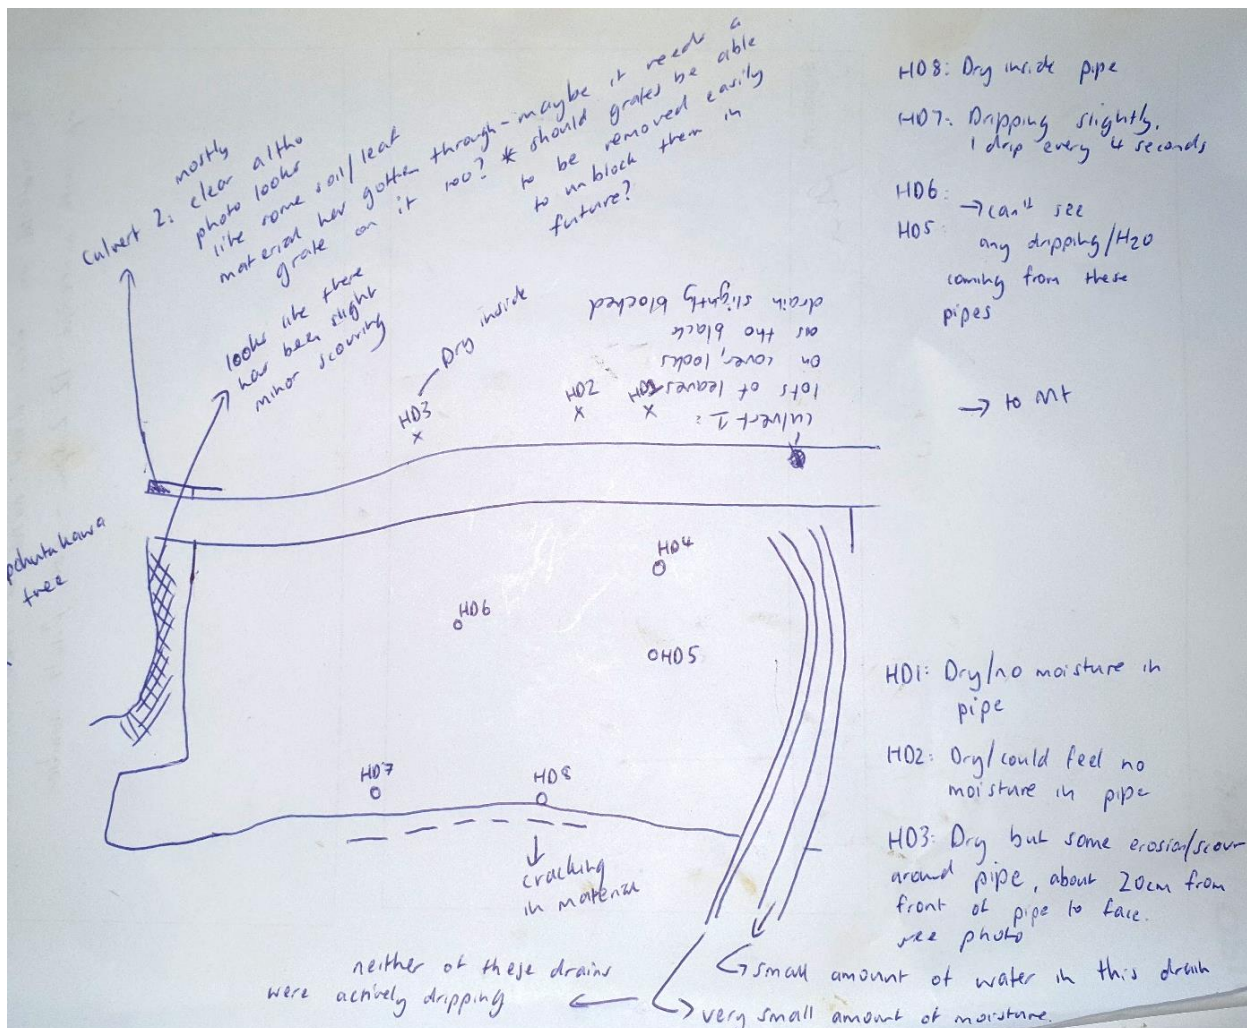
Figure 1 - diagram of site and notes

- The track at repair level was checked. Refer to diagram sketched in Figure 1. The track itself was wet but there was no ponding, erosion, or deformation / cracking observed on the track itself. The track however may need some additional track metal at some stage (Photographs 1 and 2).

- Horizontal drains HD01 - HD03 (Figure 1) on the slope above the repaired track were checked. There was no moisture inside any of these drains indicating that it was unlikely that any had been flowing during the heavy rain overnight. Drain H03

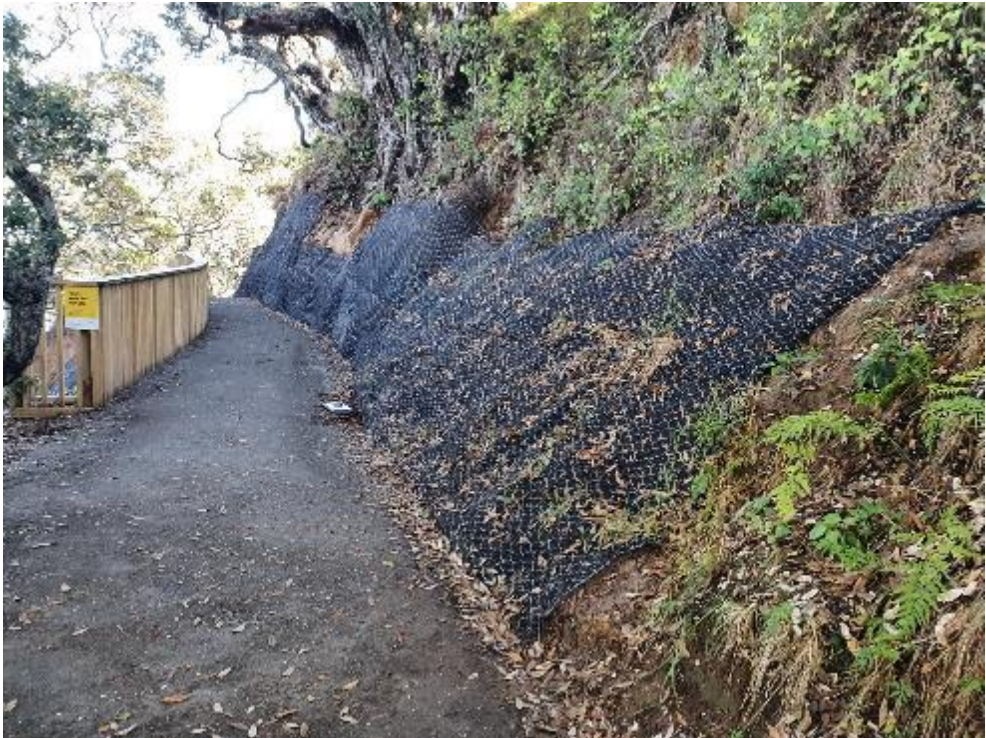
- All grates entering culvert inlet at the north side of the track on the eastern side of the repair were clear - however they were covered with leaves (Photographs 1 and 2). The green drainage socks that collect water from this culvert and outlet at the bottom of the slope had a small amount of moisture in them, indicating that water had been flowing overnight but had since stopped. There was no water draining from these socks when observed.
- The geometry of the track has a reverse grade to the swales that lead to the culvert inlets.

Photograph 1 - At the start of the track looking west

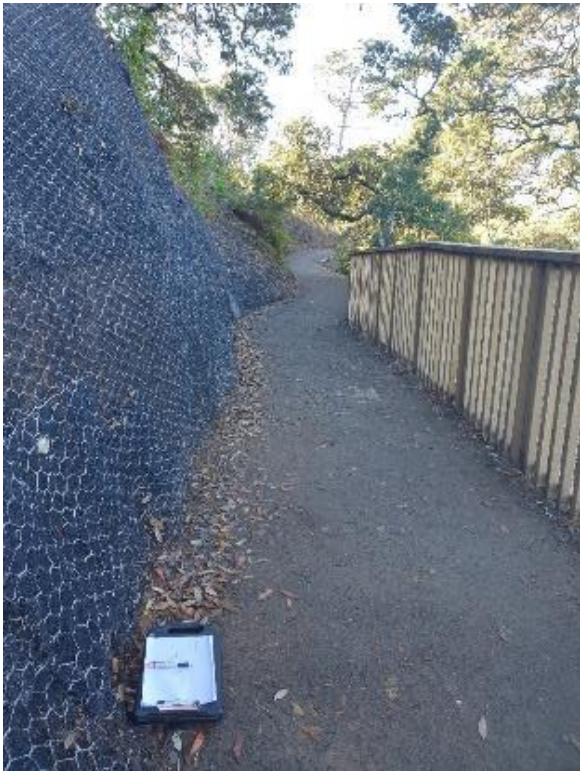
Photograph 2 - From the middle of the track above the slip looking east

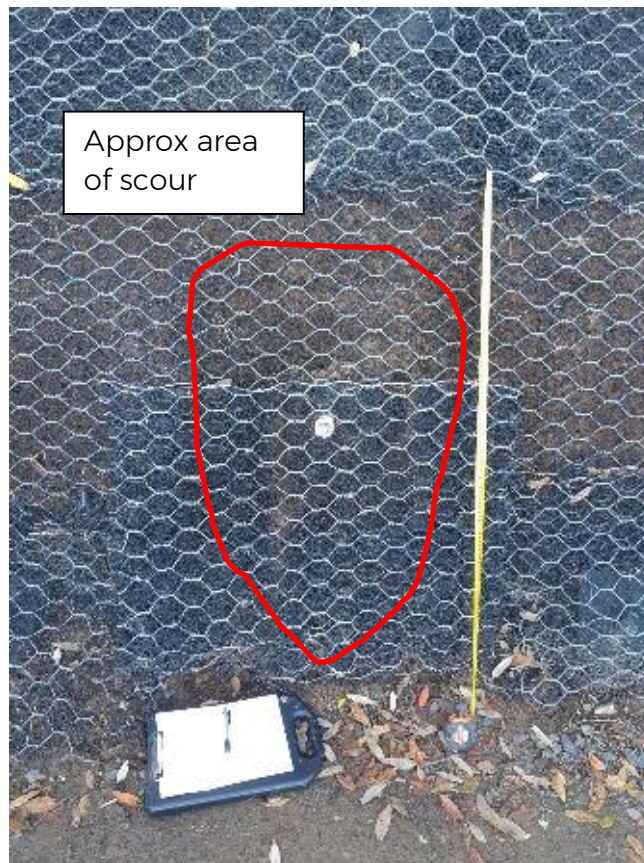
was dry however there looked to be some scouring / slight earth movement around the pipe (but this may have been there since construction, so we will continue to monitor).

Photograph 3 - There appears to be scour around Horizontal Drain 3. We will continue to monitor this.

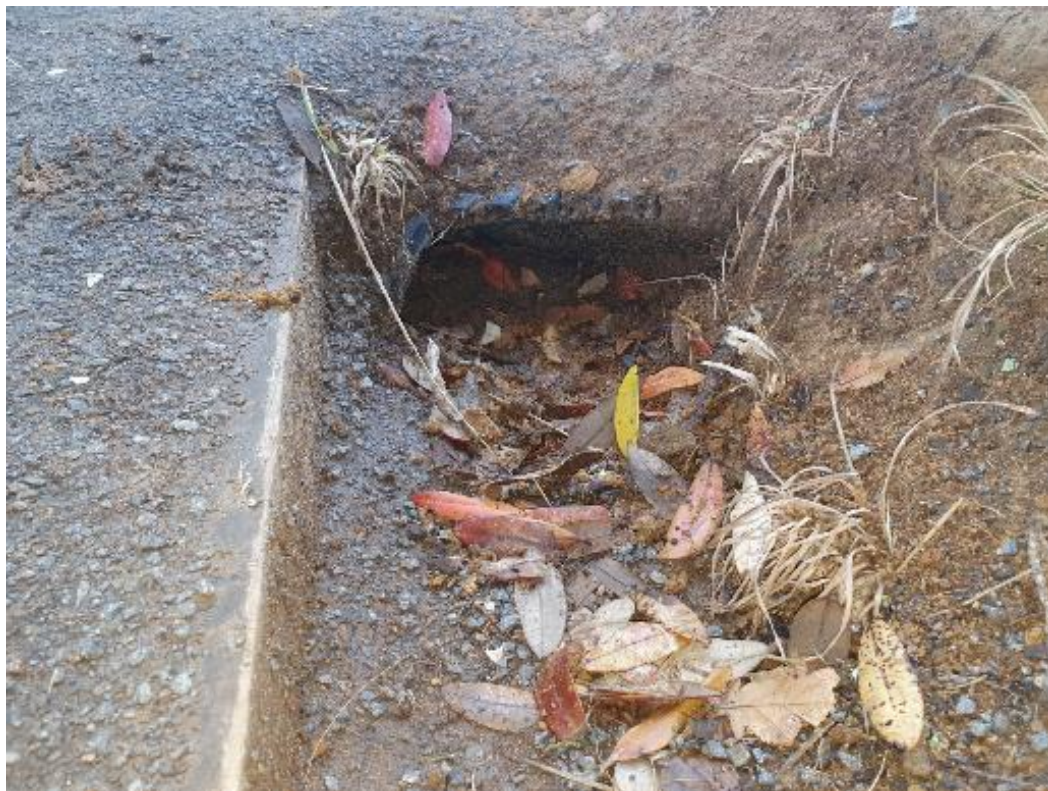
- The soil around the pipe was wet and was quite weak. The geogrid was not attached to the slope face in the vicinity around the drain. The drain down by the harbour end of the base track (CO2, Figure 1) was mostly clear except for a minor buildup of silt/clay material on the inside. (Photographs 4 and 5).
- At the bottom of the slope no water was observed dripping from horizontal drains on the slope (H04, H05, H06, H08), with the exception of H07, which had a very minor amount of water dripping out of it - about 1 drop every 4 seconds.
- On the slip scarp itself there were no signs of soil nail deformation / movement. The material / debris immediately below the geogrid cover at the base of the slope showed minor cracking - see Photographs 10 & 11.

Photograph 4 - Culvert 2

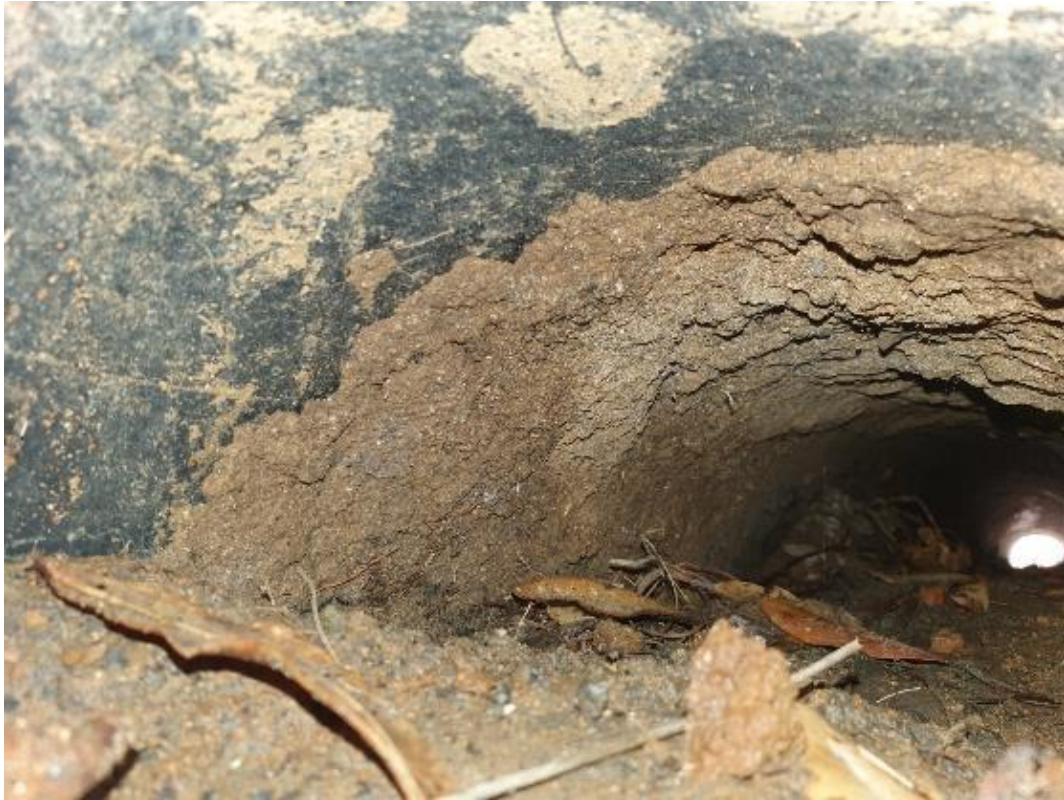
Photograph 5 - View inside Culvert 2 from track to edge of slope

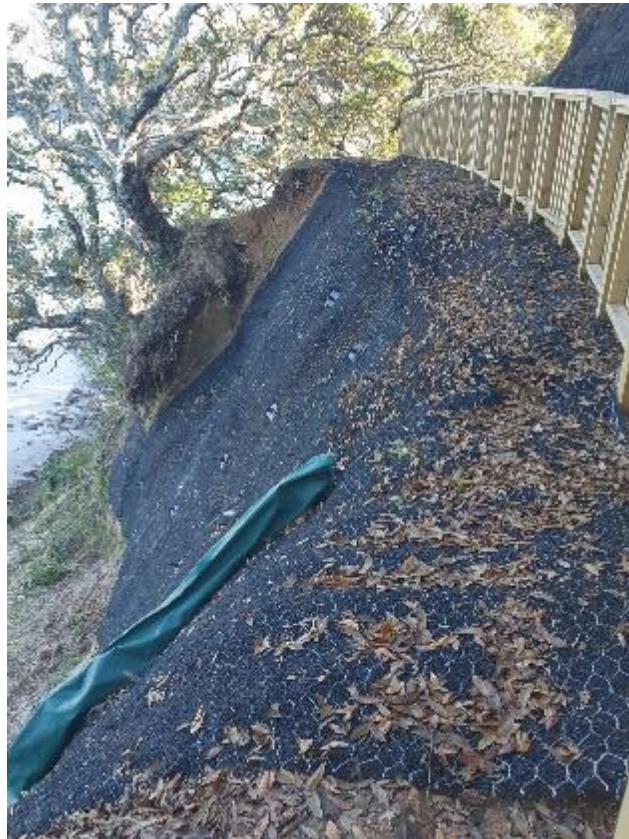
Photograph 6- View of slope looking west

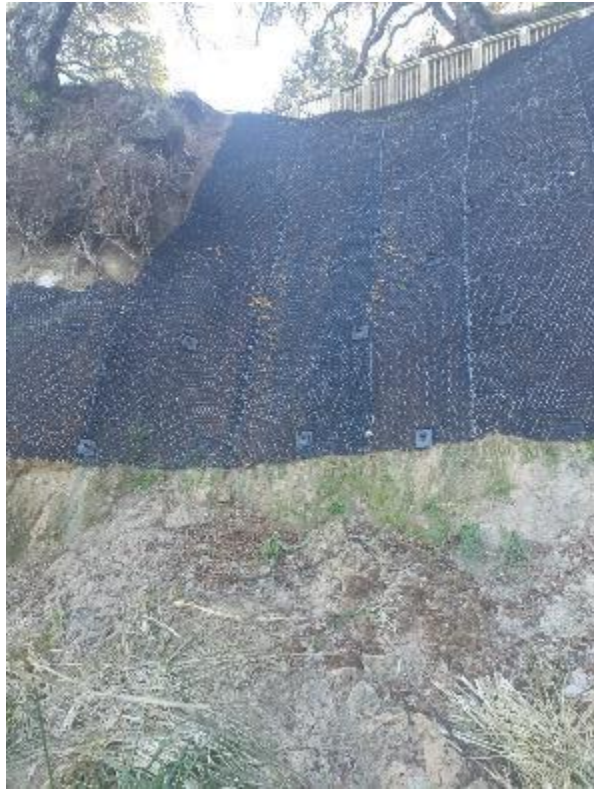
Photograph 7 - View looking upslope

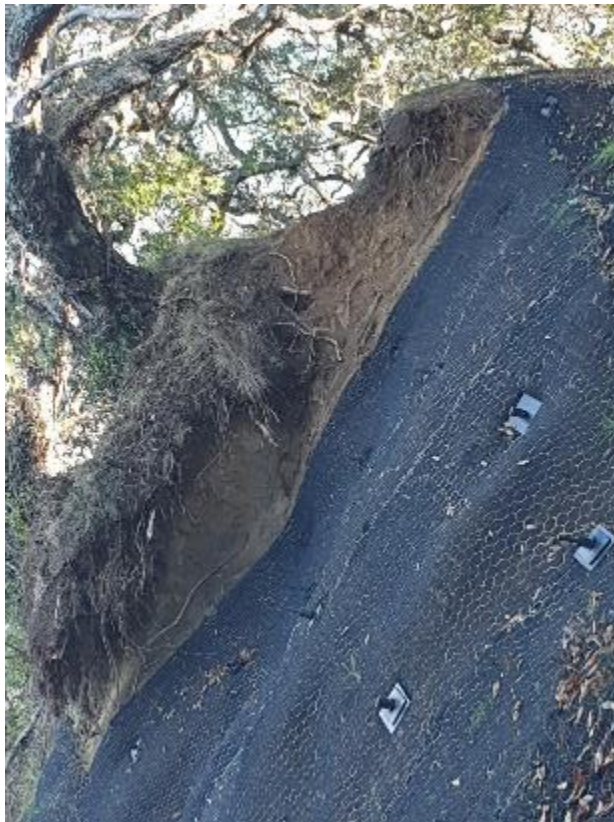
Photograph 8 - Looking west across slip face towards the Pohutukawa tree

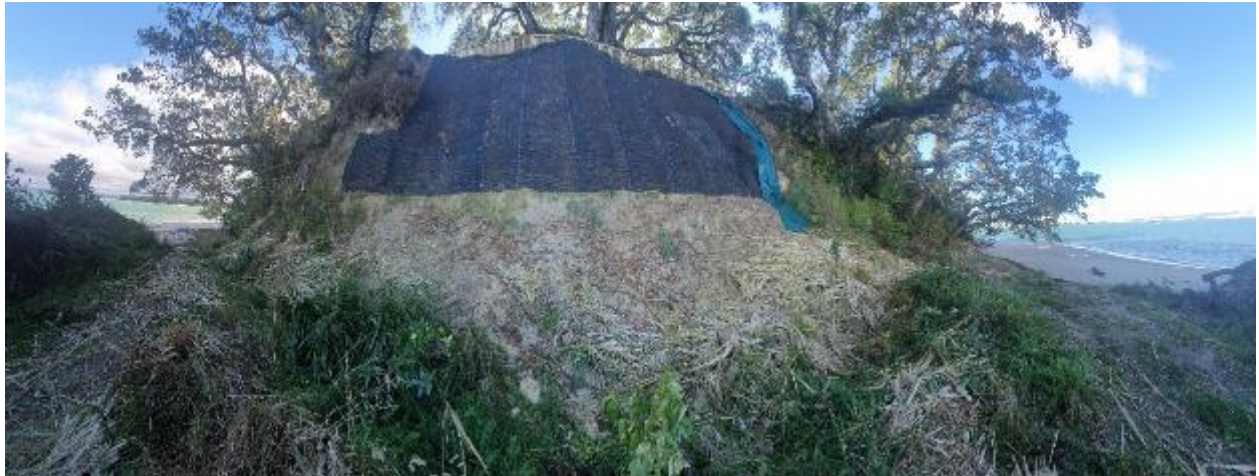
Photograph 9 - View of slip face from bottom of slope

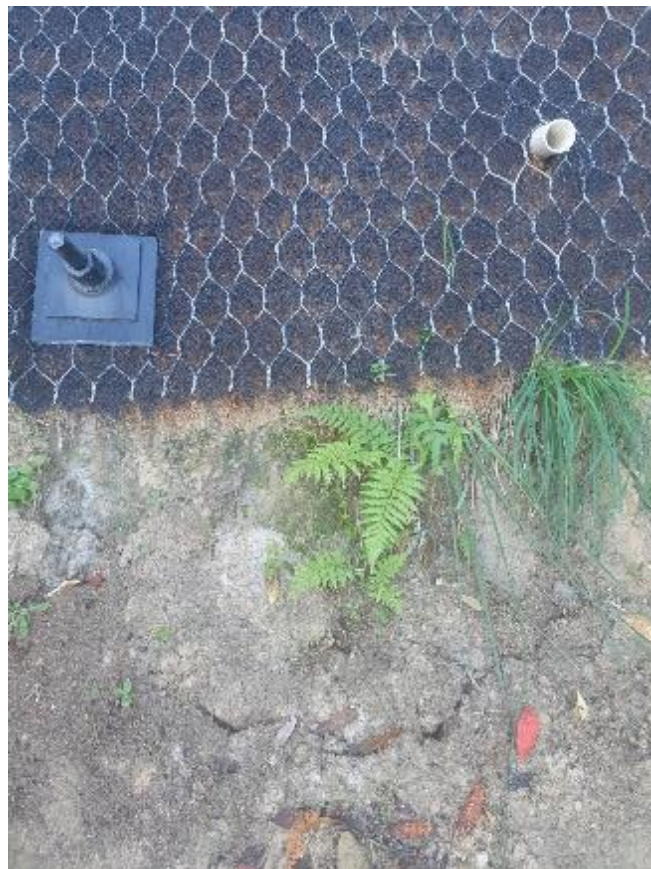
Photograph 10 - Horizontal drain O8 with slight cracking in material below

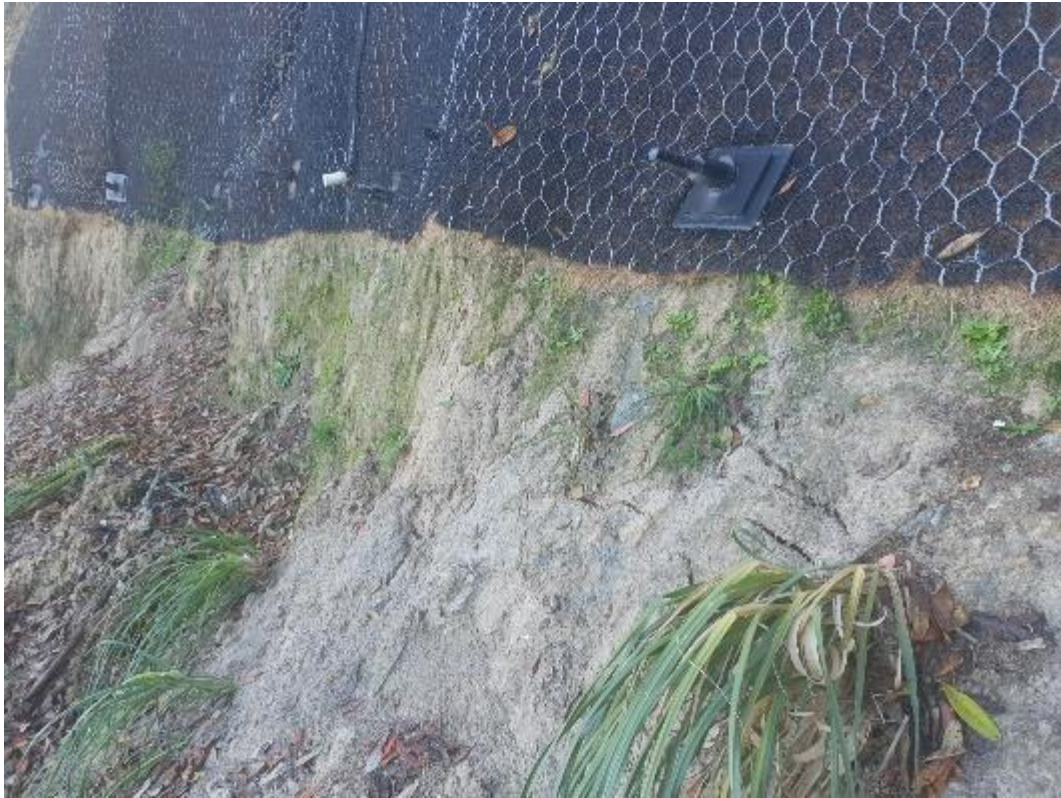
Photograph 11 - Looking east from horizontal drain 08 to horizontal drain 07

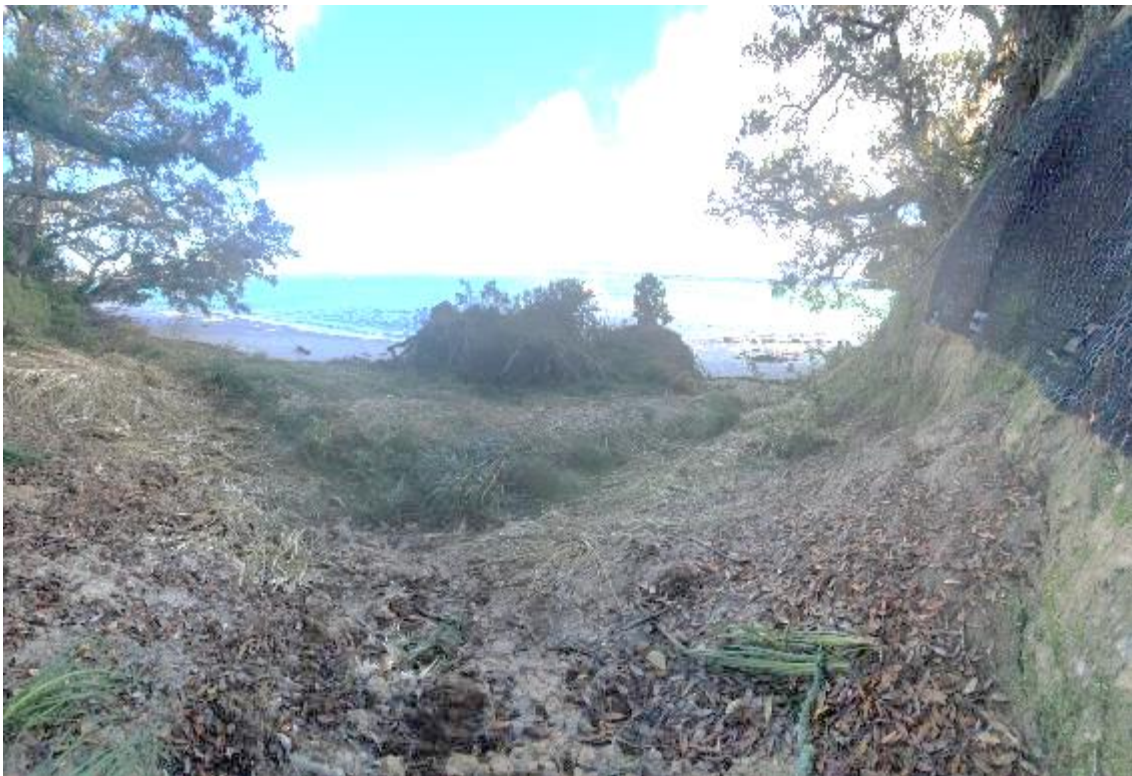
- There were no signs of wave / water erosion of the toe of the slope or between the toe of the slope and debris remains (Photograph 12, 18).
- Note the WSP survey team has since surveyed the toe area to monitor coastal erosion see additional photos below (Photograph 17).

Photograph 12 - View of toe of slip

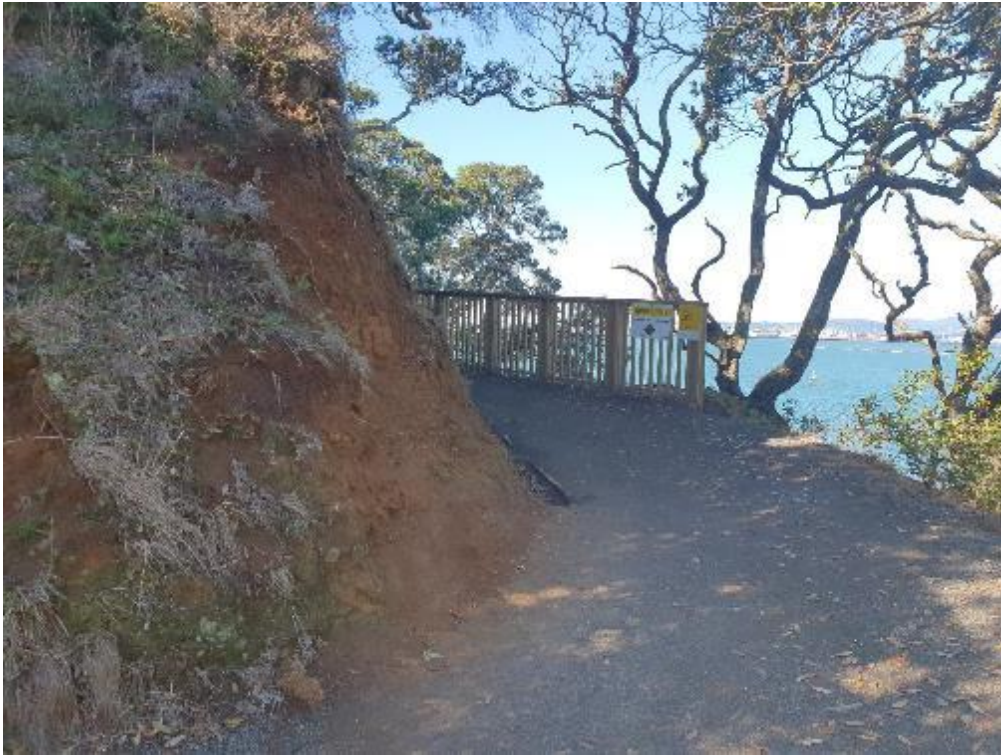
Photograph 13 - The start of the track from the west end

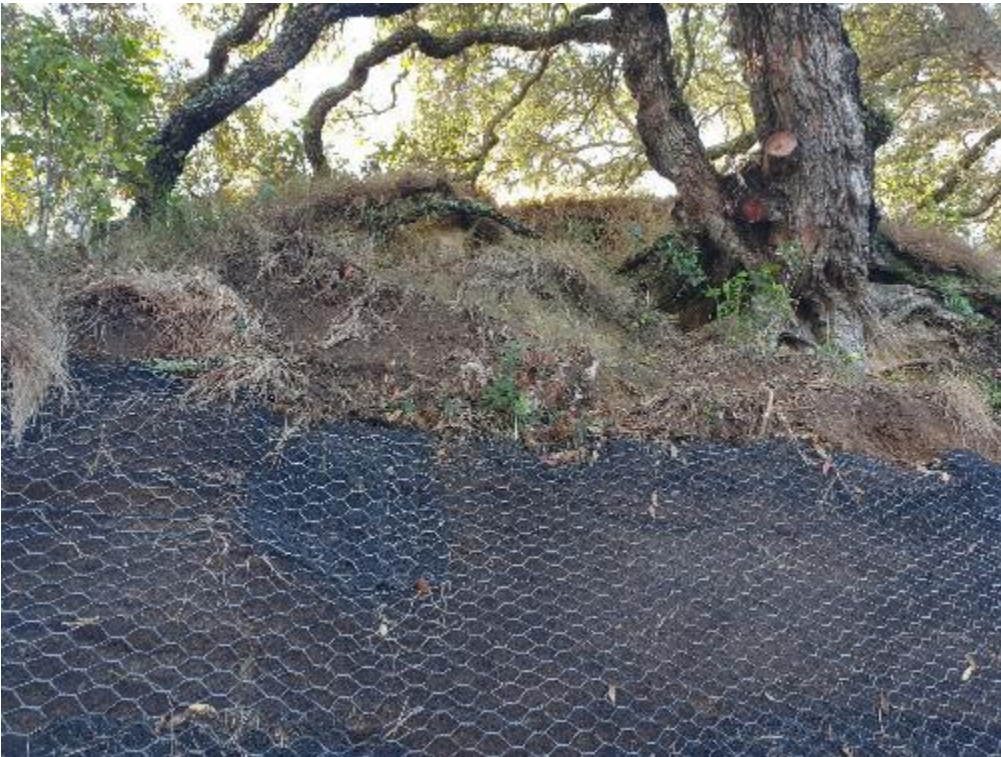
Photograph 14 - looking up to the slope above the top of the track

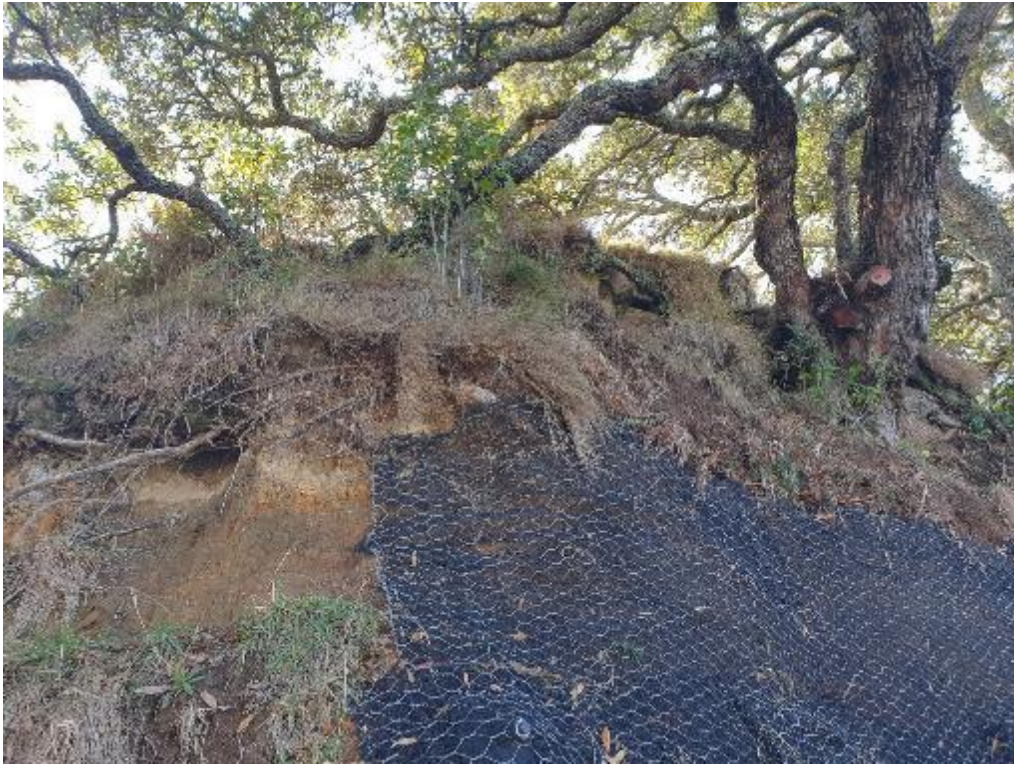
Photograph 15 - looking up to the slope above the top of the track

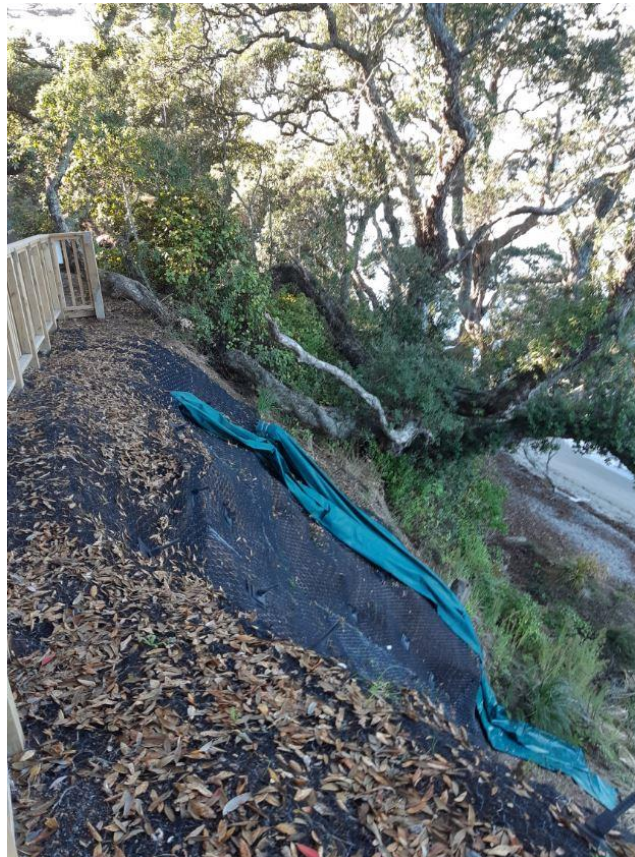
Photograph 16 - View of slope surface looking east

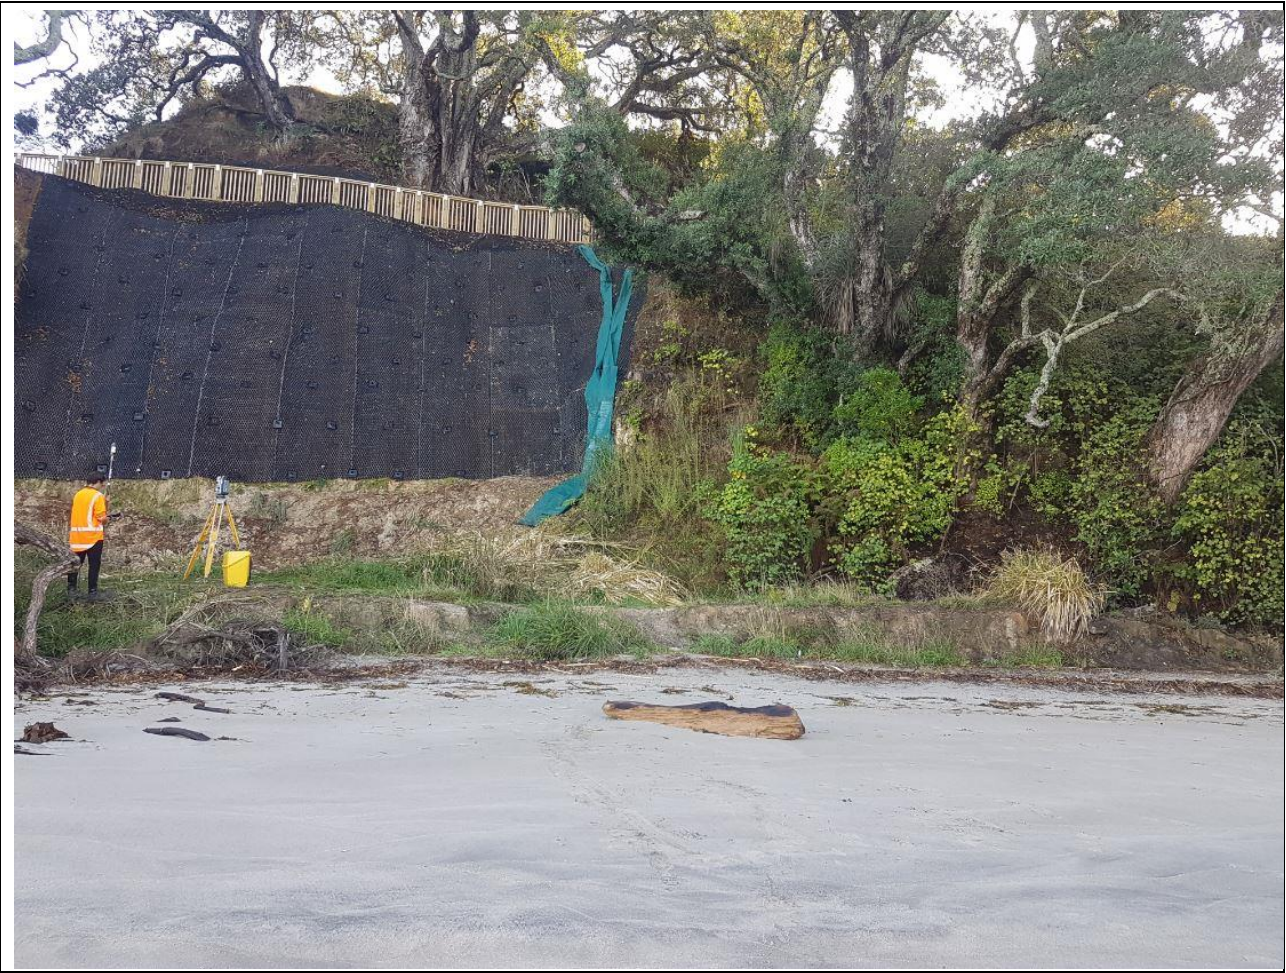
Photograph 17 – Survey team surveying the slope

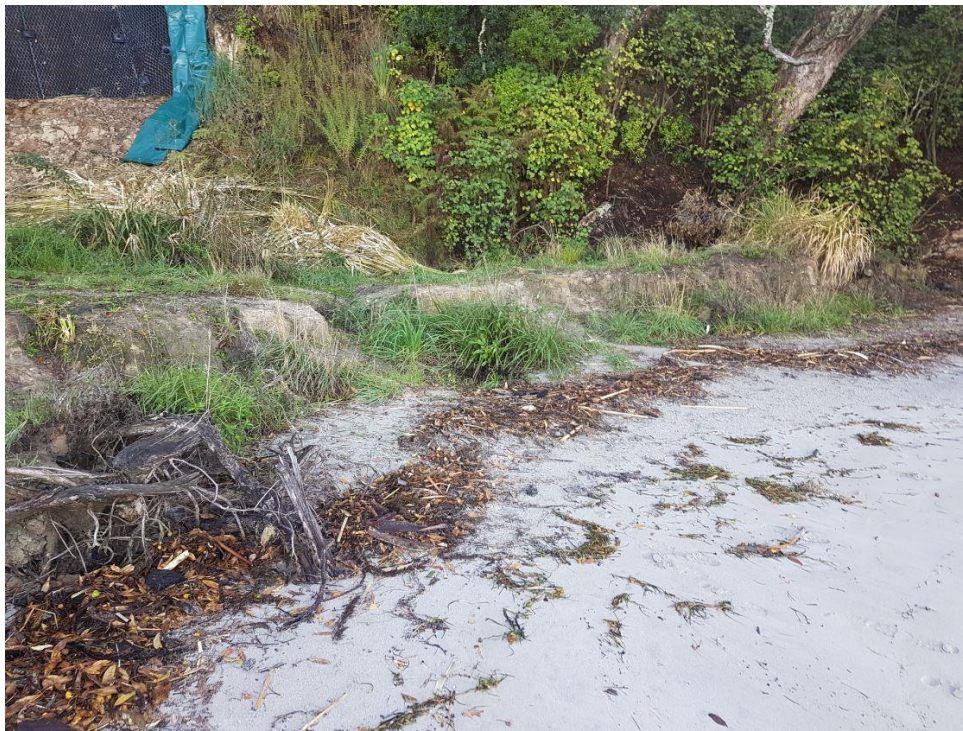
Photograph 18 – The tidal platform at the eastern edge of the slope
