Report on:

Mauao Slopes: May 2006

Rockfall & Landslide Risk Review

Avalon Report No: 0627 A

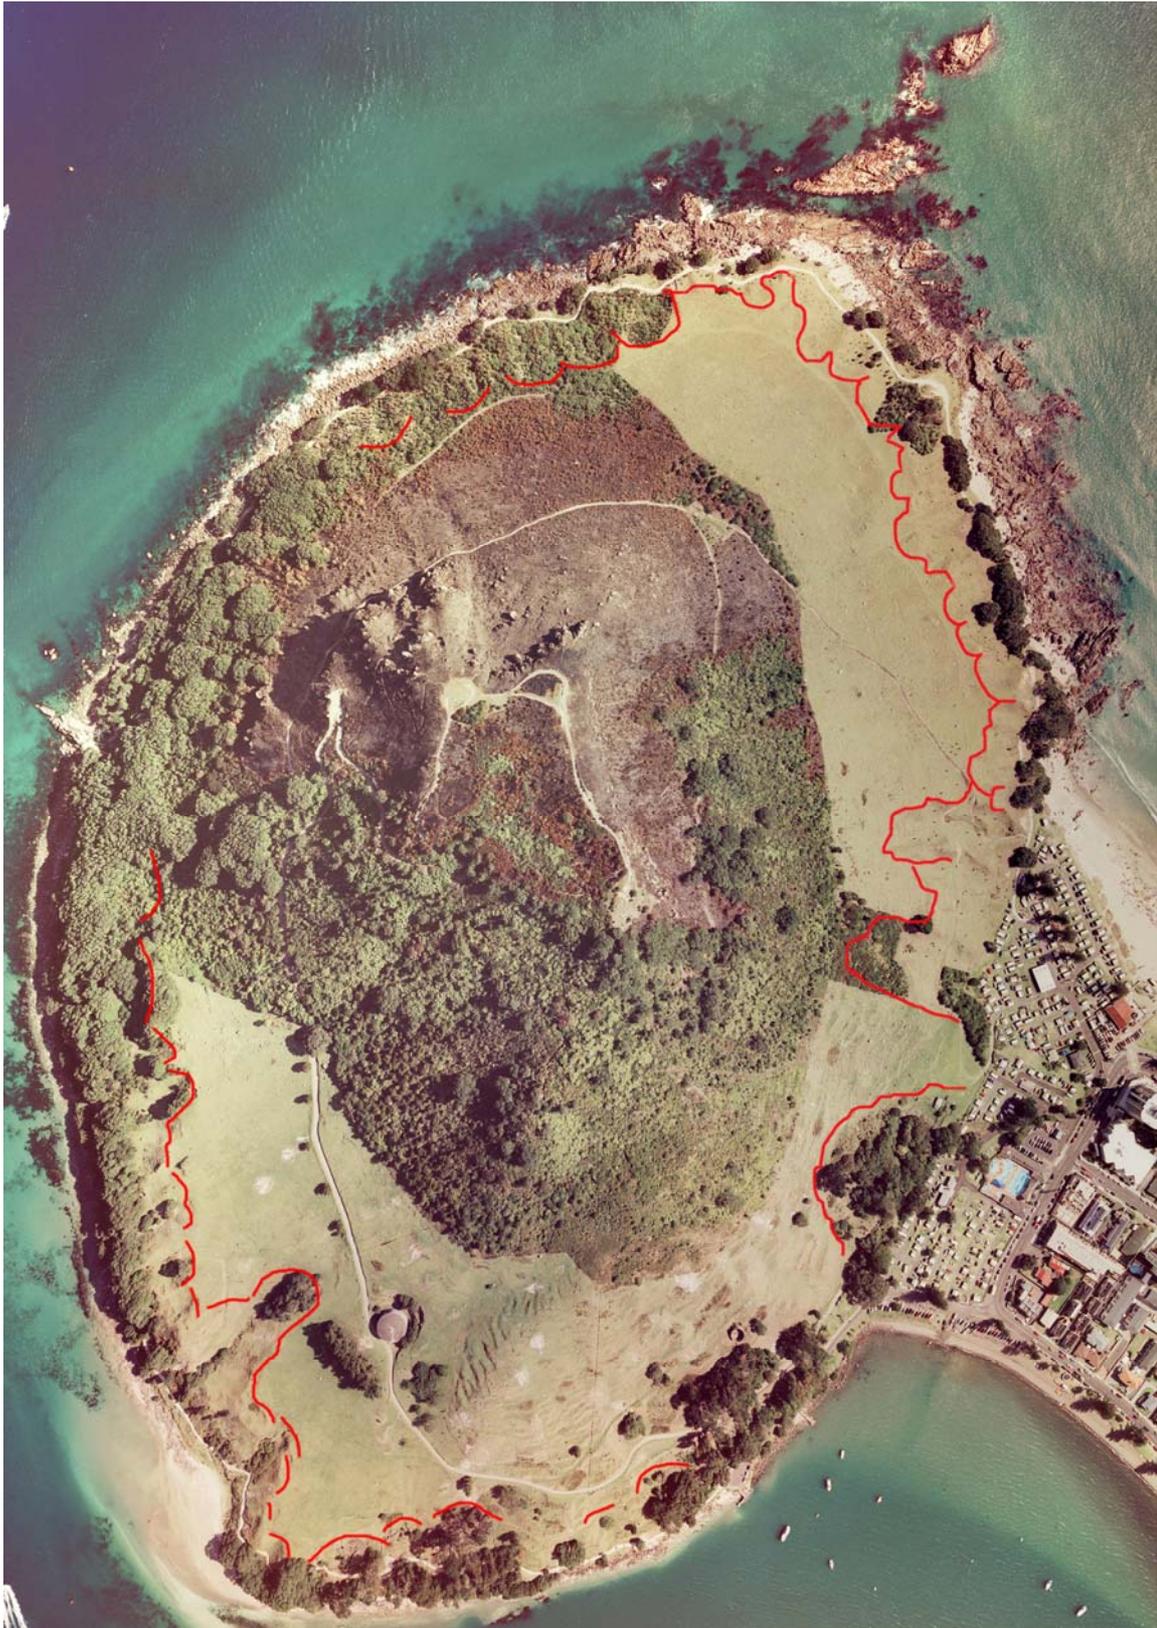
In May 2005 one slip of 8,000m³ occurred following an (approx) 50 year return period intense rainfall.

Photo' 2. Slip scarp locations (also showing 2003 fire area).

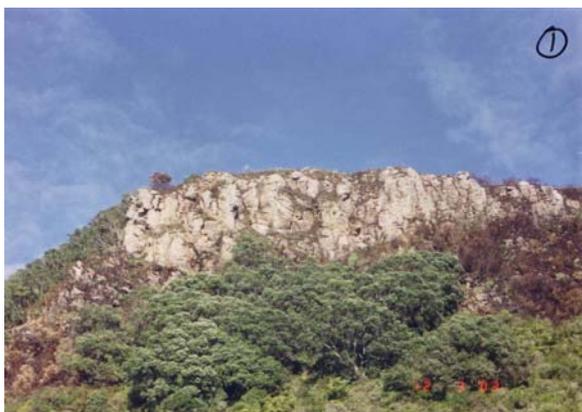
Photo' 3. Eastern bluffs post fire.

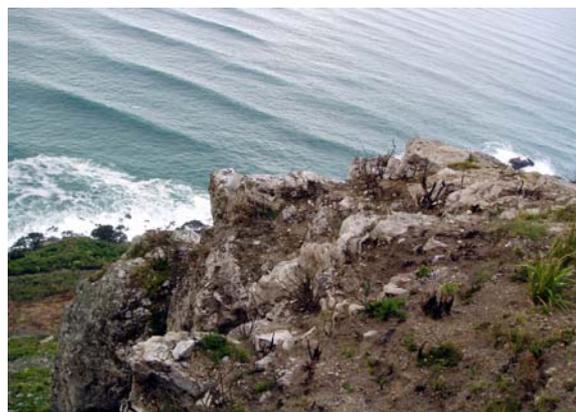
Photo' 4. Northern bluffs post fire.

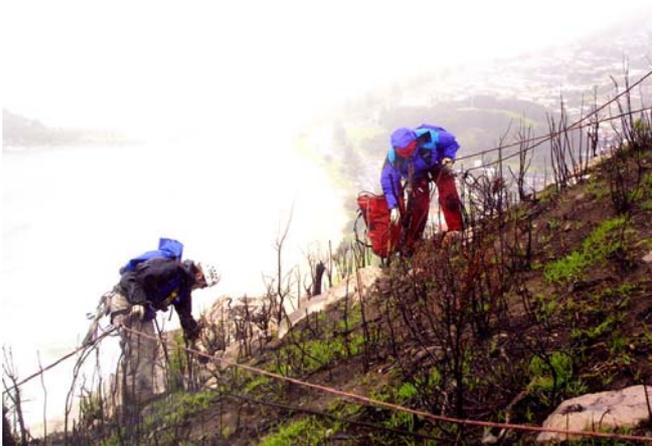
Photo' 5. Scaling by hand on the upper slopes.

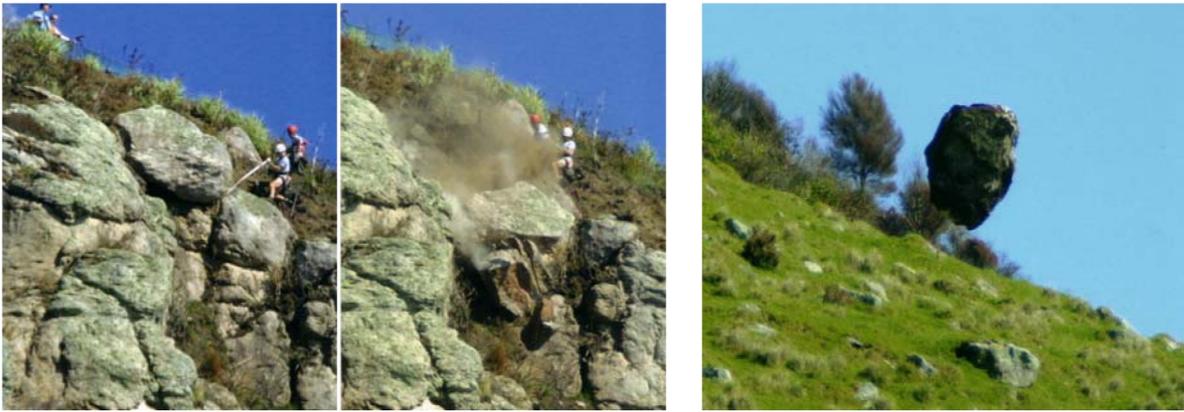
Photo' 6 a,b,c. Seventeen tonne boulder scaled by crowbar.

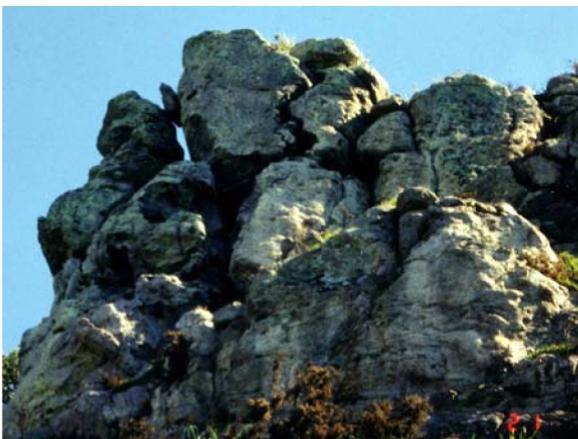
Photo' 7. Camp Bluff from below.

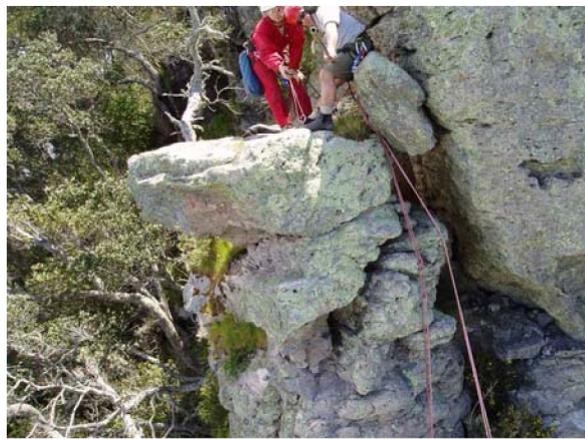
Photo' 8. Spalling at load transfer point.

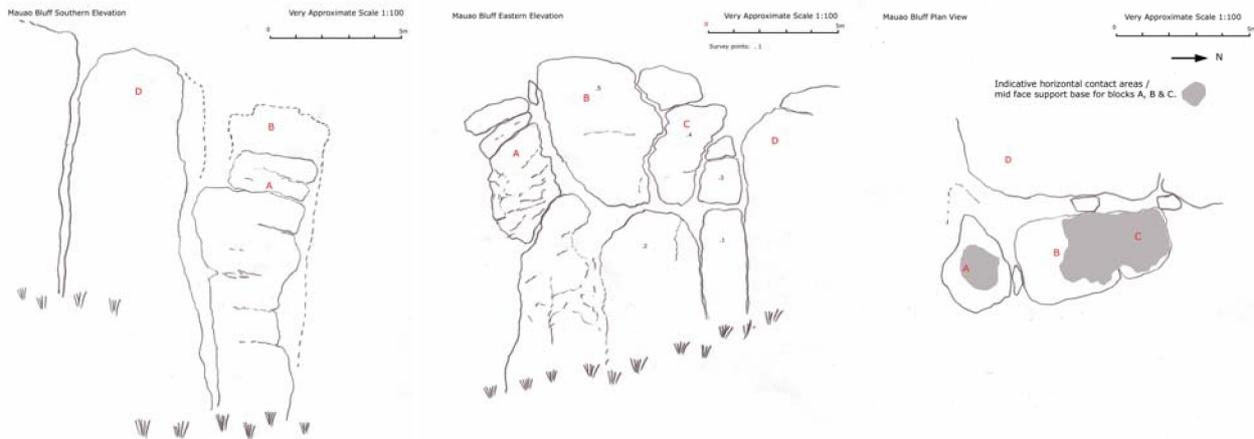
Drawing 1. Blocks A, B & C were extremely near failure.

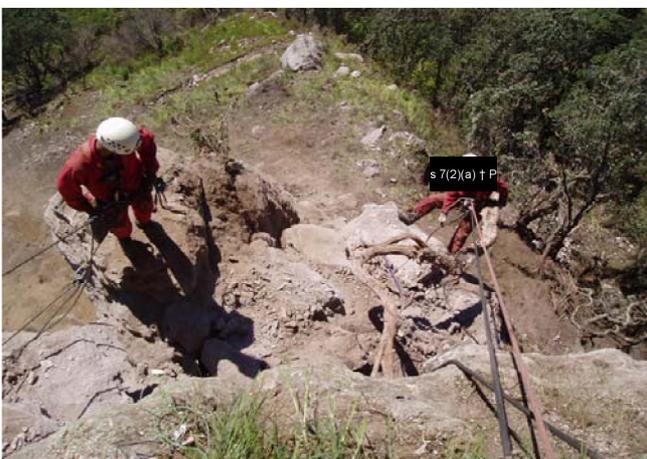
Photo 9. Post scaling; note the rotted tree roots.

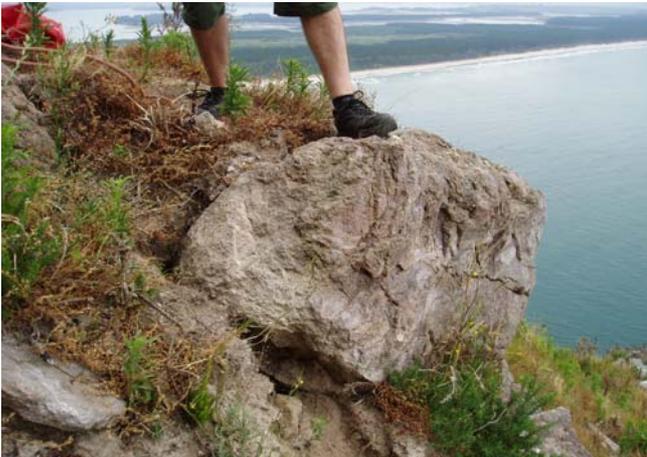
Avalon inspected and it was easily scaled by crowbar. The boulder crossed the Oruahine track high in the air and rolled across the Base Track, coming to rest on the shoreline.

Photo' 10. Boulder scaled in January 2004.

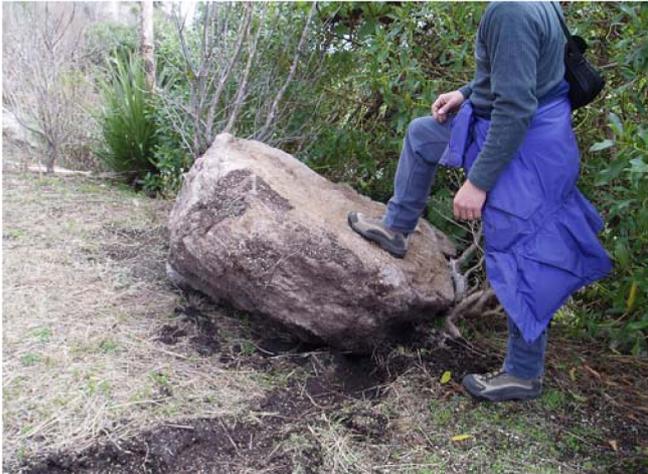
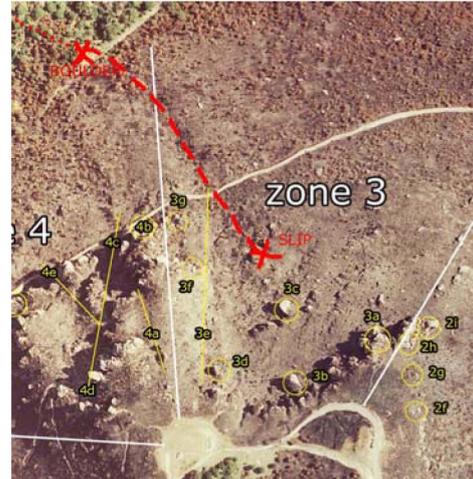
Photo' 11 a & b. Boulder which crossed the Oruahine Track.

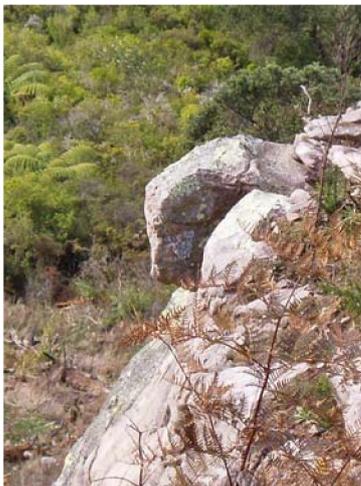
Photo' 12. Boulder moved out from rock face.

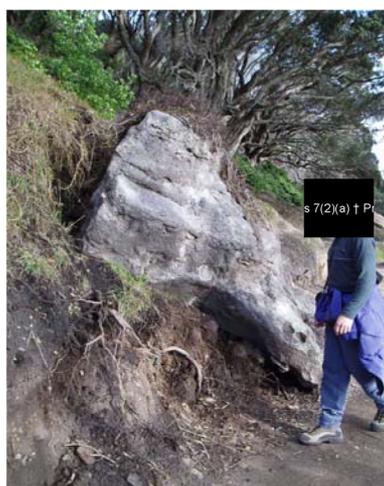
Photo' 13. Boulder movement above Base Track.

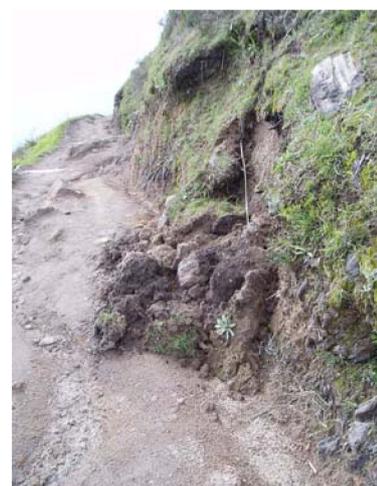
Photo' 14. Typical small slip above Oruahine track.

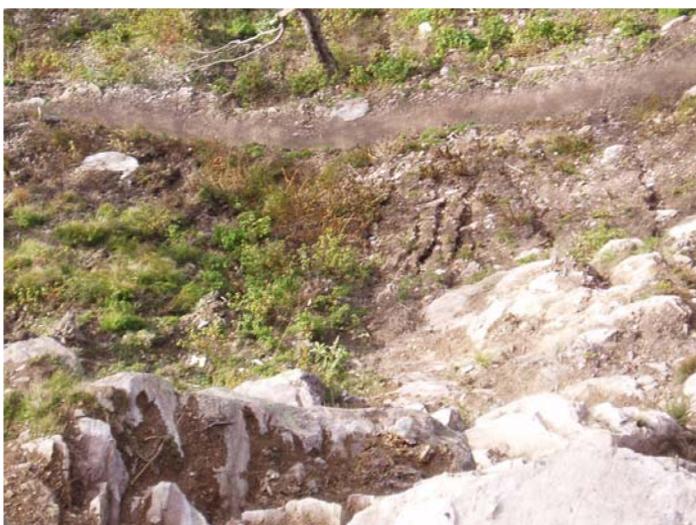
Photo' 15. Looking down on scour channels above the Waikorere Track.

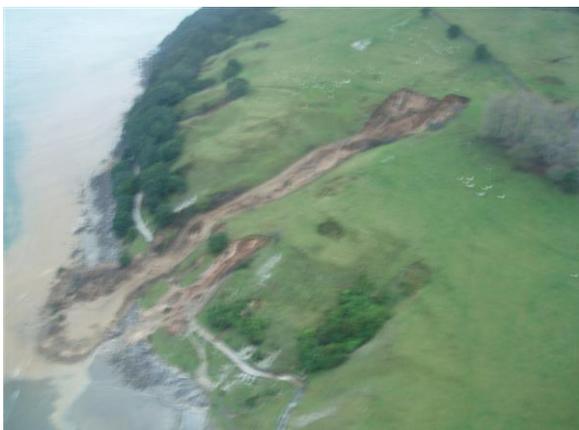
The largest single mass slip involved an estimated 8,000m³ of material. The next largest was around 250m³.

Photo' 16. 8,000m³ slip on SW slopes.

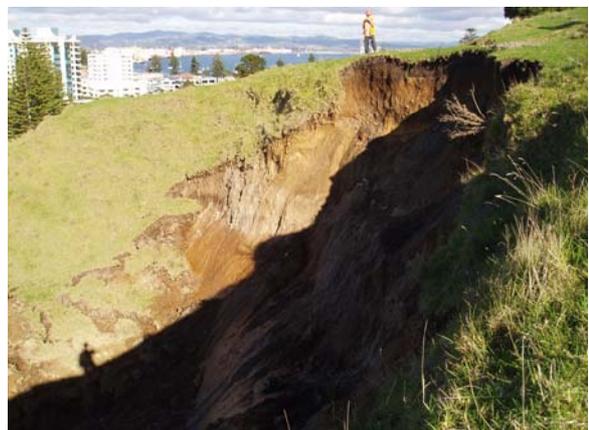
Photo' 17. 250m³ slip above campground.

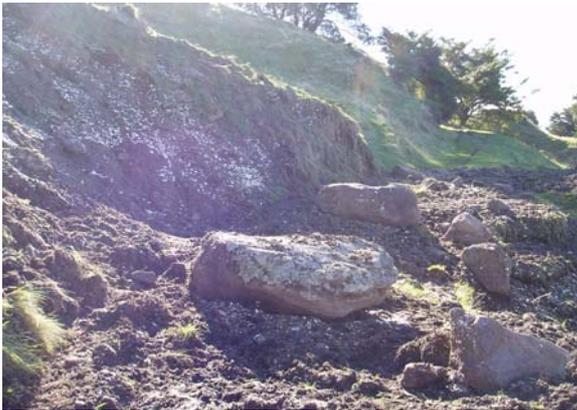
Photo' 18. Boulder fall.

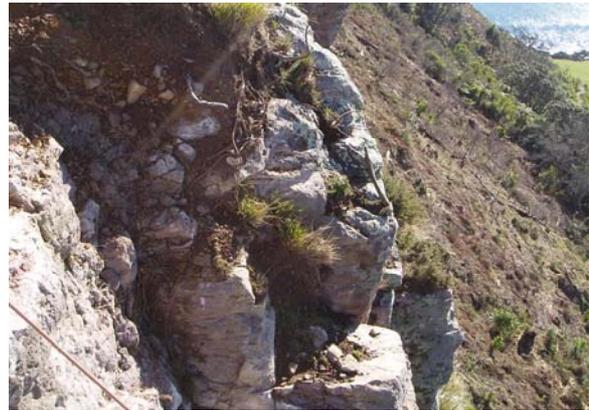
Photo' 19. Scour on Camp Bluff.

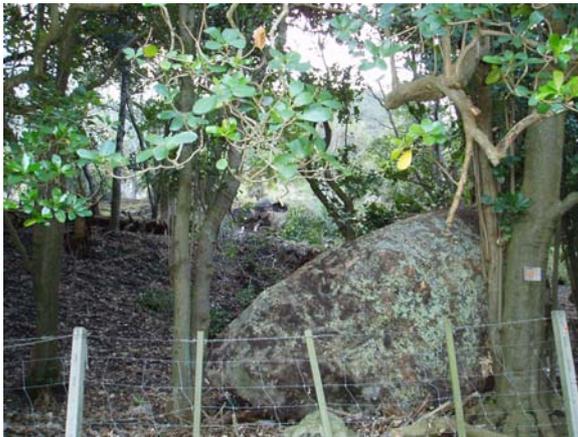
A well rounded boulder, 2 to 3m in diameter and weighing around 20 tonnes was found at rest behind the campground boundary fence. It failed from 25m up the 30° slope and whilst rolling had dislodged a second, 1.5m diameter boulder.

Prior to failure the main boulder appears to have been shallowly embedded above a rotted out tree stump. Shell middens below, indicated the boulder had probably already moved previously, post Maori occupation.

Photo' 20. Boulder at camp boundary.

The slopes in this vicinity contain many rotted tree stumps and decayed roots. This, along with the 18 May flood and another spell of further heavy rain preceding the event, appear likely to be contributing factors in the failure.

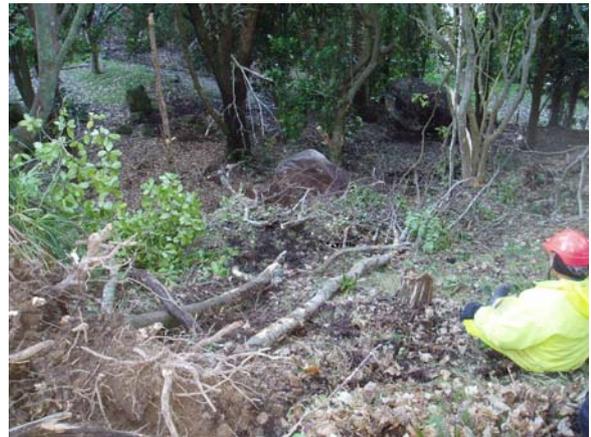
Photo' 21. View down from source.

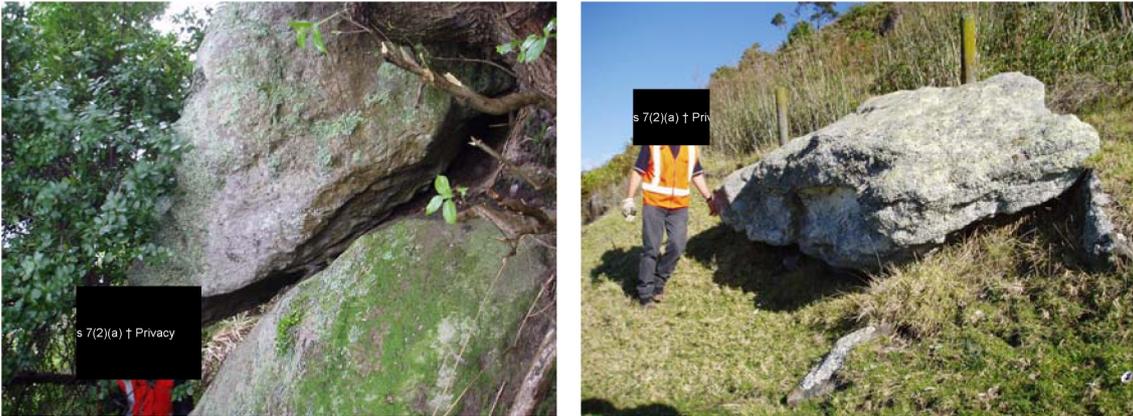
Twenty three individual boulders were noted as appearing particularly marginal and around half of these appeared likely to be readily scaleable using crowbars.

Photo' 22 & 23. Marginally stable boulders above campground (now scaled).

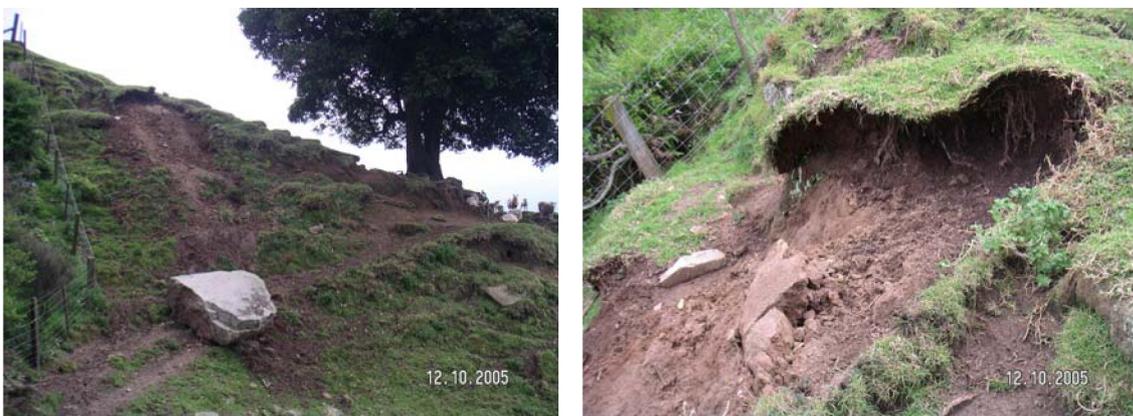
Mauao's Ranger reports a rock above the camp ground that slipped during rain and killed two sheltering lambs.

Photo' 24 & 25; The boulder which killed the lambs.

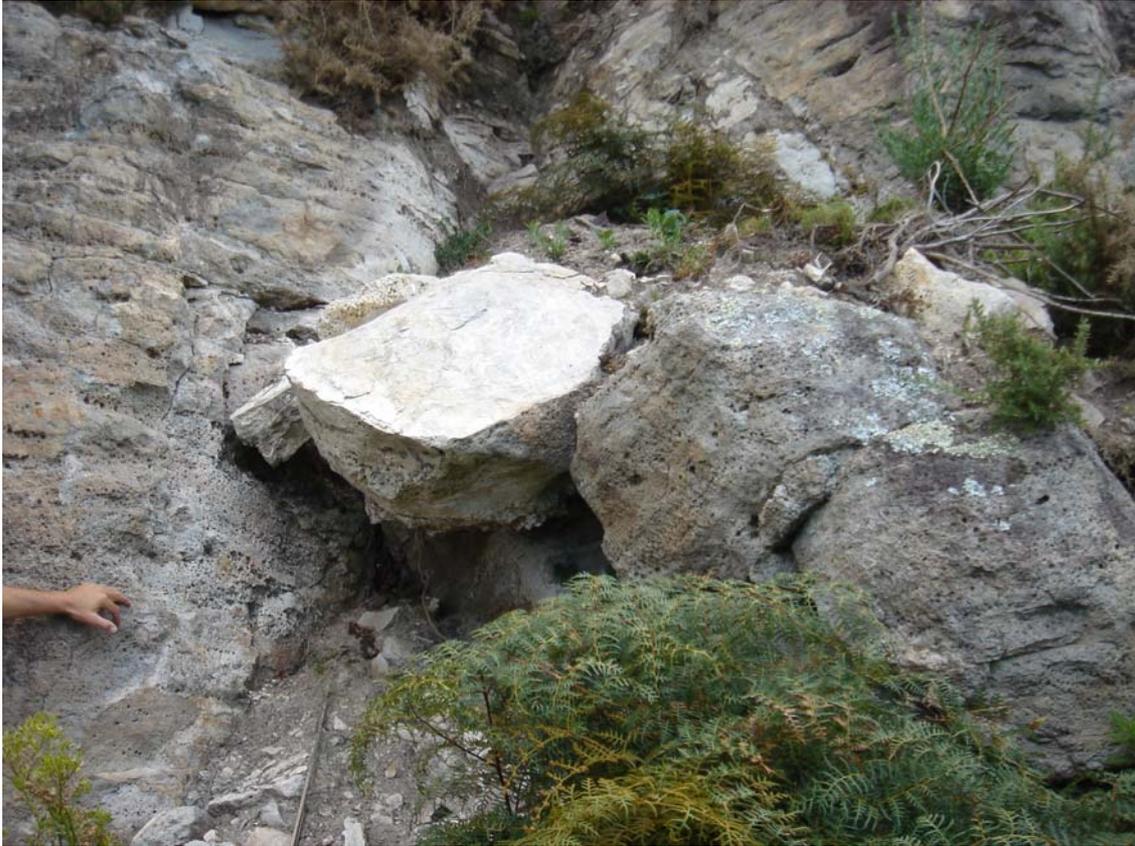
Photo' 26; The scoured boulder before scaling; 22/3/06.

The pale grey stain (pointed at) was surface level one year earlier.

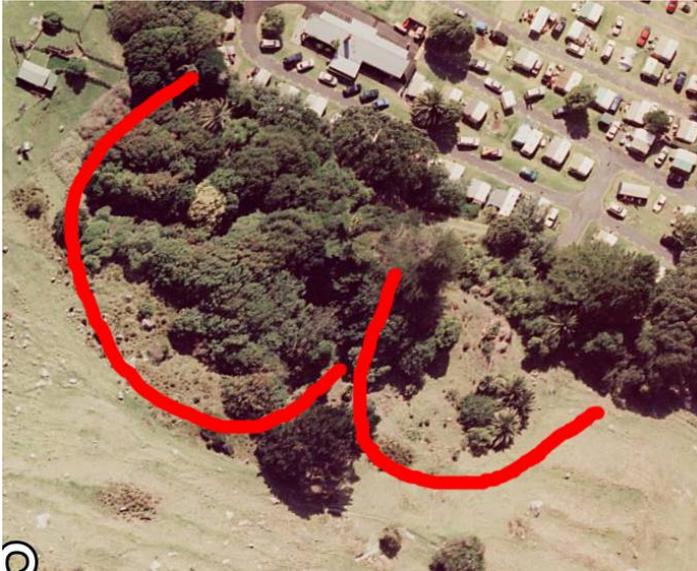
Photo' 29. Slip scarps above campground.

These slip events appear likely to have been over five times larger than the 18th May 2005 slip on the south western slopes (see Photograph 16) and probably released a similarly fast moving, liquefied debris flow.

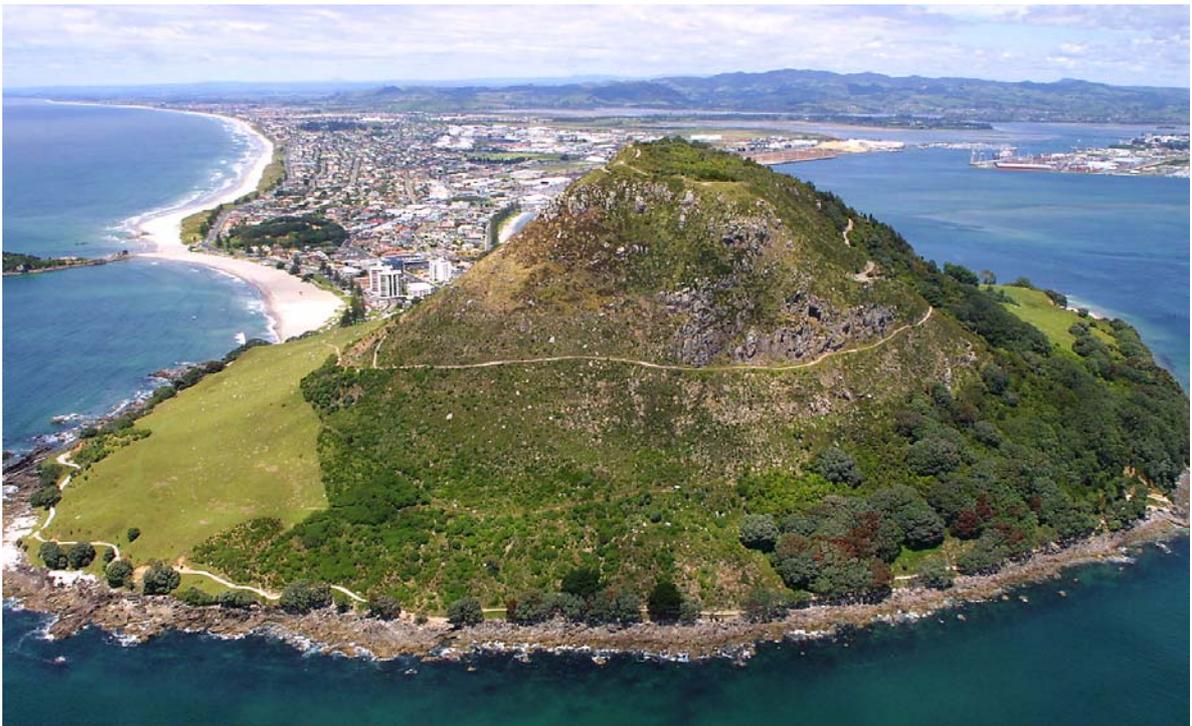
Photograph 30. NW Slopes with highest risk section of Oruahine Track.

Avalon would recommend that the simplest mitigation be effected for the highest risk area; the Zone 4 Oruahine track and would be achieved via; regular scaling, access restriction, rock climber education, grass growth and possibly small catch fences (in no particular order).
