# Mauao Base Track Reinstatement

Design Report

## Geotechnical Completion Report

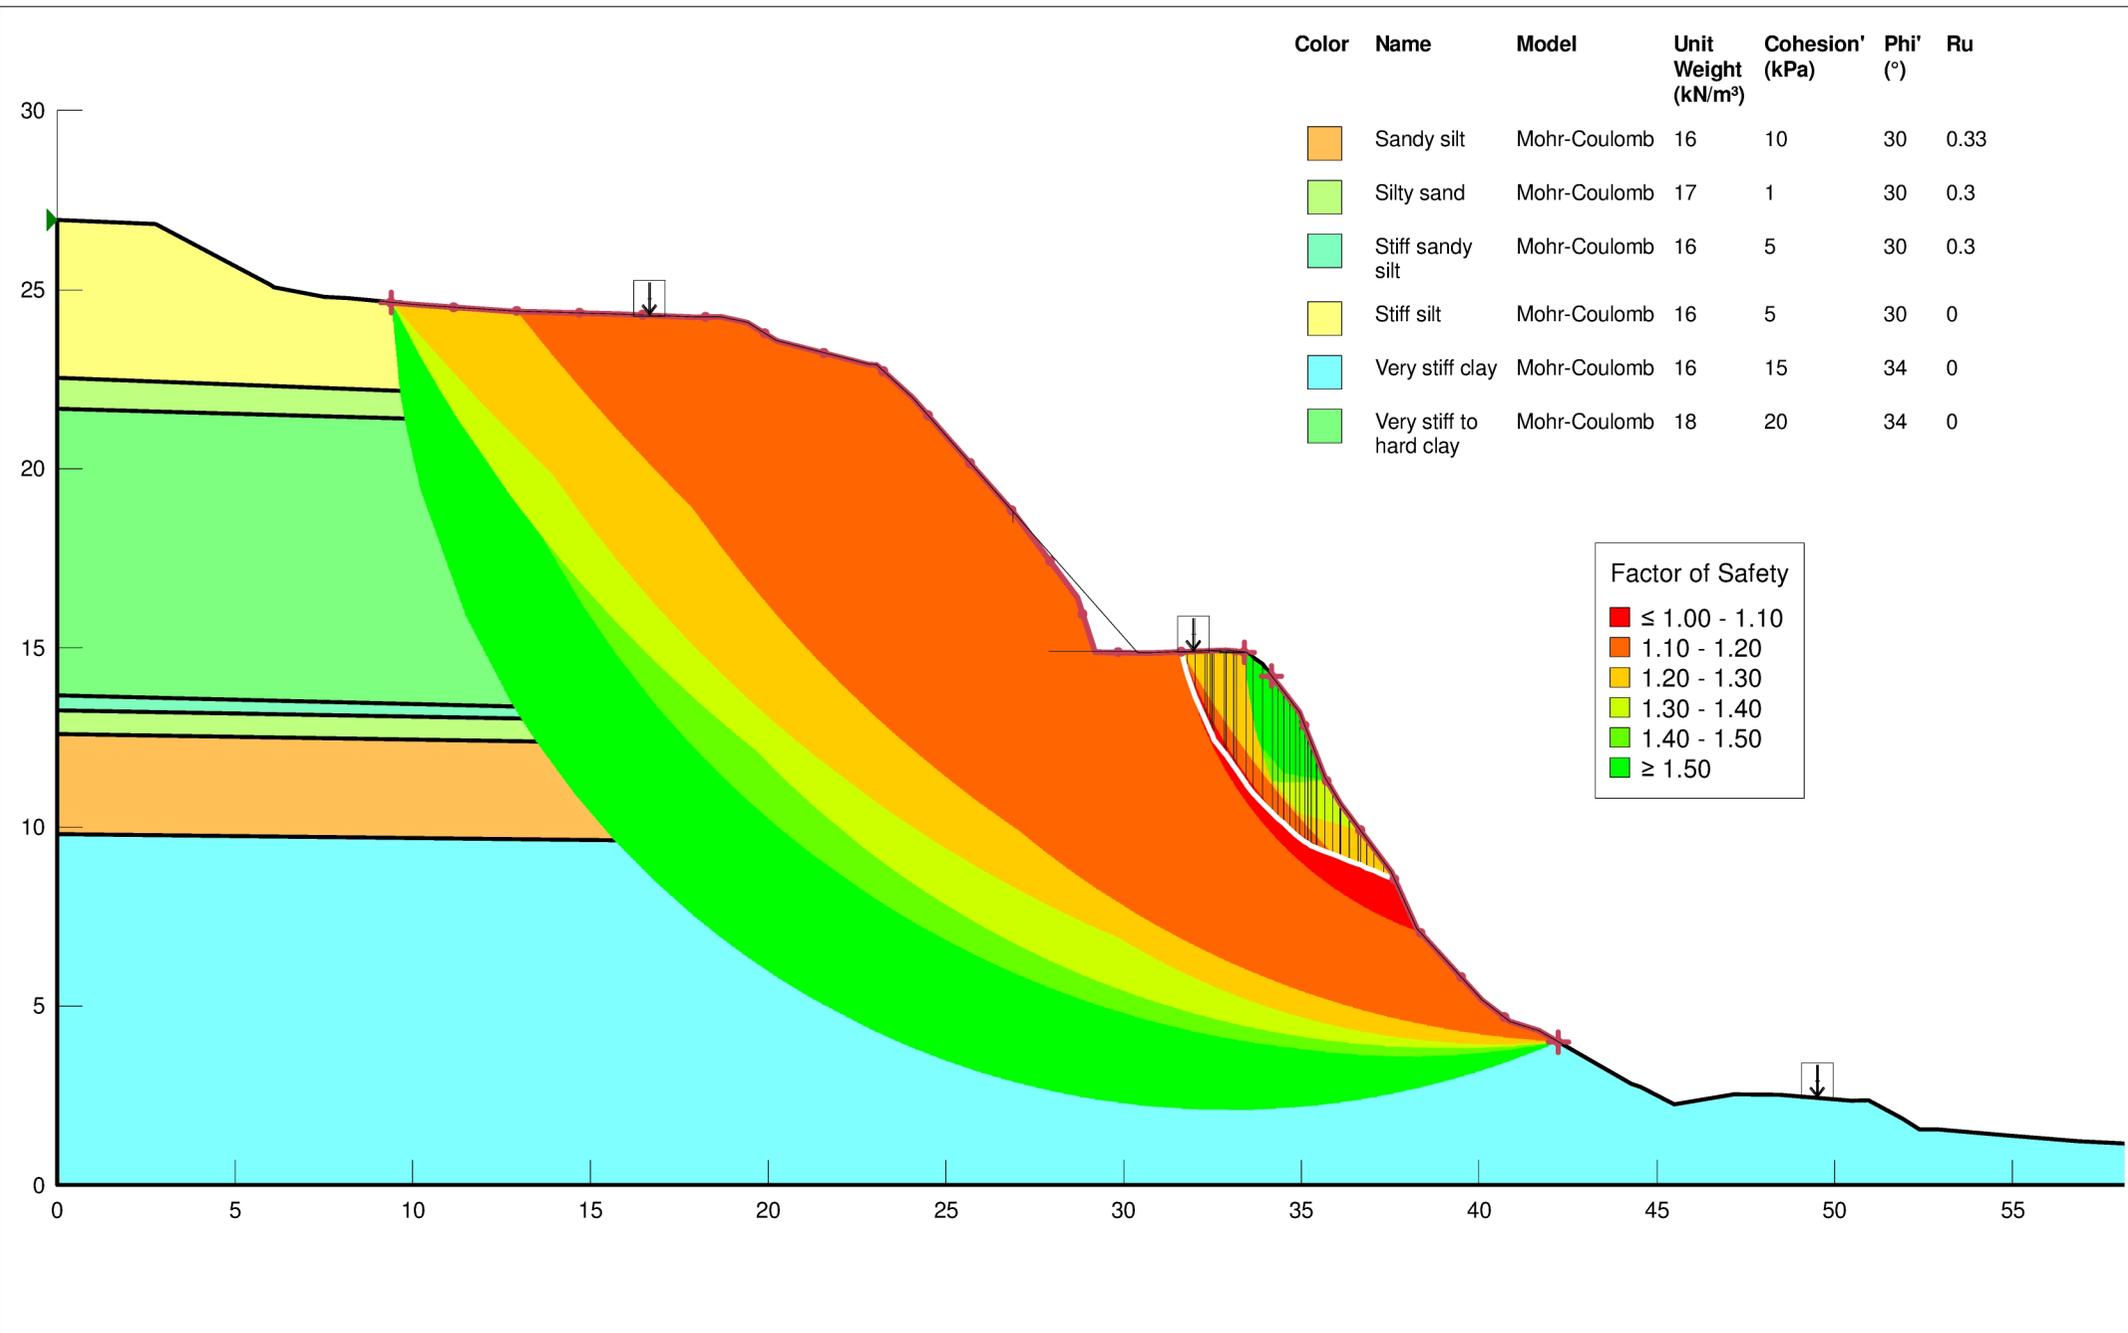
Based on these observations, we believe that the slip was likely caused by a build-up of pore water pressure in the slope along permeable sand and silt layers combined with water pressure build up along the tension crack and increased weight of the slope due to the infiltration of rainfall. The large Pohutukawa trees may have also contributed by penetrating topsoil and colluvium layers on the slope face creating a high-density root mass on the edge of the slope which could reduce the permeability and increase pore water pressures at the face.

Project: <b>2-9B463.00 - Mount Base Track</b> Analysis: <b>CH37.5_Final Model 141119 back analysis</b> Modelled By: [Redacted] s 7(2)(a) † Privacy Checked By: [Redacted] s 7(2)(a) † Privacy	Model	SLOPE/W	Proj No.	2-9B463.00
	Method	Morgenstern-Price	Date:	10/12/2019
	PGA	g	Scale	1:150
	FOS	1.01	Sheet No.

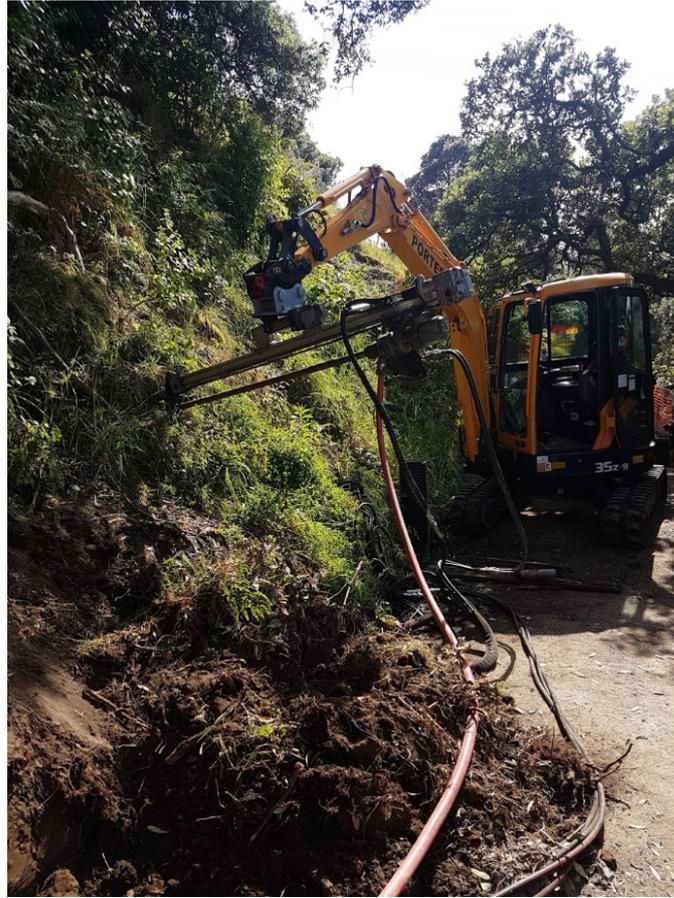
Photograph 1 - 1<sup>st</sup> test anchor installation prior to track widening.

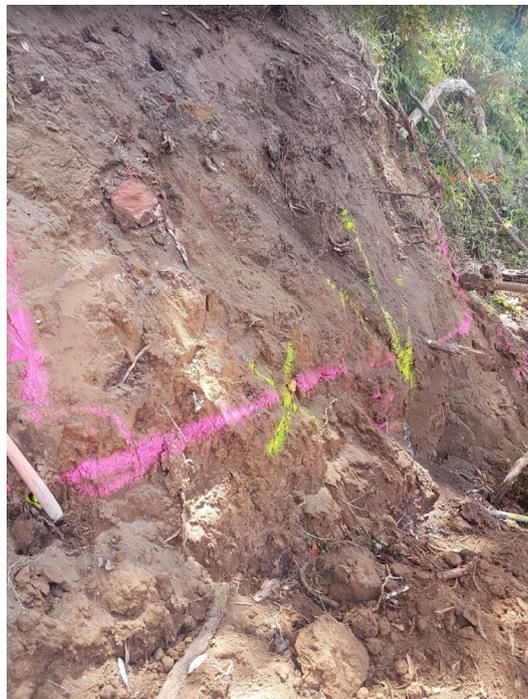
Photograph 2 - Setting out of soil nails above track level.

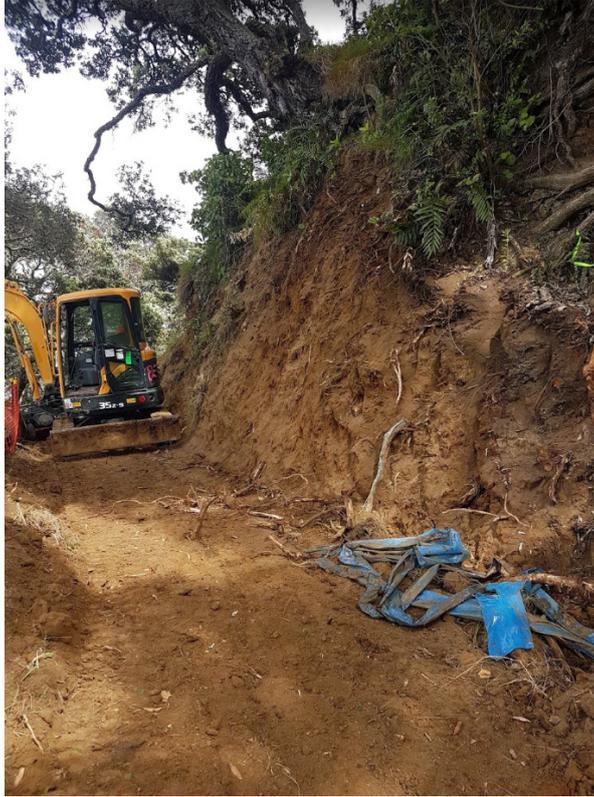
Photograph 5 - Earthworks for track widening advancing.

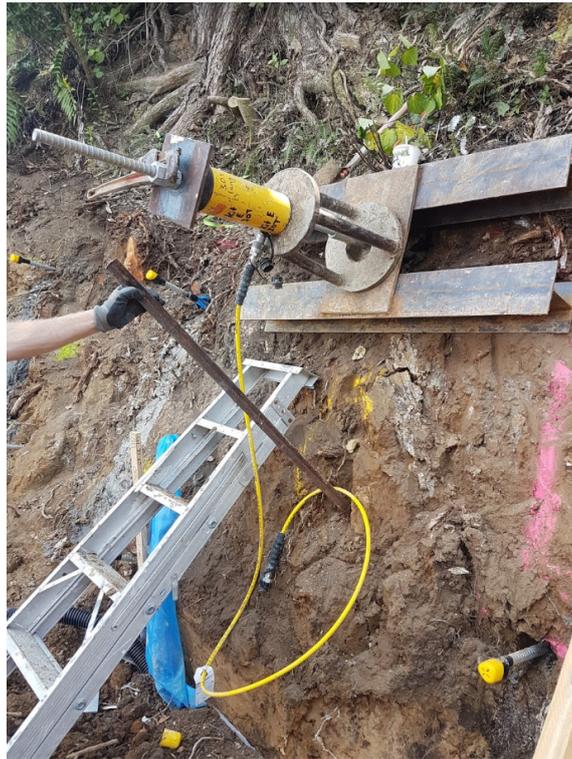
Photograph 9 – Setup for test anchors.

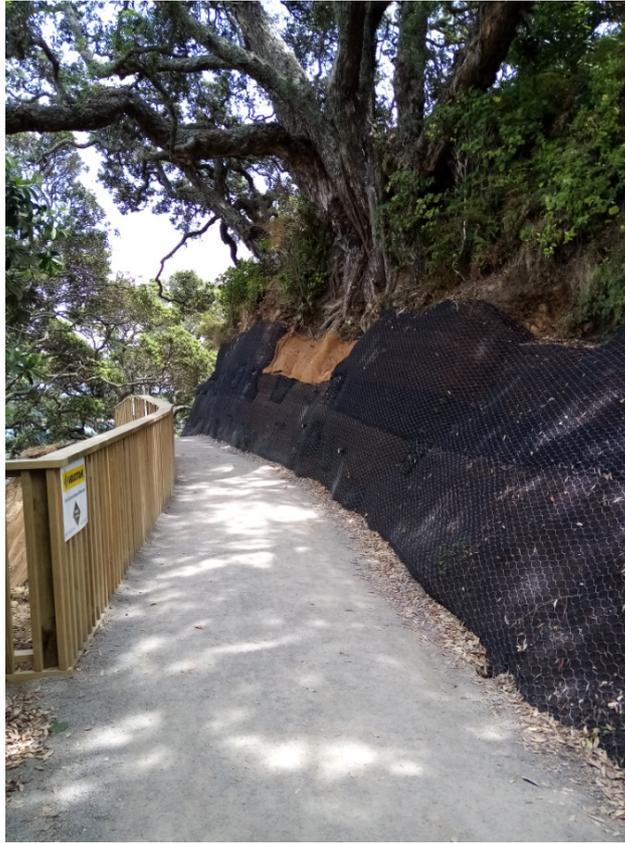
Photograph 15 – Completion of stage 2 of works as per design report.

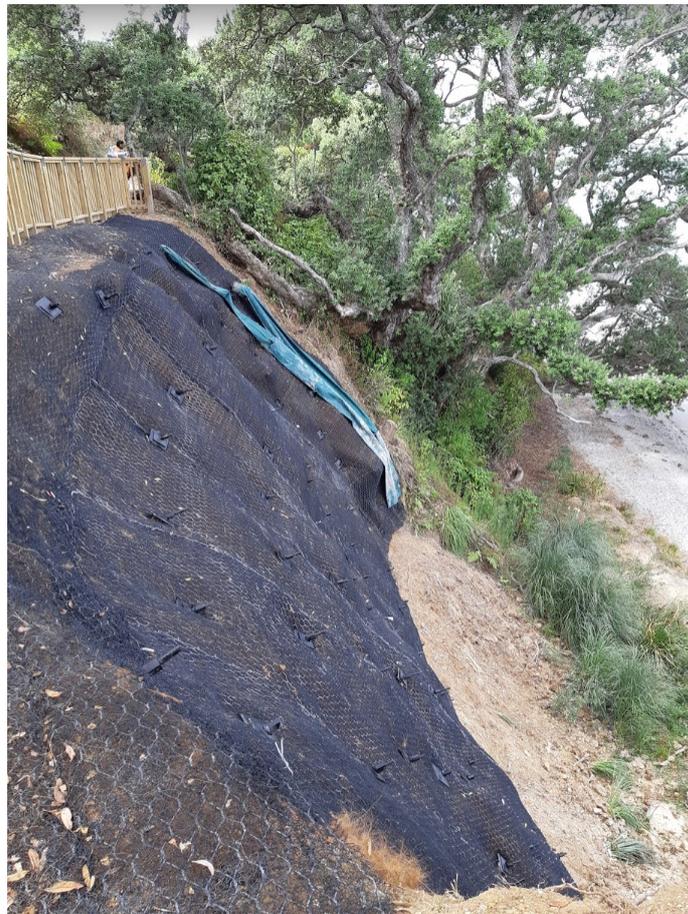
Photograph 17 & 18

Photograph 17, 18 – All soil nails completed and Macmat for lower slope.

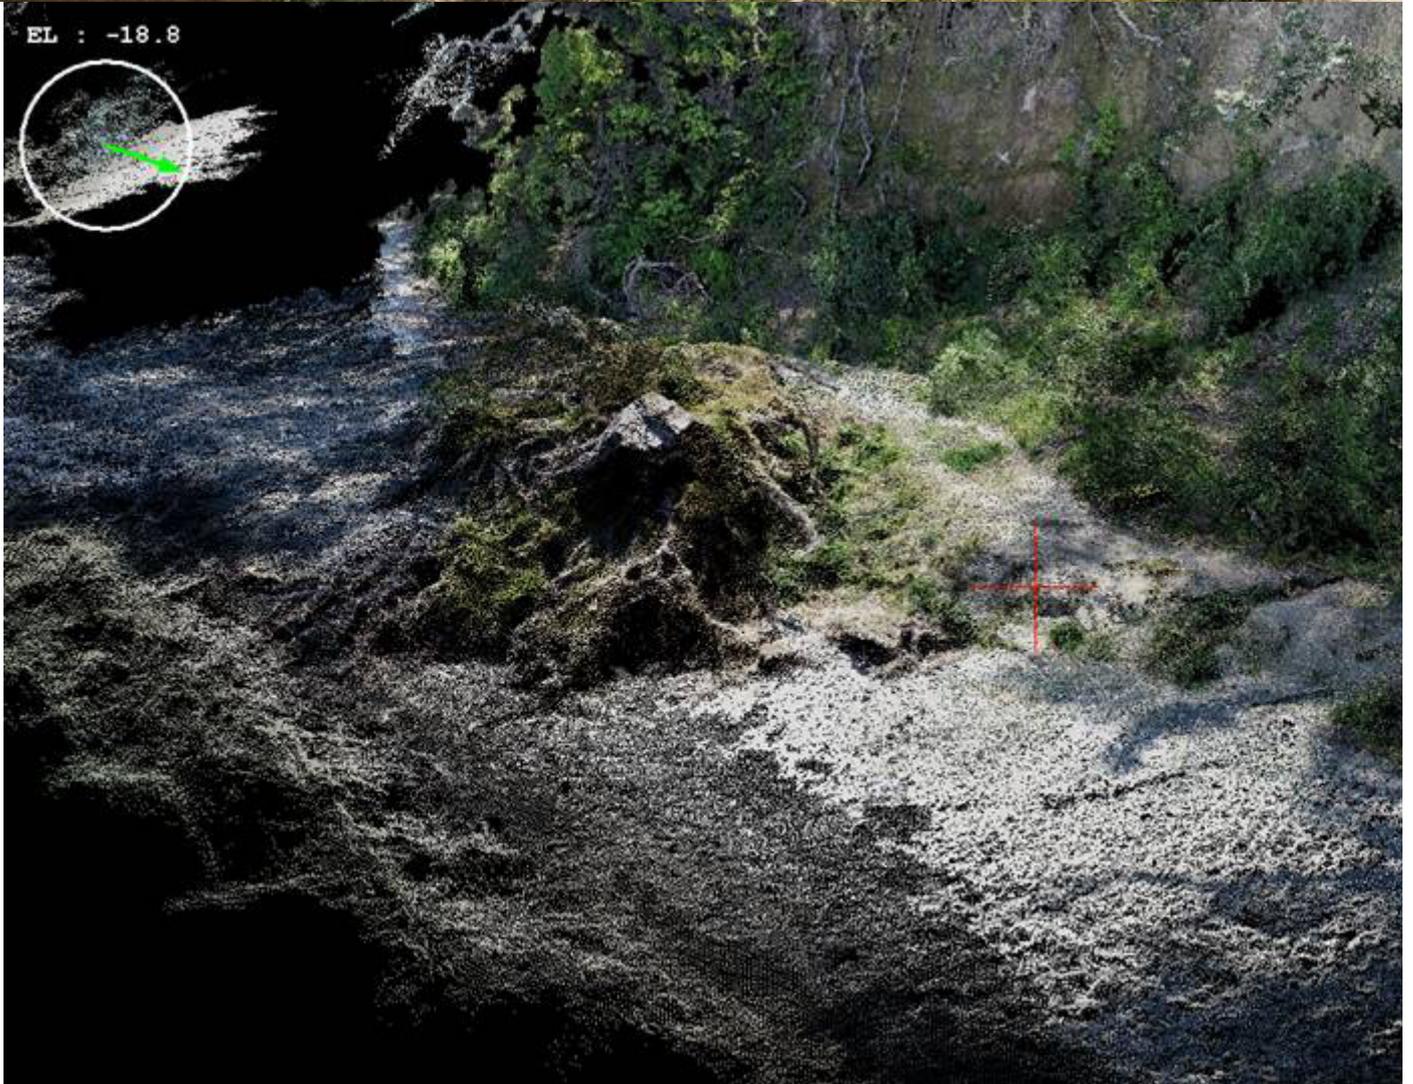
- In addition to the above, the condition of the toe should also be inspected. There is a small wave cut bank at the base which is about 0.4m high (see images below where the red crosshair is on the 3D image below ). This needs to be inspected for signs of regression and erosion as does the toe of the slope. I think the best way to do this would be to survey 6 monthly or after storms. It could also be done by tape and visual but would not be as good as would be hard to know if you were measuring the same points each time. We can provide this service if you require?

- In addition, the establishment of vegetation on the face should be monitored as this will enhance the erosion protection capability of the erosion mat.
