Project Number: 2-9B463.00

Mauao Base Track Reinstatement

Geotechnical Completion Report

24 June 2020

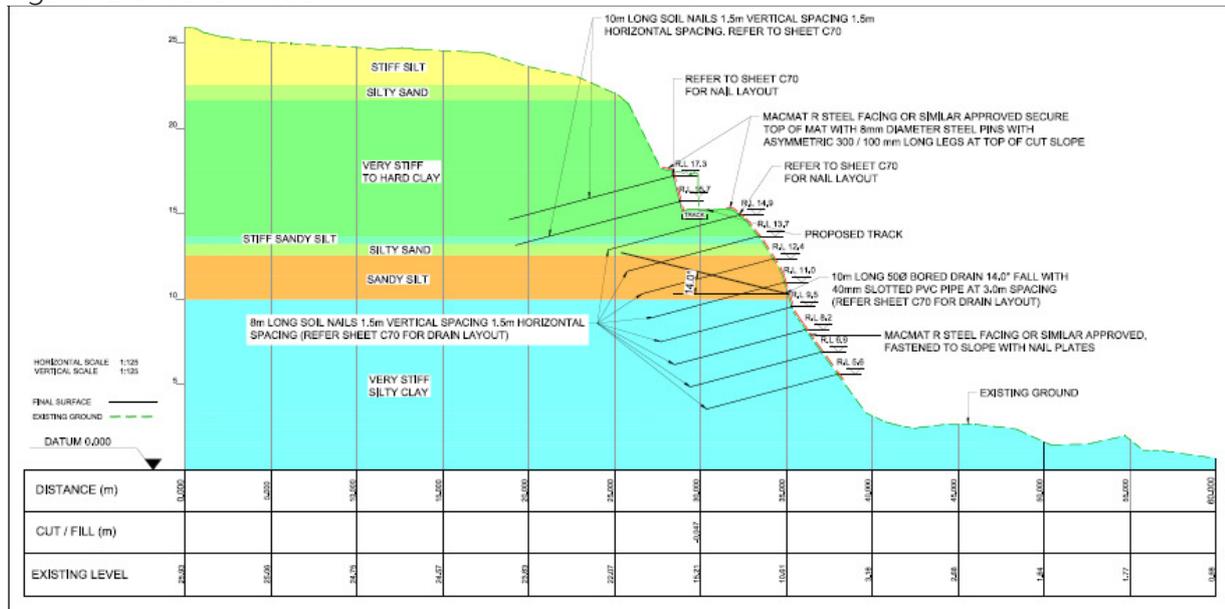
Figure -2 Ground Model

The geotechnical ground model was based on hand augers and field mapping of geologic units on site. Ground conditions observed during construction were generally as described in the design report. Figure 2 from our design report summarises the geotechnical ground model used for the design of the soil nails.

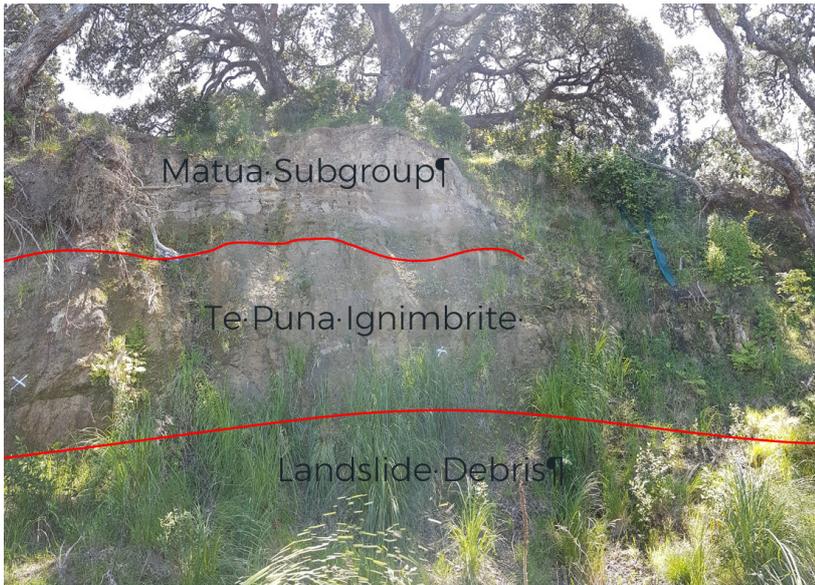
Figure - 3 Geologic units observed in the slip scarp.

The geology encountered at the site (Figure 3, borehole logs 1 – 5, Appendix B) comprised a sequence of colluvium and air fall tephra units (above the level of the base track), alluvial deposits of the Matua Subgroup (directly below the base track) and a weakly welded ignimbrite (near the toe of the slope).

The landslide debris consists of weak, remoulded Matua Subgroup and possibly the Te Puna Ignimbrite.

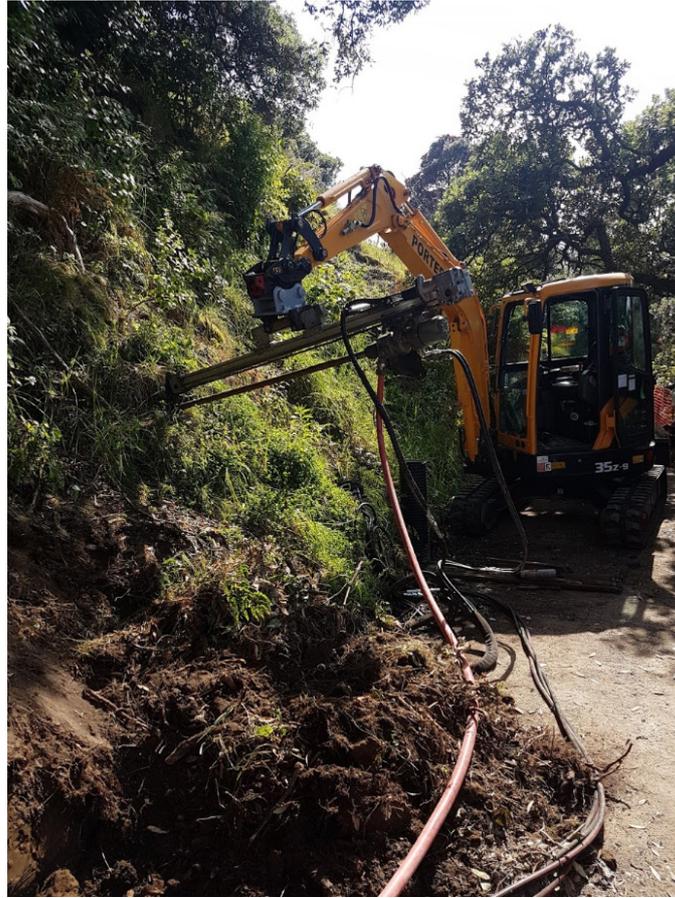
Photograph 1 - 1st test anchor installation prior to track widening.

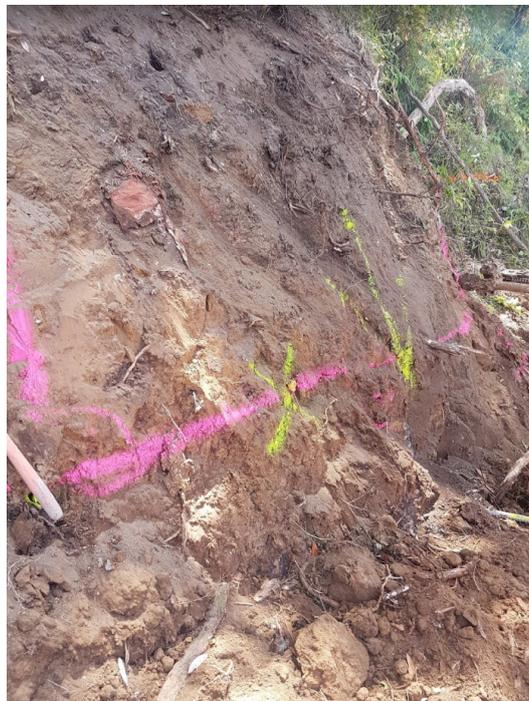
Photograph 2 - Setting out of soil nails above track level.

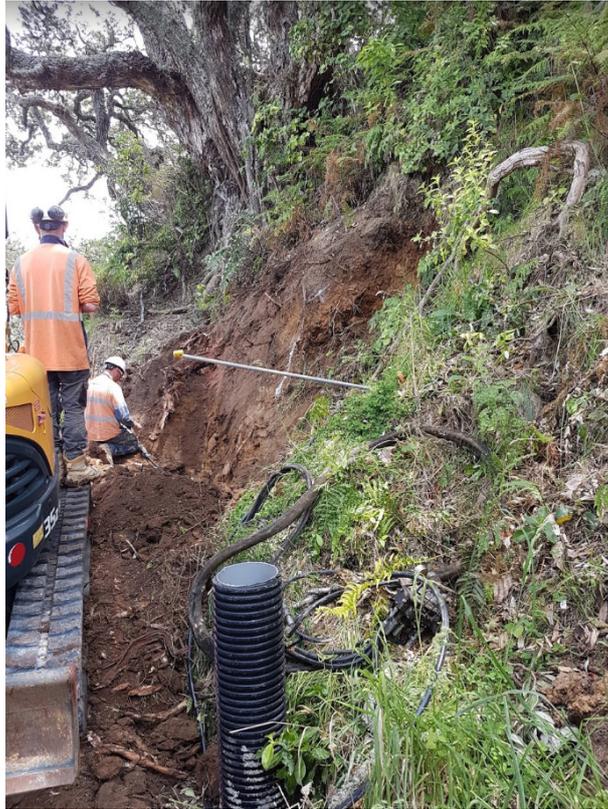
Photograph 3 - Excavations for track widening. Cultural monitor inspecting the excavation.

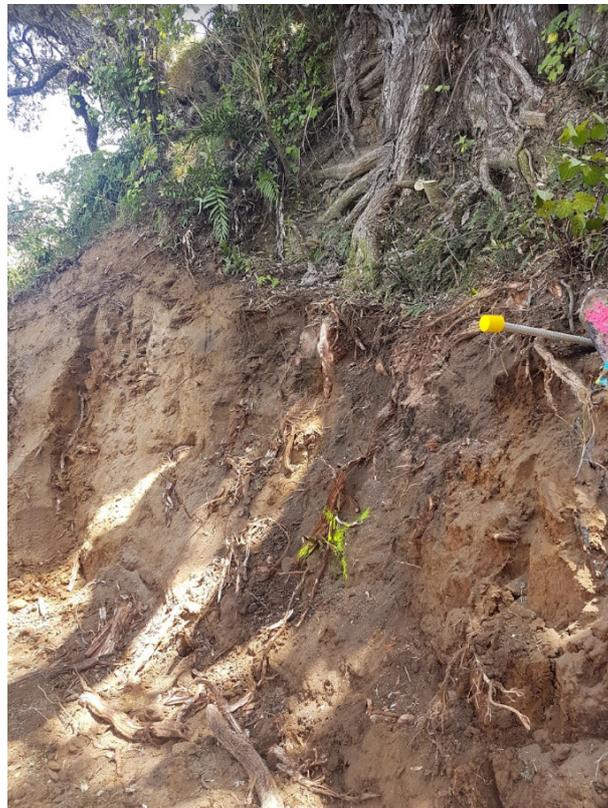
Photograph 4 - Further track widening and soil nail installation.

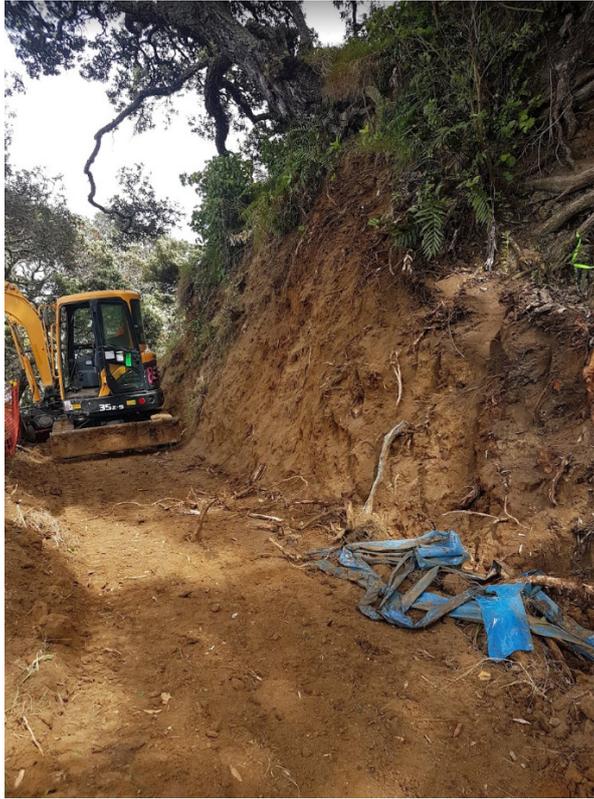
Photograph 5 - Earthworks for track widening advancing.

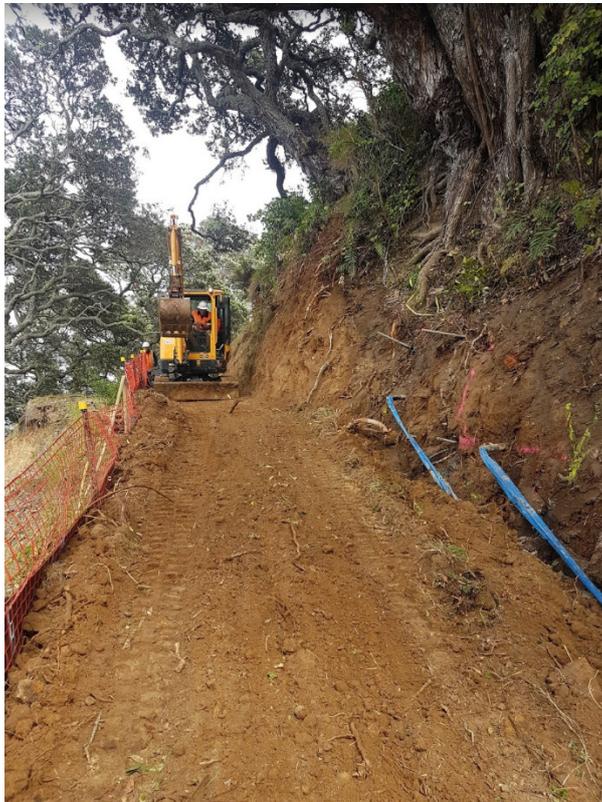
Photograph 6 - Subgrade preparation.

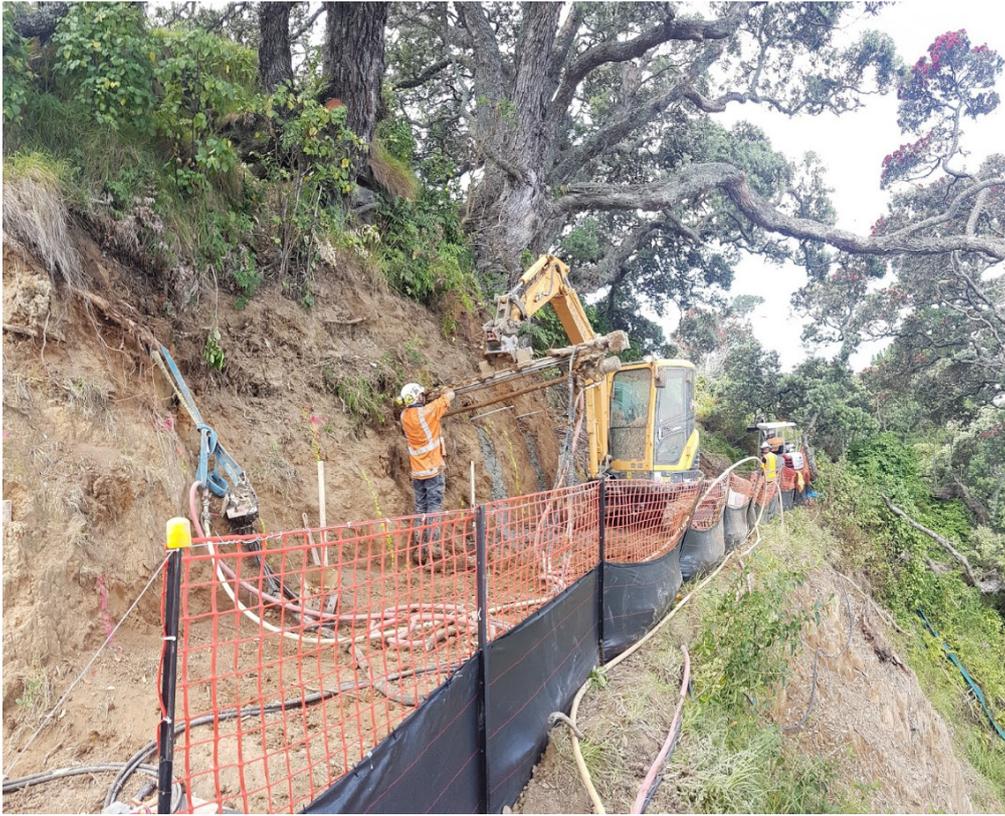
Photograph 7 - Soil nail installations, top row above track level.

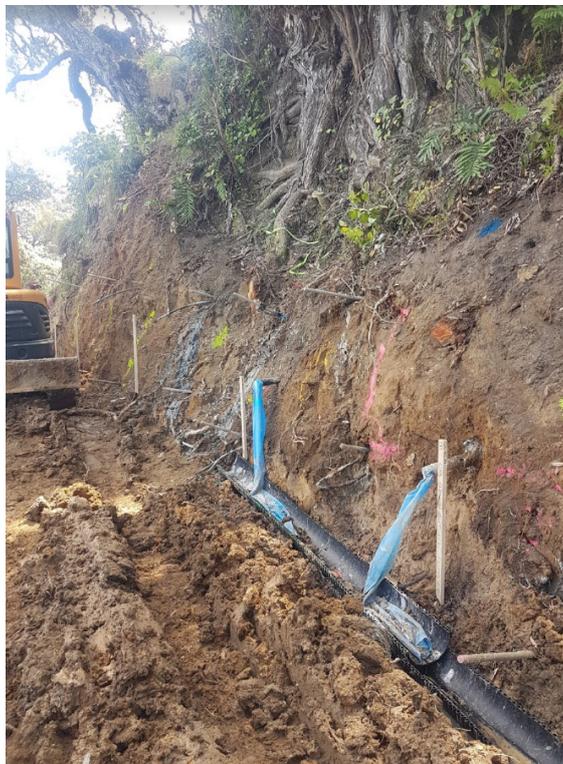
Photograph 8 - WSP installation of set out pegs for checking track alignment.

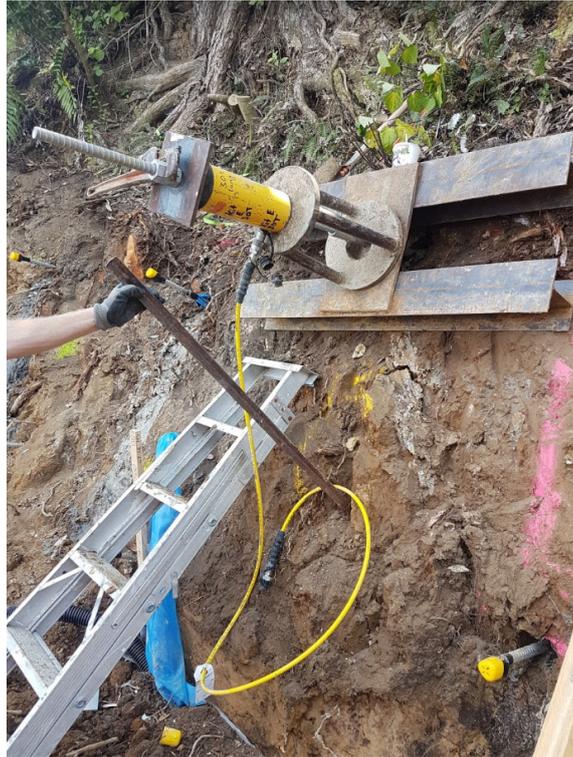
Photograph 9 – Setup for test anchors.

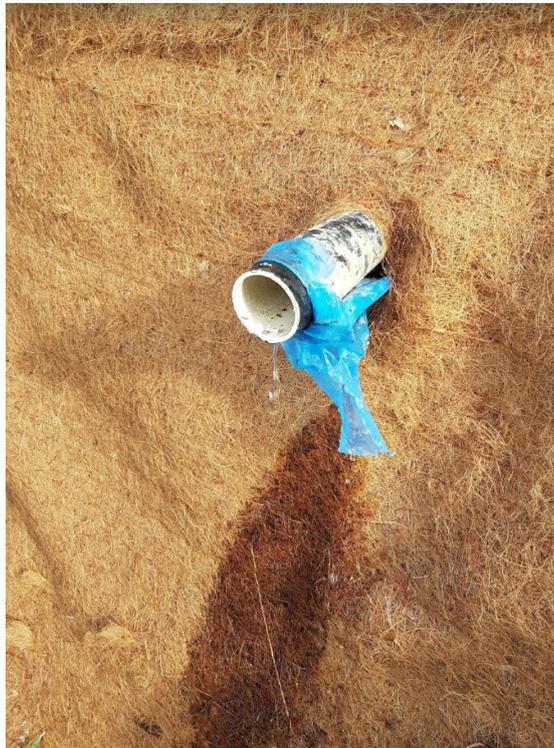
Photograph 10 - Horizontal drain installed above track level.

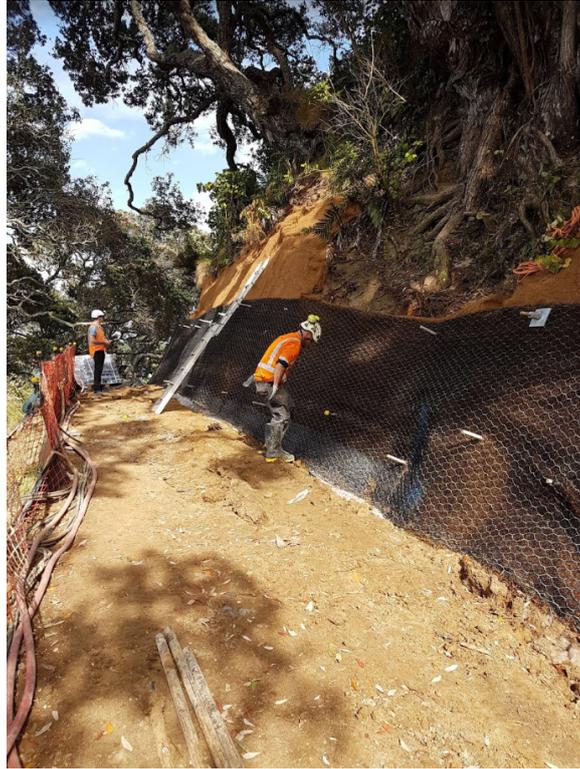
Photograph 11 - Installation of Macmat R above track level.

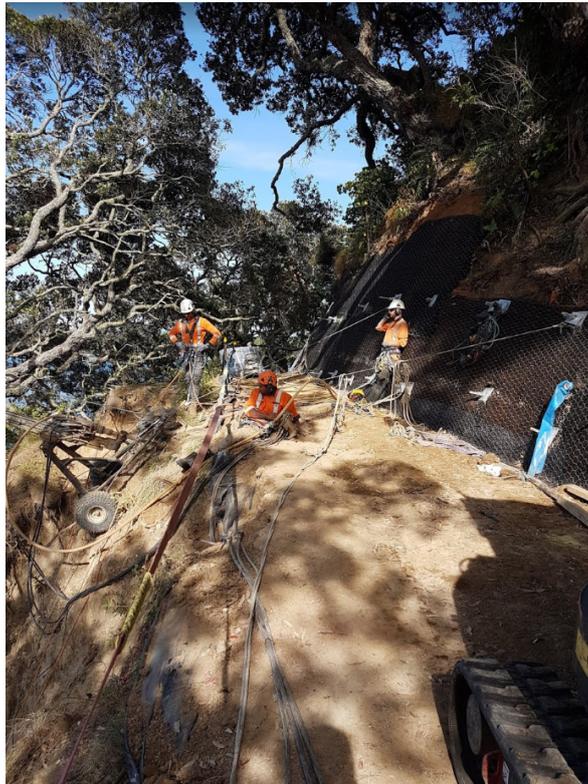
Photograph 12 - Installation of first row of anchors below track level.

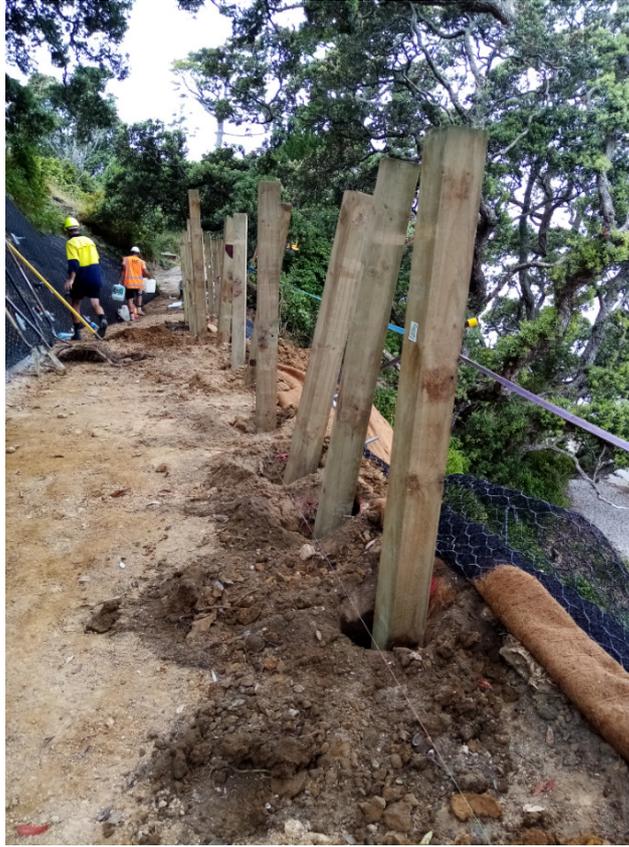
Photograph 13 - Installation of safety fence posts.

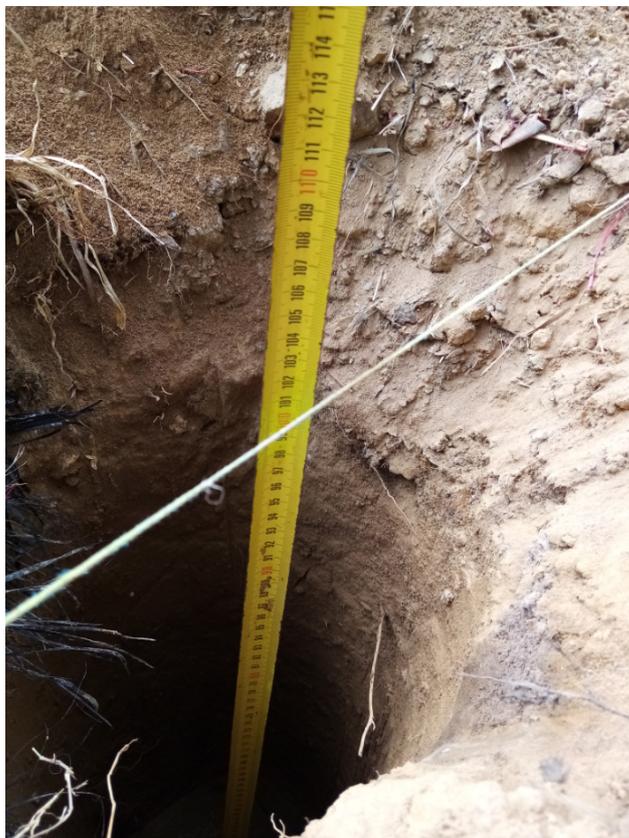
Photograph 14 - measuring hole depths for posts.

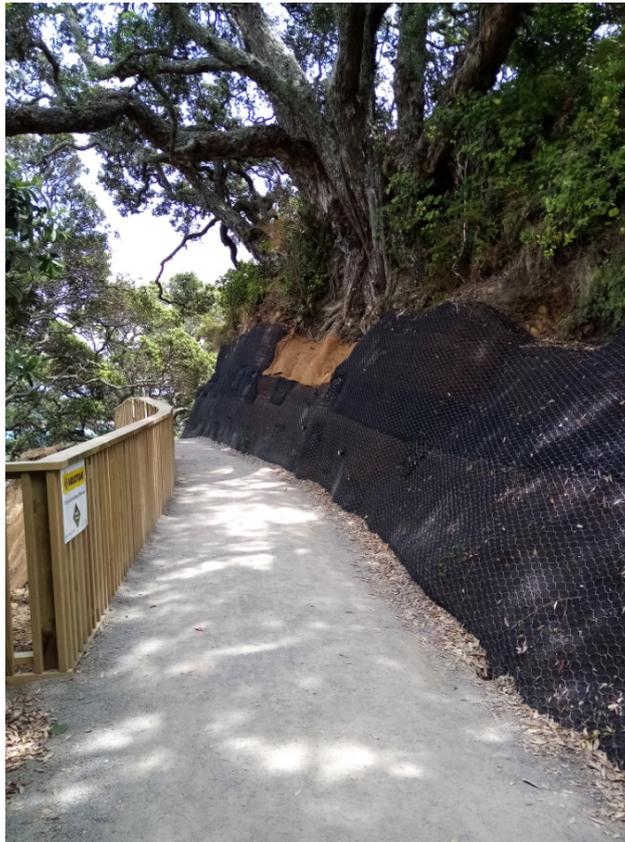
Photograph 15 – Completion of stage 2 of works as per design report.

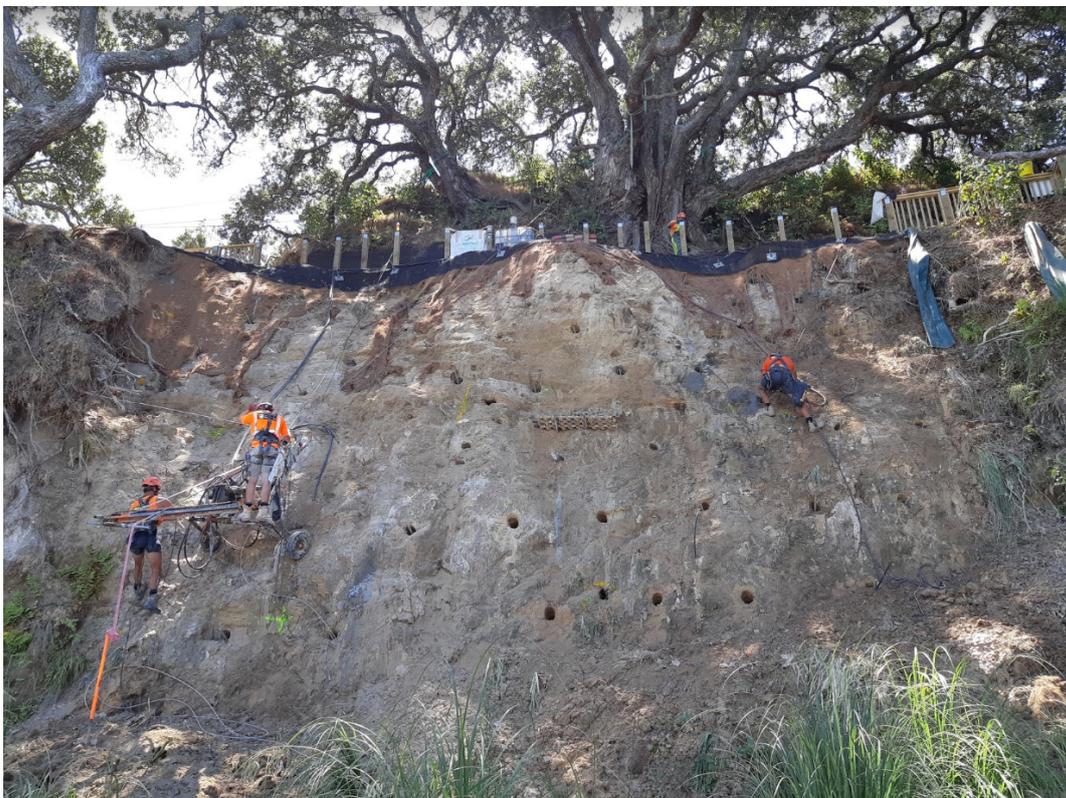
Photograph 16 – Soil nail installation, lower slope.

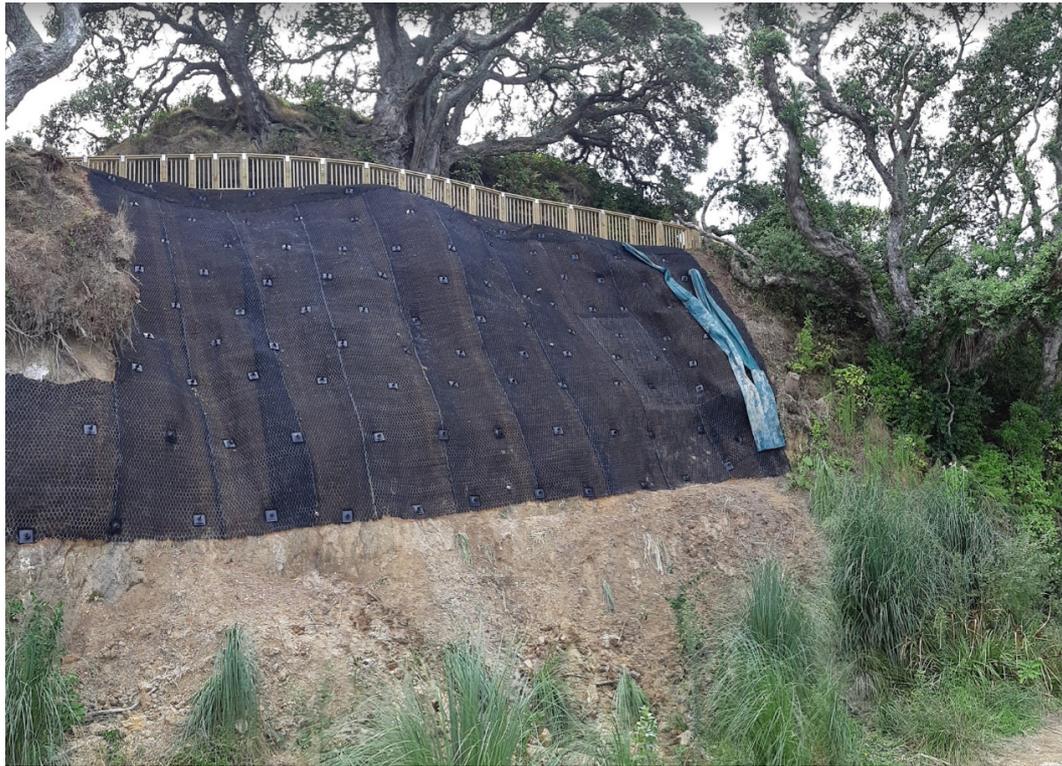
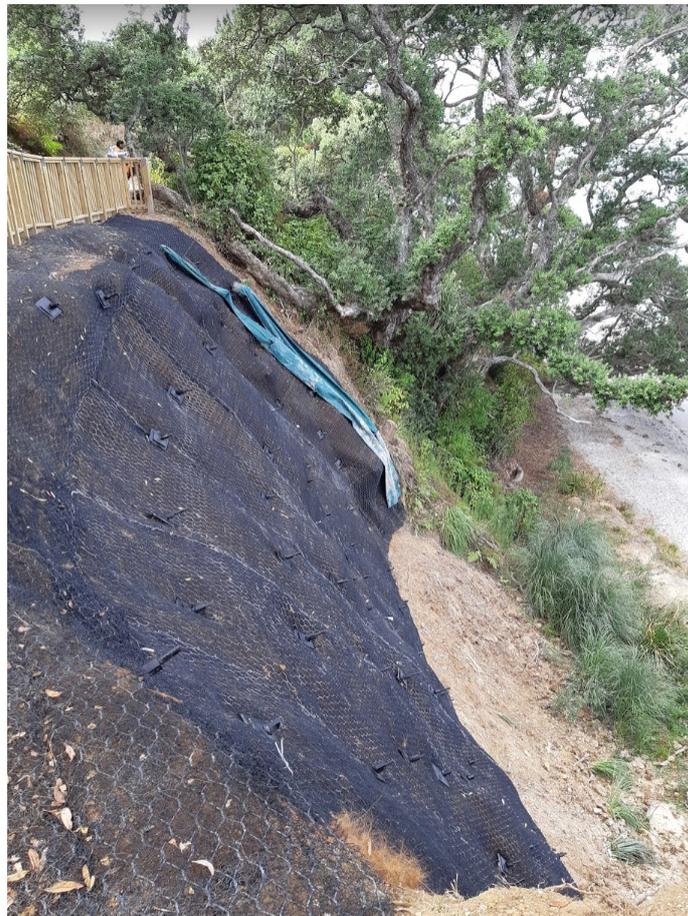
Photograph 17, 18 – All soil nails completed and Macmat for lower slope.

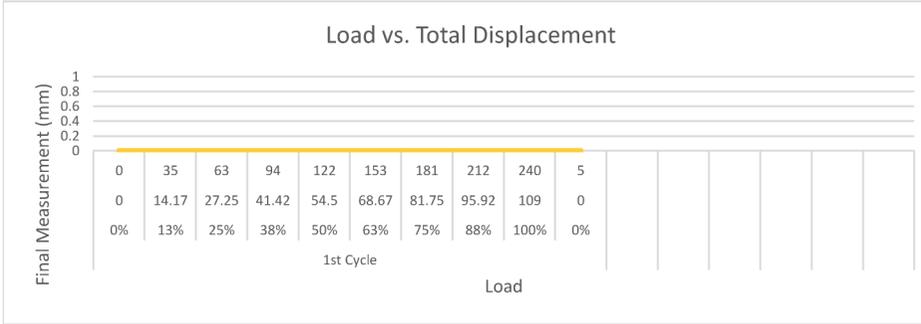
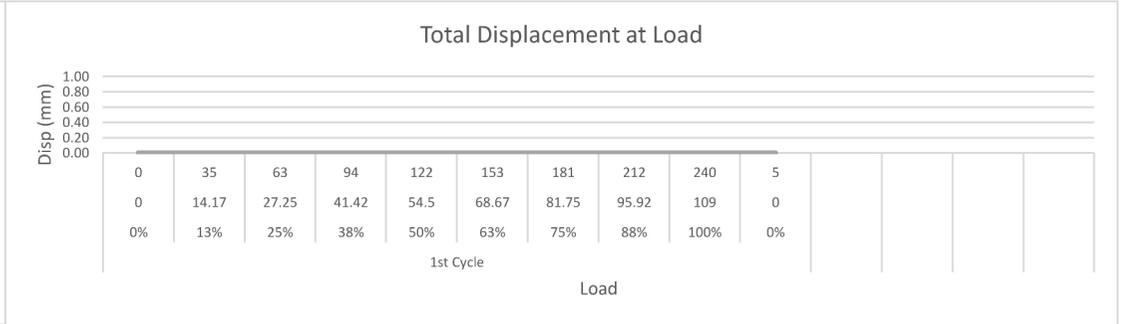
Anchor #	4B
Date	6/12/2019

Failed at 55KN - when preloading bar

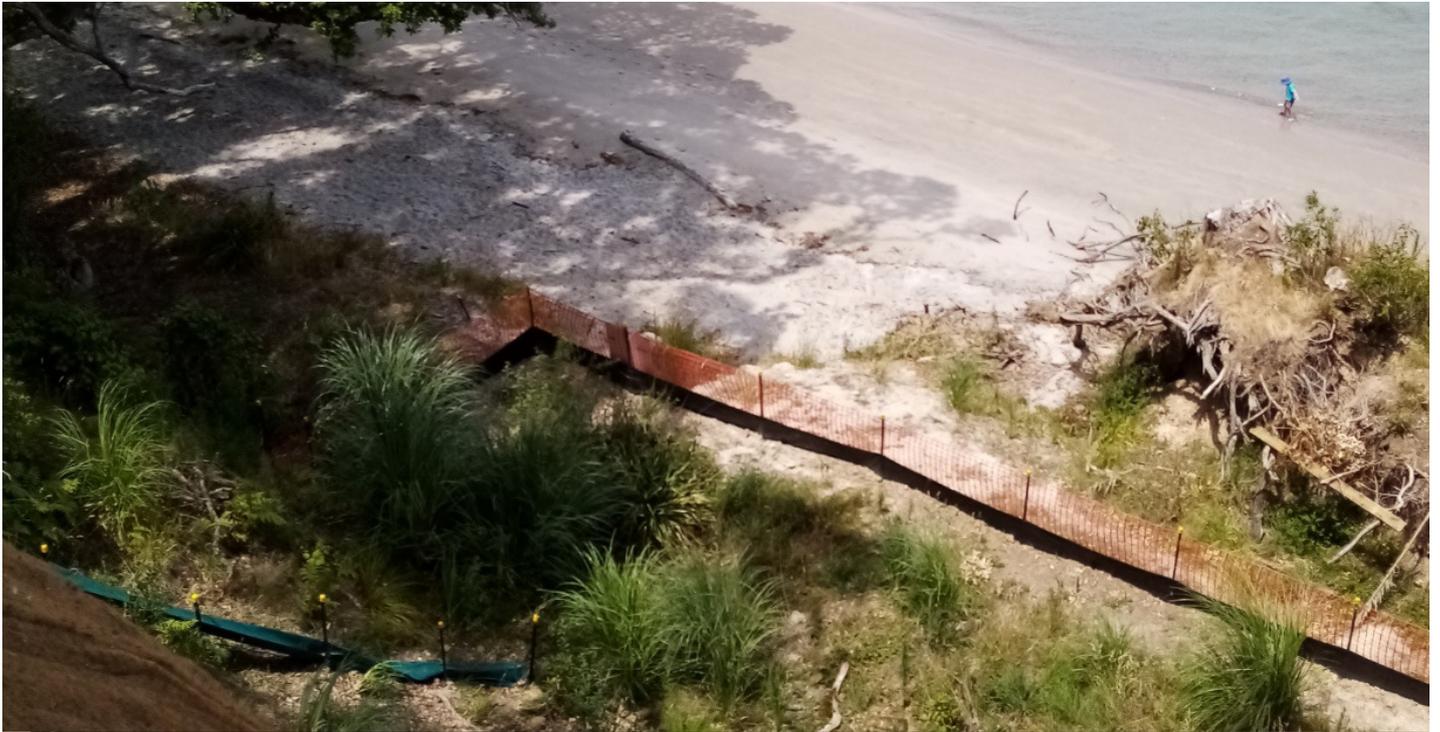
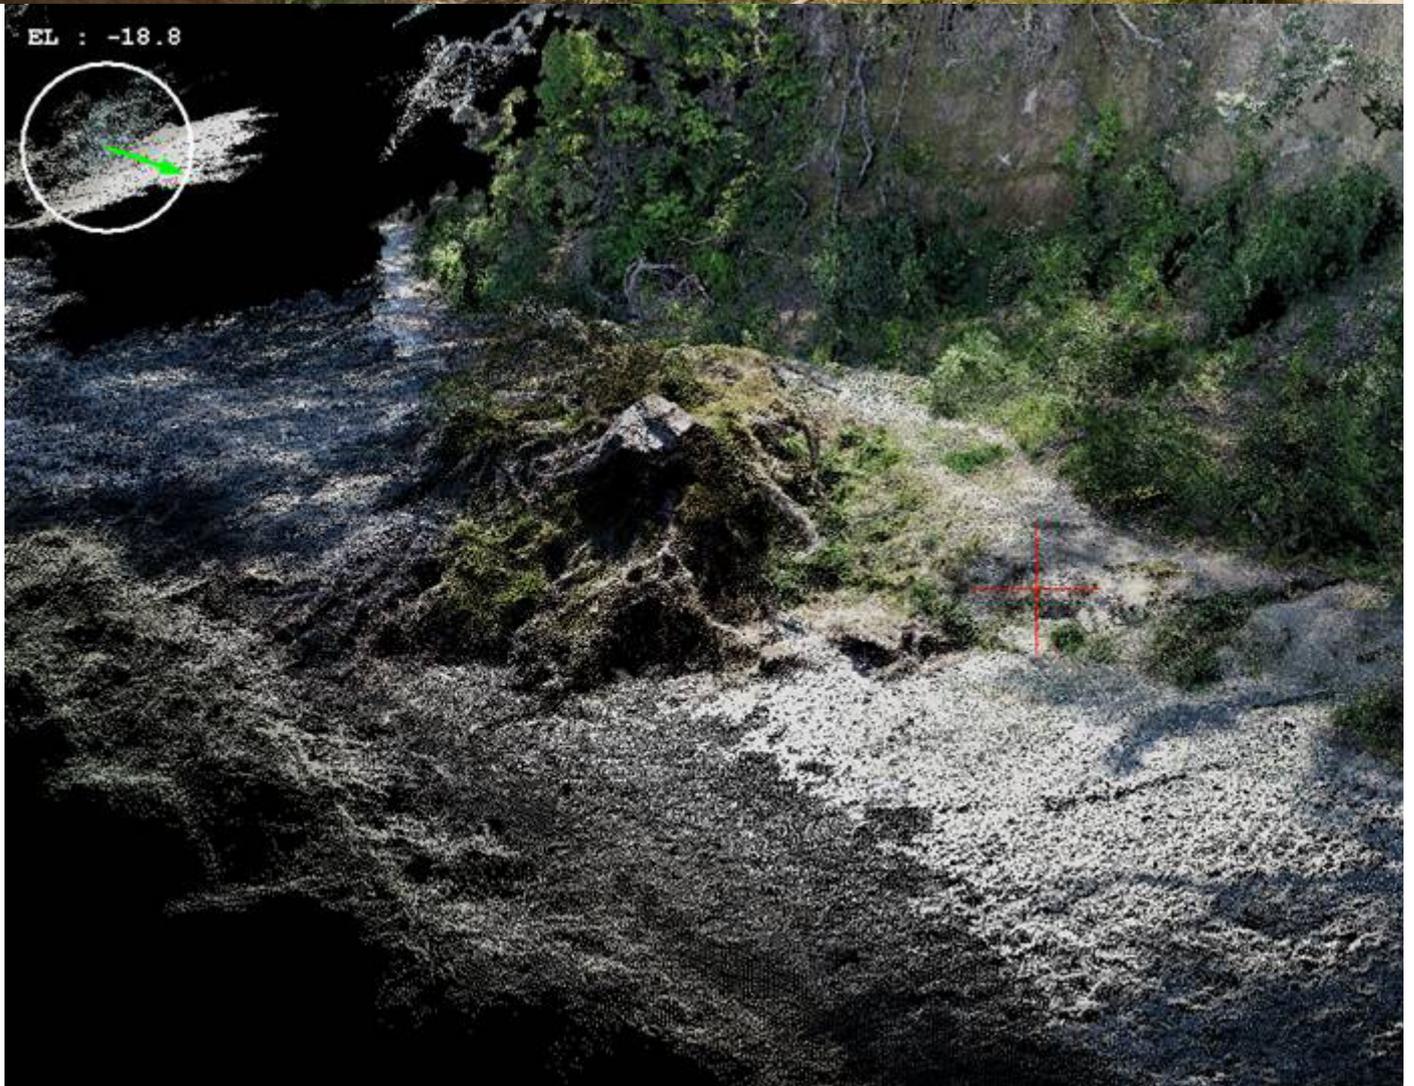
- In addition to the above, the condition of the toe should also be inspected. There is a small wave cut bank at the base which is about 0.4m high (see images below where the red crosshair is on the 3D image below). This needs to be inspected for signs of regression and erosion as does the toe of the slope. I think the best way to do this would be to survey 6 monthly or after storms. It could also be done by tape and visual but would not be as good as would be hard to know if you were measuring the same points each time. We can provide this service if you require?

- In addition, the establishment of vegetation on the face should be monitored as this will enhance the erosion protection capability of the erosion mat.
