Geotechnical Assessment Report

Whare Manaaki Mauao Project

MAUAO TRUST
1 ADAMS AVENUE, MOUNT MAUNGANUI

9 DECEMBER 2025

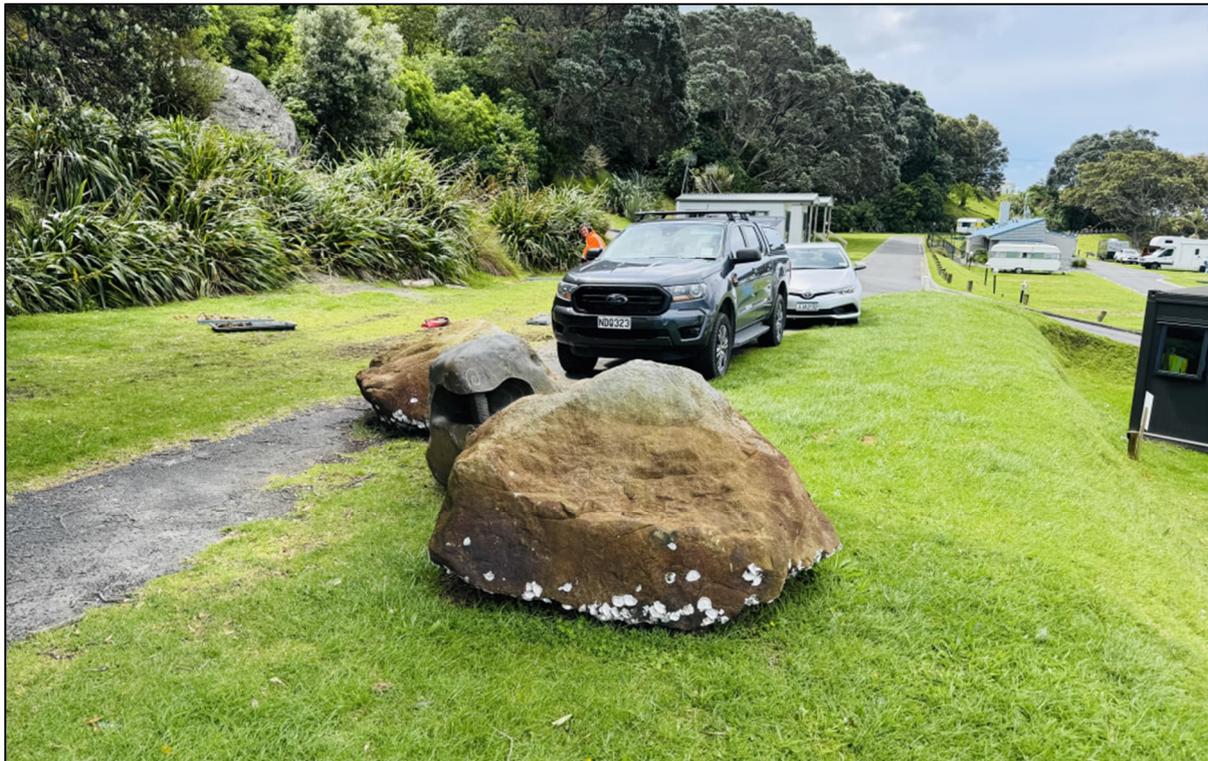
Boulders are also evident in exposures on the terrace slopes above and below the site within a silty/sandy matrix, inferred to be colluvium.

- No unstable rocks were observed on or below the grassed slopes above the subject site during our site walkover.
- The slopes above the site are hummocky with some creep type movement exaggerated by stock movement. Some anthropogenic terraces are evident on the slopes above the site.
- On the slope below the terrace within the area of the proposed buildings, the slope is not uniform with some minor erosion.

Figure 3 | Site photo showing the platform area of the proposed buildings with terrace slopes above and below (note boulders have been placed). Photo taken facing north-east.

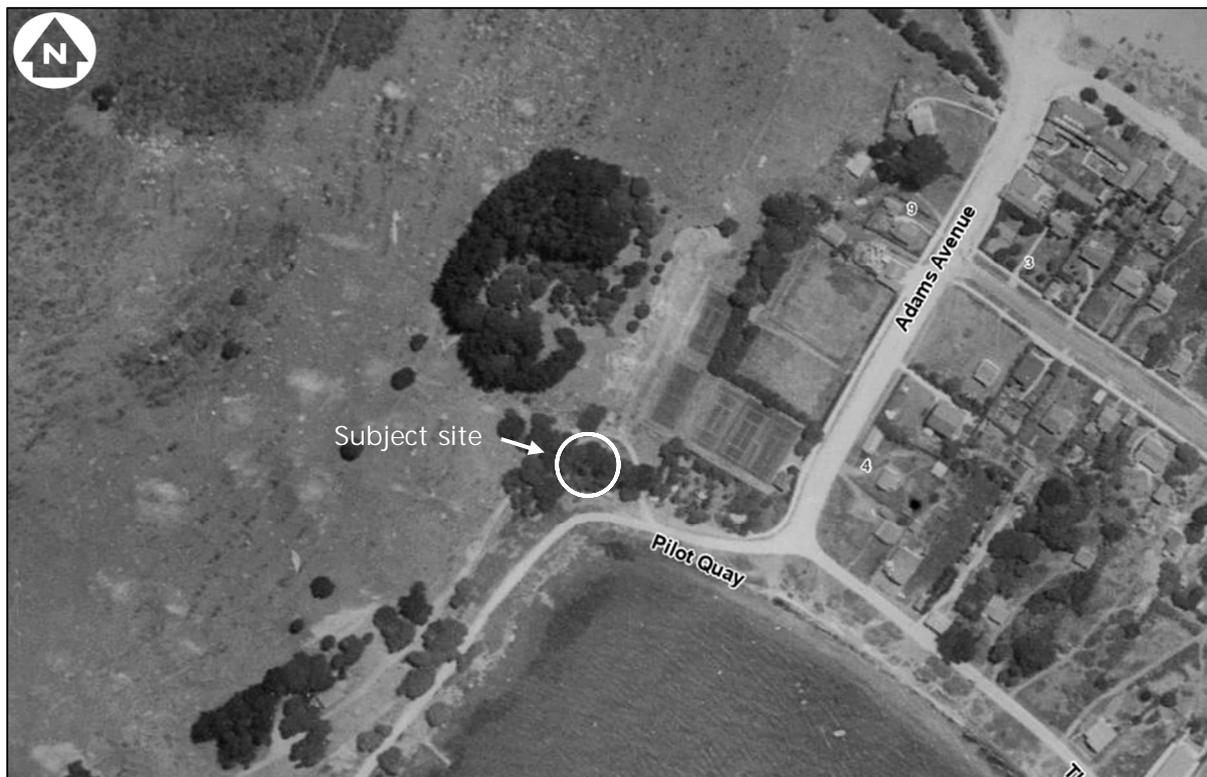
Mauao in the 1940s was grassed on the lower portion with vegetation on the upper portion and western side and some tracks are evident. The vegetation varied slightly and the tracks became established over the years. A water tank was constructed to the south-west of the site, evident in the image from 1977. Landslide features are evident on the lower portion of the slope to the north of the site dating back to 1943. Various small to large scale, shallow and less commonly deeper instability is evident on the lower slopes over the years. Boulders are evident on the lower parts of the slopes in the aerial photographs, suggesting historic rockfall.

Figure 4 | Historical aerial photograph of the area from 1943 showing the approximate location of the subject site (TCC Mapi).

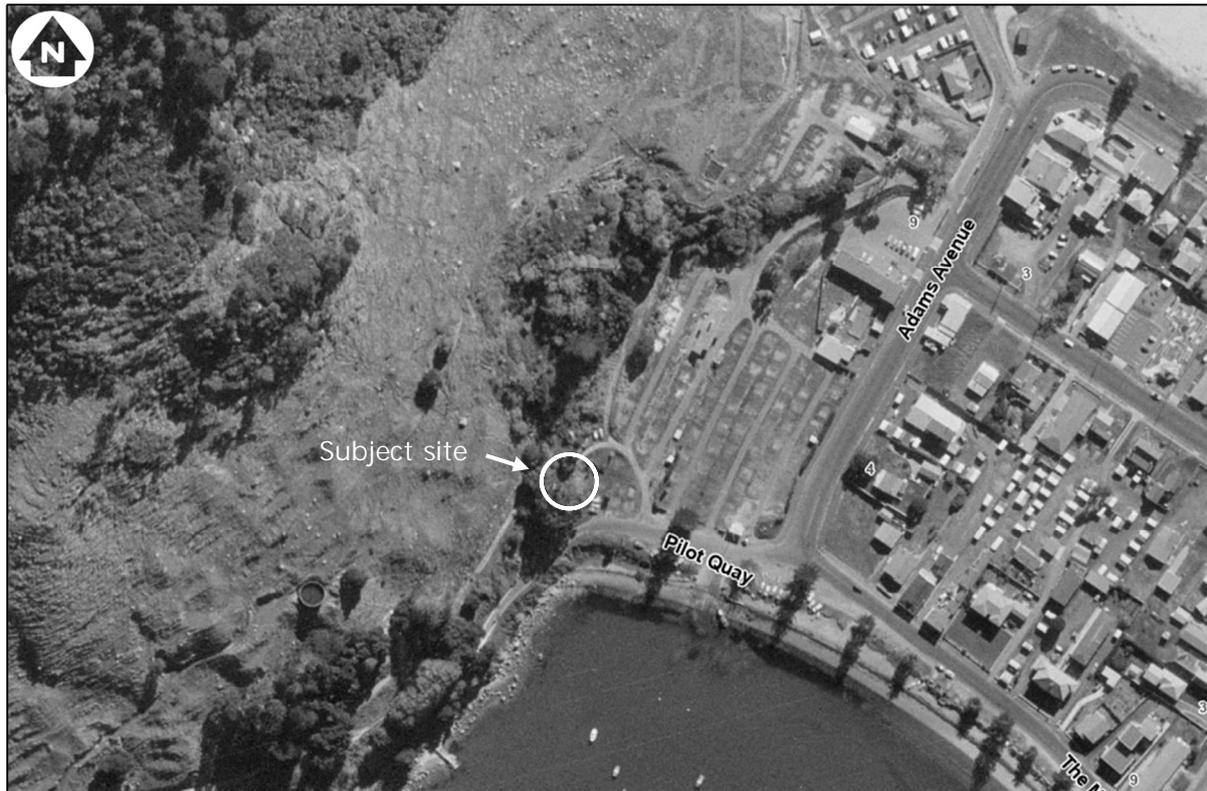
Figure 5 | Historical aerial photograph of the area from 1977 showing the approximate location of the subject site (TCC Mapi).

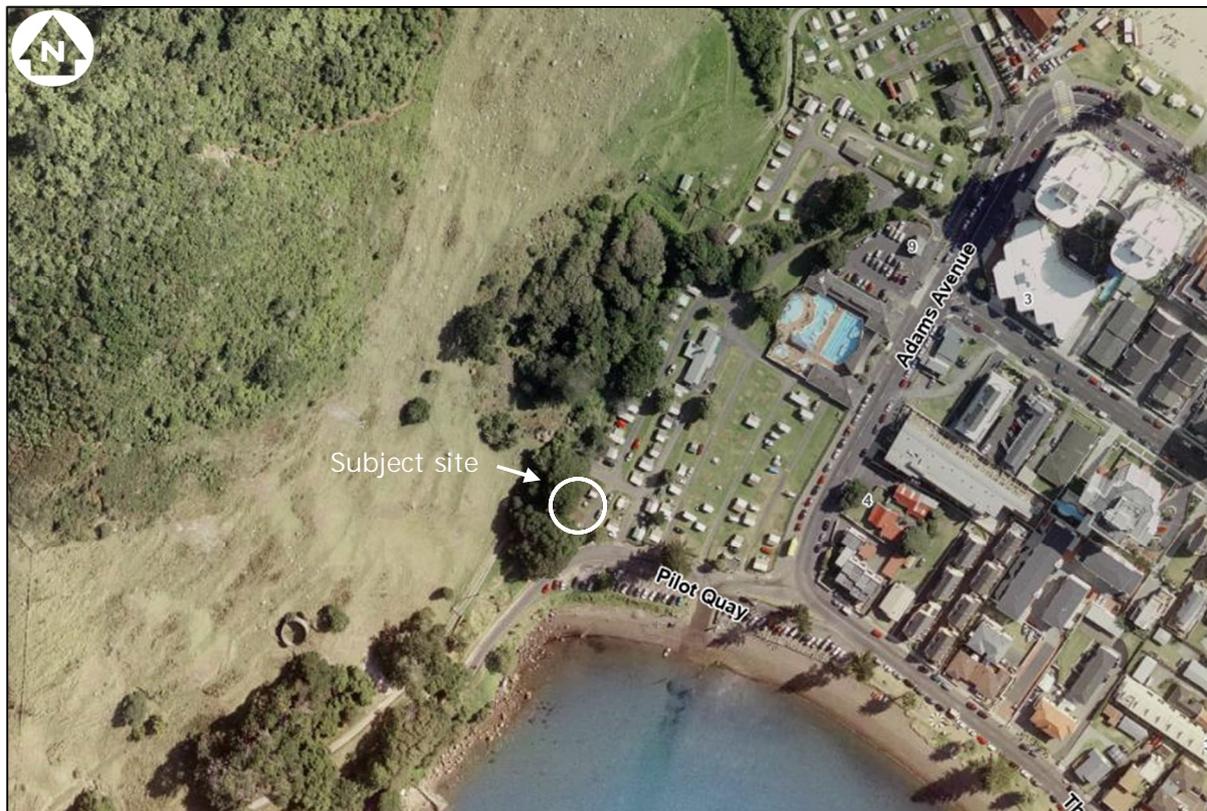
Figure 6 | Historical aerial photograph of the area from 2003 showing the approximate location of the subject site (TCC Mapi).
