Tauranga District Council  
Private bag 12022  
Tauranga

24 April 2017

## **Mauao Slopes; Monitoring Report for April 2017**

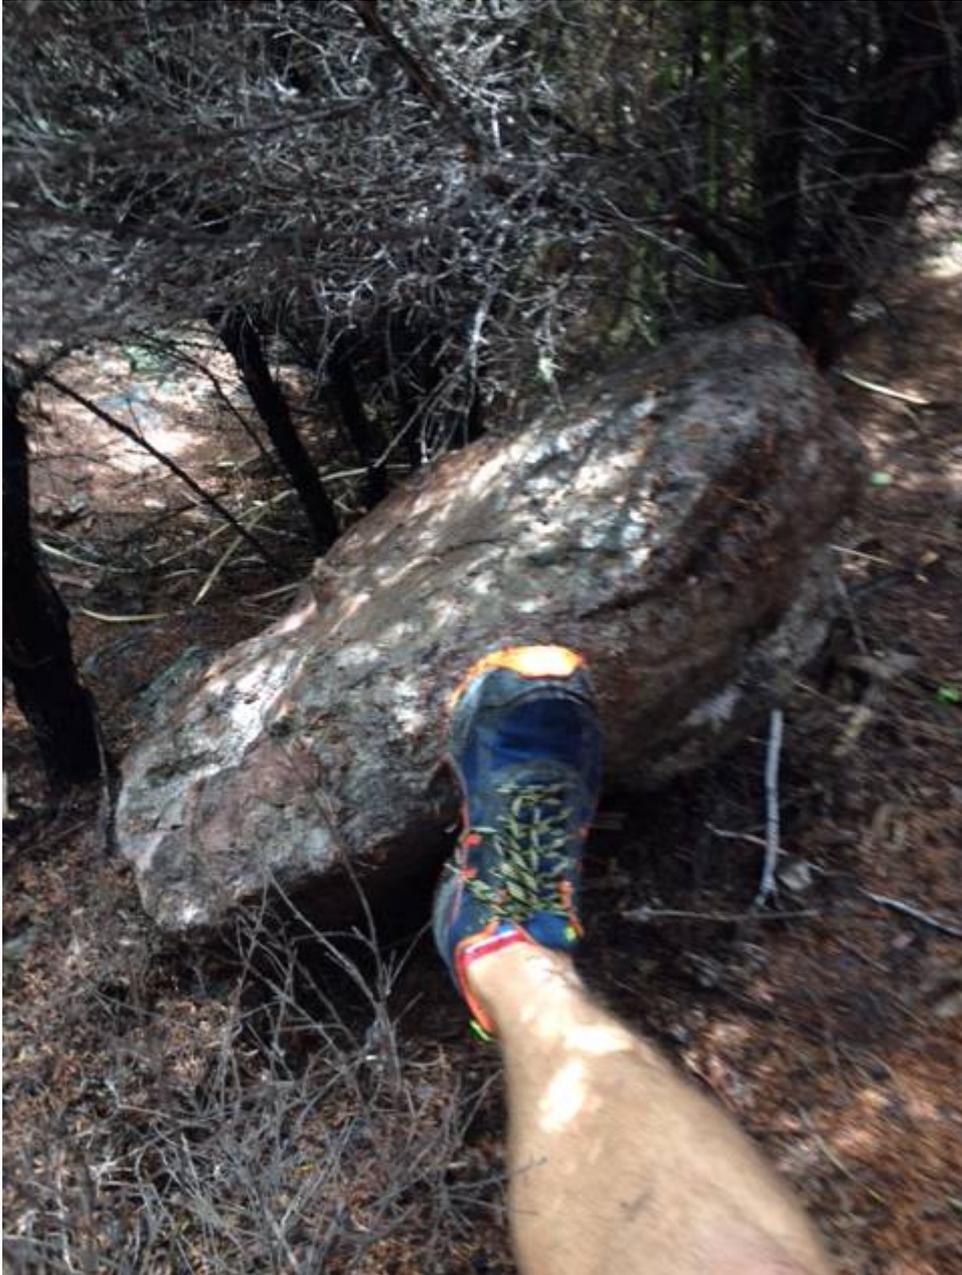
*"a rock of approximately 900 x 700 x 500 millimeters came down at speed from the northern bluffs and crossed the Oruahine track at speed bouncing on the outside edge of the track before coming to rest approximately 50 meters below in the vegetation"*

TCC implemented an immediate track closure and Avalon made a site visit the following day. The rock had impacted the edge of the Oruahine track leaving a hole around 500x500mm and 500mm deep.

The rock was located at rest in the scrub around 30m below track level.

Photo #1; Rock which crossed track 9 March 2017.

A drone inspection was carried out and the slope above the track hole was climbed, following indications of the rocks path. The source location was found to be a relatively small bluff high on the slope. 1 to 1.5 cubic metres of boulders was found that had moved but not fallen and were marginally stable. These were subsequently scaled in a controlled operation with Oruahine and base track closures, after which the tracks were reopened.

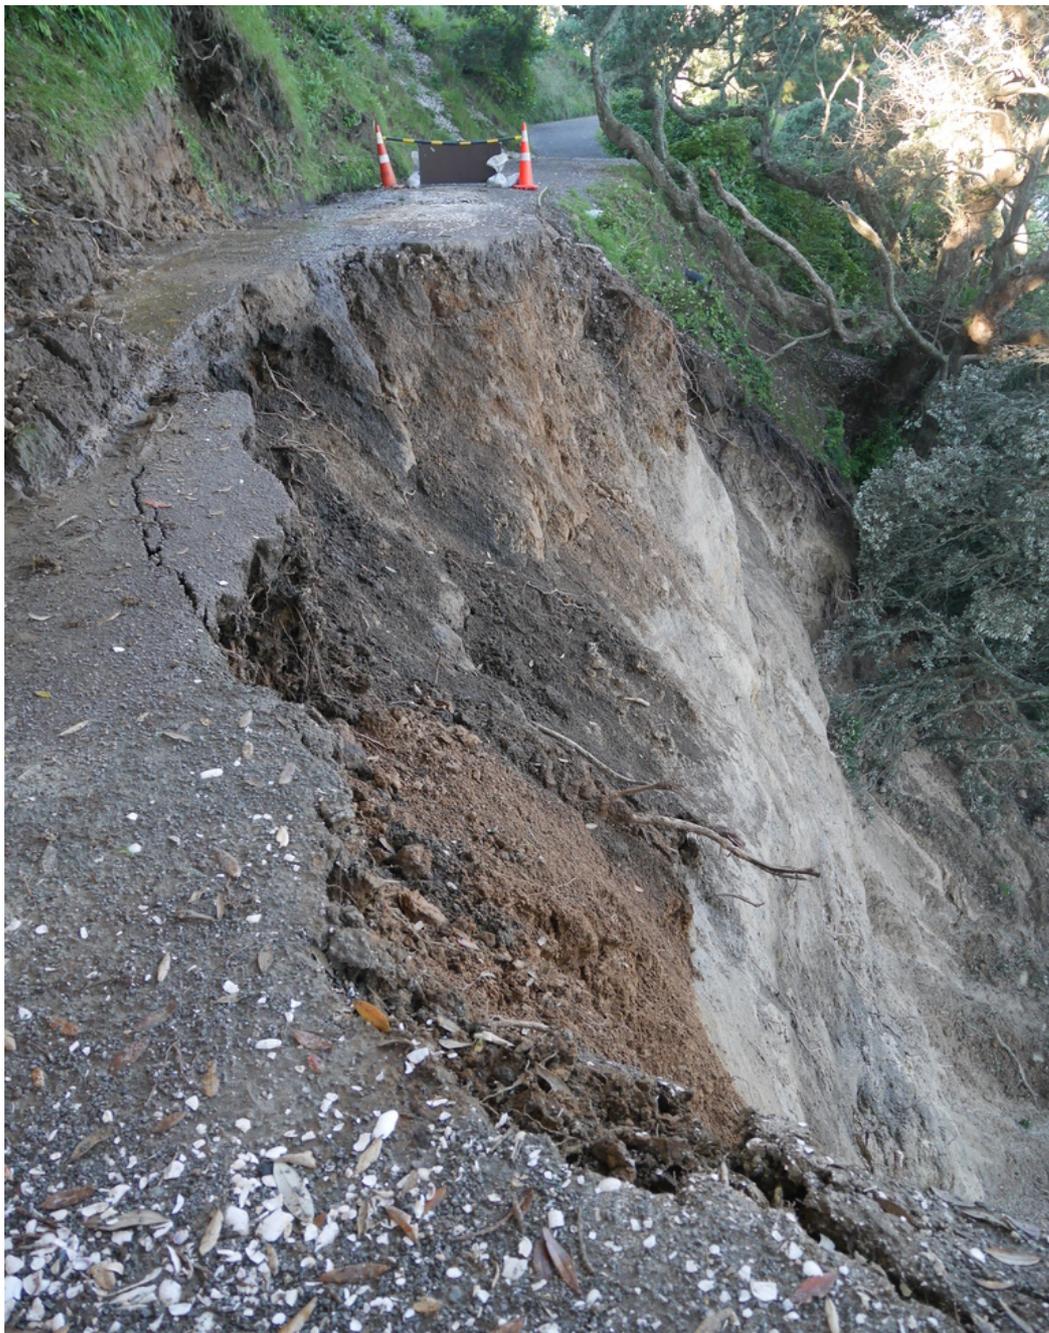
The one major slip was a drop out of the slope below the southern section of the base track resulting in over 10m of track loss and will take significant time and resources to repair.

Photo #2; Base track drop out 5 April 2017

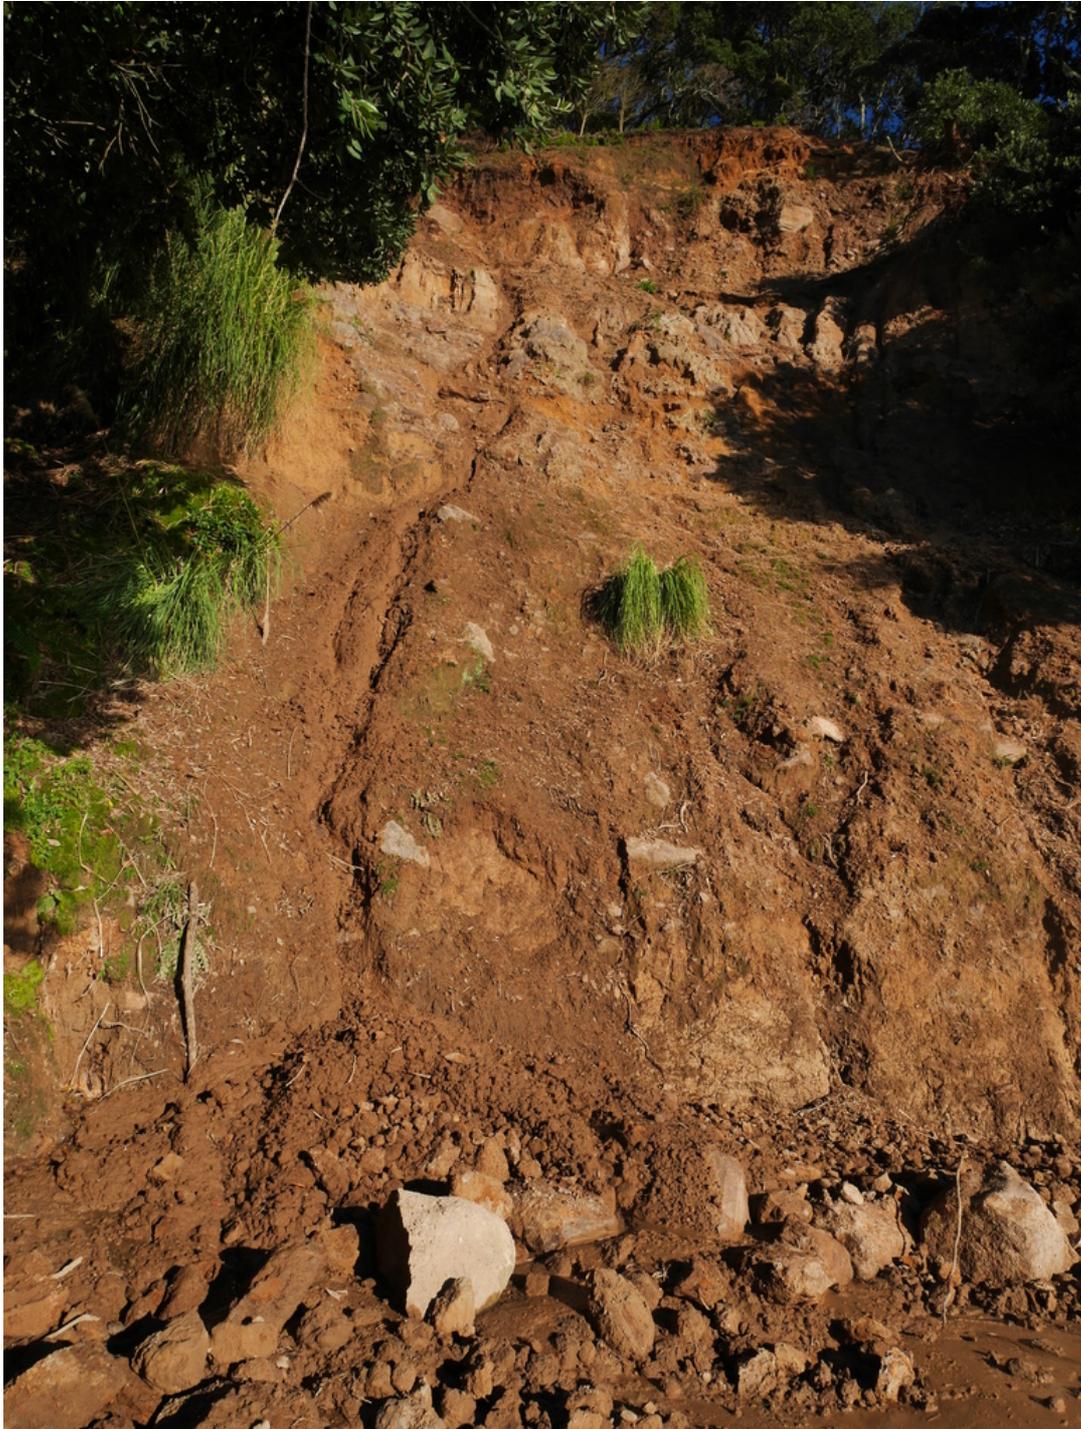
The base track corner slope which was reported in detail at the last monitoring (October 2016) and subsequently lightly scaled but has again been badly scoured in this rainfall event and it was deemed prudent to scale it again.

Photo #3; Western side Base track slip.

During the previous scaling we observed the rockfall trajectories which revealed that a fence to mitigate the risk at this location would need to be 4m in height.

For a longer term solution we could install a fence with posts at 3m centres and 8mm wire rope reinforced DT rockfall mesh. The bottom panel would be designed to allow cleaning out and replacement occasionally. The posts would be around 100mm diameter, founded at

2m depth. The top of the posts would be reinforced via wire ropes running back up behind the crest of the slipped area and anchored via trees or ground anchorages.

Erosion control on the slope was considered as an alternative option but would cost double the cost of a fence.

The length of fence required would be around 25 linear metres. The fence budget cost as described would be around \$40,000.
