**Mauao slopes 2005; Zone 6**

**Southern campground and hot pools**

**Rockfall hazard & risk assessment**

**Avalon Report No: 0534 A**

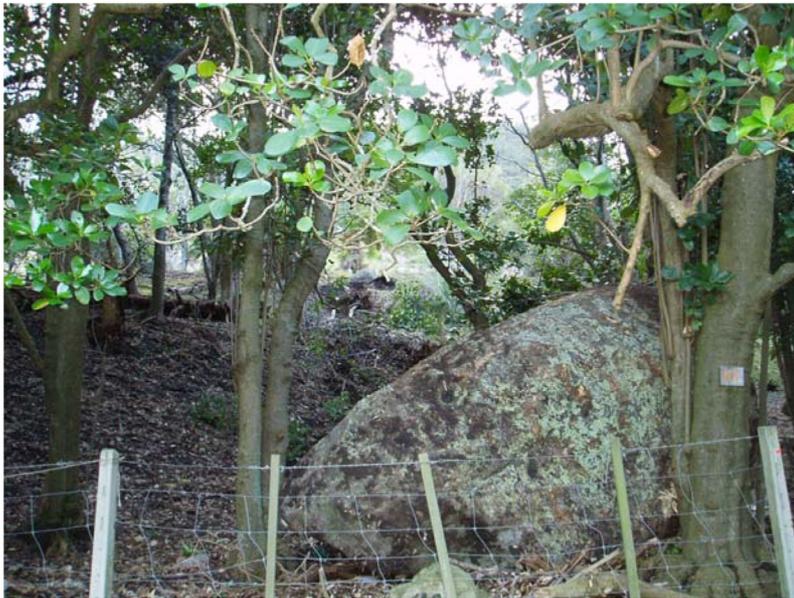
Photograph 1. Main boulder at rest adjacent to campground fence.

The boulder can be seen in the foreground of photograph 1 at rest behind the fence above camp site location No 98.

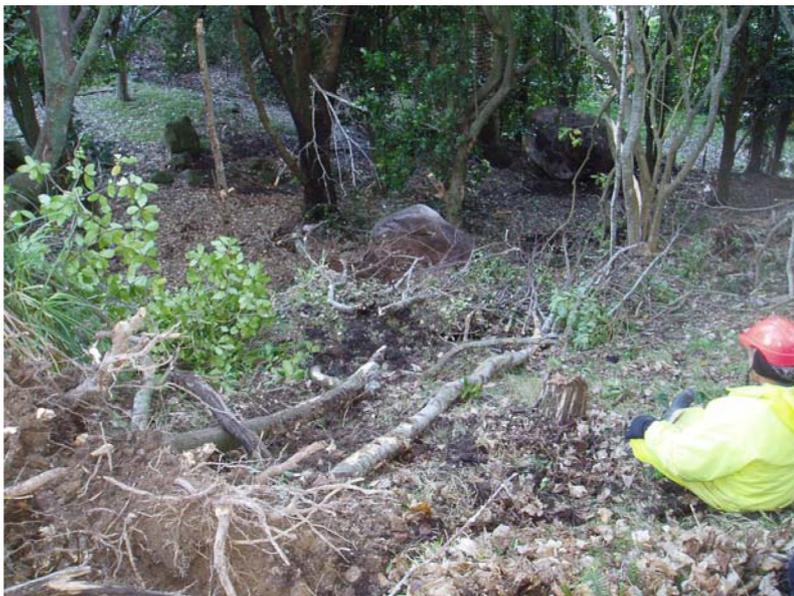
Photograph 2. View down fall line from source location.

The failure was from approximately the position of the photographer in photograph 2, 25m up the slope which lies at approximately 30°. The boulder was well rounded and approximately 2 to 3m in diameter.

A few metres down slope it collided with the small trees in the foreground of photograph 2 and then continued to roll through a few more trees before, approximately two thirds of the way down its track, striking a glancing blow to and dislodging a second boulder. This second boulder was approximately 1.5 to 2m in diameter and rocked forward approximately 1m and came to rest against a tree.

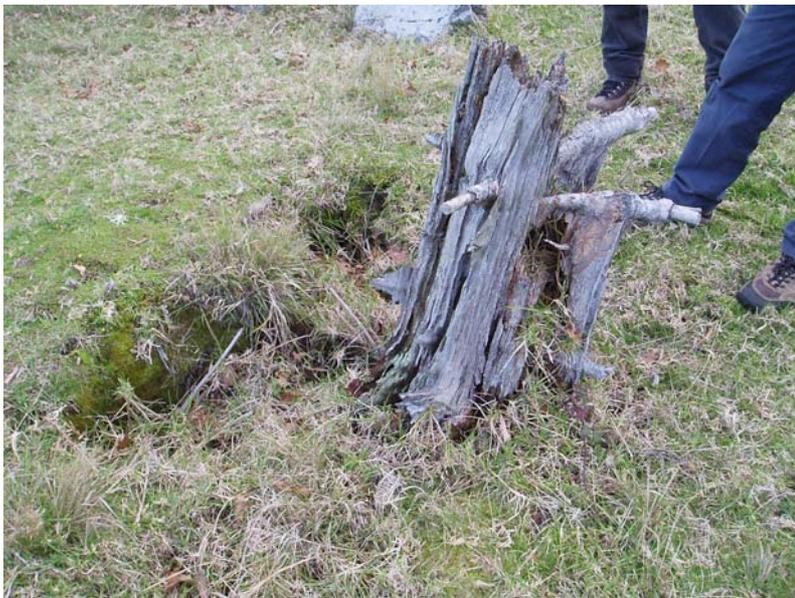
The slopes in this vicinity contain many highly rotted stumps. The decay of roots is causing localised subsidence as can be seen in photograph 3 below.

Photograph 3. Localised subsidence due to decaying root systems.

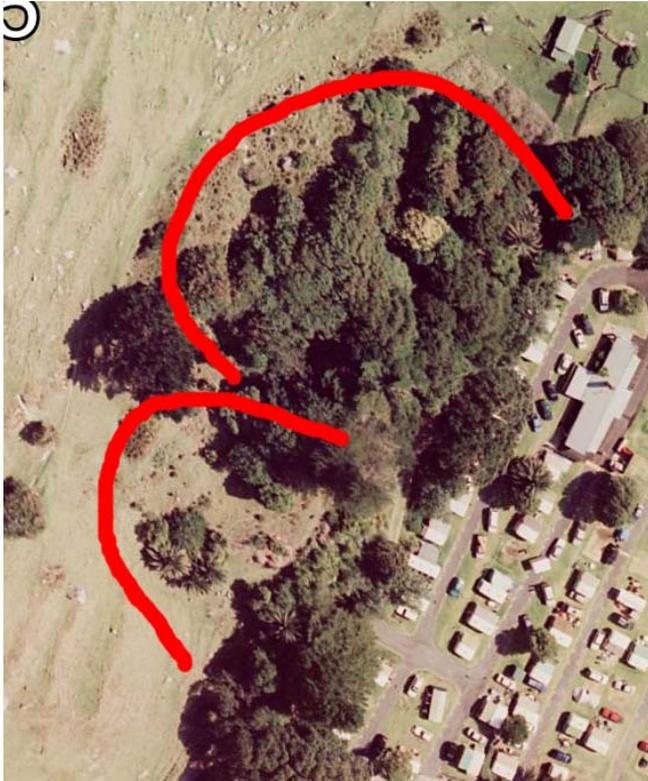
Photograph 6; Very approximate locations of two typical historical mass slips.

Photograph 6 indicates historical circular mass slips in the colluvial slopes immediately above the campground (others are also present). These events appear likely to have been over five times larger than the 18<sup>th</sup> May 2005 slip on the south western slopes and probably released a fast liquefied debris flow.

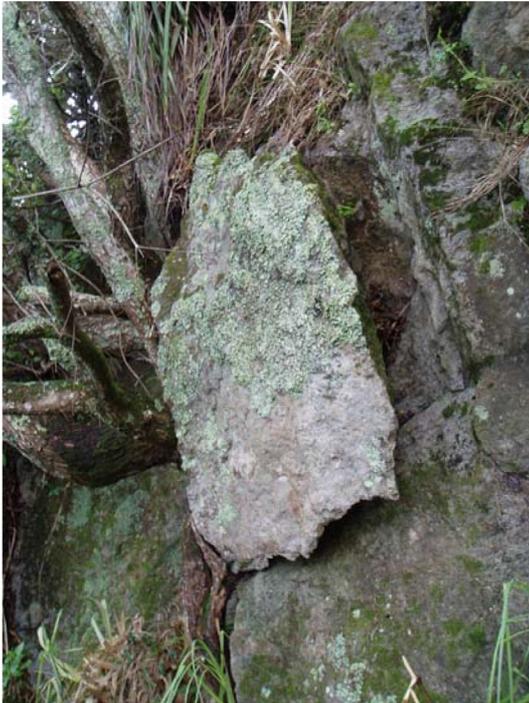
### 3.6.1 **6a**; detached boulder on face of outcrop

A broken bluff up to 4m in height runs from 6a to 6b and 6c. At 6a a 'flake' of rock approximately 1 x 1 x 0.4m has become detached, mostly due to root jacking. The rear joint is open over 100mm. Very marginally stable. The disc shape could allow this boulder to roll a considerable distance.

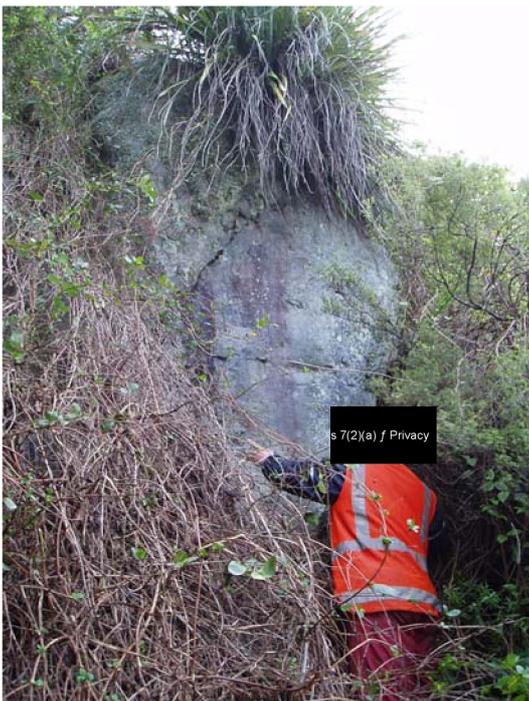
### 3.6.2 **6b**; detached boulder forms face of outcrop

The lower area of this outcrop shows very fresh looking stress fractures. A 'flake' approximately 2.5 x 2 x 0.5m is marginally stable. The rear joint is open 30-50mm and seeping water. Freshness of fractures suggests they could have formed in last year's earthquake event.

Appears likely to split on failure but main piece would remain disc shaped.

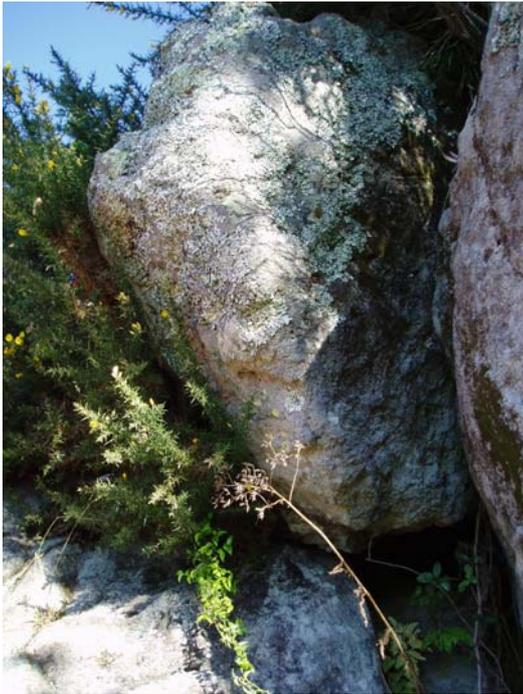
### 3.6.3 **6c**; detached boulder on top of outcrop

A relatively small boulder, 1 x 0.5 x 0.5m. Detached and temporarily wedged but root jacking could destabilise.

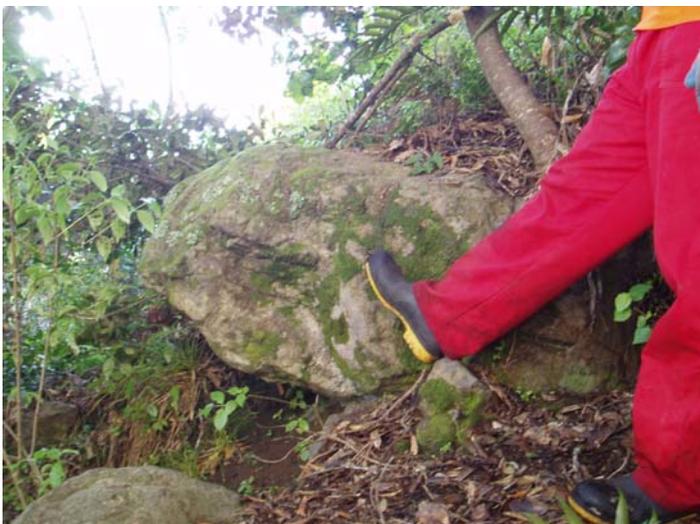
### 3.6.4 **6d**; surface boulder

Approximately 1.2 x 1.0 x 0.8m. Toe undercut by erosion but relatively stable in the short term. Further erosion and growth of tree behind could further destabilise.

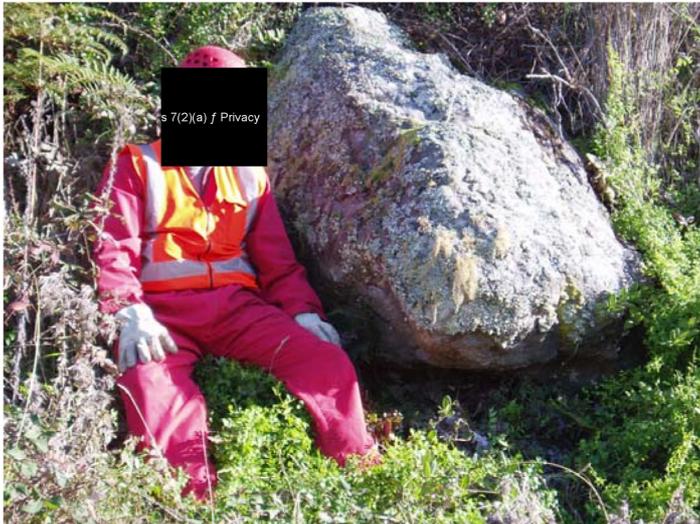
### 3.6.6 6f; surface boulder

Approximately 1.2 x 0.8 x 0.8m. Toe undercut by erosion. Further erosion could destabilise. Ground immediately below is very steep.

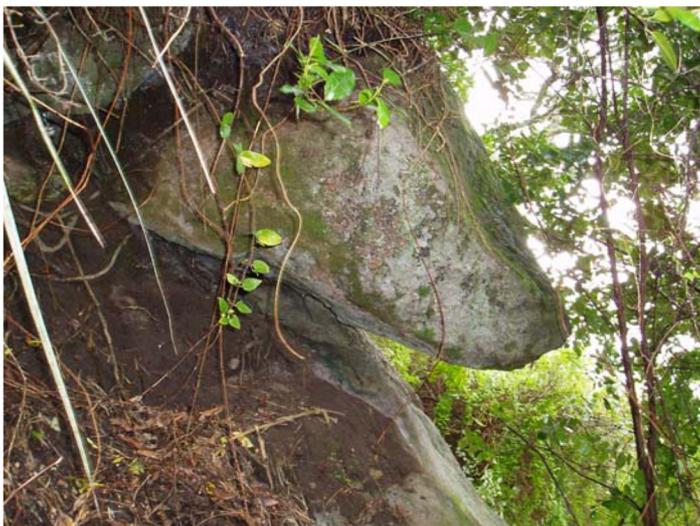
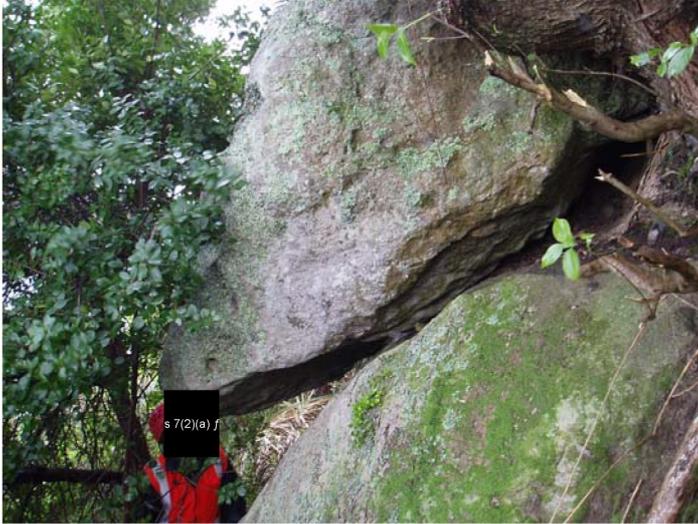
### 3.6.7 6g; weathered outcrop with detached boulder on top

A relatively severe hazard, appears to have very marginal stability. Approximately 2 x 3 x 1.2m. Tree behind is jacking the upper block forward. Steep slope immediately below.

Wedge shape will resist rolling but mass of boulder and steepness of ground are not favourable.

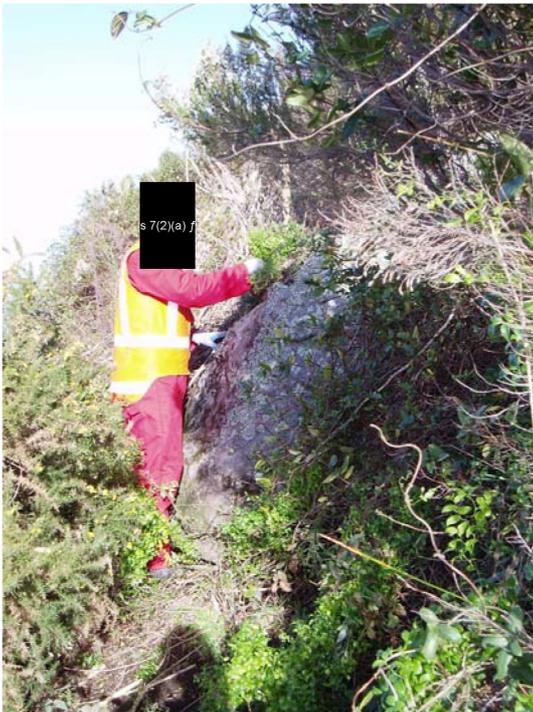
### 3.6.9 **6i**; surface boulder

1.5 x 1.5 x 1m. Moderately eroded and undercut base. Steep ground below but relatively stable in the short term.

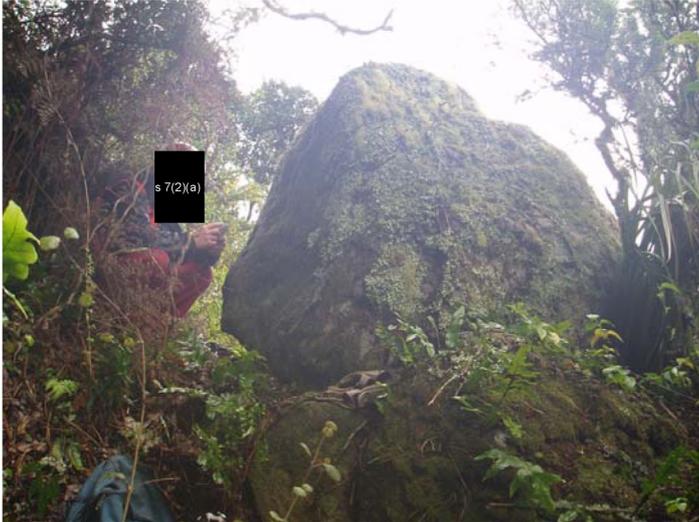
### 3.6.11 **6k**; large outcrop boulder

5 x 5m outcrop with boulder of 1.5 x 2 x 2m resting on top. Low angle contact between boulder and outcrop is stable regarding erosion but potentially becomes a hazard given seismic loading.

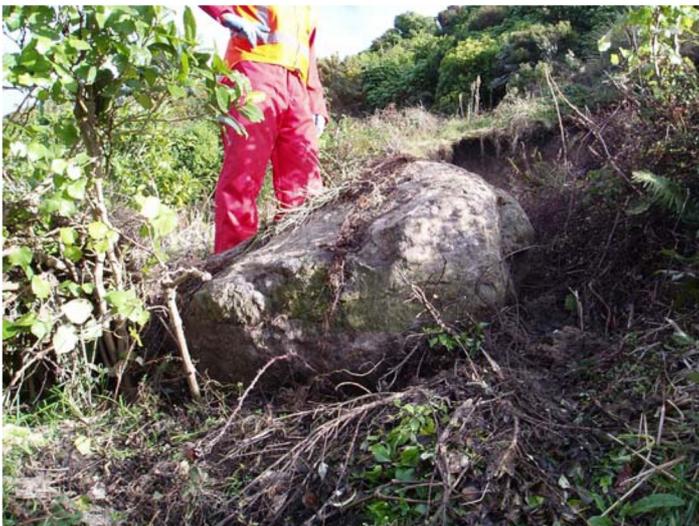
### 3.6.13 **6m**; surface boulder disturbed by recent mass slip (slip item 9).

1.2 x 1.2 x 0.6m. Has been rolled to a relatively stable position.

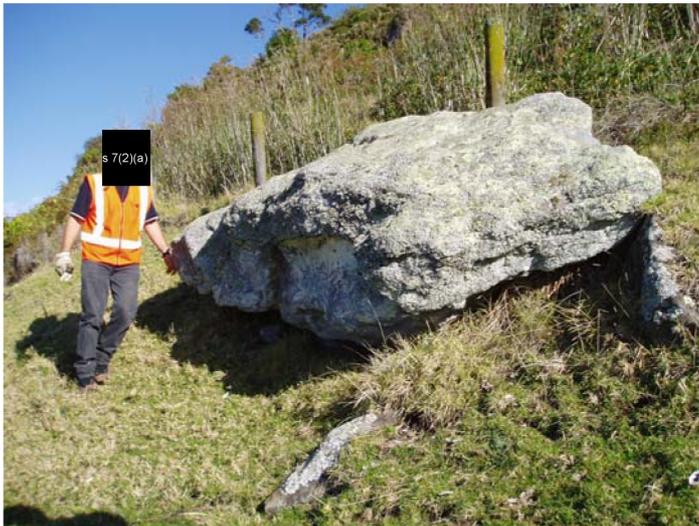
### 3.6.14 **6n**; surface boulder in paddock

2 x 2.5 x 0.8m. Moderately stable in short term but on steep ground and with potential for erosion below. Hazardous in earthquake. Could split into two on rolling.

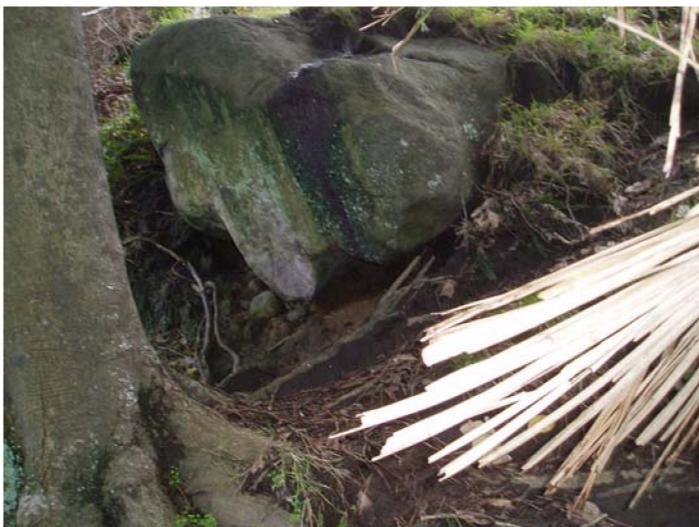
### 3.6.17 **6q**; surface boulder on margin of historical mass slip

2 x 1.5 x 1m. Embedded in top of steep historical mass slip scarp. Moderately stable in the short term but eroding slowly below.

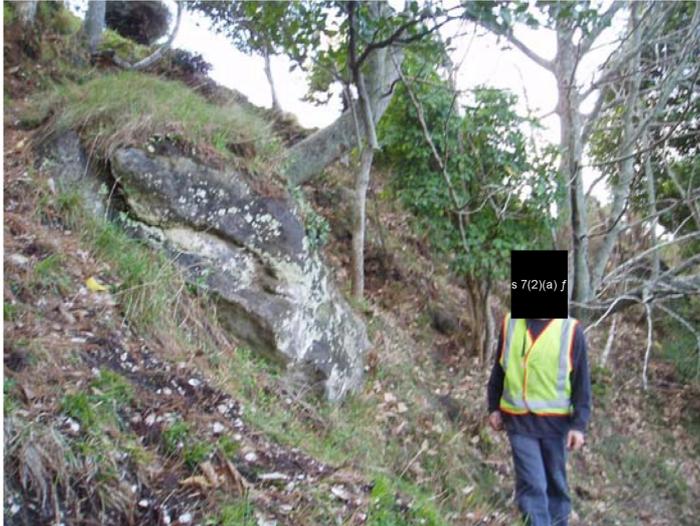
3.6.18 **6r**; surface boulder on margin of historical mass slip

2 x 2m. Embedded in steep historical slip scarp. Stable in short to medium term.

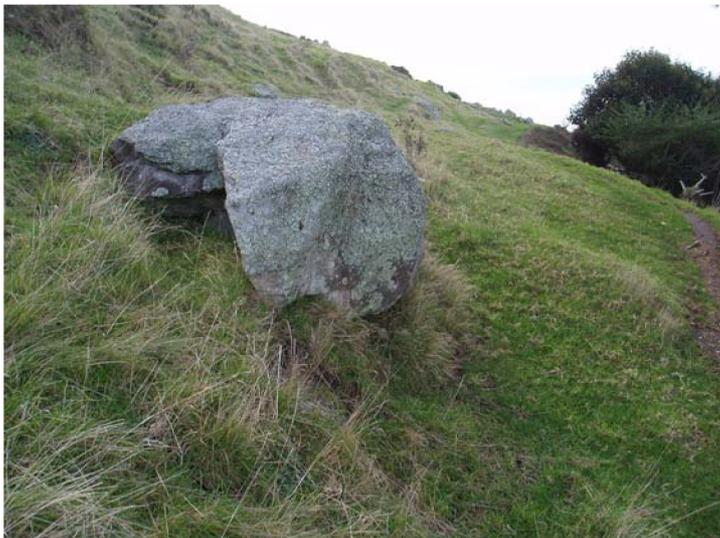
3.6.19 **6s**; surface boulder in paddock

1 x 0.8 x 0.6m. Embedded and moderately stable in the short term.

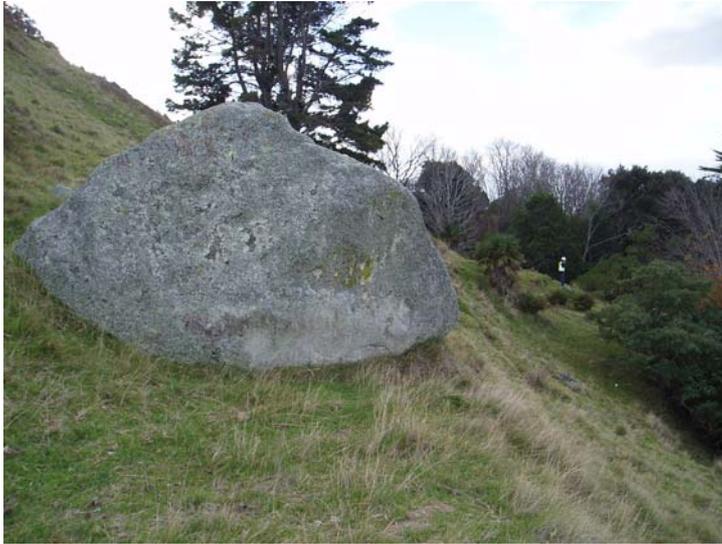
### 3.6.20 **6t**; surface boulder in paddock

2 x 2 x 1.5m. Stable in short term but potentially hazardous should steep soil slope drop out from below.

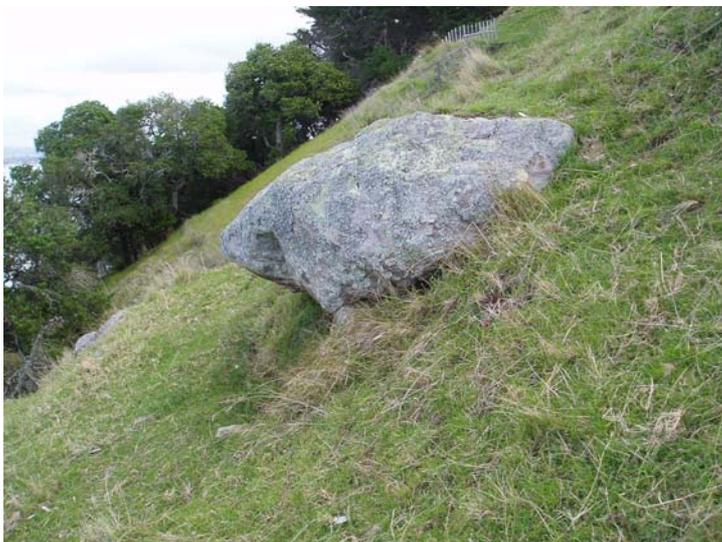
### 3.6.21 **6u**; surface boulder in paddock

2 x 1.5 x 1.5m. Moderately stable in the short term but undercut and on very steep ground.

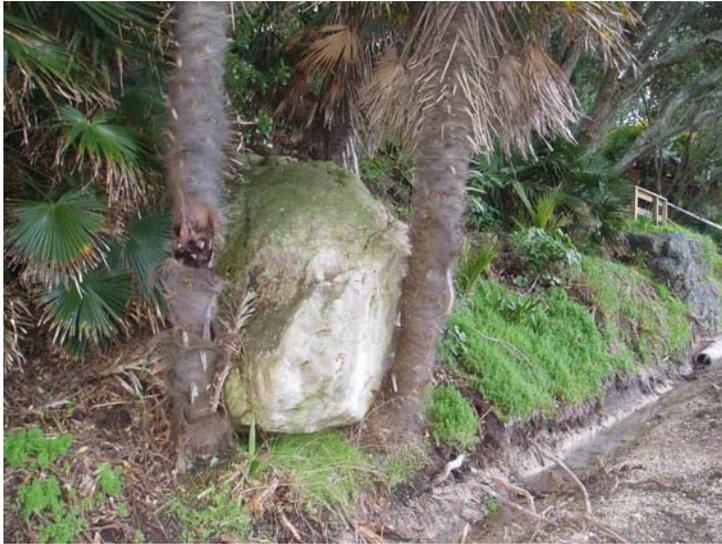
### 3.6.22 **6v**; surface boulder at campground boundary

1.5m diameter. No significant hazard but appears likely to have been creeping down cut slope. Now bearing on the small palm trees.
