7 August 2020  
 Avalon Project #20149

## **Mauao Slopes; Monitoring Report for August 2020**

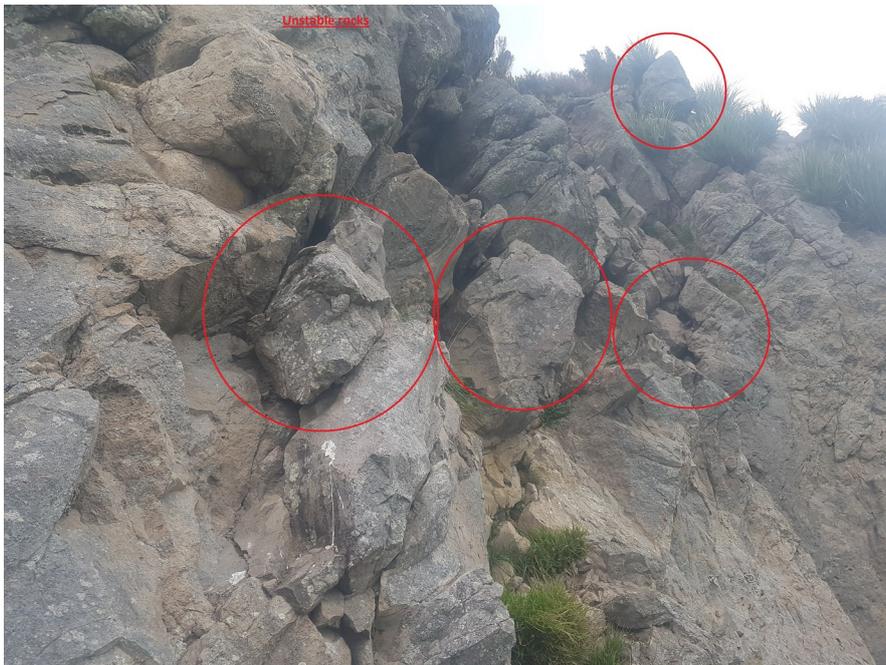
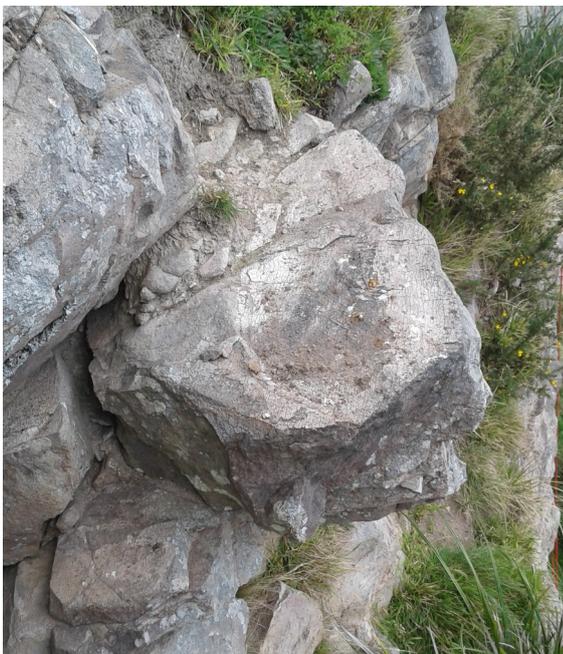
In 2017 Avalon provided a team of two technicians to assist with vegetation survey work above the Oruahine track. During that work the team came across a number of unstable areas of rock face.

Some larger unstable boulders were found, indicated in the following photos. These could not be scaled at the time with the resources available. We recommend these hazards be scaled. Track security would be required.

Loose rock identified on the bluffs above the Oruahine track.

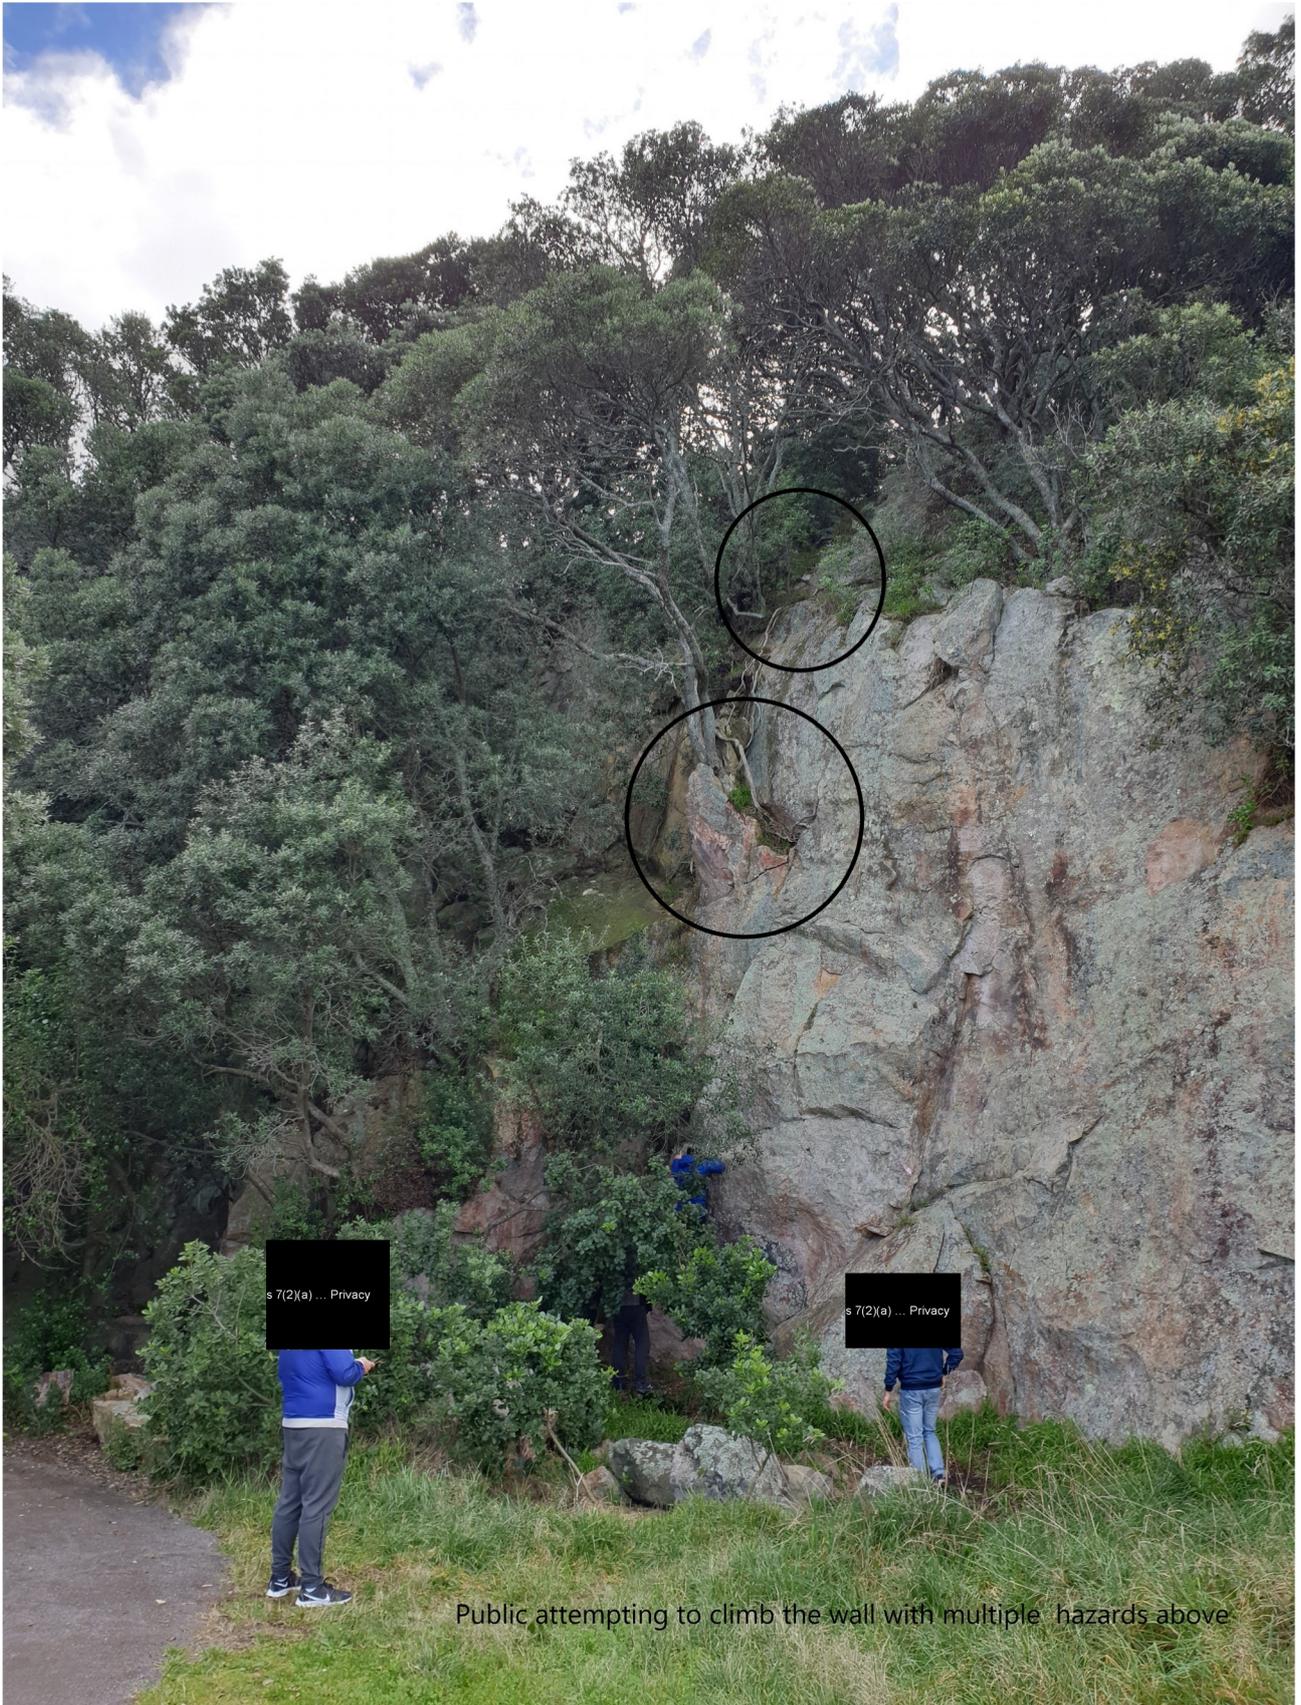
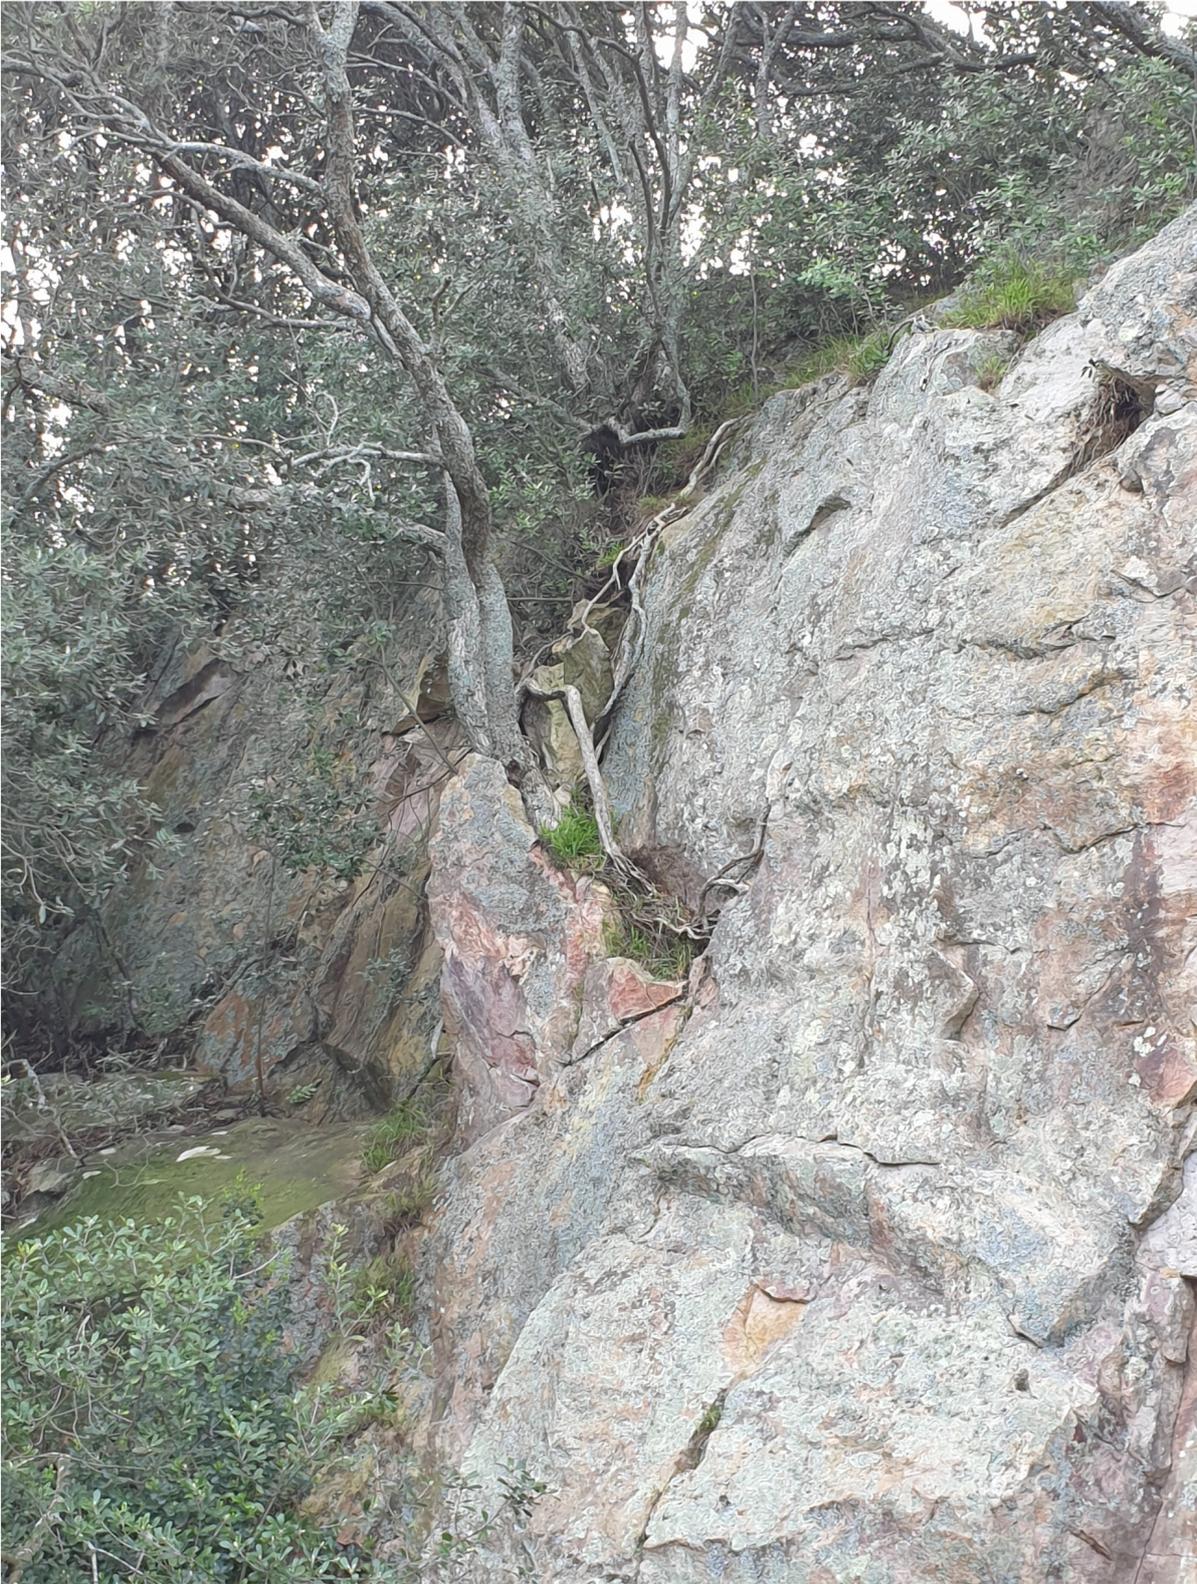
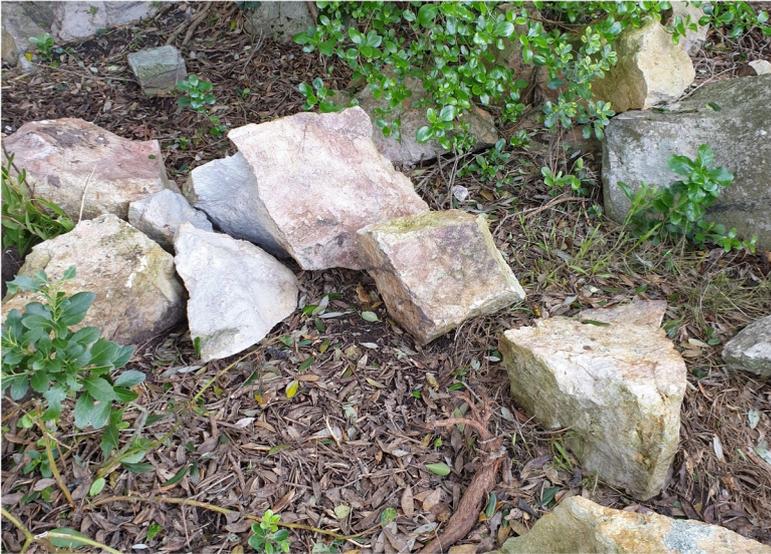
Whilst on a recreational visit to Moturiki island one of Avalon's technicians identified evidence of rockfall and persons rock climbing on a face with a number of obviously marginally stable areas.

Evidence of recent rockfall was found immediately below

We would recommend a close inspection and light scaling operation to reduce the rockfall hazard in this vicinity
