Mauao Base Track Remediation
Geotechnical Assessment

October 2018

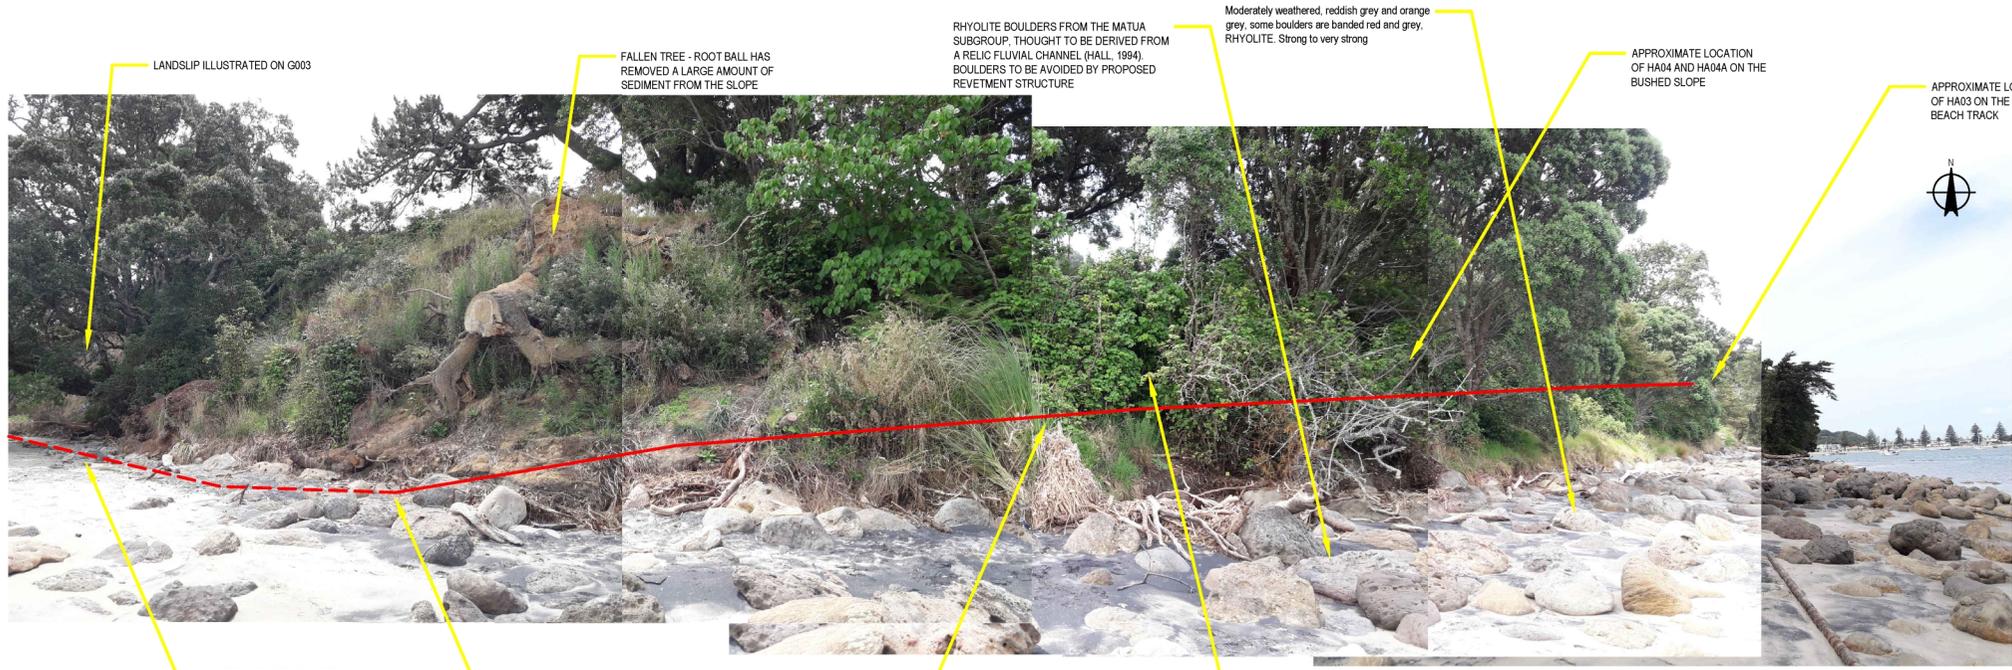
LANDSLIP ILLUSTRATED ON G003

FALLEN TREE - ROOT BALL HAS REMOVED A LARGE AMOUNT OF SEDIMENT FROM THE SLOPE

SLOPE IS APPROXIMATELY 10 - 15 m HIGH. SEE GENERALISED SLOPE PROFILE IN SECTION BELOW

GENERALISED PROFILE THROUGH THE SLOPE THAT THE ON-GRADE SECTION OF TRACK IS PROPOSED TO TRAVERSE

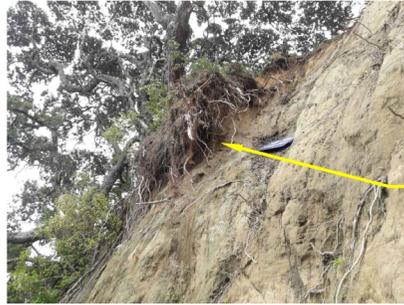
EROSION OF SOIL AROUND TREE ROOT SYSTEM. COLLAPSE OF TREES MAY RESULT IN FURTHER CLIFF FAILURE

- We recommend that during construction, large trees are either pruned or removed (after specific assessment by an arborist). We recommend that as much vegetation as possible is retained to maintain stability of the slopes.

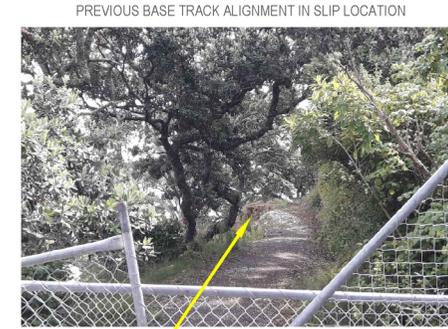
PREVIOUS BASE TRACK ALIGNMENT IN SLIP LOCATION

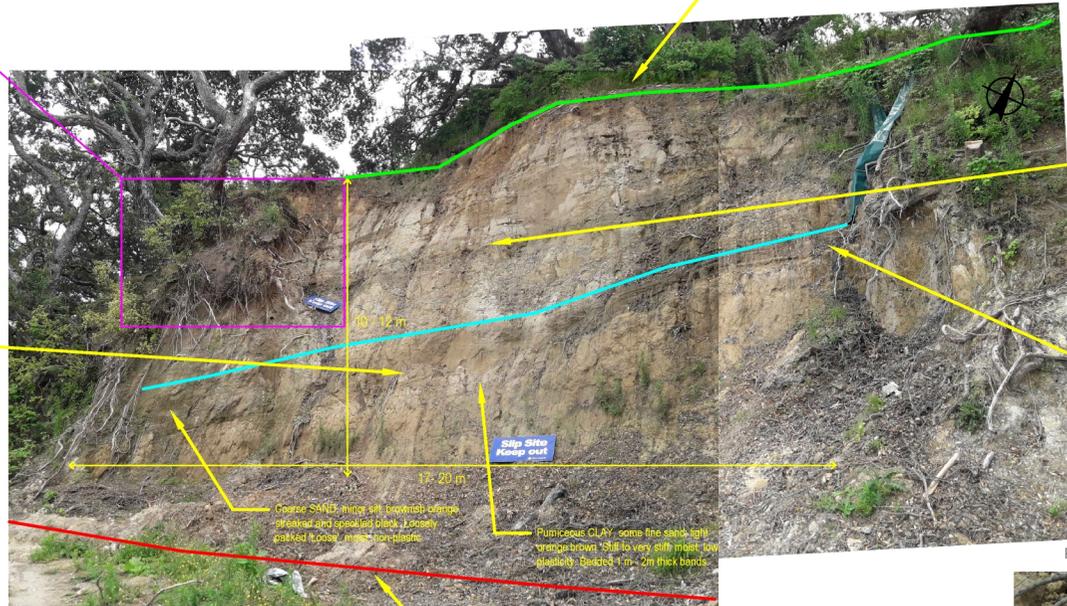
PREVIOUS MAUAO BASE TRACK, HALF REMOVED BY LANDSLIP

TOP OF SLIP HAS REMOVED APPROXIMATELY HALF THE WIDTH OF THE PREVIOUS BASE TRACK

SLIP SCARP AND COLLUVIUM PILE

PUMICEOUS SILT ENCOUNTERED IN COLLUVIUM PILE

- Following re-grading of localised overhangs we recommend that the exposed slip face is covered in MacMat, DuraMAT or other suitable approved product. The matting should be secured in place with suitably designed anchors.
- Once installed the MacMat, DuraMAT or other suitable approved product can be hydroseeded. Vegetation growth on this surface will further improve stability of the slip face.

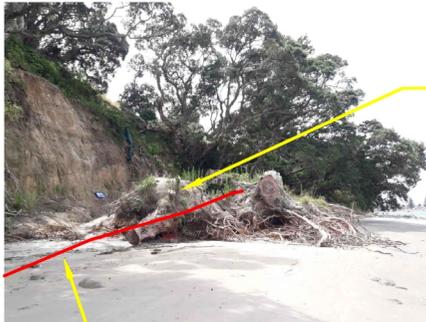
COLLUVIUM FROM LANDSLIP SILT & SAND IS BEING REMOVED BY TIDAL EROSION. TREE STUMPS AND ROOT SYSTEMS LIKELY CONTRIBUTED TO FAILURE

APPROXIMATE POSITION OF PROPOSED BASE TRACK

ORANGE BANDING LIKELY INDICATING THIN AIR FALL DEPOSITS

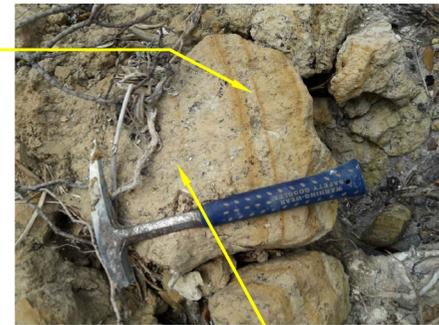
Pumiceous SILT, some fine sand, pale orange brown, banded orange. Stiff to very stiff, moist, low plasticity

APPROXIMATE POSITION OF PROPOSED TRACK

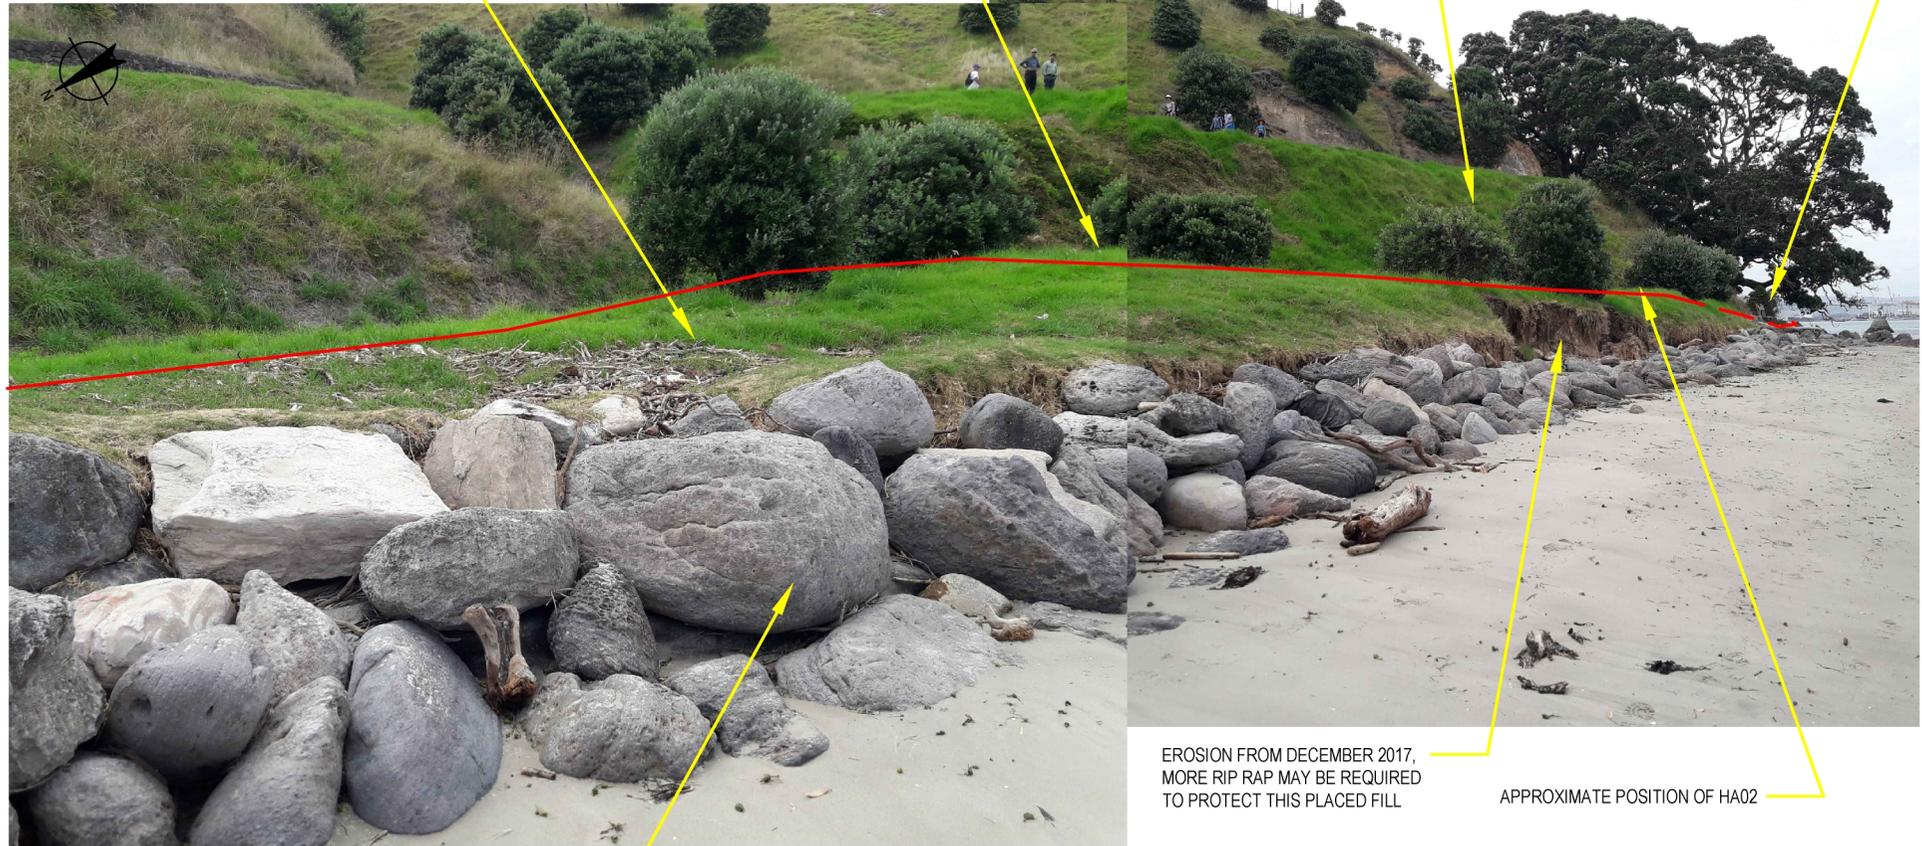
COLLUVIUM MATERIAL TAKEN FROM A PREVIOUS LANDSLIDE ON MAUAO AND COMPACTED IN PLACE

APPROXIMATE POSITION OF PROPOSED BASE TRACK ON-GRADE

EROSION FROM DECEMBER 2017, MORE RIP RAP MAY BE REQUIRED TO PROTECT THIS PLACED FILL

APPROXIMATE POSITION OF HA02

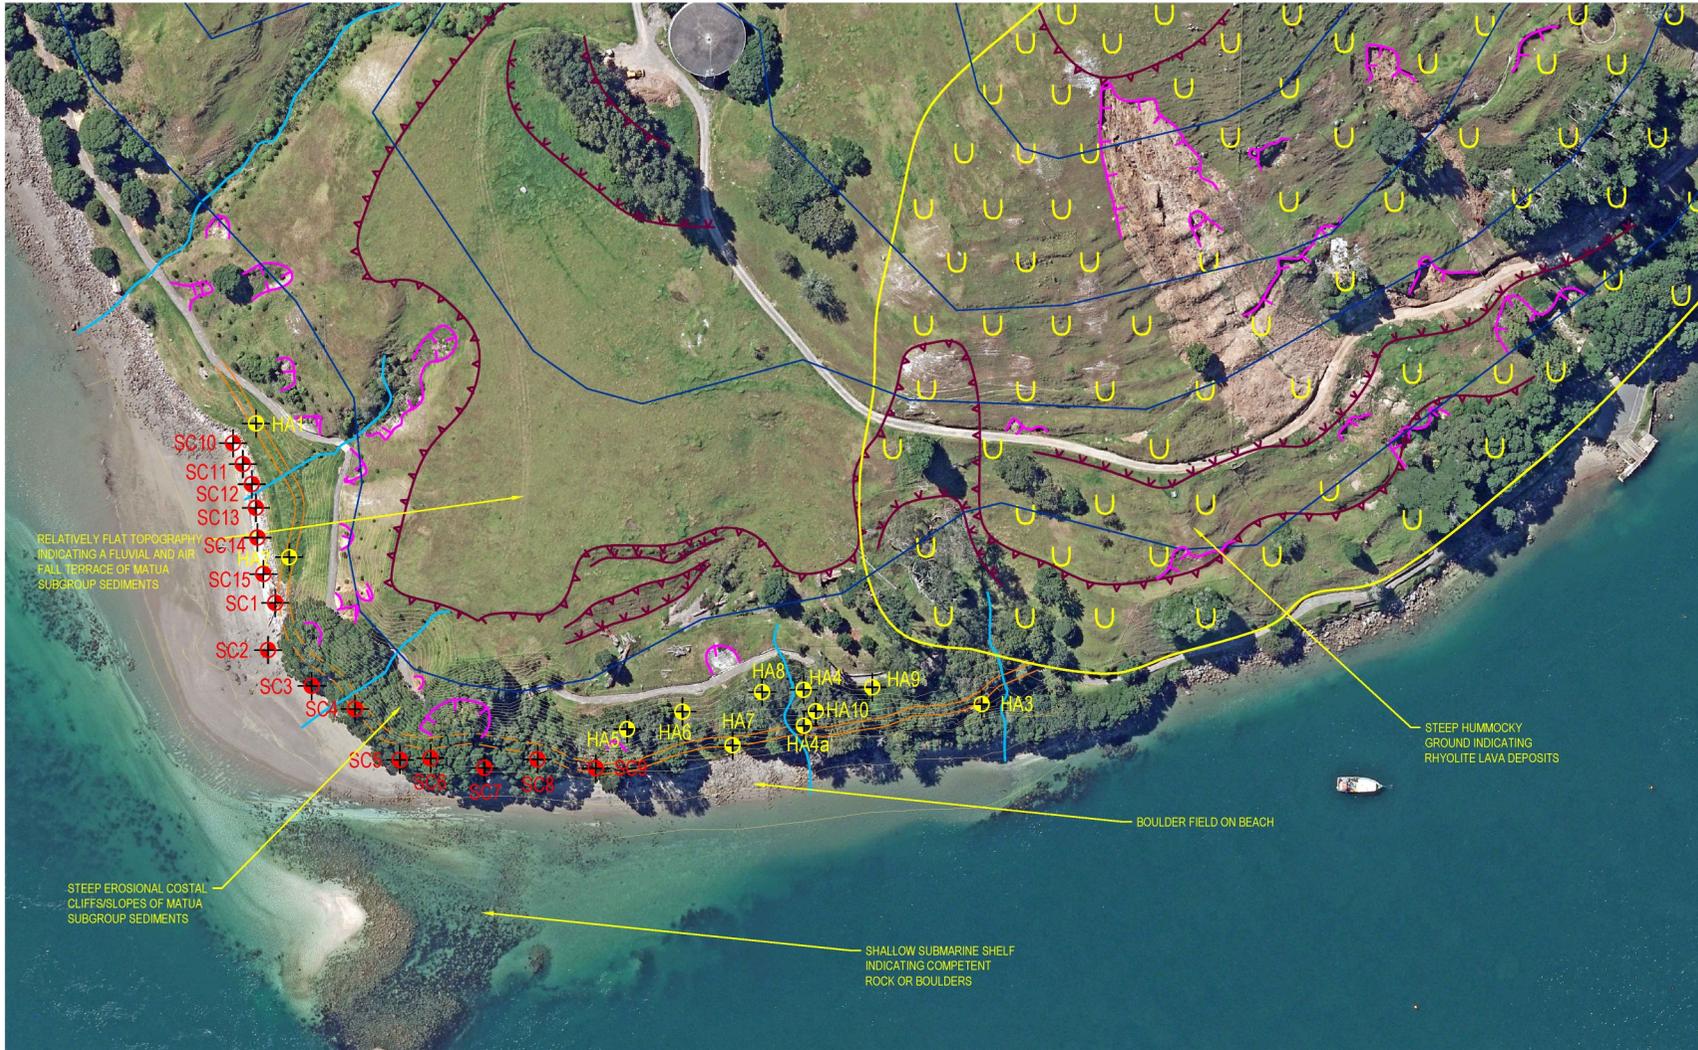
The findings of the geological assessment are summarised by the geomorphic map - drawing 51-37691-G001, attached in Appendix B and the three annotated photos illustrating key areas
