### **Mauao Slopes; Monitoring Report for November 2015**

This letter is to report on survey benchmark monitoring and site geotechnical walkover on 23 November 2015.

**Rockfall hazard & risk assessment**

**Avalon Report No: 0534 A (Issue 2)**

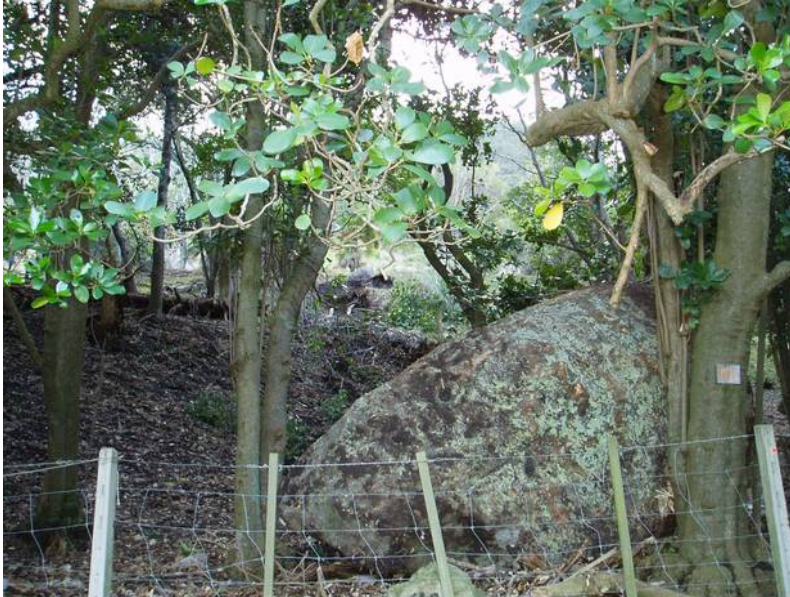
Triggered by a rain event in June 2005 a very large, around 2.5m diameter, well rounded boulder failed from this slope and rolled 25m, coming to rest just above the campground boundary fence.

Photograph #1. A Boulder fell in this area in 2005.

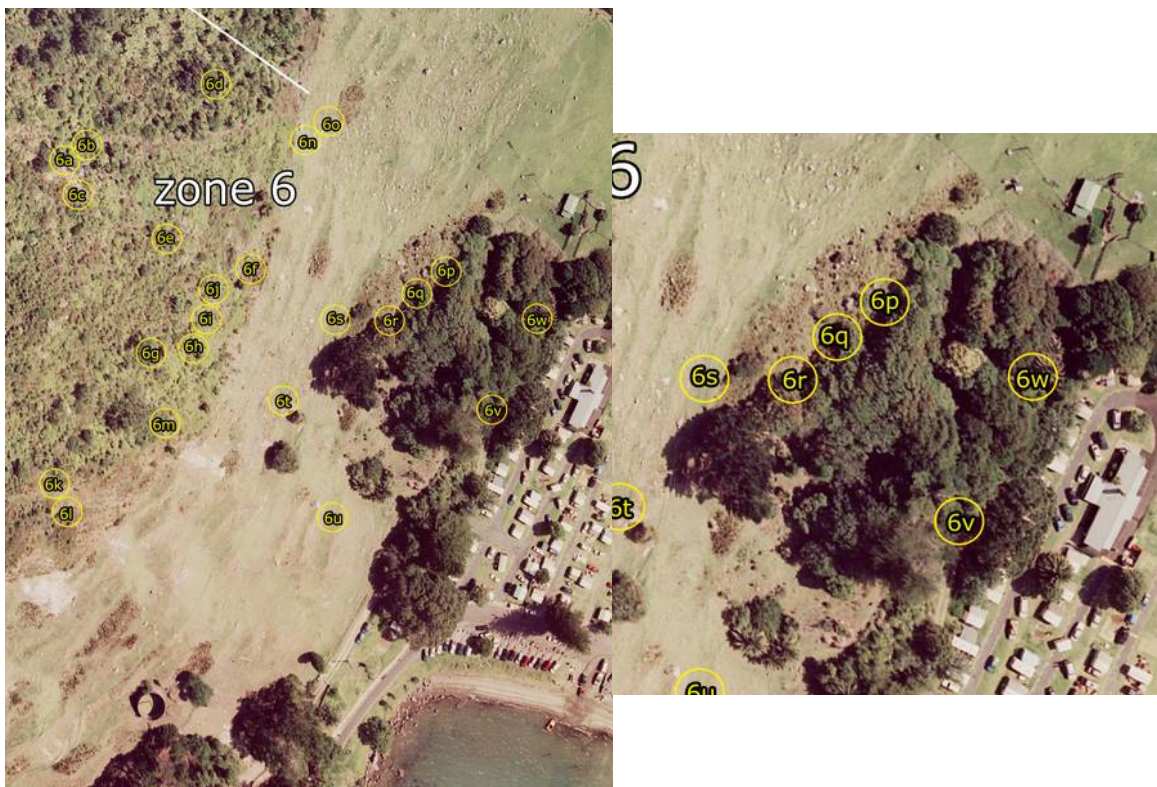
Photograph #2. Hazard mapping in 2005.

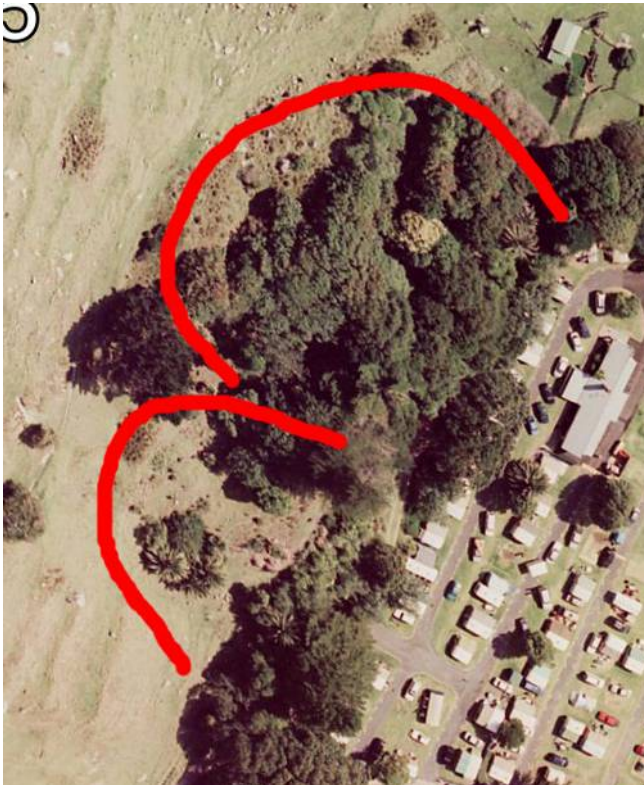
Photograph #3. Scarps of old landslips.

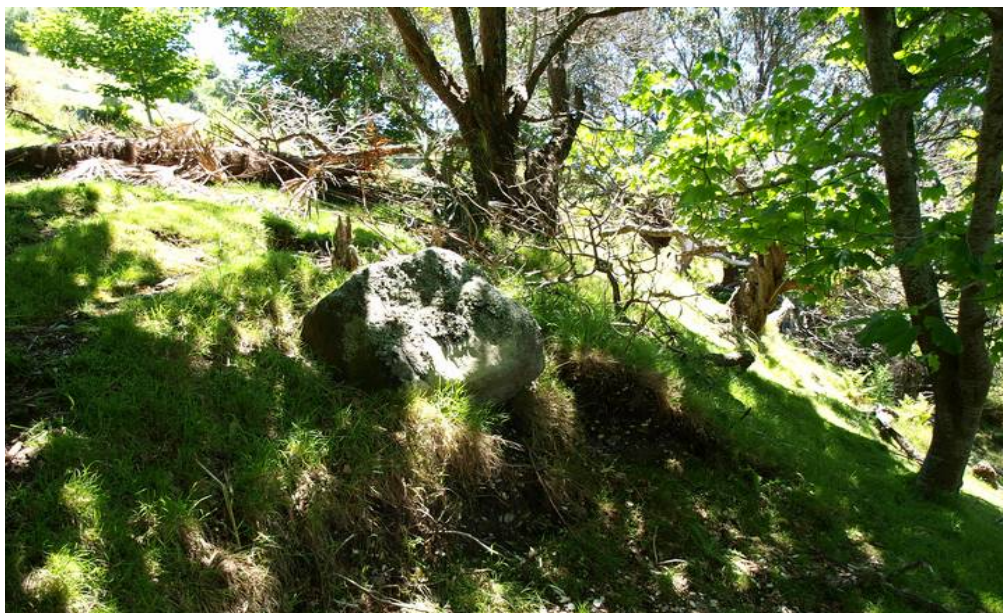
Photograph #4. Boulder **6p**; 0.8m, well rounded, now far more exposed than in 2005.

This boulder 6p currently represents the highest hazard as in addition to the likely eventual weather event trigger it is in a size and position where it could be pushed by children.

In reviewing these areas this year it was found that erosion from rain, animals, and general weathering has now further exposed some surface boulders to the point where it could be prudent to deliberately trigger them to roll, with steps taken to slow them as much as possible and with areas below cleared and isolated of course.

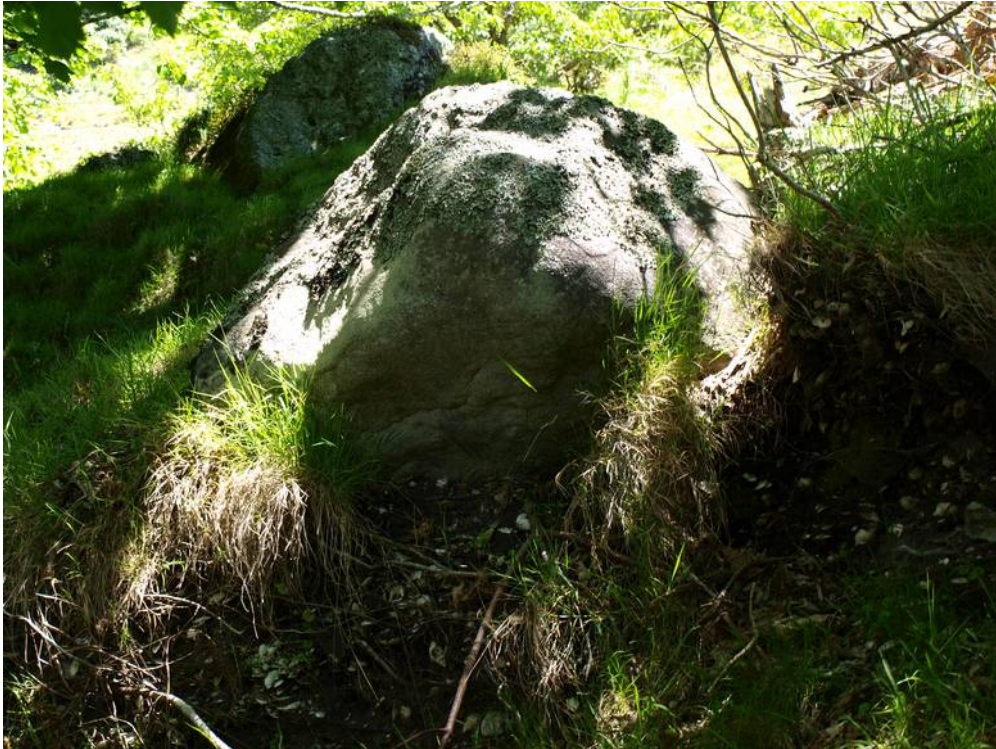
Photograph #5. Boulder **6p**; close up it can be seen to be sitting on highly erode-able midden material.

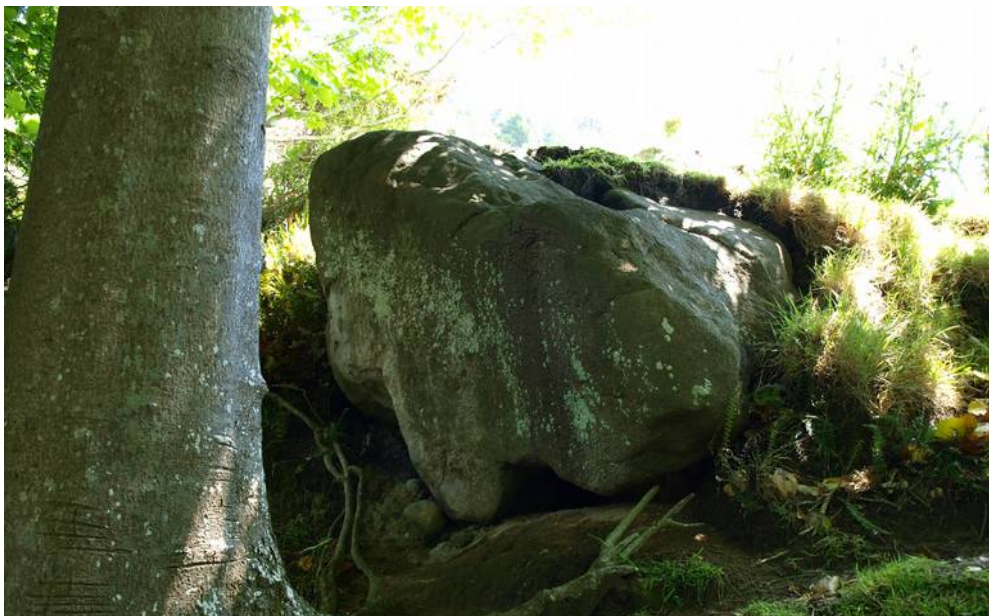
Photograph #6. Boulder **6q**; 2 x 1.5 x 1m. Embedded in crest of slip scarp.

**6q** still appears reasonably well embedded but should be more closely checked whilst dealing with 6p.

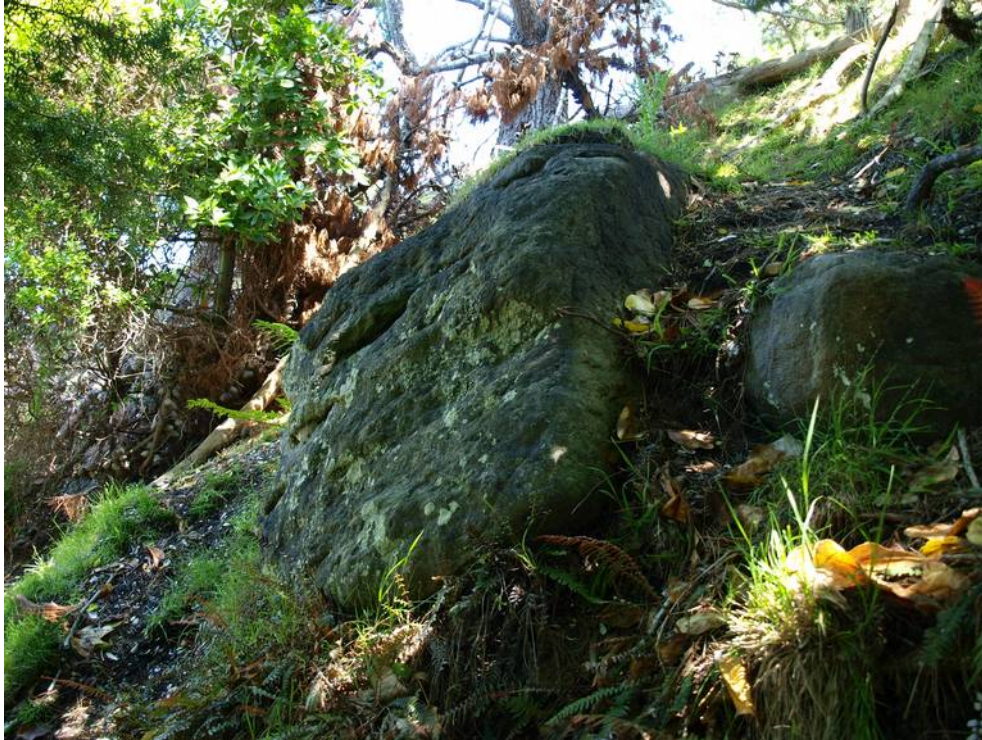
**6r** is another large boulder, around 2x2m, also somewhat more exposed than 10 years ago and also worth re-checking whilst dealing with **6p**.

Photograph #7. Boulder **6r**

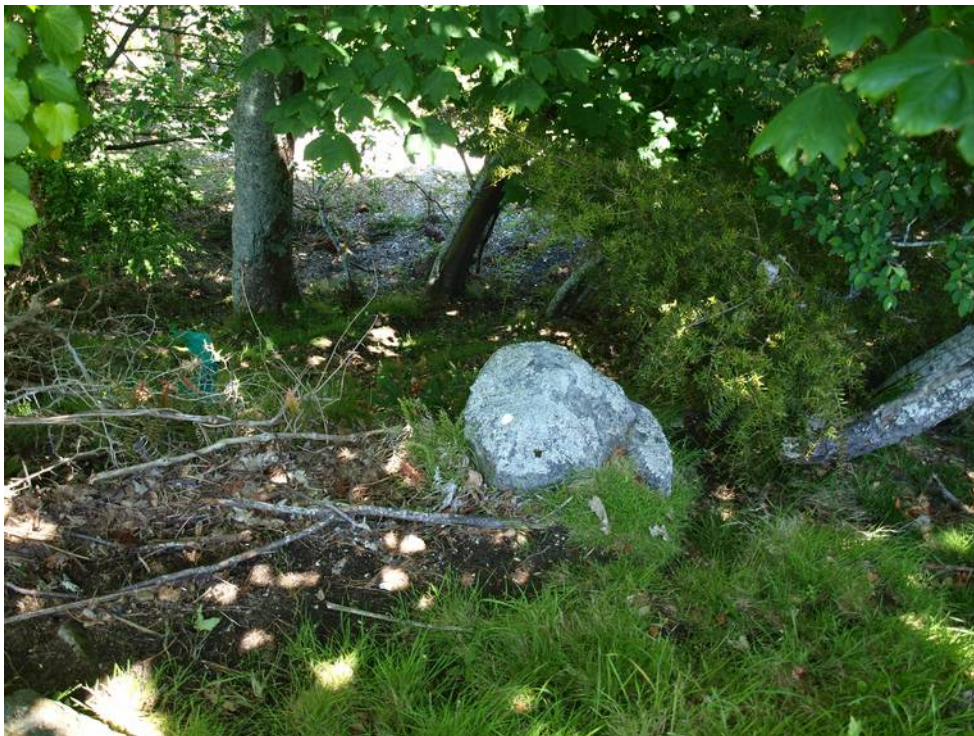
There are a few other smaller surface boulders in the vicinity, not specifically designated, such as in photograph #8, below, which could also ideally be removed at the same time as dealing with **6p**.

Photograph #8. Smaller marginally stable stable surface boulder.

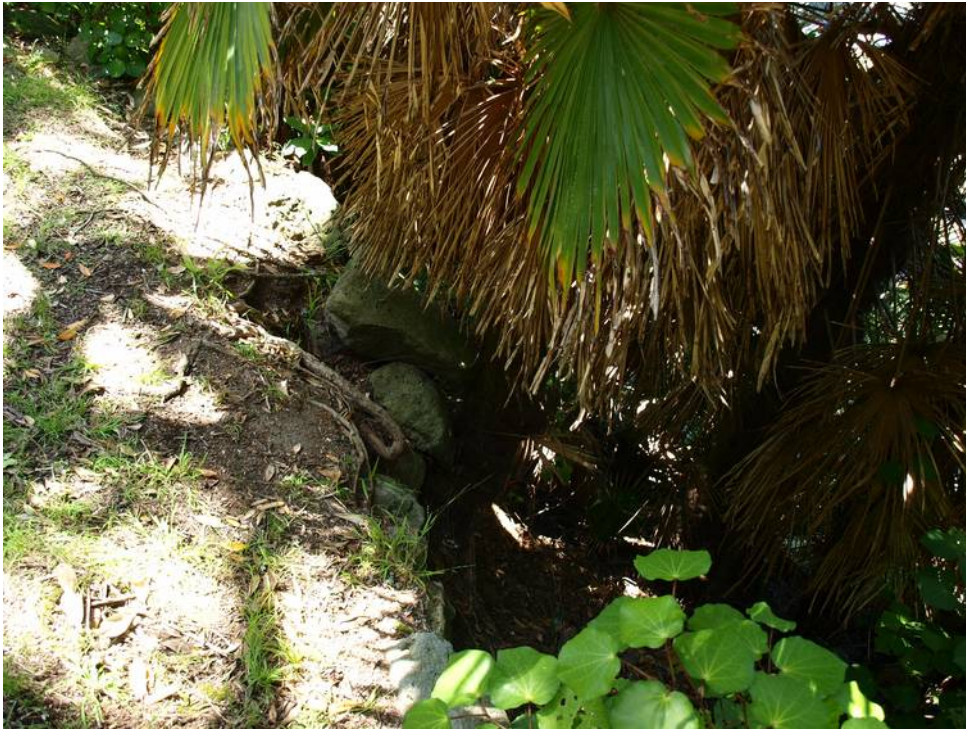
The southern area of the camping is bounded by a cut slope around 3m in height. This slope has some localised improvised stone retaining walling which was found to be failing in at least one location:

Photograph #9. Failure of retaining wall at top of cut slope behind camp site.

It is recommended that this failing rock be removed and reinstated and the rest of this cut slope closely inspected.

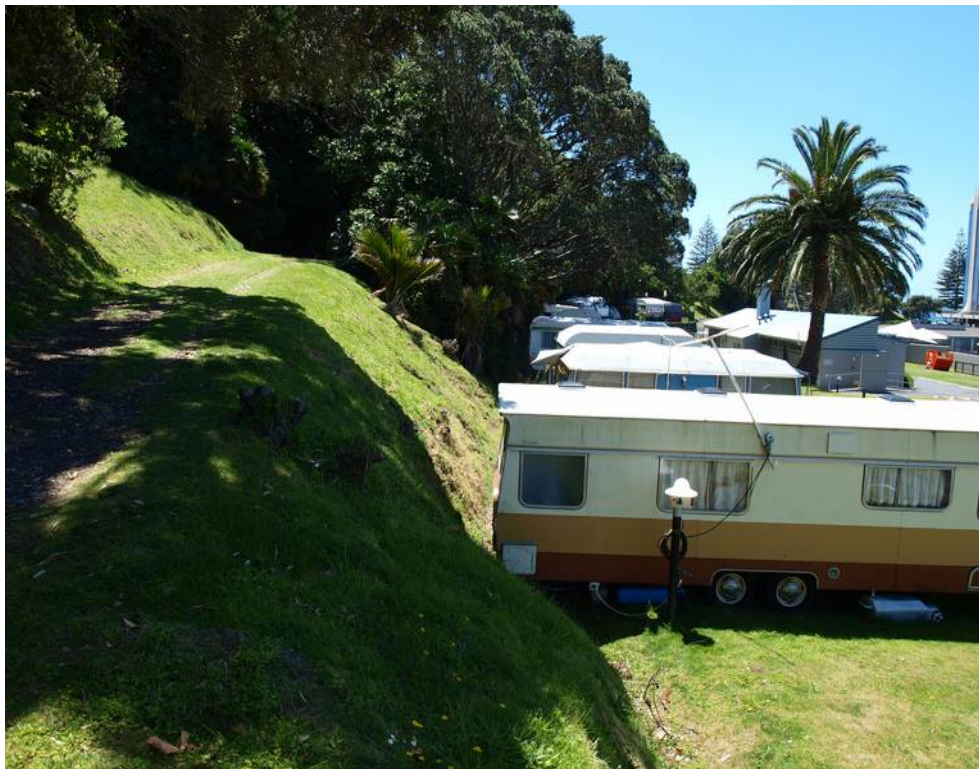
Photograph #10. The cut slope. Photograph #8 taken just behind the palm.

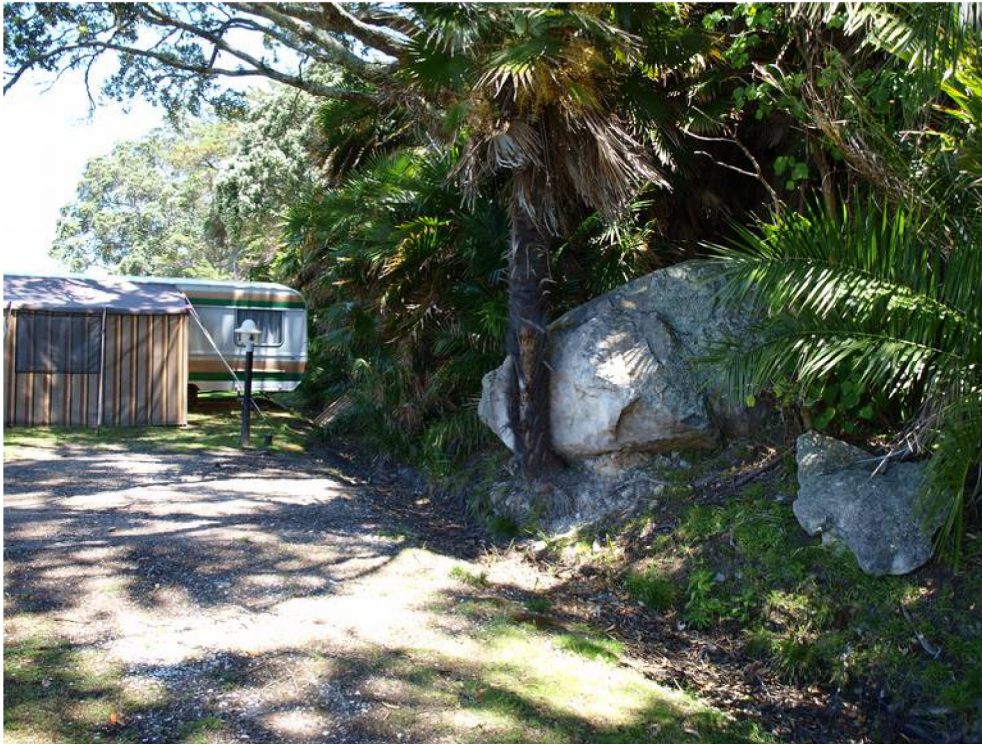
Photograph #11. 6v

One other boulder worth noting is the one previously designated **6v**. It is no great hazard but will probably eventually push the tree over and slide to the lower level.

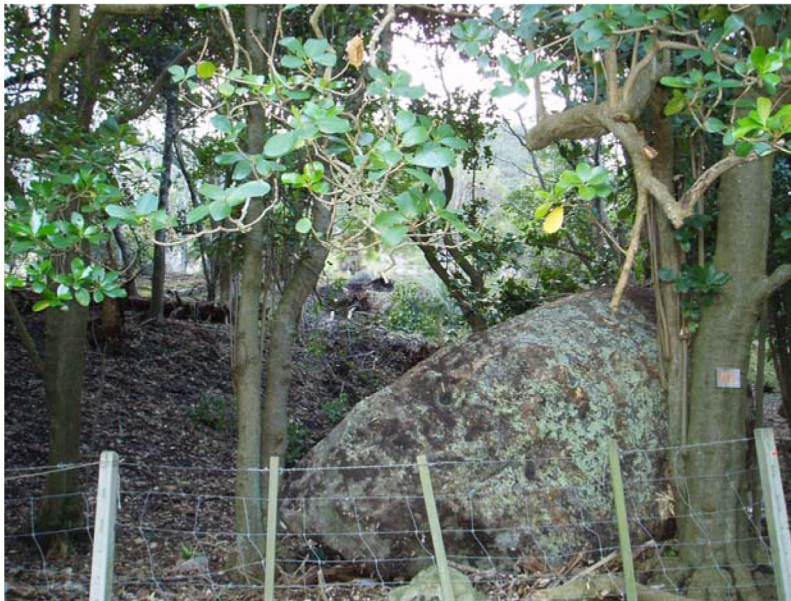
Photograph 1. Main boulder at rest adjacent to campground fence.

The boulder can be seen in the foreground of photograph 1 at rest behind the fence above camp site location No 98.

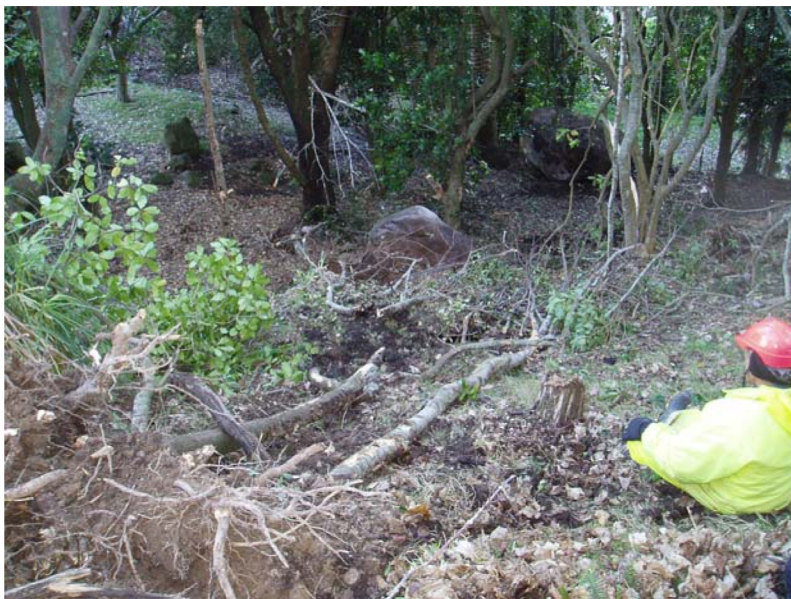
Photograph 2. View down fall line from source location.

The failure was from approximately the position of the photographer in photograph 2, 25m up the slope which lies at approximately 30°. The boulder was well rounded and approximately 2 to 3m in diameter.

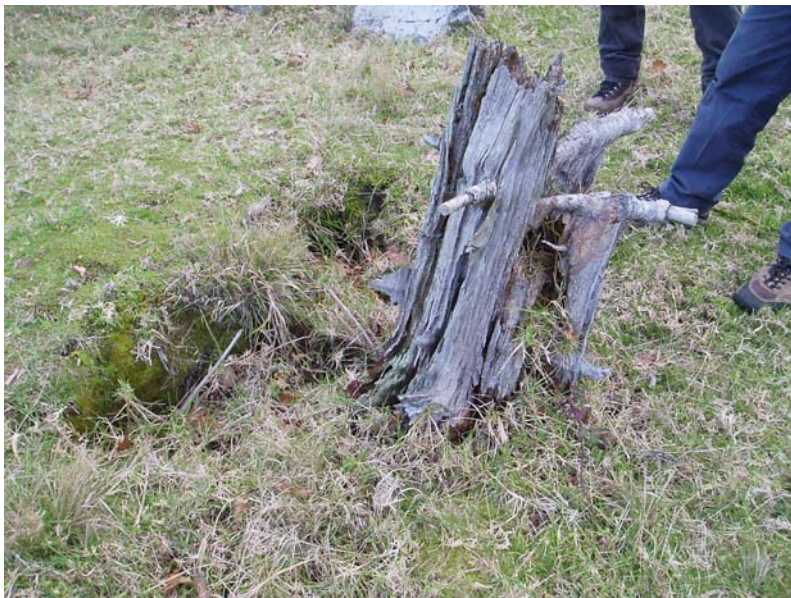
The slopes in this vicinity contain many highly rotted stumps. The decay of roots is causing localised subsidence as can be seen in photograph 3 below.

Photograph 3. Localised subsidence due to decaying root systems.

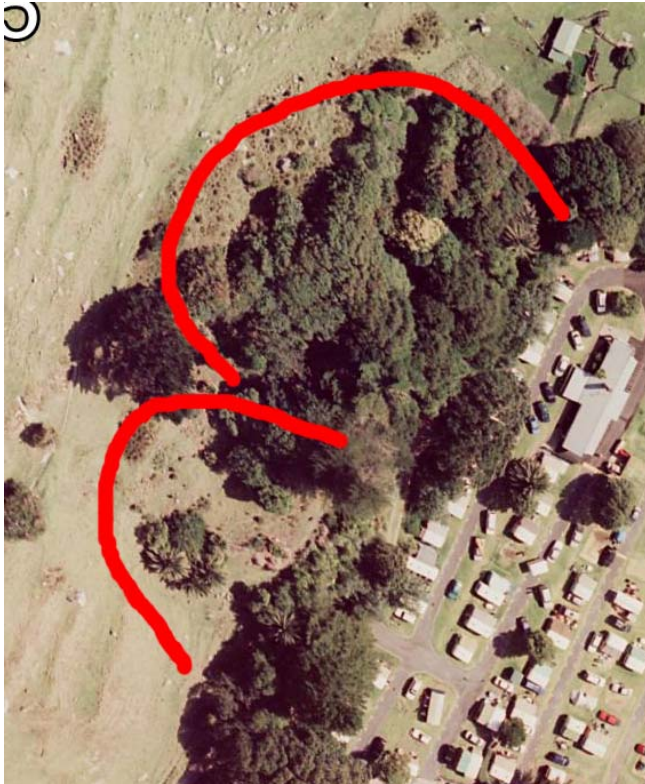
Photograph 6; Very approximate locations of two typical historical mass slips.

Photograph 6 indicates historical circular mass slips in the colluvial slopes immediately above the campground (others are also present). These events appear likely to have been over five times larger than the 18<sup>th</sup> May 2005 slip on the south western slopes and probably released a fast liquefied debris flow.

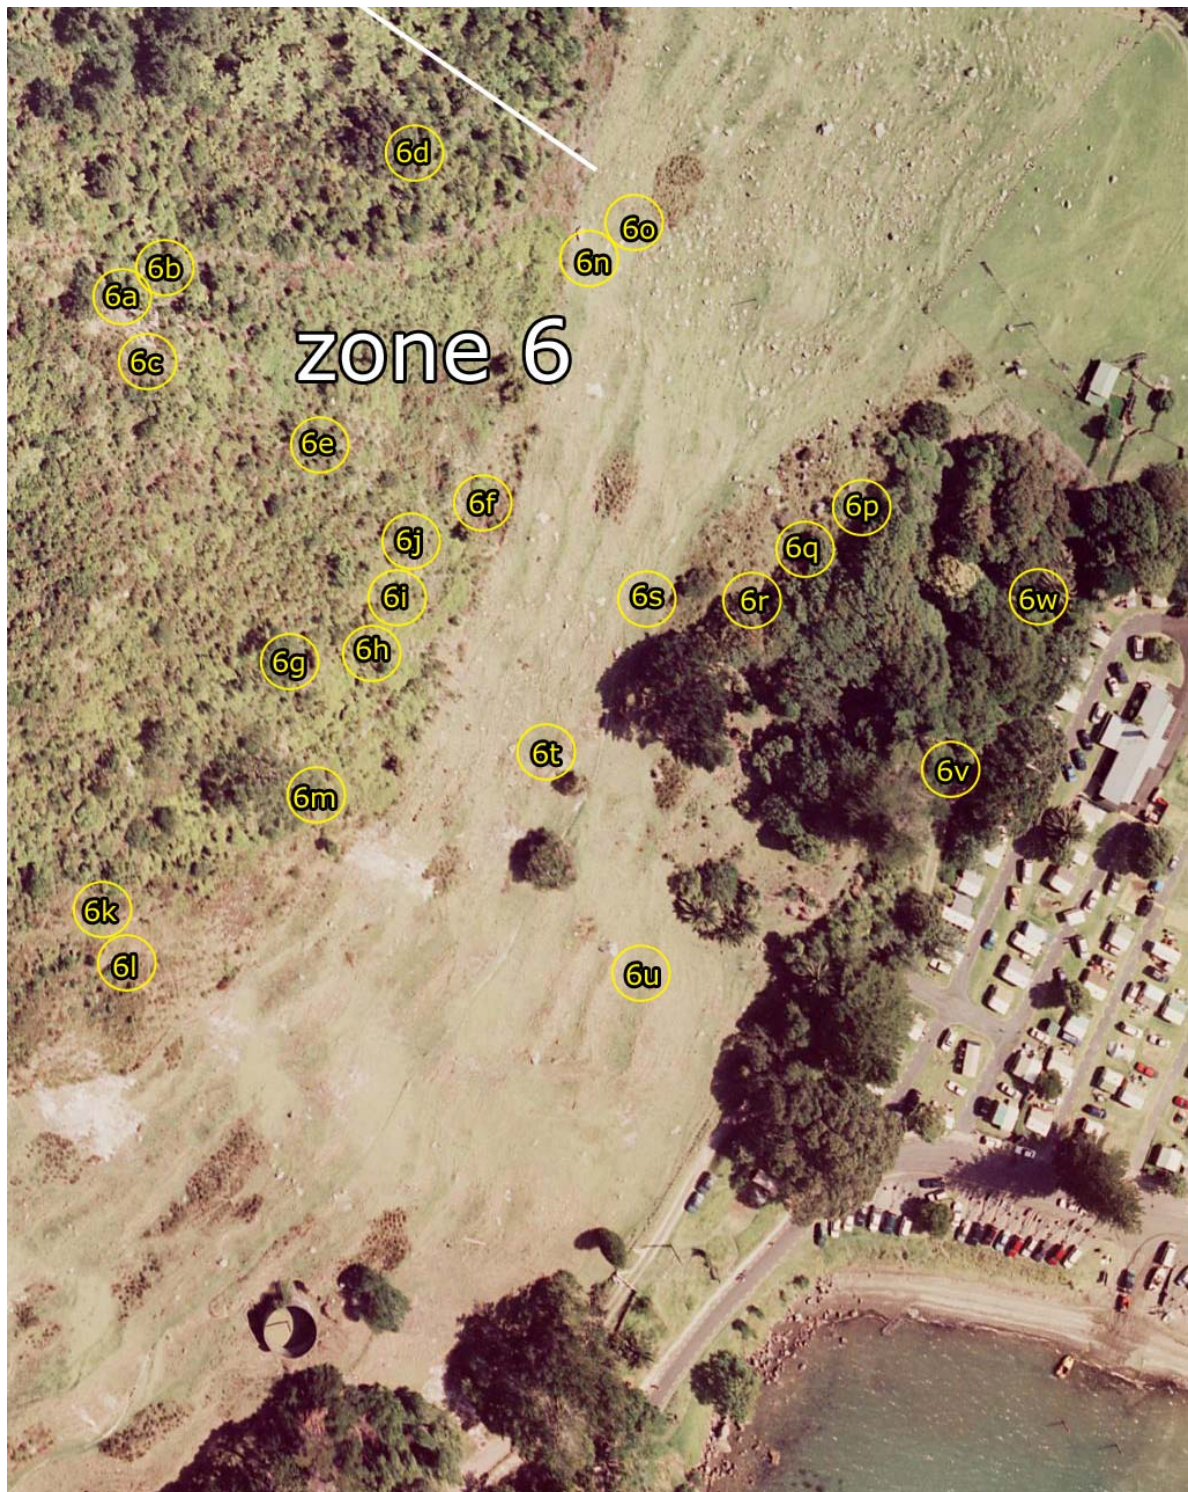
Photograph 7. Zone 6 specific boulder hazard locations.

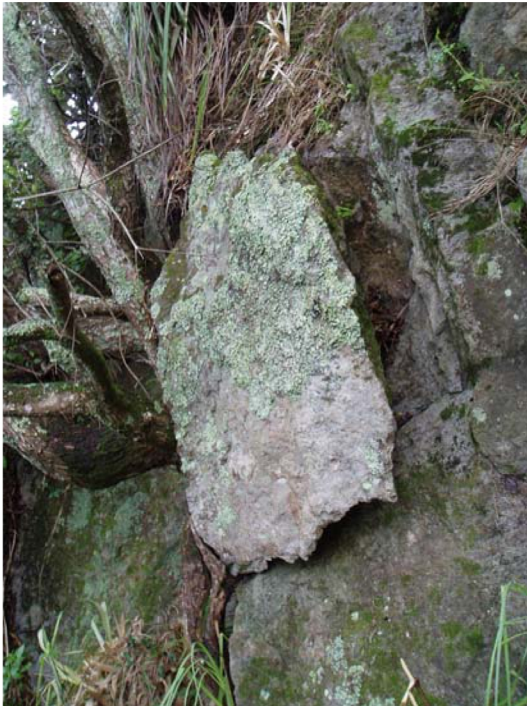
### 3.6.1 **6a**; detached boulder on face of outcrop

A broken bluff up to 4m in height runs from 6a to 6b and 6c. At 6a a 'flake' of rock approximately 1 x 1 x 0.4m has become detached, mostly due to root jacking. The rear joint is open over 100mm. Very marginally stable. The disc shape could allow this boulder to roll a considerable distance.

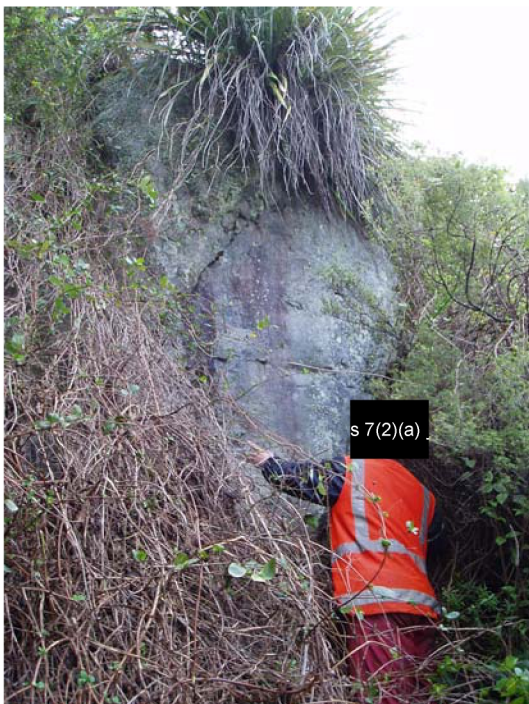
### 3.6.2 **6b**; detached boulder forms face of outcrop

The lower area of this outcrop shows very fresh looking stress fractures. A 'flake' approximately 2.5 x 2 x 0.5m is marginally stable. The rear joint is open 30-50mm and seeping water. Freshness of fractures suggests they could have formed in last year's earthquake event.

Appears likely to split on failure but main piece would remain disc shaped.

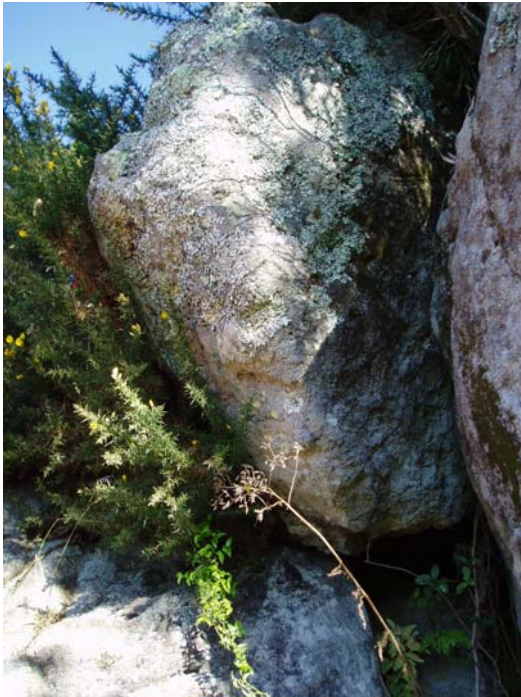
### 3.6.3 **6c**; detached boulder on top of outcrop

A relatively small boulder, 1 x 0.5 x 0.5m. Detached and temporarily wedged but root jacking could destabilise.

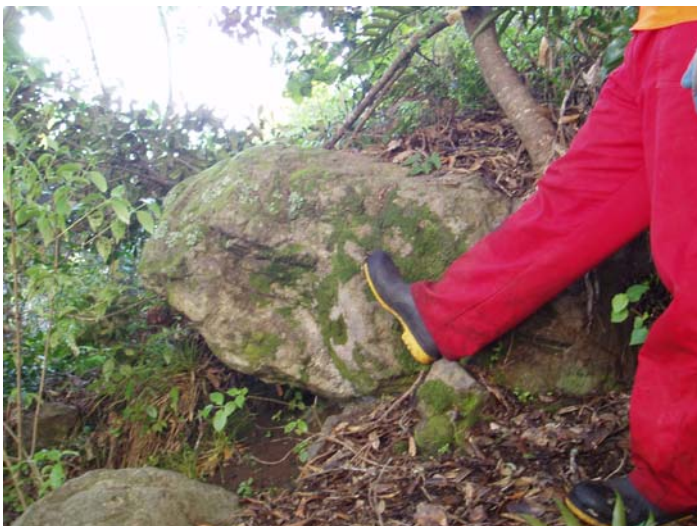
### 3.6.4 **6d**; surface boulder

Approximately 1.2 x 1.0 x 0.8m. Toe undercut by erosion but relatively stable in the short term. Further erosion and growth of tree behind could further destabilise.

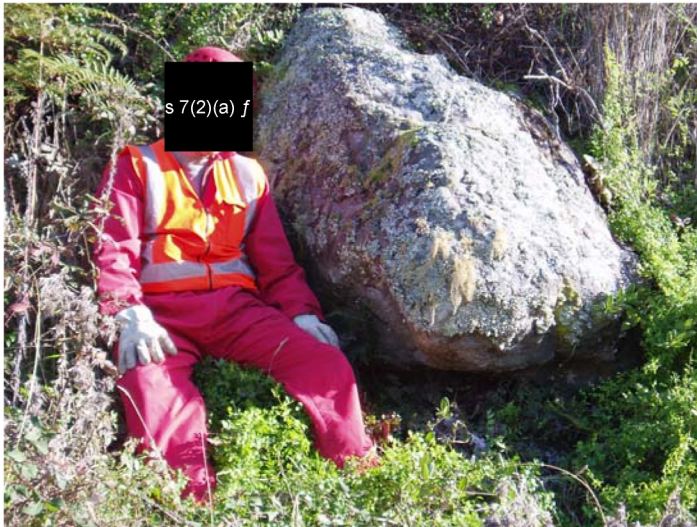
### 3.6.6 6f; surface boulder

Approximately 1.2 x 0.8 x 0.8m. Toe undercut by erosion. Further erosion could destabilise. Ground immediately below is very steep.

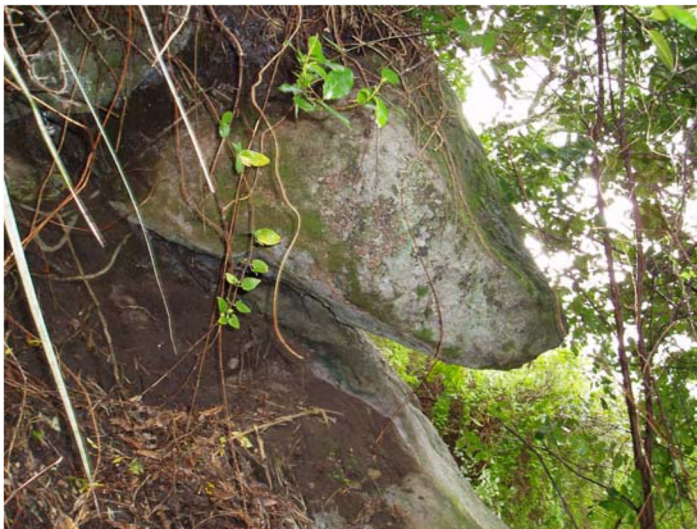
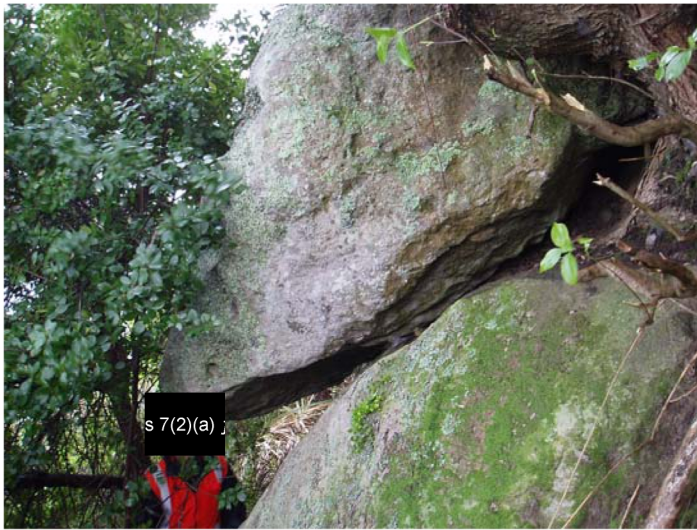
### 3.6.7 6g; weathered outcrop with detached boulder on top

A relatively severe hazard, appears to have very marginal stability. Approximately 2 x 3 x 1.2m. Tree behind is jacking the upper block forward. Steep slope immediately below.

Wedge shape will resist rolling but mass of boulder and steepness of ground are not favourable.

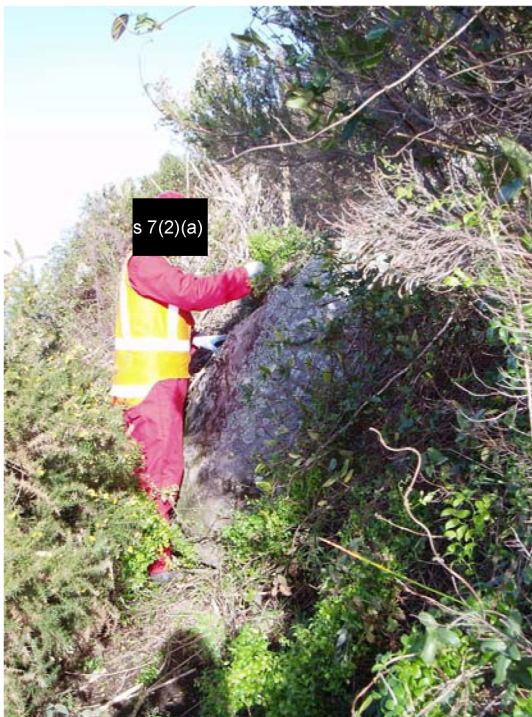
### 3.6.9 **6i**; surface boulder

1.5 x 1.5 x 1m. Moderately eroded and undercut base. Steep ground below but relatively stable in the short term.

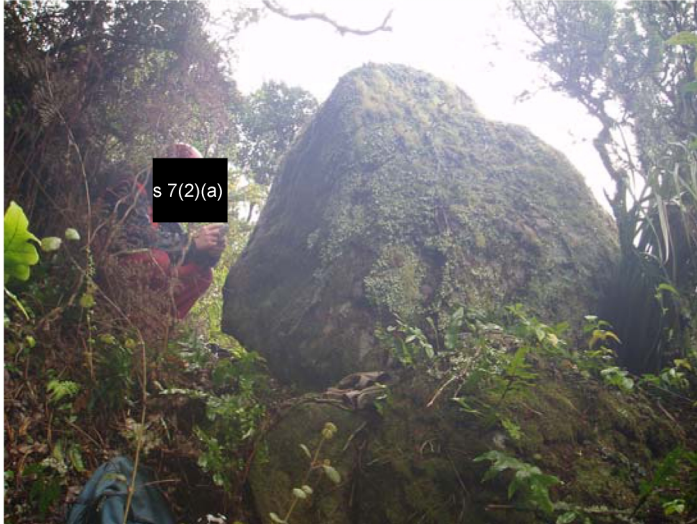
### 3.6.11 **6k**; large outcrop boulder

5 x 5m outcrop with boulder of 1.5 x 2 x 2m resting on top. Low angle contact between boulder and outcrop is stable regarding erosion but potentially becomes a hazard given seismic loading.

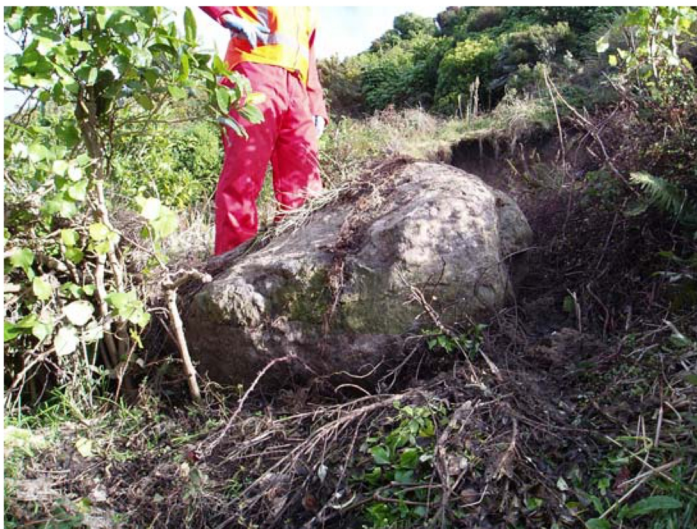
### 3.6.13 **6m**; surface boulder disturbed by recent mass slip (slip item 9).

1.2 x 1.2 x 0.6m. Has been rolled to a relatively stable position.

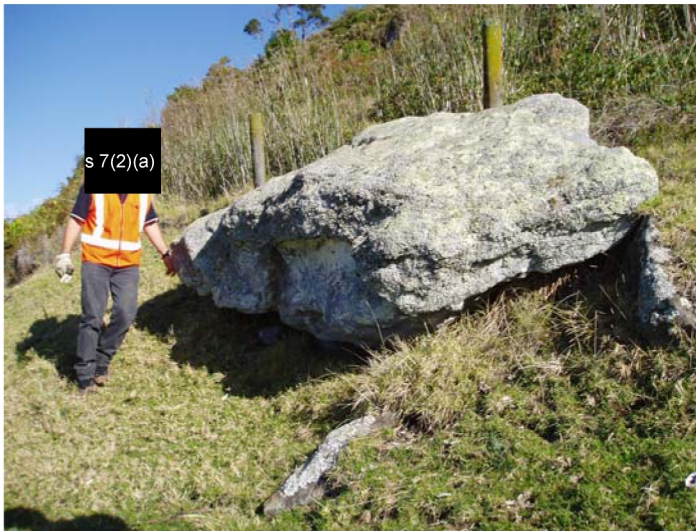
### 3.6.14 **6n**; surface boulder in paddock

2 x 2.5 x 0.8m. Moderately stable in short term but on steep ground and with potential for erosion below. Hazardous in earthquake. Could split into two on rolling.

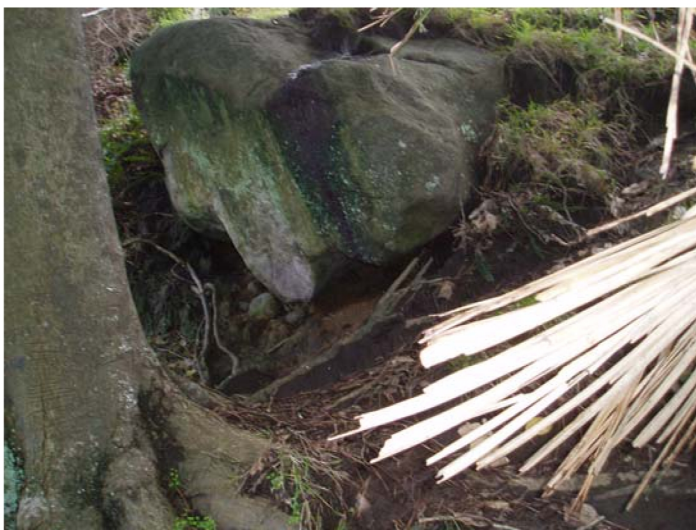
### 3.6.17 **6q**; surface boulder on margin of historical mass slip

2 x 1.5 x 1 m. Embedded in top of steep historical mass slip scarp. Moderately stable in the short term but eroding slowly below.

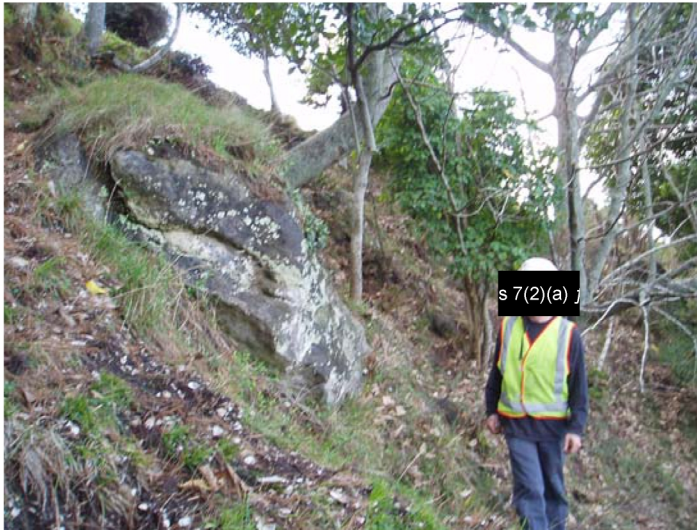
3.6.18 **6r**; surface boulder on margin of historical mass slip

2 x 2 m. Embedded in steep historical slip scarp. Stable in short to medium term.

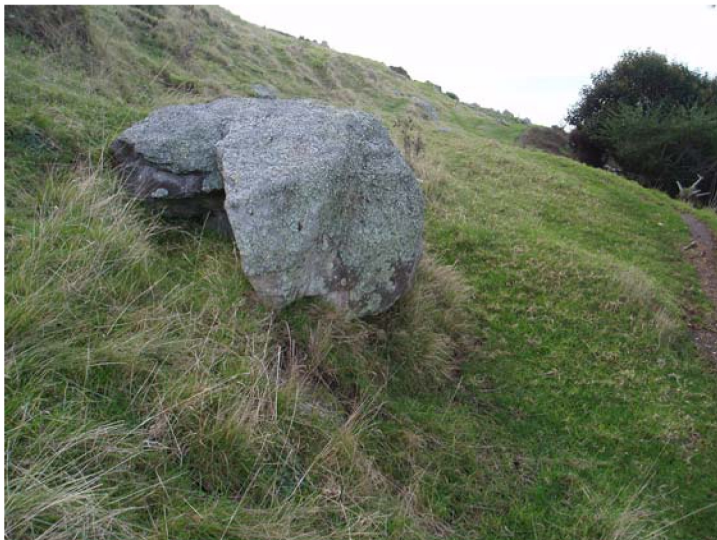
3.6.19 **6s**; surface boulder in paddock

1 x 0.8 x 0.6 m. Embedded and moderately stable in the short term.

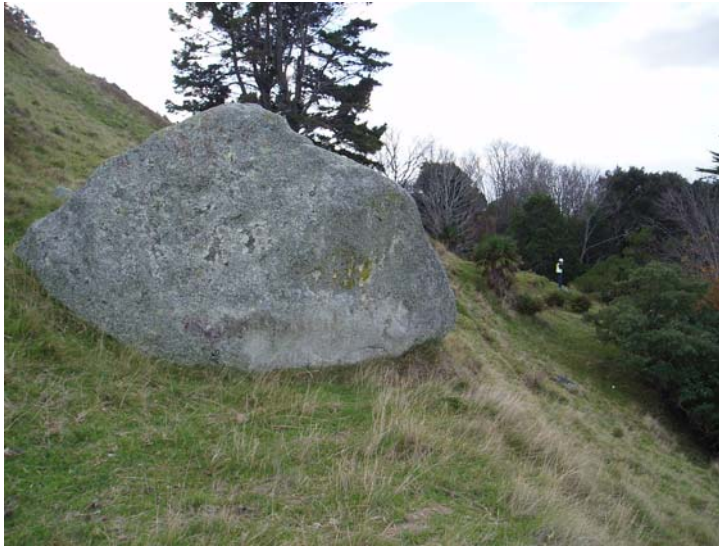
### 3.6.20 **6t**; surface boulder in paddock

2 x 2 x 1.5m. Stable in short term but potentially hazardous should steep soil slope drop out from below.

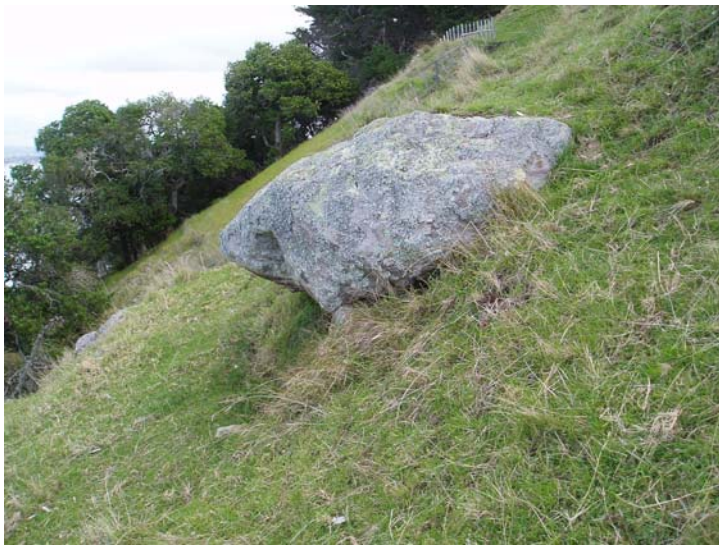
### 3.6.21 **6u**; surface boulder in paddock

2 x 1.5 x 1.5m. Moderately stable in the short term but undercut and on very steep ground.

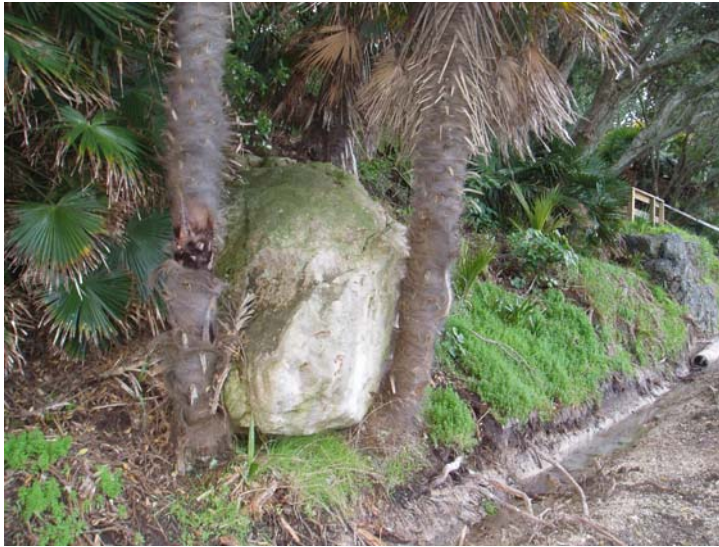
### 3.6.22 **6v**; surface boulder at campground boundary

1.5m diameter. No significant hazard but appears likely to have been creeping down cut slope. Now bearing on the small palm trees.
