# **Mauao Rock Slopes & Rockfall Hazards**

**Client: Tauranga District Council**

**July 2003**

**Avalon Report No: 0314**

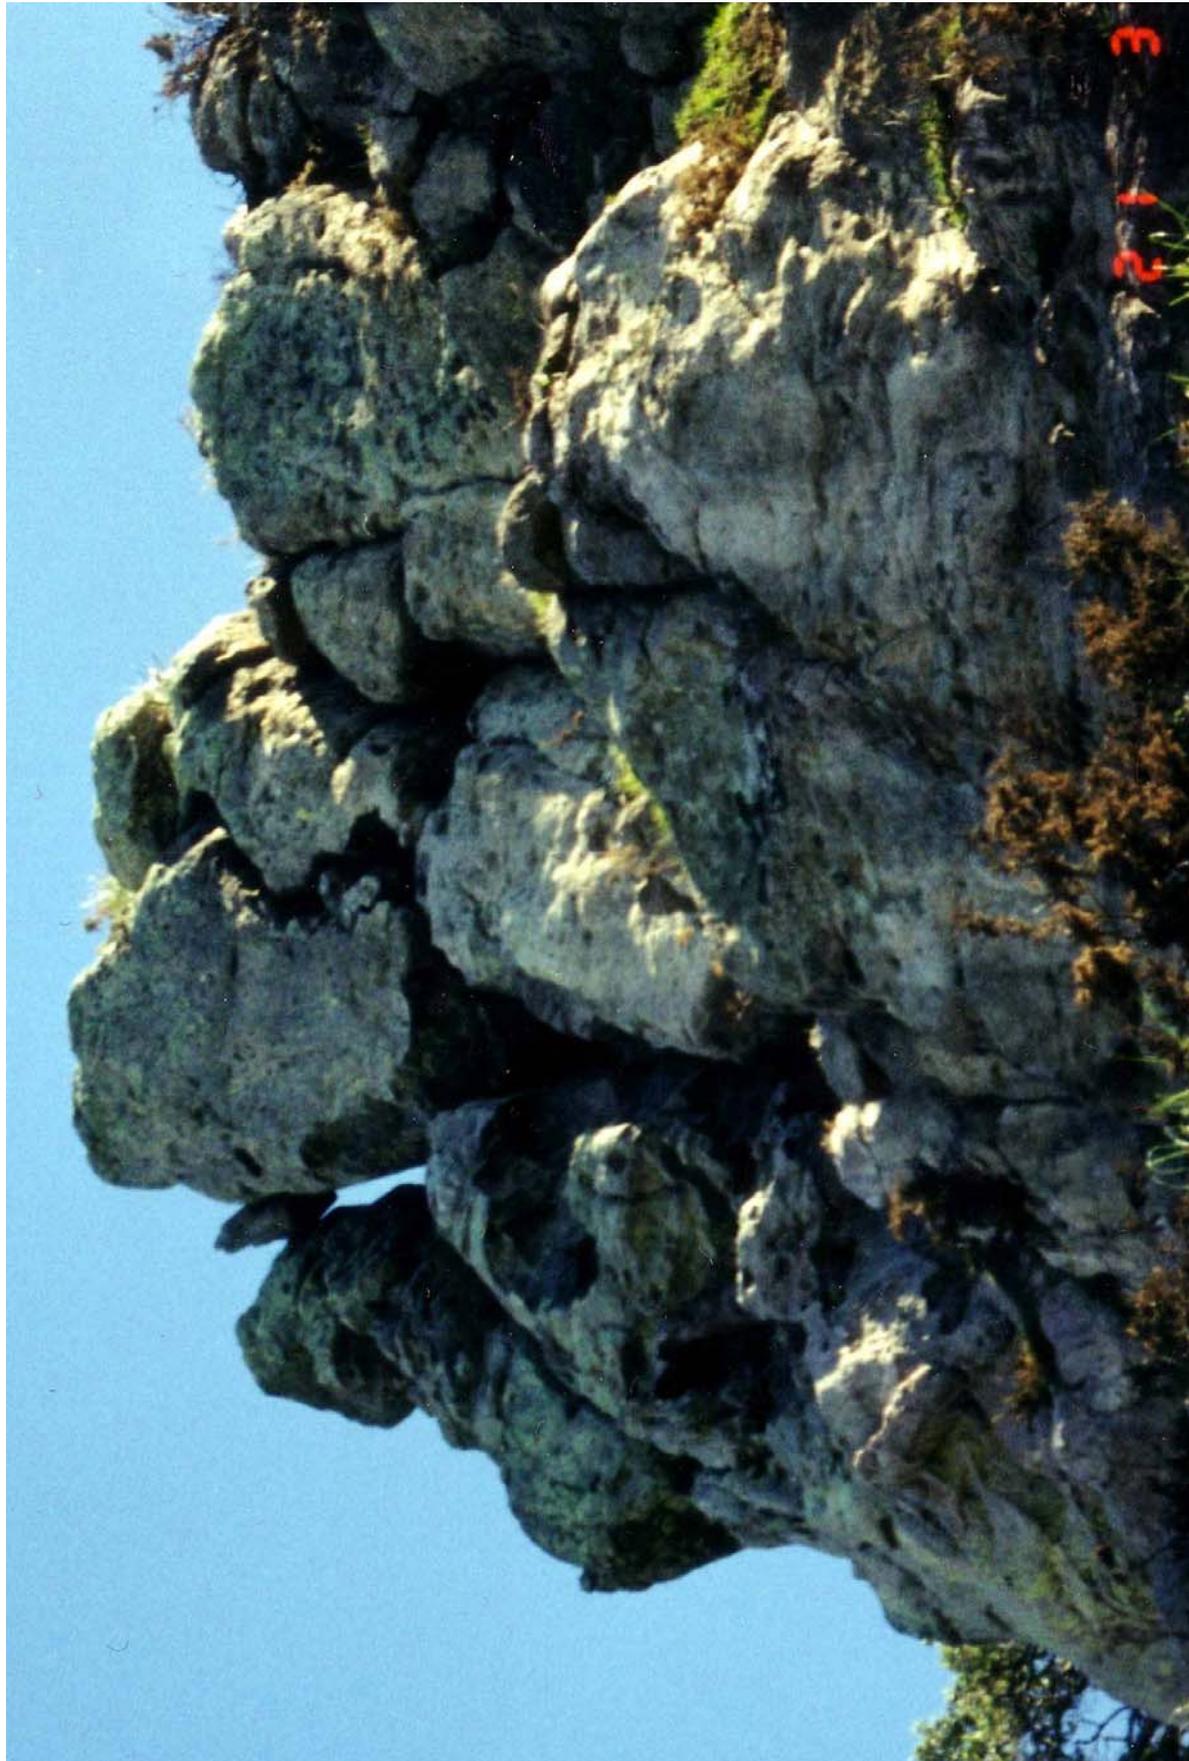
Photograph No 9; 1a east elevation.

When a major failure occurs here it might include individual boulders up to 70m<sup>3</sup> each. The upper mass which might fail is comprised of approximately 7 main blocks ranging in volume from 7 m<sup>3</sup> to 70 m<sup>3</sup>. Larger failures might also involve other lower blocks.

A large portion of this mass could potentially fail in a single event and it represents a severe hazard to the camp ground, which lies on the fall line directly below.

This high hazard rating takes into account the high risk exposure time for camp ground users (relative to track users). 1a is at the present time considered the highest priority hazard on Mauao, even though similarly unstable and even larger masses exist on the northern slopes.

However; to get some quantitative appreciation of the potential hazard; the stability of this mass appears so marginal that failure might be expected to be initiated by erosion within, say, 100 to 500 years? When a major failure occurs, at least some of the boulders will be very likely to enter the camp ground.

The bluff appears to be in such a condition that a relatively small earthquake might also be able to initiate failure.

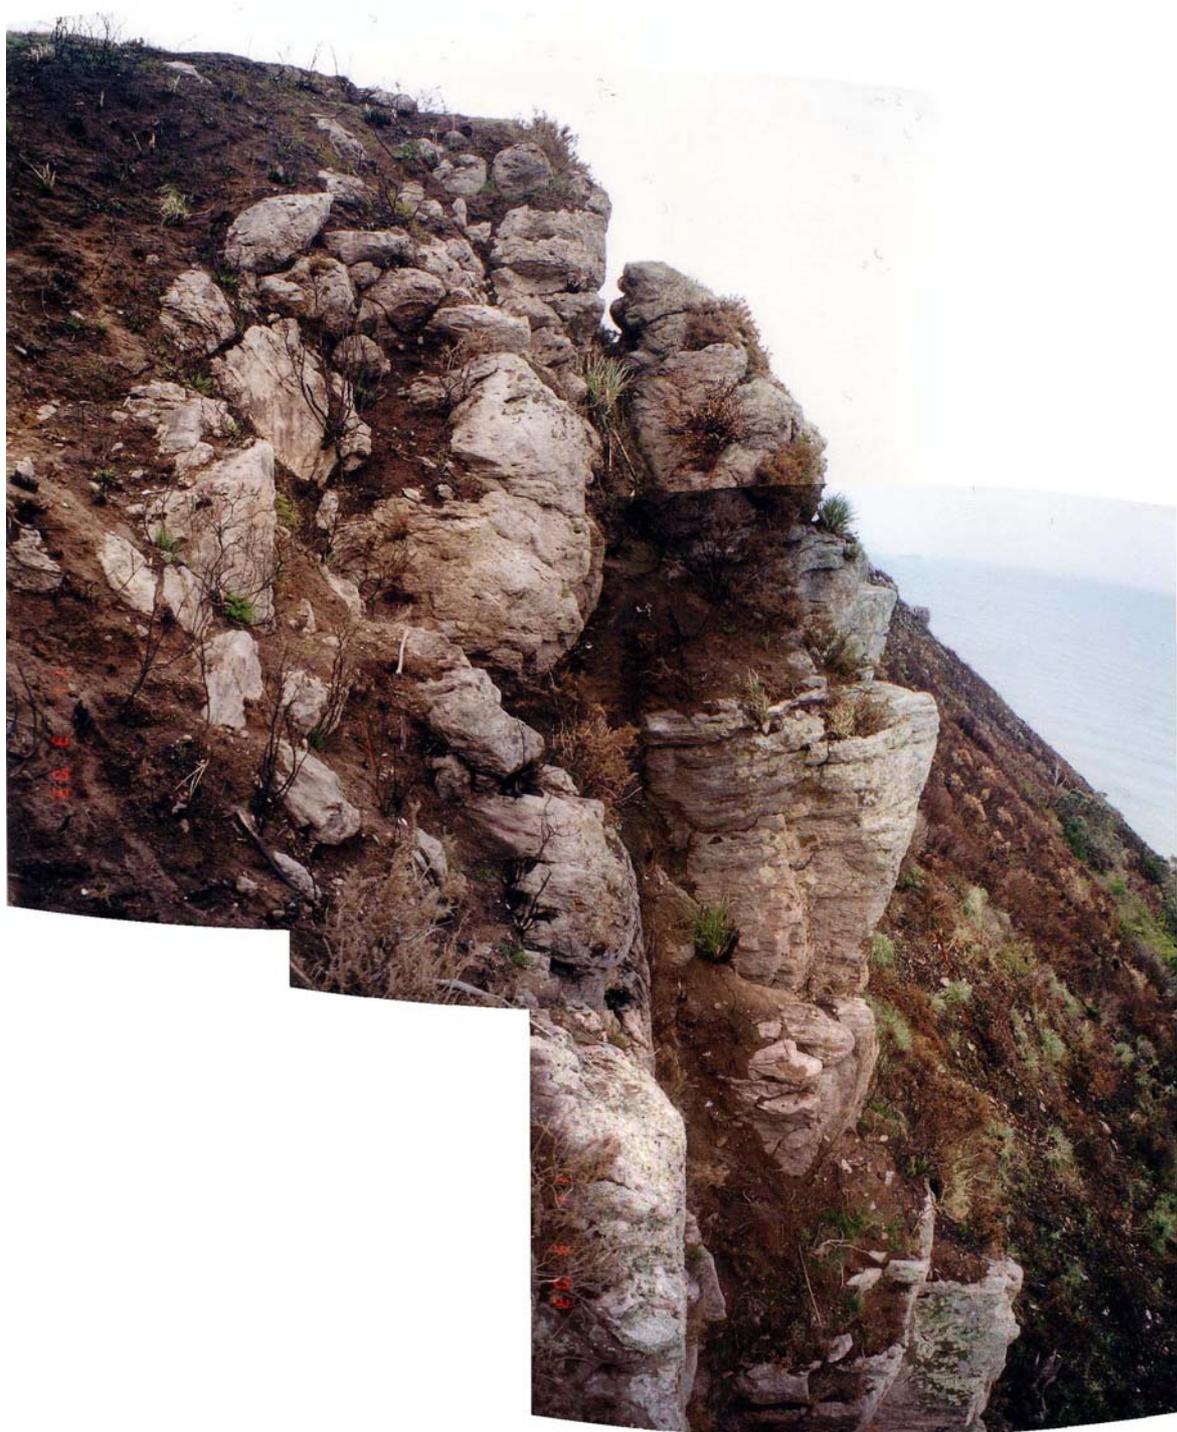
Photograph No 12; 2a view from rock face to south.

A 'detached' column standing forward of the main outcrop line, the joint between it and the main bluff is open by up to 500mm. This column is approximately 4m wide, 1.5m thick and 7m high, a potentially failing mass of maybe 100 tonnes.

The column appears reasonably stable at present and unlikely to fail in the short/medium term, other than in a seismic event. However, if this column were to fail the resulting boulders would be of such a size, and in such a position, that they would pose a severe hazard to the camp ground.

If remedial measures were being taken to address the hazard at 1a it may be prudent to extend the scope of work to also address this hazard.

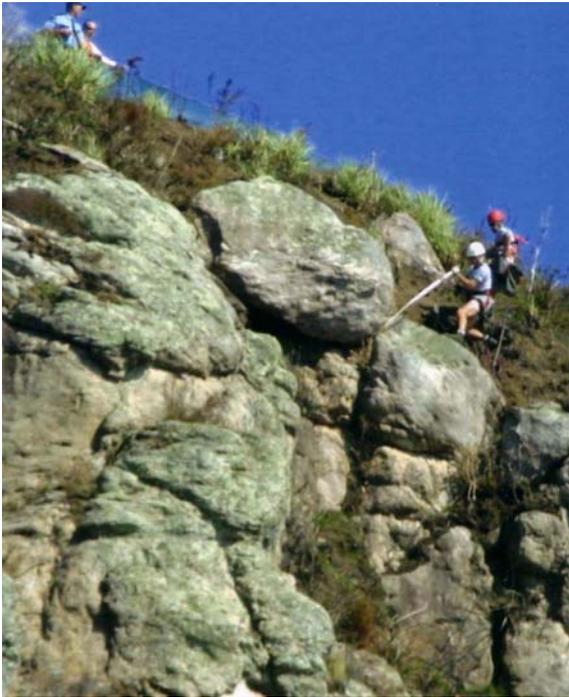
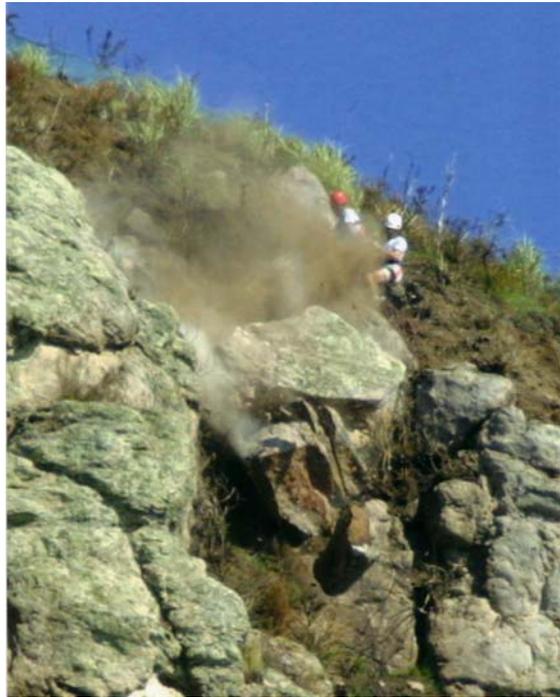
Photographs No 15 & 16; 2b being scaled, March 2003.

See photographs No's 15, 16 & 17. This hazard is no longer present.

An extremely unstable boulder (approximately 17t weight) was found on the crest of the slope at this location.

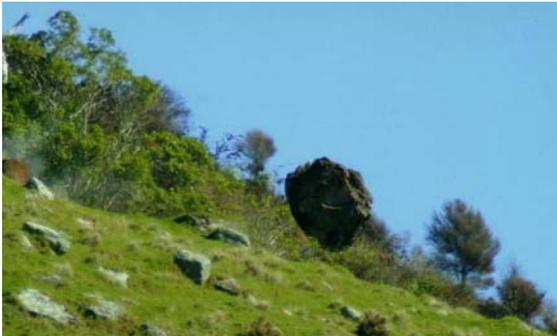
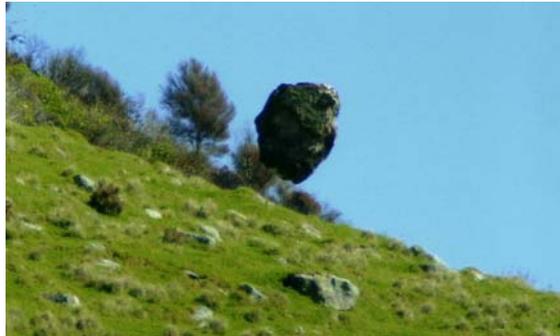
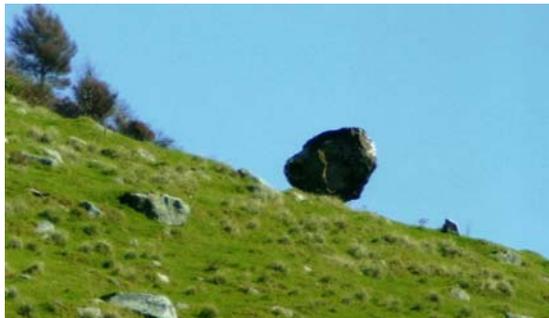
Photograph No 17 (sequence); 2b falling towards Base track..

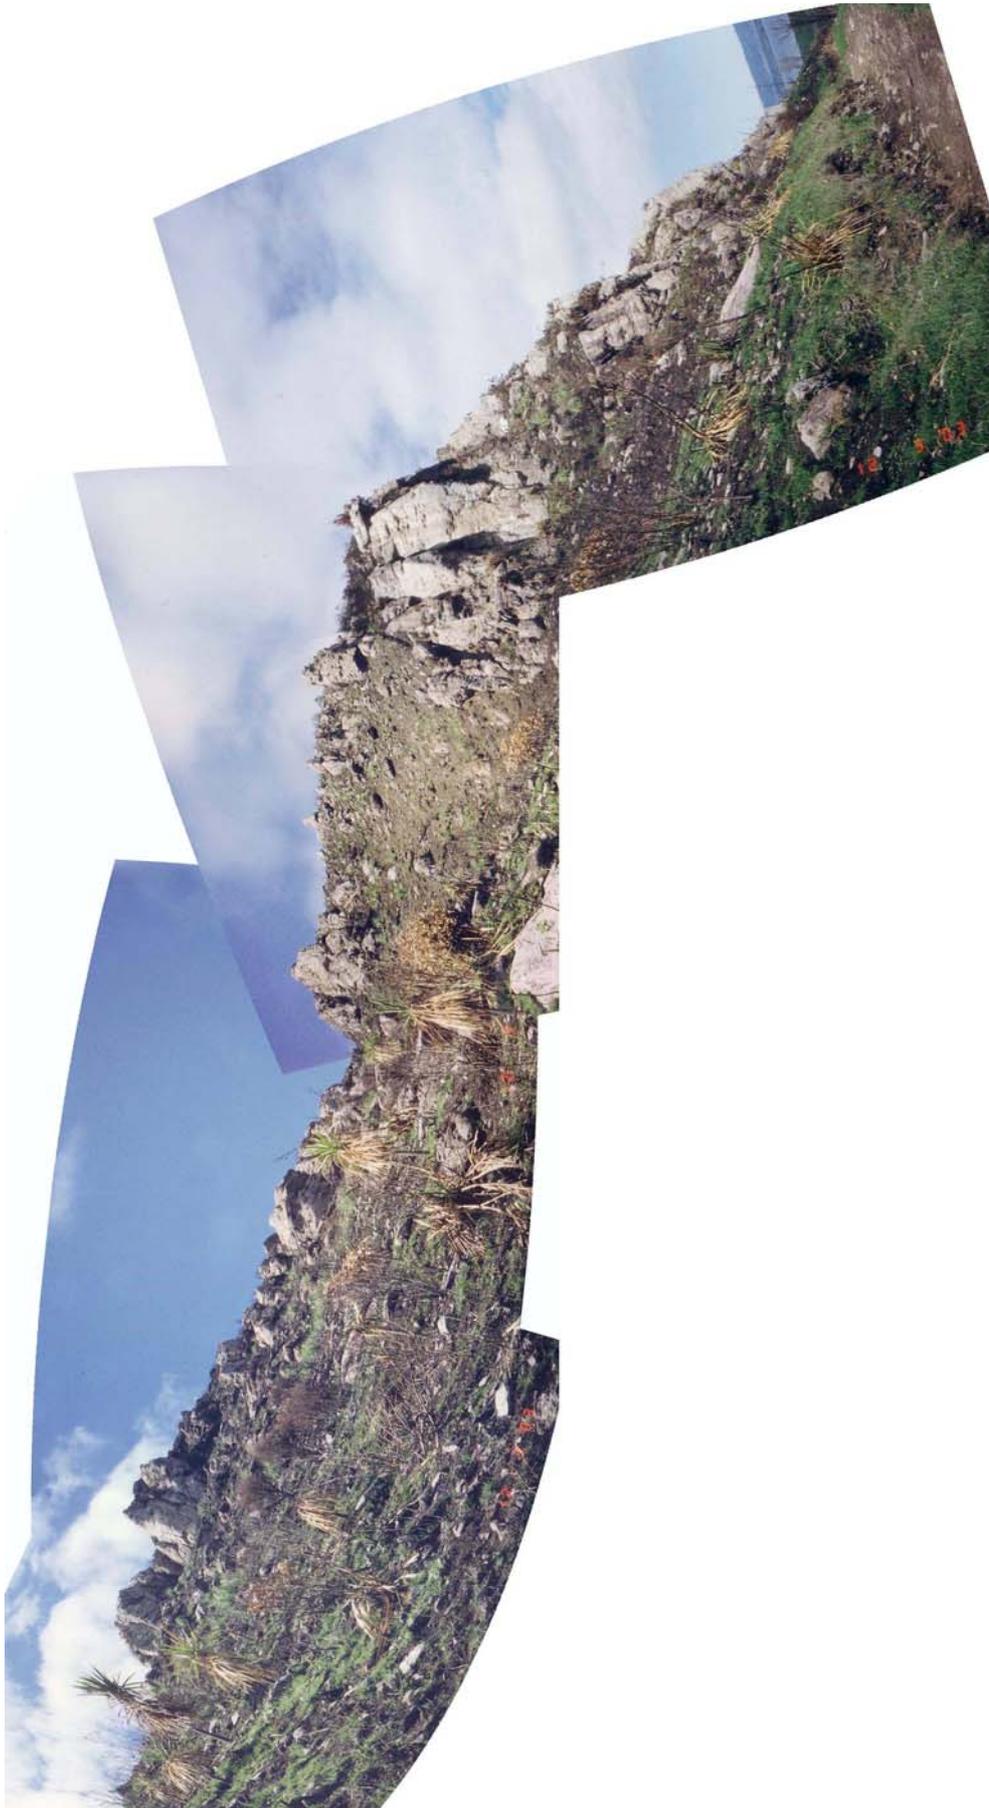
All rockfall in this zone threatens the Oruahine track. Larger rocks falling in this zone can easily bounce all the way down to sea level, at high velocity, creating a hazard to both the Oruahine track and the Base track.

Photograph No 18; View up into zone 3 from the Oruahine track.

Following the March 2003 assessment, the hazard to persons using the upper north western Oruahine track was considered unacceptably high, at least until vegetation was to become re-established. The track was closed pending re-inspection in the spring.

It is recommended that this slope zone be subject to regular monitoring and occasional targeted scaling as required.

A limited length rockfall catch fence in gully 3e, approximately 10m above the Oruahine track, could be very cost effective to reduce the rockfall hazard. Further investigation is recommended.

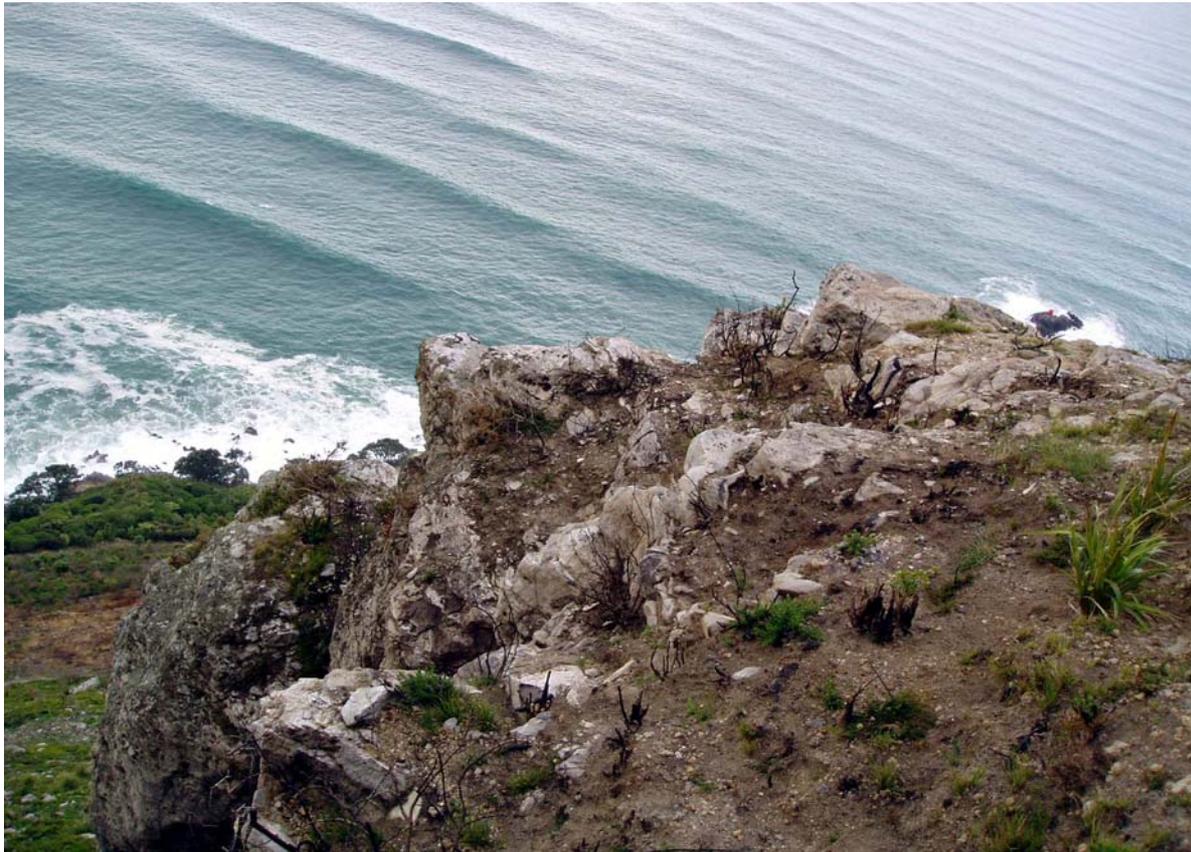
A very broken bluff exists at 3a.

Photograph No 19; Top of bluff at 3a.

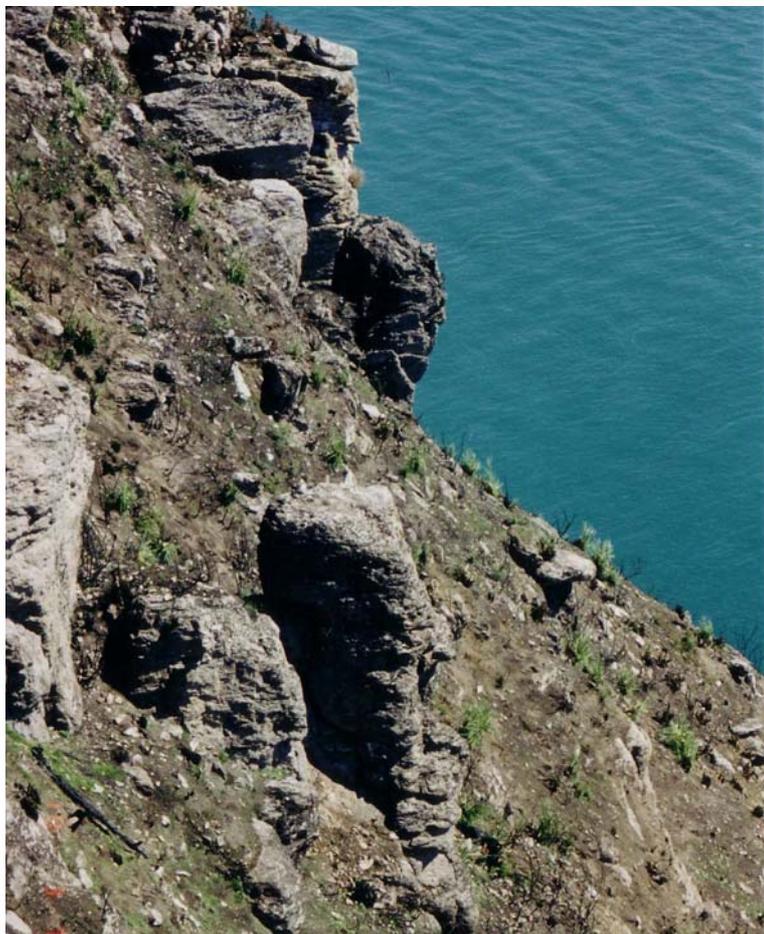
The remaining column appears quite unstable having a small and degraded base support.

Photograph No 22; Unstable column at 3d.

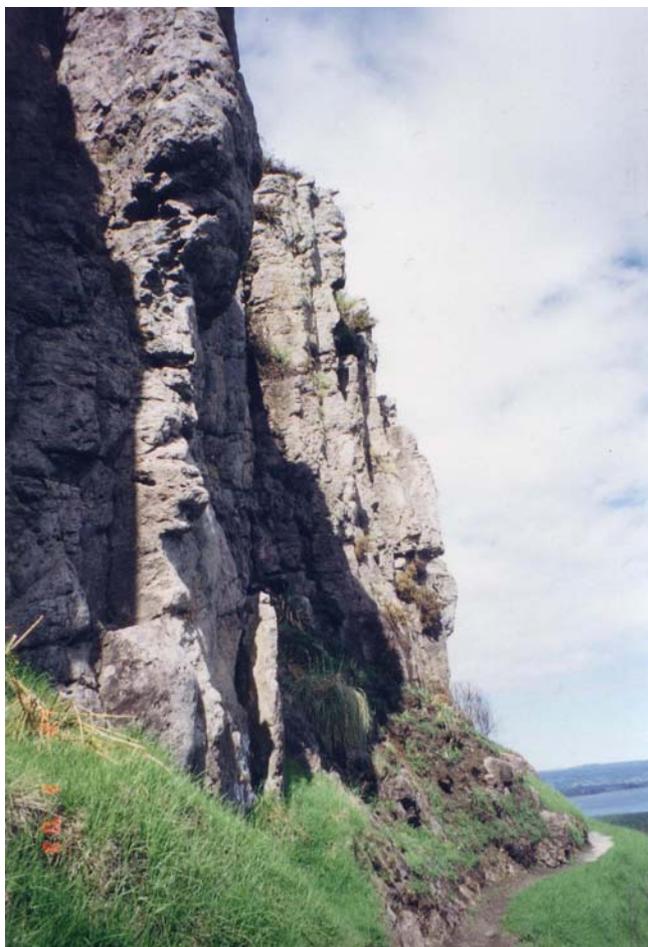
The rock on the climbing routes themselves is reasonably sound as far as climbers are concerned, having been regularly climbed for a number of years. A significant hazard comes with climbing routes from which the normal exit is a 'walk-off' from the top of the route, rather than a 'lower-off' on ropes.

Photograph No 24; Rock climbing crag at 4b.

When the Oruahine track is reopened it is recommend that signage be established to the effect that climbers enter and climb at their own risk and that traversing the slopes above the crags is prohibited, along with climbing of routes where lowering off is not possible (giving the reasons why) and reinforcing this by stating that all climbers must use the 'lowering off to track level' technique.

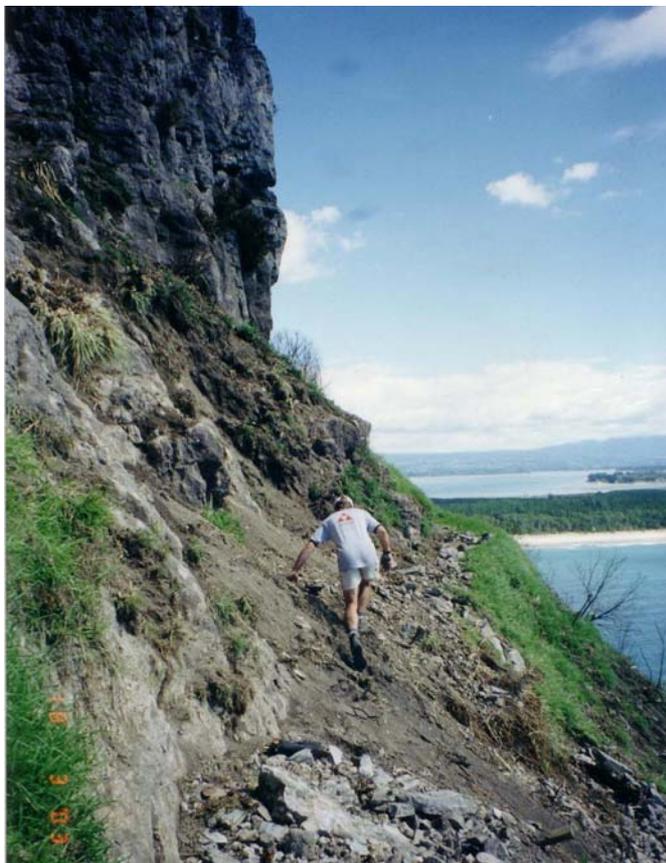
Much material failing around 4d is channeled to 4c, although some breaks off and follows a more minor gully which crosses the Oruahine track at 4e.

Photograph No 26; Oruahine track hit by rockfall at 4c, March 2003.

Limited length rockfall catch fence on the slopes immediately above the rock climbing crag, in gullies 4c and 4e, possibly also at a higher level in gully 4d, could be very cost effective to reduce the rockfall hazard. Further investigation is recommended into this.

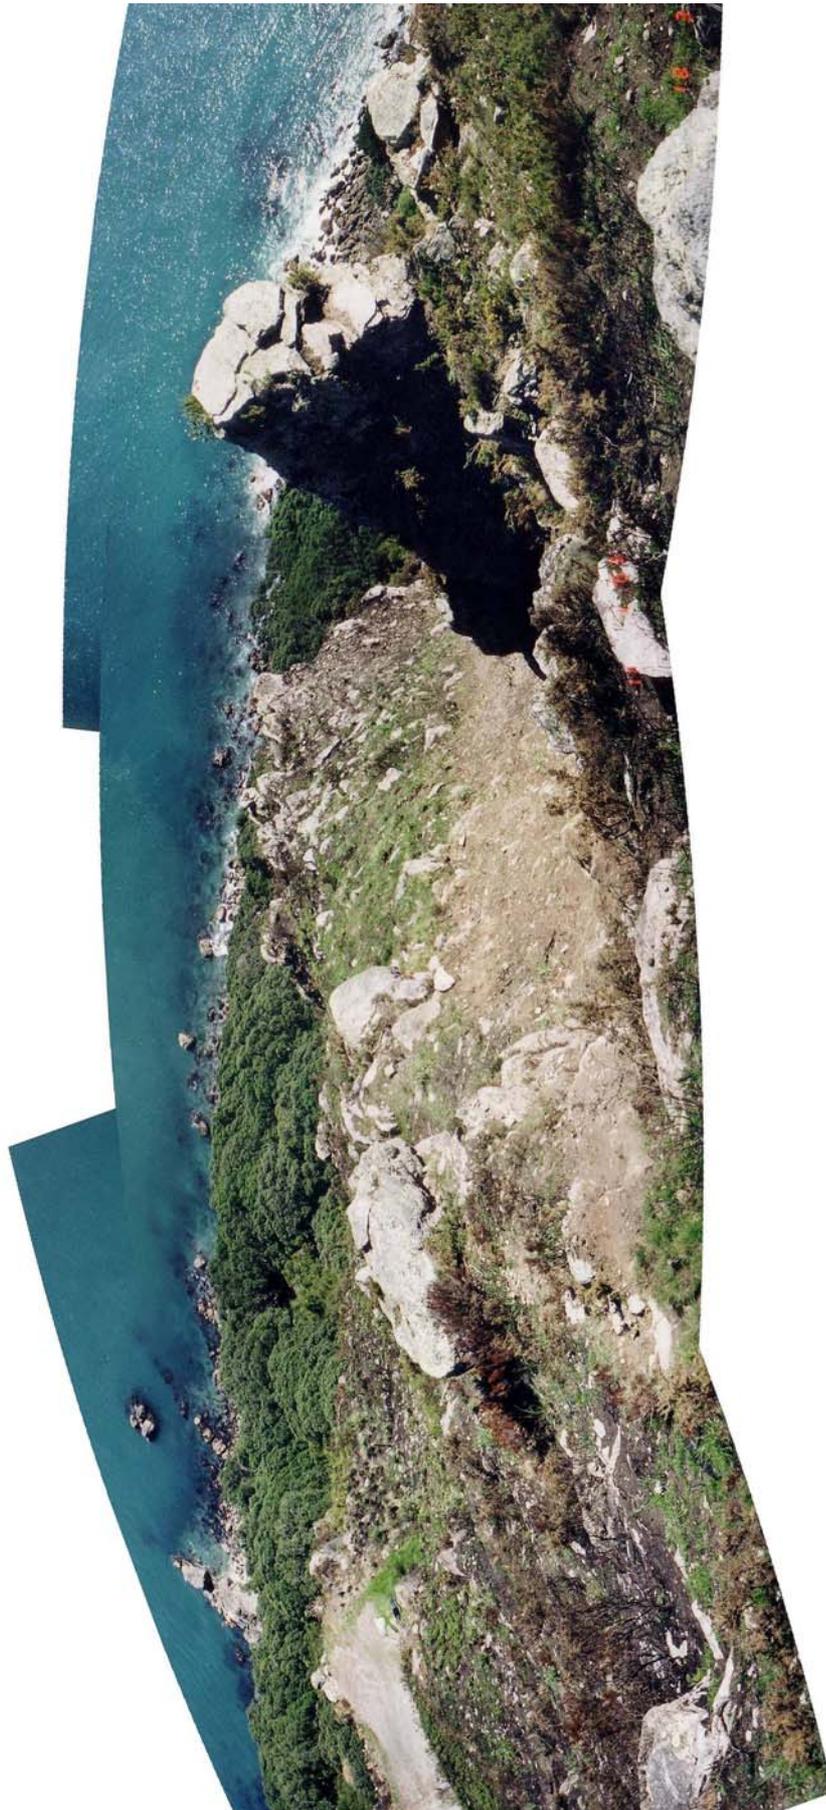
Photograph No 27; View into gully at 4d.

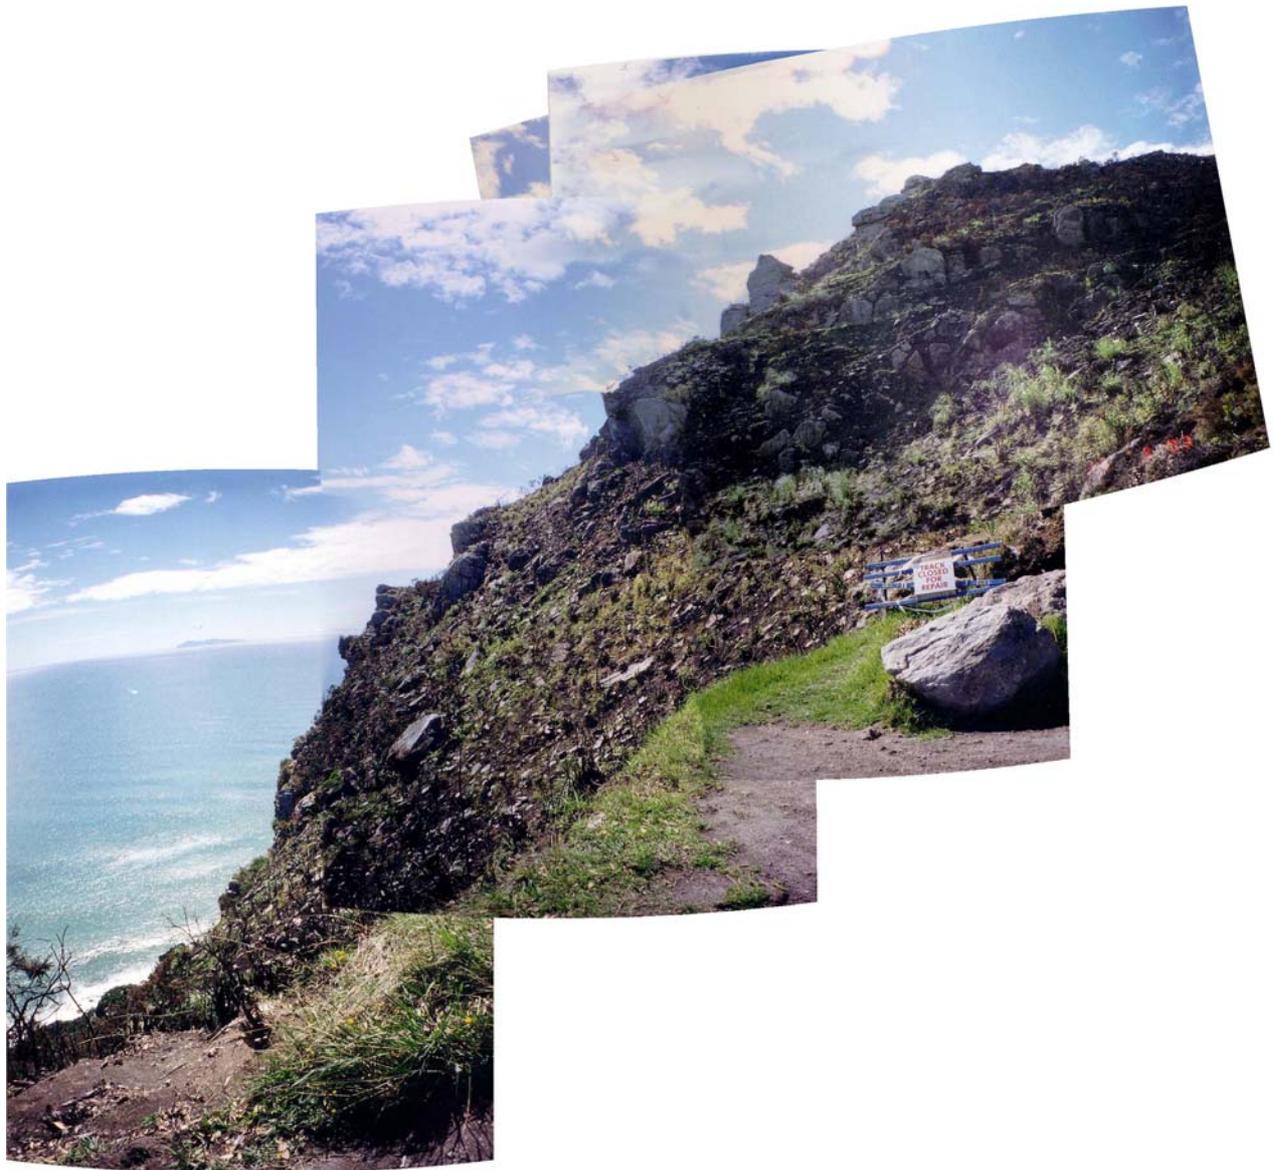
The slope is typical of the more open areas of slope above the climbing crag in zone 4. It is littered with loose surface rock and is likely to be susceptible to further destabilisation by rain scour.

Photograph No 28; View to slope at 4g.
