Boffa Miskell Limited  
Mauao Base Track Remediation  
Geotechnical Assessment

July 2018

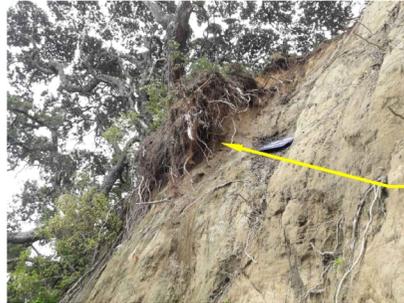
EROSION OF SOIL AROUND TREE ROOT SYSTEM. COLLAPSE OF TREES MAY RESULT IN FURTHER CLIFF FAILURE

- We recommend that during construction, large trees are either pruned or removed (after specific assessment by an arborist). We recommend that as much vegetation as possible is retained to maintain stability of the slopes.

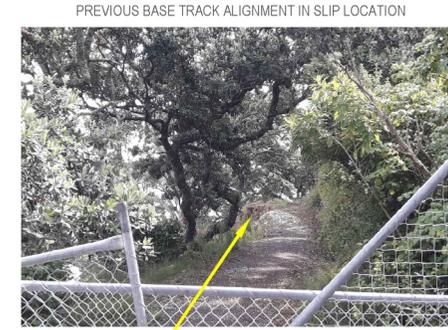
PREVIOUS BASE TRACK ALIGNMENT IN SLIP LOCATION

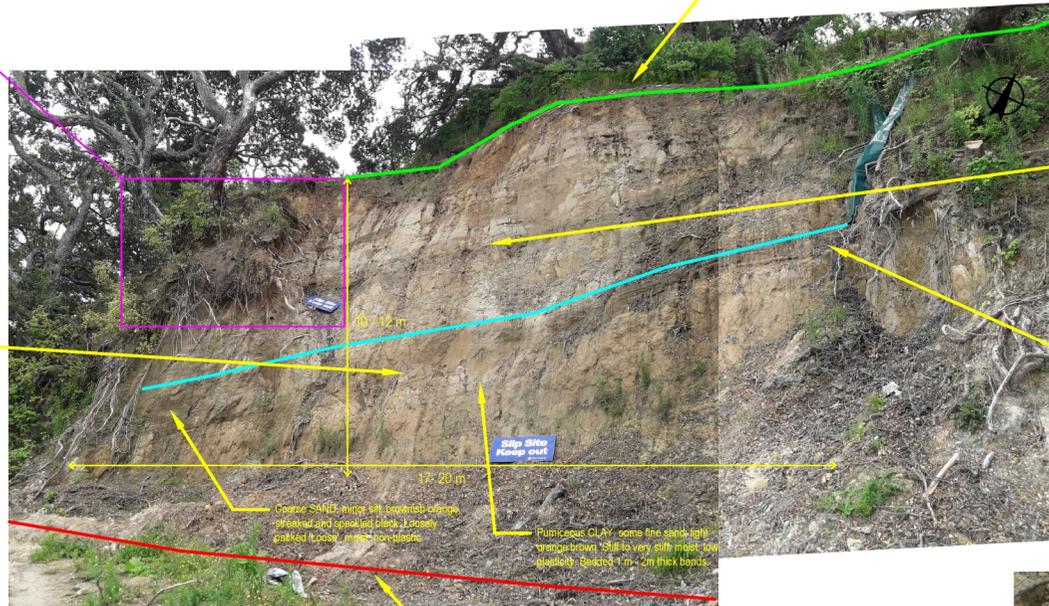
PREVIOUS MAUAO BASE TRACK, HALF REMOVED BY LANDSLIP

TOP OF SLIP HAS REMOVED APPROXIMATELY HALF THE WIDTH OF THE PREVIOUS BASE TRACK

SLIP SCARP AND COLLUVIUM PILE

- Following re-grading of localised overhangs we recommend that the exposed slip face is covered in MacMat, DuraMAT or other suitable approved product. The matting should be secured in place with suitably designed anchors.
- Once installed the MacMat, DuraMAT or other suitable approved product can be hydroseeded. Vegetation growth on this surface will further improve stability of the slip face.

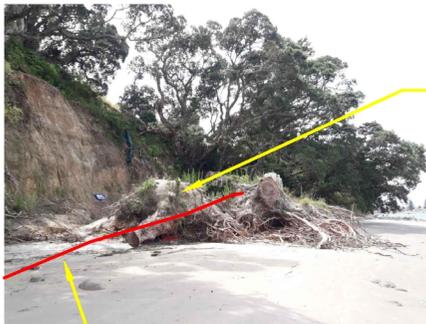
COLLUVIUM FROM LANDSLIP, SILT & SAND IS BEING REMOVED BY TIDAL EROSION. TREE STUMPS AND ROOT SYSTEMS LIKELY CONTRIBUTED TO FAILURE

PUMICEOUS SILT ENCOUNTERED IN COLLUVIUM PILE

ORANGE BANDING LIKELY INDICATING THIN AIR FALL DEPOSITS
