Report on: **Mauao Slopes**

May 2005 Flood damage &

Slope remedial works

Avalon Report No: 0534 B

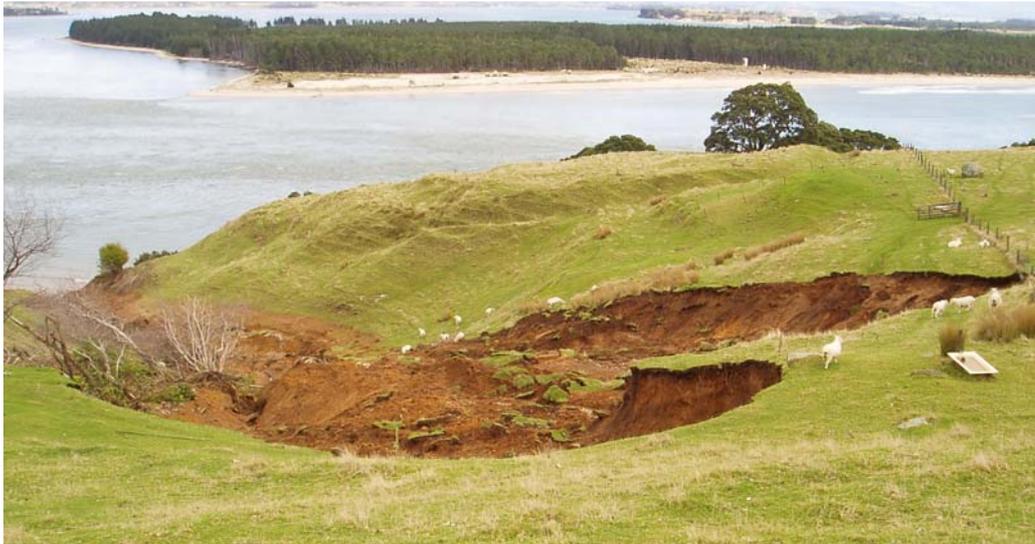
The largest single slip however, between the Base and 4WD tracks in the south west, was much larger than any others (see photograph below) and alone involved around 8,000m³.

Photograph 1. The largest single slip, est 8,000m³ (Item 34).

34.	Rejuvenated slip 15m wide x 20m down slope x 5m deep. Approximately 25m above base track. Overhanging topsoil above v steep headwall. Evidence of layering in old colluvium. Debris swept onto base track. Crest of slip is encroaching on access track.	Re-route access track approx 4m back from present position. Reprofile slip crest; approx 2m to cut back. Fence. Clear base track. Seed.

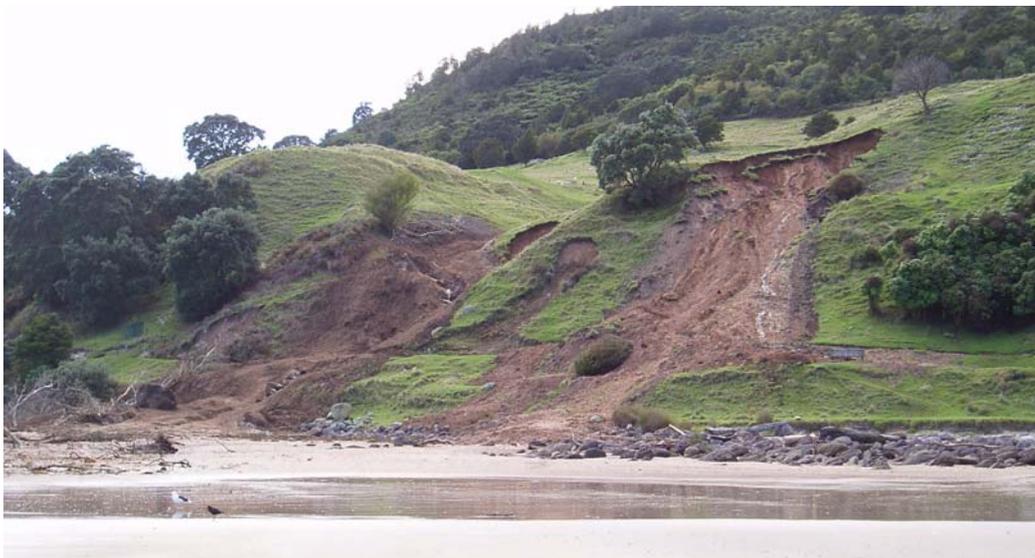
Photograph 2. Debris flow from above (left) and slip 34 (right).

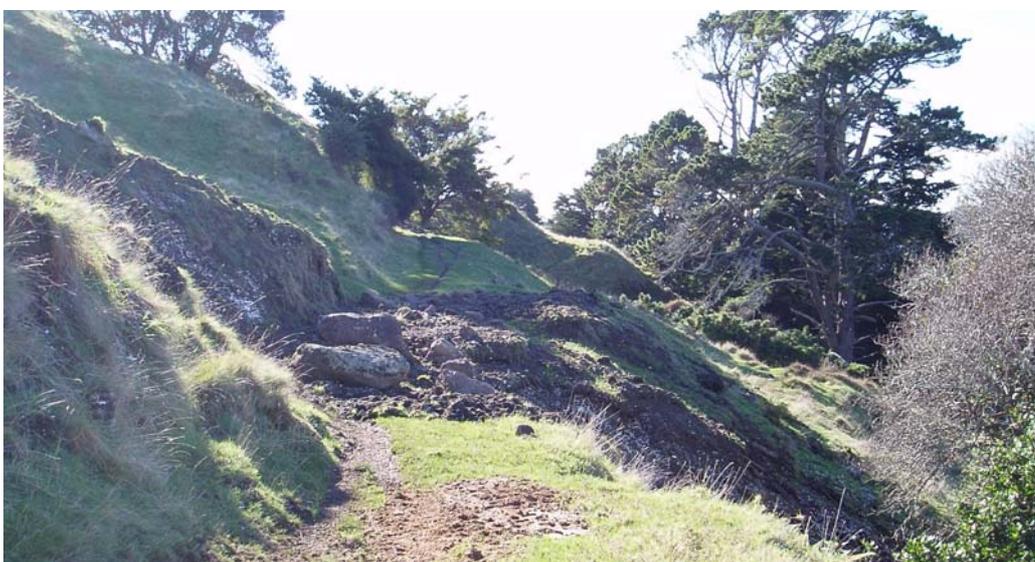
Photograph 3. Slip onto farm track also released boulders to 4WD Track (Item 34).

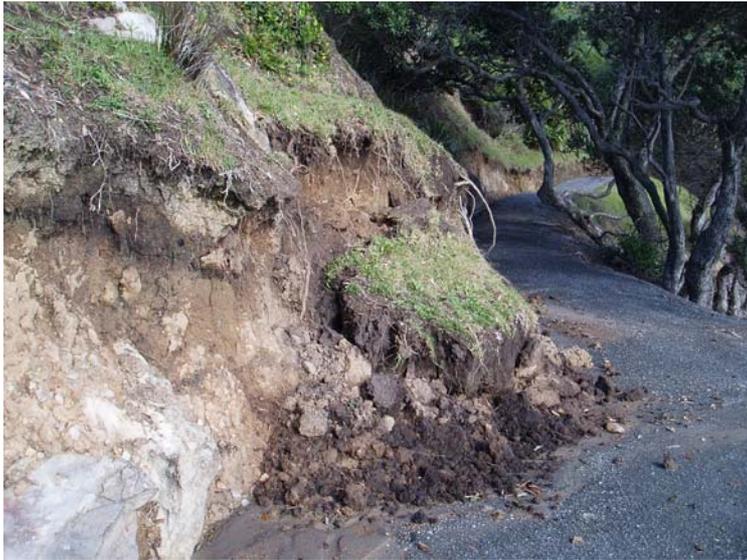
Photograph 4. Typical Base Track cut slip (item 31).

31.	Minor slip in steep cut slope immediately over base track.	Approx 1m3 debris to clear from track.
32.	Slip in slip over base track. 5m x 5m x 2m.	Approx 10m3 debris to clear from track. Minor crest reprofiling & lightly scale surface. Seed.

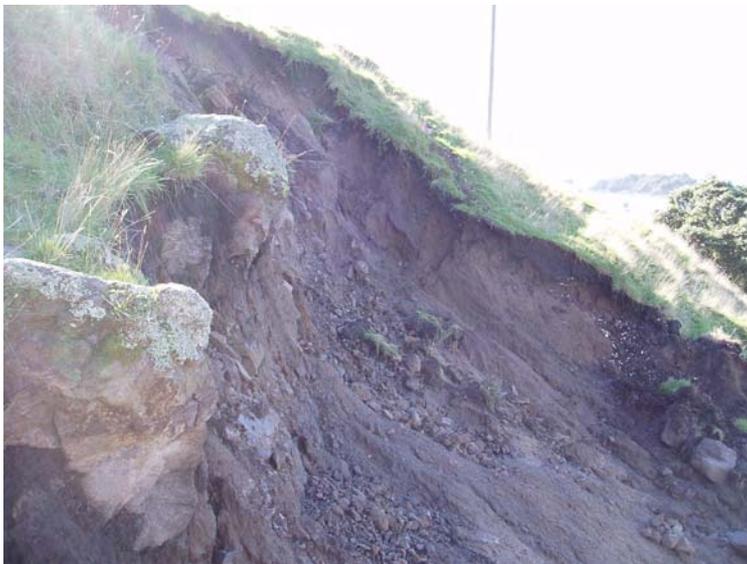
Photograph 5. Slip in colluvium with boulders over 4WD Track (item 8).

8.	Slip 120m (up slope distance) above 4WD track. 3m wide x 3m up slope x 1m deep. Debris including rock swept to 4WD track. Some rock & boulders at rest on old farm track mid slope. Boulders in unstable positions on slip scarp.	Scale rock debris from slip and debris slope & locally re-profile slip crest. Seed.

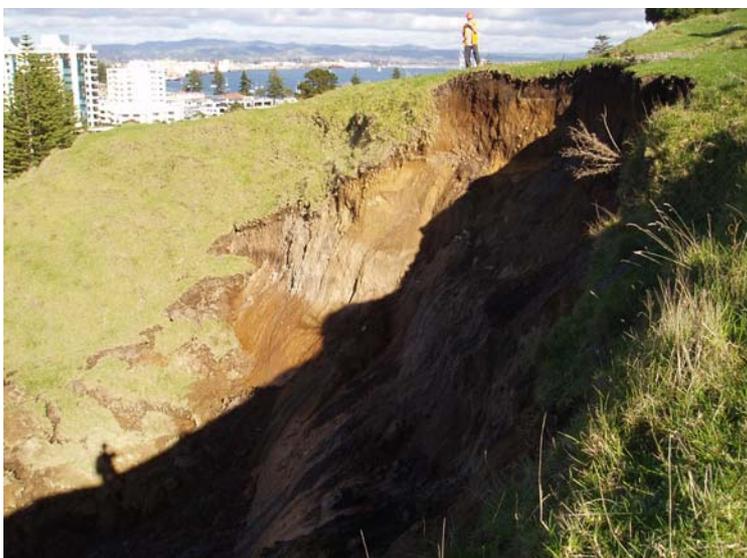
Photograph 6. Slip in colluvium above campground (item 34).

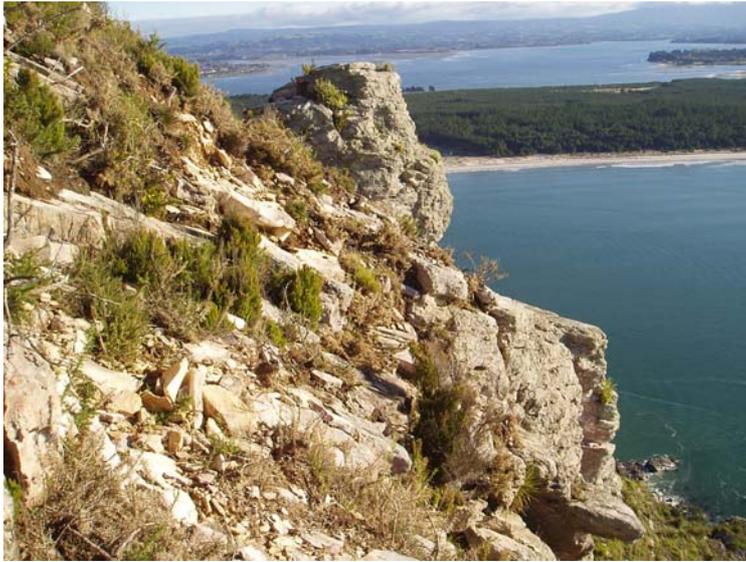
Photograph 7. Typical scour above Oruahine Track.

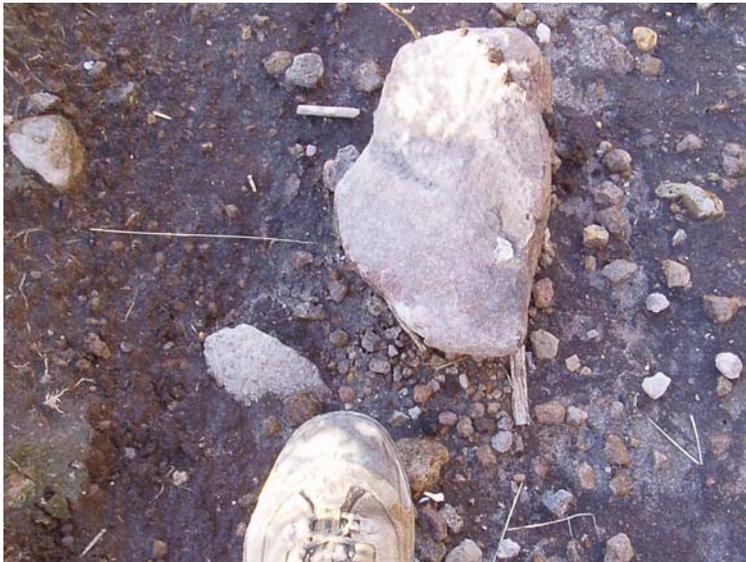
Photograph 8. Fresh rockfall onto Oruahine track.

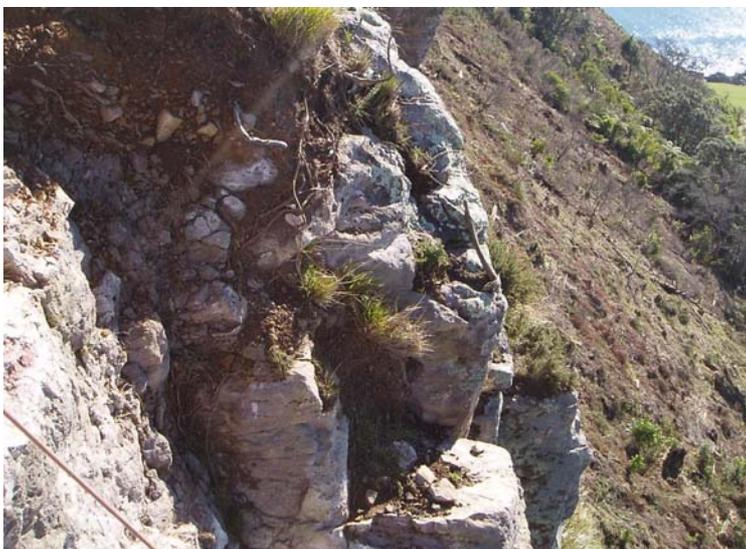
Photograph 9. Scour high on bluff above campground.
