GEOTECHNICAL

30 August 2021  
Avalon Project #22102

## **Mauao Slopes; Rockfall incident response and Routine monitoring report August 2021**

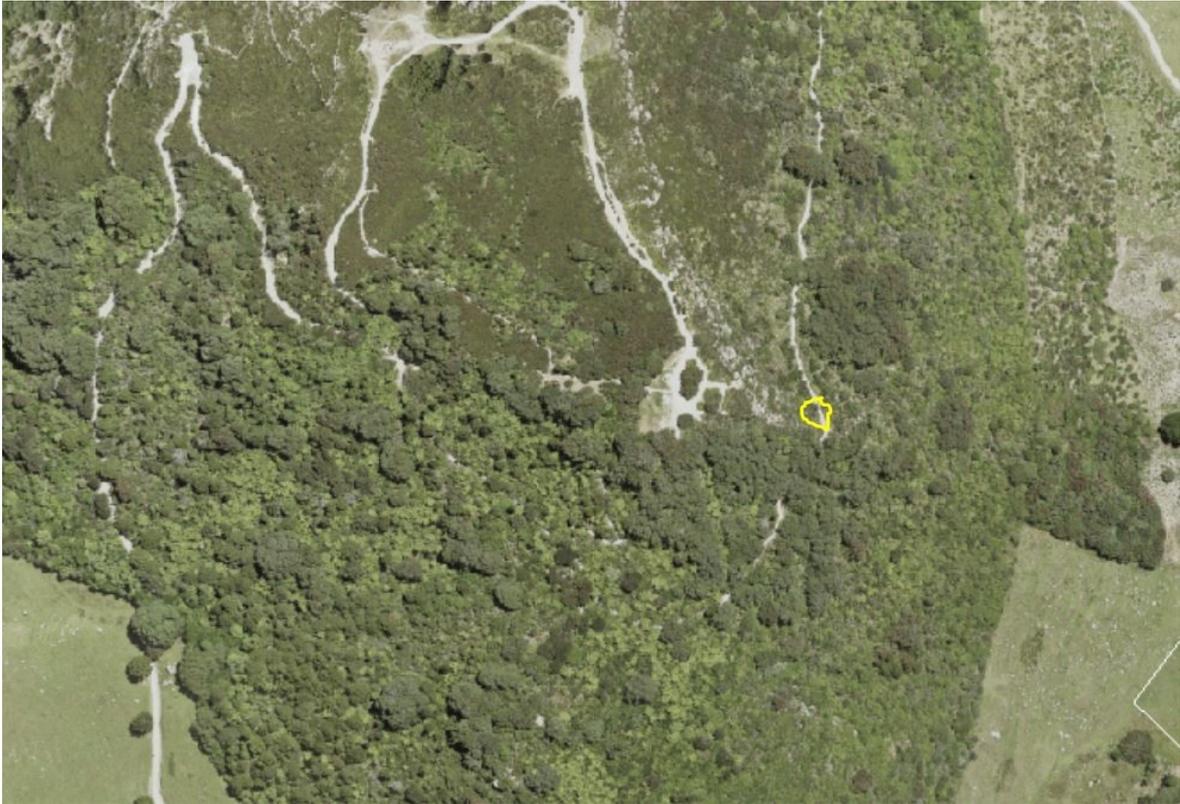
The rock in question was reported as "boogie board sized" so presumably relatively thin and around 0.5 to 0.8m along the sides.

It impacted the Waikorere track a few metres in front of the person in question. The person reportedly had heard the rockfall whilst it was rolling/bouncing down from above, then saw it exiting the bush just above the track and thus were able to safely move away from the fall line.

*Photo 1; The rockfall crossed the Waikorere track at this location.*

From the description the rock's weight could have been around 100kg, clearly large enough to present a risk of fatality to a person in its path.

Our most recent numerical rockfall risk evaluation (2020) was based on an estimate that 2 to 3 rocks of this size cross the Waikorere track per year, which outputs the risk level to an individual on one crossing as  $1.2 \times 10^{-7}$ , well within the tolerable individual level. With present visitor numbers this risk level equates to a fatality incident return period of around 26 years.

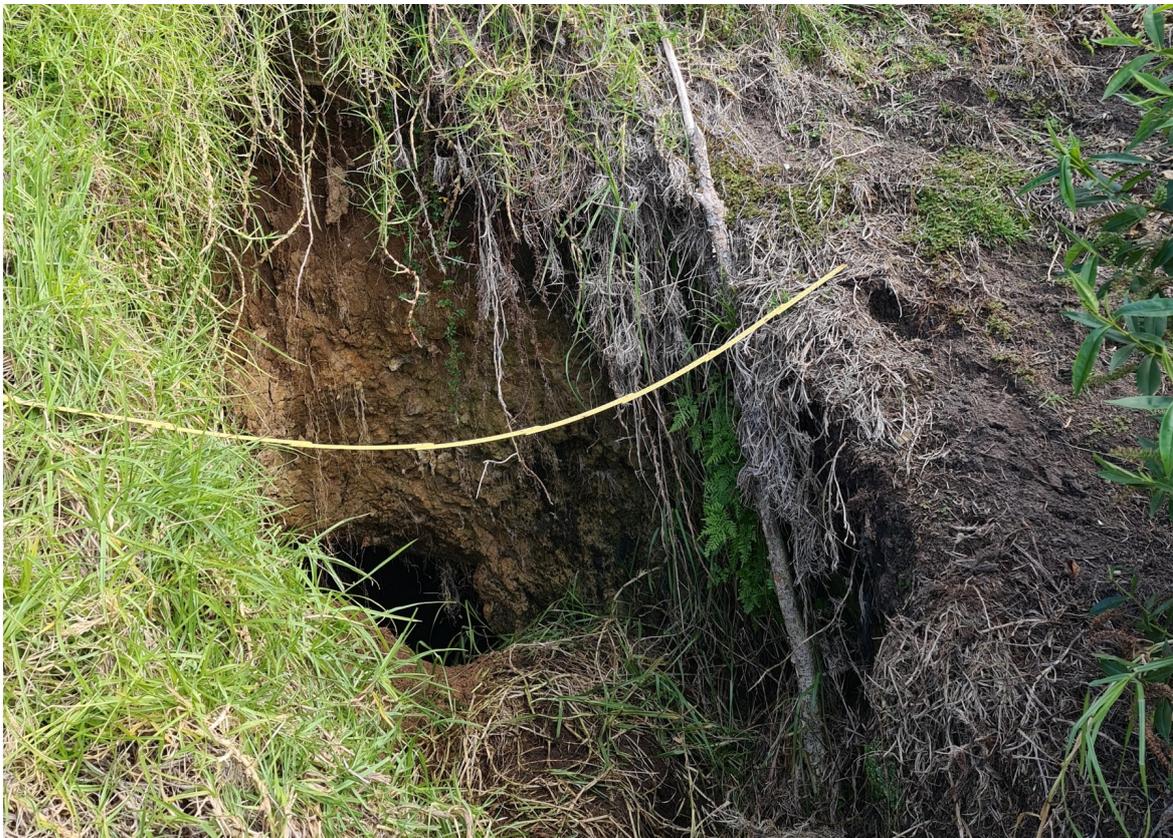
The springs that issue around the lower colluvial slopes around Mauao indicate widespread underground water flow. Underground drainage routes will tend to form at levels where sandy, relatively permeable colluvium, overlies impermeable clay (weathered volcanic ash) layers. The 'piping' effect, scouring out sand, can create open 'pipes', 'small tunnels'.

This feature looks likely to be a 1m<sup>3</sup> or so void collapse above a small underground watercourse in a natural "pipe", scoured out by flowing water.

*Photo 2; The sinkhole at the surface (2m scale).*

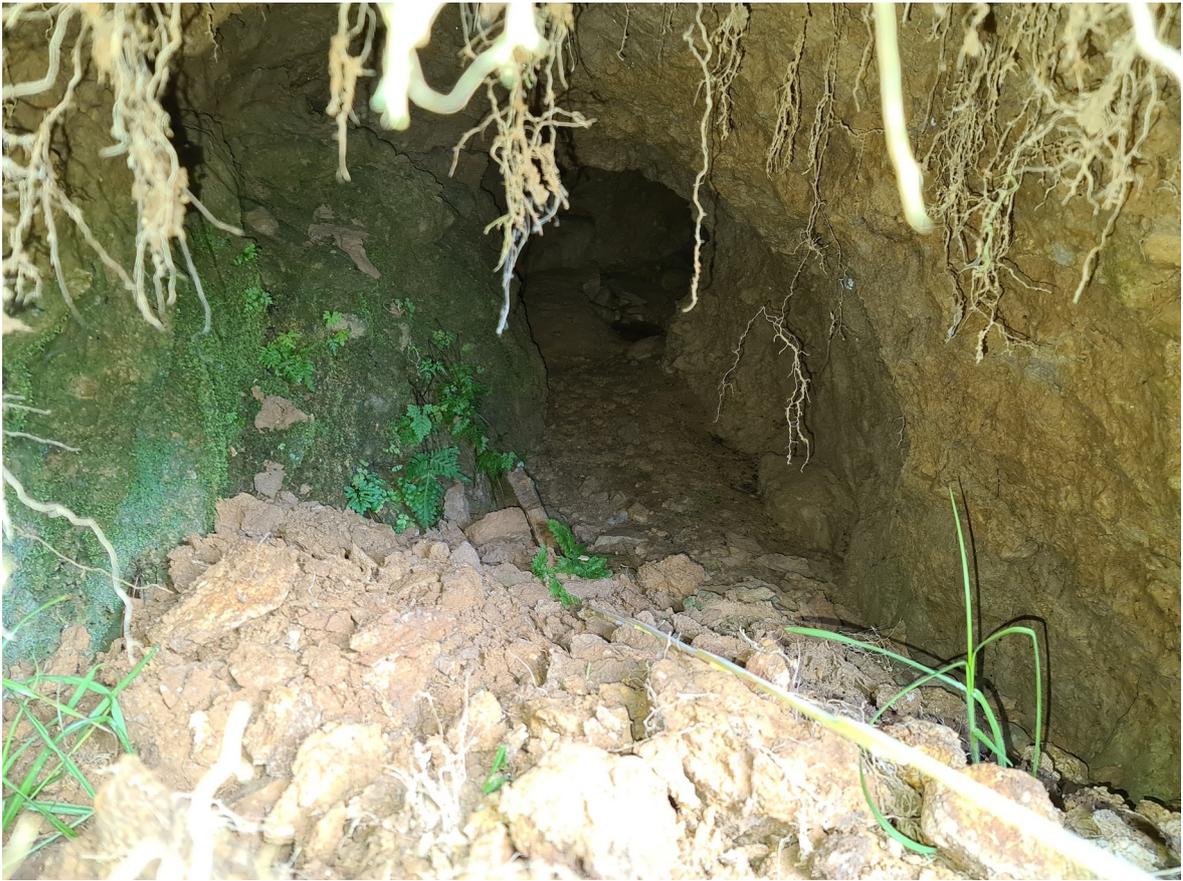
*Photo 3; The sinkhole entrance.*

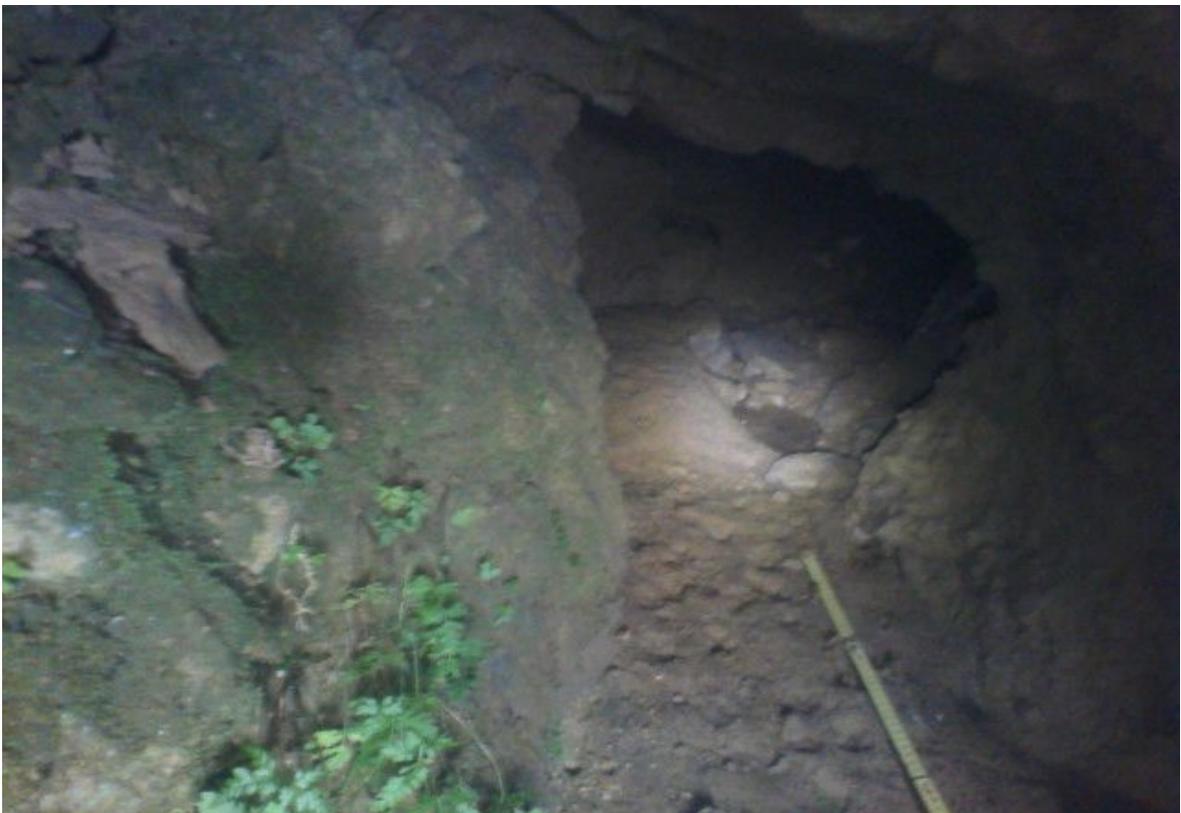
*Photo 4; Looking further in the 'tunnel' appears to continue to the right. A small pool of water can be seen on the floor.*

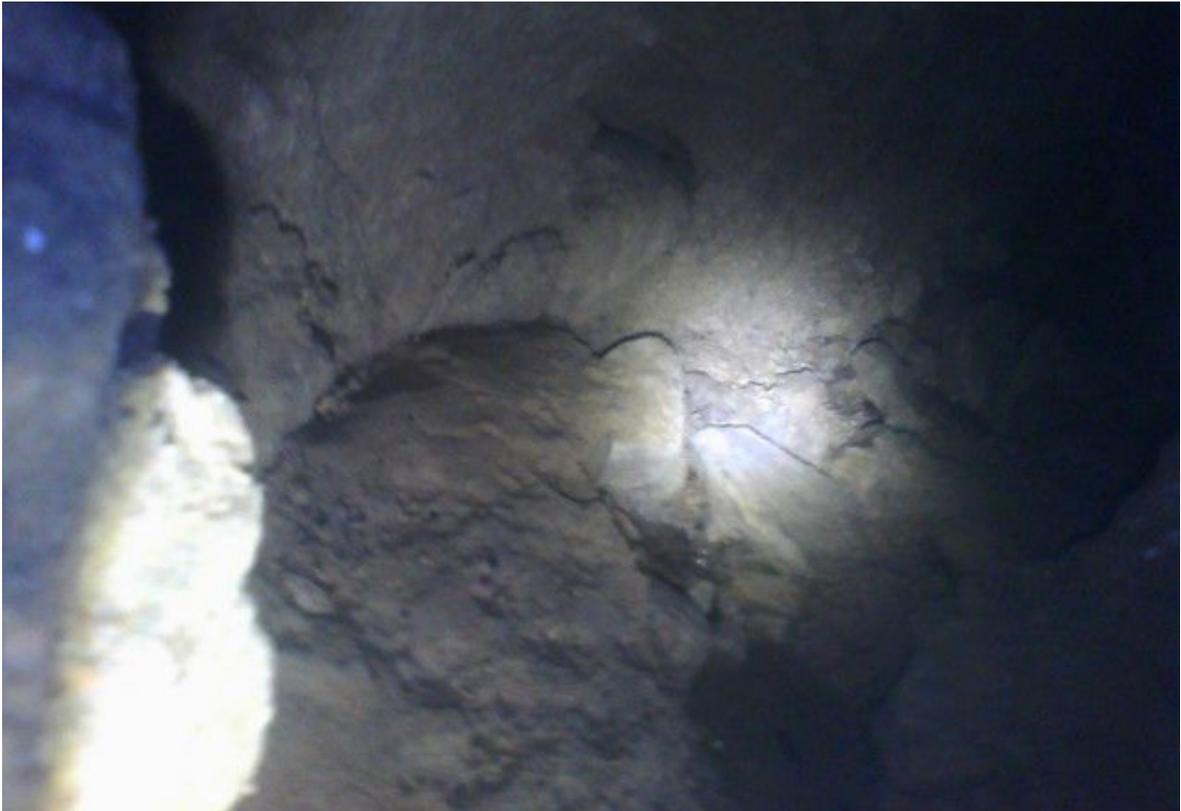
*Photo 5; The tunnel continues to the right. Furthest view in photo is around 5m from the entrance. The diameter of the tunnel here is around 0.5m.*

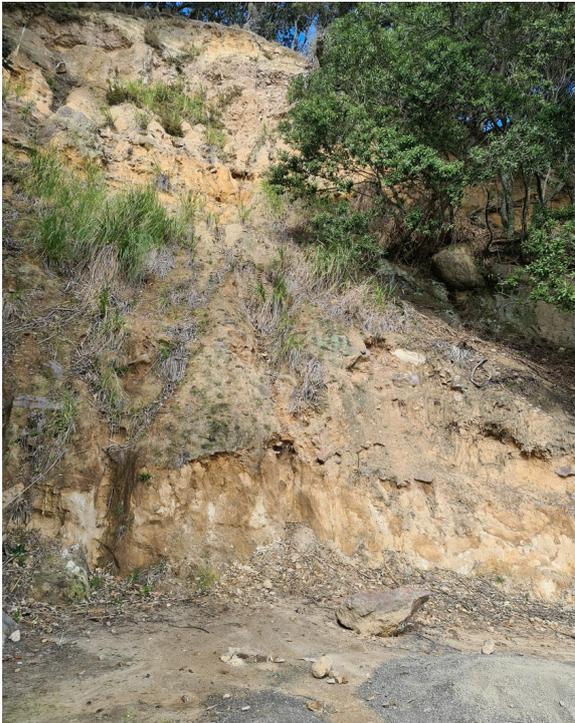
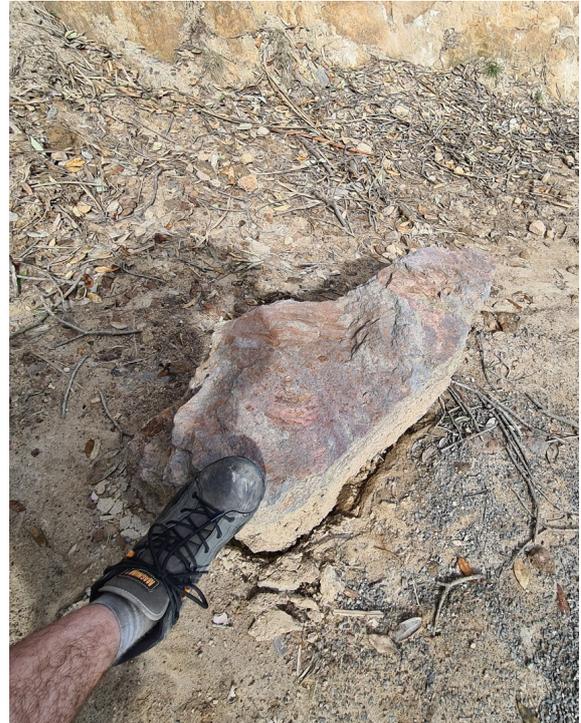
*Photo 6 & 7; A recent rockfall from the actively eroding slope above the Western Base track.*

As has been the case for many years, this slope continues to actively erode and generate occasional falling rock.

We recommend that this particular slope should continue to be scaled regularly as required, as new surface rocks are exposed.

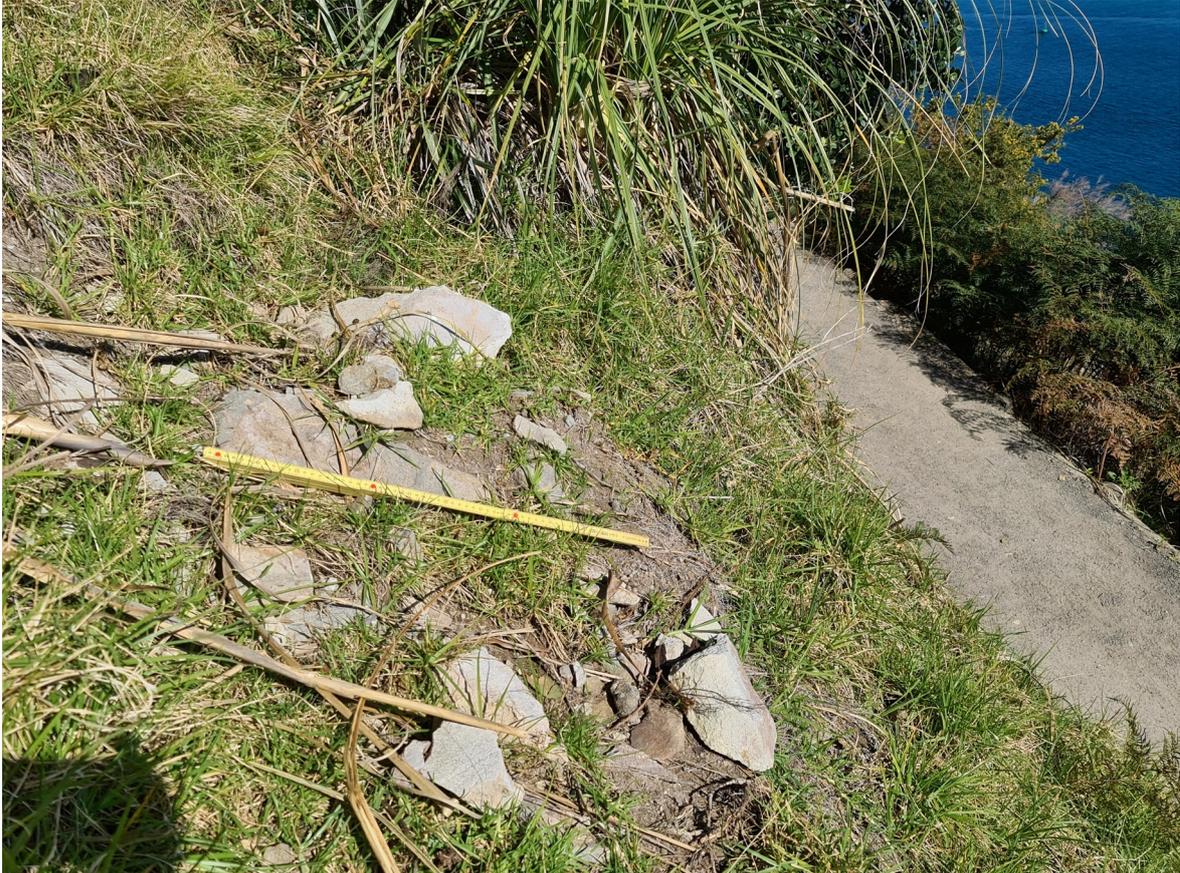
*Photo 8; Rock resulting from a small soil slip above the Oruahine track.*

In this case the rock is only 2m above the track so does not present a hazard but it illustrates how small soil slips and erosion continue to bring new rock to the surface.

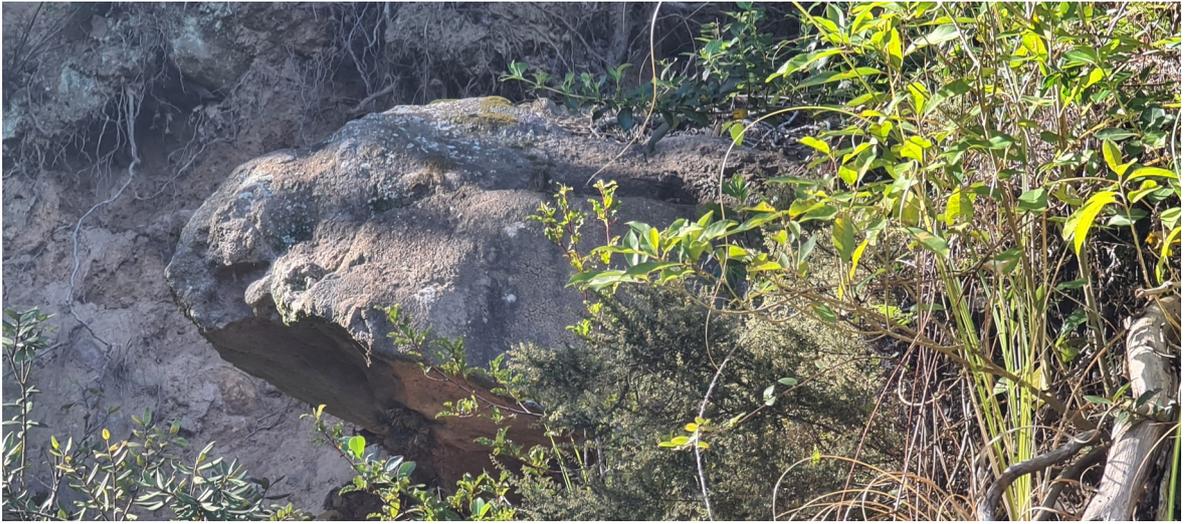
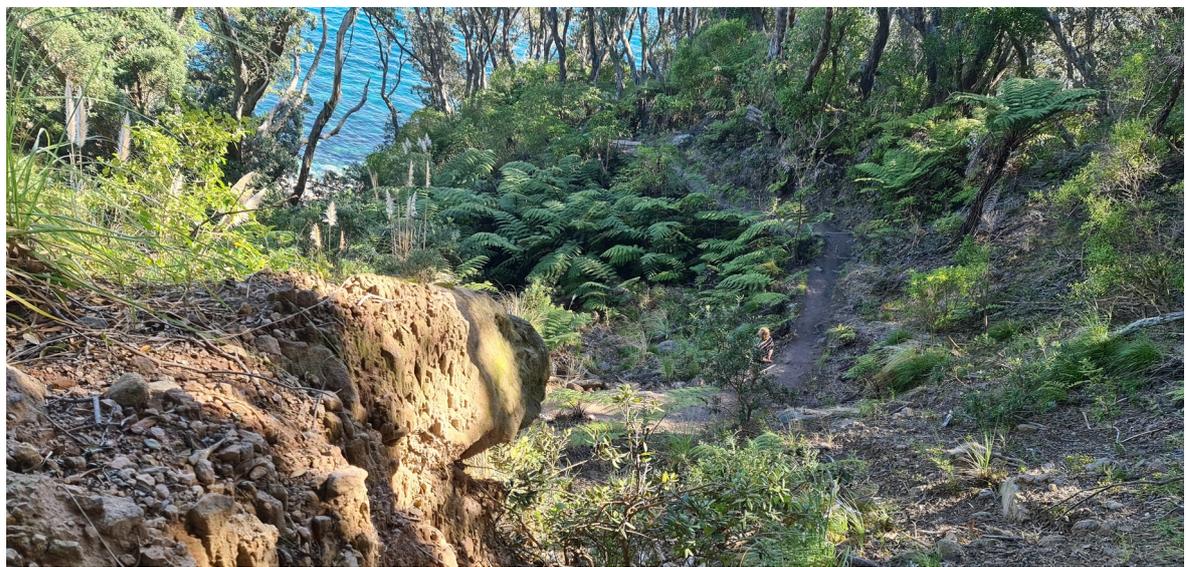
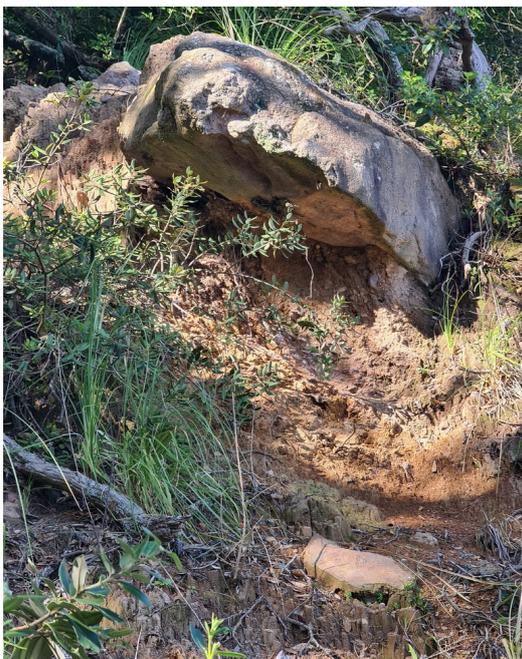
See photographs on following page. This boulder has now eroded out to such a degree that it may be marginally stable.

The location is at the crest of an exposed slip face around 10m above the mid Goat track. The boulder does pose a hazard to persons using the track below.

*Photo 9, 10, 11; Overhanging boulder above Goat track.*

This boulder appears likely be able to be scaled relatively easily. Although it is unlikely to pick up enough speed to reach the Base track, there is a small possibility that it may therefore a temporary Base track closure would be required.

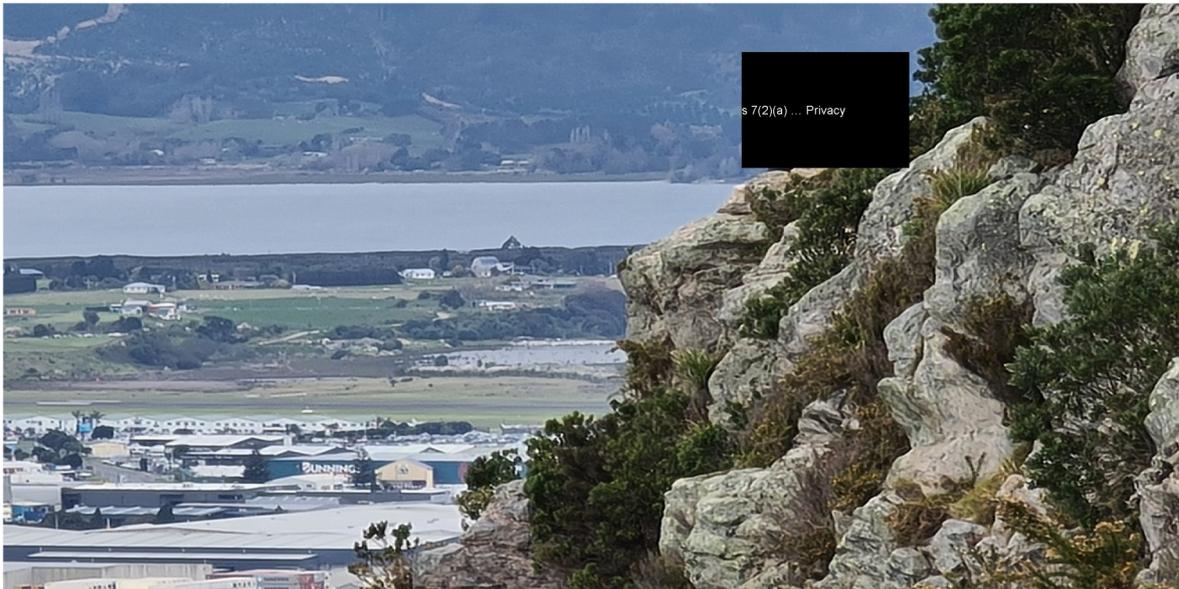
*Photo 12; Off track persons on bluff crest above Waikorere track.*

We have no reason to believe such persons triggered the 2 August rockfall, although it is possible.

Of course these persons are at risk of falling, however, we are not aware of any accidental falls and the vast majority of visitors do not leave the designated tracks as these persons have actively chosen to.

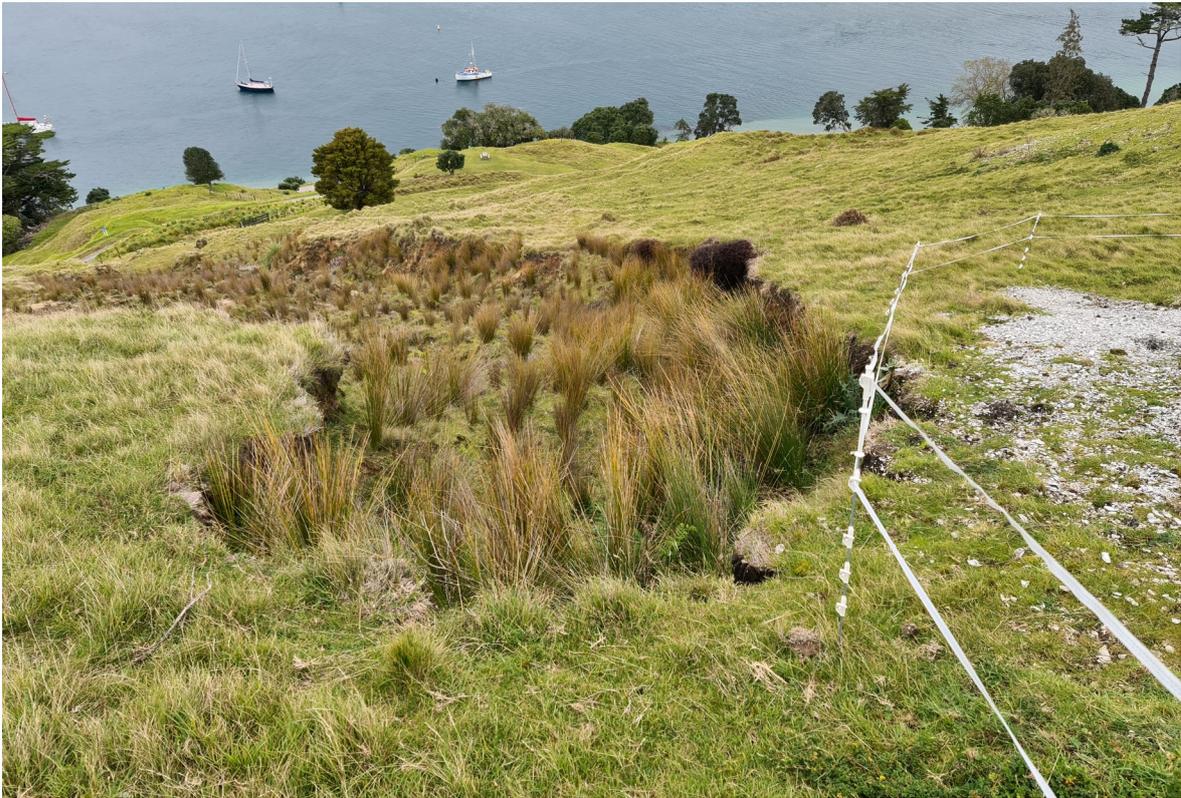
This slip scar does not present any hazard to persons but has been actively eroding and enlarging for 16 years. The location is 37° 38' 1.8494" S, 176° 10' 17.0897" E

This slip was triggered by a large storm event in May 2005. 350mm of rain fell in 24 hours. It was initially two smaller slips, designated #7 and #8 out of a total of 52 slips generated by that rainfall event. *Extract from Avalon Report 0534B*

These separate slips eventually joined together and continued to expand, resulting in the picture today. Planting efforts have helped slow the erosion rate.

*Photo 13; Slip from above. Note midden on right.*

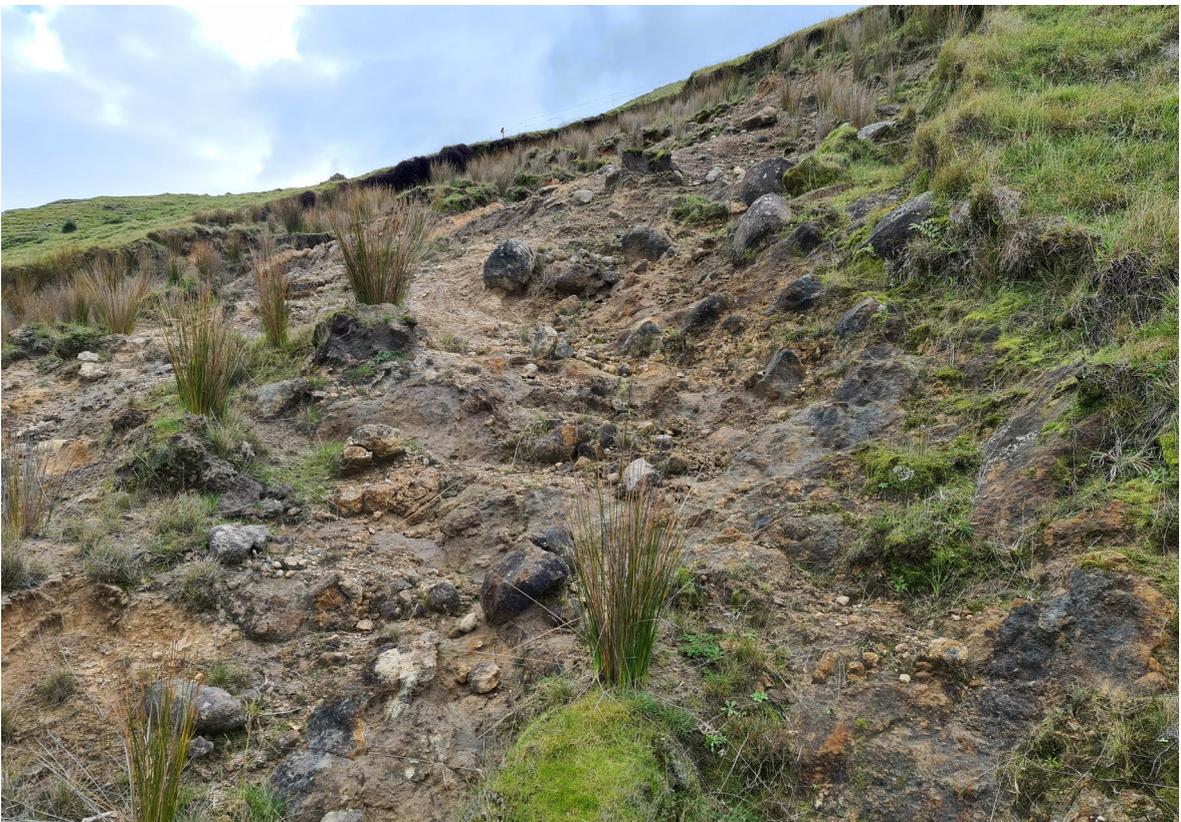
*Photo 14; Slip from below. Very rocky, difficult for vegetation to establish.*

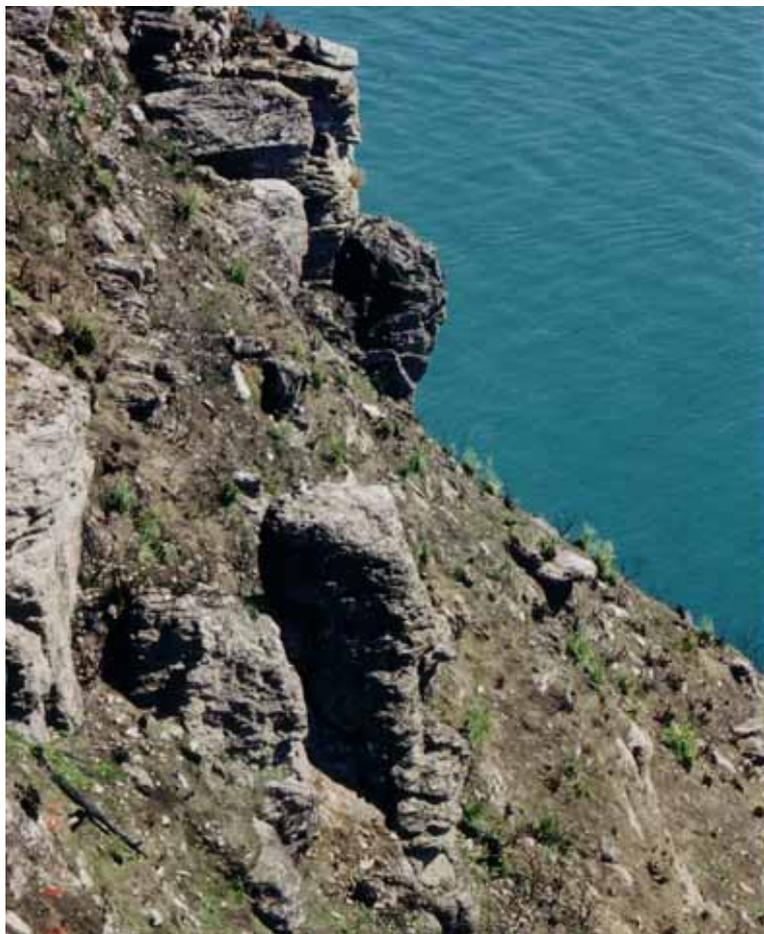
Photograph No 22; Unstable column at 3d.
