**Archaeological Site
Condition Monitoring Report**

Mauao Historic Reserve, Tauranga

11 September 2020

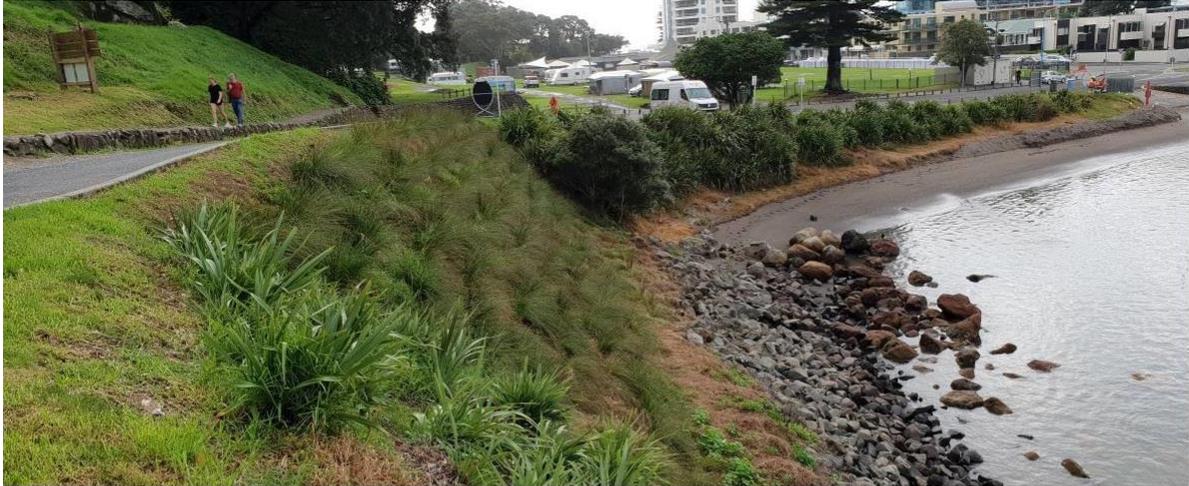
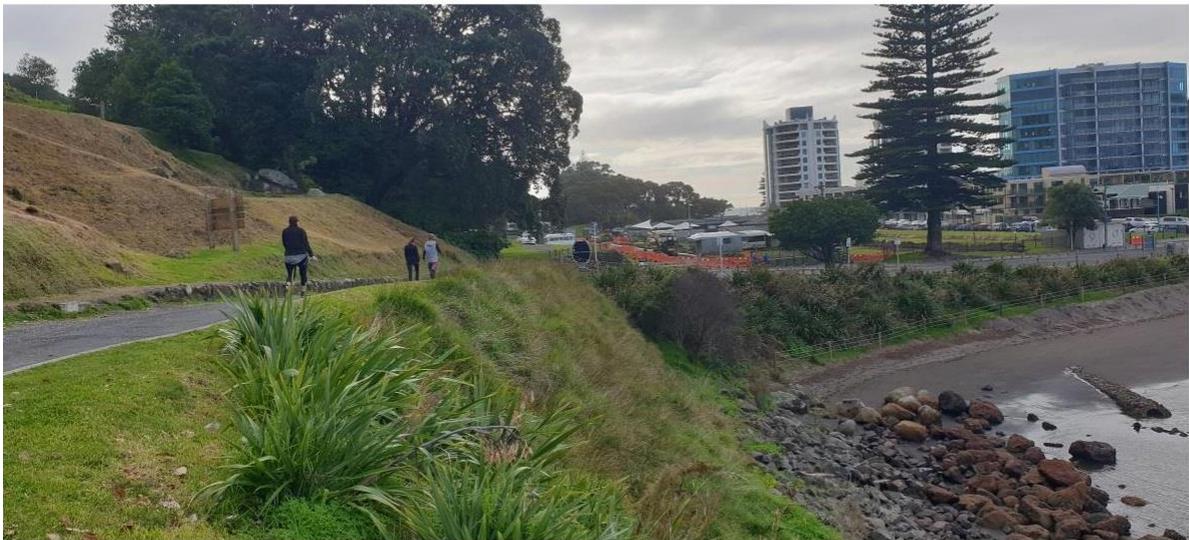
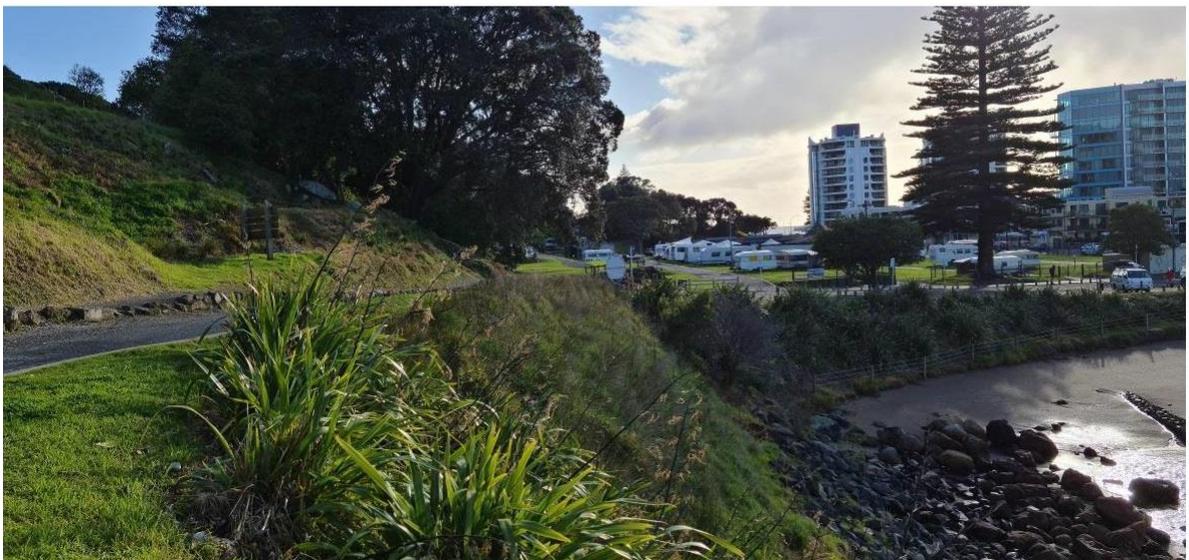
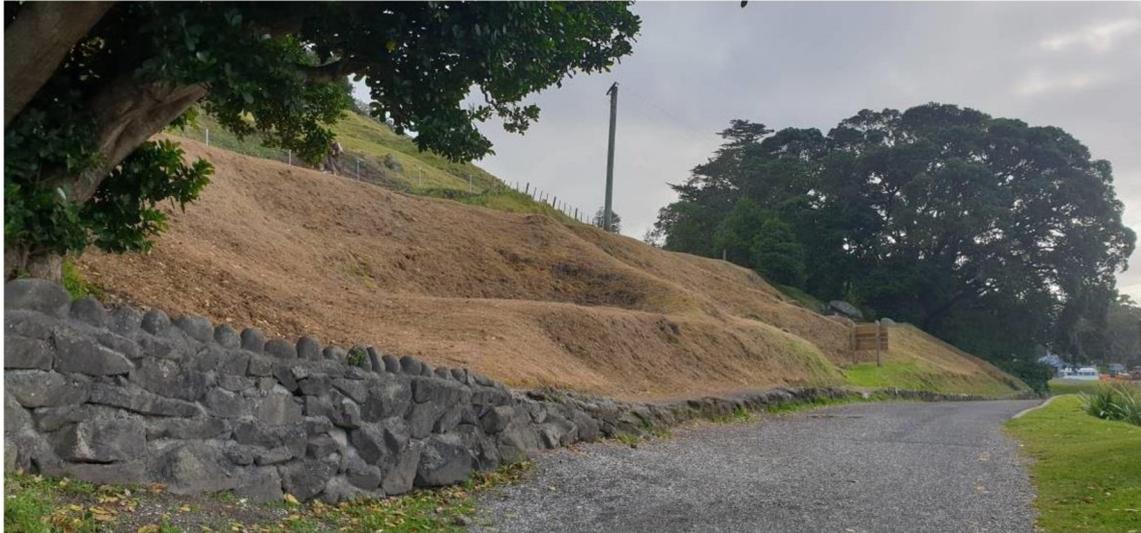
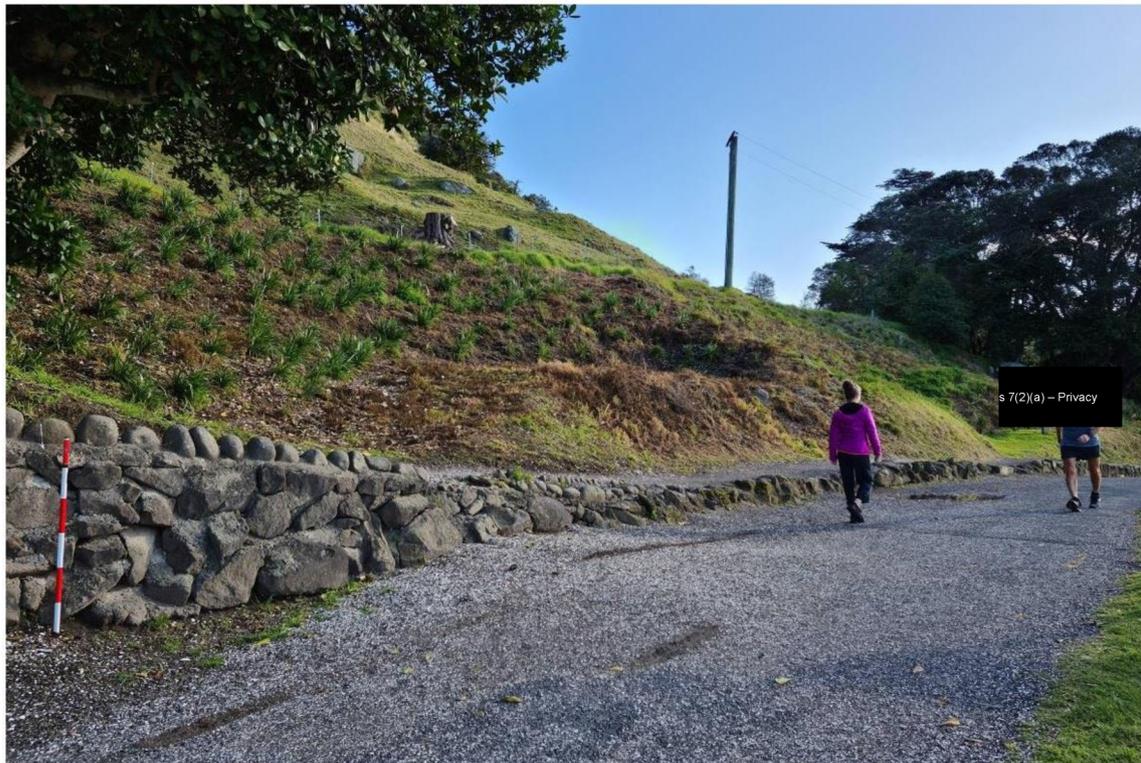
Monitoring point 1:

Notes: Grass cover decreased from 2019, but no new erosion visible. Grass cover should be monitored and re-sown if it does not naturally re-establish during spring. The area of terraces to the east of the monitoring point planted in winter 2019, becoming established. Bare ground where release spraying has occurred.

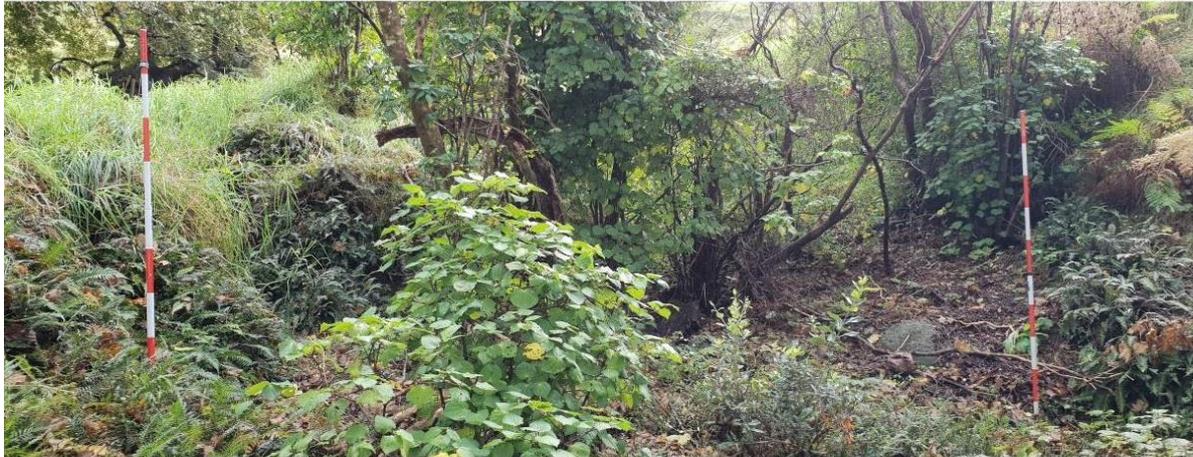
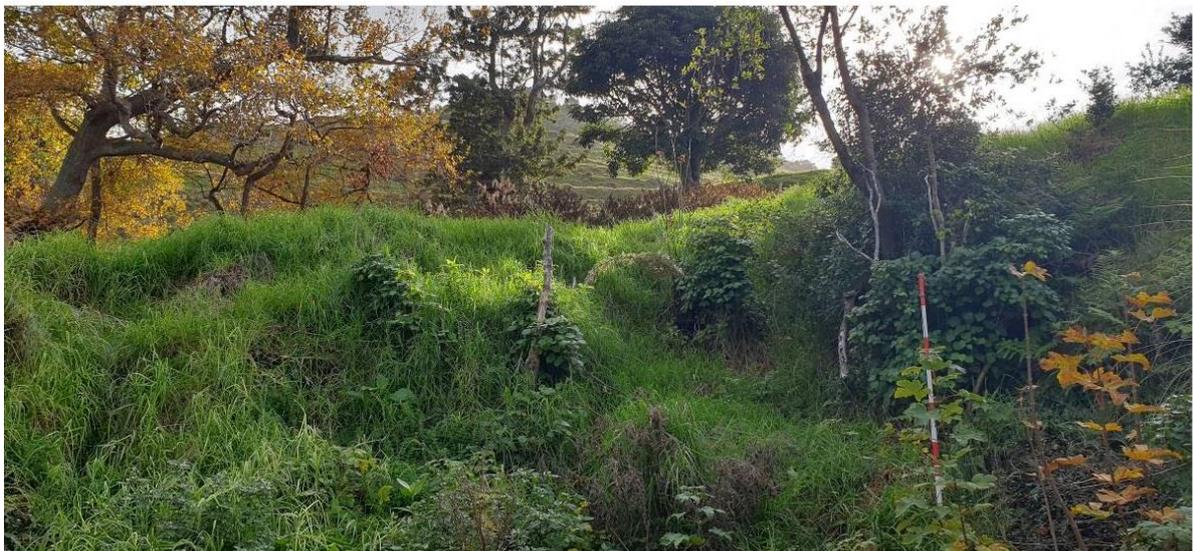
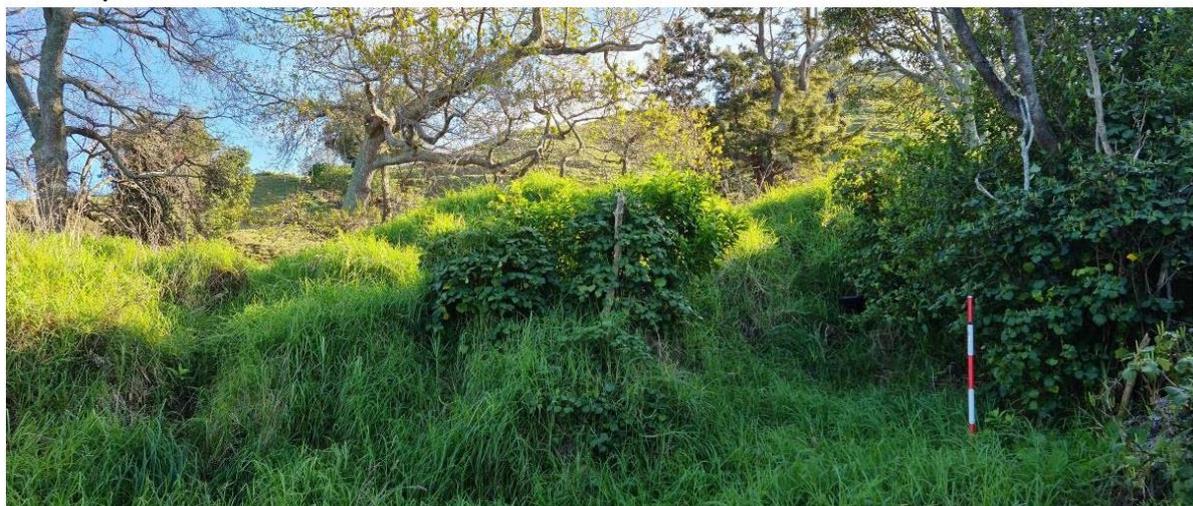
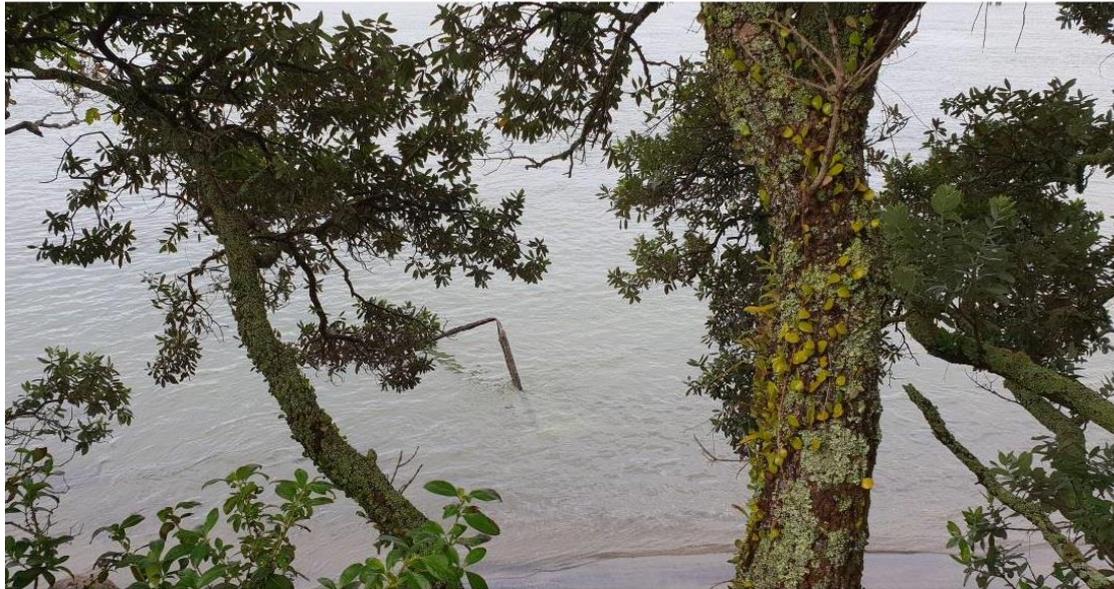
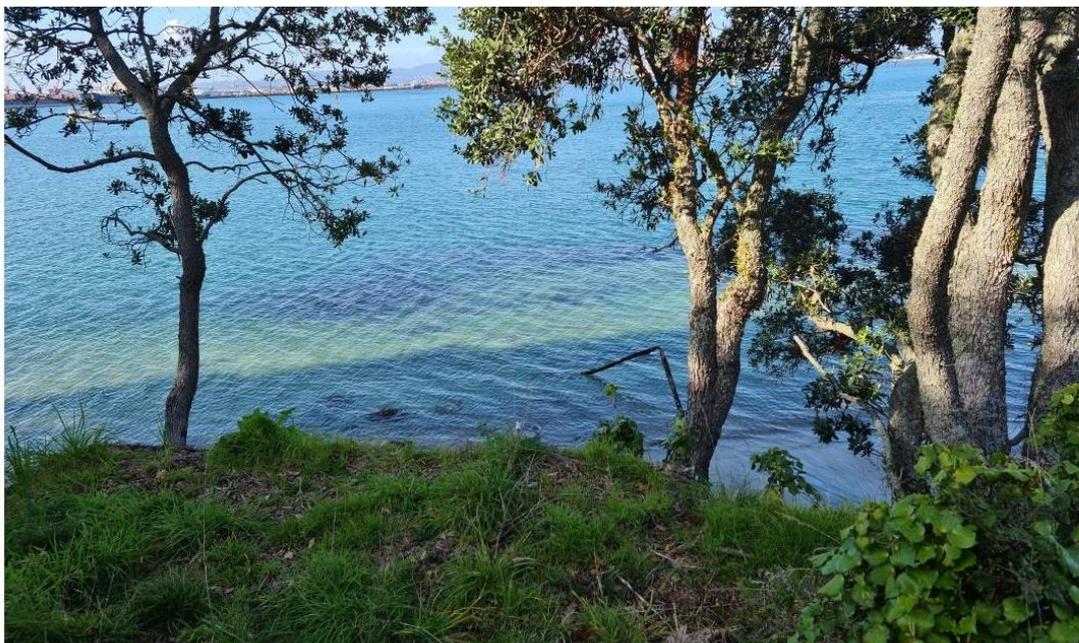
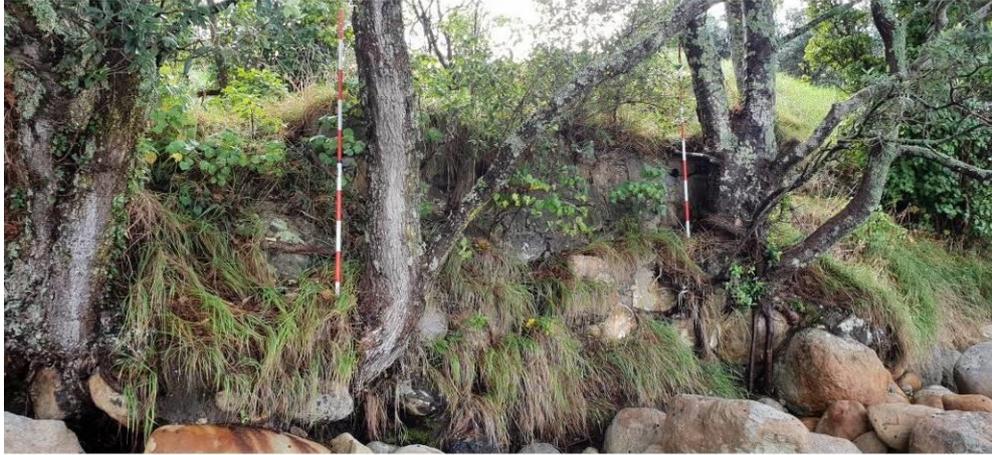
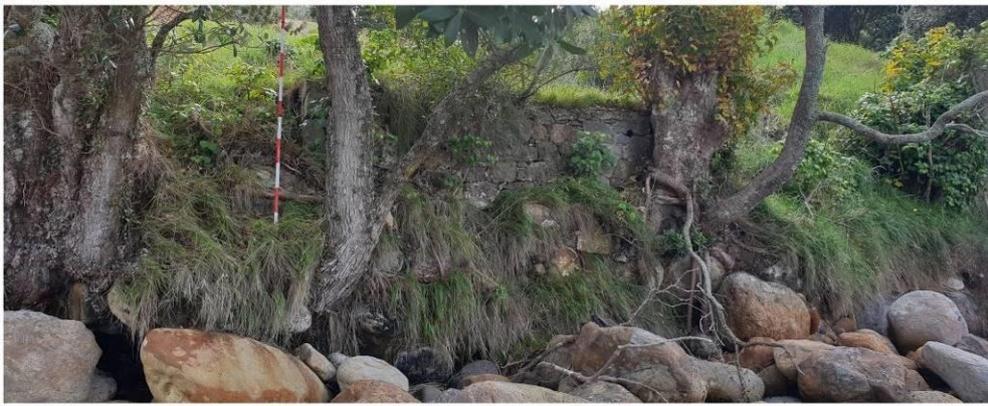
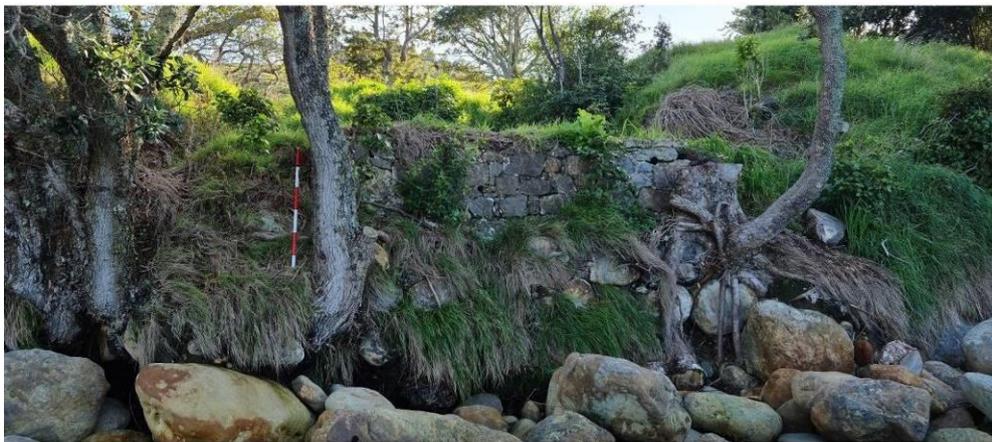
Monitoring point 2:

Notes: Vegetation clearance has been completed to reduce pohutukawa and sycamore growing on the stonework face of the jetty. Possible interpretation could be developed at the jetty. It should be maintained in low vegetation/ferns/rank grass, with periodic weed eating. Terrace surface less visible than in 2018. The view shaft to the iron debris offshore should be maintained.

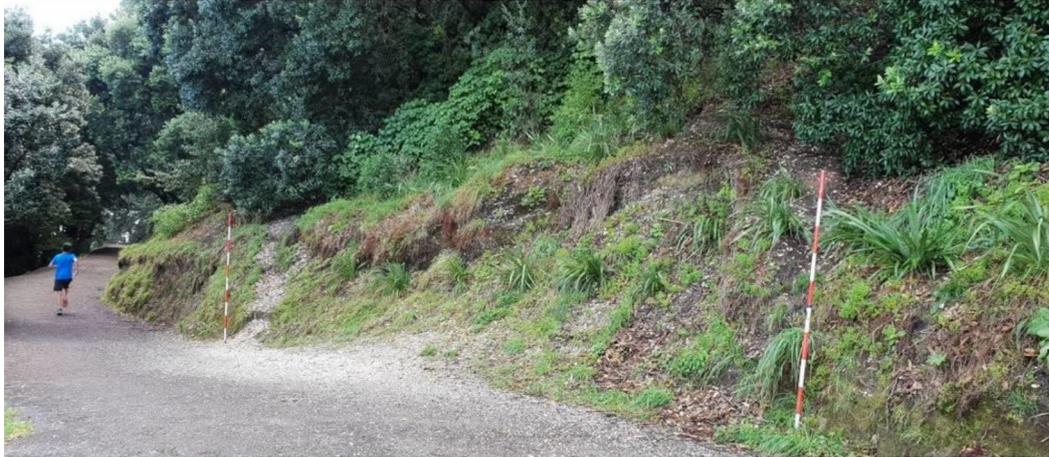
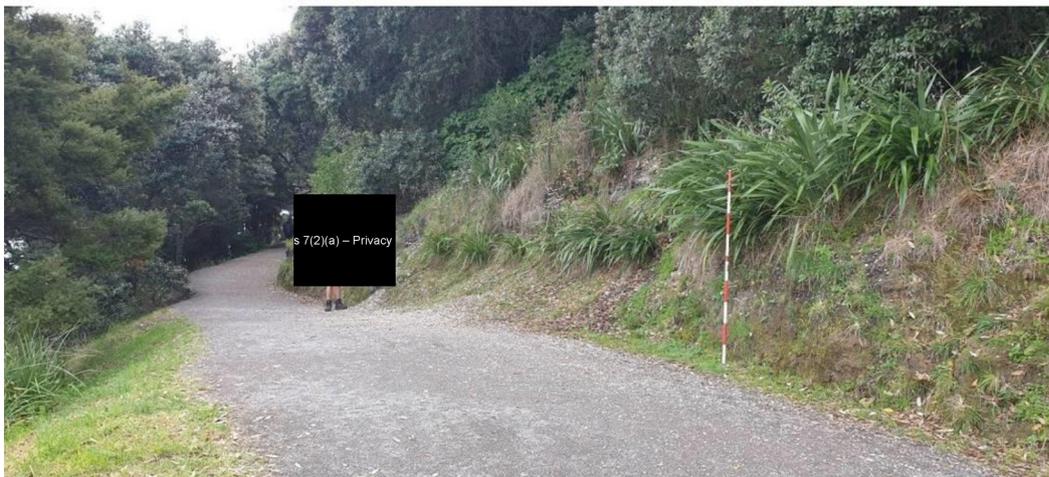
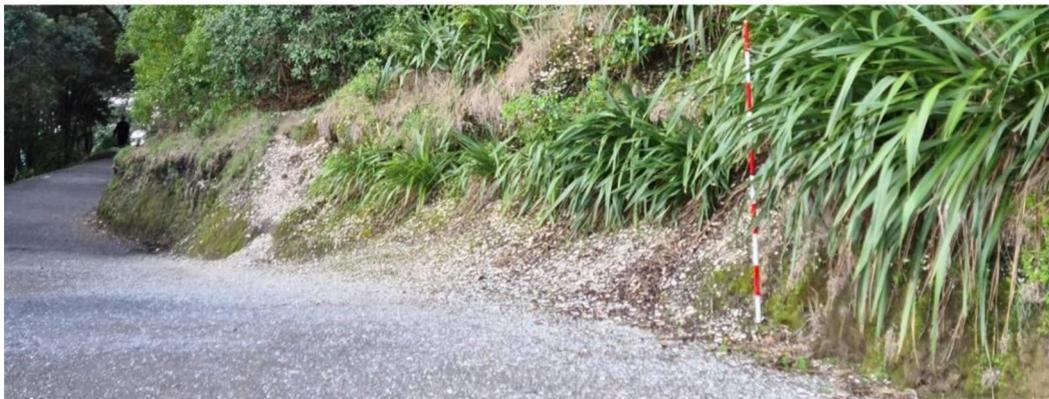
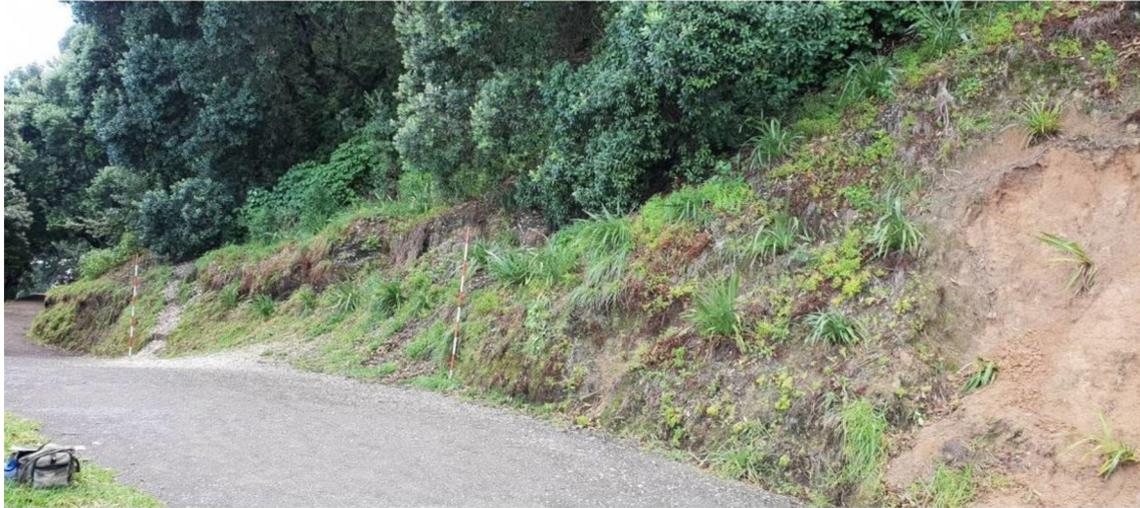
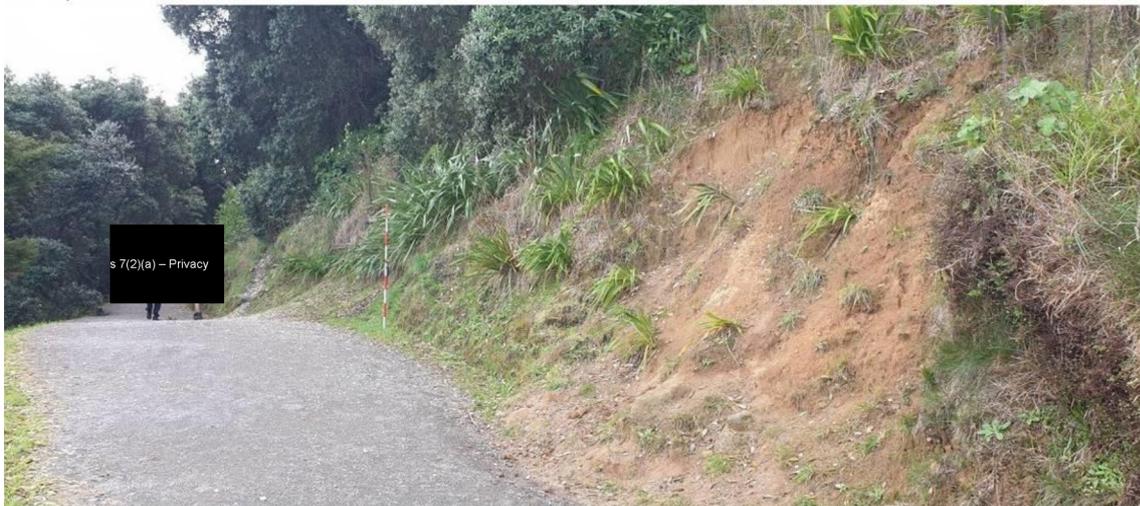
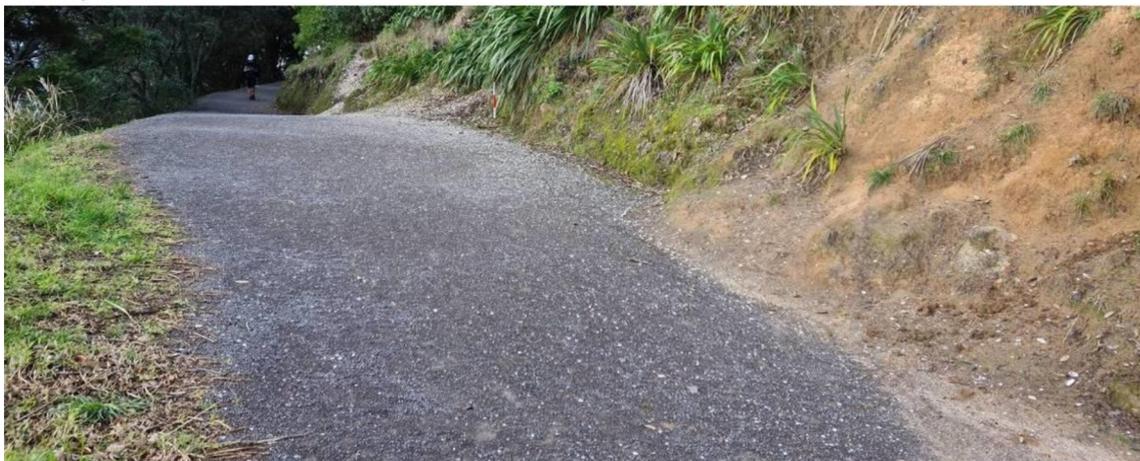
Monitoring Point 3:

Notes: No significant advance in vegetation cover over the year and eroded face is still highly visible. Shell is still accumulating at the base of the slope, but no active rabbit browse. 2019 planting has not significantly advanced.

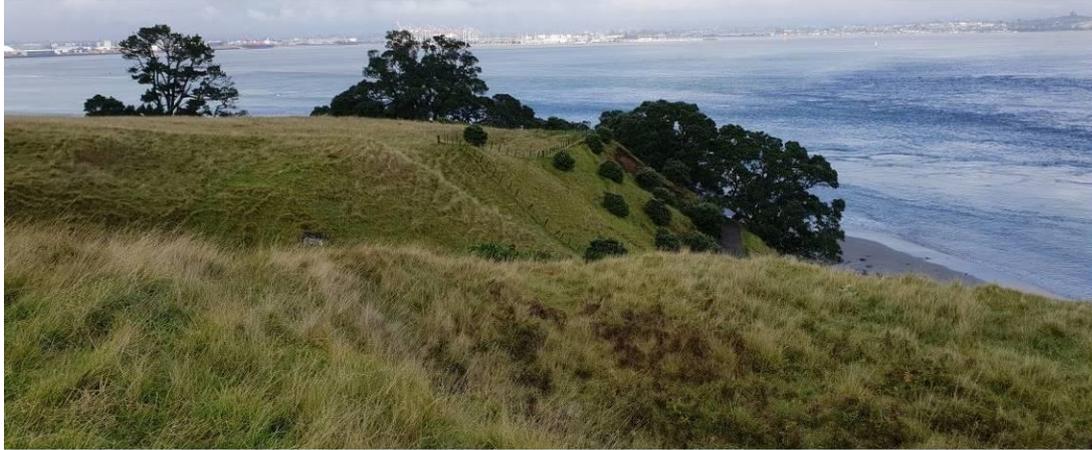
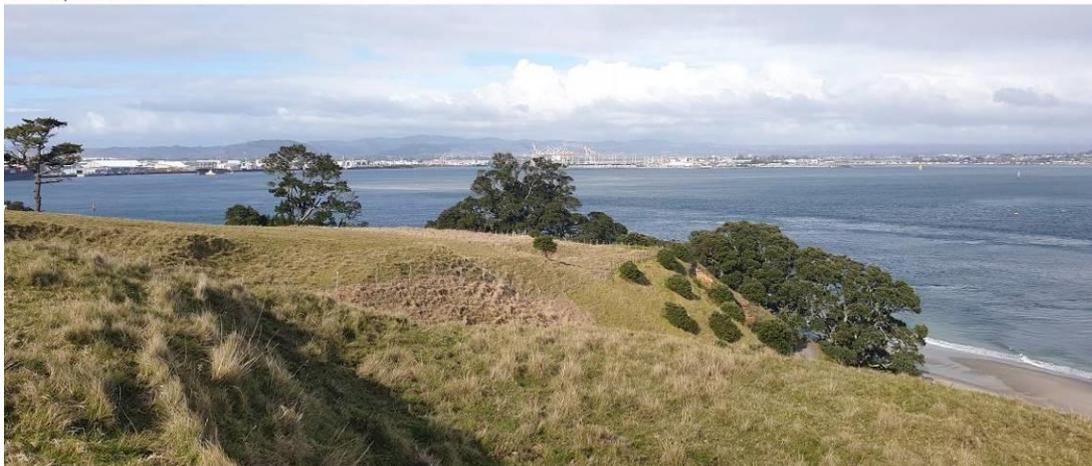
Monitoring Point 4:

Notes: In 2019 the fence alignment was adjusted to remove it from archaeological features, using new waratah standard and netting system. Slope below has been planted, and livestock have been excluded from steep areas, to stabilise midden and protect features uphill. There is more growth appearing on the slope since rabbit numbers were reduced. Midden is less visible. Two years on the plantings are becoming well established, midden is less visible and the fence system is well maintained. Bare ground where plants have been release sprayed.

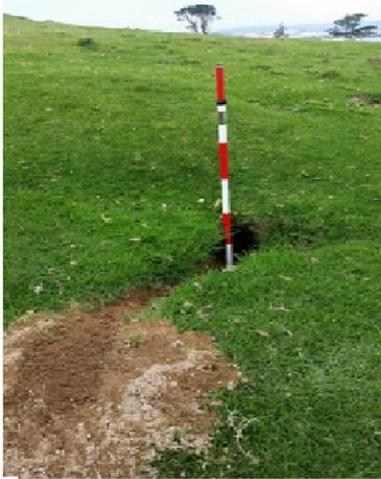
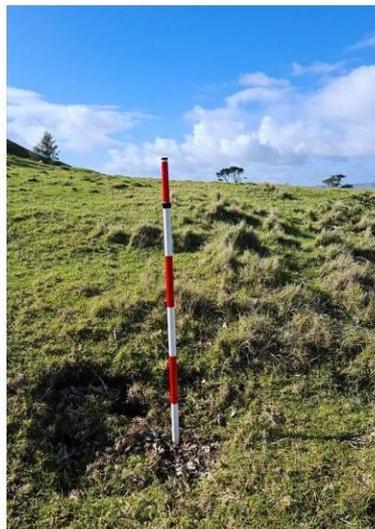
Monitoring point 5:

Notes: Old rabbit damage, visibility decreasing. Note danger that such features start to look like archaeological depressions over time. Area around burrow entrance has deflated over time.

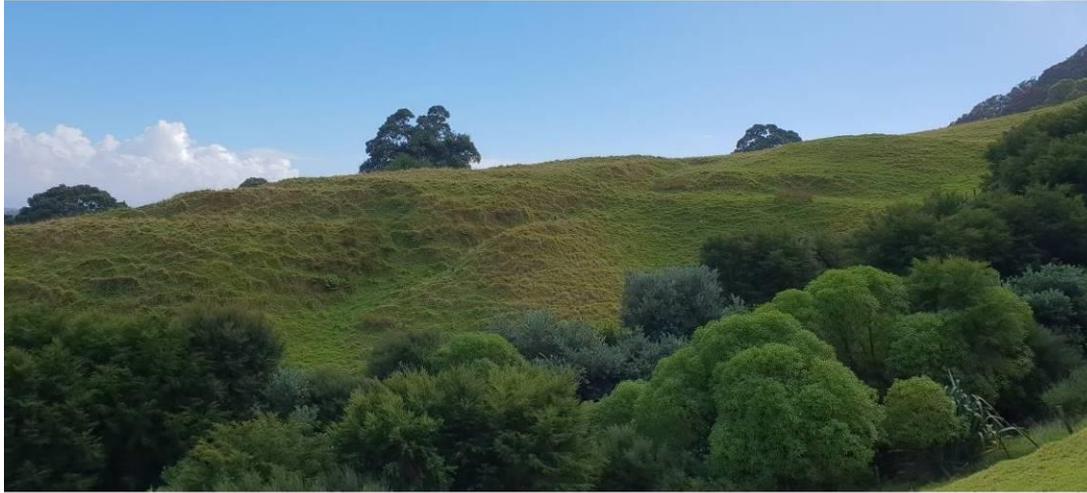
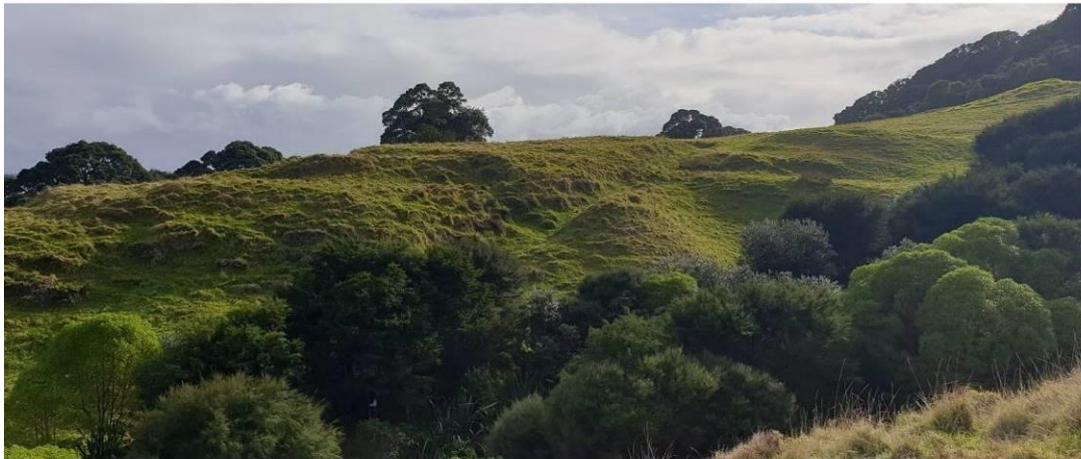
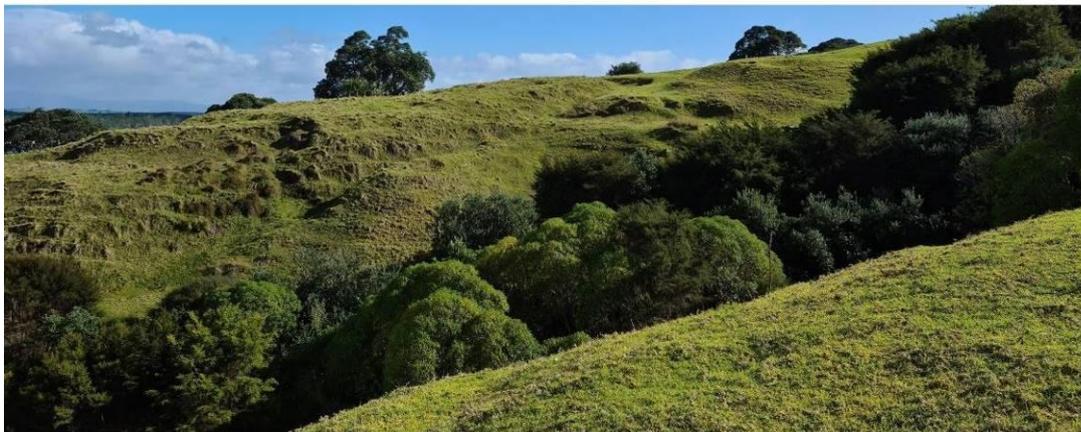
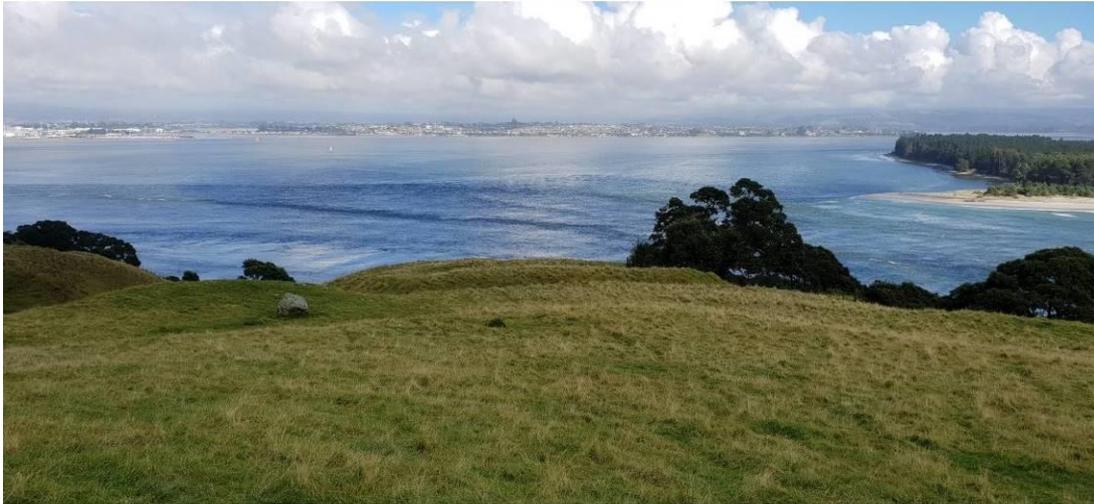
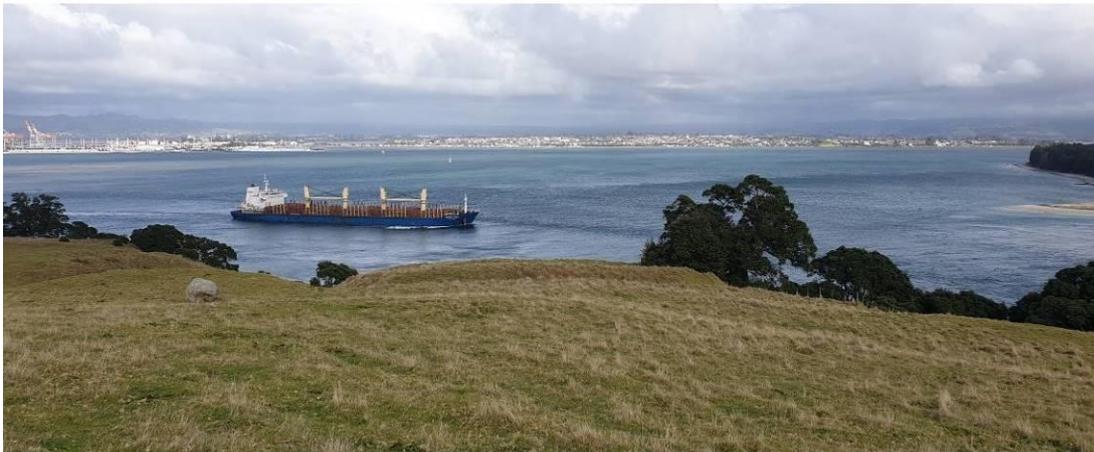
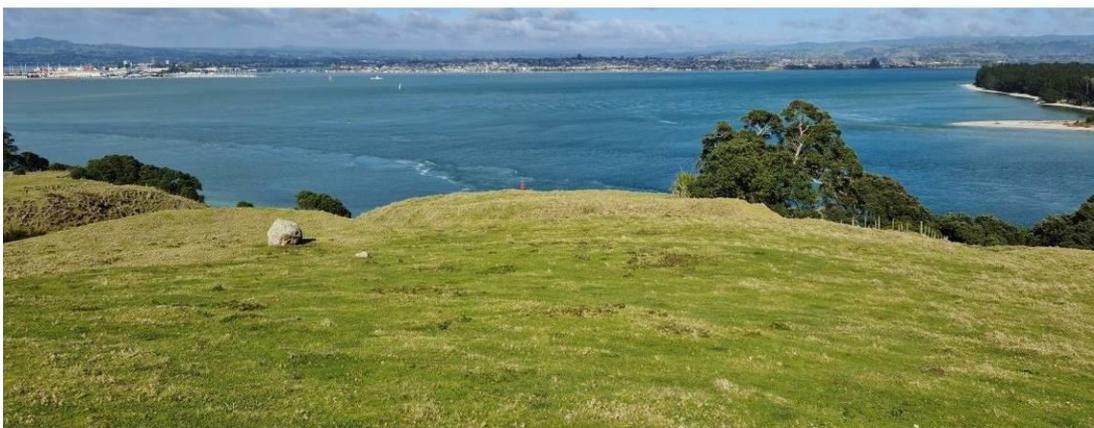
Monitoring point 6:

Notes: General views across pa to demonstrate grass cover. Site is stable with good ground cover being maintained. Very little evidence of recent rabbit browse.

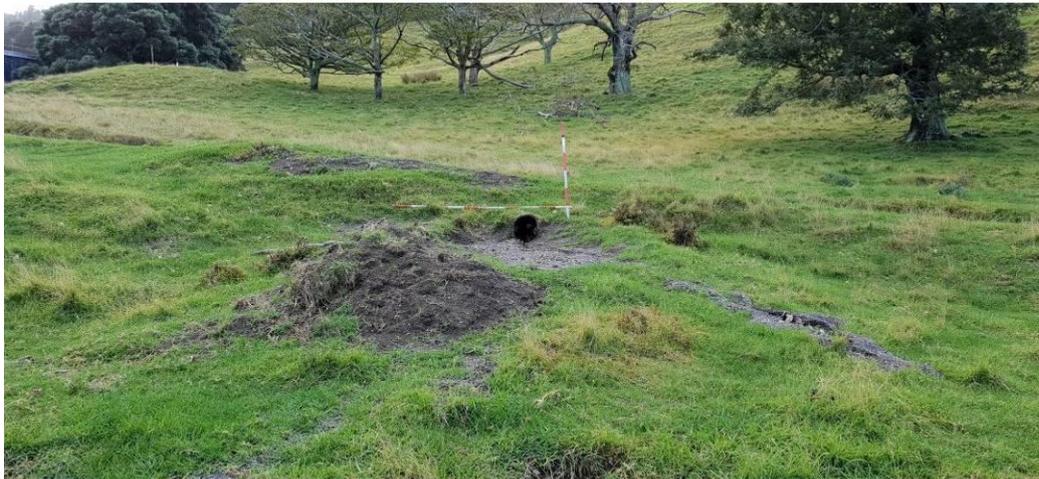
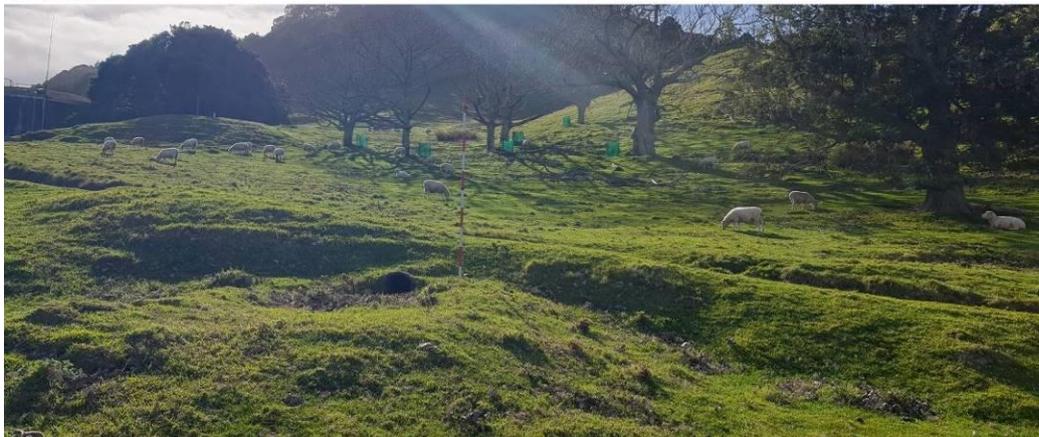
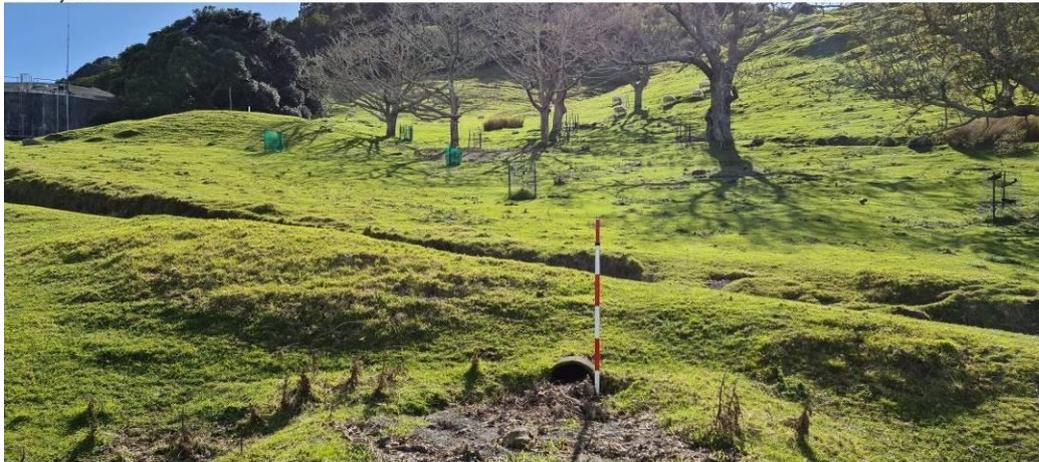
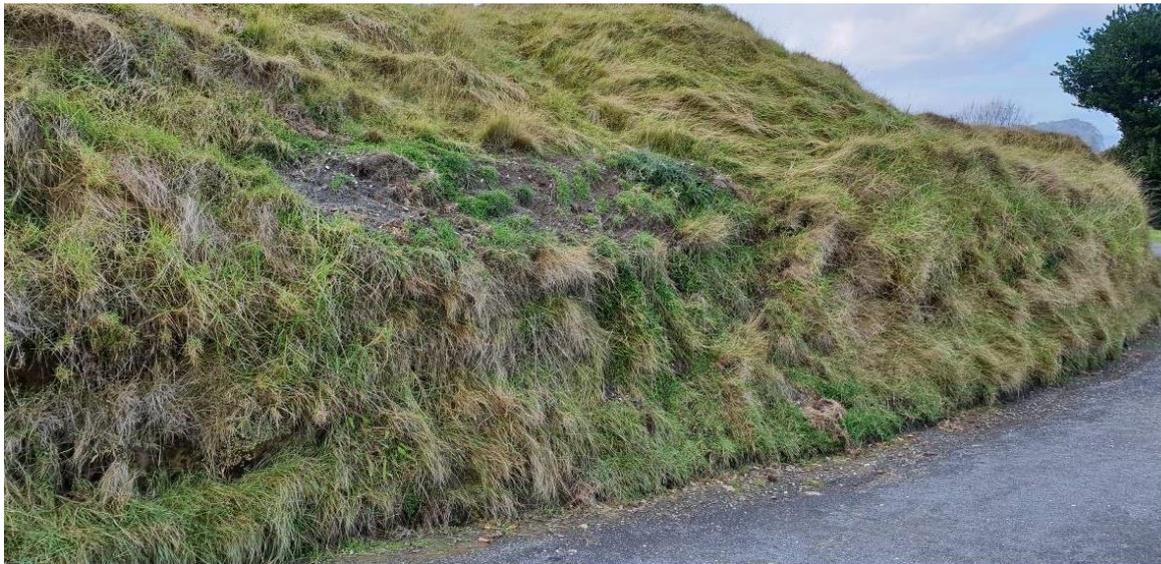
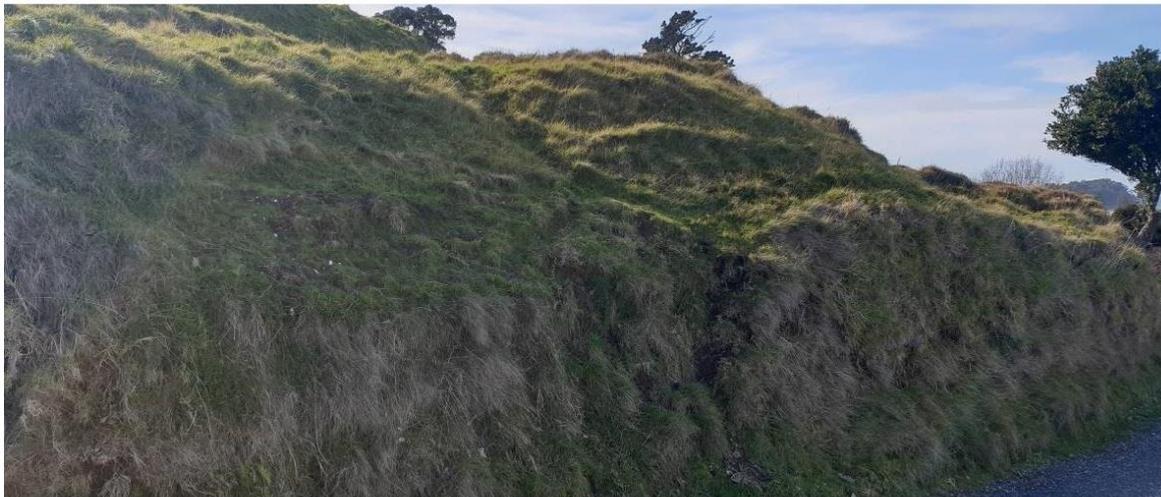
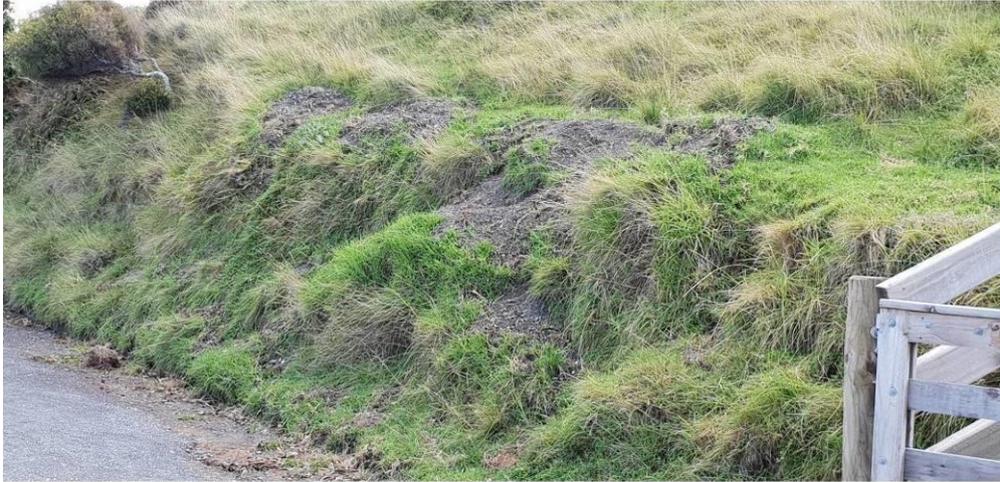
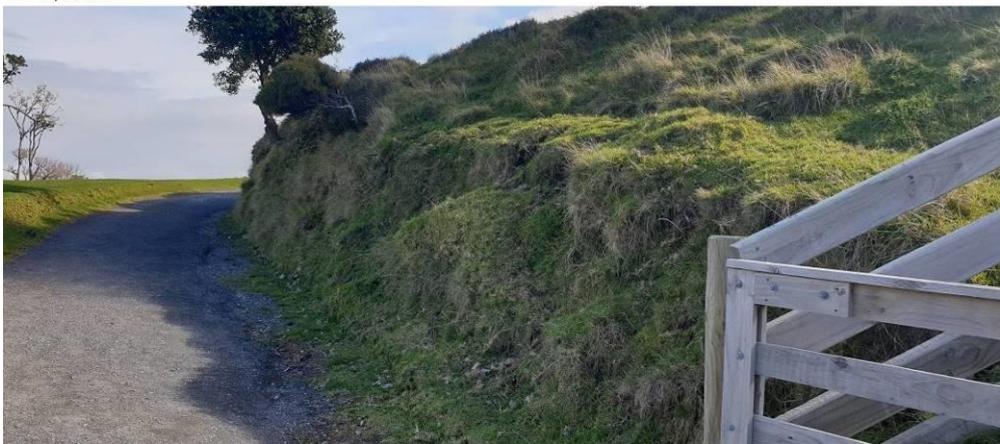
Monitoring point 7:

Notes: There is no recent evidence of tailings being dumped on archaeological features above the track, as was the issue in the past. However, the artificial build-up of material continues to ‘create’ features adjacent to the track. Remedial and maintenance issues relating to the 4WD track have been on-going, and there is still a significant issue with metal being distributed onto terraces below the track. The distance between culverts, their function and the treatment of tailings needs further management attention. Consideration should be given to removal of artificial build-up with archaeological supervision.

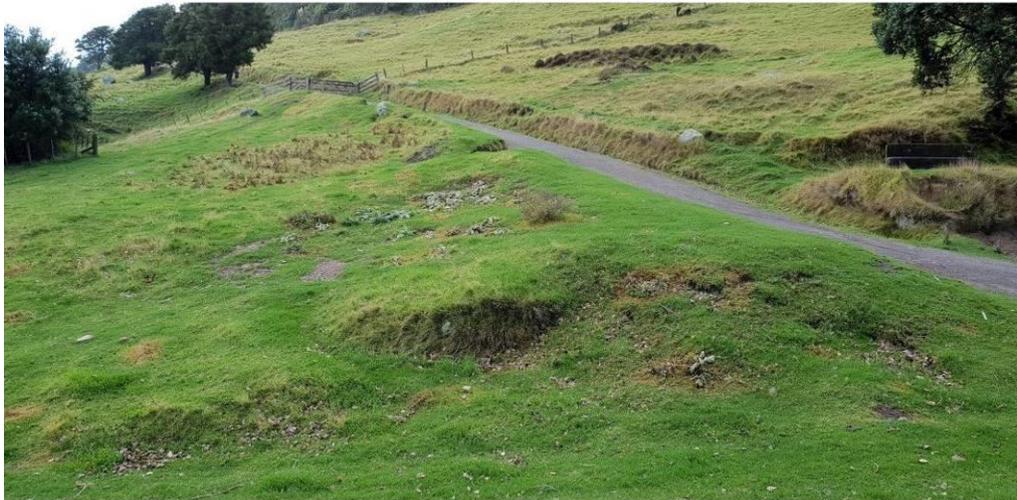
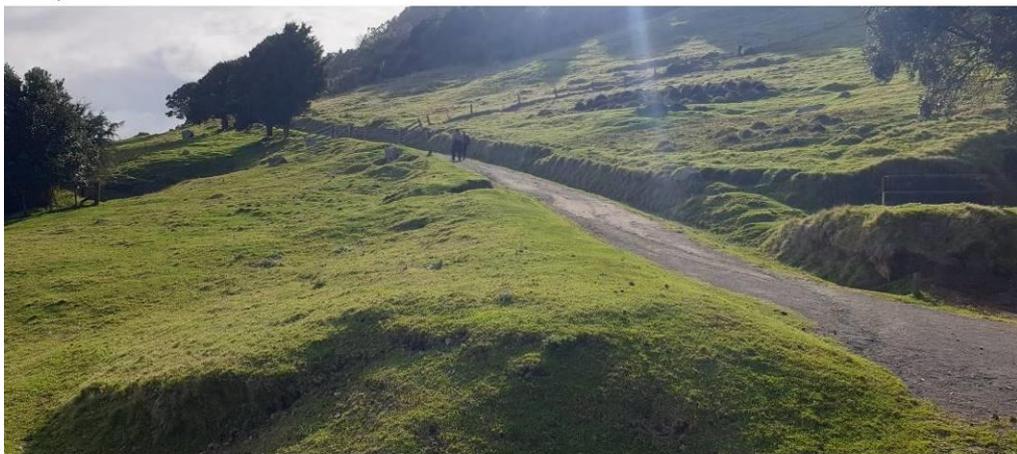
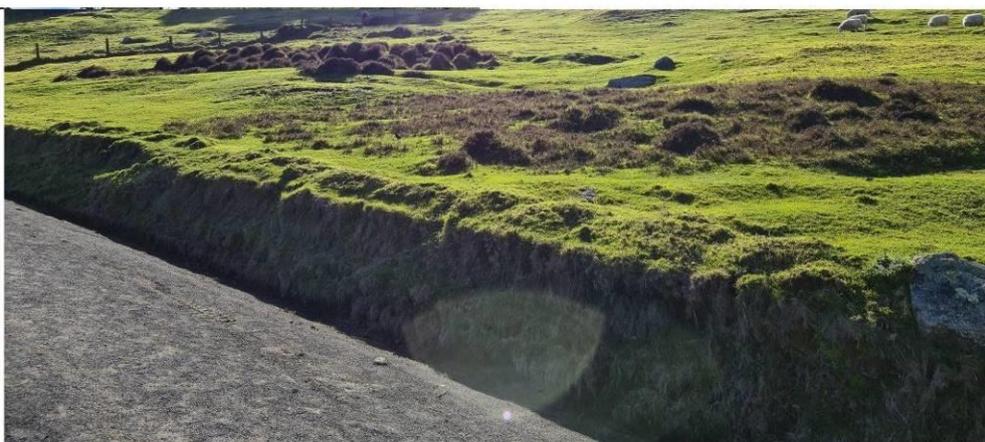
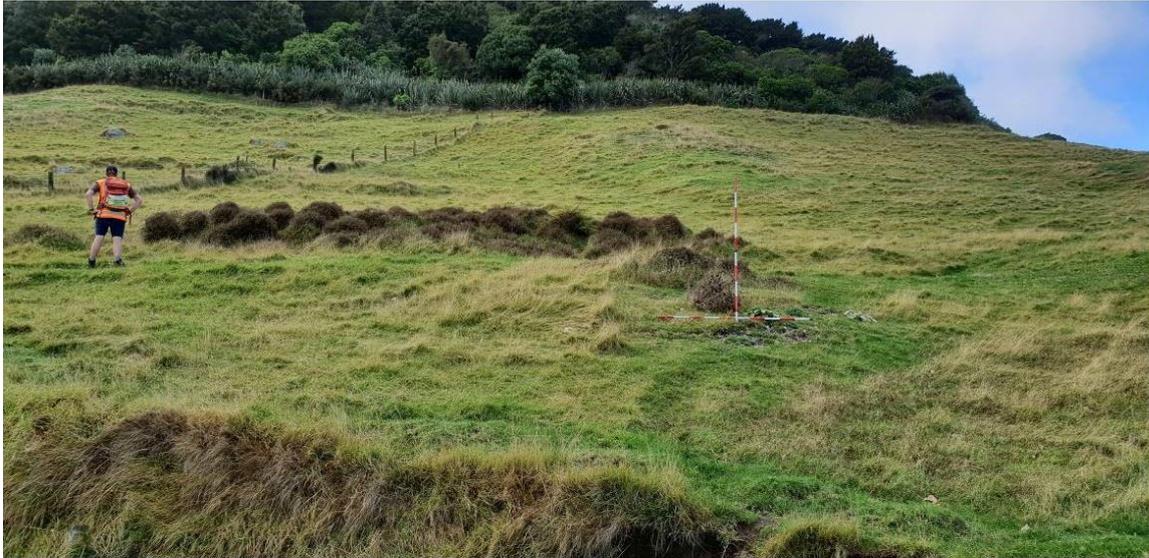
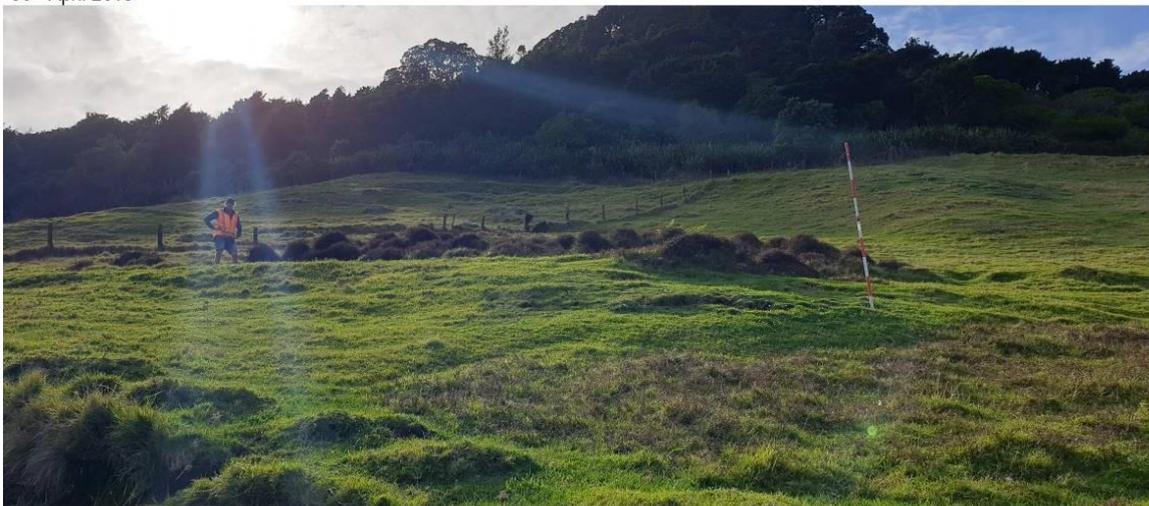
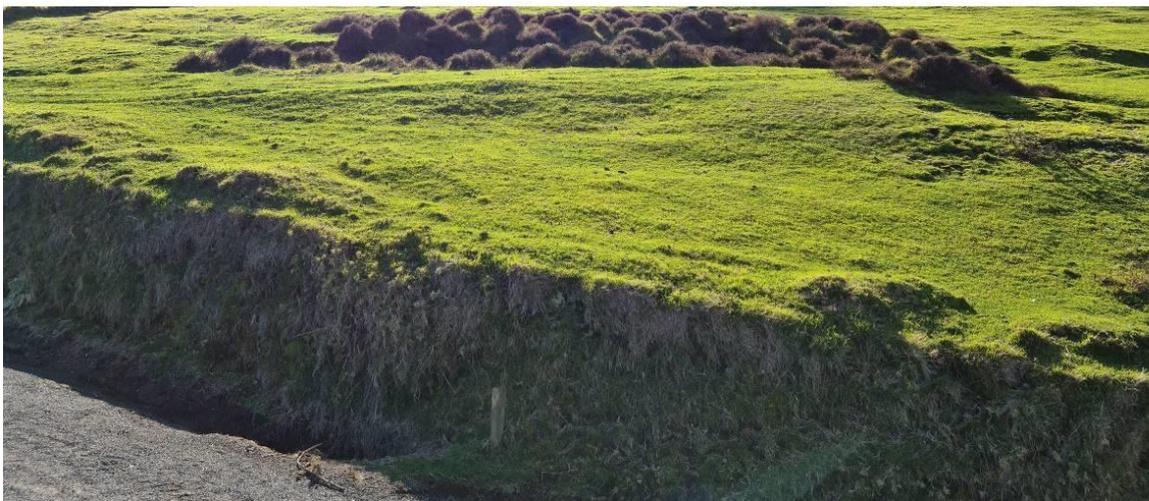
Monitoring Point 8:

Notes: Mingimingi cover on midden mound above water reservoir is stable and is slowly spreading to adjacent areas with lower stock numbers. Monitoring of spread and condition should continue.
