**Archaeological Site
Condition Monitoring Report**

Mauao Historic Reserve, Tauranga

11 September 2020

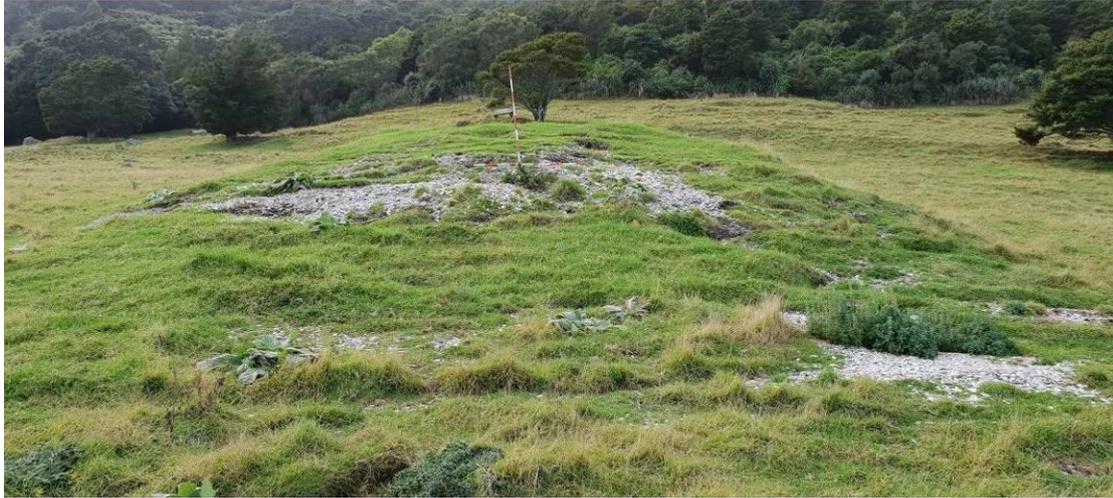
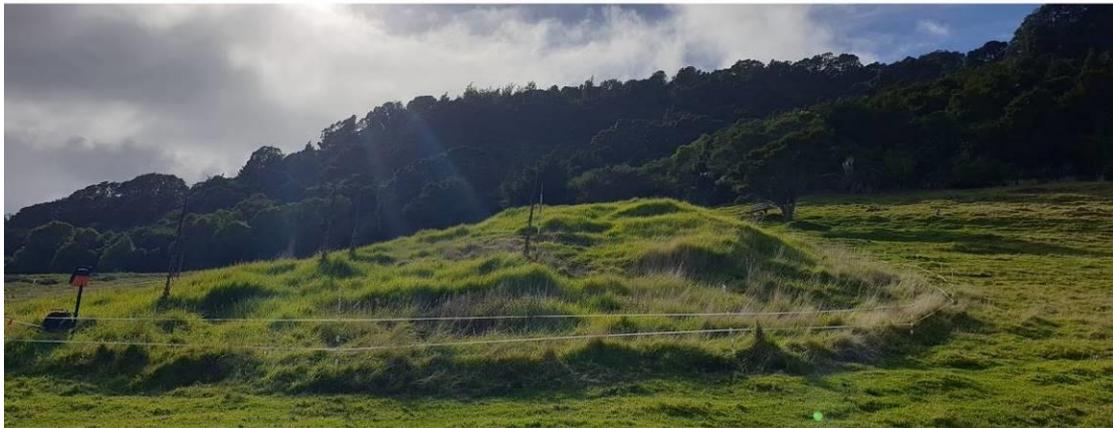
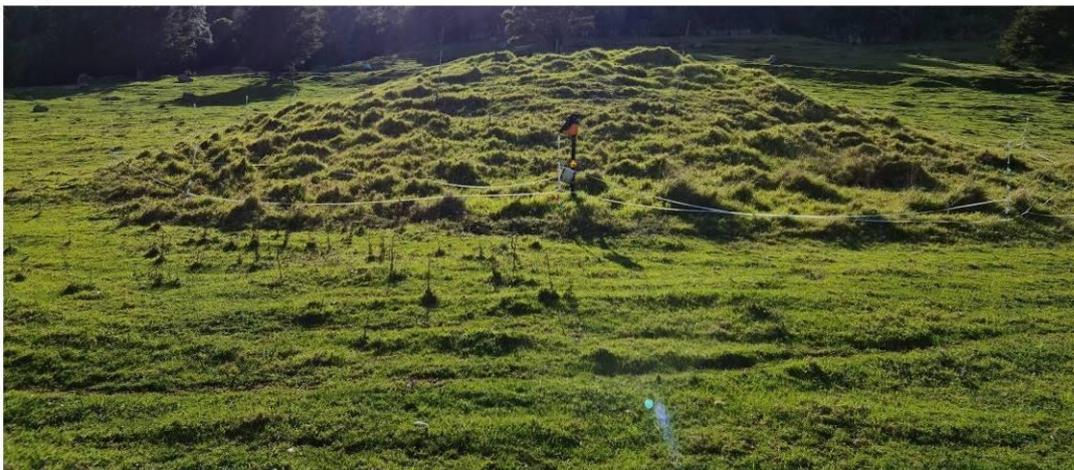
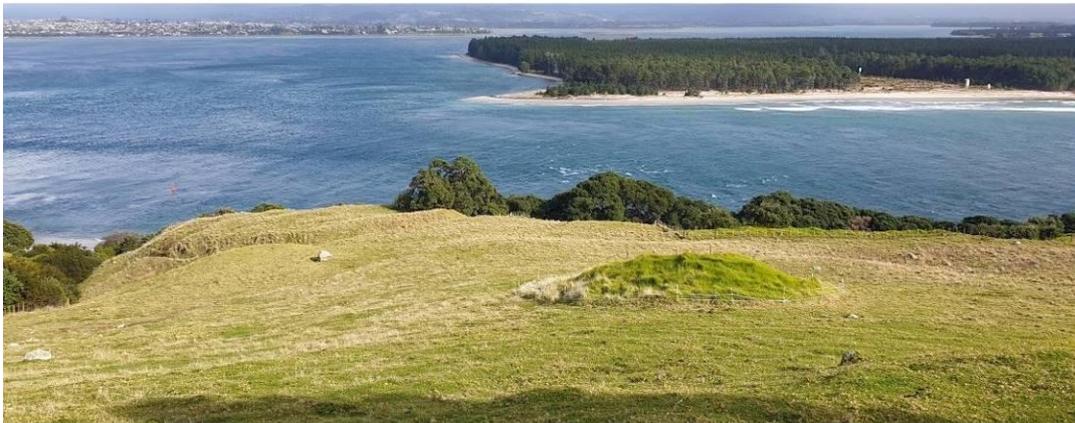
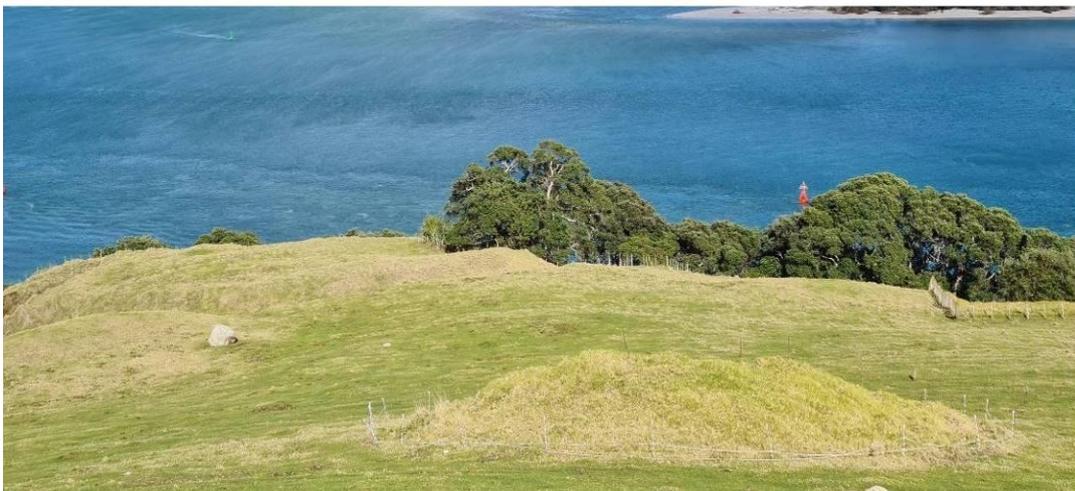
Monitoring point 9:

Notes: Grass sward is dense kikuyu; stock have had access to the mound since December 2019. Due to the long sward being less palatable, fewer rabbits, and reduced stocking numbers; the cover on the mound has remained intact with limited browsing. The trial has been successful and it should now be replicated on other exposed shell mounds in the Reserve.

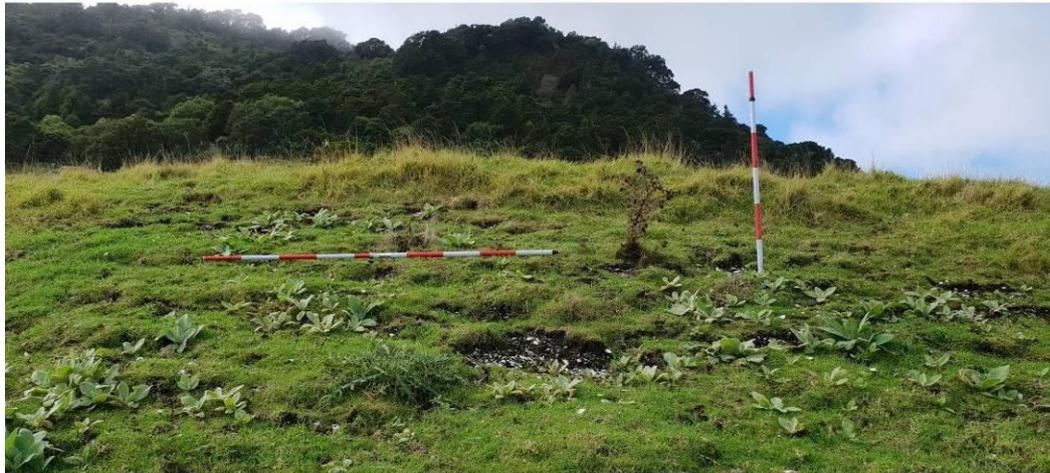
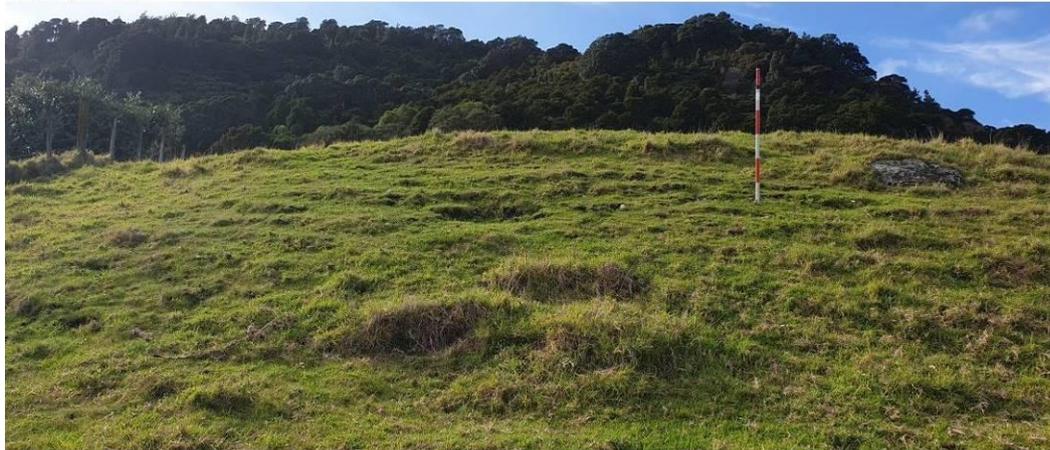
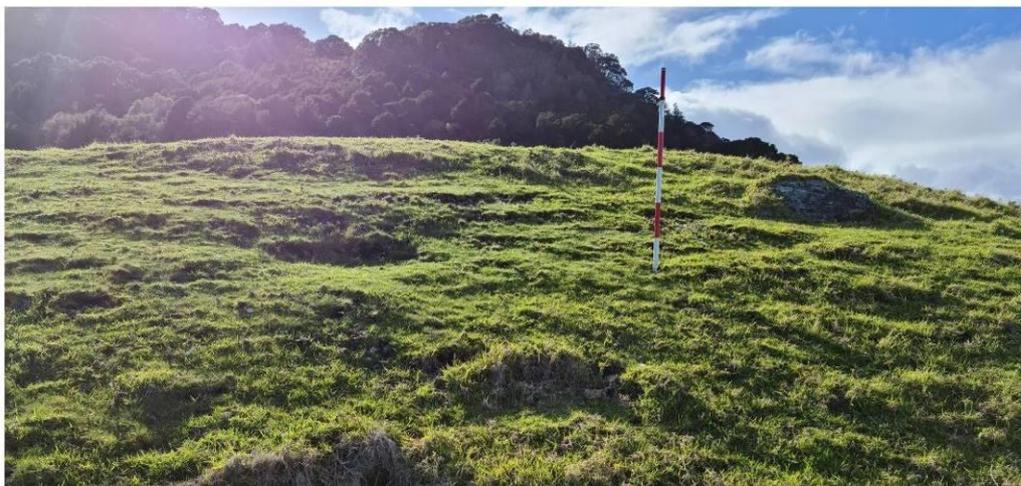
Monitoring point 10

Notes: Vegetation cover has significantly improved as greater rabbit control measures are in place. Lower stock numbers are also assisting.

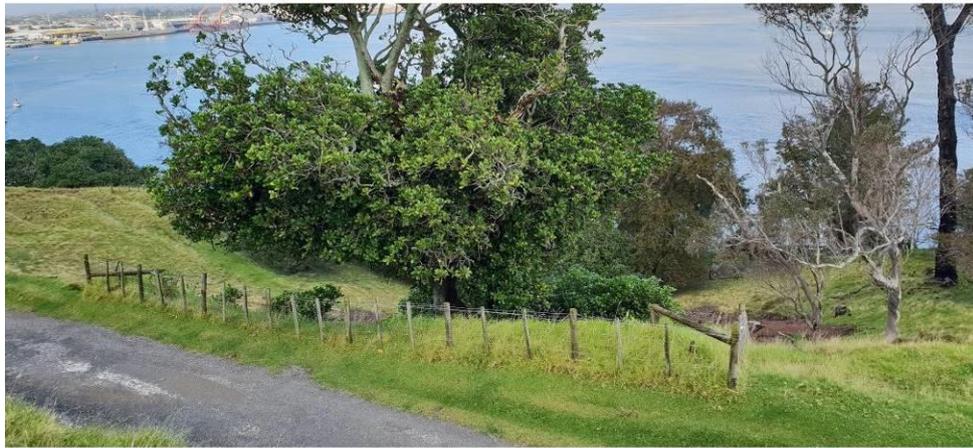
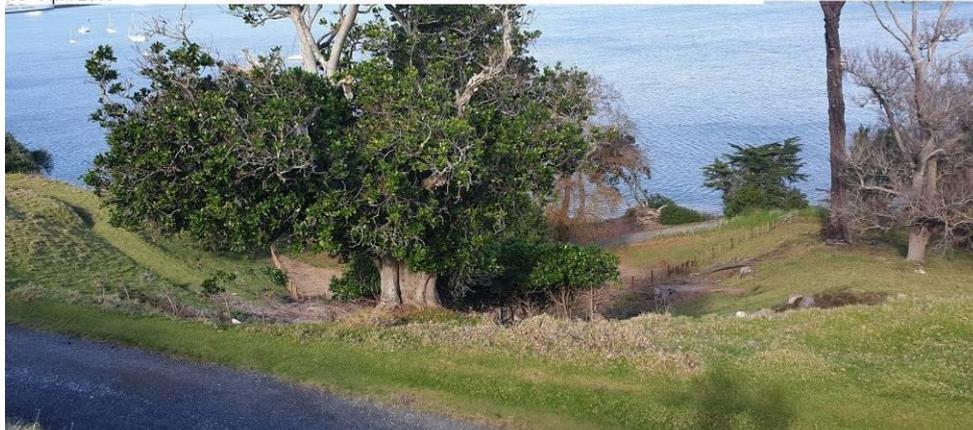
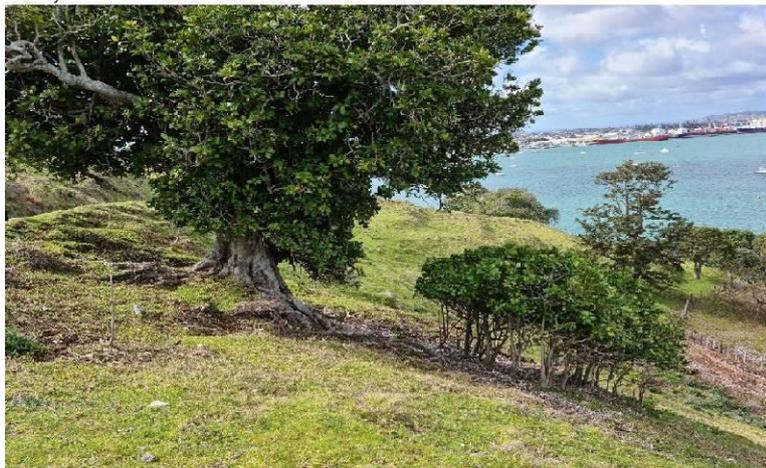
Monitoring point 12

Notes: Fence around middens that was installed in 2003 was removed in 2018. Some browse of young karaka by livestock but no new erosion of midden in evidence. Continue to monitor condition.

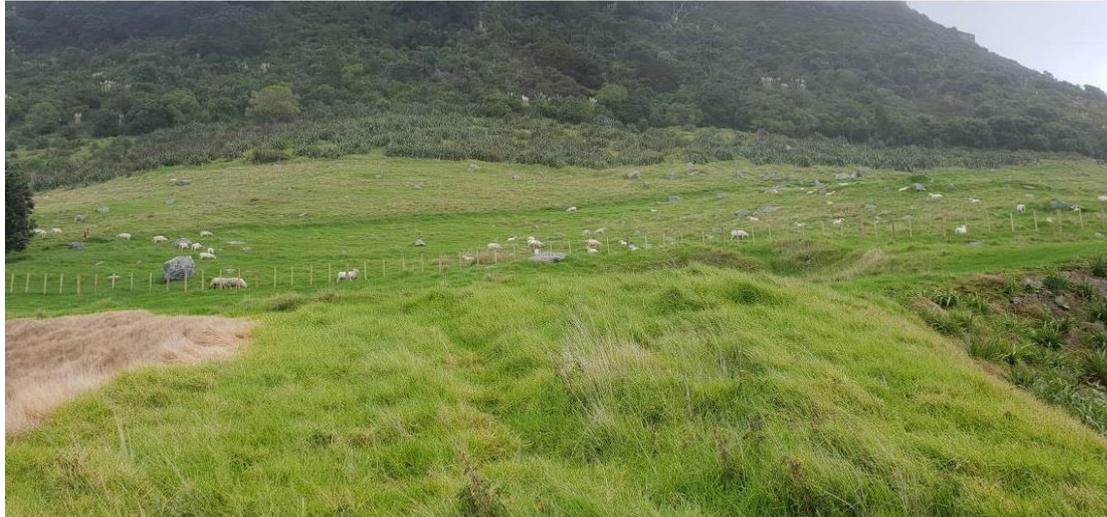
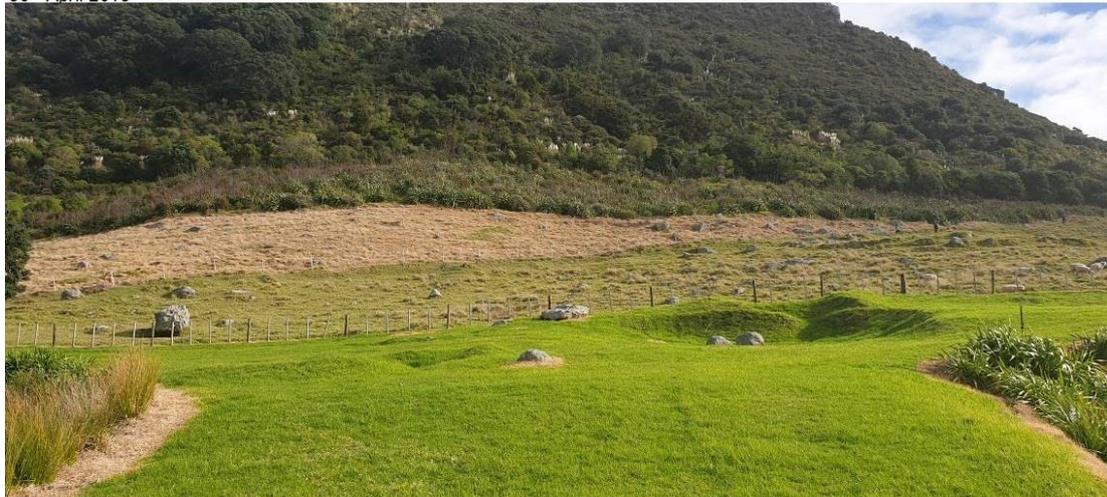
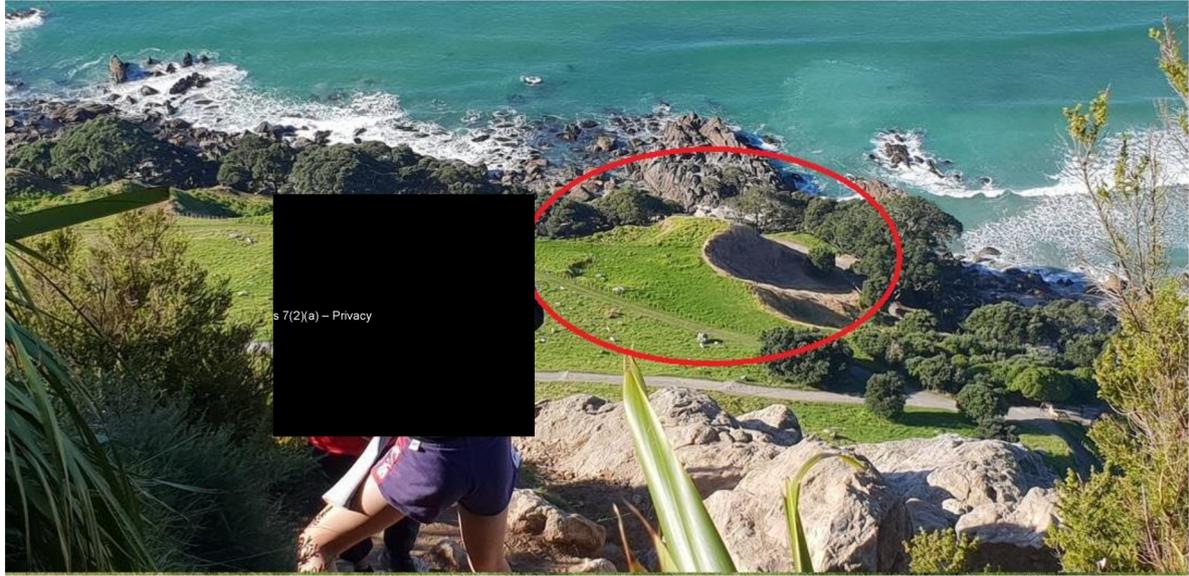
Monitoring point 13

Notes: Management of vegetation and site visibility has significantly improved following cessation of grazing.

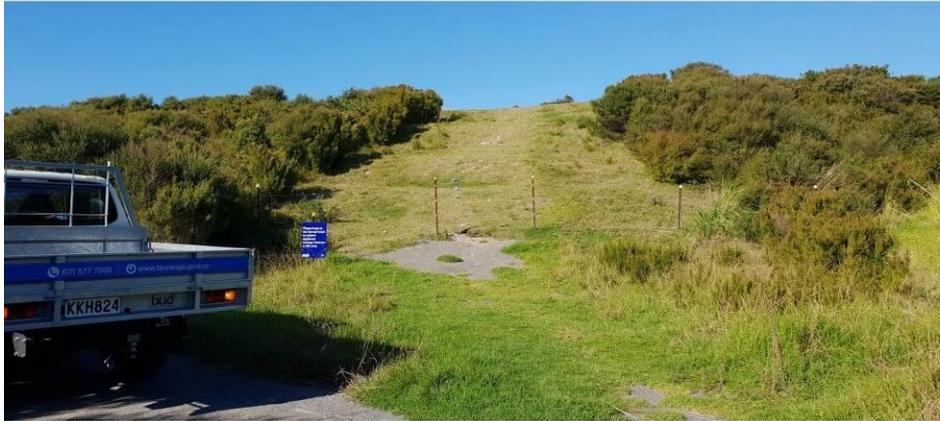
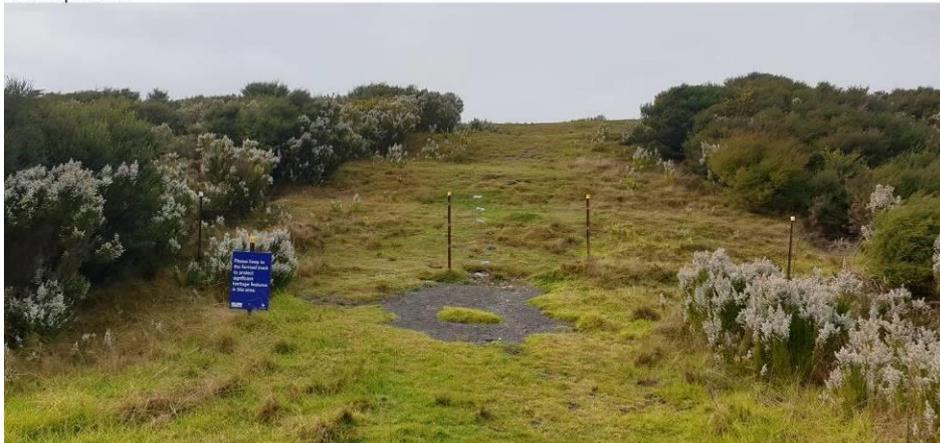
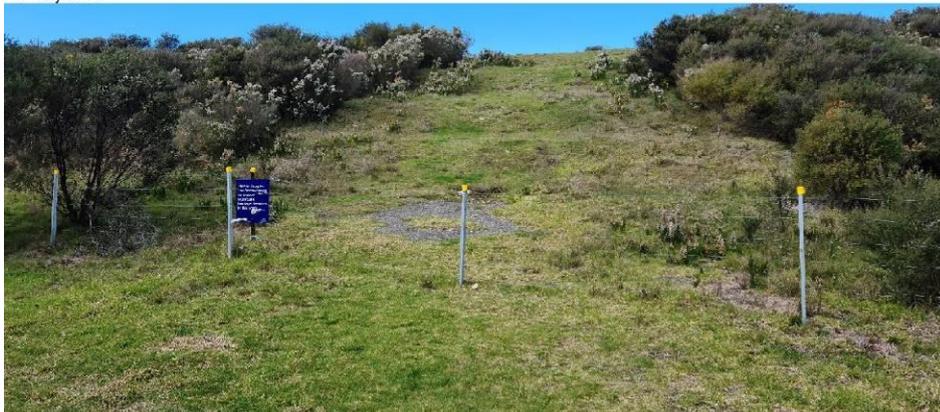
Monitoring Point 14

Notes: Repair to terraces completed in 2013. The aggregate at the base of the slope was not moved as recommended last year. Fence at the base of the terraces was moved back closer to road and encroaching vegetation has been partially managed to keep terraces visible, but this needs to continue. Desire line that was developing up the terraces in 2018 is reducing.

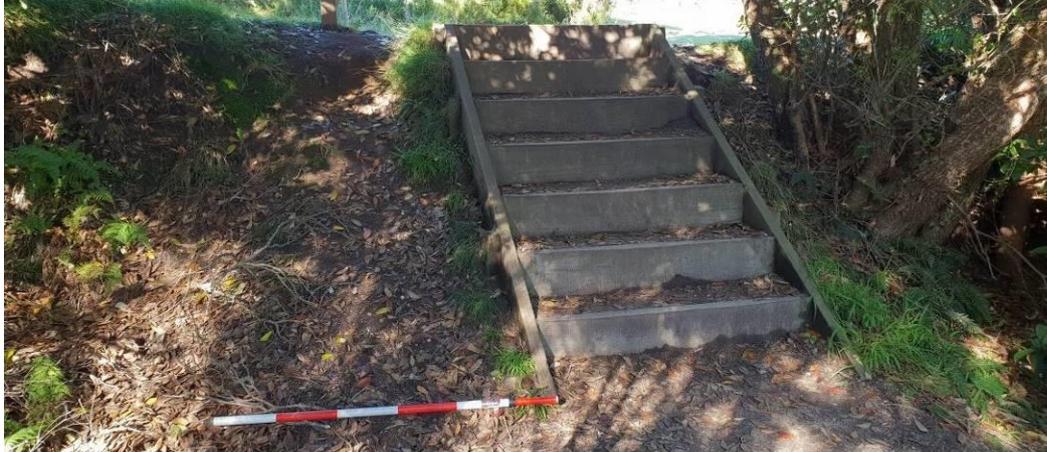
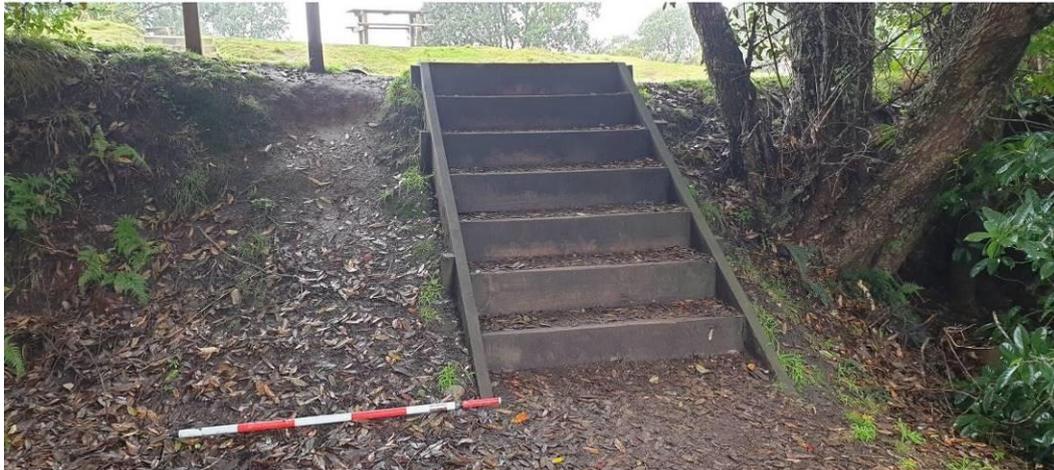
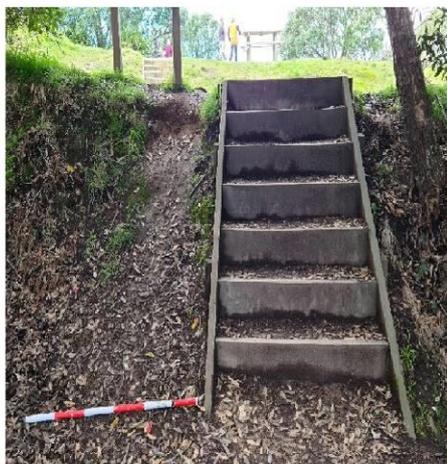
Monitoring point 15

Notes: Desire line/wear next to steps is increasing, action is needed to block access to prevent further damage. Widening the steps is the best option and could be done with minimal ground disturbance.

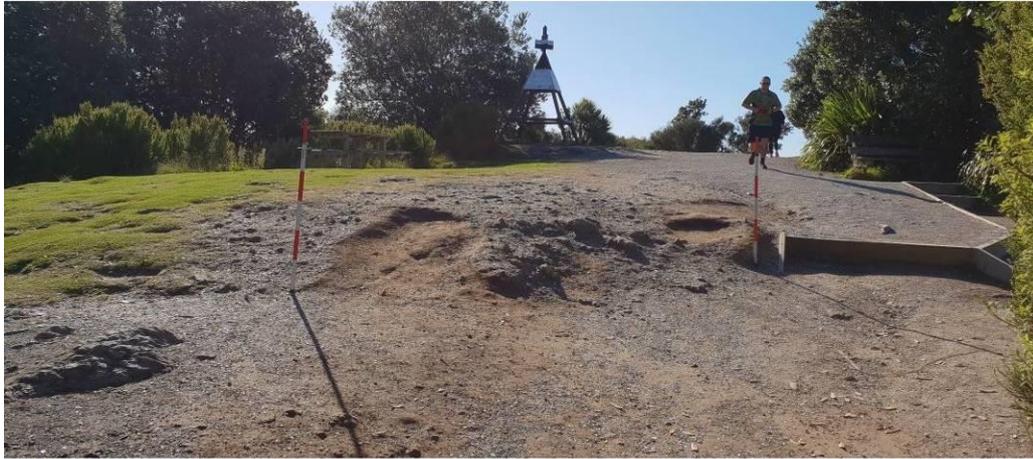
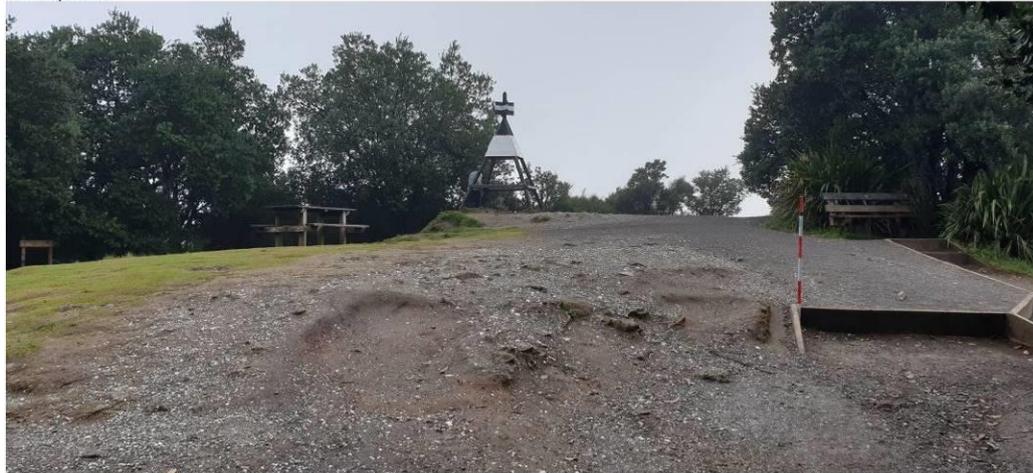
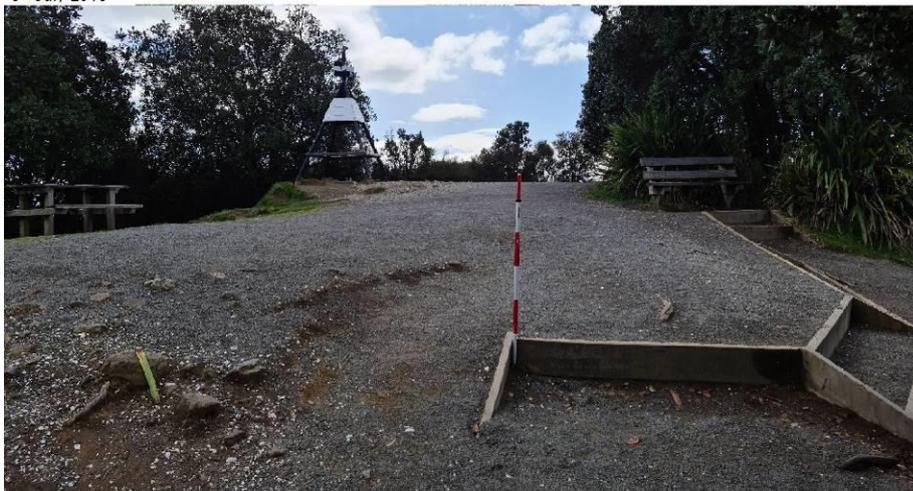
Monitoring point 16

Notes: There is on-going wear of imported armouring material on summit; recapping is required by bringing in additional material from stockpile.

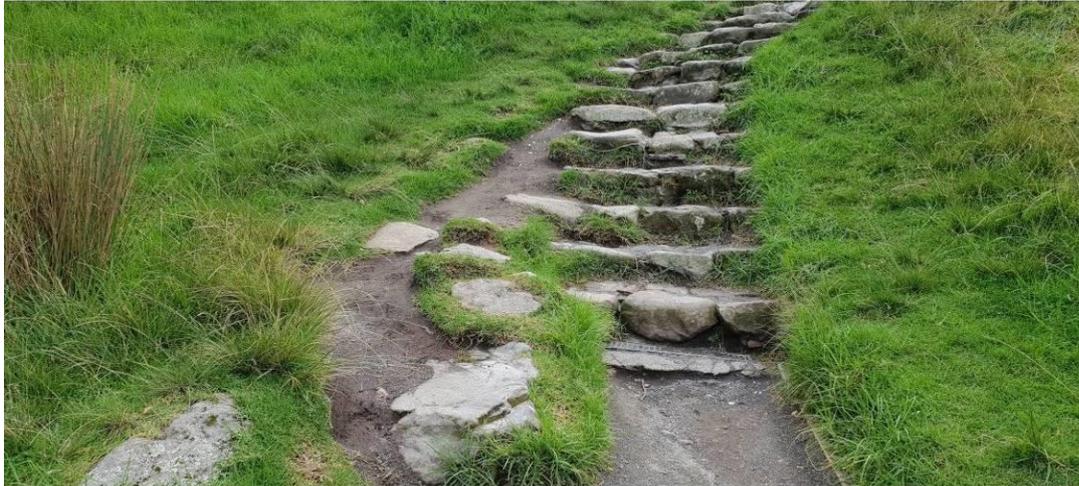
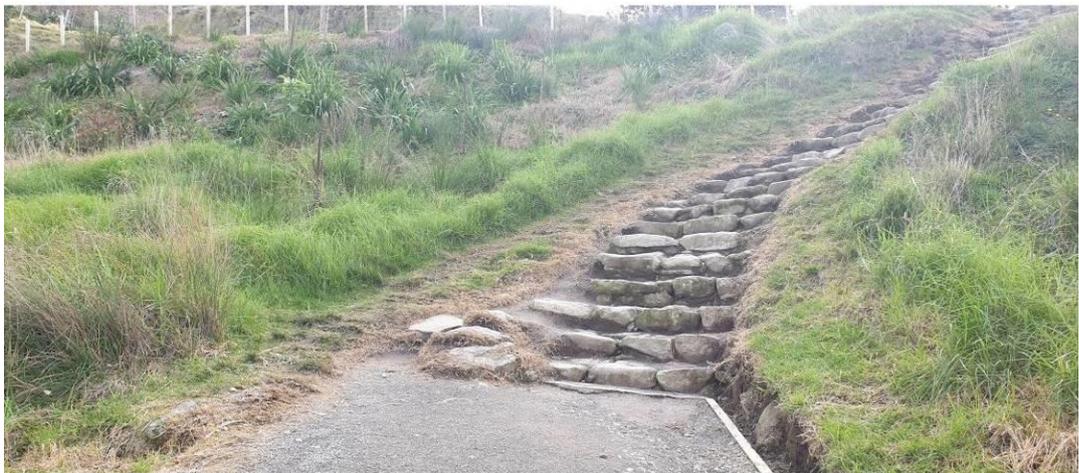
Monitoring point 18

Notes: Stone work stable at present, but erosion from desire line more visible than in 2019, basically back to 2018 level, if not worse. Continue to monitor.
