Tauranga City Council
Private Bag 12022, Tauranga 3143, New Zealand

Mauao Base Track, Crack Observations and Recommendations

2-9B463.00

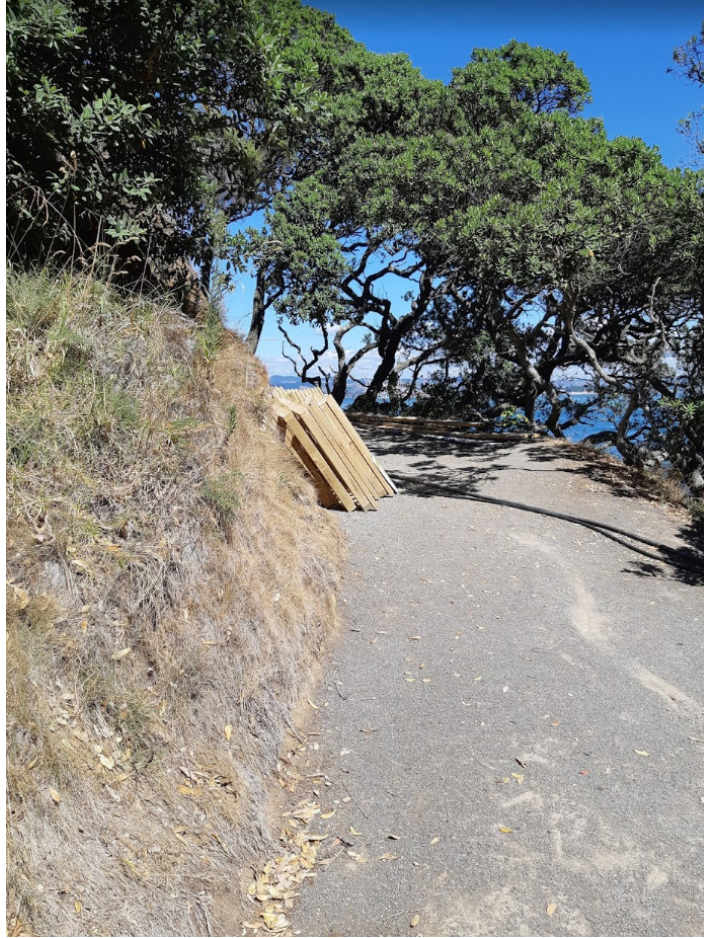
- The drilling contractor first noticed the cracking at 9am on 25 February.
- The crack has an irregular (wavy) shape. Small holes in the track surfaces were also noted with an aperture of 10 to 20mm.

- The crack has a length of approximately 4.37m with no vertical difference either side of the crack.
- The slope below the track at the location of the crack is approximately 40 degrees and the slope above the track ranges from 50 to 60 degrees relative to horizontal.

Due to the history of the site, there is an on-going risk of slips along the base track, however such landslips are usually triggered by heavy rainfall events or occur shortly after such events. From our inspection and review of rainfall records we believe the cracking is more likely related to shrink / swell of the soils as there was a period of wetting and drying prior to the crack being noticed.

Photograph 1 - View of crack looking to the east

- We would recommend that the track is undercut to approximately 200mm depth at the crack location and replaced with 200mm compacted track surfacing metal to seal the crack to prevent surface water entering.
- We would also recommend that the area is monitored for any signs of movement or extension. This could be carried out during our proposed inspection program for the base track slip repair as detailed in our offer of service dated 14 February 2020.
- We would also recommend that TCC commission the installation of bored horizontal drains below the track at this location to mitigate against excess pore water pressure in the slope.

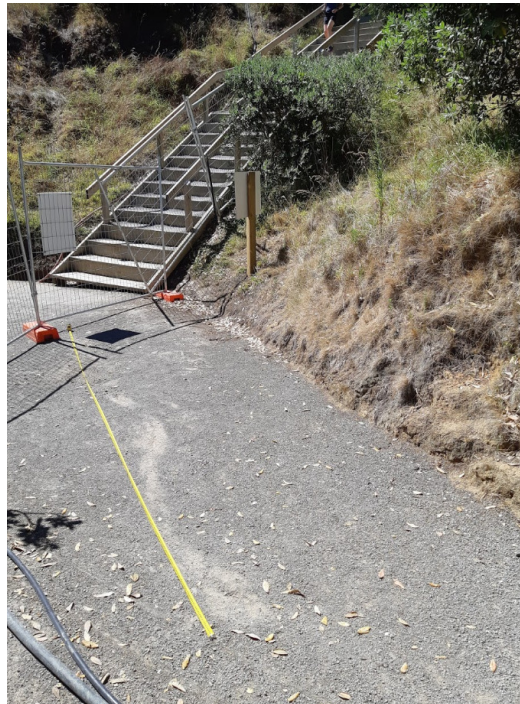
Photograph 2 - View of crack looking west

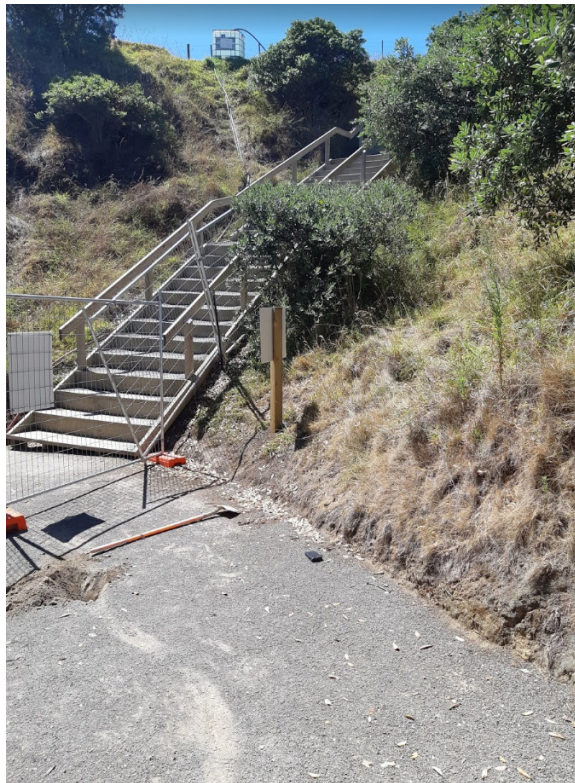
Photograph 3 - View looking upslope

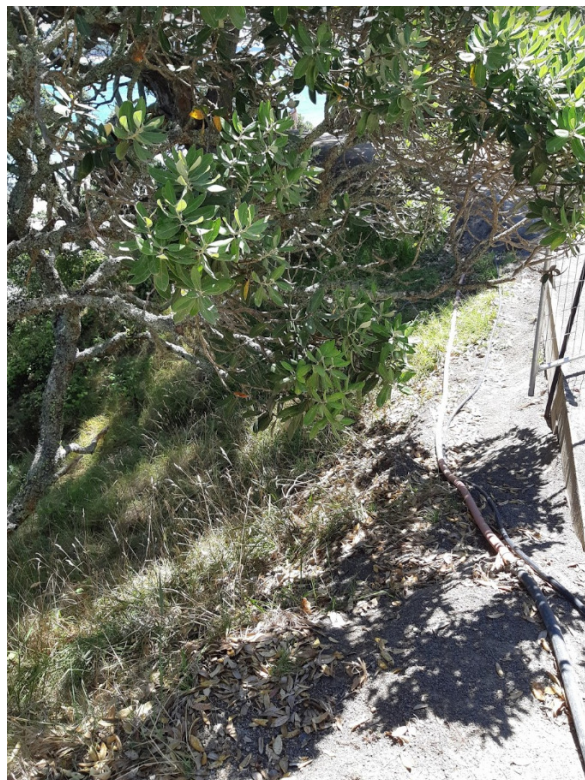
Photograph 4 - View of downslope
