GEOTECHNICAL

30 August 2021
Avalon Project #22102

Mauao Slopes; Rockfall incident response and Routine monitoring report August 2021

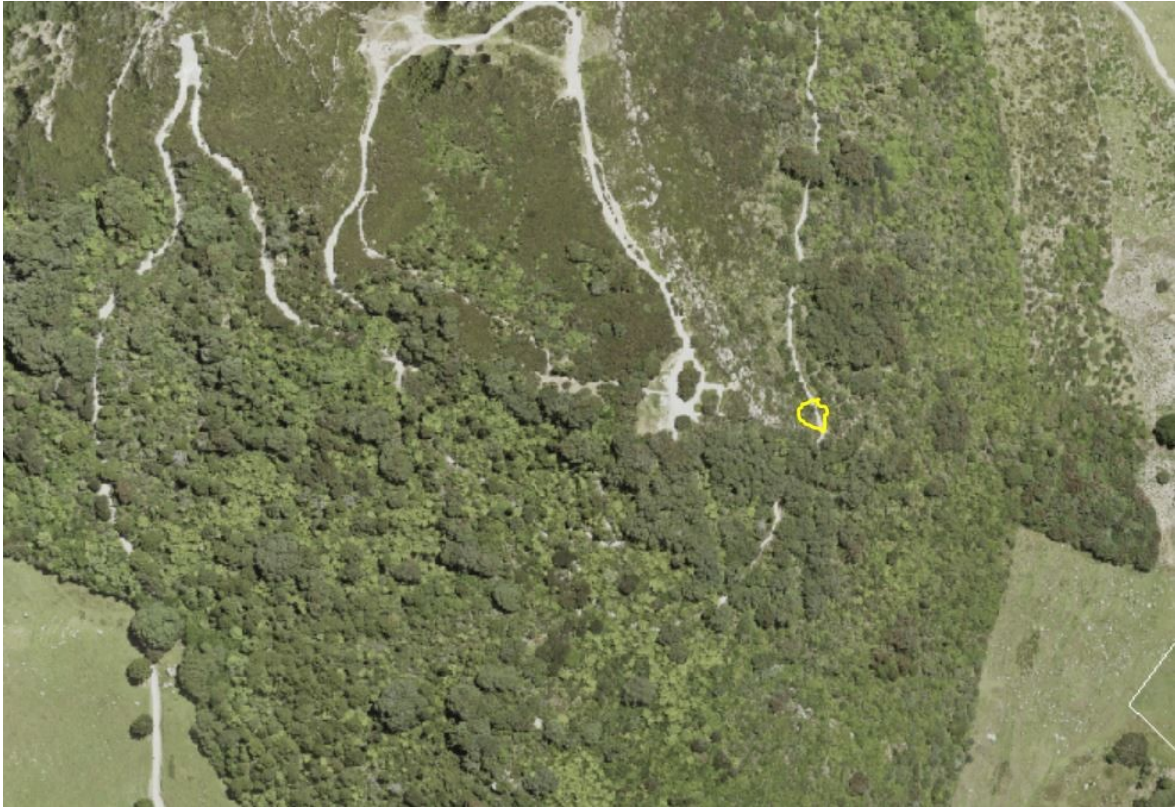
The rock in question was reported as "boogie board sized" so presumably relatively thin and around 0.5 to 0.8m along the sides.

It impacted the Waikorere track a few metres in front of the person in question. The person reportedly had heard the rockfall whilst it was rolling/bouncing down from above, then saw it exiting the bush just above the track and thus were able to safely move away from the fall line.

Photo 1; The rockfall crossed the Waikorere track at this location.

From the description the rock's weight could have been around 100kg, clearly large enough to present a risk of fatality to a person in its path.

Our most recent numerical rockfall risk evaluation (2020) was based on an estimate that 2 to 3 rocks of this size cross the Waikorere track per year, which outputs the risk level to an individual on one crossing as 1.2×10^{-7} , well within the tolerable individual level. With present visitor numbers this risk level equates to a fatality incident return period of around 26 years.

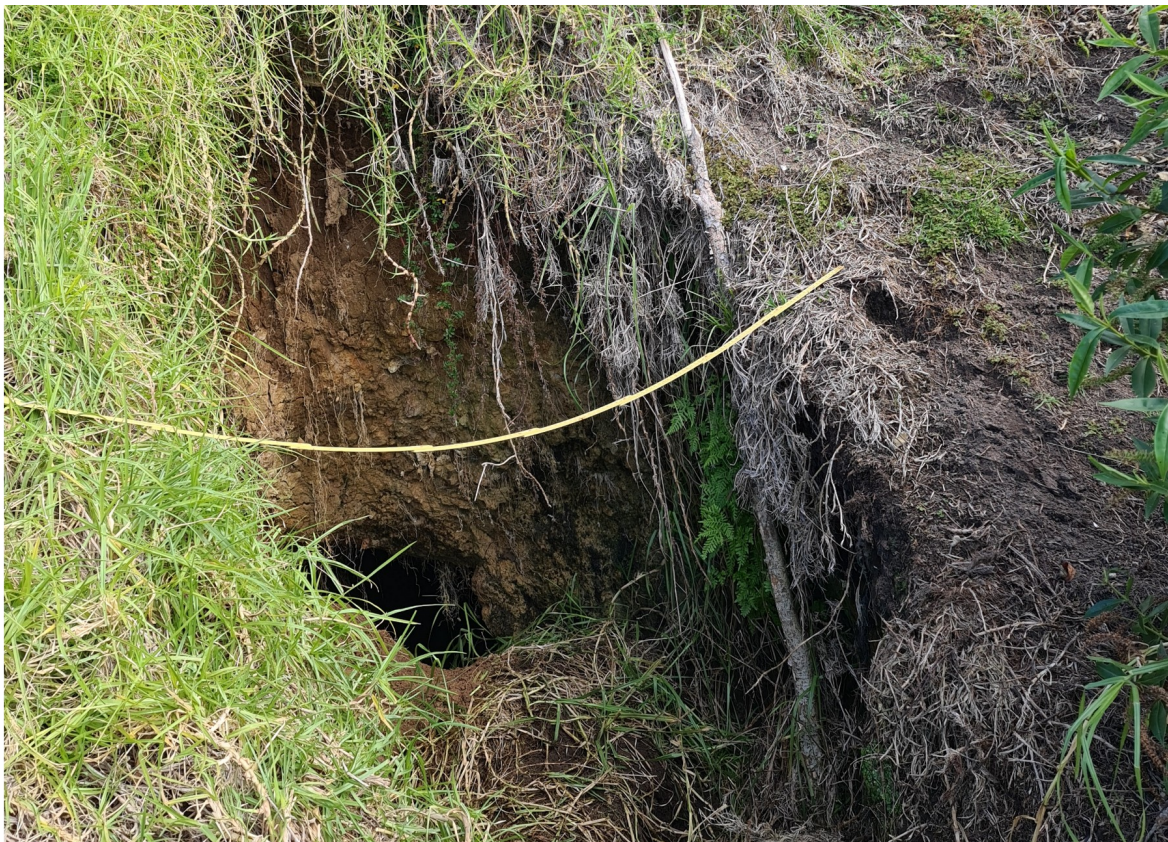
The springs that issue around the lower colluvial slopes around Mauao indicate widespread underground water flow. Underground drainage routes will tend to form at levels where sandy, relatively permeable colluvium, overlies impermeable clay (weathered volcanic ash) layers. The 'piping' effect, scouring out sand, can create open 'pipes', 'small tunnels'.

This feature looks likely to be a 1m³ or so void collapse above a small underground watercourse in a natural "pipe", scoured out by flowing water.

Photo 2; The sinkhole at the surface (2m scale).

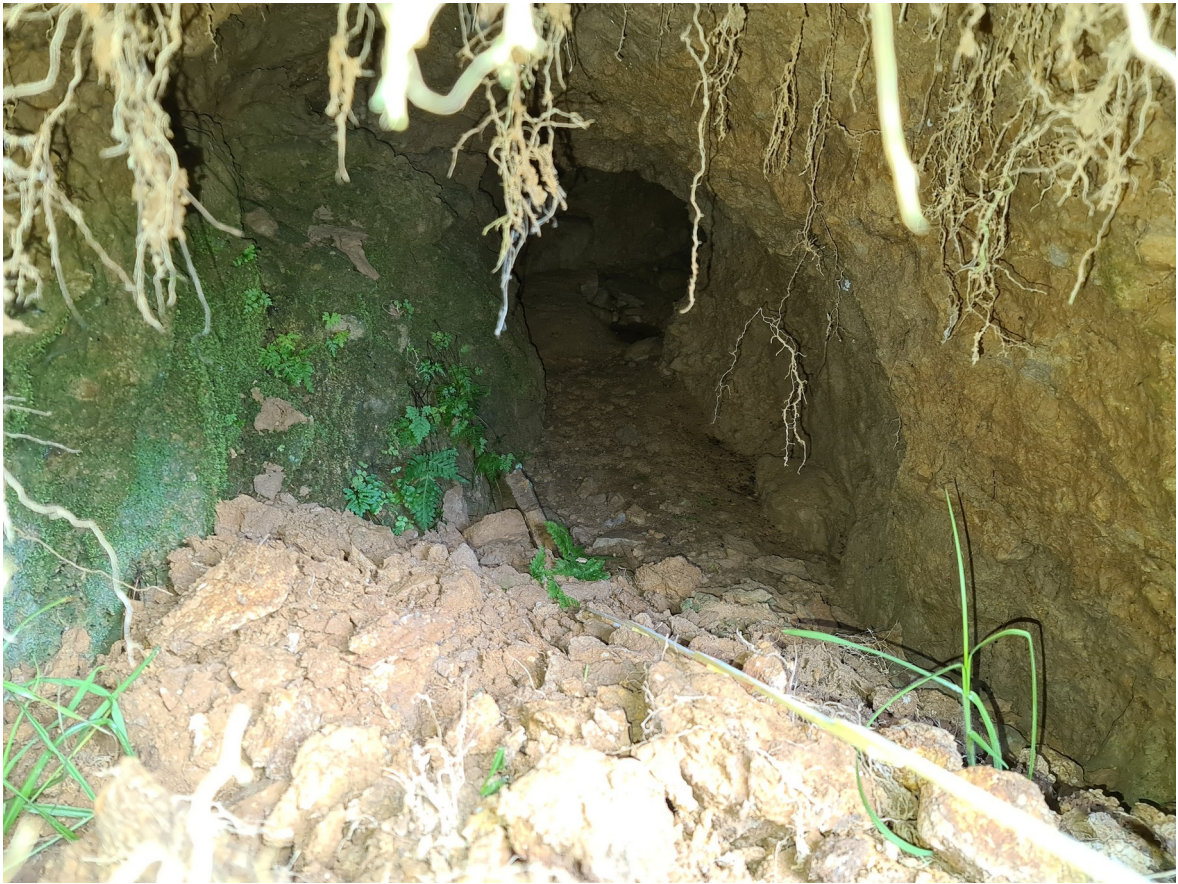
Photo 3; The sinkhole entrance.

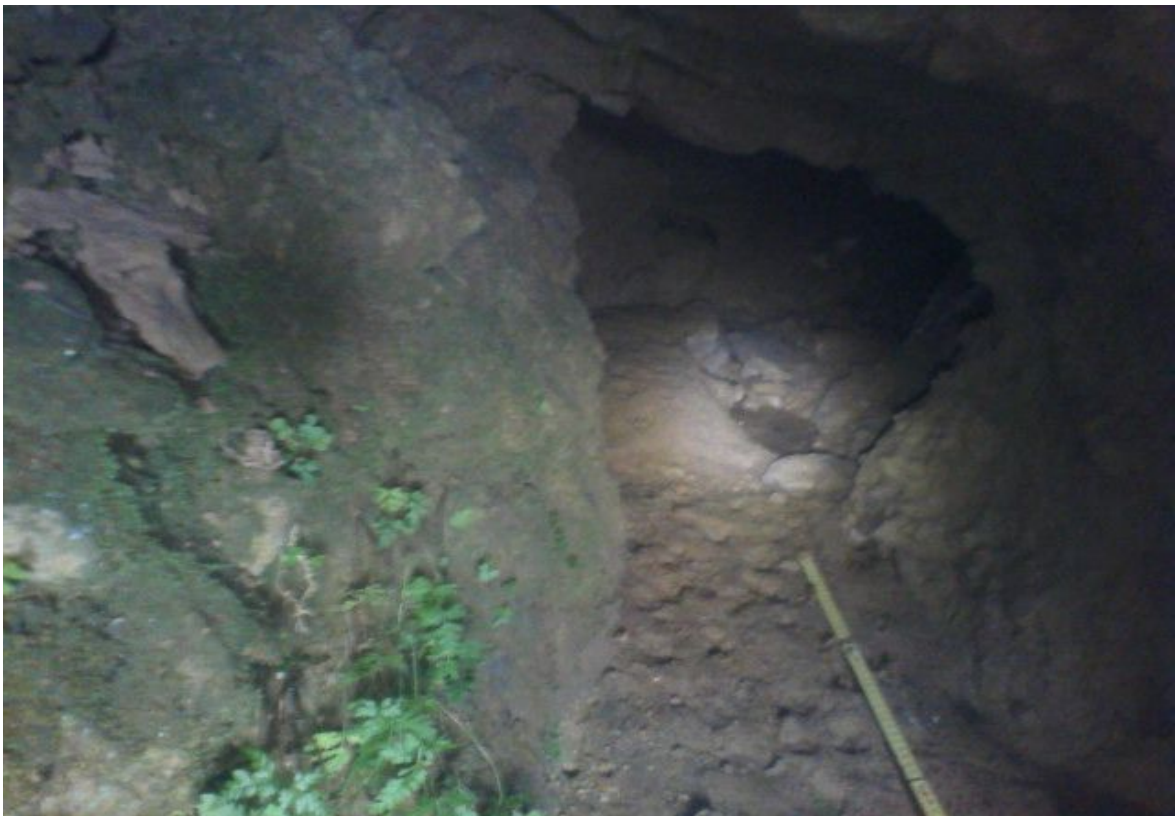
Photo 4; Looking further in the 'tunnel' appears to continue to the right. A small pool of water can be seen on the floor.

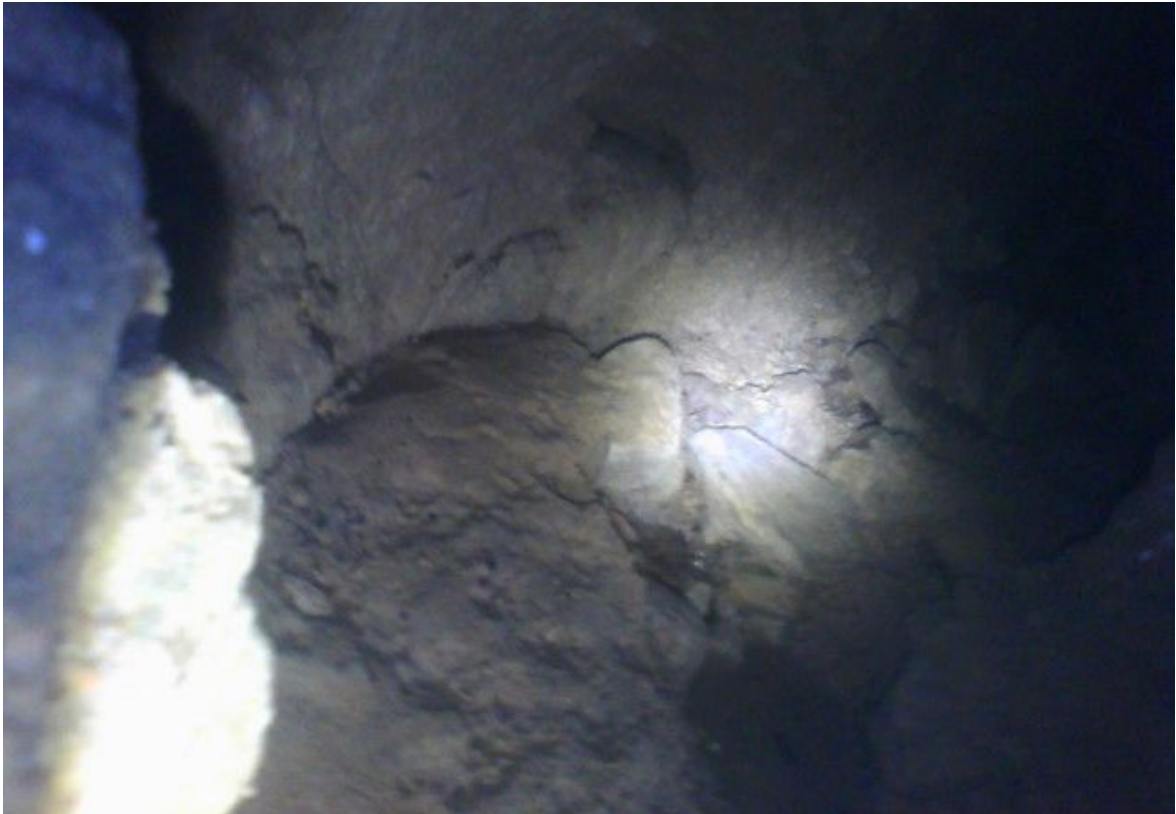
Photo 5; The tunnel continues to the right. Furthest view in photo is around 5m from the entrance. The diameter of the tunnel here is around 0.5m.

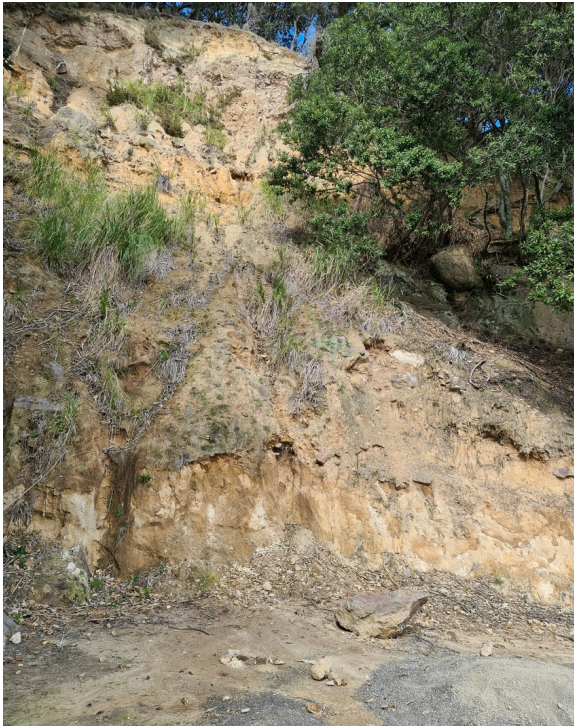
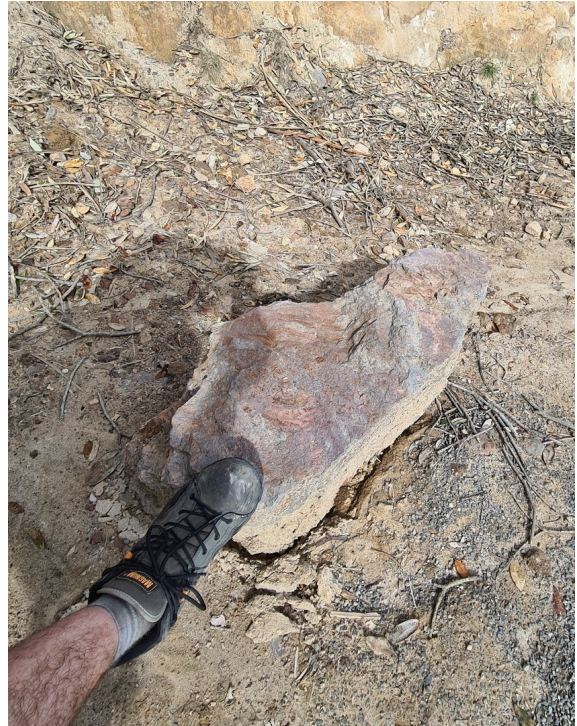
Photo 6 & 7; A recent rockfall from the actively eroding slope above the Western Base track.

As has been the case for many years, this slope continues to actively erode and generate occasional falling rock.

We recommend that this particular slope should continue to be scaled regularly as required, as new surface rocks are exposed.

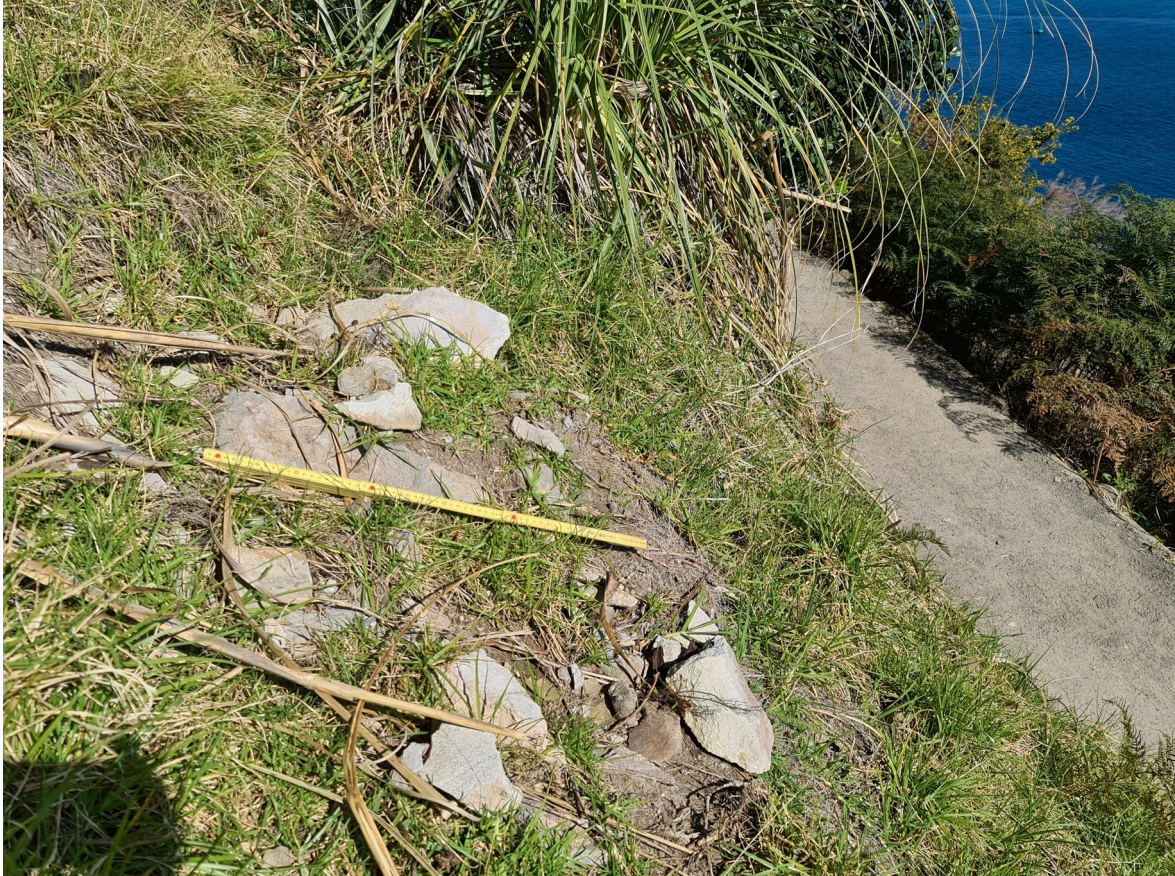
Photo 8; Rock resulting from a small soil slip above the Oruahine track.

In this case the rock is only 2m above the track so does not present a hazard but it illustrates how small soil slips and erosion continue to bring new rock to the surface.

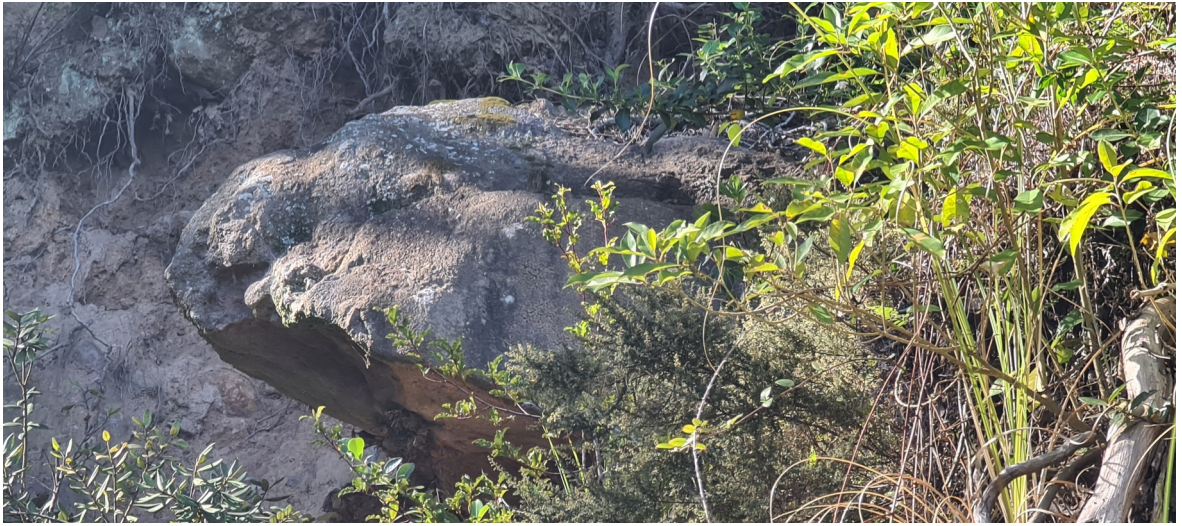
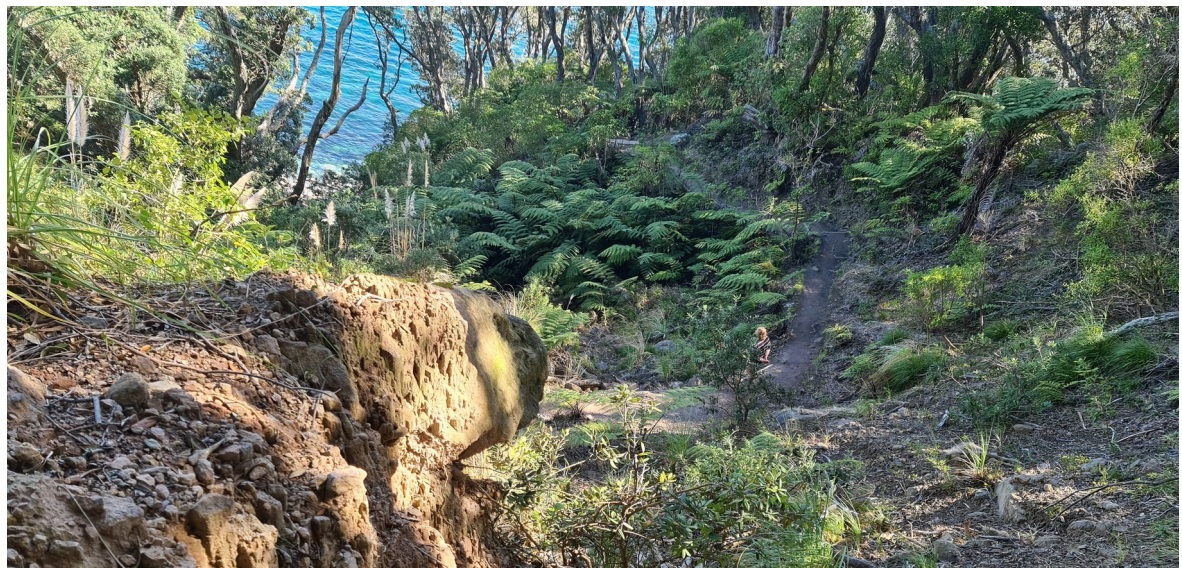
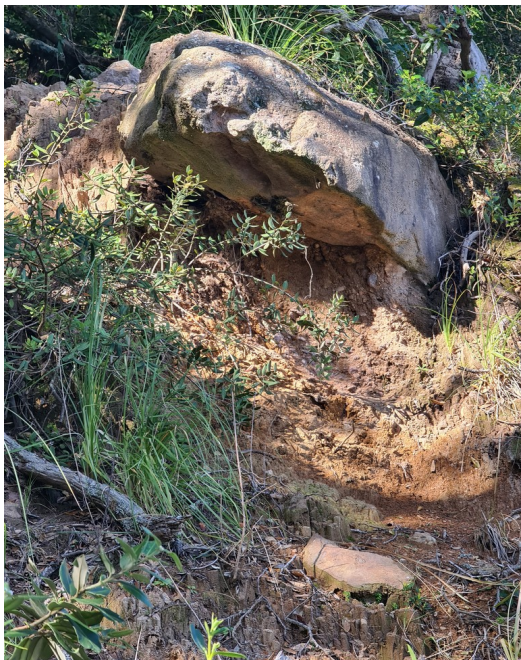
See photographs on following page. This boulder has now eroded out to such a degree that it may be marginally stable.

The location is at the crest of an exposed slip face around 10m above the mid Goat track. The boulder does pose a hazard to persons using the track below.

Photo 9, 10, 11; Overhanging boulder above Goat track.

This boulder appears likely be able to be scaled relatively easily. Although it is unlikely to pick up enough speed to reach the Base track, there is a small possibility that it may therefore a temporary Base track closure would be required.

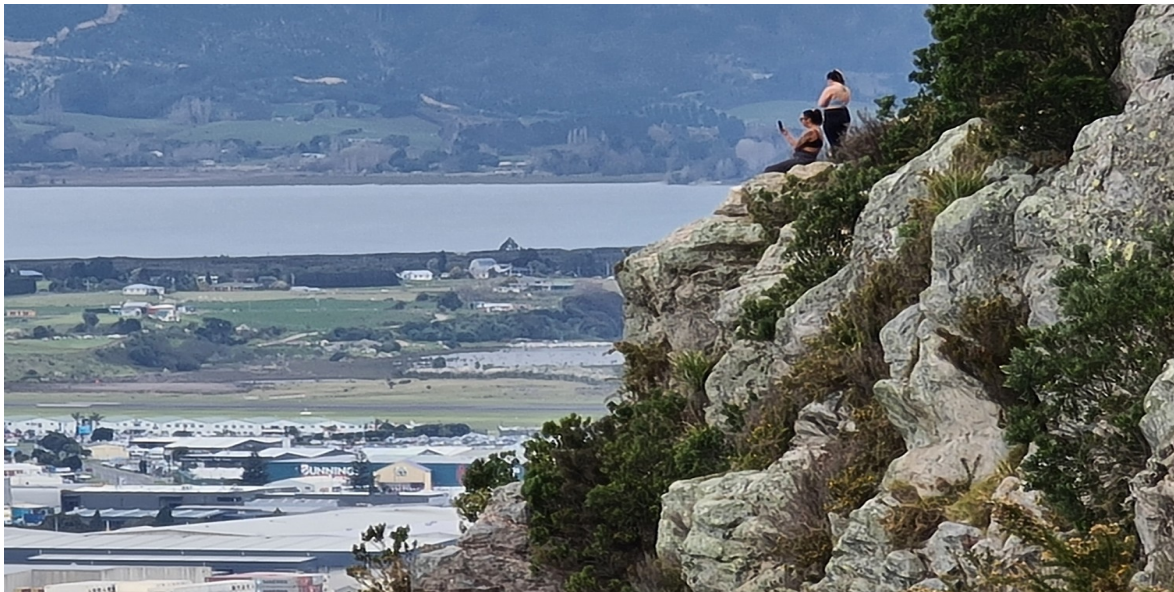
Photo 12; Off track persons on bluff crest above Waikorere track.

We have no reason to believe such persons triggered the 2 August rockfall, although it is possible.

Of course these persons are at risk of falling, however, we are not aware of any accidental falls and the vast majority of visitors do not leave the designated tracks as these persons have actively chosen to.

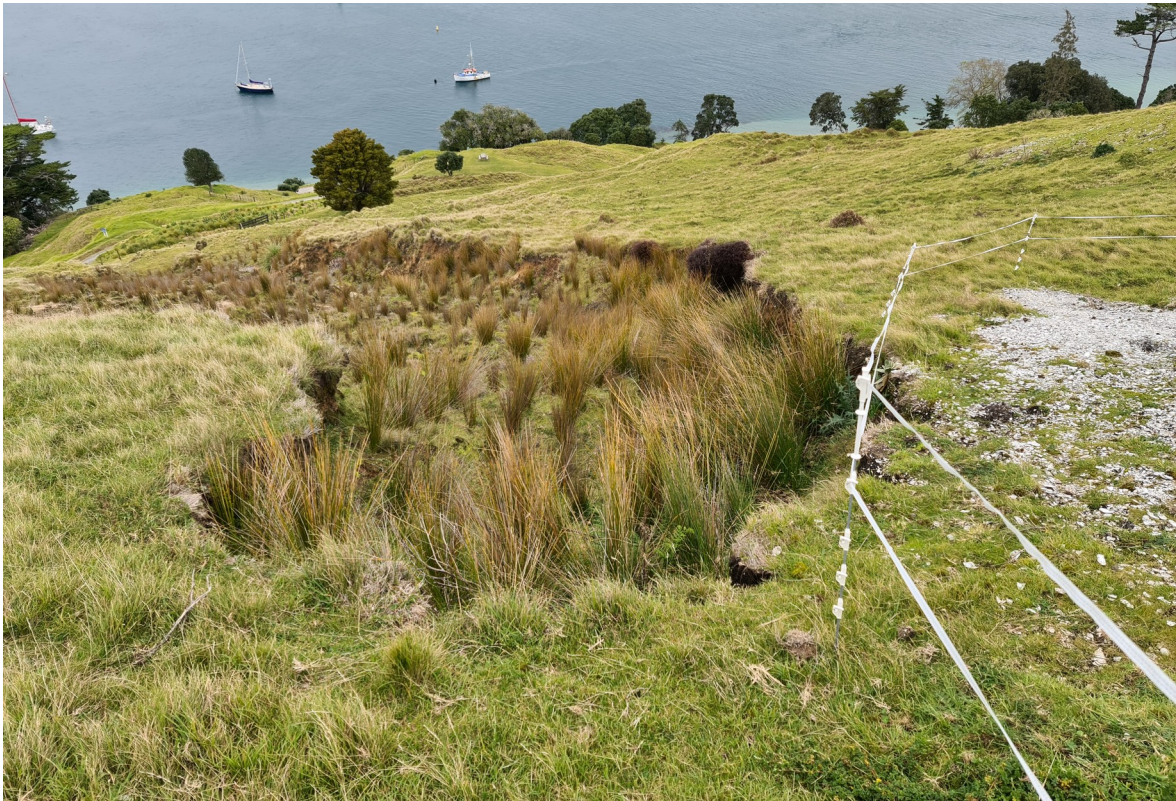
This slip scar does not present any hazard to persons but has been actively eroding and enlarging for 16 years. The location is 37° 38' 1.8494" S, 176° 10' 17.0897" E

This slip was triggered by a large storm event in May 2005. 350mm of rain fell in 24 hours. It was initially two smaller slips, designated #7 and #8 out of a total of 52 slips generated by that rainfall event. *Extract from Avalon Report 0534B*

These separate slips eventually joined together and continued to expand, resulting in the picture today. Planting efforts have helped slow the erosion rate.

Photo 13; Slip from above. Note midden on right.

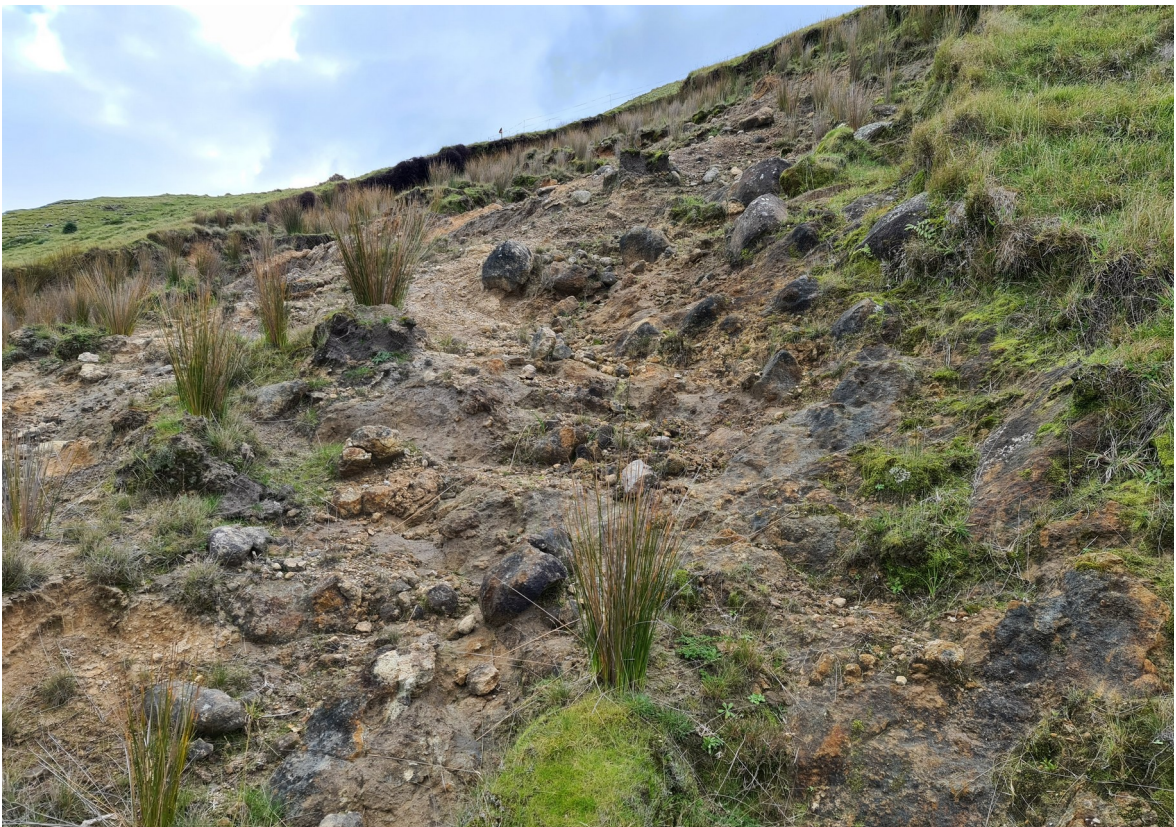
Photo 14; Slip from below. Very rocky, difficult for vegetation to establish.
