Tauranga District Council
Private bag 12022
Tauranga

26 July 2007

Mauao Slopes; Monitoring Report; July 2007

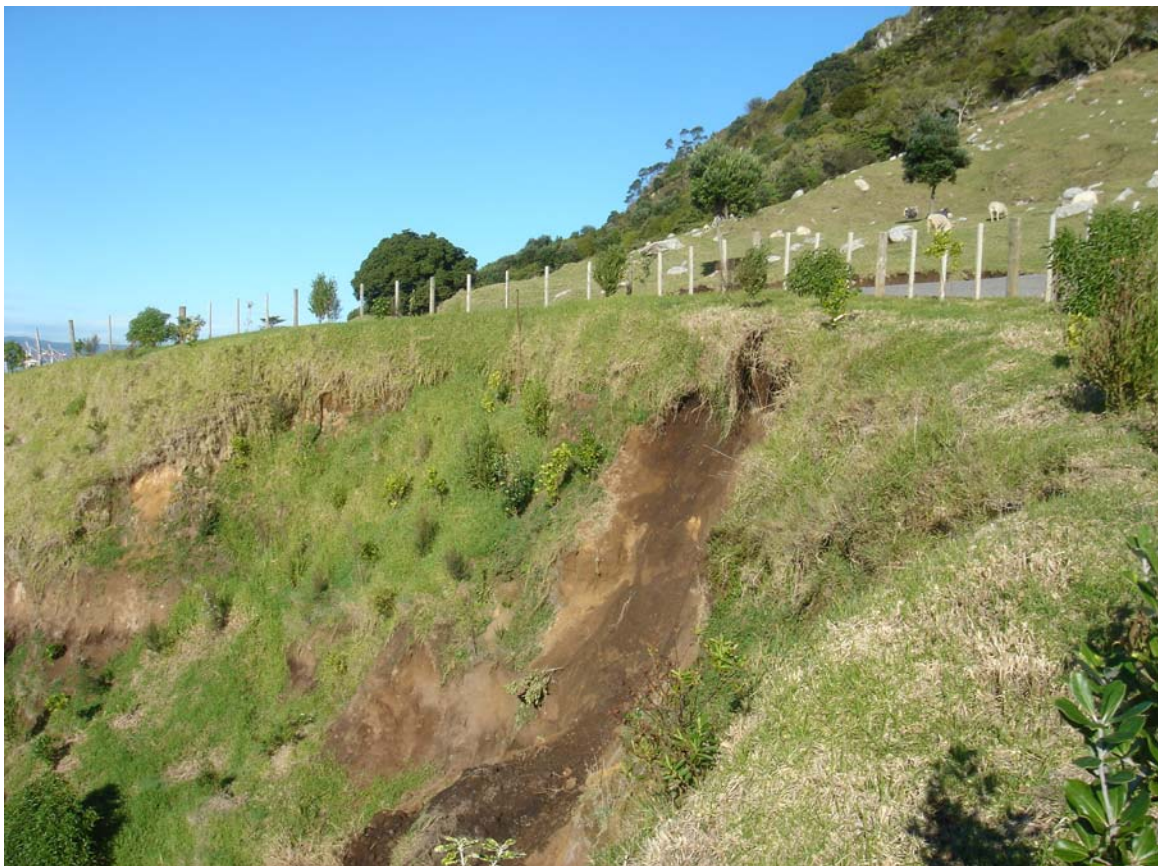
Photograph 1; Minor shallow slipping continues (slip 34)

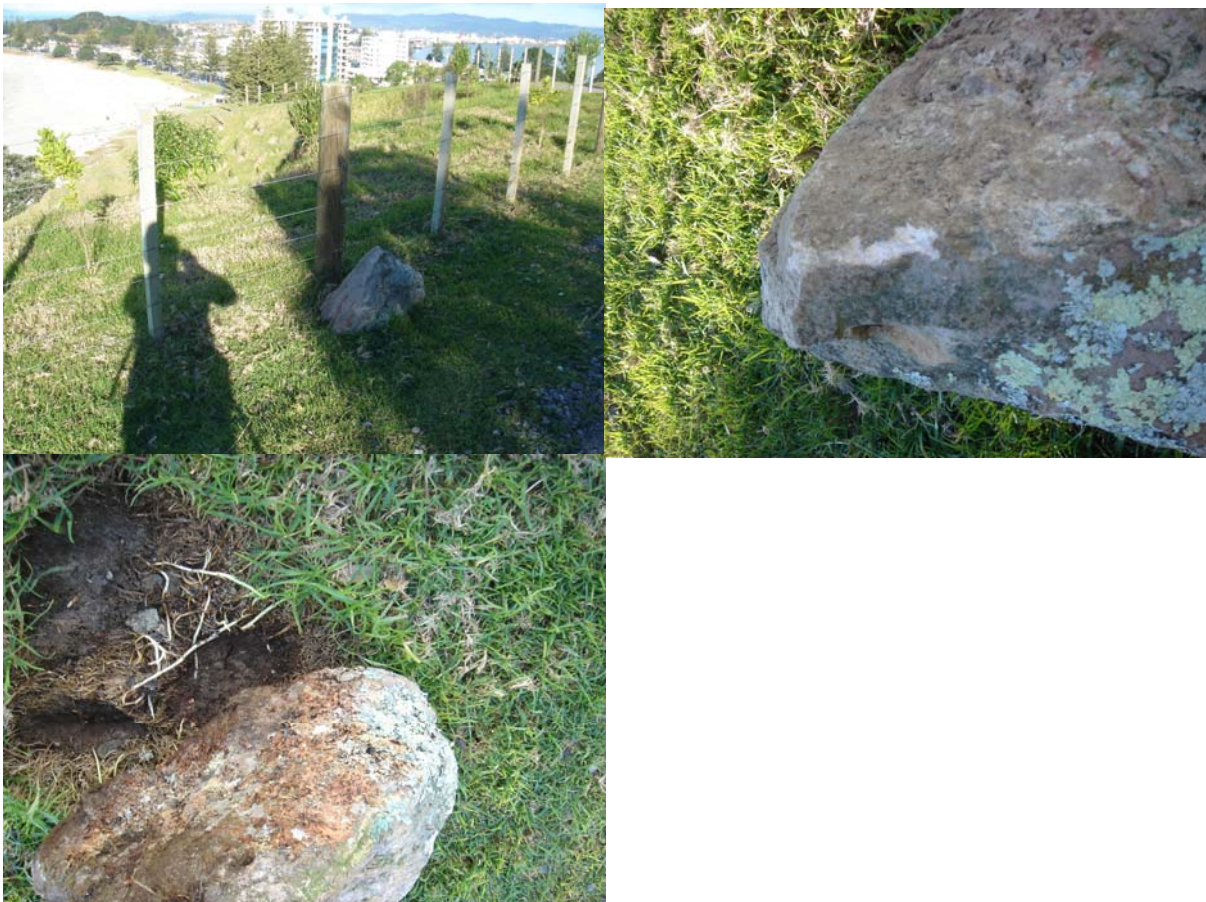
Photograph 2 (a,b,c); Surface boulder above slip 34 shows signs of impact and has decaying grass underneath.

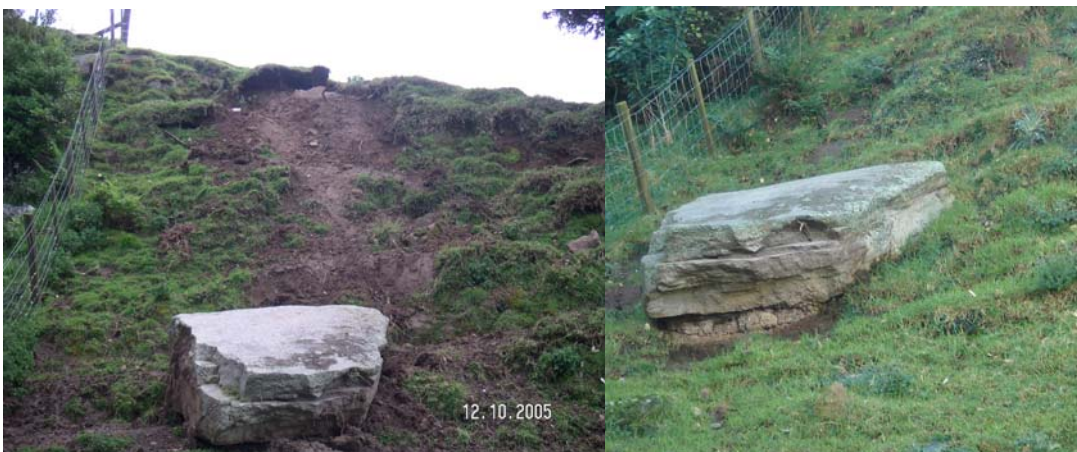
Photograph 3 (a & b); 18 months after moving 10m this boulder is well embedded again.

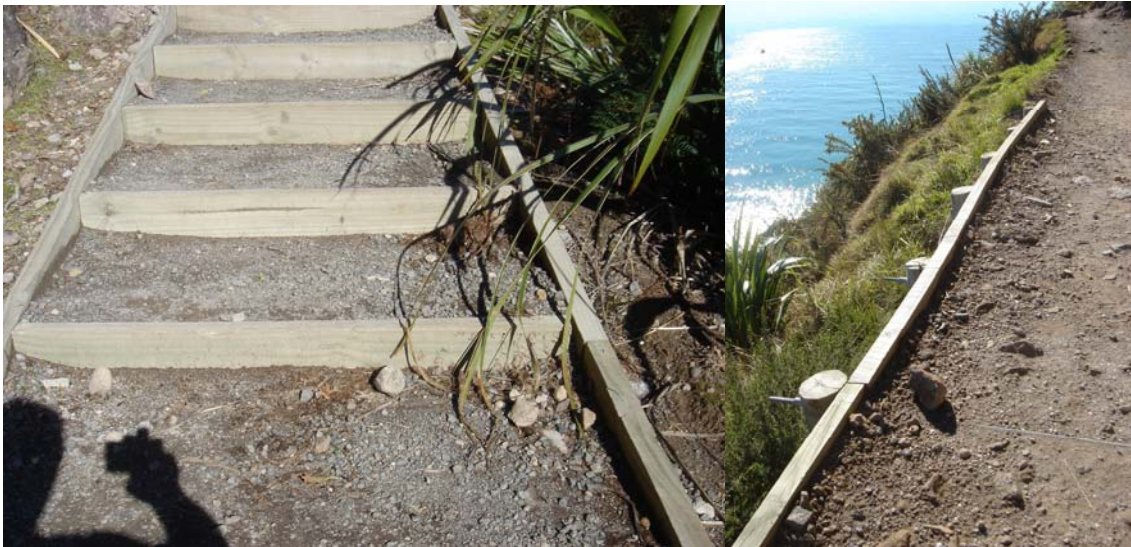
Photograph 4 (a & b); Small rocks on the Oruahine track appear likely to have fallen from above.

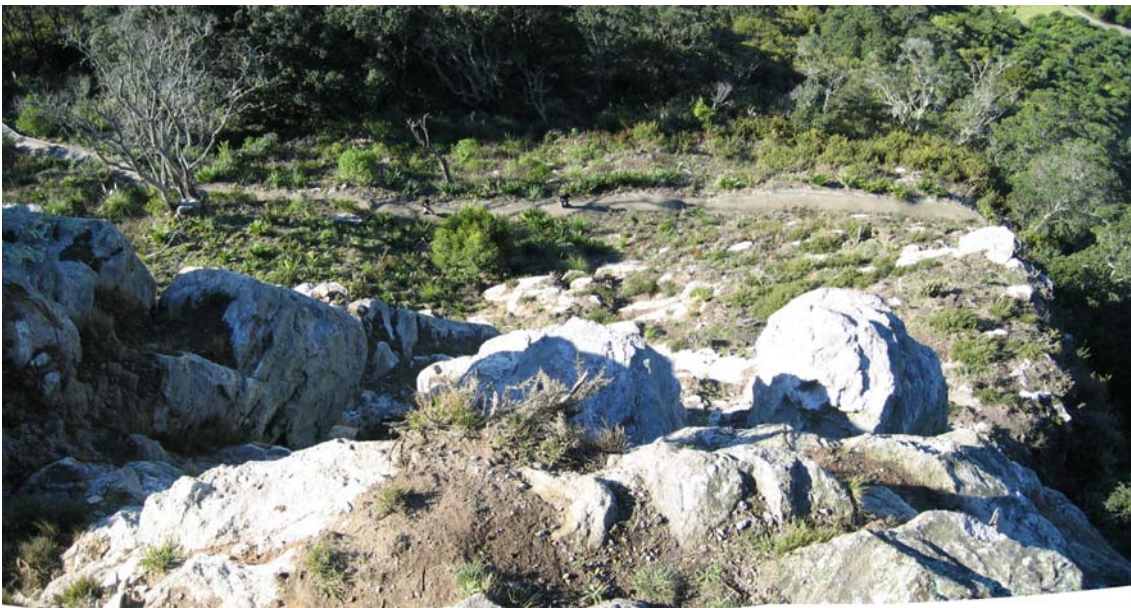
Photograph 5 (a & b); Ongoing scour on the camp bluff.

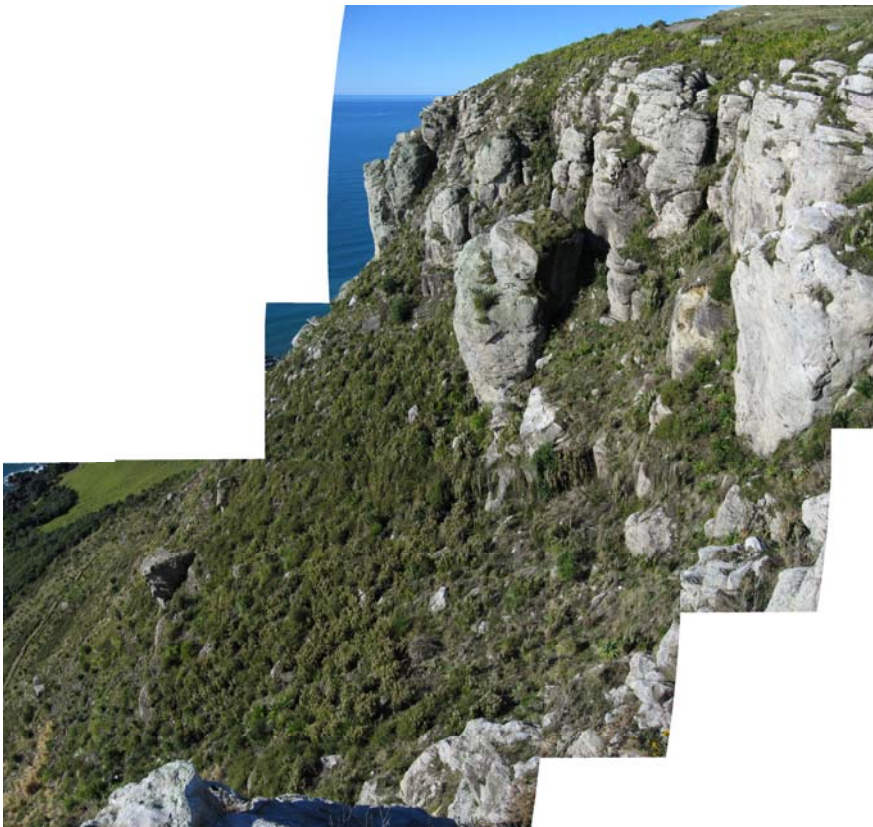
In the period since the herbicide spraying programme has been 'on hold', vegetation continues to re-establish. Although the fastest growth has been in some weed species, they are beneficial from a geotechnical point of view in reducing scour and increasing stability.

Photograph 6; Vegetation re-establishing on the North Western slopes.

- *TDC's planting and weed control programme should give priority to establishing grass to help stabilise the loose colluvium.*
- *Public off track access to the steep upper slopes should be prohibited.*
- *Effective track closures must be in place before any TDC staff or contractors access the steep upper slopes off track. Any persons entering these areas must be suitably experienced, competent, trained, equipped, insured etc.*
- *Monitoring and inspection should continue six monthly.*
- *Annual rock scaling is recommended.*
