Tauranga District Council
 Private bag 12022
 Tauranga

Mauao Slope Monitoring July 2007; pipe trench adjacent to 4WD track dropout

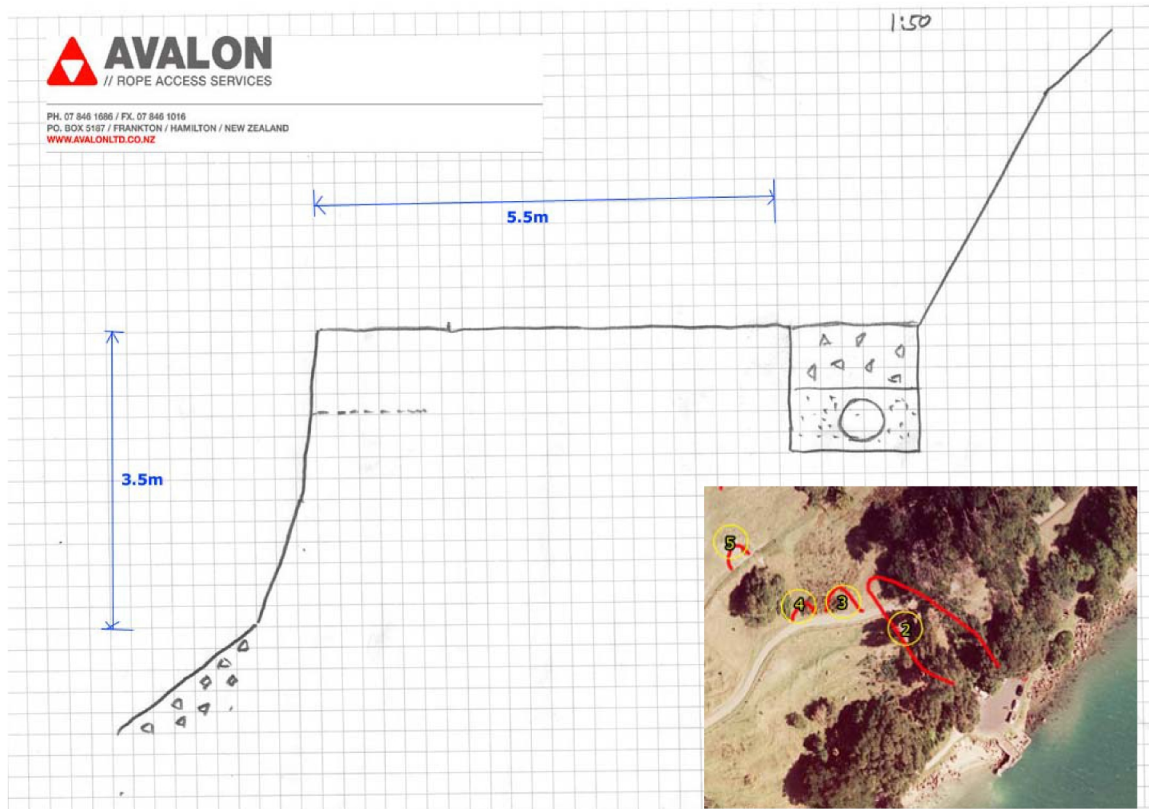
Further to our discussion on site please find below a sketch section of a 'dropout' of particular concern below the 4WD track, between the base and the water tower. The slip is approximately at location 2 in the inset photograph.

This slip in question occurred during the May 2005 floods and was triggered by intense rainfall and high flows in a spring directly downslope.

It is fortunate that the near vertical face did not fail further in the preceding two years as the slope is overly steep for these materials; the upper metre or so appears to be fill and below this lies a chaotic colluvial mix, predominantly clayey but with sandy layers and buried topsoil.

I understand that the slip is scheduled for some form of remedial stabilisation. To minimise the risks it would probably have been preferable to stabilise the slope prior to trenching, however, I would now recommend that the work now be commenced asap.

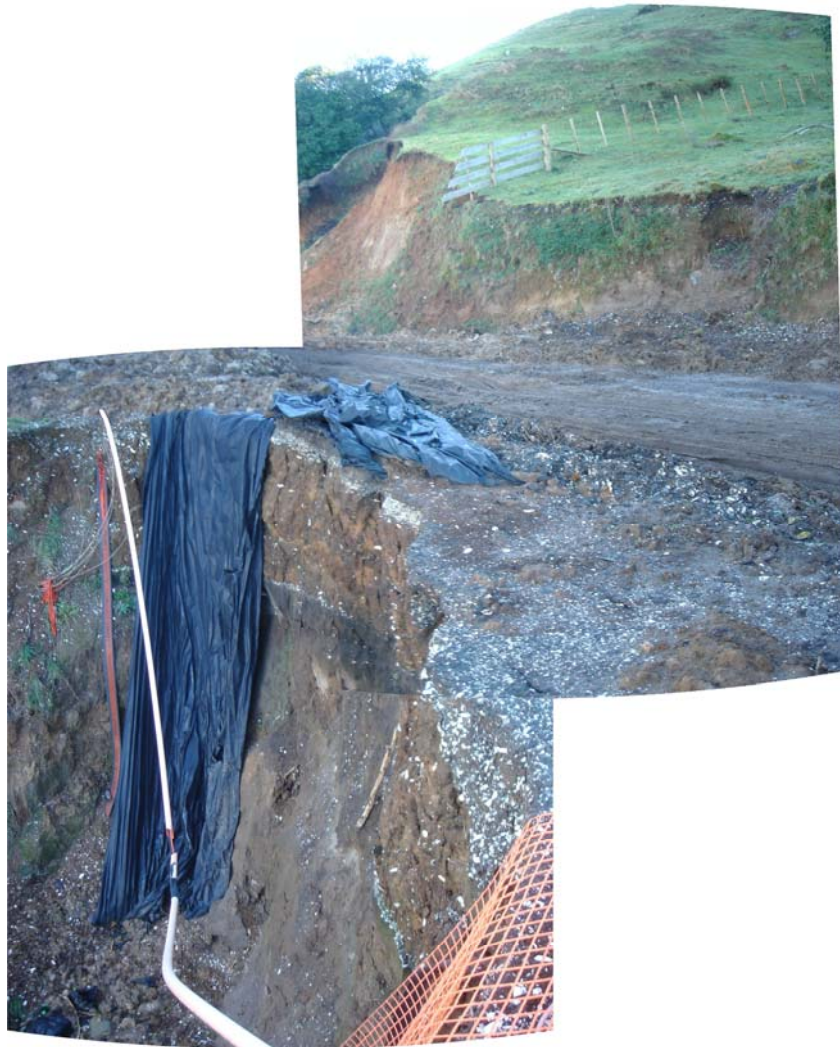
The adjacent natural slopes are not stable at such steep angles as this slip face.

Tension cracks can be seen up to 500mm back from the crest.

My first concern on seeing the new trench was that construction might have the potential to alter the local groundwater and that this might not be ideal, considering the adjacent marginally stable slope.

The lower 700mm or so depth of trench is being back filled with pumice sand, which should provide excellent drainage down the trench, however, the colluvium contains interlayered clay and sand therefore the excavation still has the possibility of creating new flow paths.

The excavated colluvium is being reused for capping above the pumice sand. Much of this material is clay and this presents two issues: 1. it is impossible to compact sufficiently (in the prevailing wet conditions) and 2. it might allow pressure to build up within the trench.

The contractor on site (s 7(2)(a) - Privacy) informed me that he has been having trouble getting compaction on the wet clay. To assist with this he installed one transverse drain to the trench (and this can be seen flowing just south of the slip). He was intending to install additional drainage but this was apparently stopped for financial reasons.

I think the cost benefit of additional drainage and importing a more freely draining material for the capping would be likely to be justifiable considering the likely costs of further slips, which could potentially leave the track unusable by vehicles.
