# Memorandum

**To:** Area Officer: Mount Maunganui/Papamoa  
**From:** Project Manager  
**Subject:** SLIP ON MAUAO  
**Date:** 26 October 2000

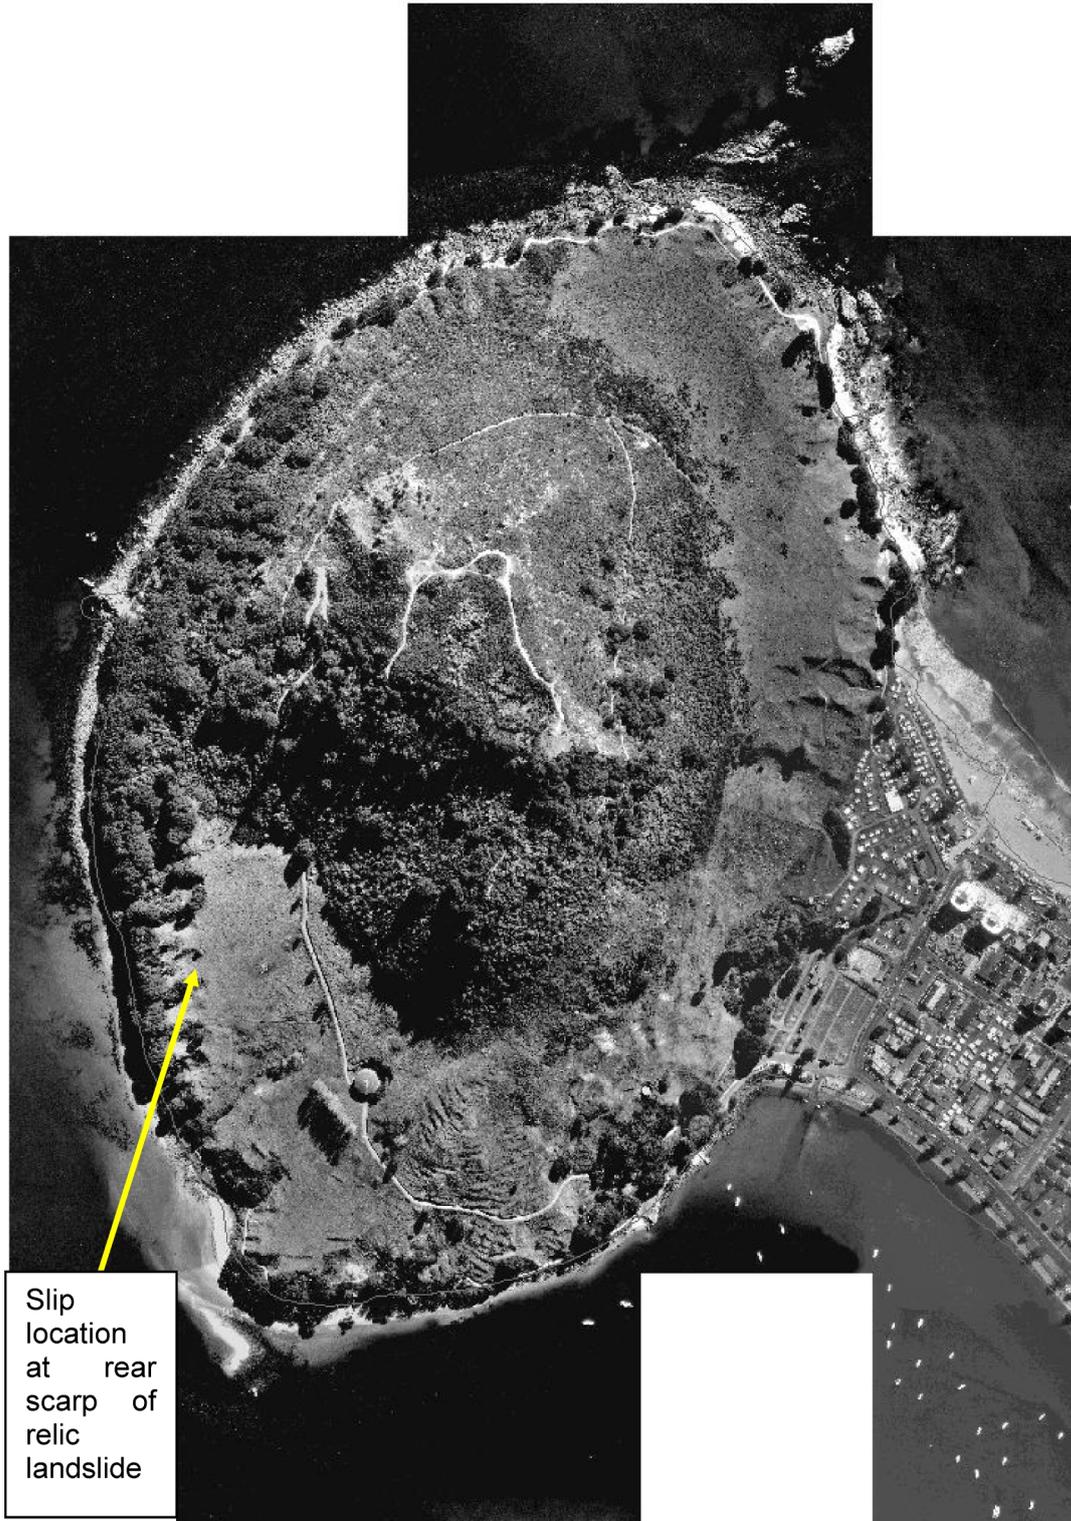
Plate 1 - Slip Location Plan

The slip is a failure of the part of a large headscarp of a historic or relic landslide, refer Plate 1 attached. The scallop shaped landforms around the margins of Mauao shown on Plate 1 are indicative of past instability. The relic landslide backscarp is near vertical and about 5-6m in height at this location. The slip is about 15m<sup>2</sup> (≈5m wide by ≈3m deep) in plan area and probably involved about 30m<sup>3</sup> to 50m<sup>3</sup> of soil. The recent failure seems likely to have been triggered by heavy water flow through a large natural pipe within the colluvium, refer Plate 2. There is also a collapsed sinkhole about 1m in diameter and 1 meter deep which is about 2m back from the new slip and inspection of this hole revealed a natural pipe at the base of about 300mm in diameter leading back up slope and on the other side of the hole towards the headscarp of the new slip. This phenomenon is consistent to the natural pipe that probably triggered the slip above the camp site in 1998 and the suggestion of sinkholes referred to be Laurie Richards in his Mauao hazard report.

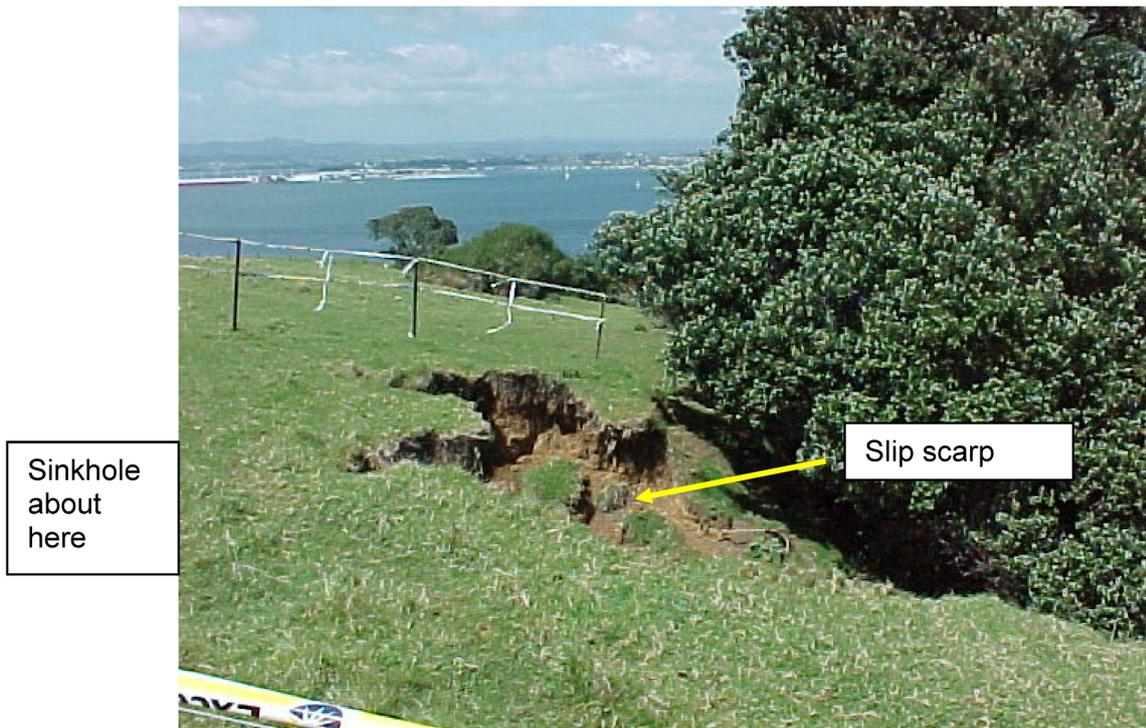
Plate 2 - View West showing slip scarp in foreground

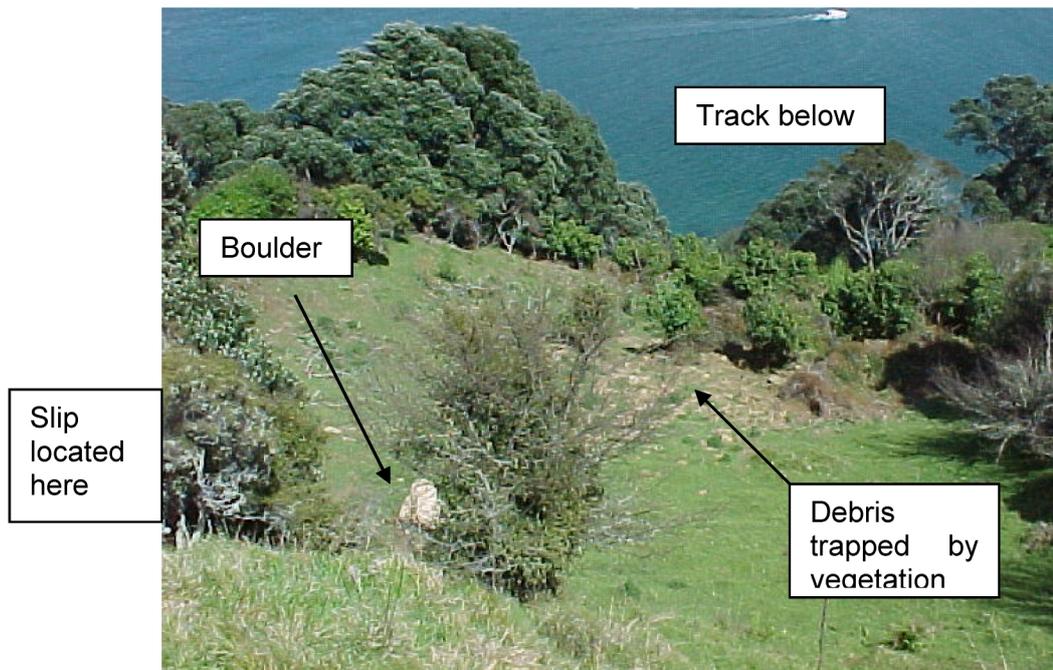
Plate 3 - Recent Slip occurred along part of a rear scarp of relic landslide

- I recommend the slip scarp be hand trimmed to remove the steep sections of the headscarp and any overhanging portions.
- I also recommend the scarp is grassed to reduce the erosion of the bare soil.
- The ongoing effect of the natural pipe is difficult to gauge - it could provide the source for ongoing erosion and scouring. I therefore recommend you inspect this area after heavy rainfall events to establish if some erosion protection works are required. This is more a management issue.
- I recommend that the density of vegetation at the base of the historic scarp be increased so as to act as a barrier to further debris flows. This philosophy could be implemented gradually around the margins of Mauao in similar locations.
- I concur with your view that these areas should be retired from grazing.

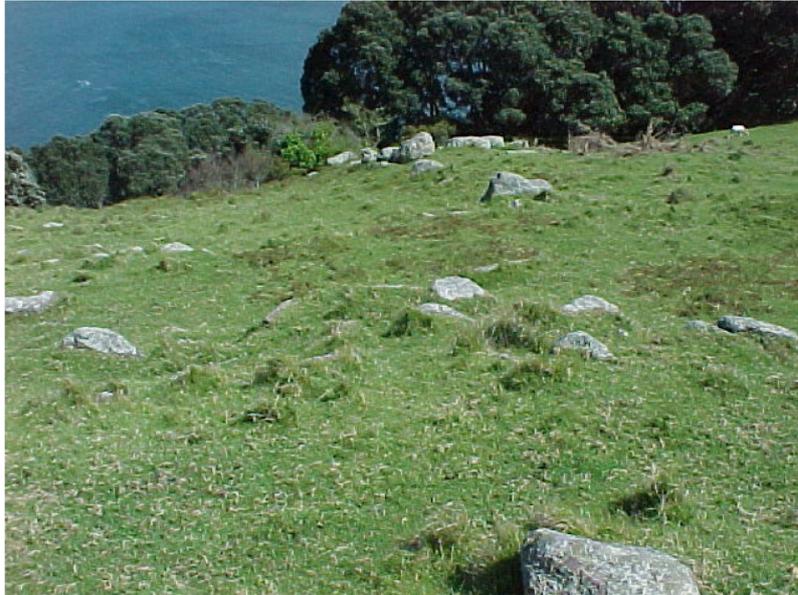
**Plate 4 - Hummocky ground above slip indicating creep and possibly sinkholes**

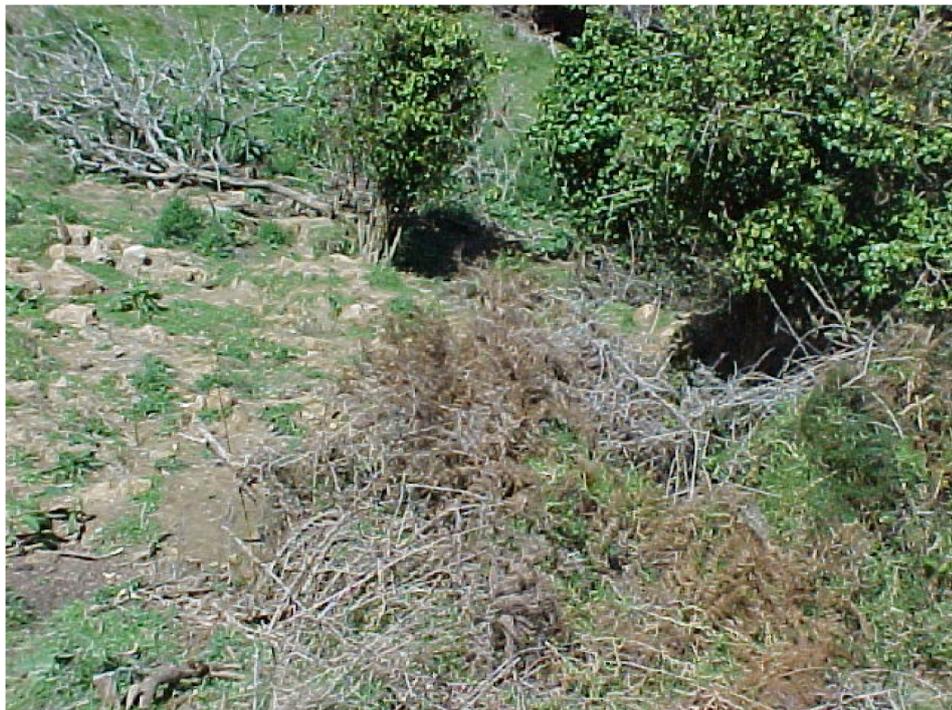
Although the slip was only discovered recently by a shepherd, I suspect the slip occurred during the 9 April 2000 rainfall event. I noted during my report following an inspection soon after the 9<sup>th</sup> that along with the 20 or so other slips that had affected the track elsewhere that an extensive flow of debris material had flowed over an escarpment above the base track at about this location. This debris flowed through the base track itself and onto the shoreline below. I did not attempt to establish the cause of the debris flow at that time due to the other slip problems that required immediate attention. I believe the reason the debris moved so far is that it debris failed into a natural overland stormwater flowpath which was concentrated due to the size and natural concave shape of the historic landslide scarp. In these circumstances the soil and mud mix to form a very fluid slurry. From my experience overseas it is common for fluid debris to travel long distances at high velocities in these or similar circumstances. It interesting to note that the vegetation existing at the toe of the large landslide scarp did stop or trap some of the debris.

**Plate 5 - Slip debris partially trapped by vegetation near toe of relic slip**
